## 1. SUMMARY associated with D1001346

## 2. PHOTOS of D1001346

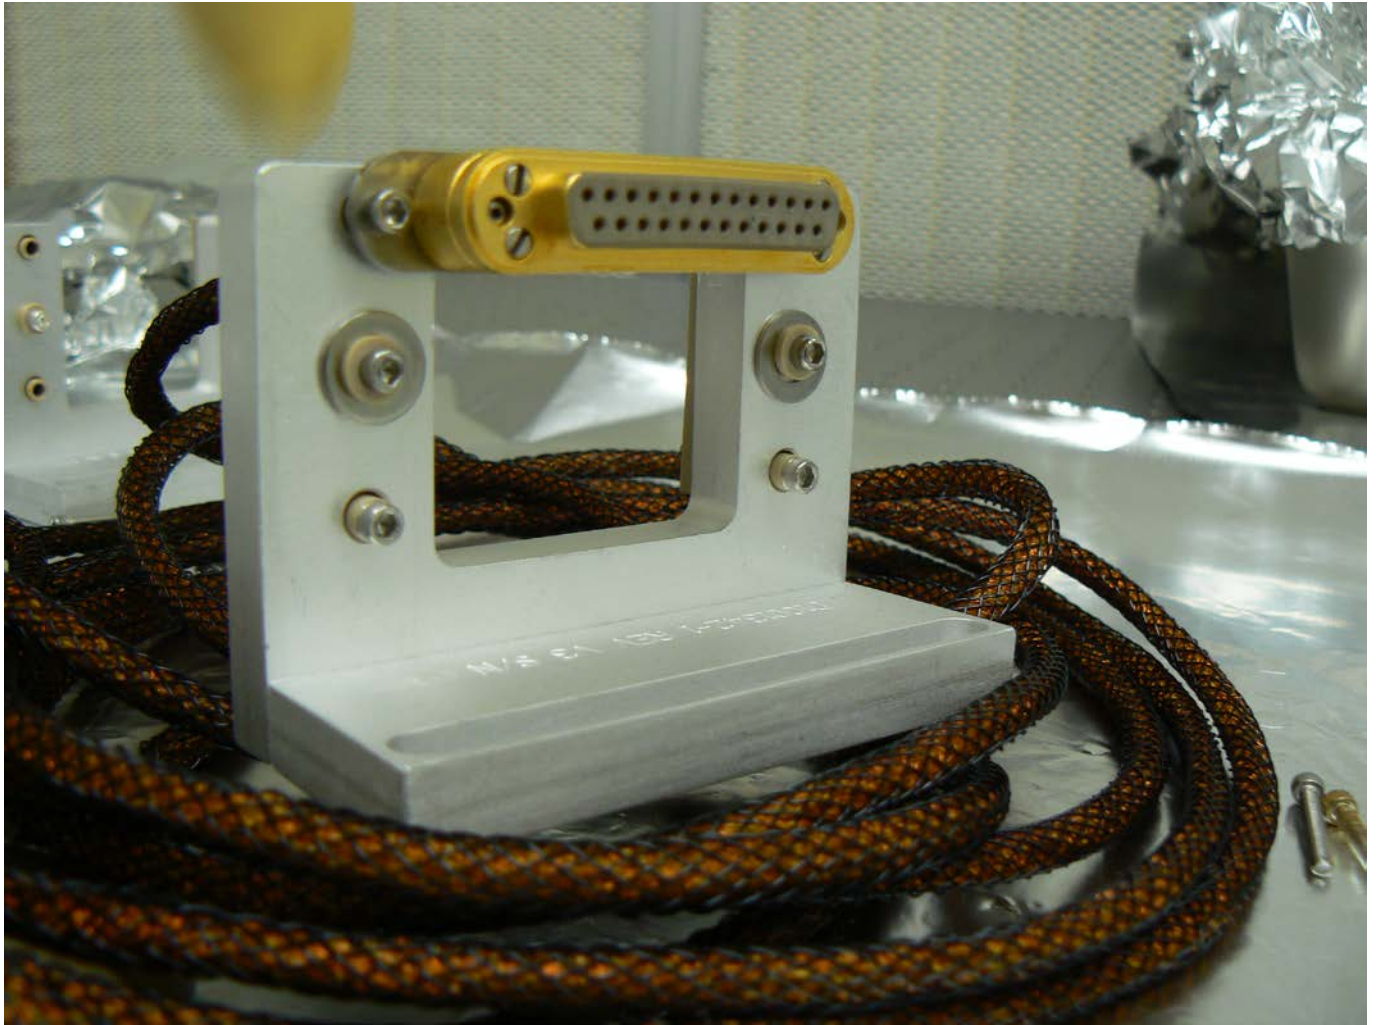
1) The screeching is definitely the clean head of the stainless SHCS against the clean PEEK. No problems, tighten through the screeching.

PLEASE NOTE PHOTO SHOWS WASHER RETROFIT WITH WRONGLY SIZED WASHER, SHOULD BE No 10 WASHER AS PER SECTION 1 OF THIS DOCUMENT

2) While item #1 removes most of the wiggling reported it does not remove all of it. So we recommend a small retrofit, which adds a washer to the assembly, see attached picture. The washer is added during assembly of the L-bracket, so does not become an issue (loose part) when you add the cables. It should be considered as required, the existing assemblies should not be adjusted. A number 10 washer (McMaster Carr, 92141A011) I have ordered several hundred of these, specifically: -

18-8 SS General Purpose Flat Washer NO. 10 Screw Size, 7/16" OD, .02"-.04" from McMaster Carr order number 92141A011.

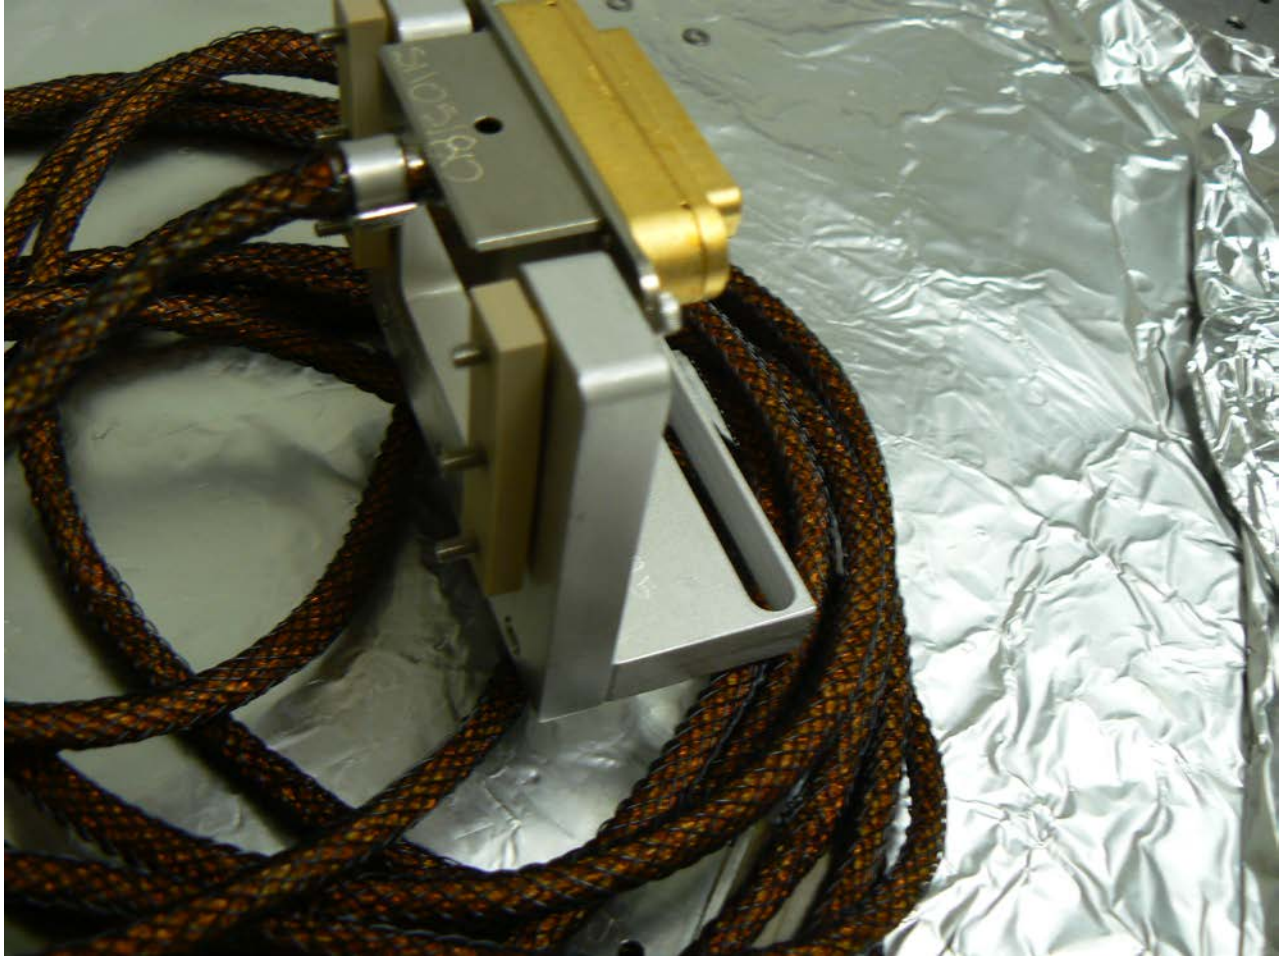
PLEASE NOTE PHOTO SHOWS WASHER RETROFIT WITH WRONGLY SIZED WASHER, SHOULD BE No 10 WASHER AS PER SECTION 1 OF THIS DOCUMENT

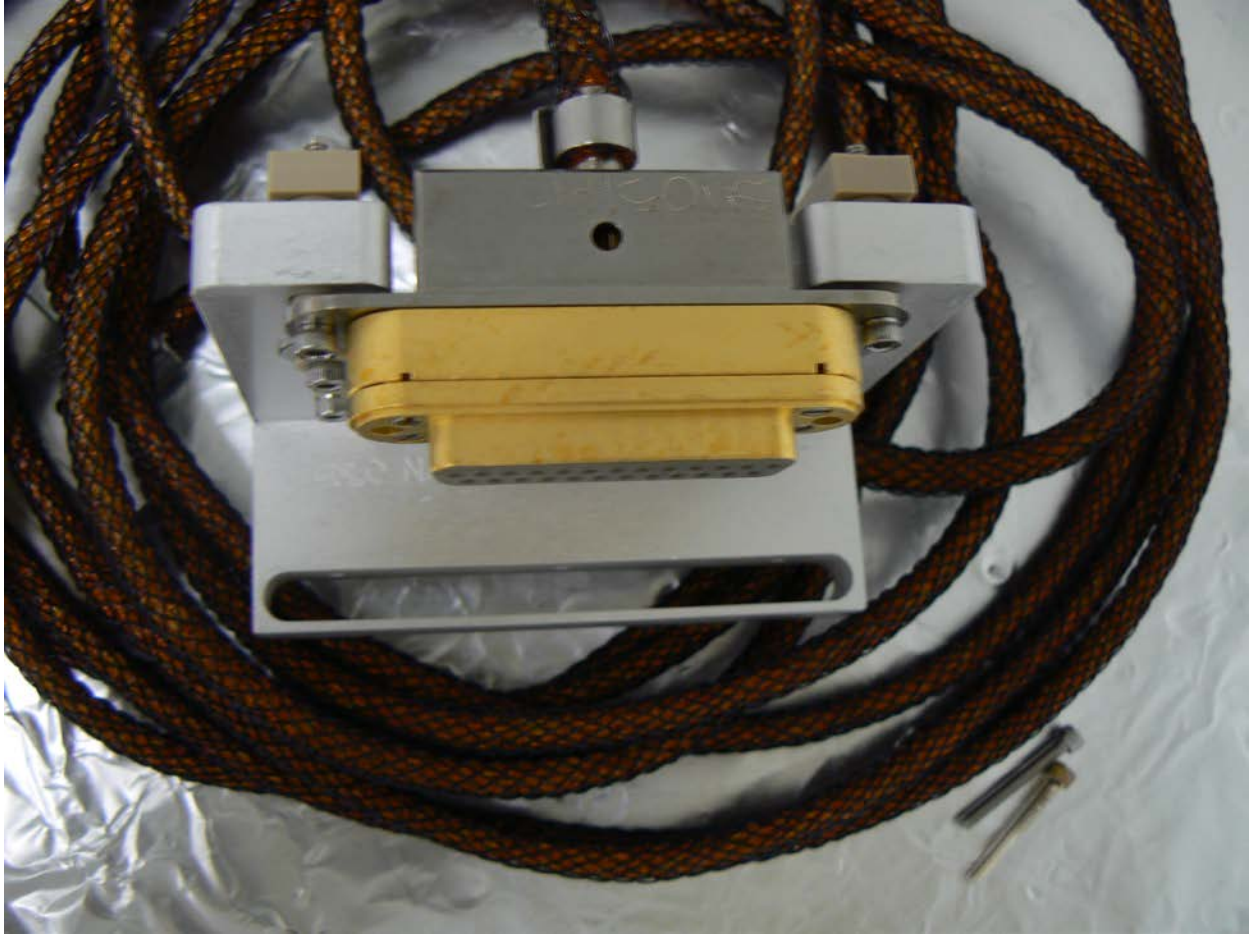
PLEASE NOTE PHOTO SHOWS WASHER RETROFIT WITH WRONGLY SIZED WASHER, SHOULD BE No 10 WASHER AS PER SECTION 1 OF THIS DOCUMENT

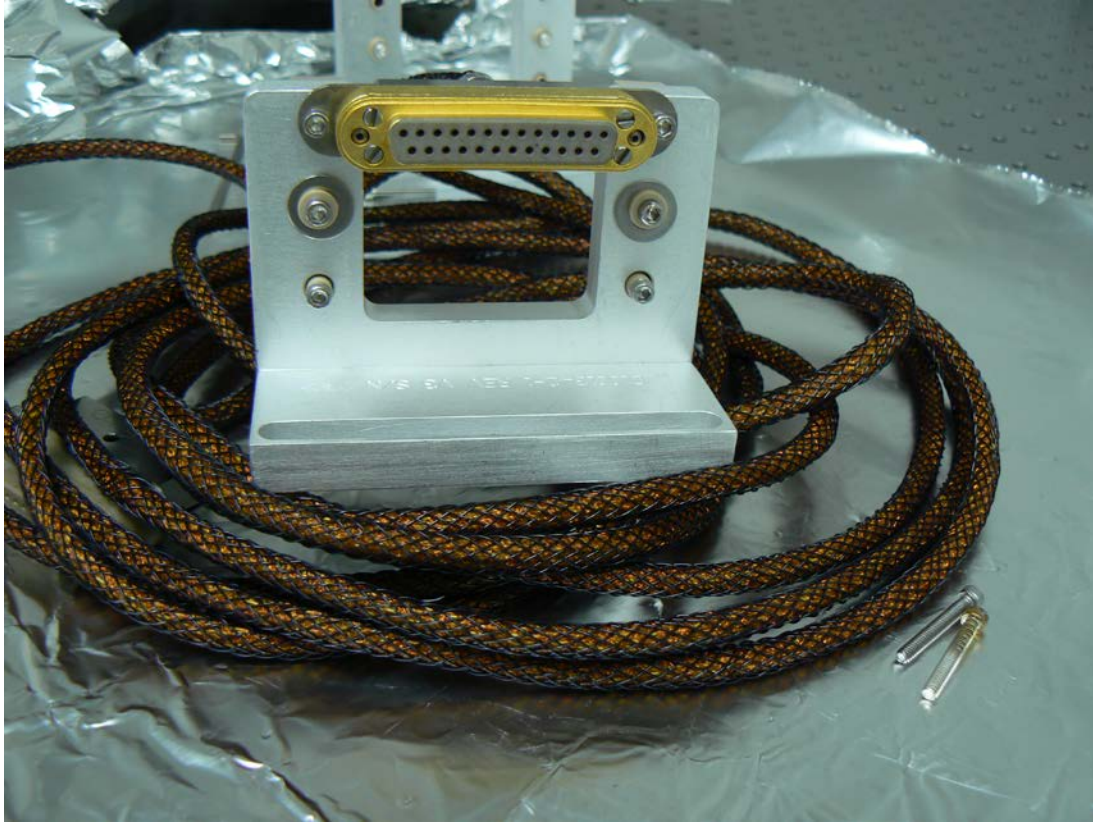
PLEASE NOTE PHOTO SHOWS WASHER RETROFIT WITH WRONGLY SIZED WASHER, SHOULD BE No 10 WASHER AS PER SECTION 1 OF THIS DOCUMENT

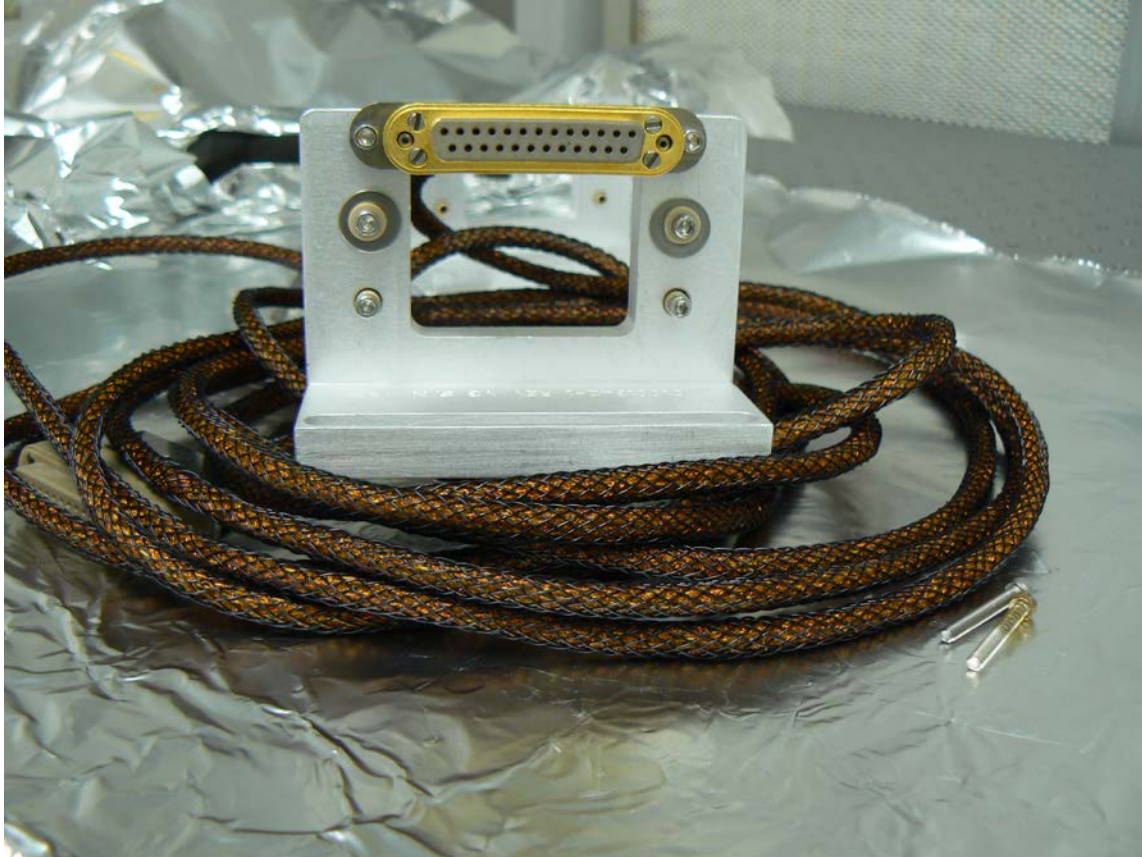
PLEASE NOTE PHOTO SHOWS WASHER RETROFIT WITH WRONGLY SIZED WASHER, SHOULD BE No 10 WASHER AS PER SECTION 1 OF THIS DOCUMENT

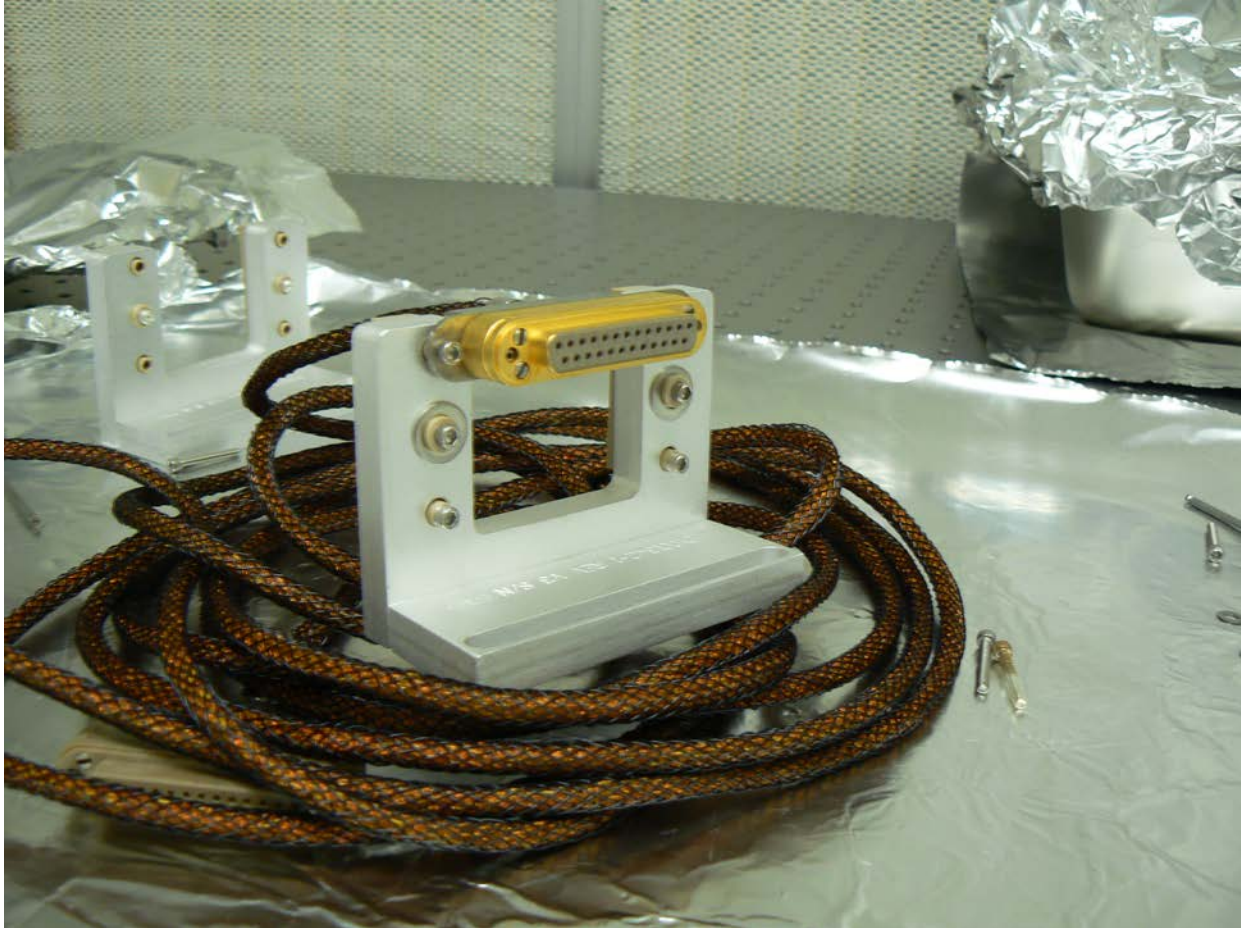
PLEASE NOTE PHOTO SHOWS WASHER RETROFIT WITH WRONGLY SIZED WASHER, SHOULD BE No 10 WASHER AS PER SECTION 1 OF THIS DOCUMENT
