LIGO- T030223-00-D

ADVANCED LIGO

17th September 2003

Review of basic shorting tests on Coil Formers **D020188-04** and **D020188-08**

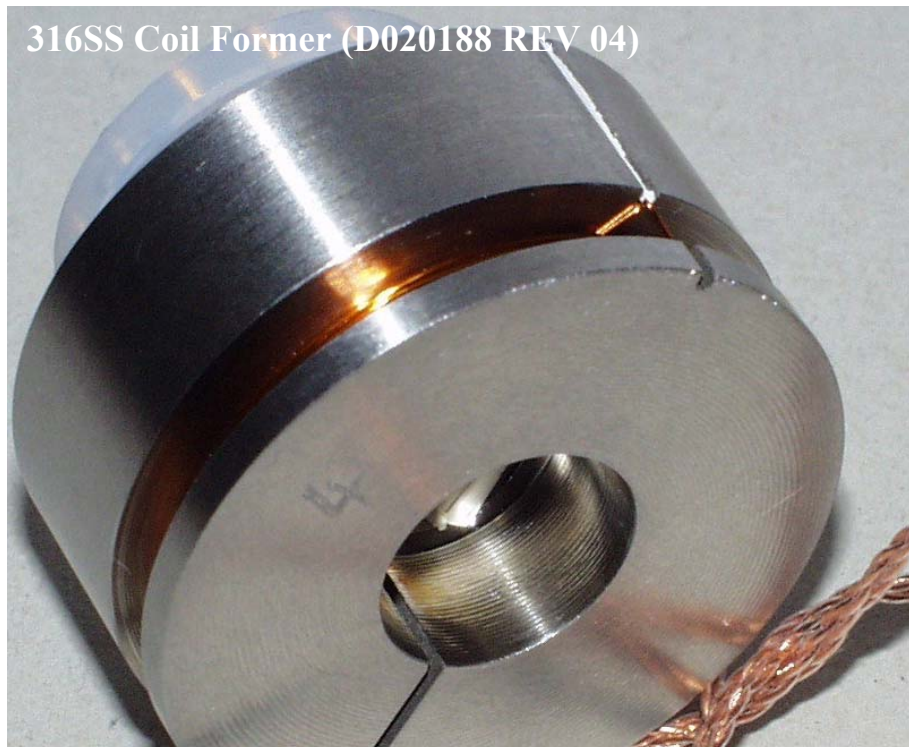
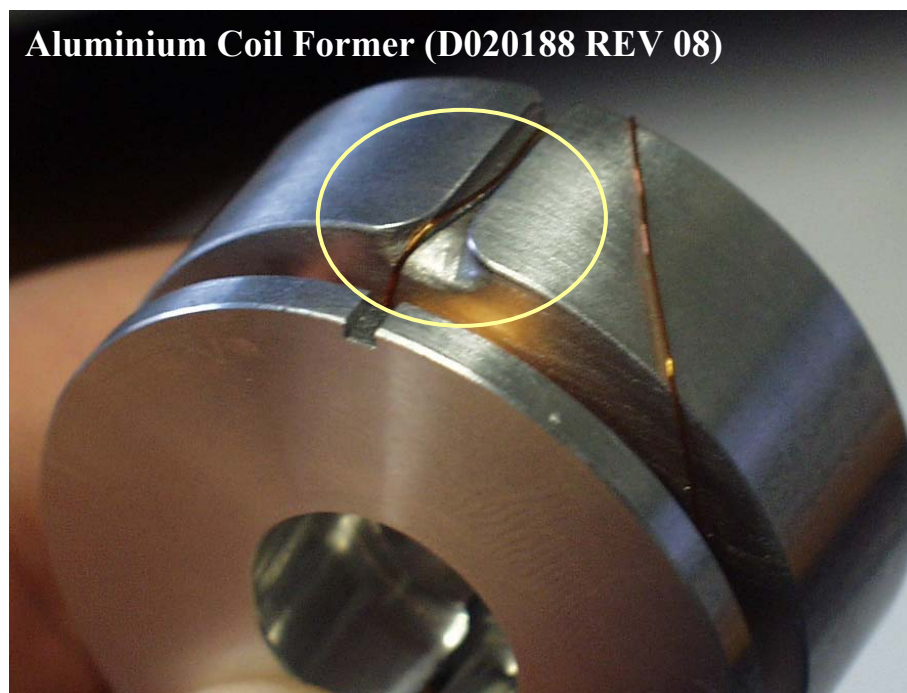
- **D020188-04**...an older design 316 Stainless Steel design with sharper edges
- **D020188-08**...the latest Aluminium former exhibiting larger fillets and also the introduction of the 'trumpet flute' impression (circled below) at a location where it had been evident that problems were occurring

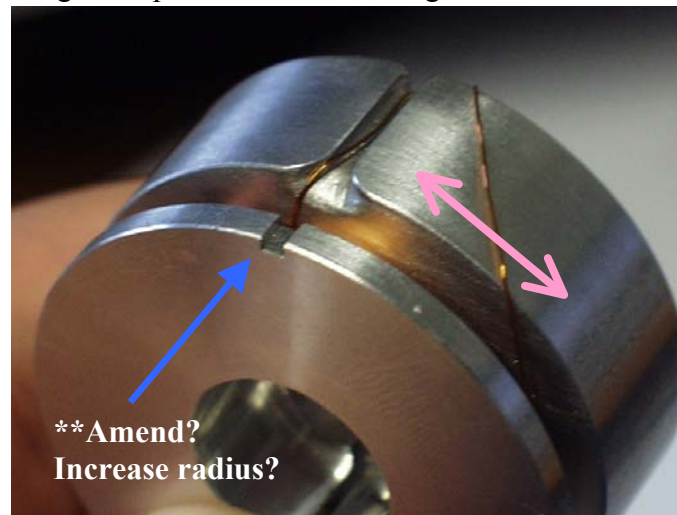
- 1) Test: Rubbing of Kapton wire over the edge of the main channel

This scenario is unlikely to cause a short during the winding given the winding set-up here at the Institute for Gravitational Research (Glasgow), as the wire is generally parallel to the walls of the channel during winding. However, if the winding responsibilities are transferred to the team at the California Institute for Technology (as is currently under discussion) it would be sensible to assess any new winding facility with respect to our Coil Former design so that any unforeseen problems can be highlighted.

I was eventually able to create a short, but this took a while. The fillets at the point of interest would appear to be adequate.

If anyone has any concerns about this scenario then we can of course increase the radius of the fillets on edges adjacent to the channel. This may be a sensible particularly on all edges that result from the slot (created to reduce eddy current effects).

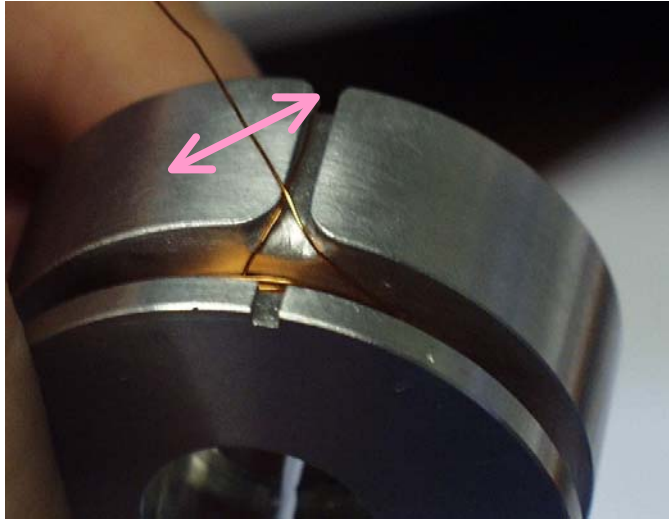
- 2) Test: Rubbing of wire inside the “trumpet flute”

Again, this a few minutes ‘rough’ treatment to breach the Kapton coating, but the repetitive wear eventually takes effect. The introduction of this feature has made a huge difference though.

Given the importance of this feature, we should consider specifying a better surface finish in this area – and indeed on other regions of the former where repetitive wear is a possibility, whether it be during winding or otherwise.

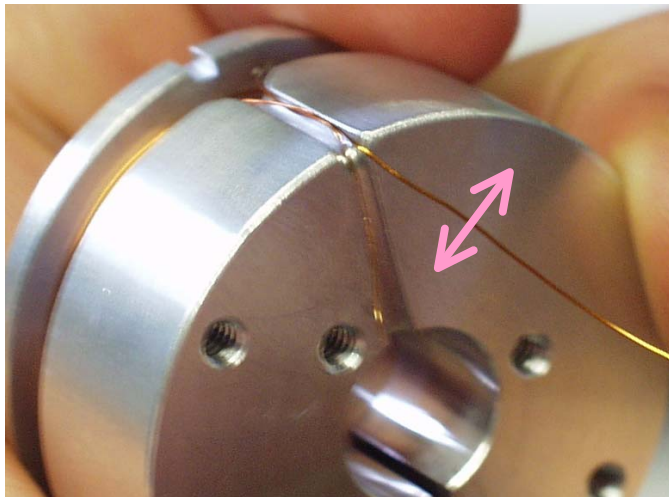
- 3) Test: Wire coming over top and down the back path

Repetitive wear again eventually caused a short.

Review engineering drawing – again in relation to fillet radius and surface finish.

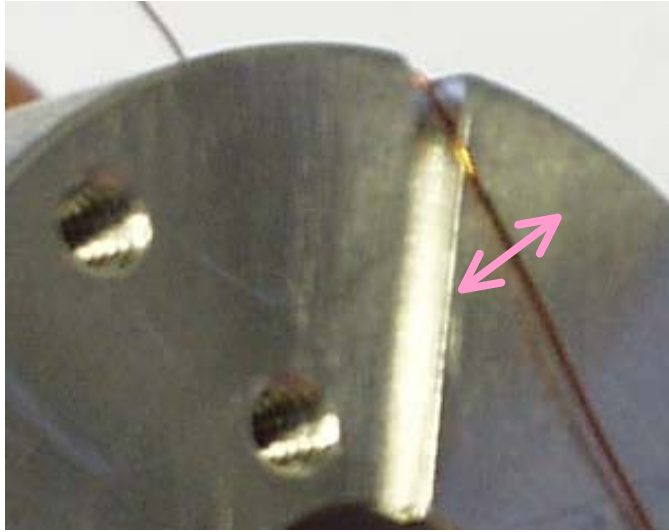
- 4) Test: the edges of the back path

Both of the following tests had the same end result as tests 1 - 3, but shorting took less effort.

Increase fillet radius and make sure that this information is clearly communicated on the manufacturing drawing.

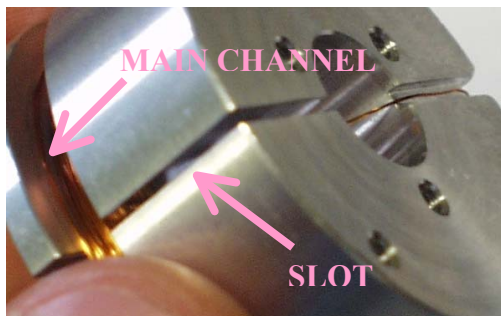
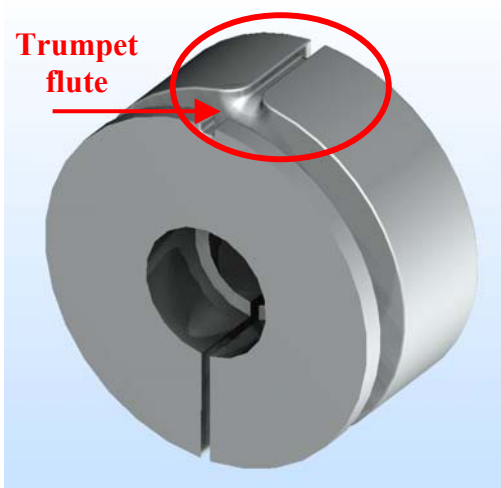
This is particularly relevant in locations where the wire comes into contact with the slot.

It is difficult to create fillets on edges created by the slot inside the main wire channel.

- We are also looking into the feasibility of using Kapton film in certain locations to provide further protection against the occurrence of shorting.

One option may be to wind some Kapton film inside the main channel prior to the winding of the copper wire as this may provide the required protection from any hard edges.

We are also considering using Kapton Film for a similar purpose, an extra layer of protection as the wire passes out the main channel, over the “trumpet flute” and down through the back pathway.
