LIGO-T060022-00-K

*Advanced LIGO*

Early tests on a bonded ear / welded fibre assembly

**C. A. Cantley, A. Heptonstall & R. Jones**

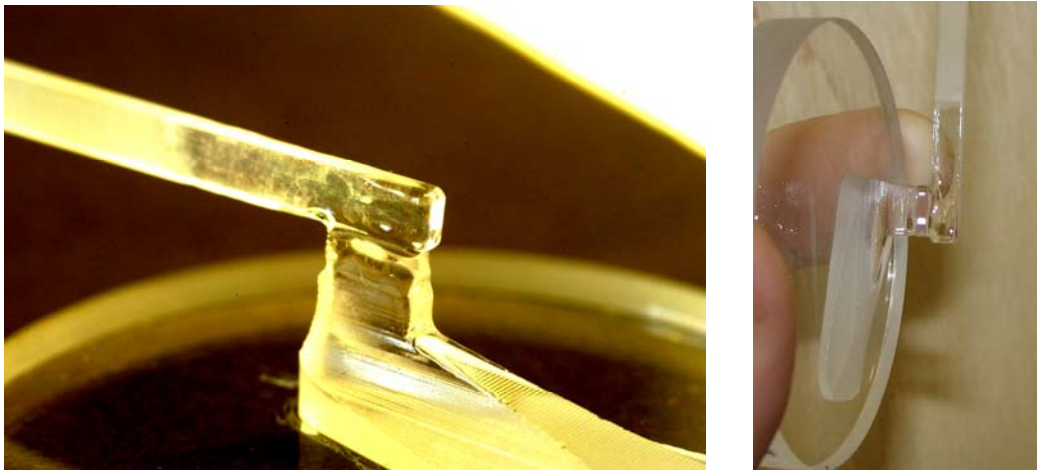
A 75 mm long silica rod of cross-section 3 mm x 1.5 mm was CO<sub>2</sub> laser welded to the horn of the (partially flame-polished) preliminary test ear (see Figure 1a & 1b).

*Figure 1a & 1b Laser welded rod (3 mm x 1.5 mm) (16<sup>th</sup> Jan 2006) on Preliminary Test Ear SN0003 bonded to Suprasil 312 disk (bonded 5<sup>th</sup> July 2005. Note that the ear has been partially flame polished in region of the horn/main body interface.*

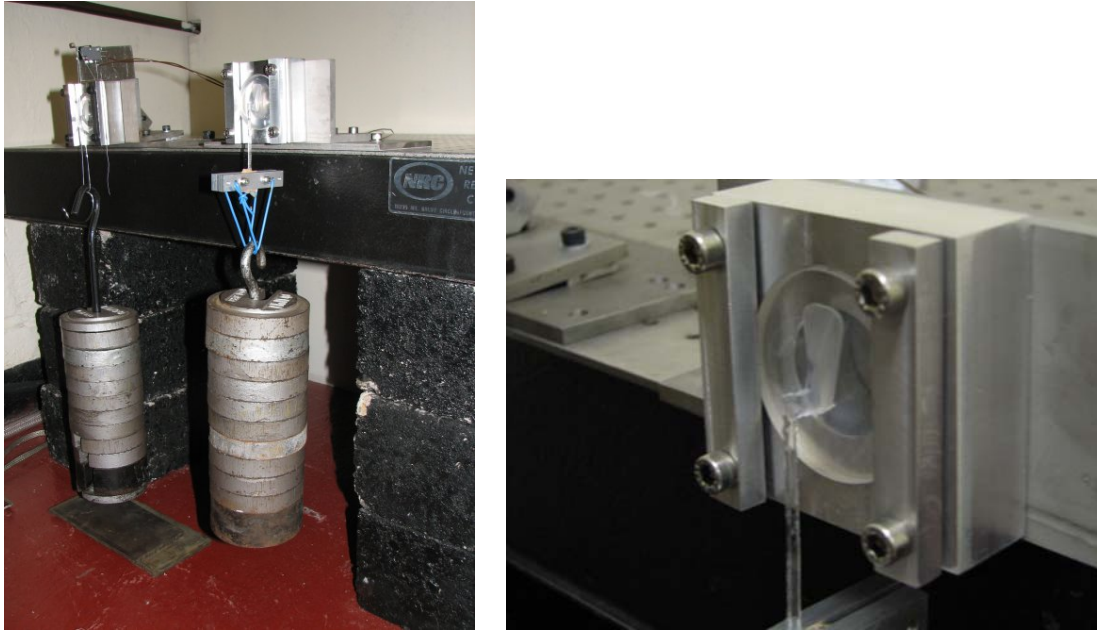
This assembly was clamped and loaded to 12.5 kg. This hung successfully for a few hours (see Figure 2a & 2b).

*Figure 2a & 2b 12.5 kg suspended from laser welded rod on bonded Preliminary Test Ear SN0003 (20<sup>th</sup> Jan 2006)- right hand side of photo*

However, after a few hours the epoxy/clamp arrangement which allowed the 12.5 kg mass to be clamped to the rod end failed (load slipped off). At this stage the silica bond and silica welds were inspected and found to look uncompromised.

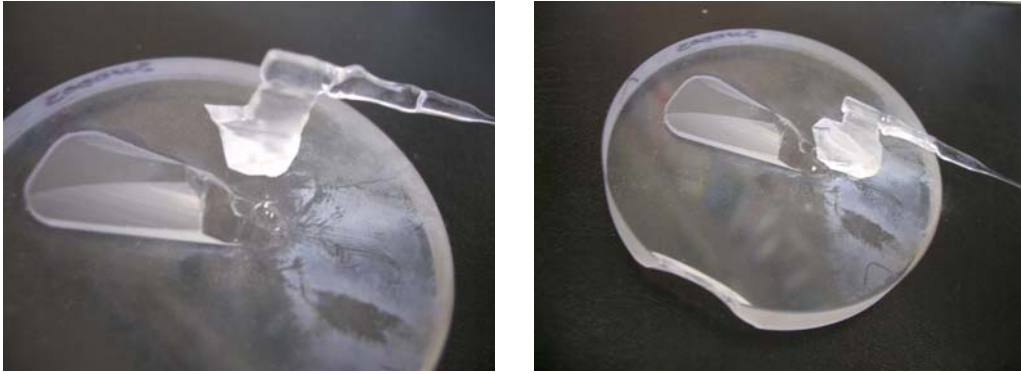
This assembly was then used to suspend 2.5 kg. When the load was increased to 4.5 kg failure occurred within the body of the ear itself (see Figures 3a, 3b, 4, 5a & 5b).

Figure 3a & 3b Failure location

Failure occurred within the preliminary test ear at the edge of flame polished region. This is where largest thermal stress from polishing would occur. Couple this with the rough finish at this non-polished location on the ear and this would explain why failure has been initiated at this particular location. This is closer towards the toe than the horn/ear interface where the largest stresses would

occur due to geometrical considerations. This sharp radius where the horn leaves the main body of the ear is flame polished hence resulting in lower stresses at this location.

*As a result of this early investigation both the ear design and surface finish requirements were refined<sup>2</sup> to improve the stress levels within the ear under loading.*

*If required light flame polishing could be considered to further improve the surface finish of the ear with a view to further reducing stress concentration levels. However caution should be applied in doing this due to the resulting thermal stresses within the ear.*

*The baseline design is to achieve the required ear surface quality during fabrication and to avoid the use of flame polishing.*

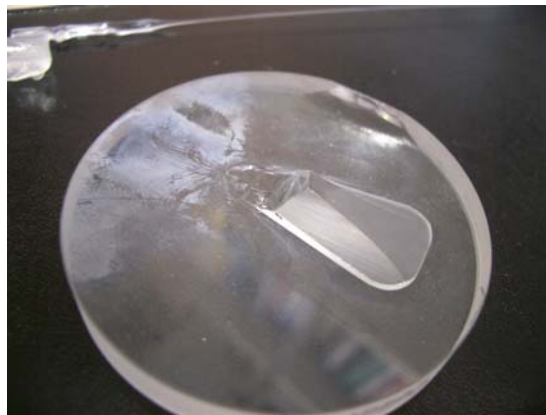
Figure 4 Failure location in ear showing torn silica – bond does not appear to have been compromised.

There was no obvious sign of bond degradation, the silica material of the ear had been fractured and torn apart.

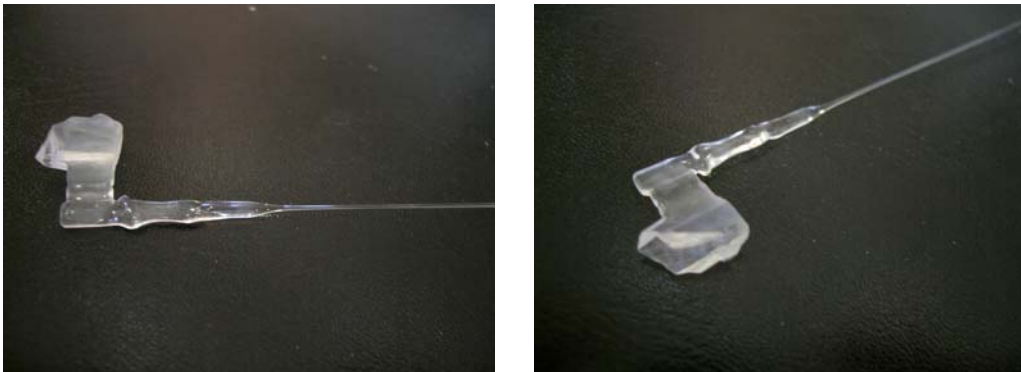
Figure 5a & 5b Failure location in welded horn
