LIGO- T080095-00-R

Stress-corrosion in Maraging blades

Riccardo DeSalvo,

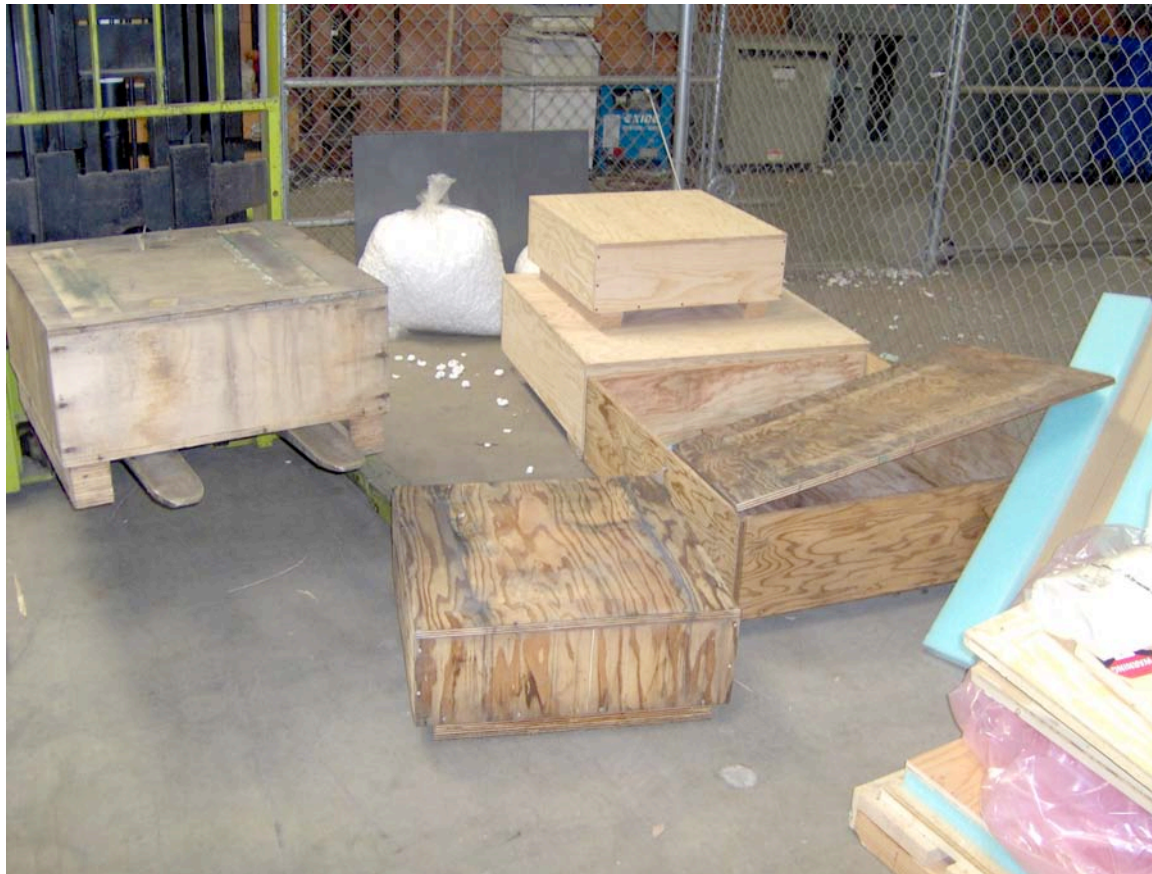
The crates found in the parking lot were all molded, unsuitable for shipment as illustrated in the figure 1.

Figure 1, photo of three of the four damaged crates next to two clean, new replacements.

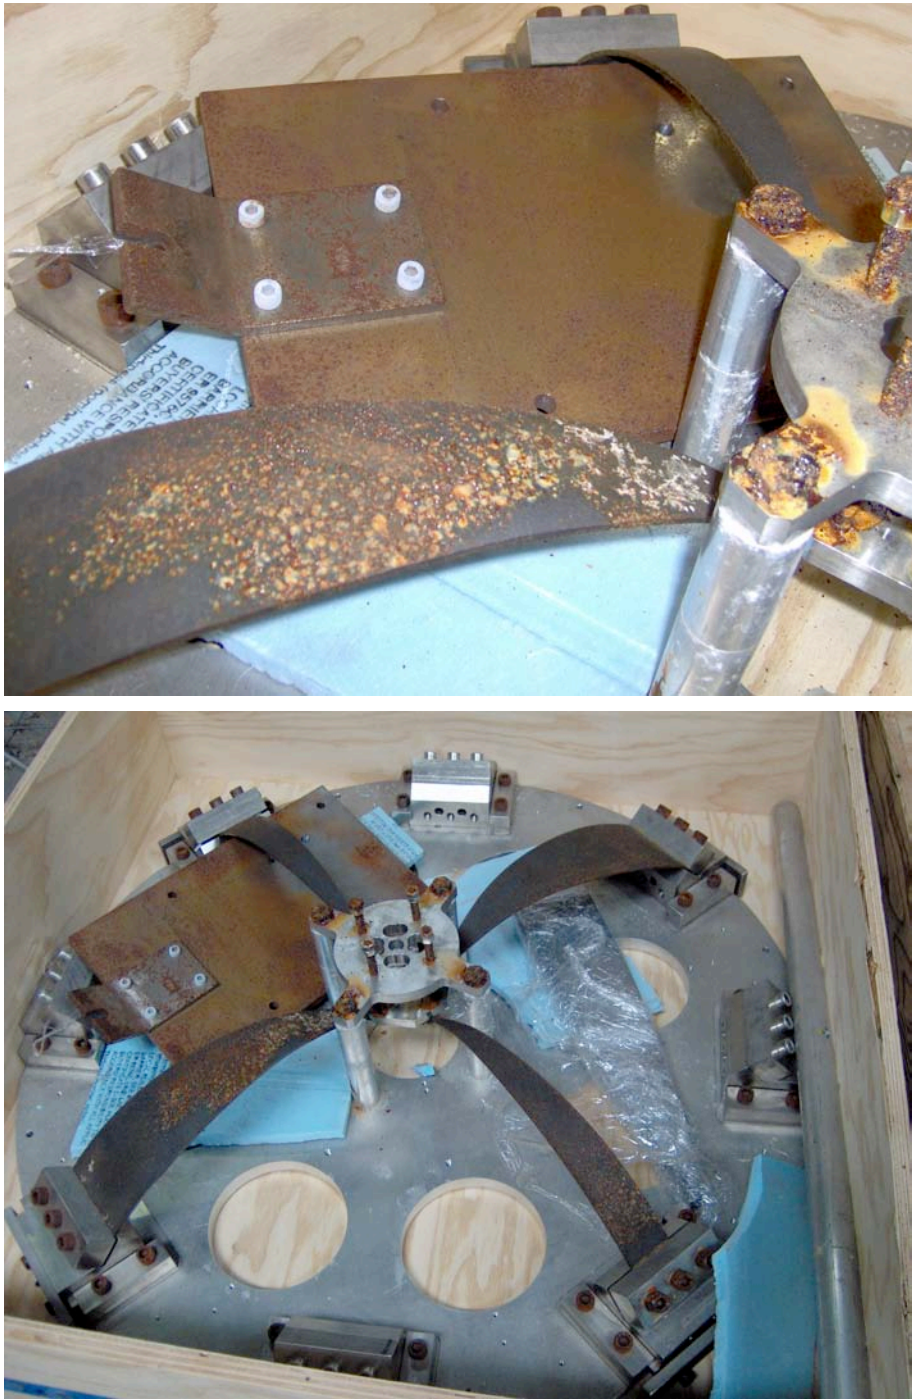
We opened the two crates that needed to be shipped. The equipment inside was wrecked by corrosion, see figure 2.

Figure 2, part of the damaged equipment (photo taken after transferring to the new crate).

All non aluminum or non stainless parts are damaged beyond repair. Even the stainless and Aluminum parts require extensive cleaning and etching.

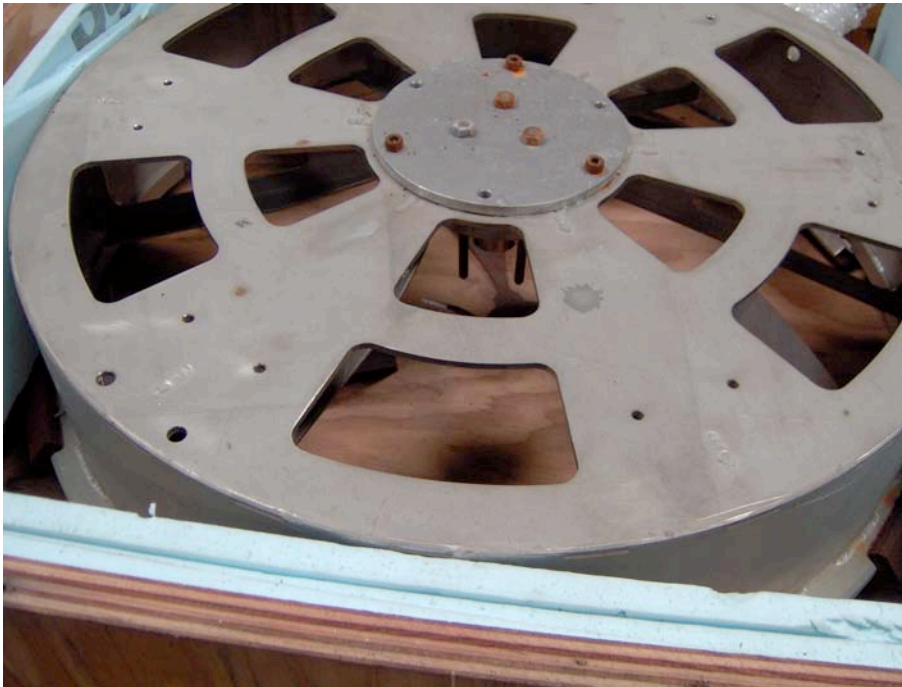
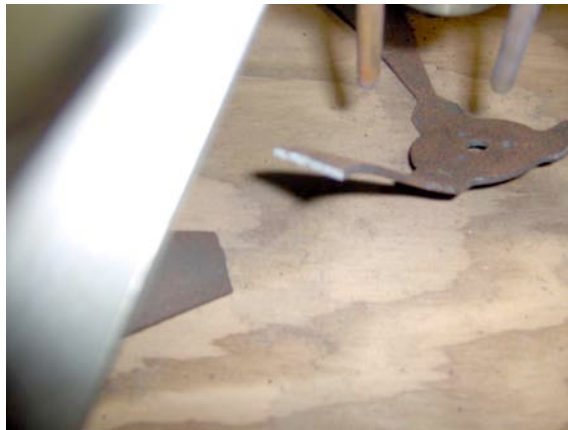
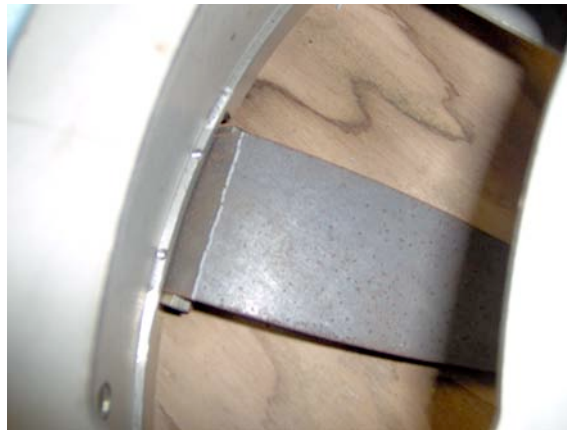
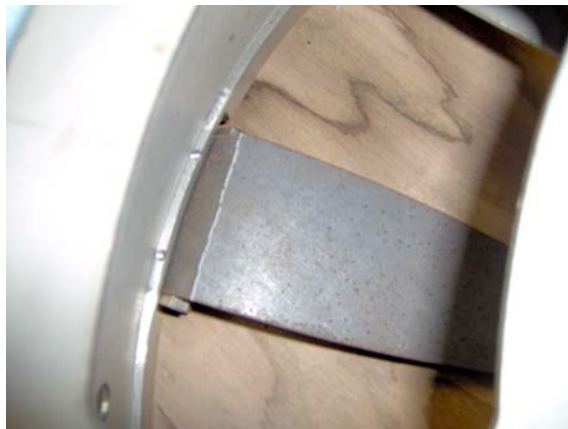
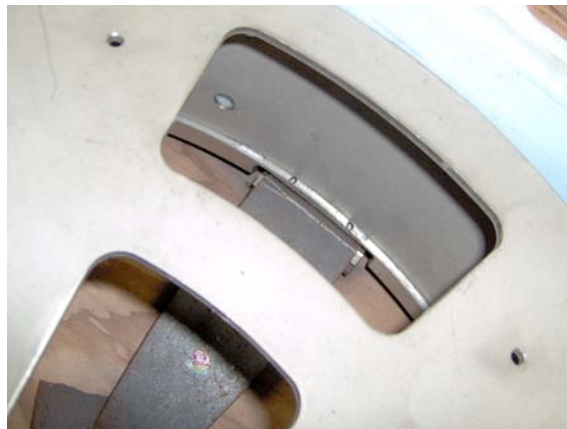
To our surprise we found that the corrosion had gone through the blades' thickness and the blades had exploded in several shrapnel-like parts inside the crate, as illustrated in figure 3 and 4.

Figure 3, filter (TAMA model) with parts of blades laying at the bottom of the crate and close-ups of the broken blades.

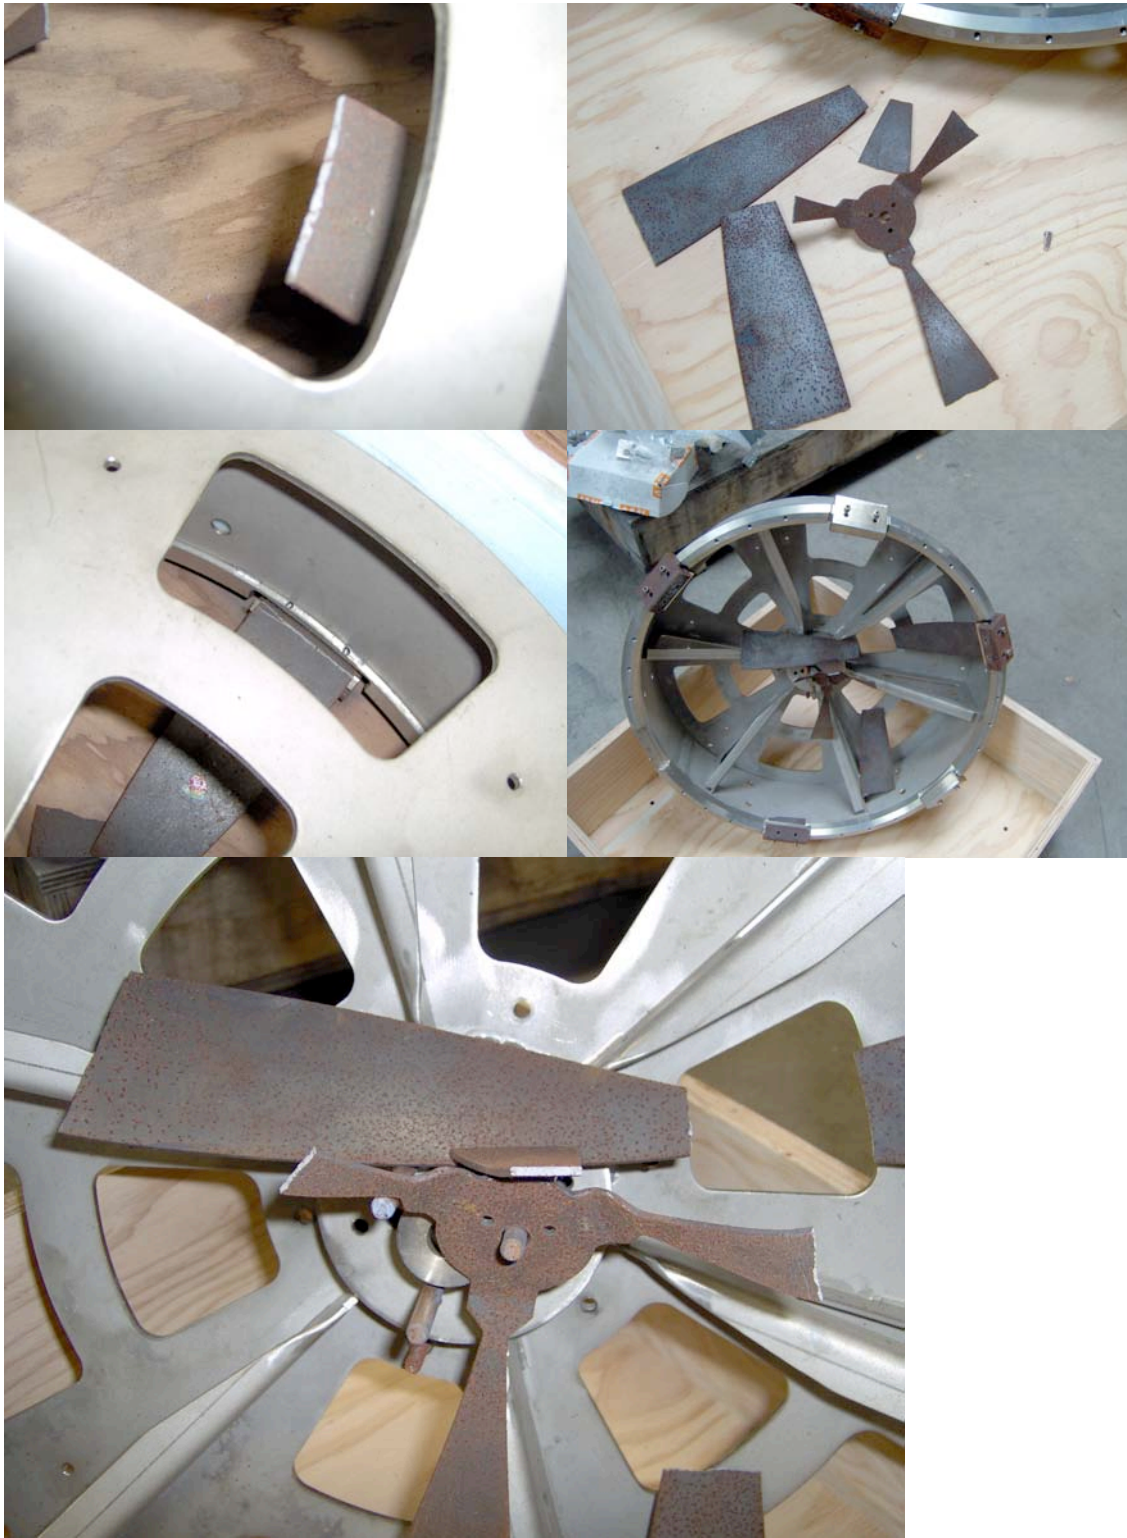
The close-ups of figure 4 show clear signs of "classical" stress driven corrosion, where oxidation wedges penetrated, knife-cut fashion, perpendicular to the tensional stress direction, and causing catastrophic failure.

Figure 4, detail of the exploded blades, showing the effects of “classical” stress-corrosion.

Stress corrosion only happens on the side subject to tensional stress. Humidity enters into any pre-existing micro-cracks opened up by the tensional stress. Iron oxide, having larger volume than the original metal, press on the wedge, thus further opening the cracks and opening the way for more humidity and corrosion, and further expansion of the wedge. The result is thin wedges of Iron oxide extending inwards perpendicularly from the surface subject to tensional stress.

From the blade use point of view, an important observation is that all debris show obvious curvature, despite the fact that the blades were loaded below 50% of the elastic limit.

This means that, besides the few cracks that cut through the thickness and generated the catastrophic collapse, many microscopic corrosion wedges distributed over the tensionally stressed surface must exist, and generate the observed permanent blade warping.

While a lot of corrosion was necessary to break the blades (and generate sizeable risk), even small amounts of humidity (including people transpiration) can generate small amount of corrosion wedges and micro warping of the blades. This would change the useful working load of the blade. Additionally, a myriad of small of corrosion filled wedges may lead to worsening of the mechanical noise characteristics of the blades.

To avoid this, and to guarantee an even higher level of passive safety, a thin Nickel plating (~1000 - 2000 Angstrom) is recommended.

Also it is recommended that systems containing blades under stress are stored in sealed bags with silica gel air dryer.
