**New Folder Name** Electrical Short at  
South End Axial Drive Corl T950010

CALIFORNIA INSTITUTE OF TECHNOLOGY  
Laser Interferometer Gravitational Wave Observatory (LIGO) Project

Subject: ELECTRICAL SHORT AT SOUTH END AXIAL DRIVE COIL (2 MARCH 95) [also see 40-M Logbook #37, p. 40-42]

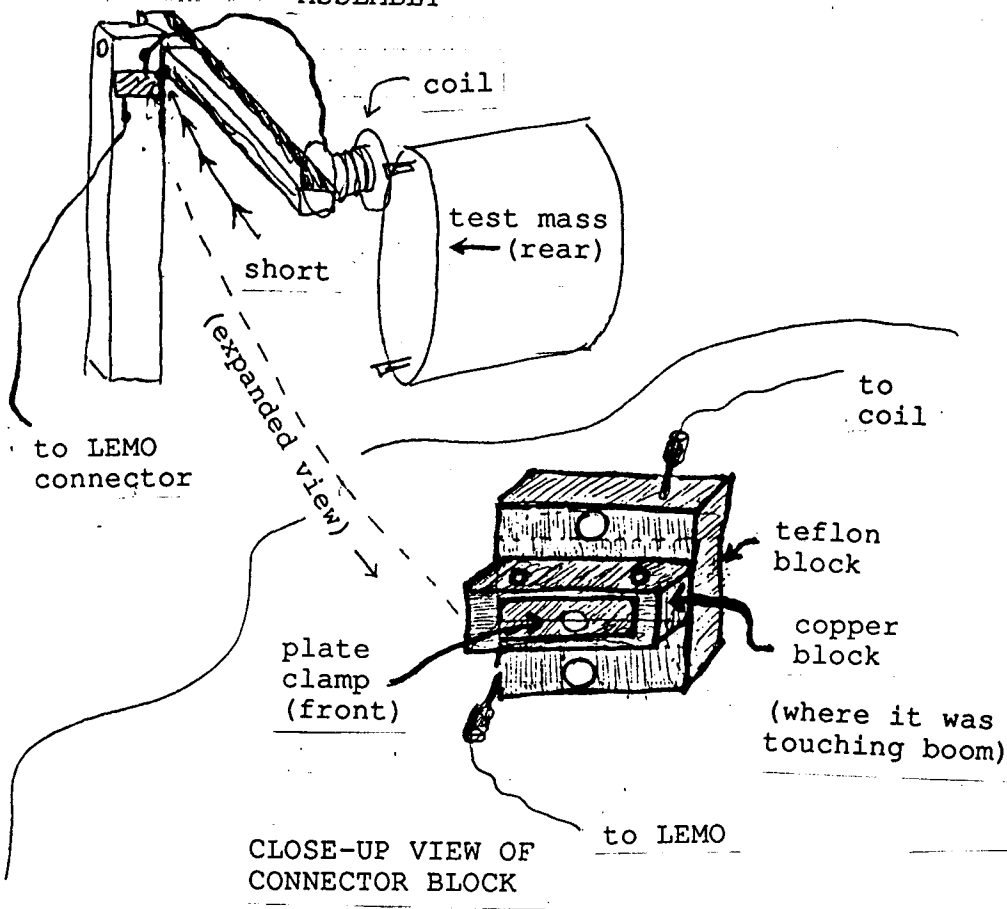
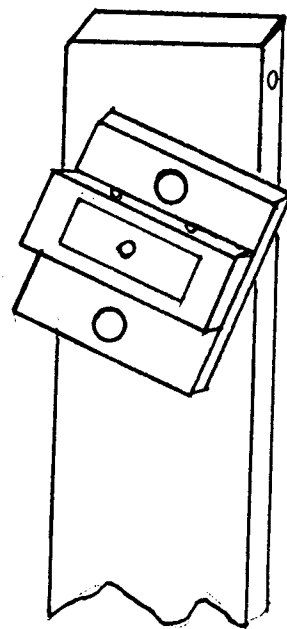
COIL-MOUNTING ASSEMBLY

In February, we had been investigating an unusually high level of line spikes in the spectrum of the 40-meter interferometer; odd harmonics of 60 Hz at 180 Hz, 300 Hz, and 420 Hz were especially prominent. Seiji finally discovered that one of the inputs to the balance network for the axial drive coils was shorted to ground. Disconnecting the four cables to the coils at the feedthrough to the vacuum envelope allowed us to measure the impedance of the two coils separately, and isolate the problem to the rear ('push') coil (it should have been open to ground, but instead was a few ohms).

Visual inspection through the chamber viewport revealed a potential problem with the mounting bracket ('boom') for the coil (which is at ground) shorting to a custom-designed copper block connector for the coil leads. (The copper connector is mounted on a block of teflon, but is flush with the edge of the teflon rather than inset, so that there is no insulation from the side.) See below for drawing and details.

We vented the system and Andy angled the connector so that it no longer touched the bracket, then we remeasured the impedance from the coil to ground; it was open, as it should be. This solution is not ideal; there was no way to adjust the position or angle of the connector holder except by omitting one of the mounting screws which secures it to the post.

From now on we plan to check for electrical shorts in the axial drive coils before each pumpdown; this problem has not come up before, but it may recur, so it is being added to our vent checklist. We also want to design a new connector block and install it during a future vent cycle. Finally, we plan to reevaluate all of the instrument wiring with an eye toward long-term redesign; we hope to reduce noise due to ground loops and upgrade some of the fragile in-vacuo connections to make the system more robust.
