Environmental Disturbances

E5, E6 and E7 Investigations

Locking Difficulties in High Wind

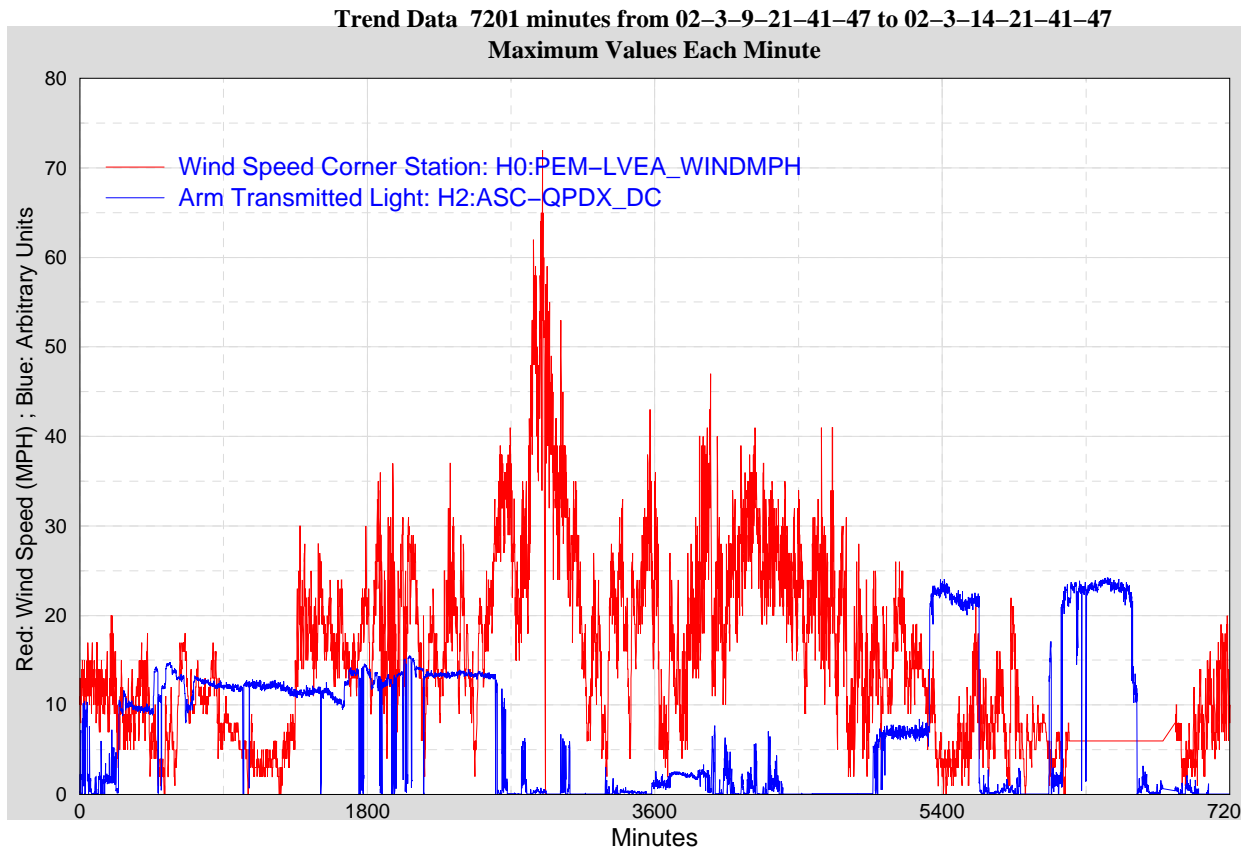
LHO 2k March 12, 2002 wind storm

Difficulties regaining or holding lock when corner station wind speeds exceeded 25 or 30 mph

This was also the rough threshold during E7 for the LHO 4k in recombined mode (elog 1/11/02).

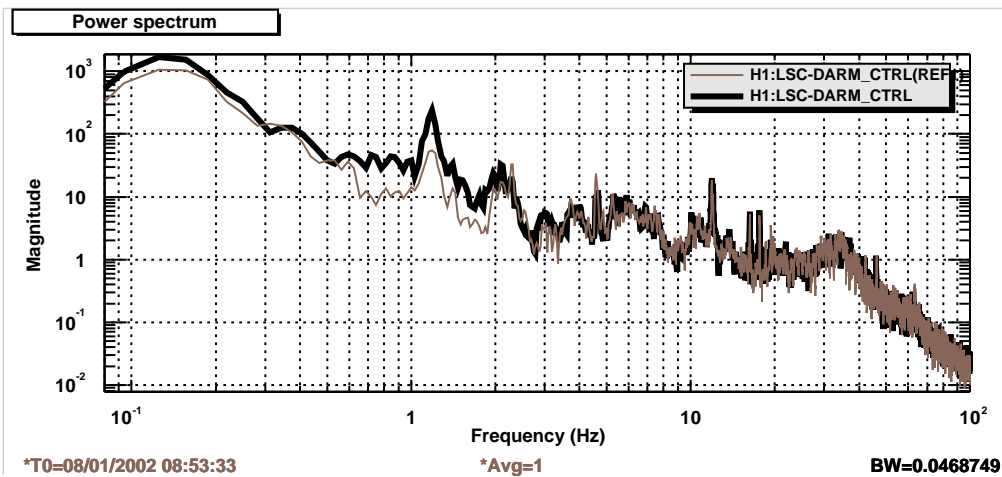
Differential Arm Control (thin reference line: 12 mph)

BSC Coupling: 33 MPH Y-end Wind

Lower wind speed elsewhere (X-end: 16 mph; Corn.: 18 mph)

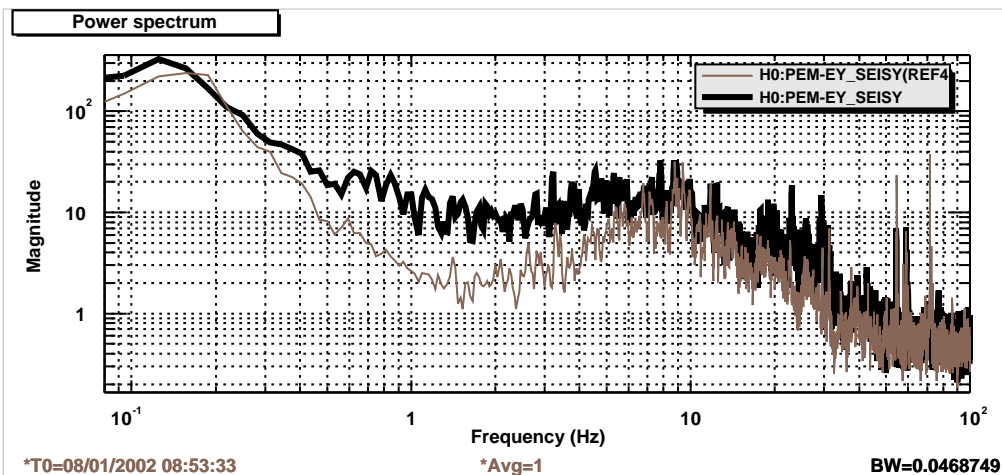
Y-end seismometer

~1.2 Hz BSC modes

MC_F and seismometers at other stations deviated little from reference spectra (elog: 01/11/02)

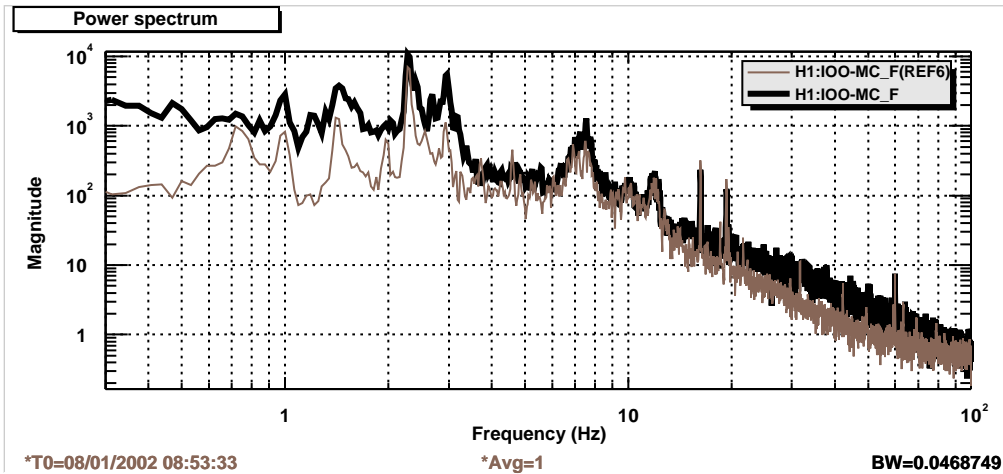
Mode cleaner control (thin reference line: 5 mph)

HAM Coupling: 40 MPH Corner Station Wind

Difference above 10 Hz does not appear in 2k MC and is consistent with signal distortion.

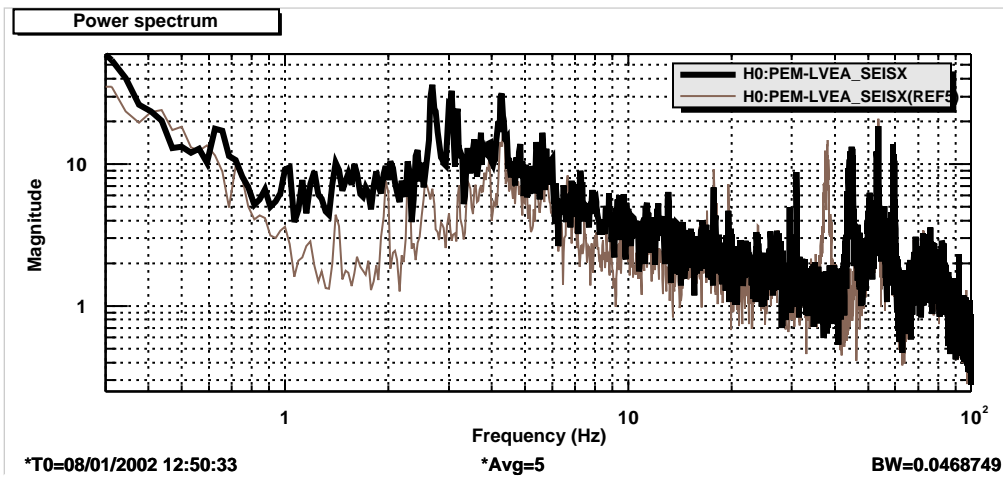
LVEA seismometer

Sub 5 Hz HAM modes

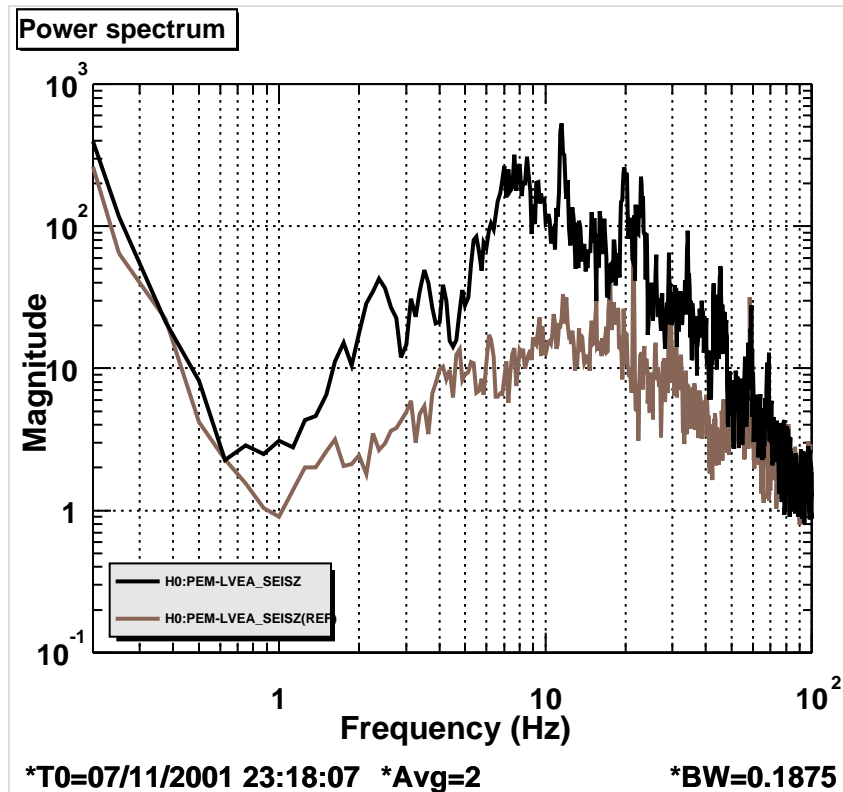
Seismic Noise Increase With Construction Near Corner Station

Could not lock with this factor of 10 increase (could hold 1 arm at factor of 5 increase)

Construction spectrum has shape of non-construction spectrum: evidence for “ground resonance” of about 10 Hz

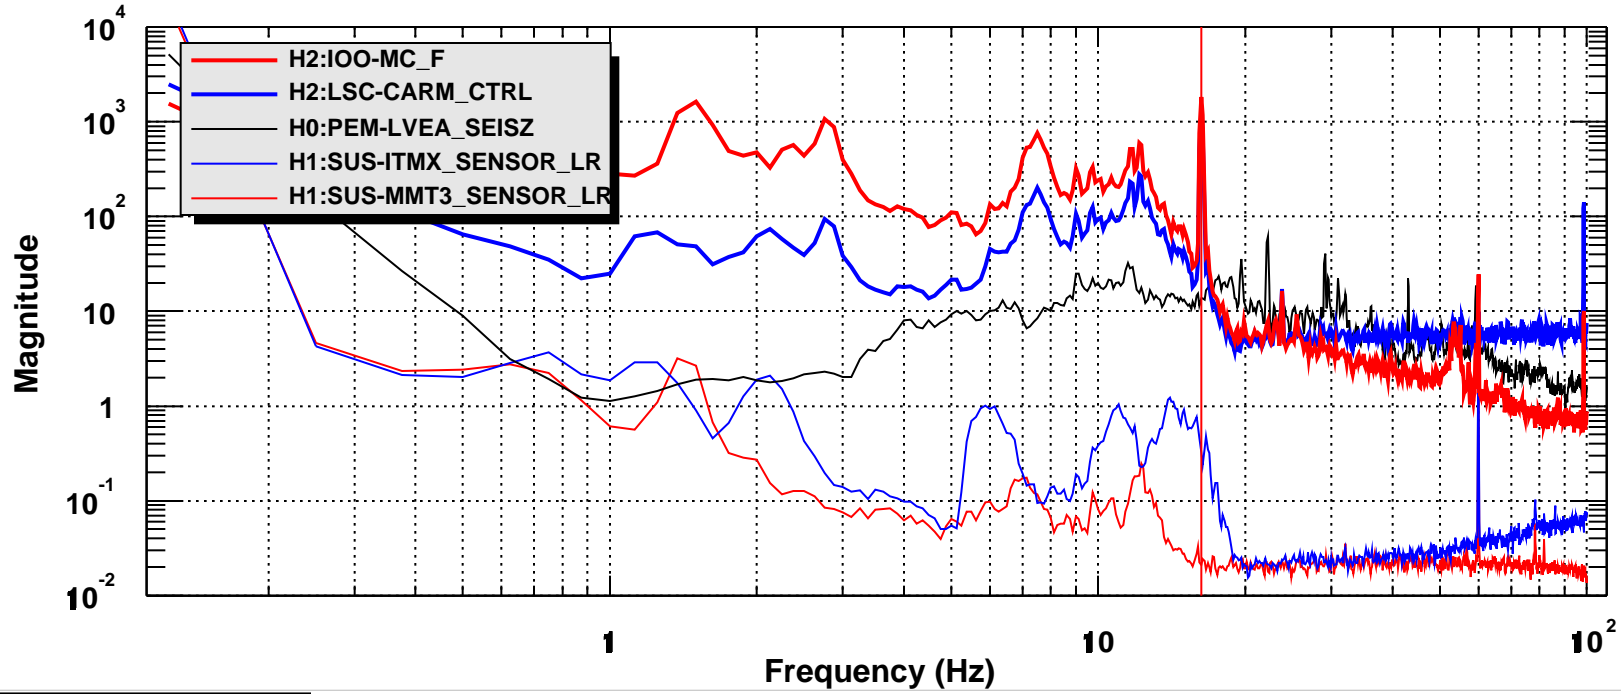
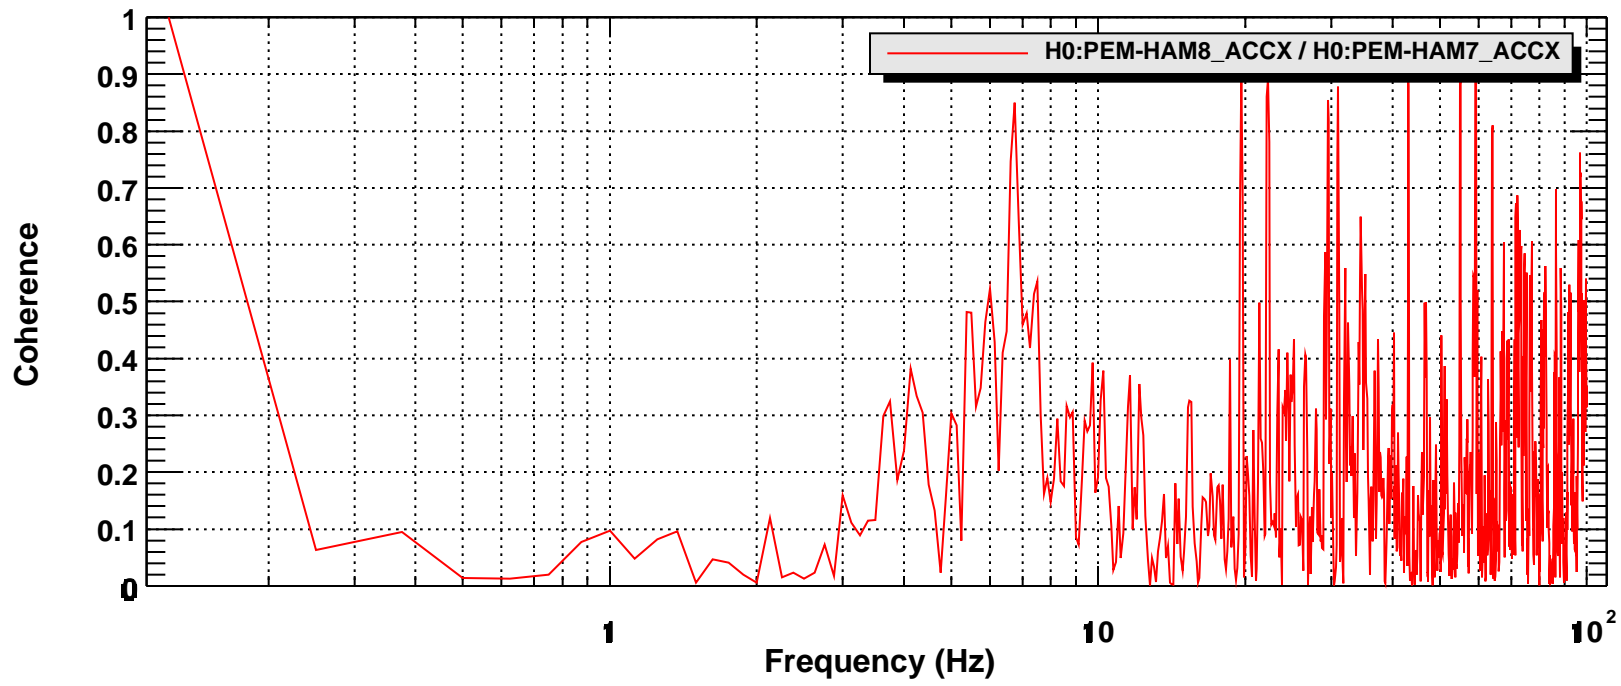
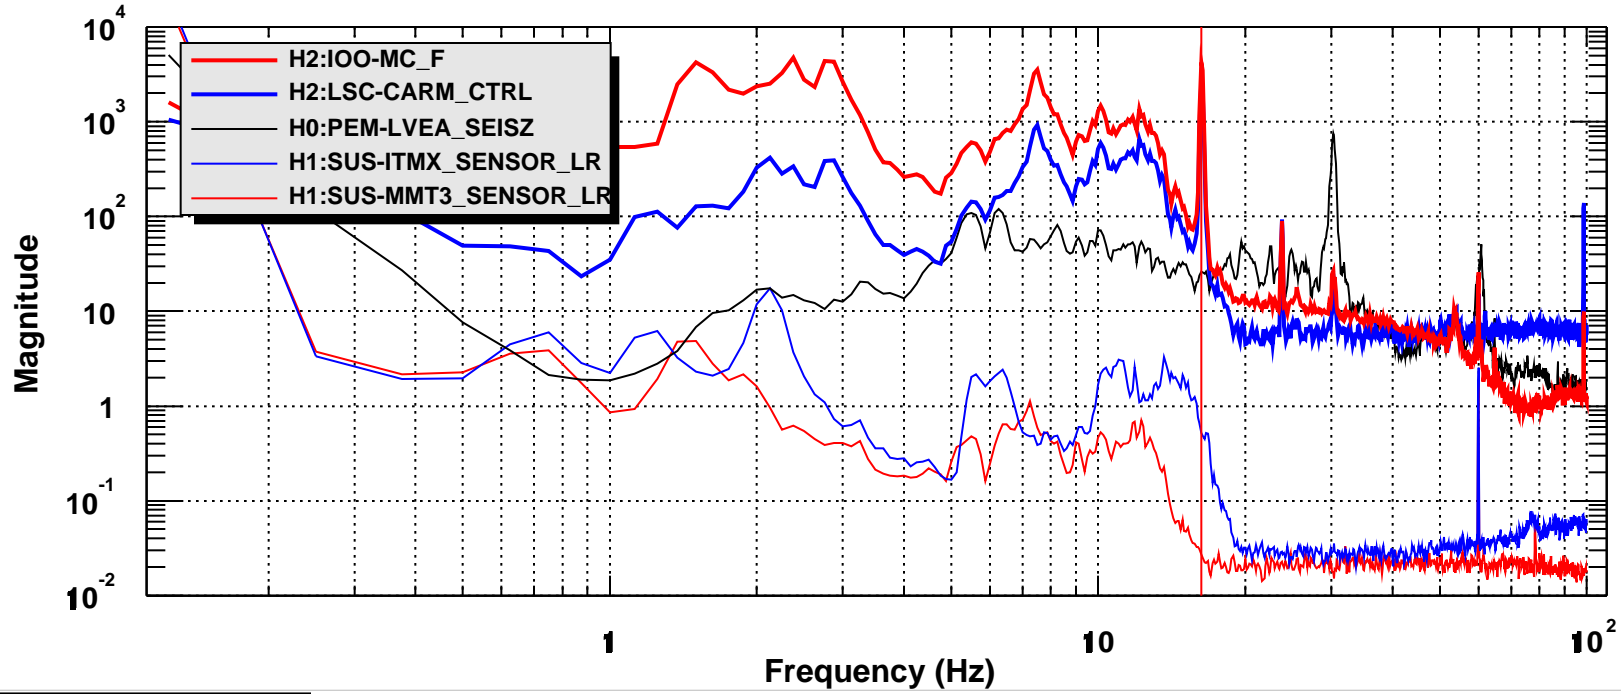
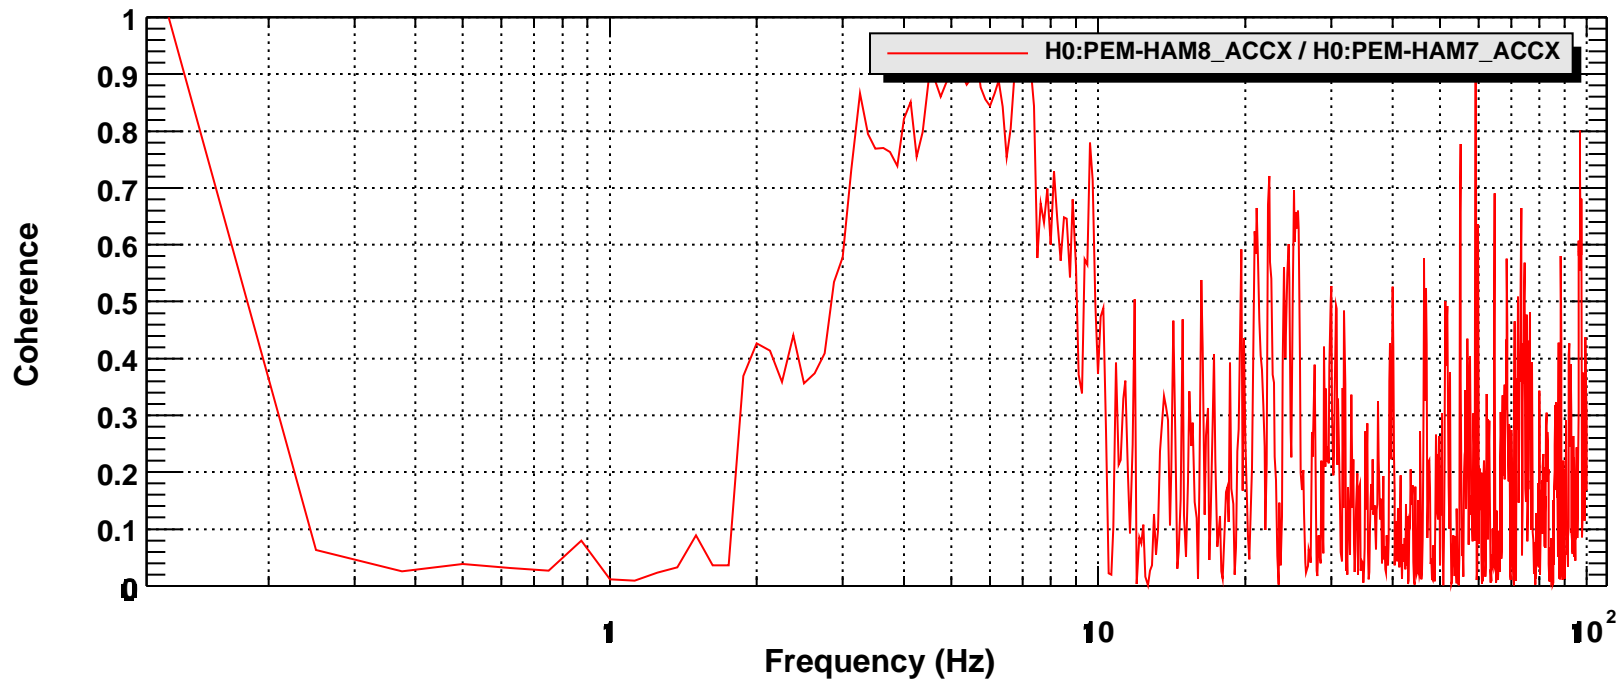
Increase in CARM above 5 Hz predominantly associated with HAM modes: mode cleaner is culprit because coherence between ends drops above 5 Hz

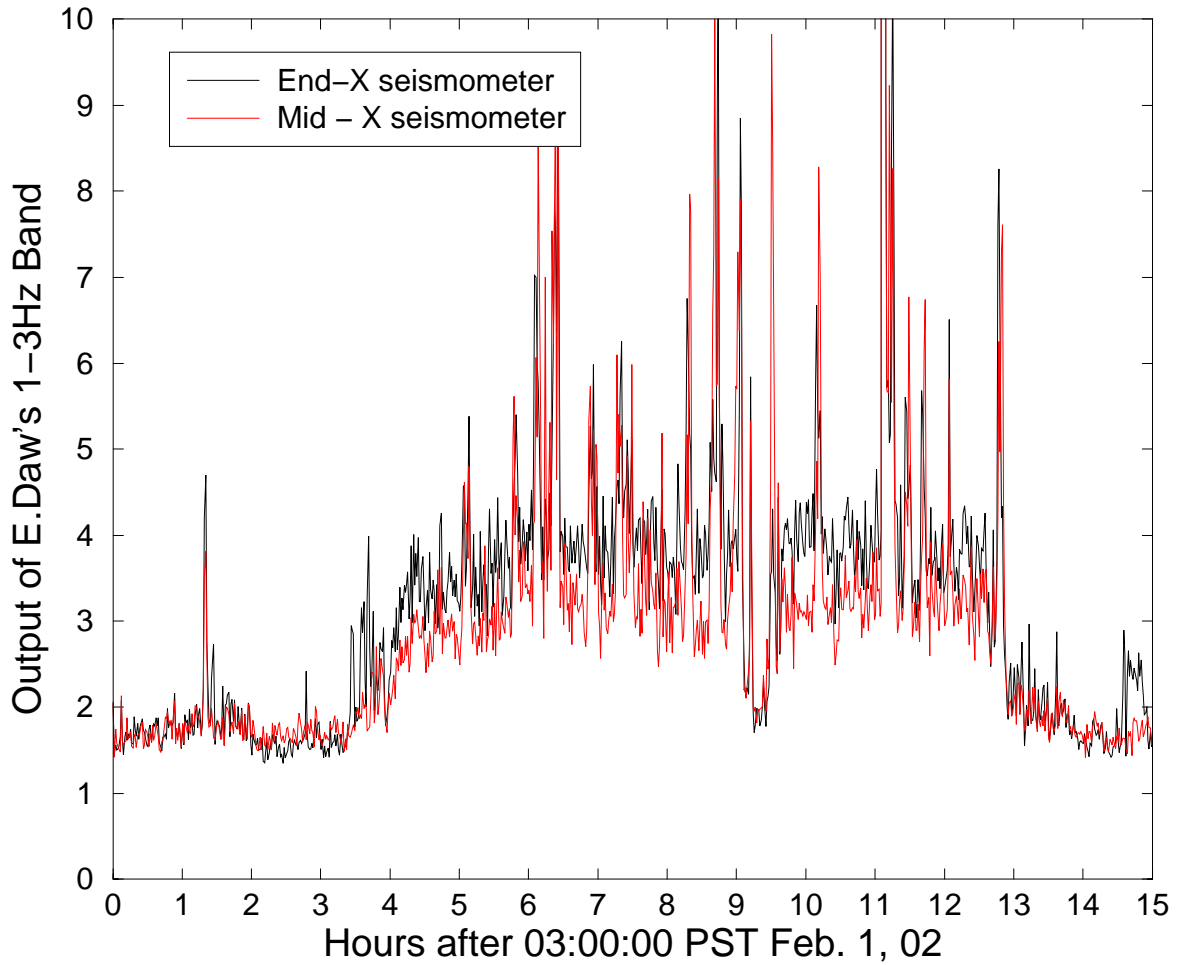
Anthropogenic Seismic Signal

Spikes are probably trucks on Route 2

Traced to Vitrification Plant Project
