ENVIRONMENTAL DISTURBANCES (INCLUDING S1 - STOPPERS)

Robert Schofield (Oregon)

Final Two Hours of MMT2 Suspension

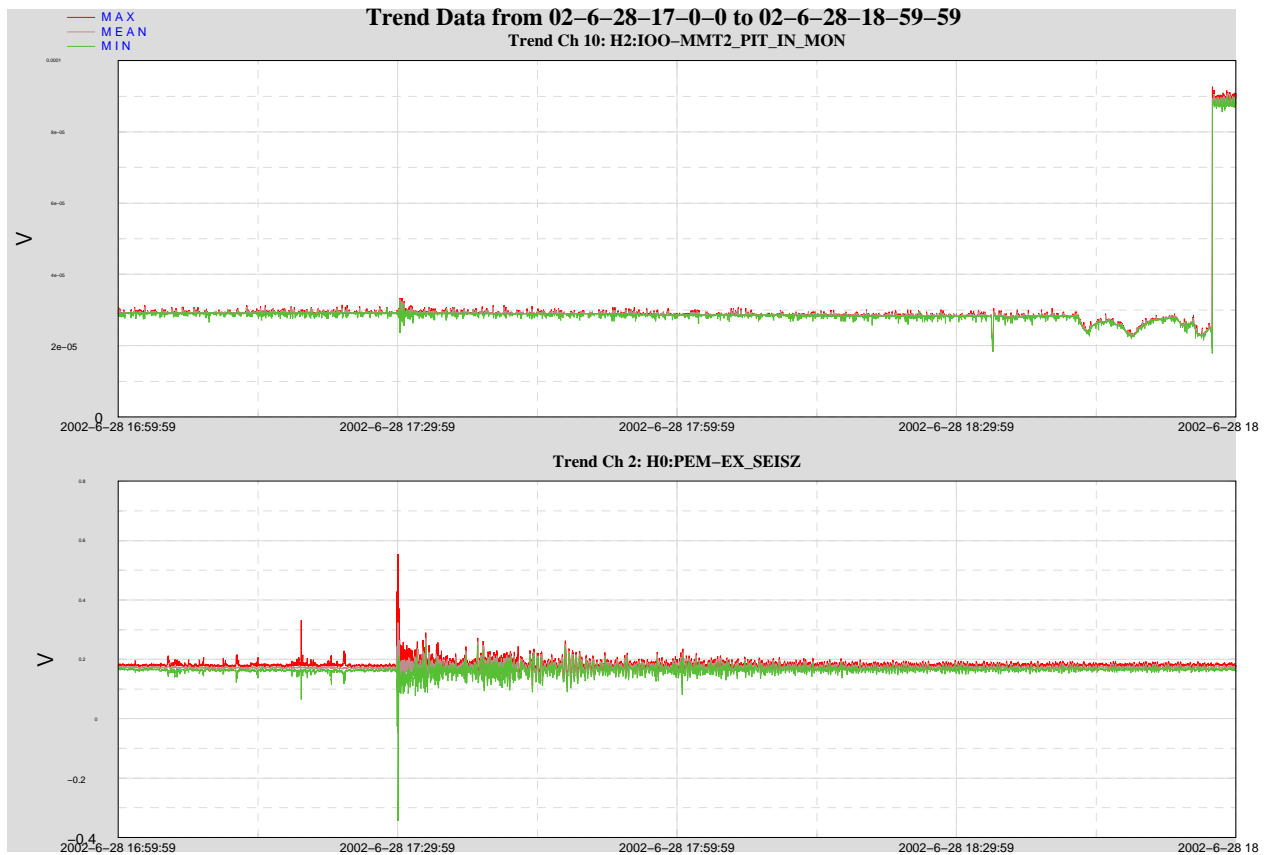
Top: MMT2 Pitch; Bottom: EX seismometer

**Yaw Bias Drop
Drift**

**Optic recovered from Russian-Chinese quake.
Also, nearby optic MC2 was steady during final motions of MMT2:
any mechanical jolt would shake both**

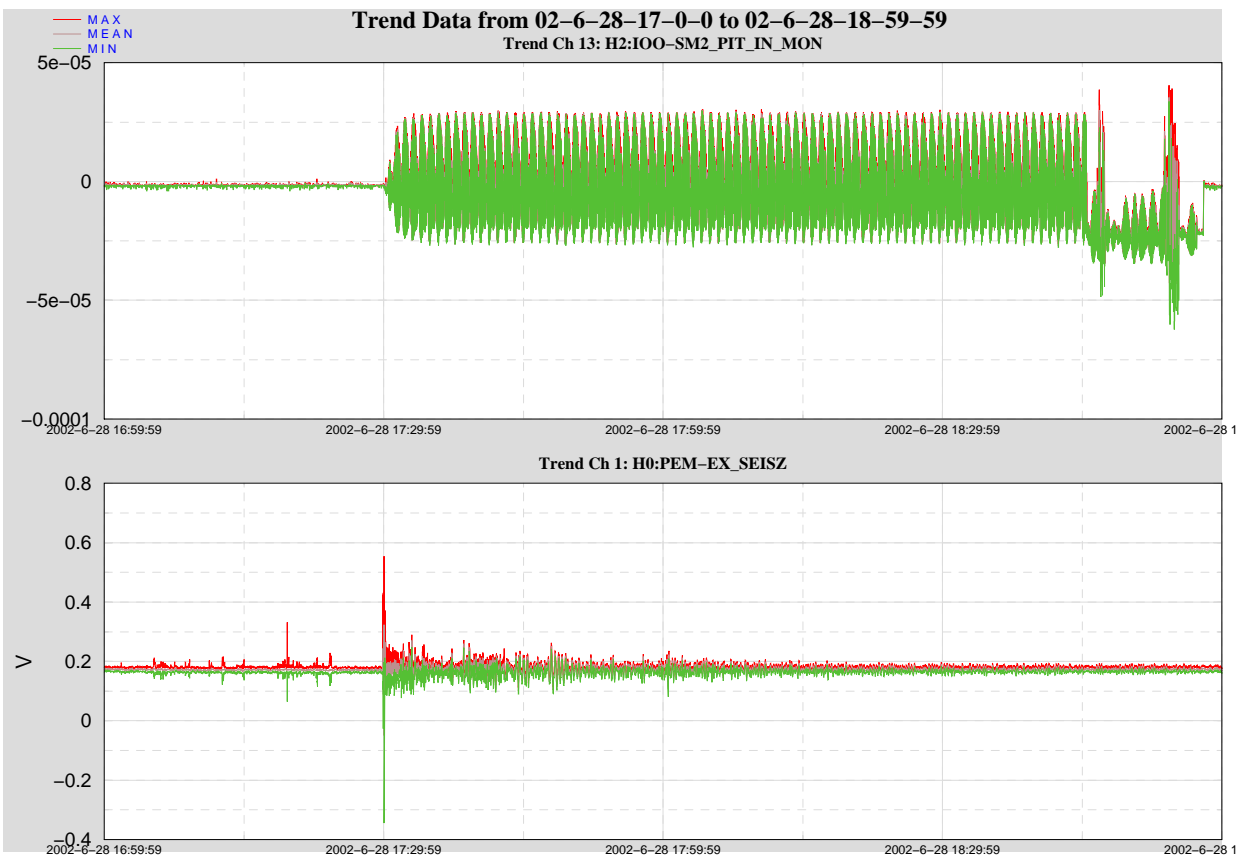
Quake Rings Up SM2

Same time period as shown previously for MMT2 pitch

Top: SM2 pitch; bottom: EX seismometer

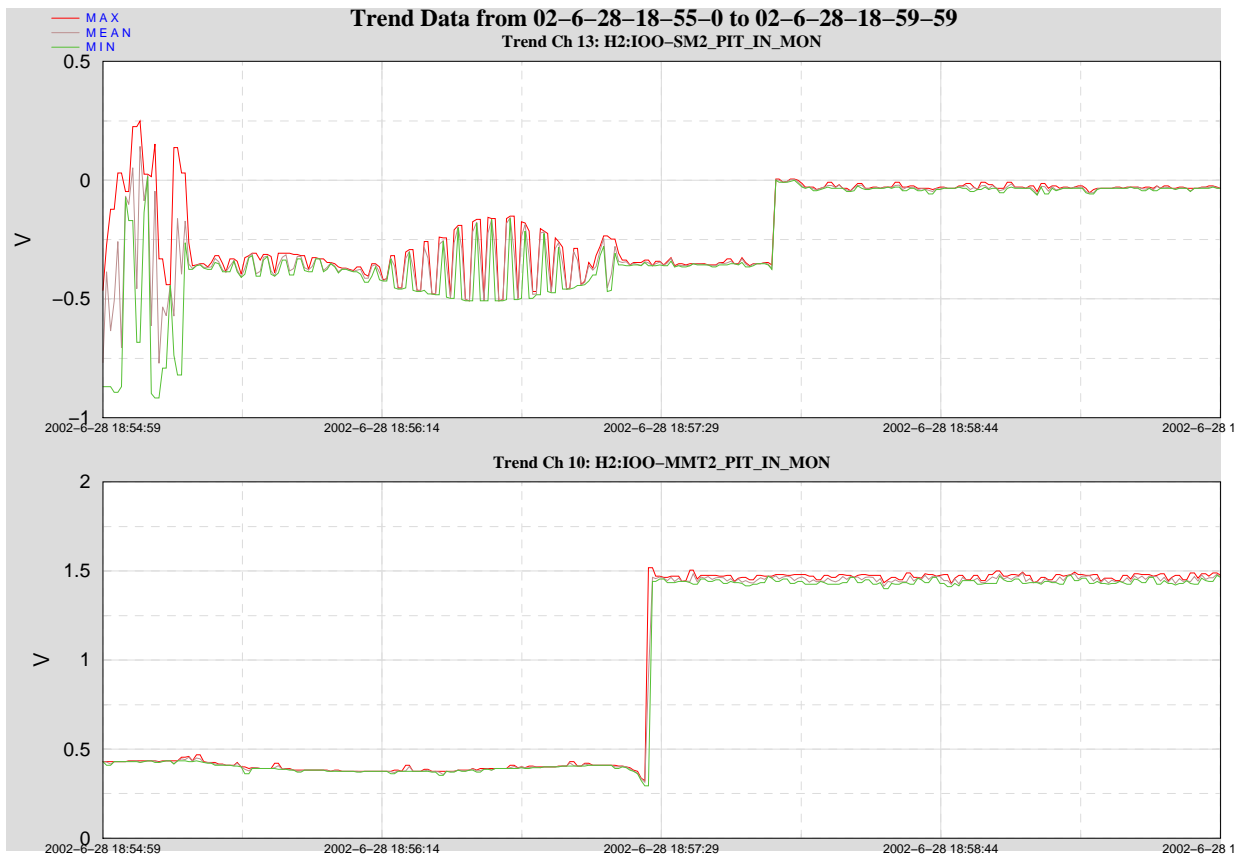
SM2 Pitch During Final Moments of MMT2

- SM2 stabilized about 5 seconds before MMT2 drop
- MMT2 pitch-drift accelerates seconds before drop

Not suggestive of sub-second wire melt.

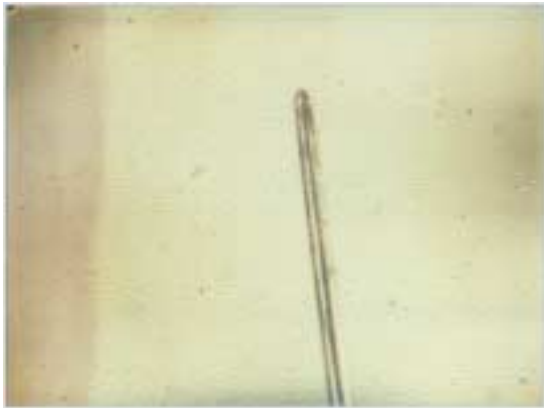
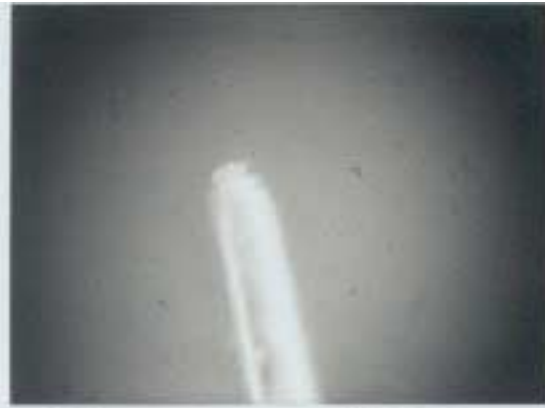
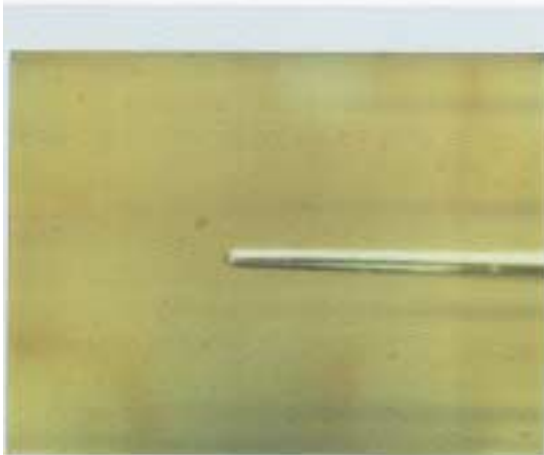
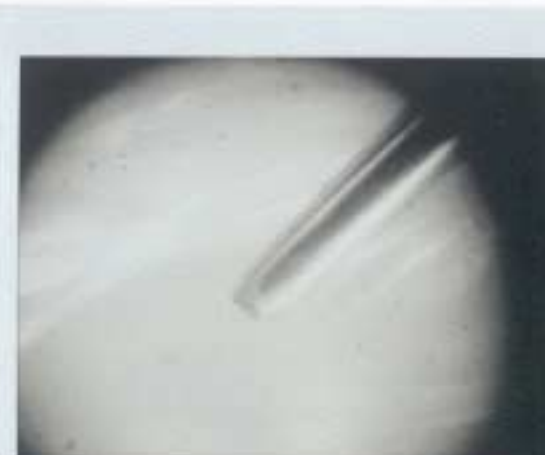
Ends of Broken MMT2 Wire

Top row: long piece; bottom row: short piece

Ends appear rounded; thin film colors near break.

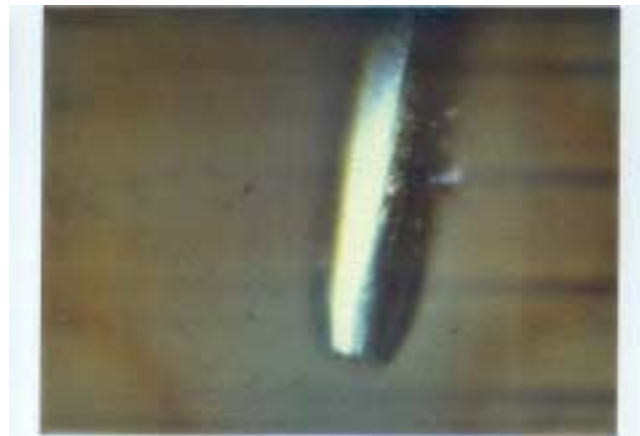
COLD

Broken at room temperature by increasing tension.

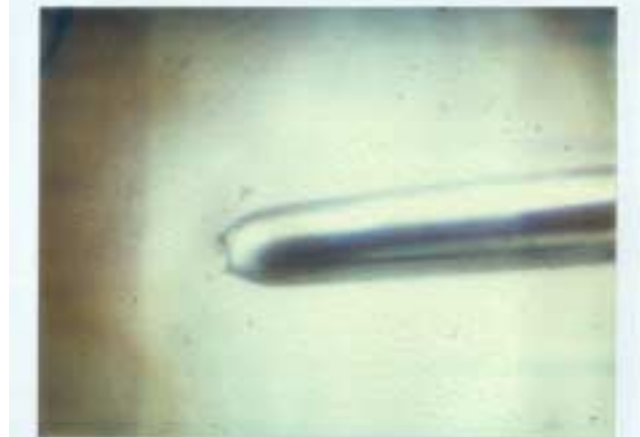
DULL RED HEATING ELEMENT

Broken by touching with dull-red stove heating element (170 gms tension)

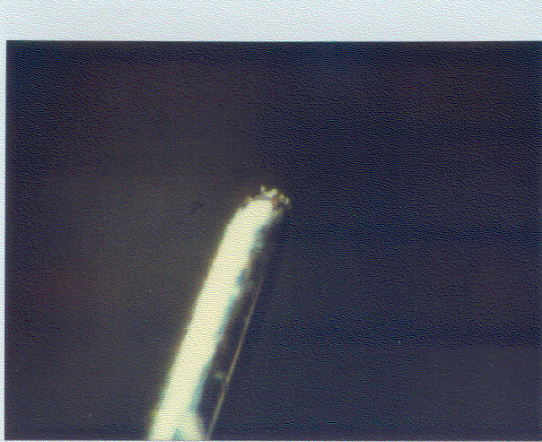
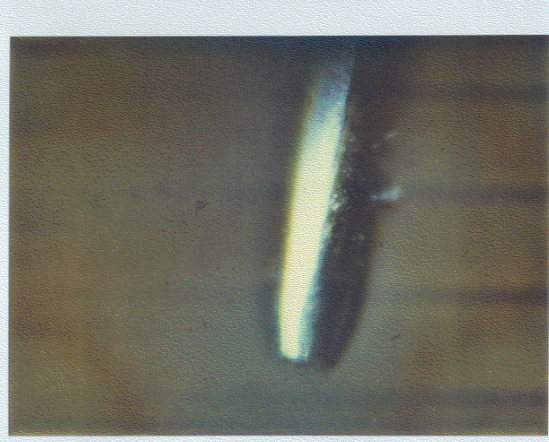
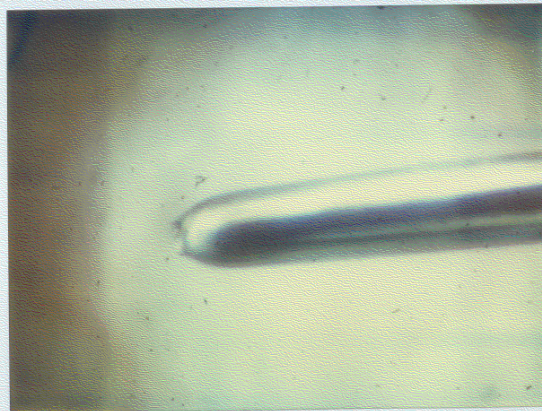
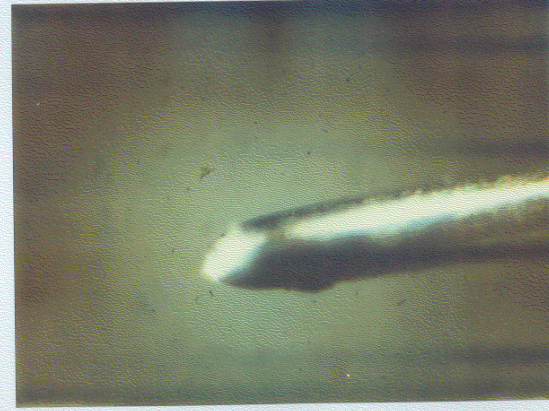
Summary Comparison

MMT2 looks most like the warmed not melted wire, but not conclusive.

- 1) Sliders can move beams onto suspension wires: limit sliders.**
- 2) Breaking a wire may take a long time: “watchdogs” could be very useful even if there is a delay in blocking the beam.**
- 3) Warming, short of melting, can cause breakage and, short of breaking, may cause alignment drift.**

H2: baffles on MC2 and MMT2‘

H1: SM and MMT1 Sliders limited and protected by watchdogs

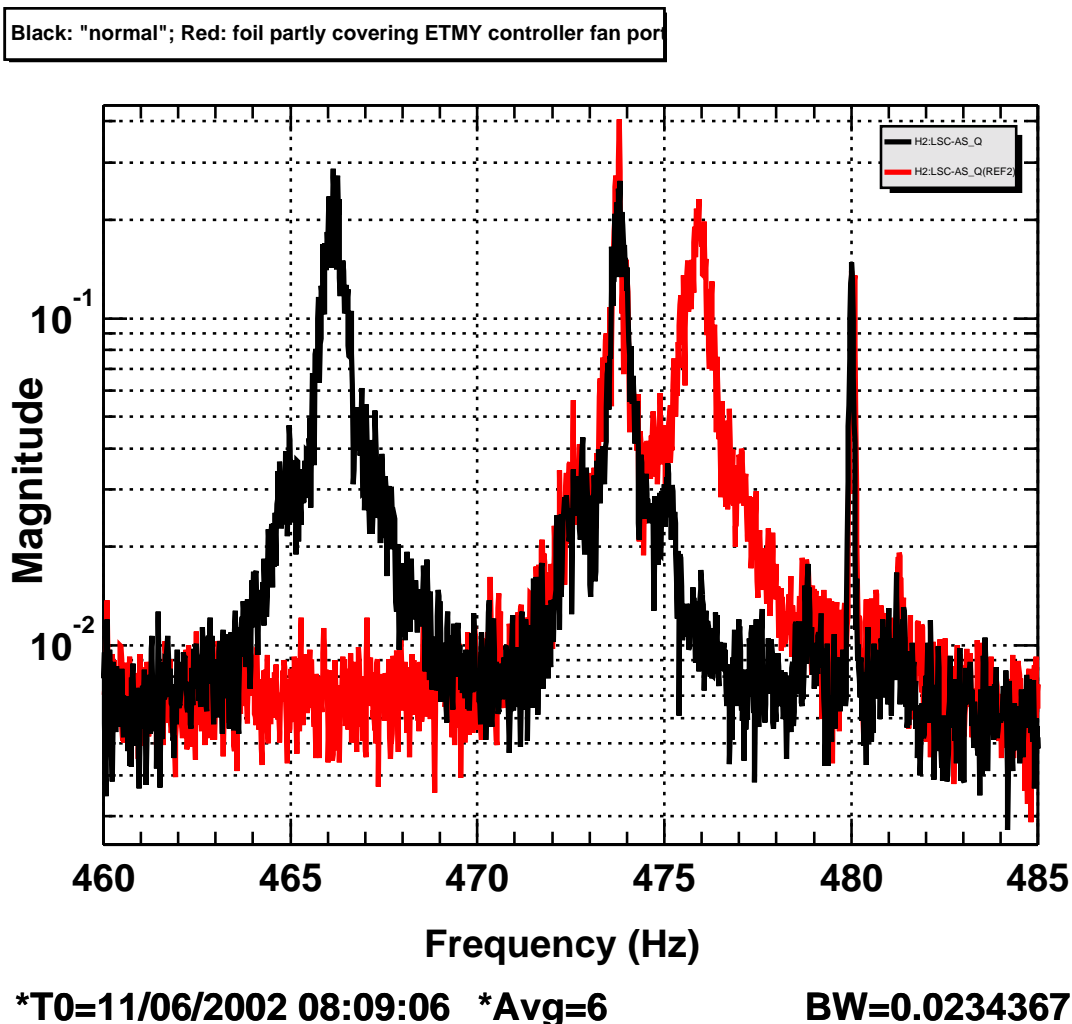
Peaks Movable

by partially covering fan port of test mass controller with foil

Separate fan power supply removed peaks - fans probably caused power supply ripple

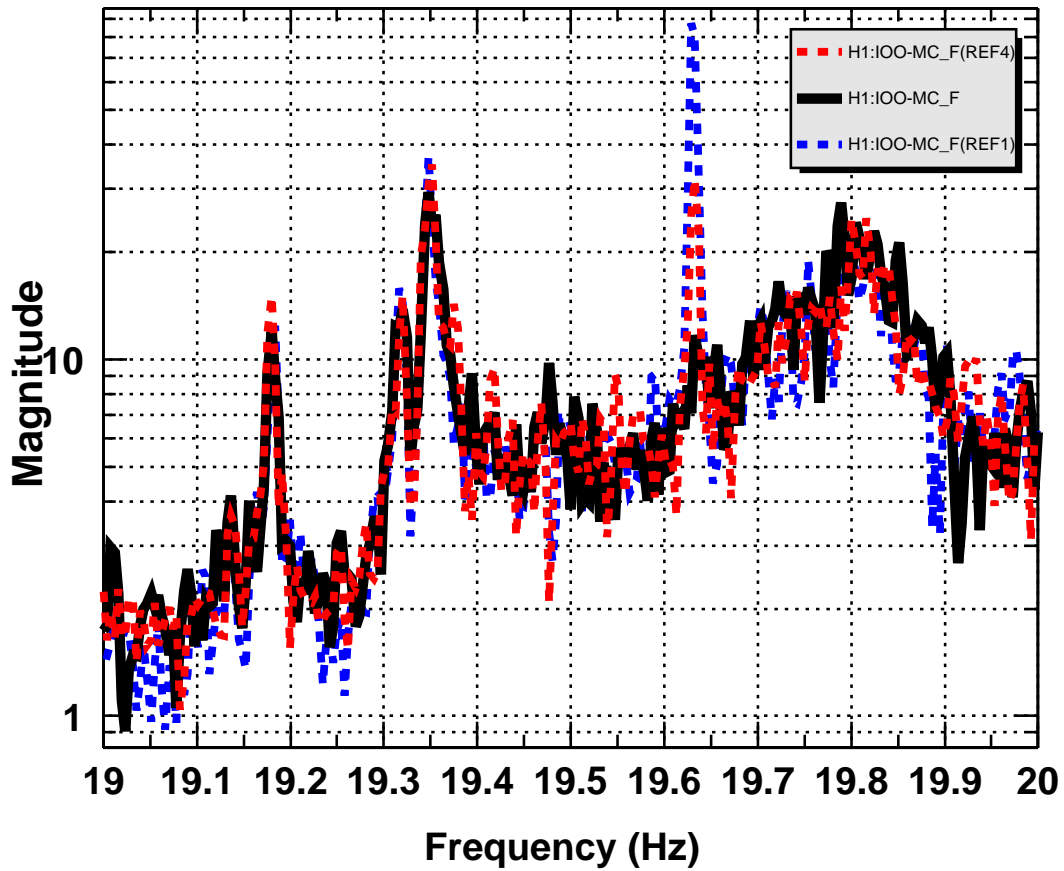
Hood Fans Responsible for 19.6 Hz Peak

“mimicked” small optic bounce mode

Blue: both hoods on; Red: bake hood only; Black: both off

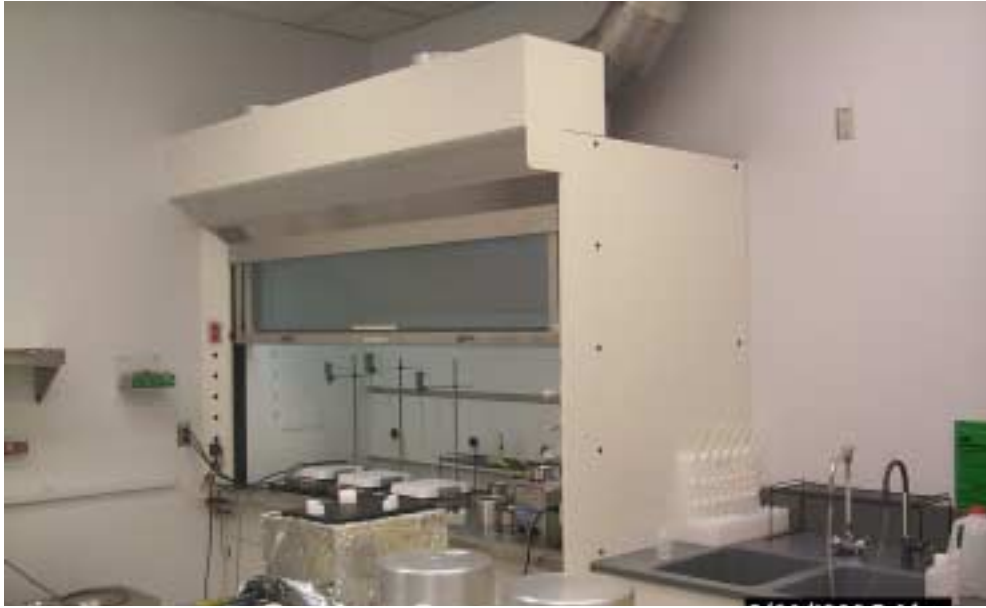
One of the two culprits:

Hood Fans Responsible for 19.6 Hz Peak

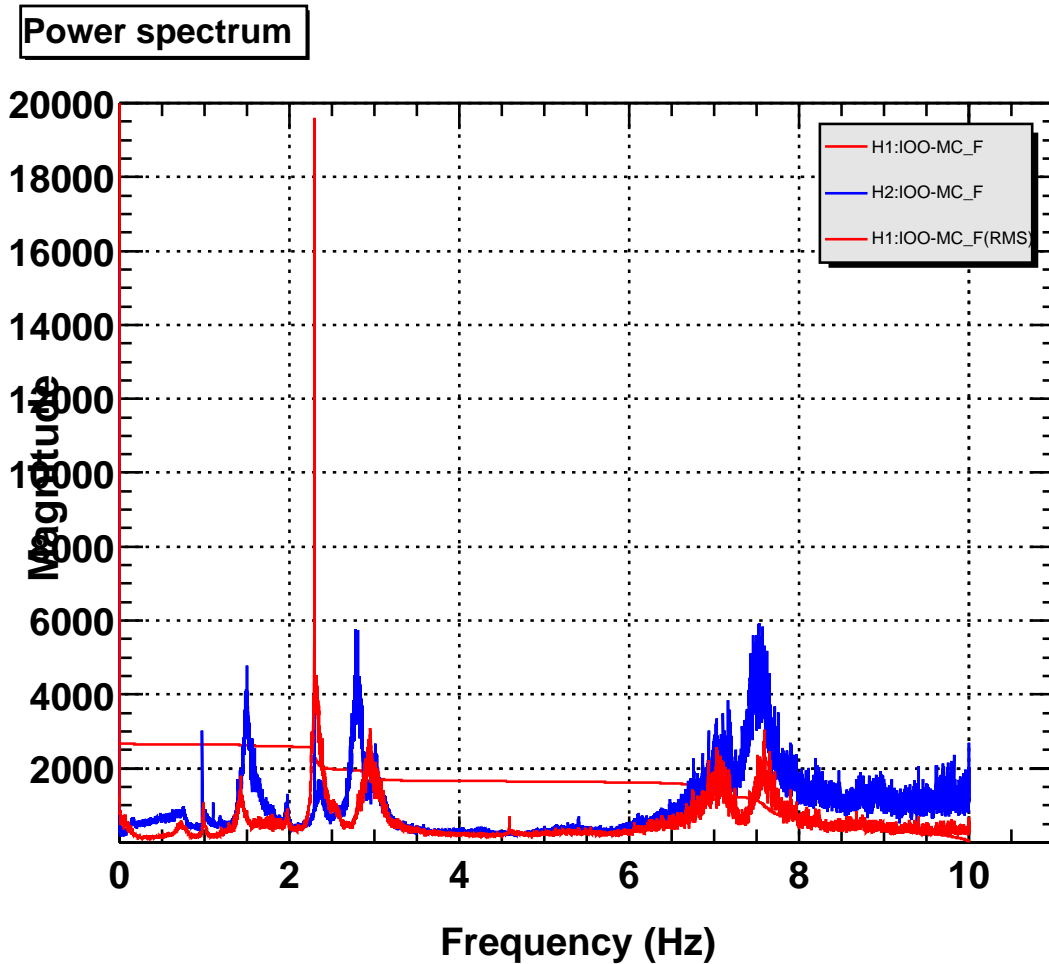
Peak at 2.295 Hz responsible for about 20% of RMS in 4k mode cleaner control

Effect since reduced by resonant gain stage, but still responsible for several percent of RMS of HAM2 coils.

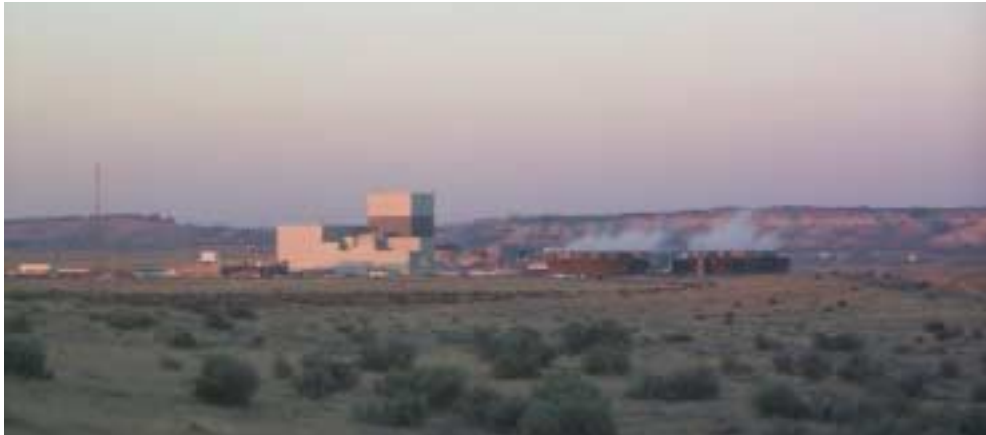
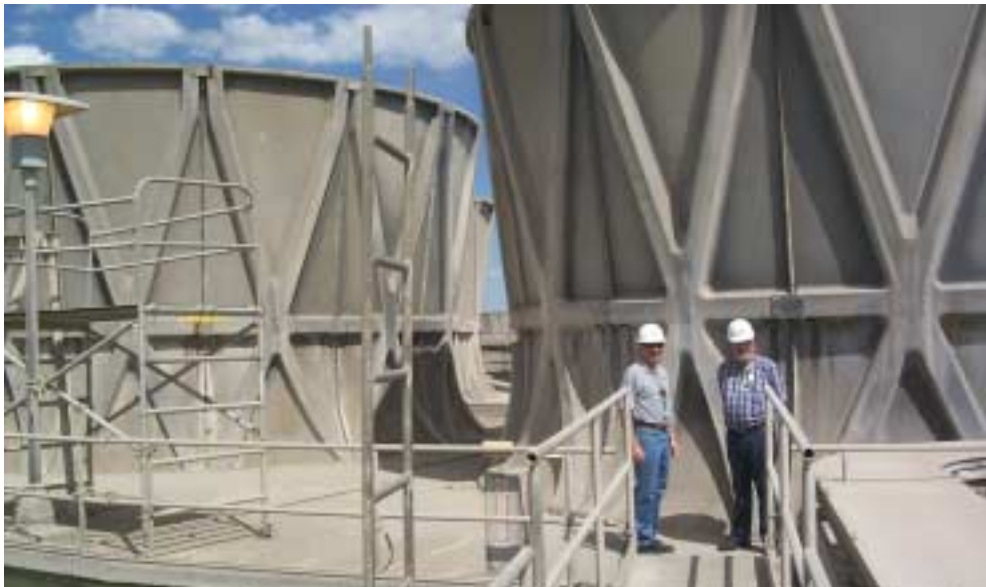
Cooling Tower Fans at ENW Nuclear Reactor

Mobile seismometer suggested cooling towers.

Motor monitors and gear-teeth ratios allowed calculation of frequency for each of 36 fans: nearly all fell within our peak.

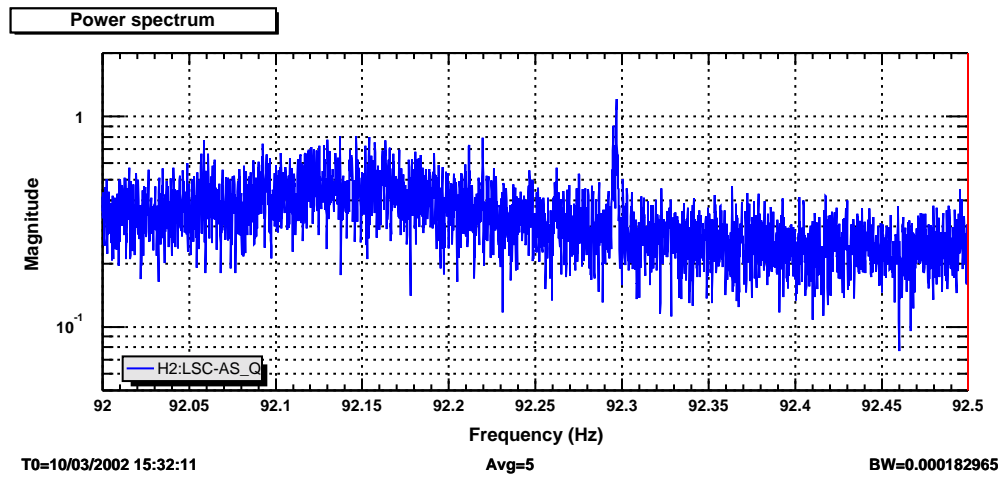
The peak at 92.295 Hz

sideband on 90 Hz injected peak

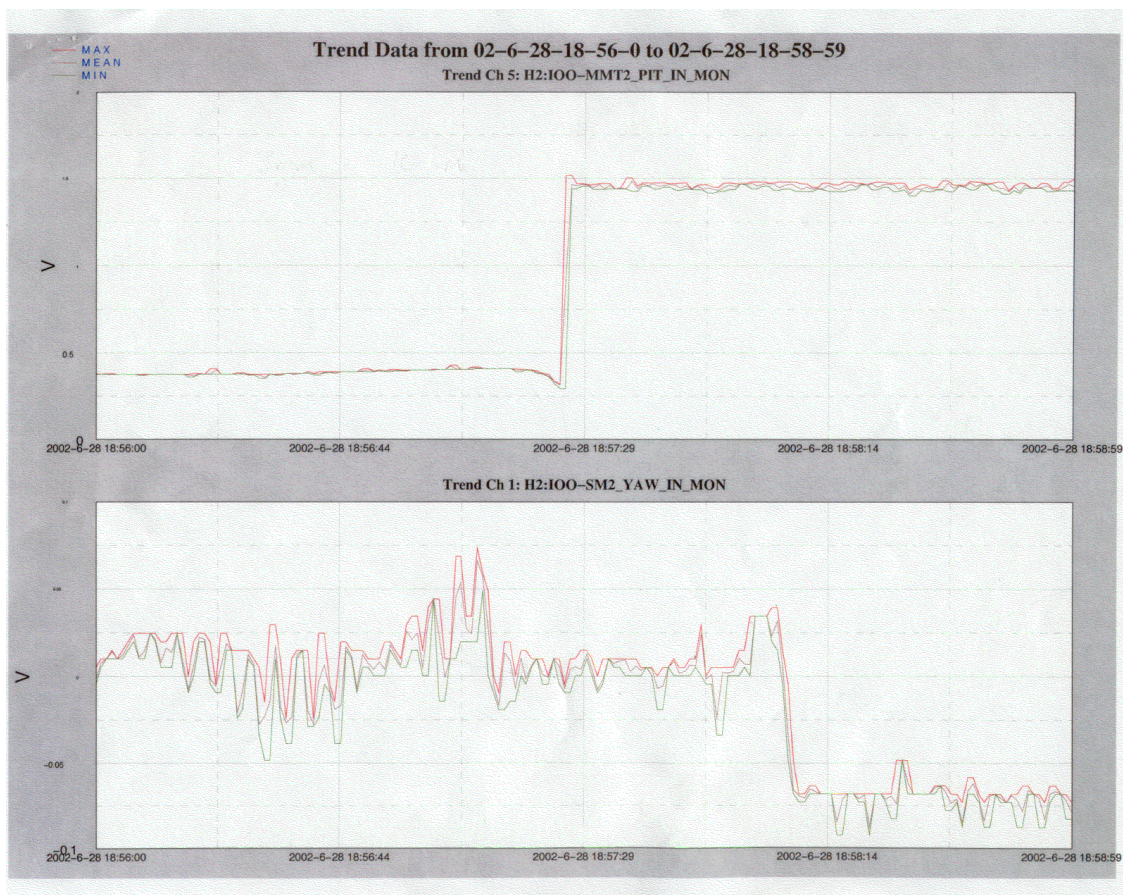
Bonus slide: SM2 Yaw During Final Moments of MMT2

Top: MMT2 pitch; bottom: SM2 yaw

Yaw appears to be offset far enough to put beam on or near wires. Motion just before drop may be a few beam diameters
