G960017-00-P

**NOTE; date on film is
not correct, these photos
were taken wk. of 2/2/96**

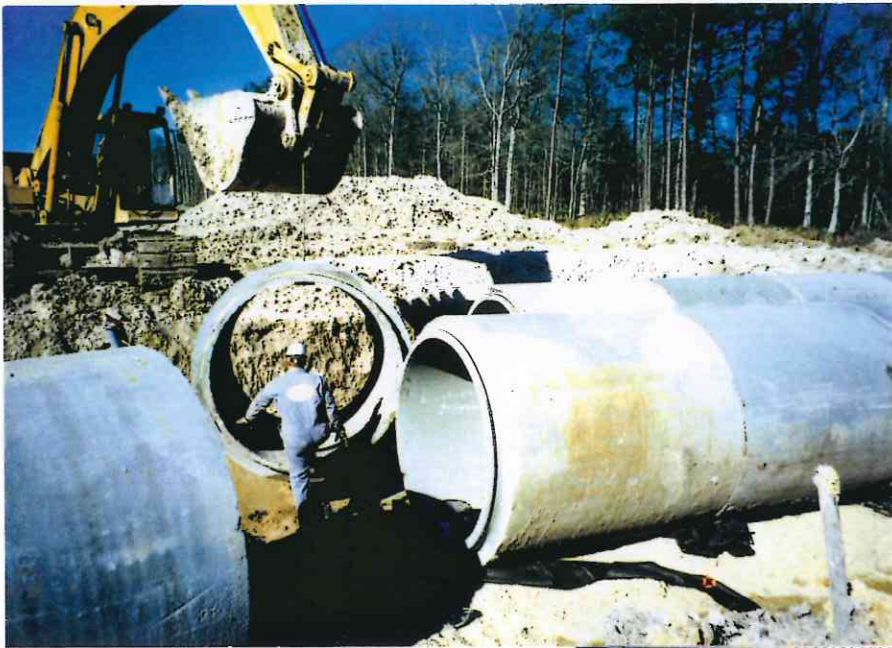
G960017-01-O-PV

1. Southwest arm ,
station 9+50 installing
72in culvert piping.

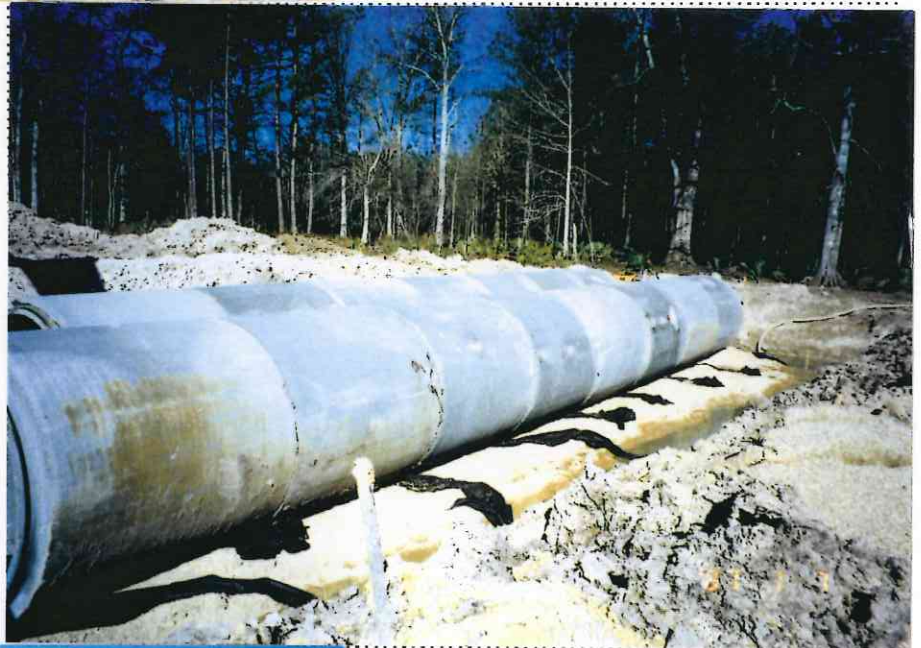
G960017-02-O-P

2. Southwest arm
station 9+50 showing
72" culvert pipe ready to
wrap joints with geotech
material.

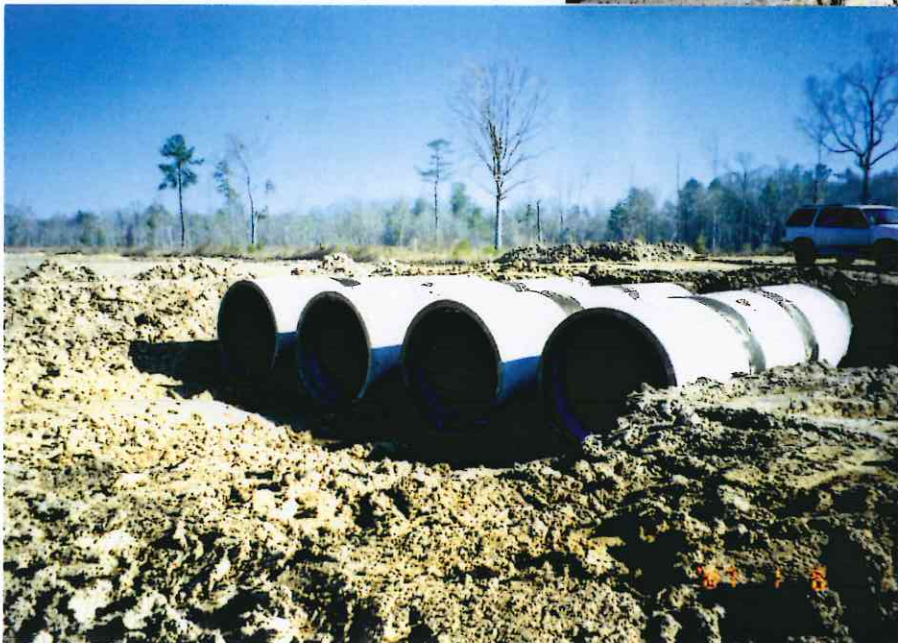
G960017-03-O-PN

3. Southeast arm , at
station 106:00 showing
72" culvert pipe .

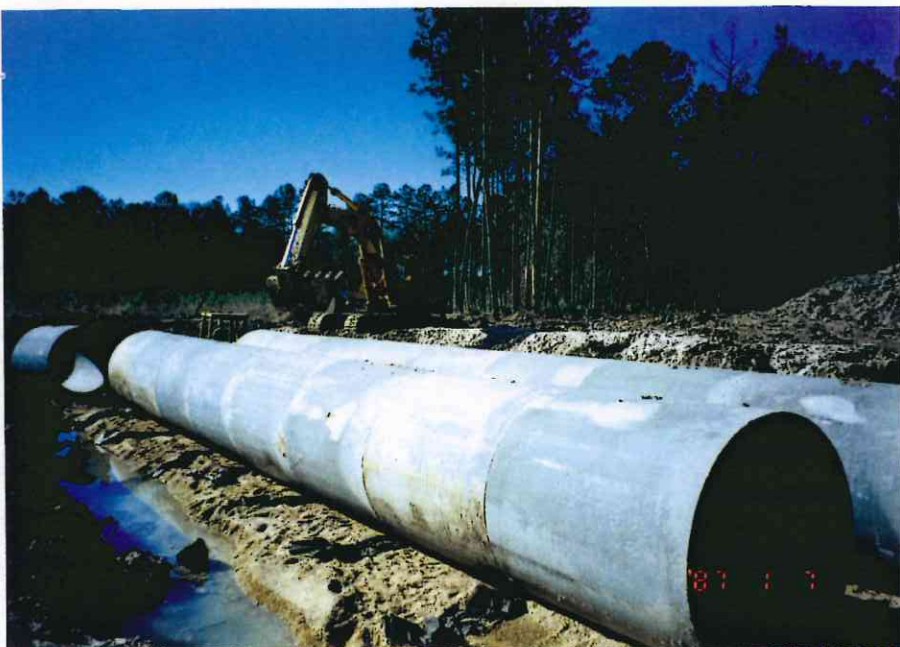
G960017-04-O-P

4. Southwest arm at station 111.00 showing 36" culvert piping on bedding.

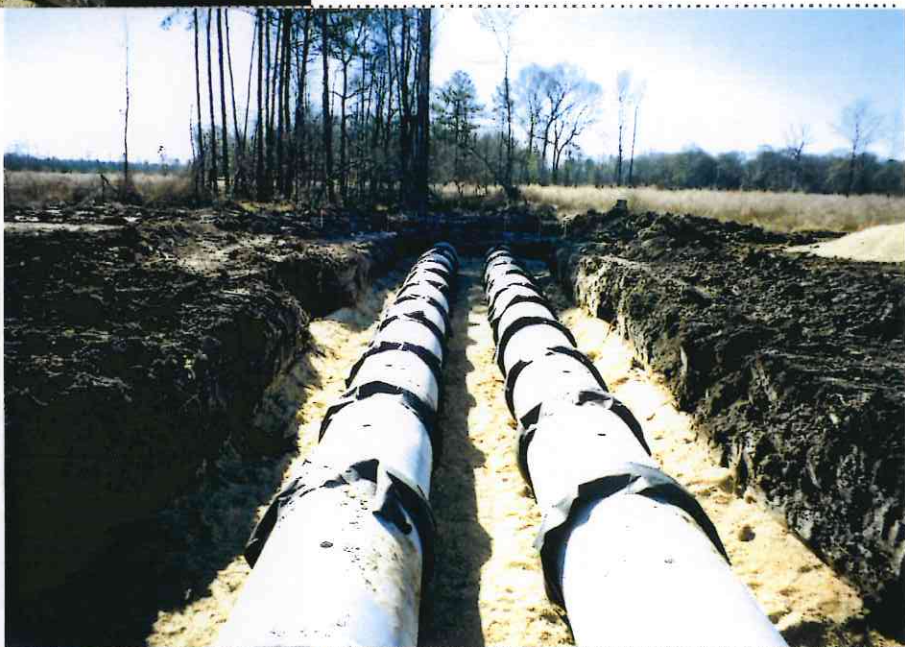
G960017-05-O-P

5. Southwest arm looking south at culvert crossing 111:00

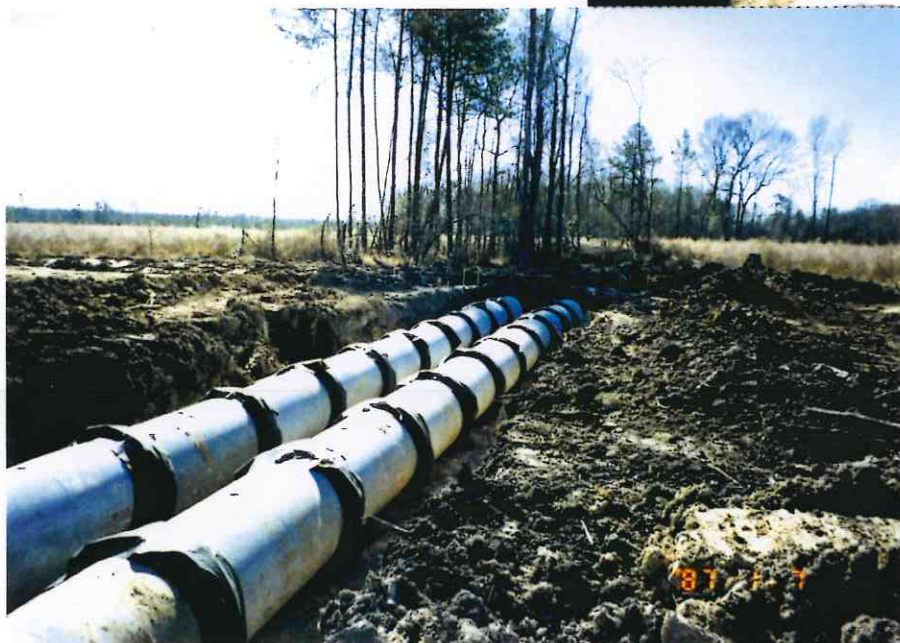
G960017-06-O-P

6. Southwest arm organic material removed from culvert crossing station 111:00

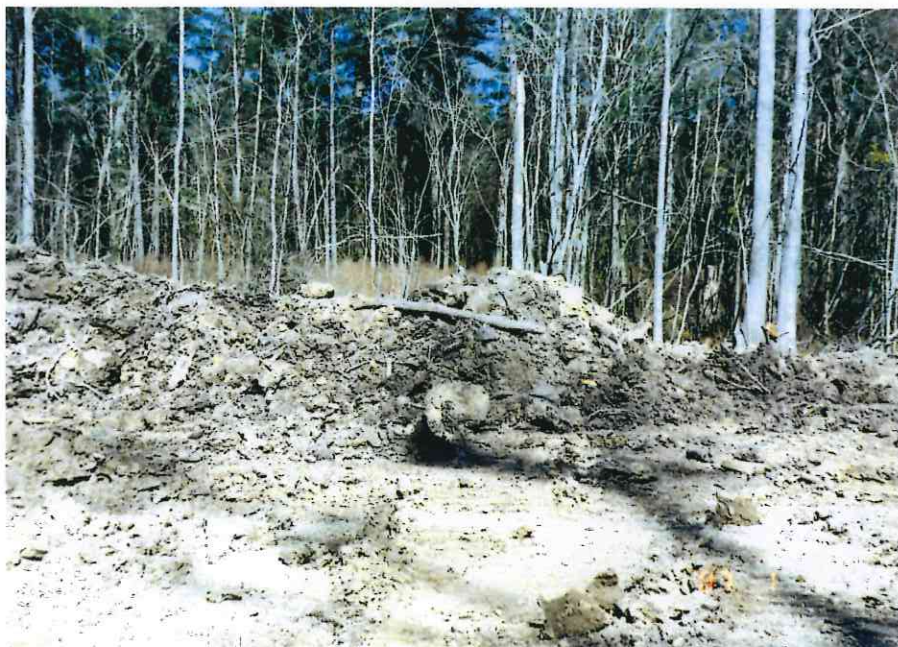
G960017-07-O-P

7. Southwest arm showing the mound of organic material removed from sta . 111:00 culvert crossing.

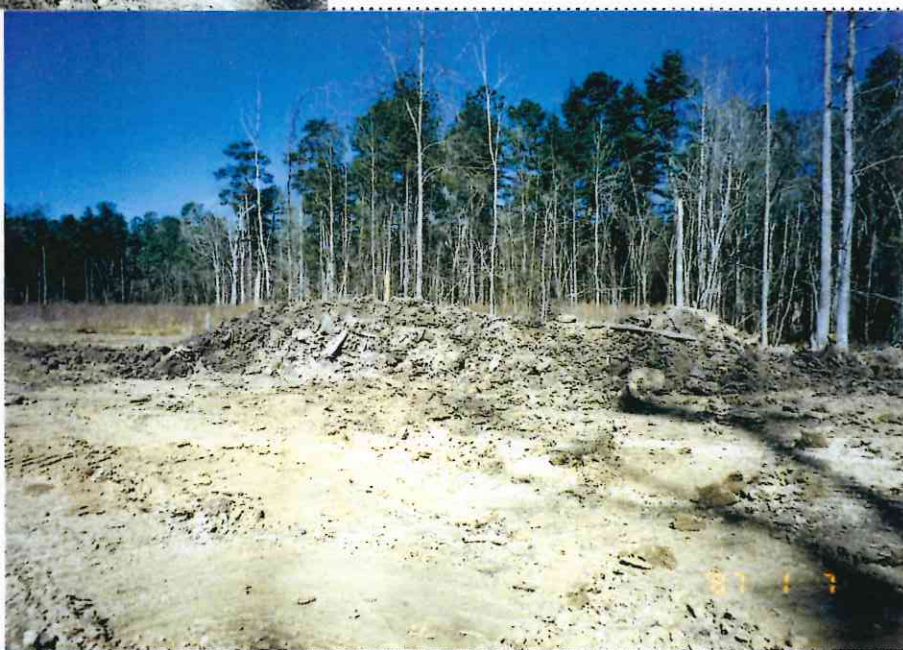
G960017-08-O-P

8. Southwest arm showing another view of organic material, sta. 111:00

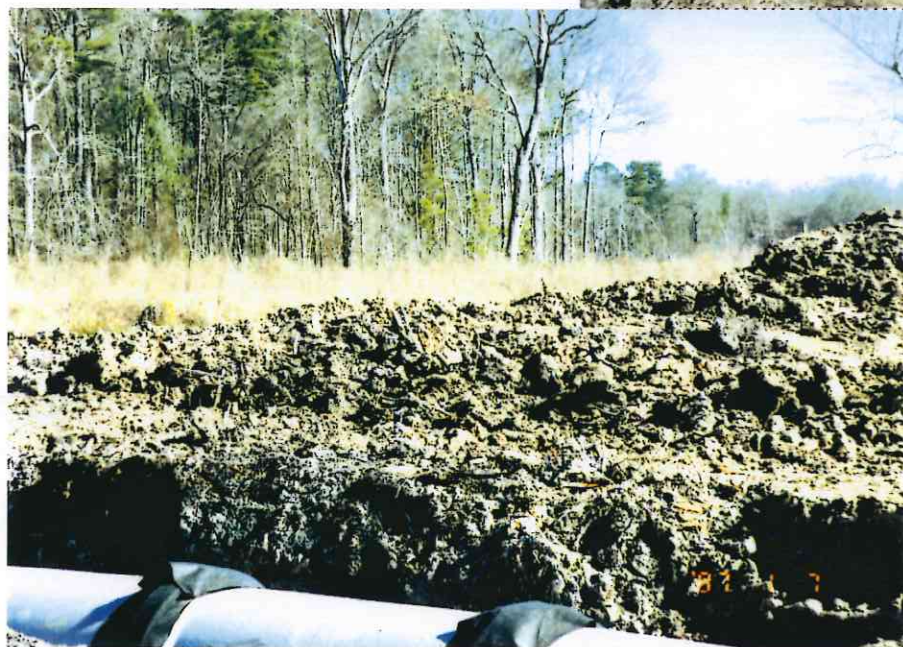
G960017-09-O-P

9. Southwest arm ,A closeup of the organic material at sta>111:00

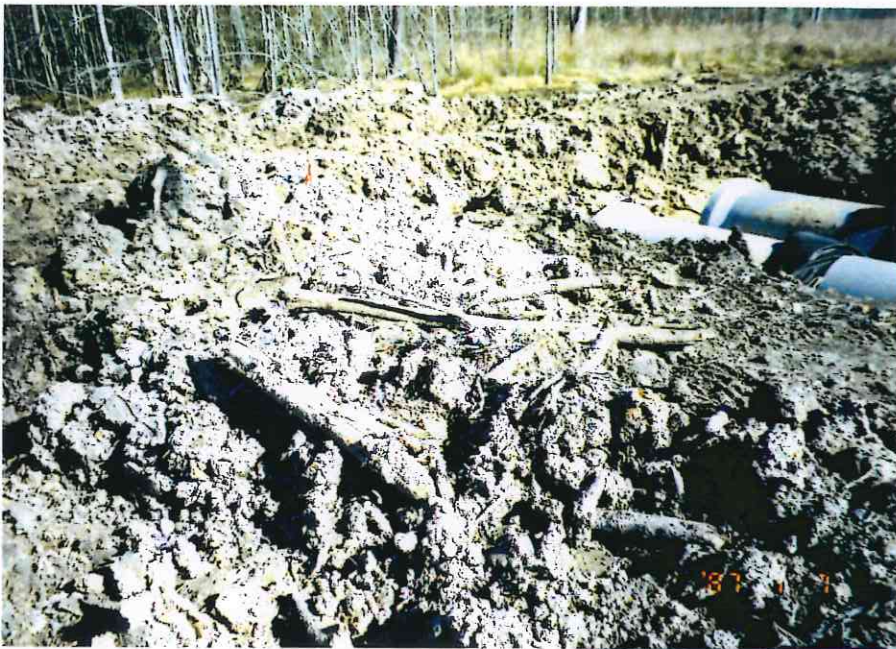
G960017-10 -O-P

10. Southwest Arm at station 111:00 a closeup view of the organic material we encounter

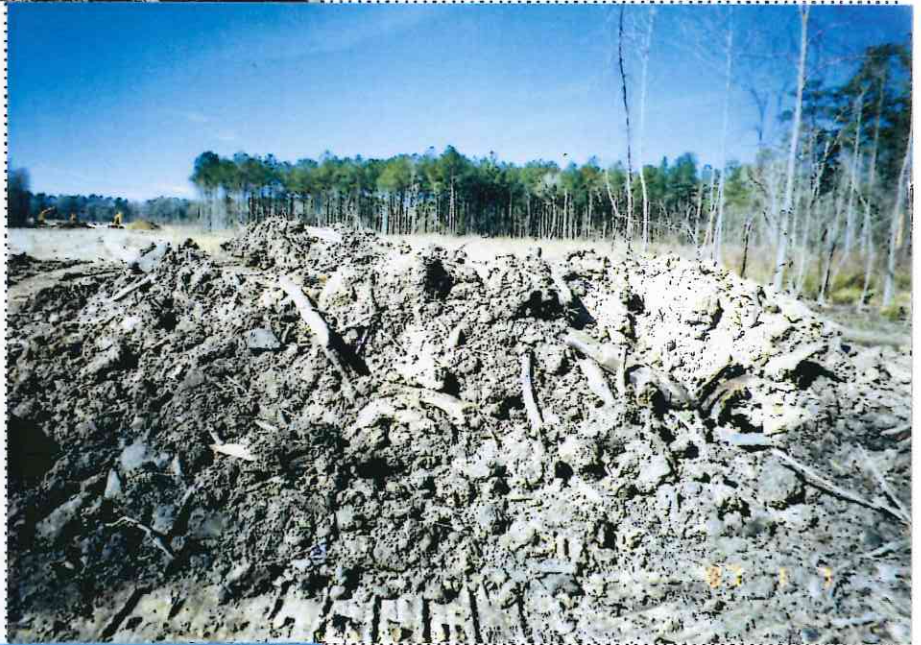
G960017-11 -O-P

11. Southwest arm showing a closeup view of organic material removed from culvert crossing at Station 111:00

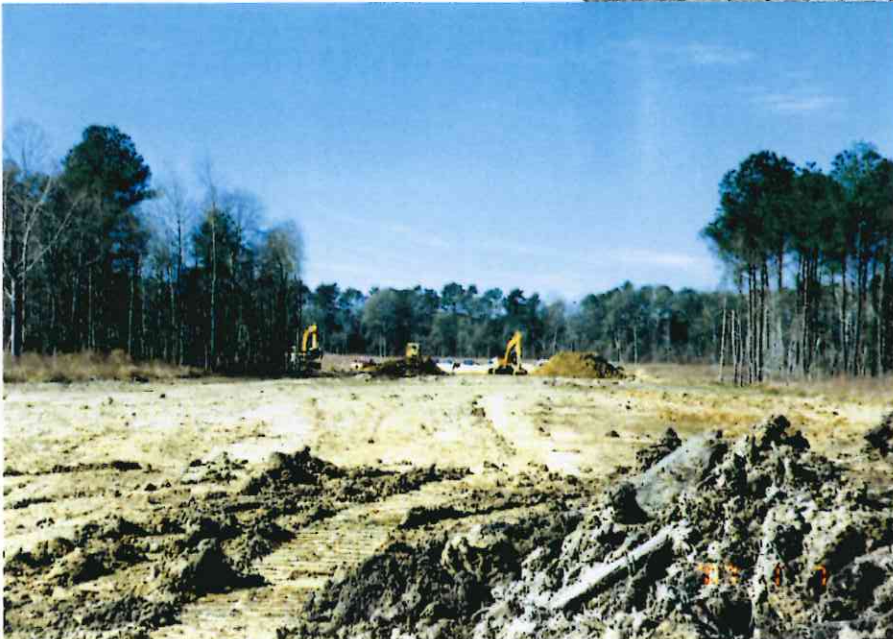
G960017-12 -O-P

12. Southwest arm standing at station 111:00 looking west at station 123:00

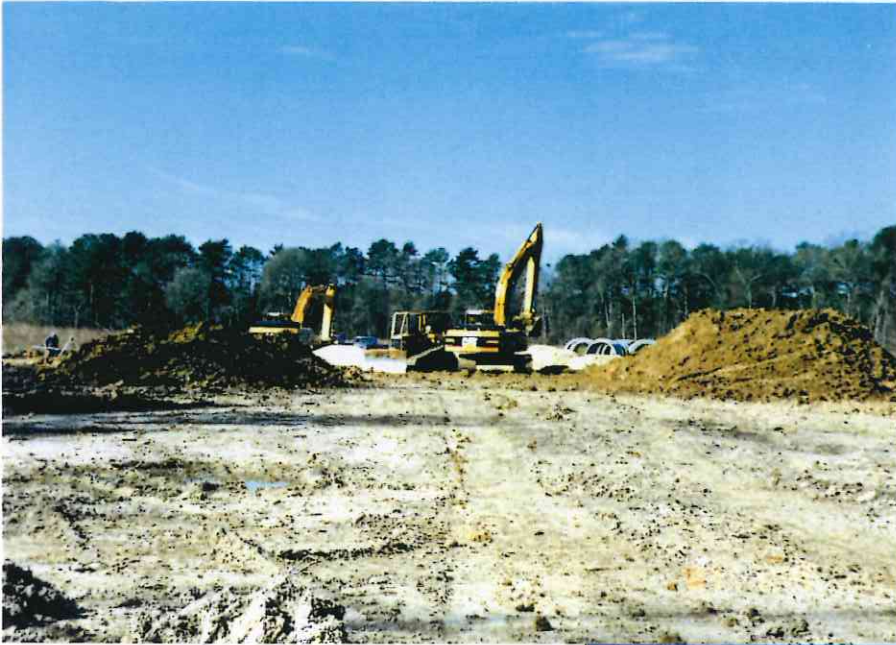
G960017-13-O-P

13.Southwest arm
excavating for the 60”
culvert pipe at station
123:00.

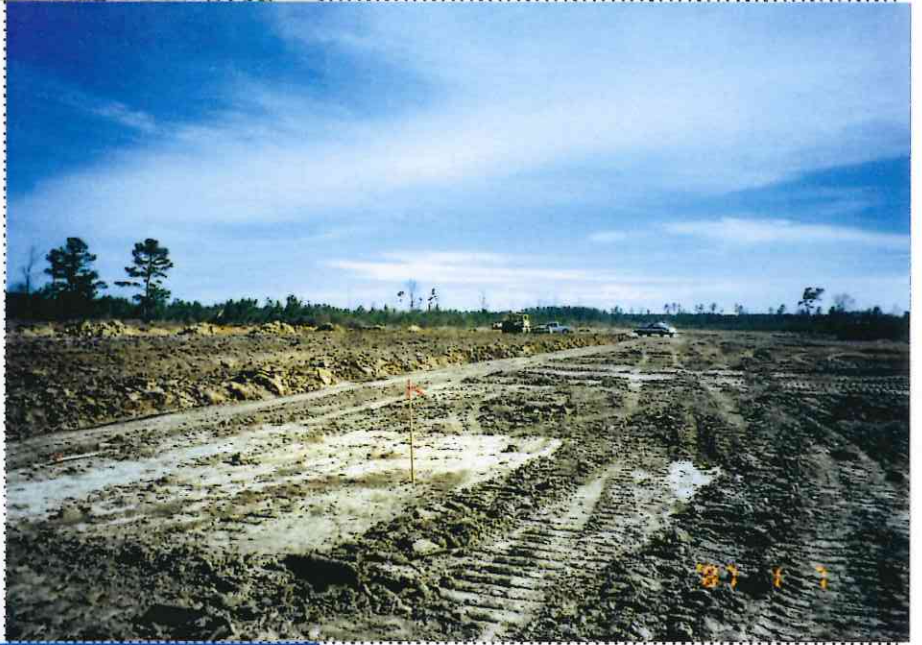
G960017-14-O-P

14. Southeast arm
Station 110:00 disking
of subbase material.

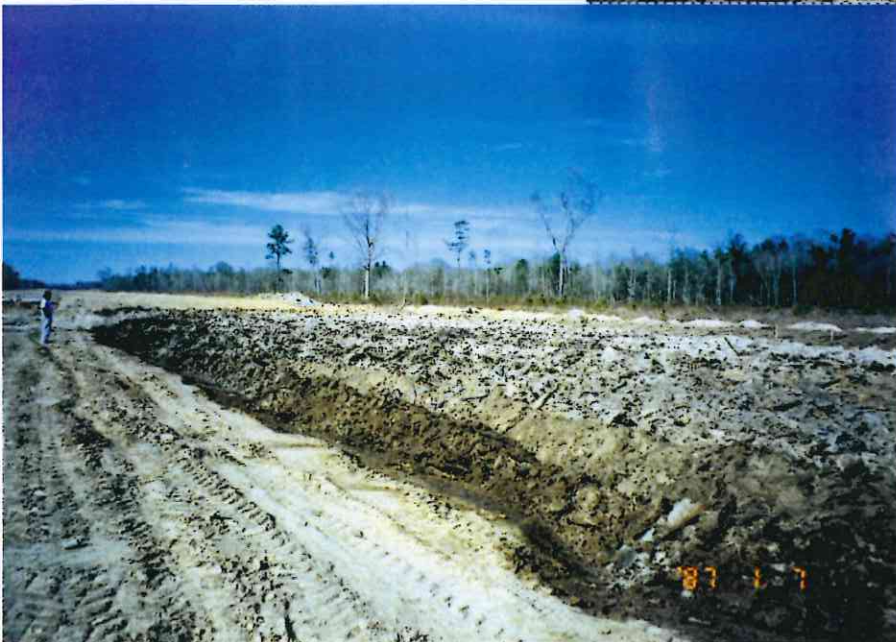
G960017-15-O-P

15.Southeast arm
between stations 107:00
and 110:00, organic
material to be removed

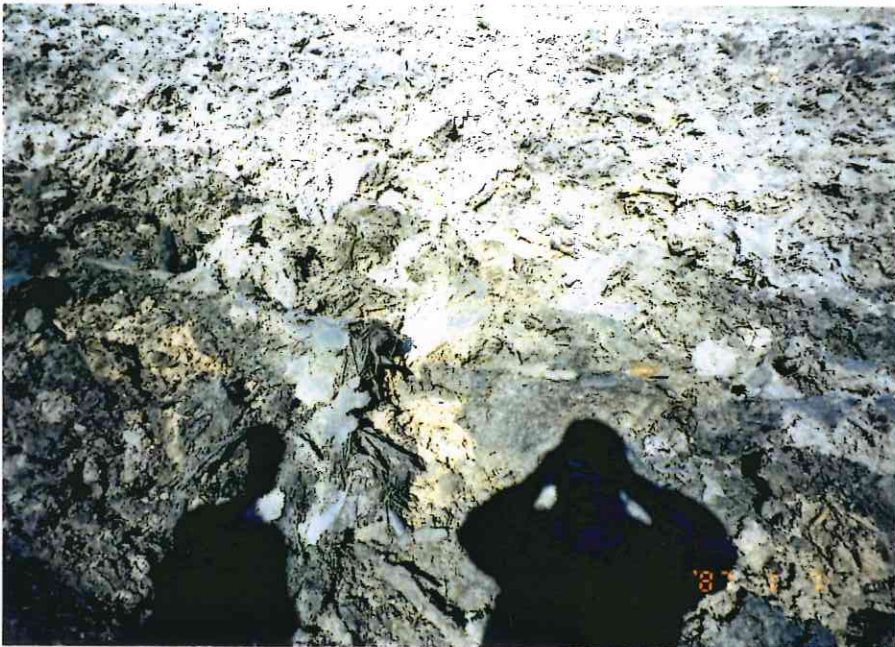
G960017-16-O-P

16. Southeast arm showing an excavated area to identify extent of organic depth, between stations 107&110,

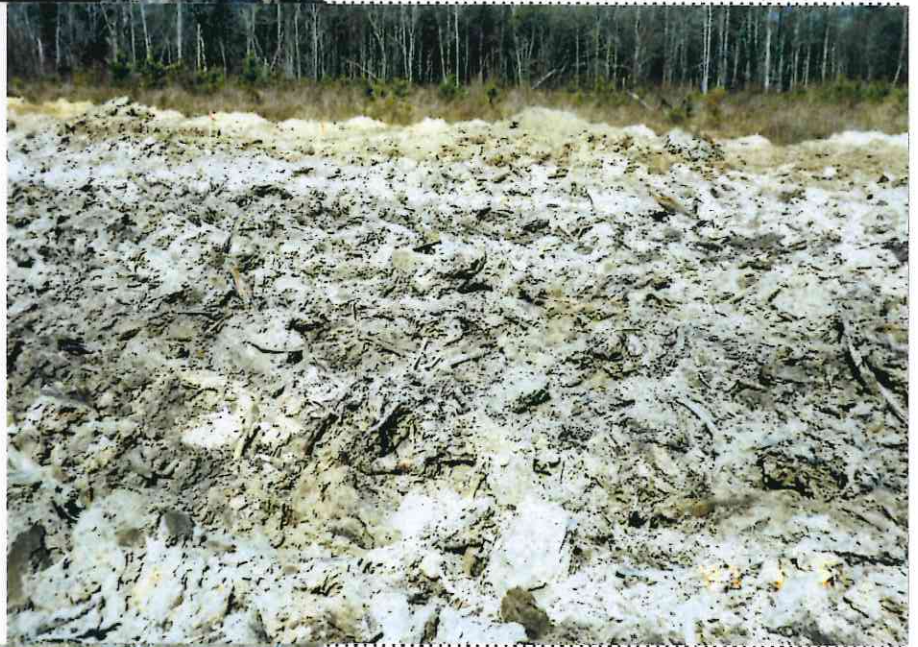
G960017-17-O-P

17. A close up view of the organic material between stations 107&110

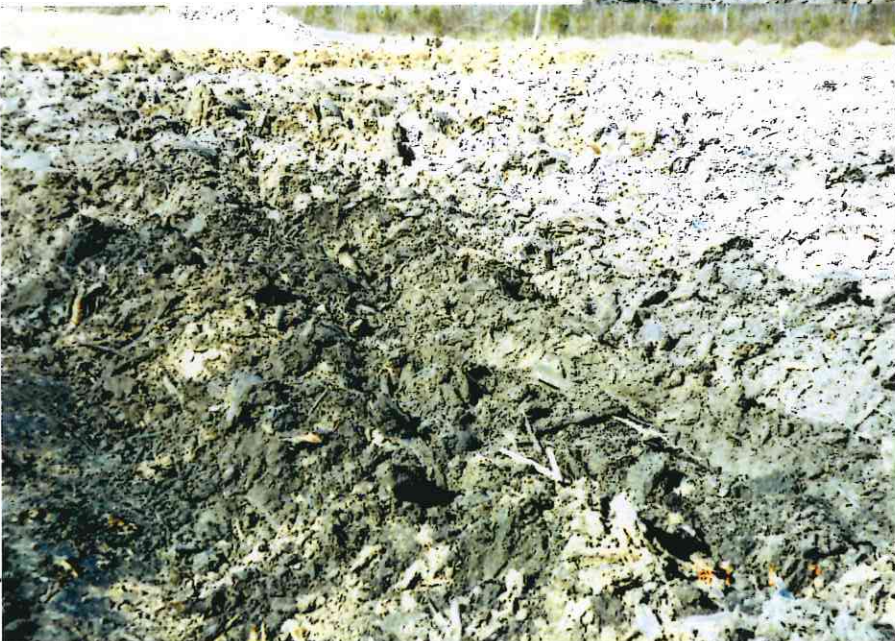
G960017-18-O-P

18. A close up view of the organic material between stations 107&110.

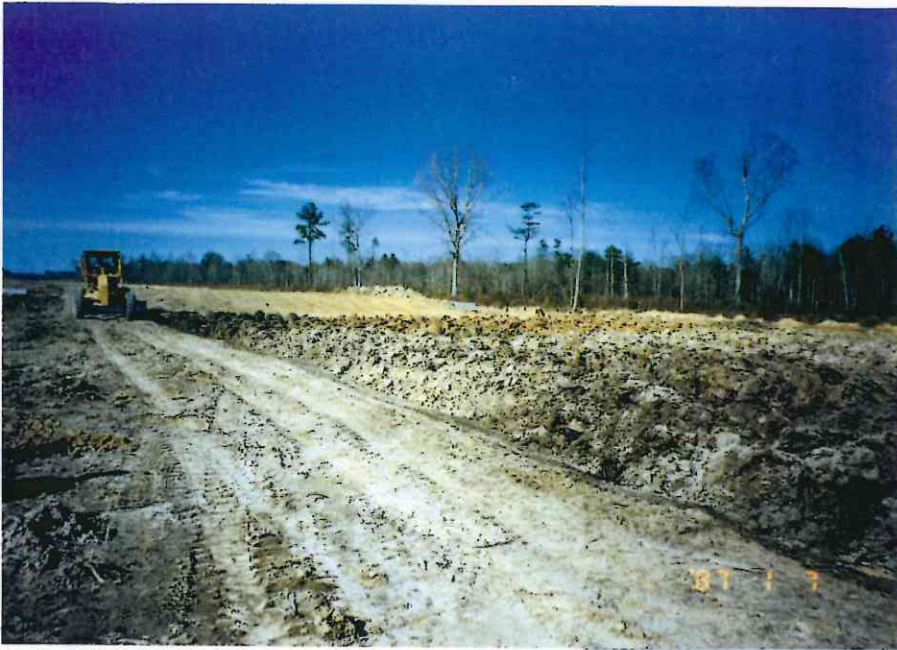
G960017-19 -O-PV

19.Southwest arm showing grader wind rowing area of organic material .

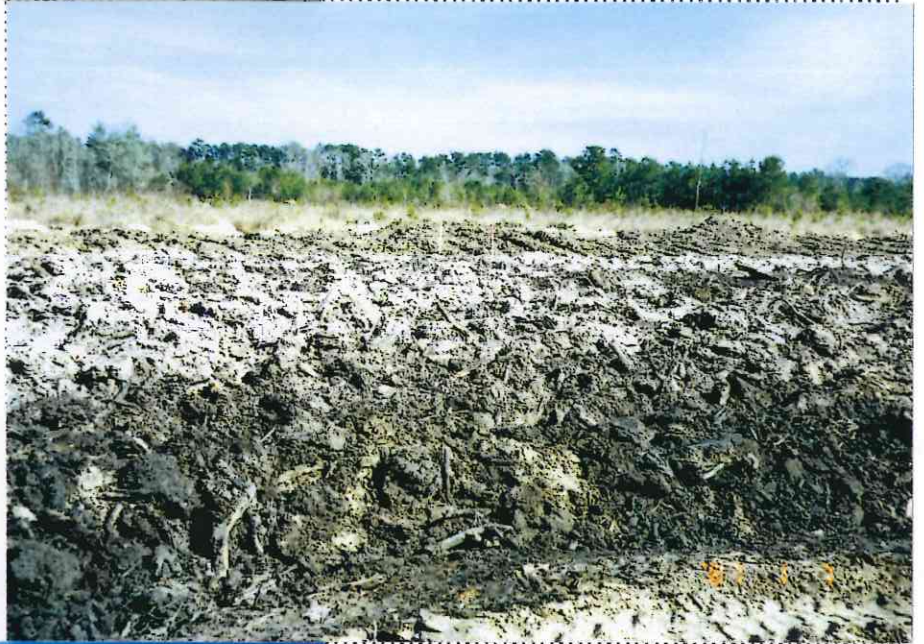
G960017-20-O-P

20. Another view of organic material to show extent at stations 107&110 southwest arm..

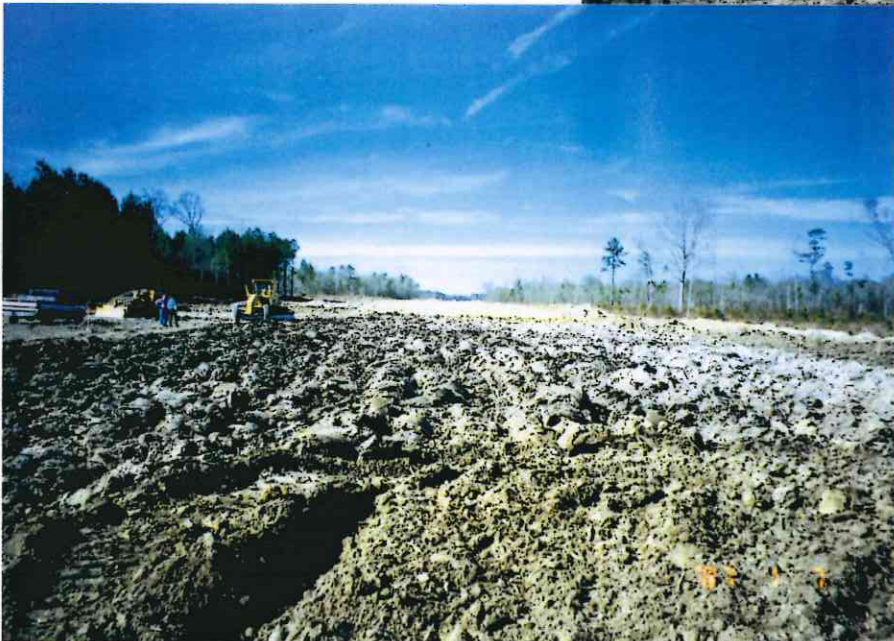
G960017-21 -O-P

21. This is the same area but a different view to help show the extent.

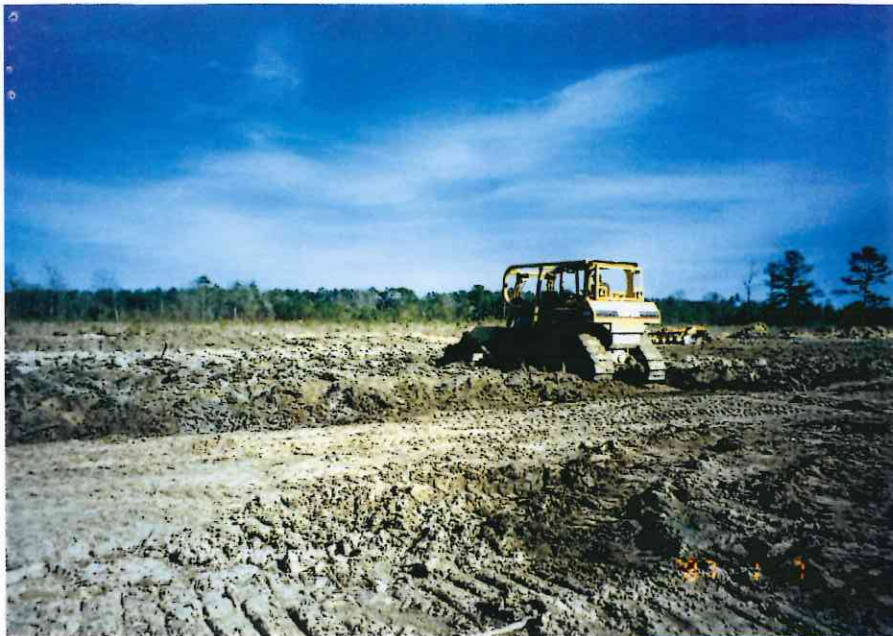
G960017-22-O-P

22. Removing organic material stations 107 & 110, SW arm.

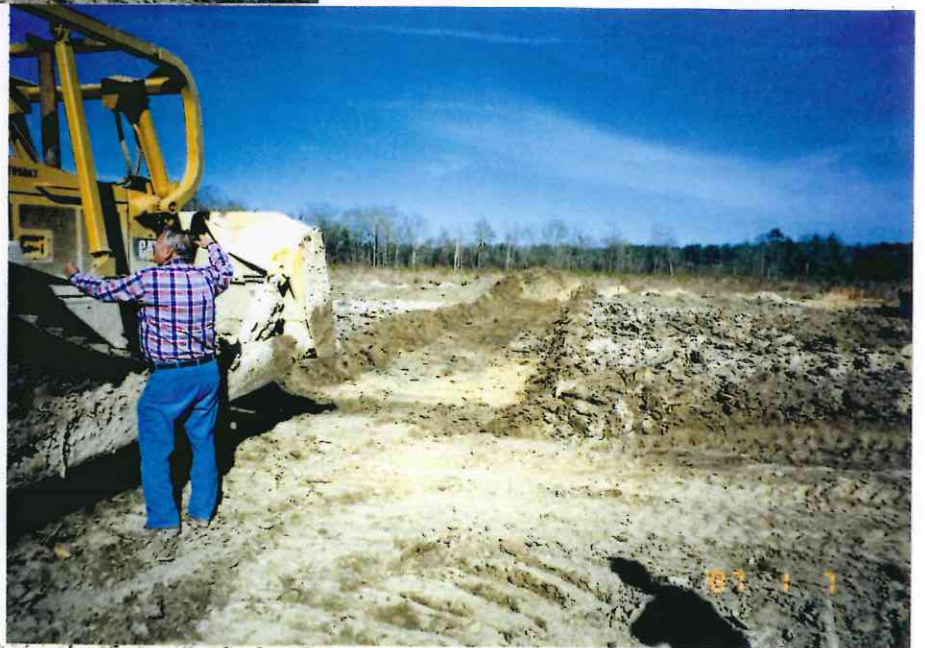
G960017-23-O-P

23. Southeast arm showing mean depth of organic material approx. 24" SE arm station 110:

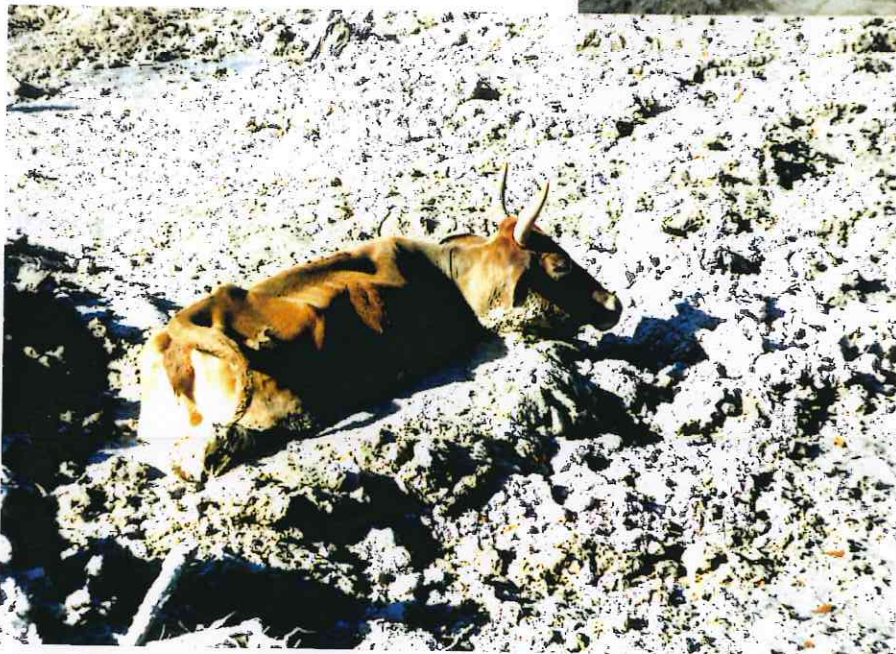
G960017-24-O-PVNE

24. Southwest Arm at station 9:50 conducting moisture content test of the soil. The cow was removed and is now traveling well.
