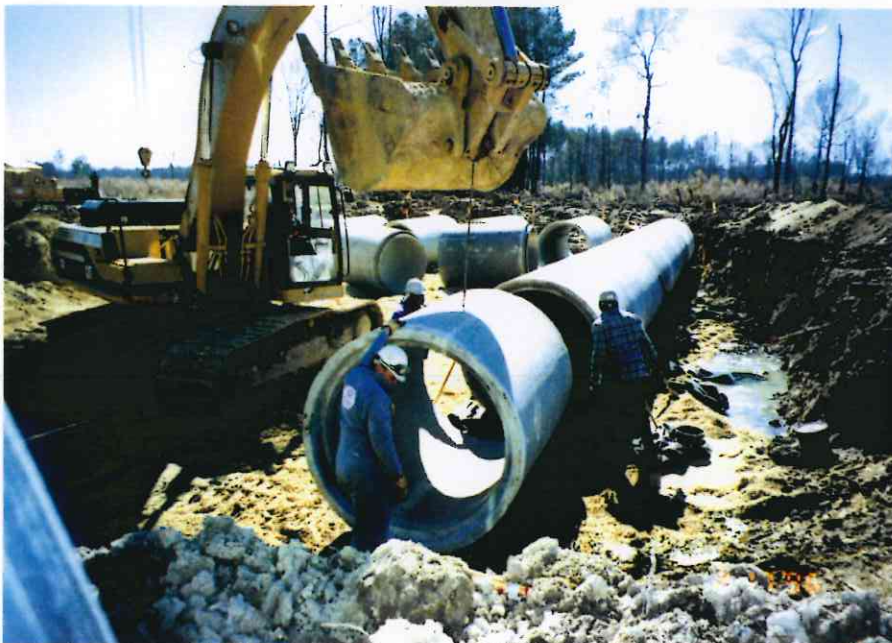
G960024-03-O-P

3. Installing 60" culvert pipe at crossing 44+60, Southwest arm.

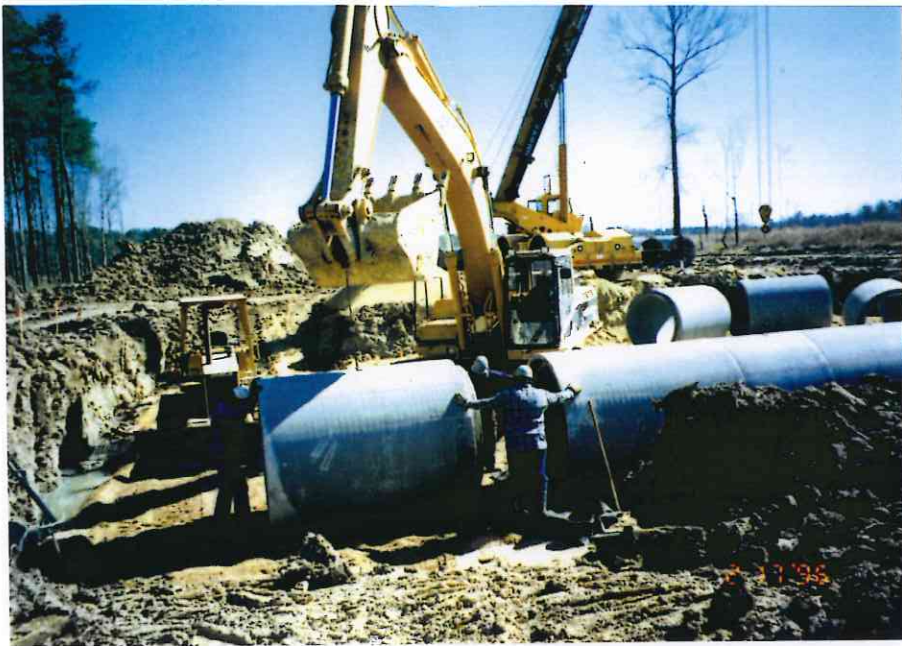
G960024-04-O-P

4. Southwest arm , at Station 60+00, installing 60" culvert pipe.

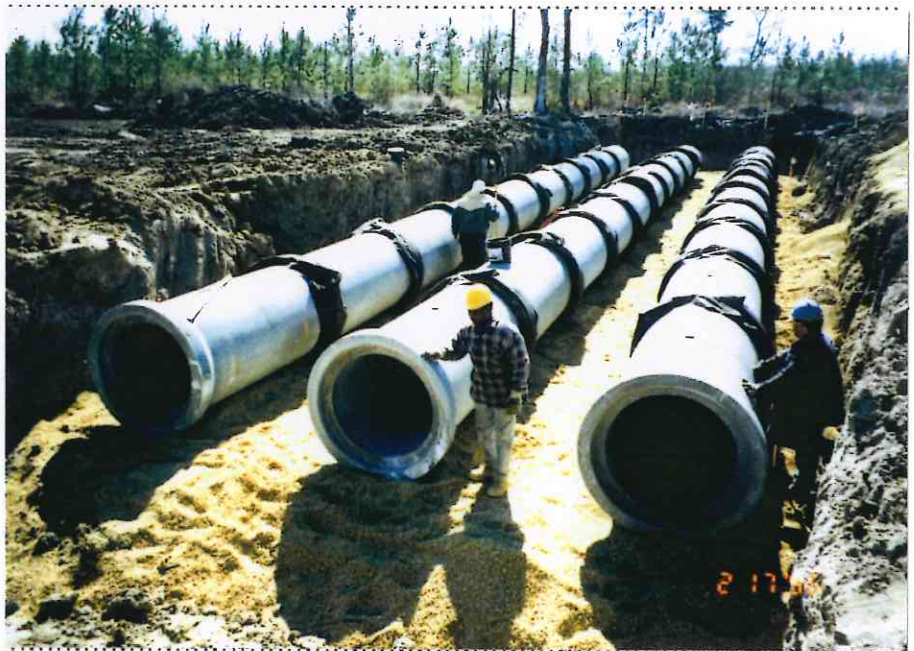
G960024-05-O-PV

5. Southwest arm at Station 60+00 getting ready to start backfilling.

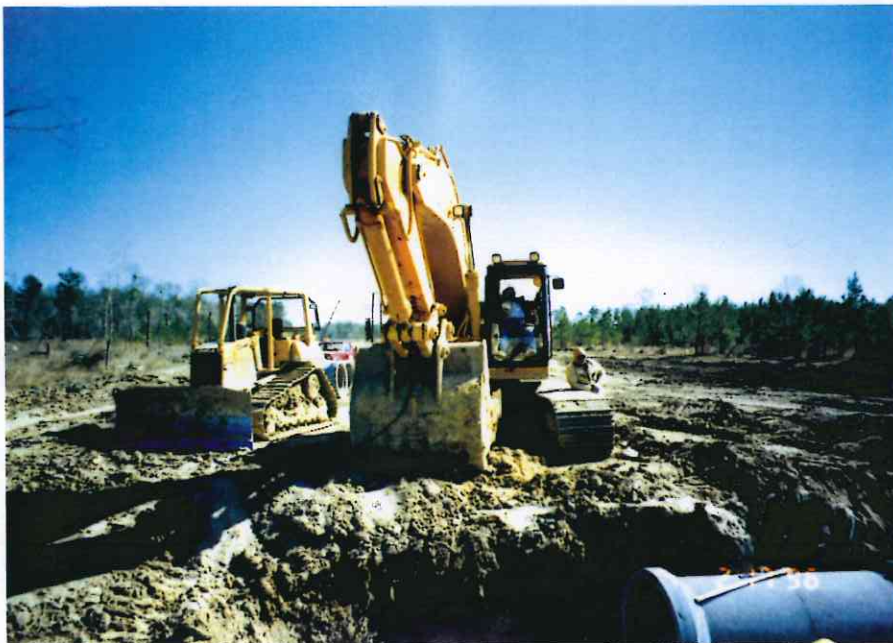
G960024-06-O-P

6 Southwest arm at station 60+00 starting to backfill

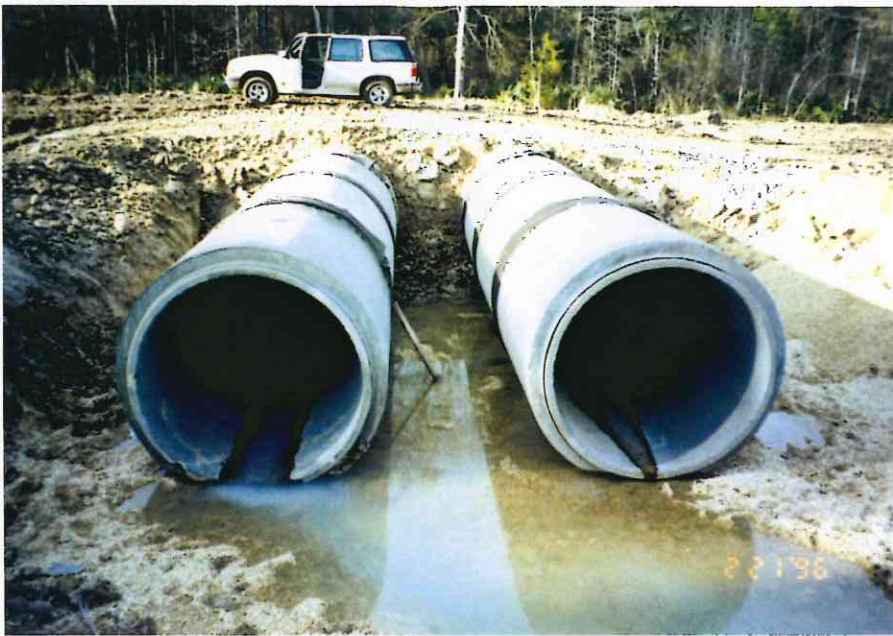
G960024-07-O-P

7.Southwest arm at station 9+50 showing cross section of backfill

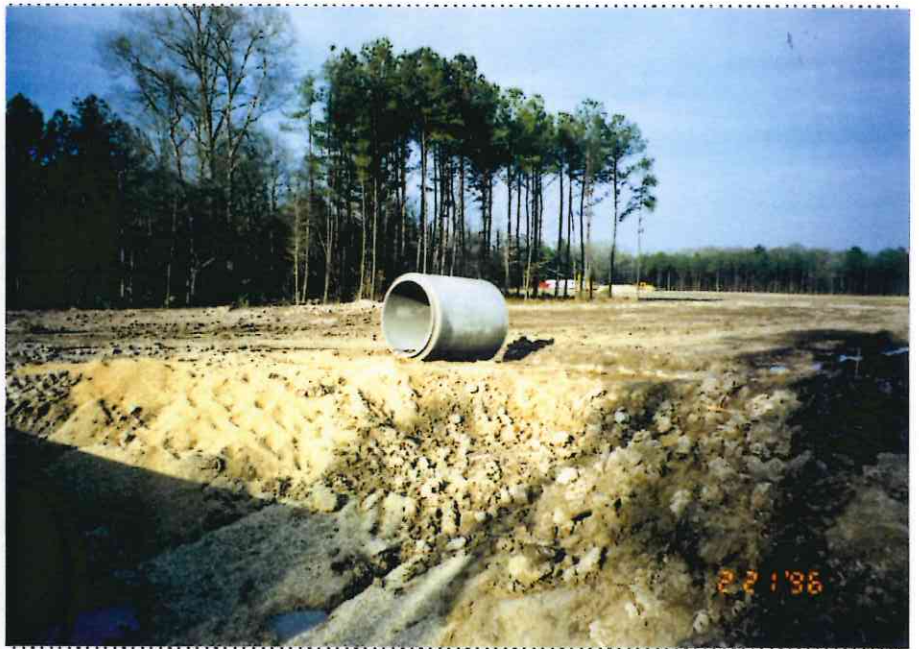
G960024-08-O-P

8.Southwest arm at station 9+50 a section of replacement pipe.

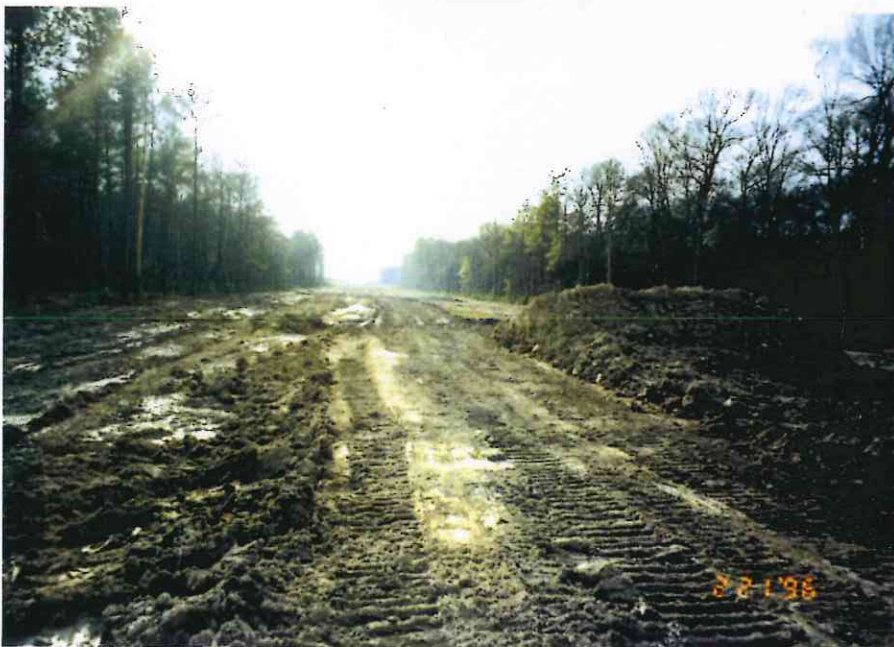
G960024-09-O-P

9.Southwest arm at station,44+60 the access road down the center of right of way

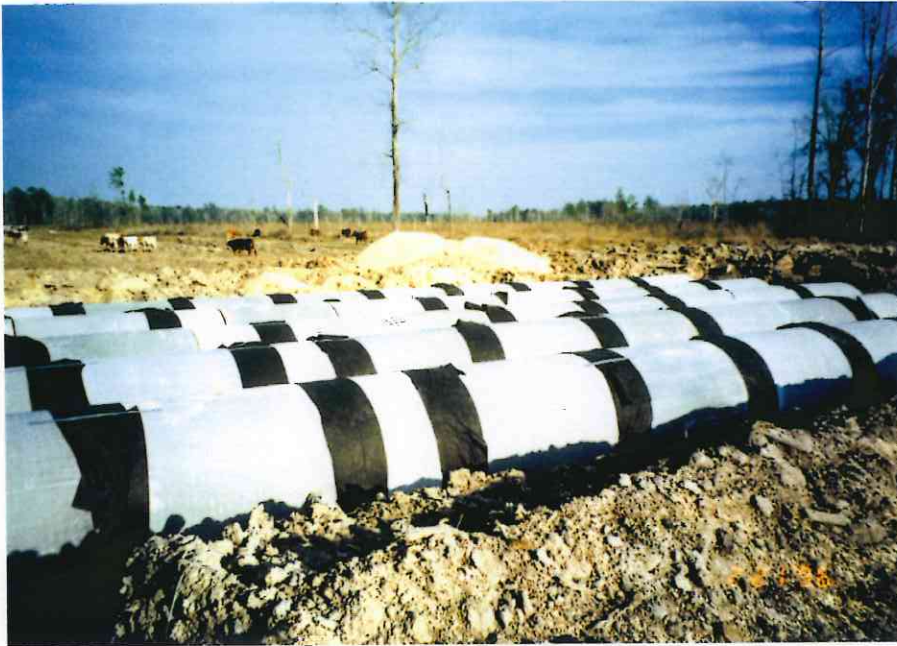
G960024-10 -O-P

10. Southwest arm at station 44+60 showing culvert pipe being prepared for backfill

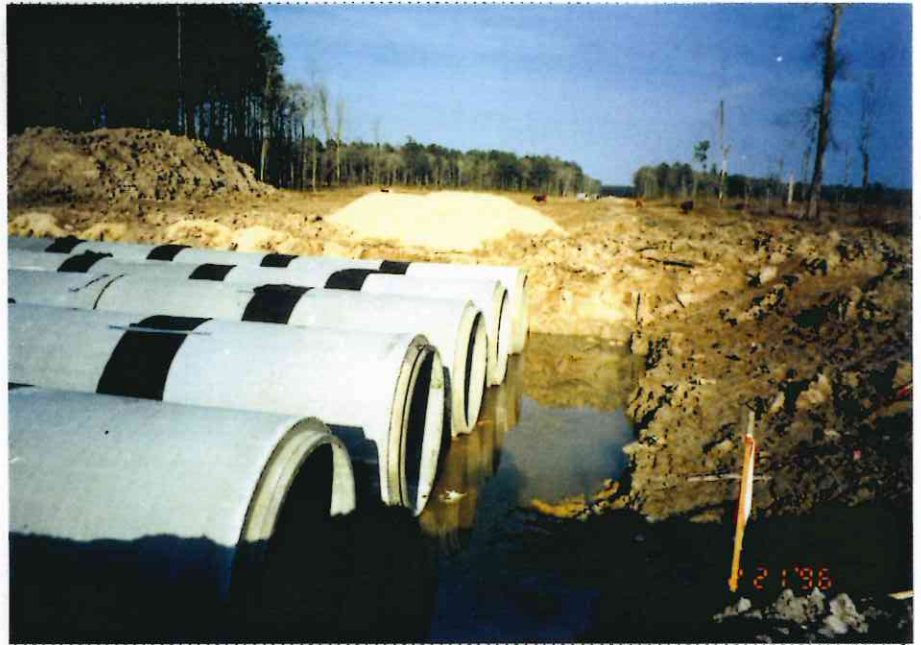
G960024-11 -O-P

11. Southwest arm at station 44+60 showing the ends of pipe

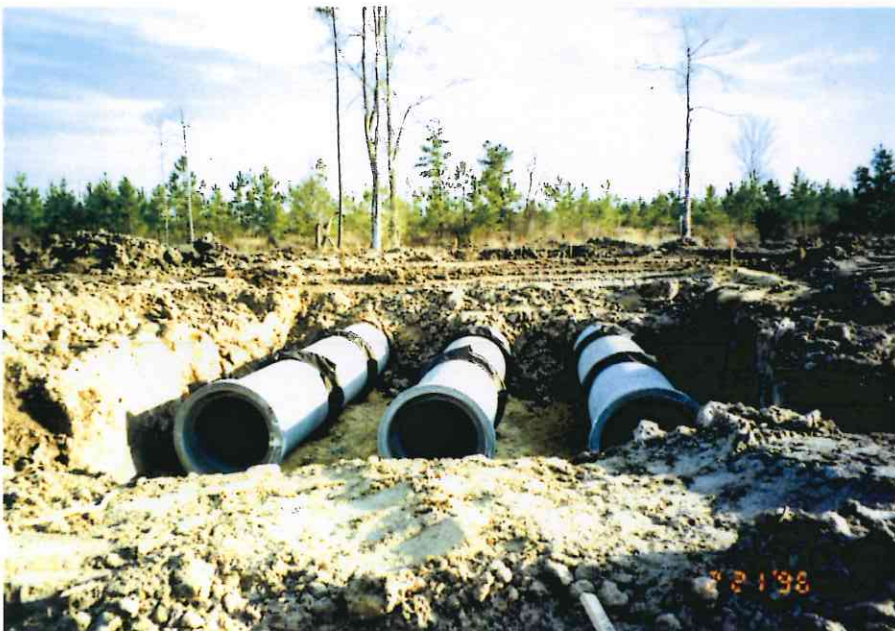
G960024-12 -O-P

12. Southwest arm at station 60+00 showing cross section of backfill

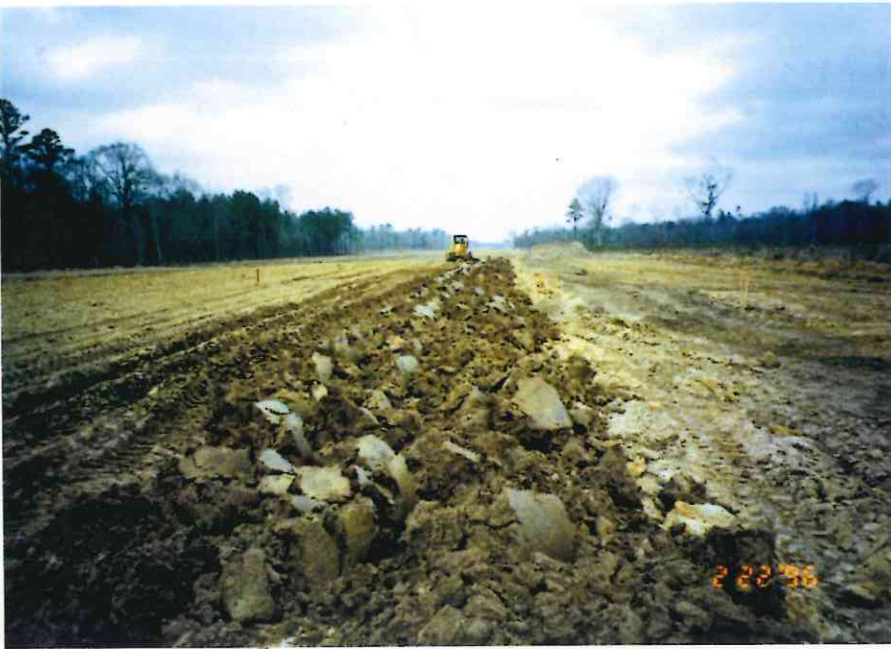
G960024-13 -O-PV

13. Southeast arm about station 113 looking north, disking berm

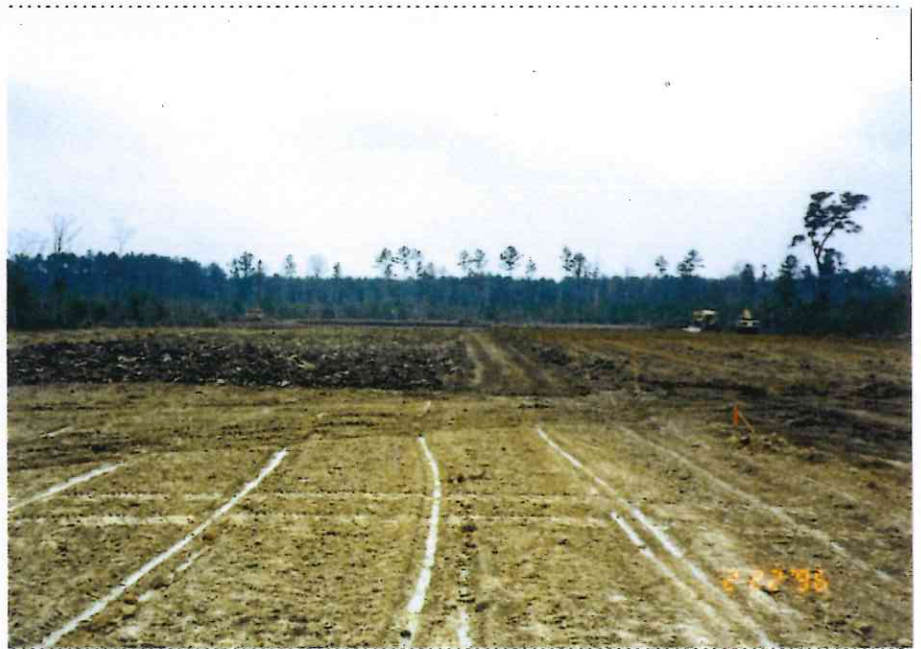
G960024-14 -O-PV

14. Southeast arm at station 115+00 looking south at disking berm material to remove moisture.

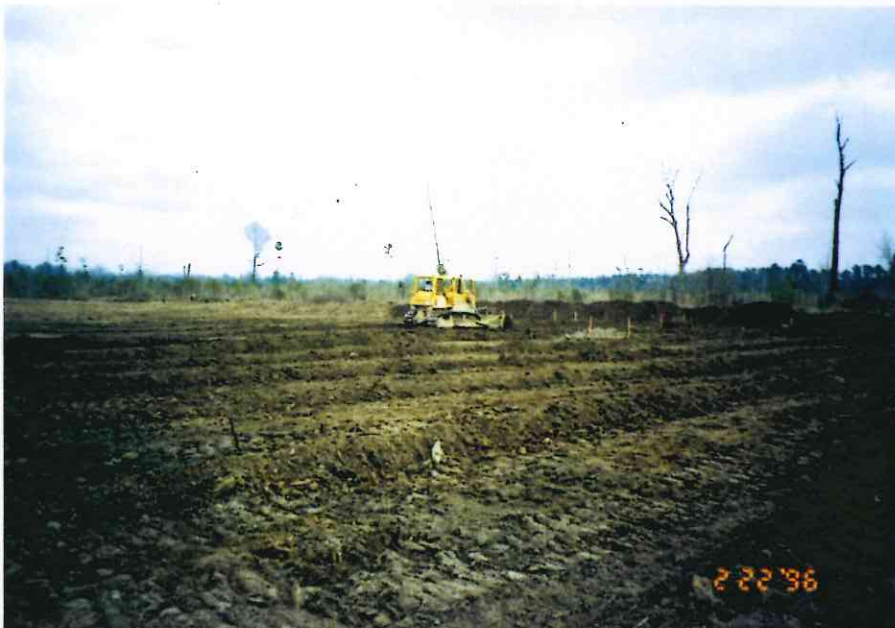
G960024-15 -O-P

15. Southeast arm at station 112+00 dozing organic material to the side.

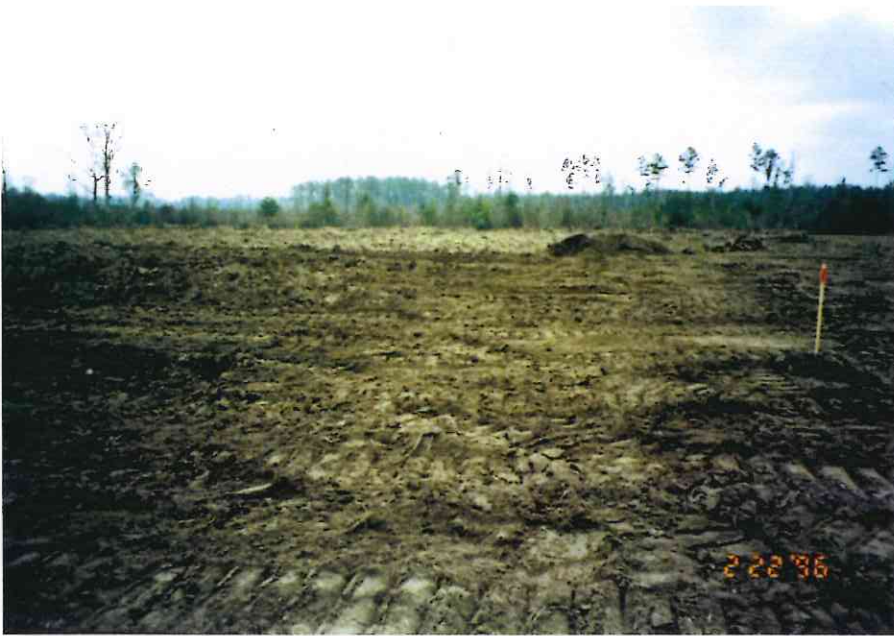
G960024-16 -O-P

16.Southeast arm at station 112+00 showing organic material

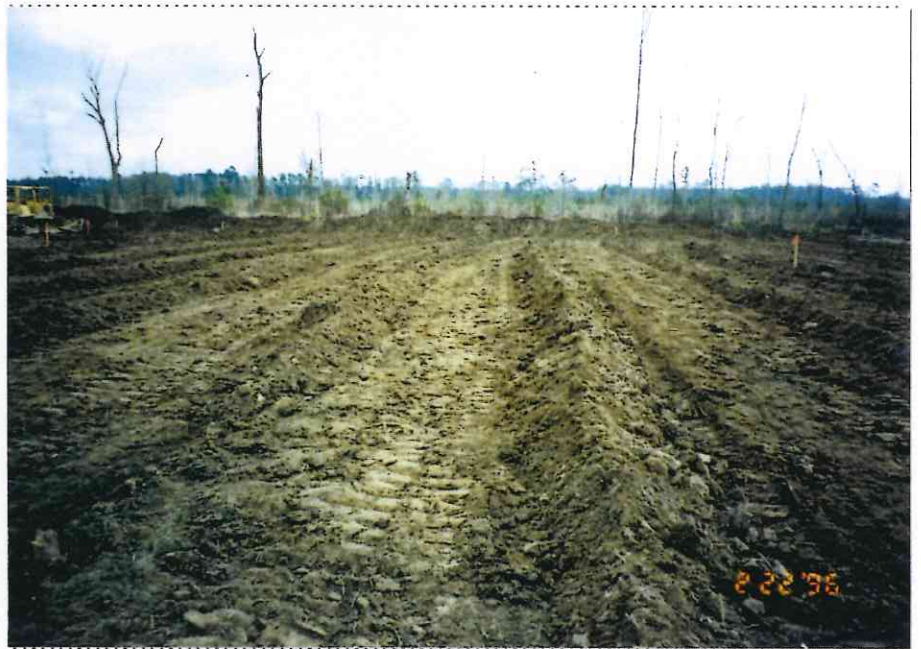
G960024-17 -O-PV

17.Southeast arm at station 111+00 a closer look at the organic material

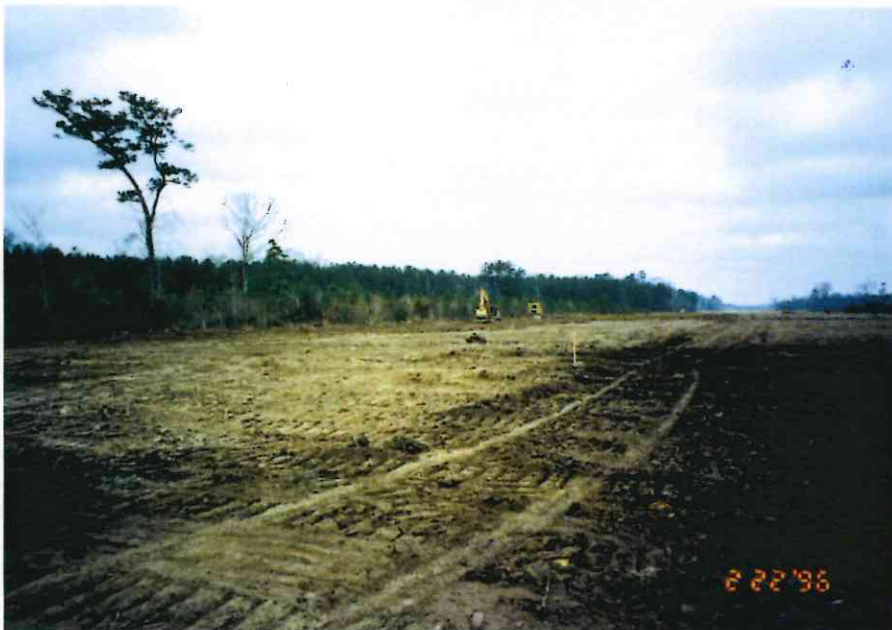
G960024-18 -O-P

18.Southeast arm at station 118 looking north showing contrast of organic material

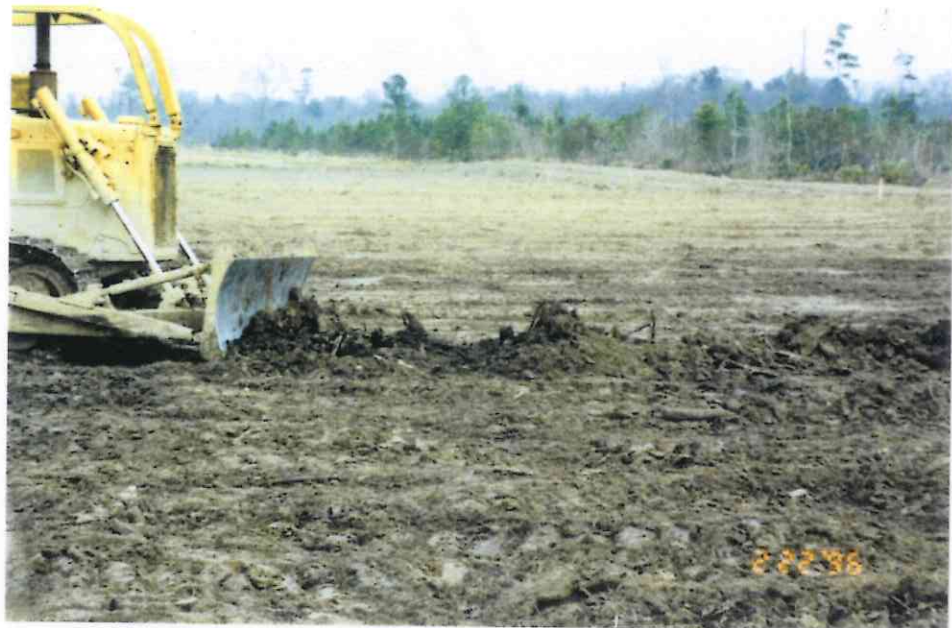
G960024-19 -O-P

19. Southeast arm at station 112 looking northeast, compacted berm.

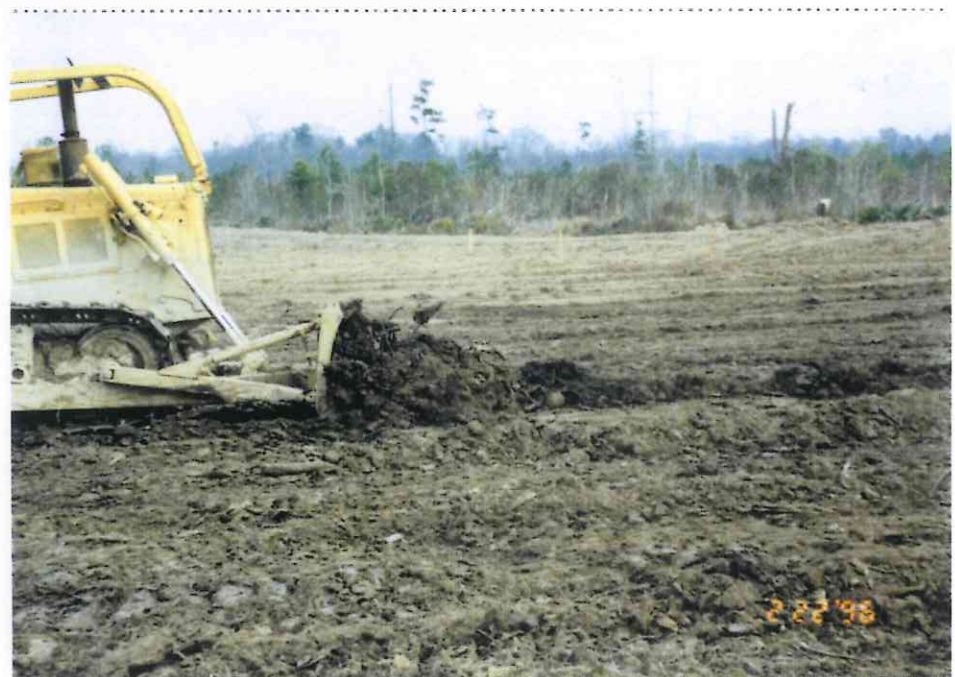
G960024-20-O-P

20. Southeast arm at station 115 showing a close up of removing organic material.
