G960032-

1

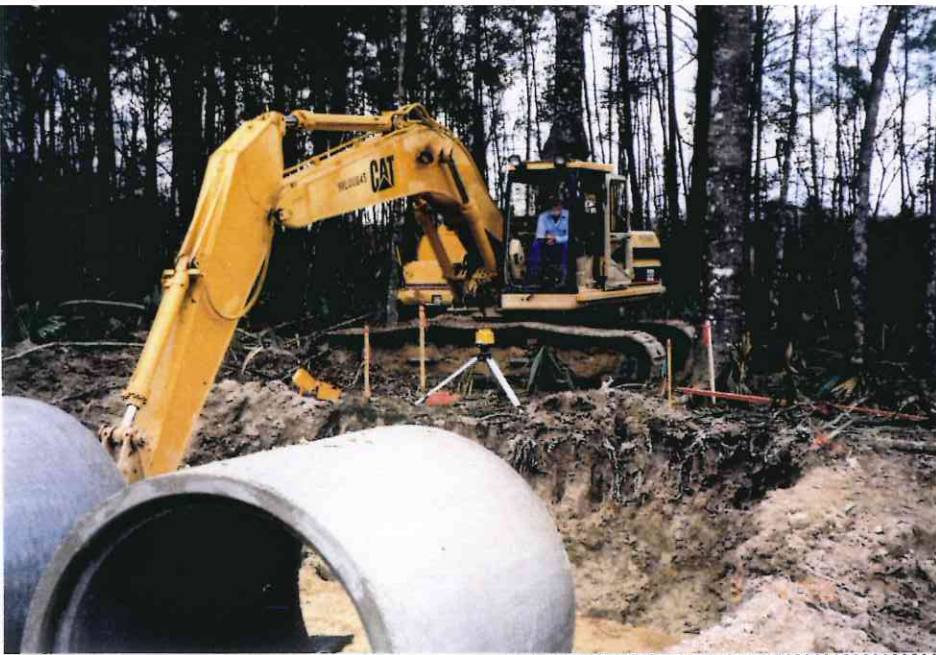
G960032-01-O

1. Southwest arm ,
station 24+70 installing
72" dia. culvert pipe

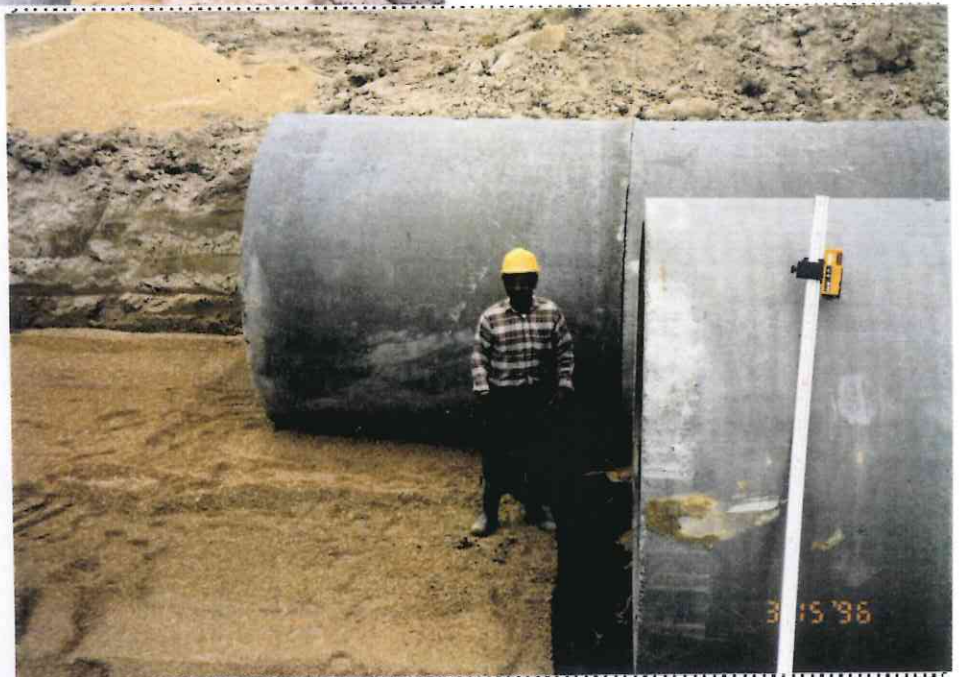
G960032-02-O

2. Southwest arm
station 24+70 Installing
72" culvert pipe, ready
to wrap joints with
geotech material.

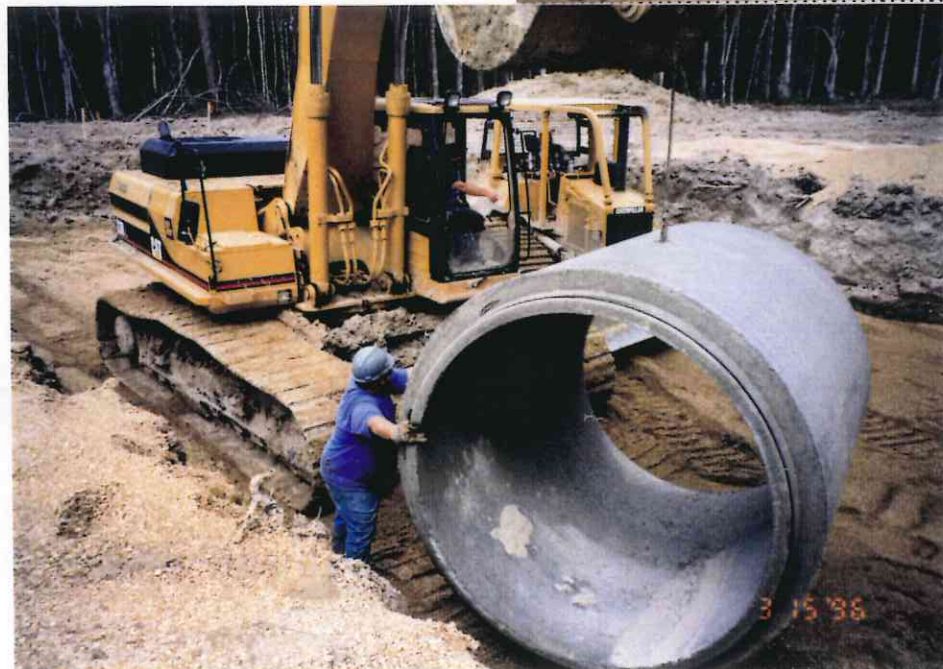
G960032-03-O

3. Southwest arm , at
station 24+70 showing
72" culvert pipe being
moved into place.

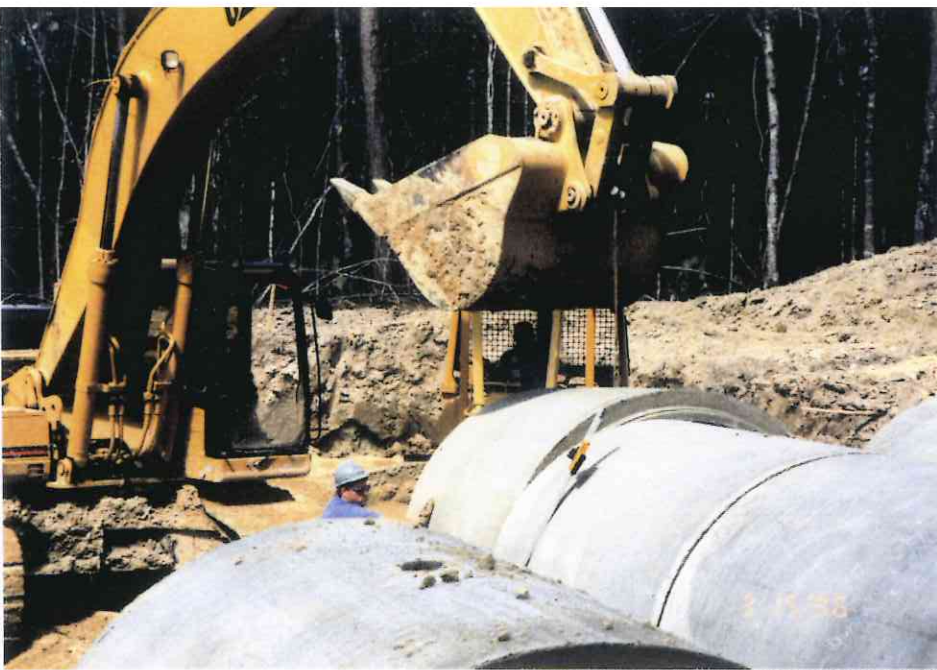
G960032-04-O

4. Southwest arm at station 24=70 showing 72" culvert piping being installed.

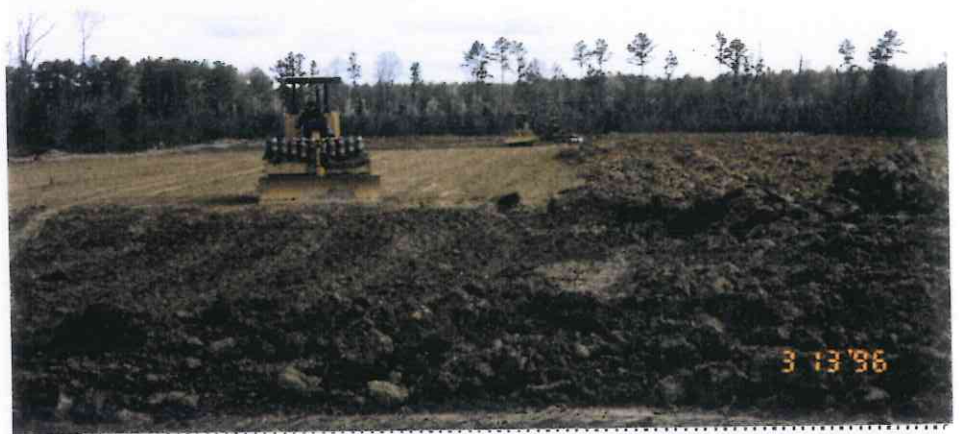
G960032-05-O

5. Southeast arm looking at station 132+00, rolling for compaction

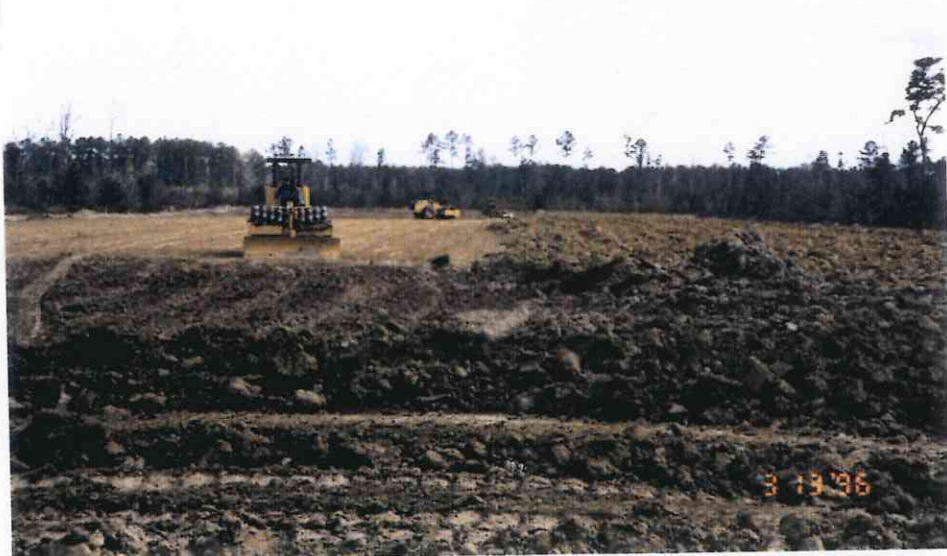
G960032-06-O

6. Southeast arm showing moist material in the foreground, two compaction rollers working to get the required compaction and a disking operation in she back ground

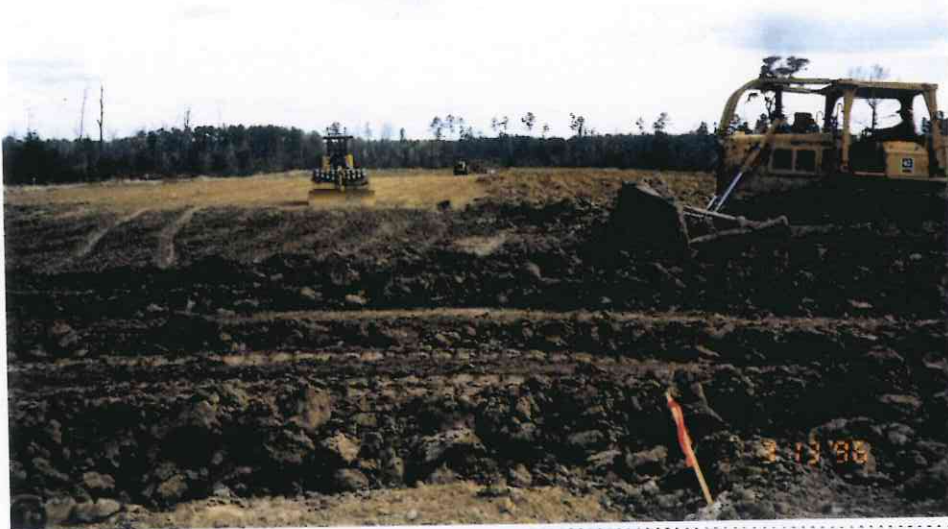
G960032-07 -O

7. Southeast Arm at station 120+00 a dozer moving moist material in place to start the drying process.

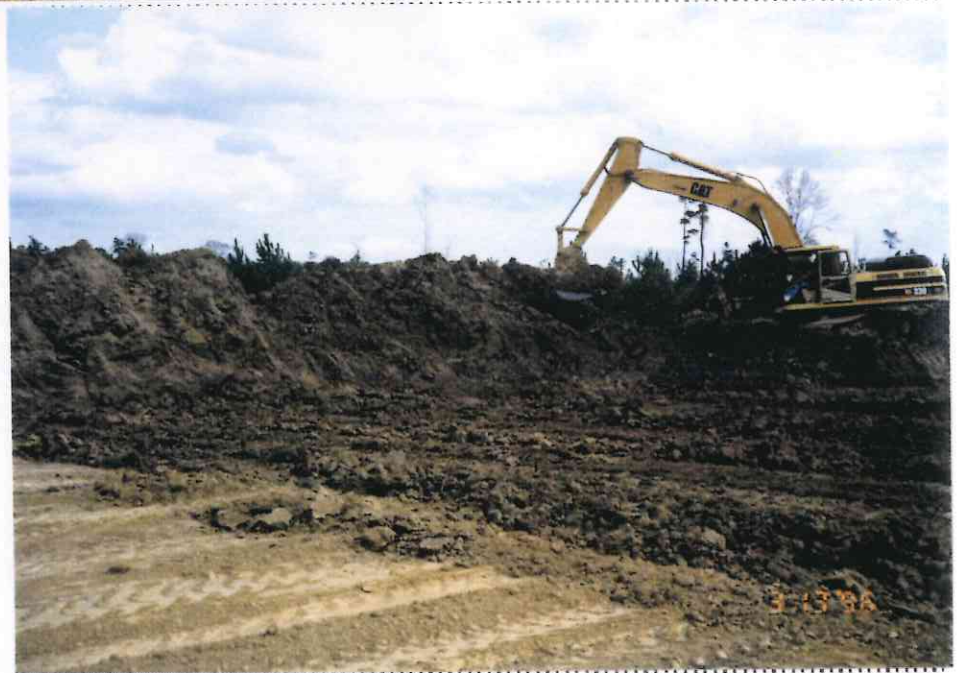
G960032-08 -O

8. Southeast arm showing an excavator stockpiling organic material off of berm to make room for acceptable material.

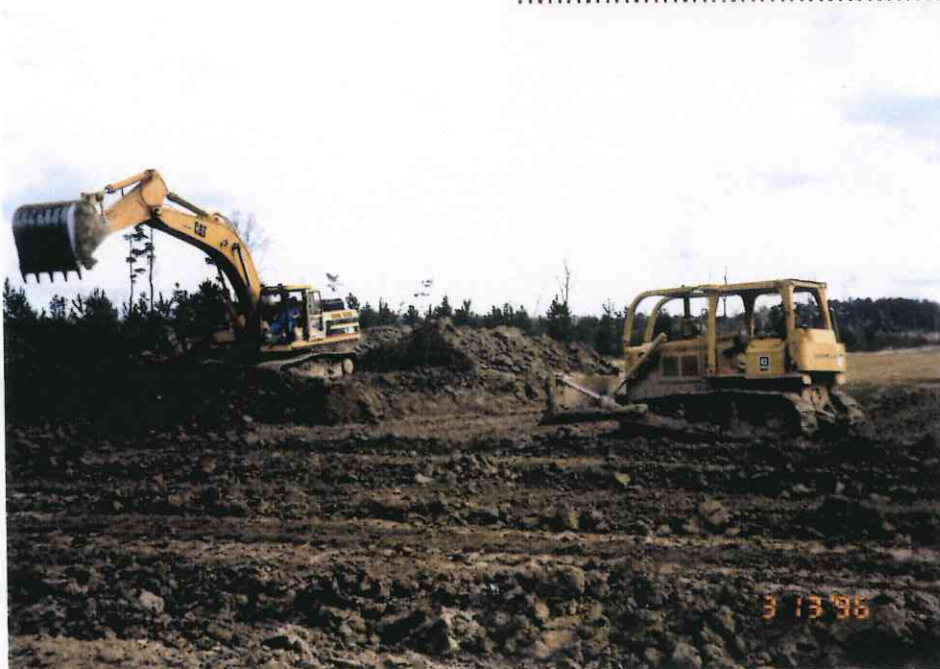
G960032-09 -O

9. Southeast Arm at station 110+00 showing the excavator (caption 8) removing organic material and the dozer bringing acceptable material excavated from trench at right.

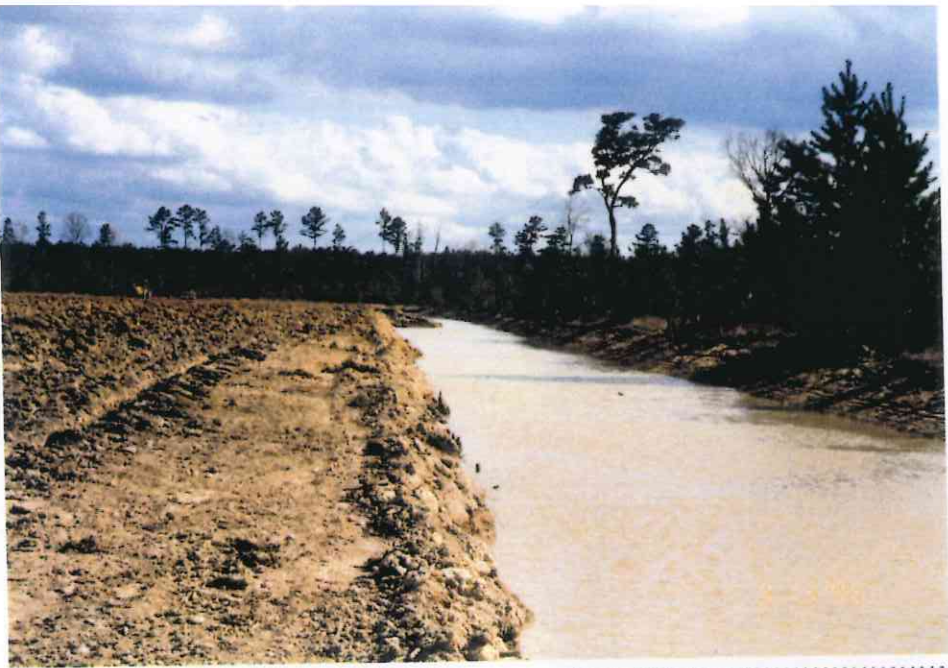
G960032-10-O

10. Southeast Arm looking SE at the end of the arm showing trench excavation.

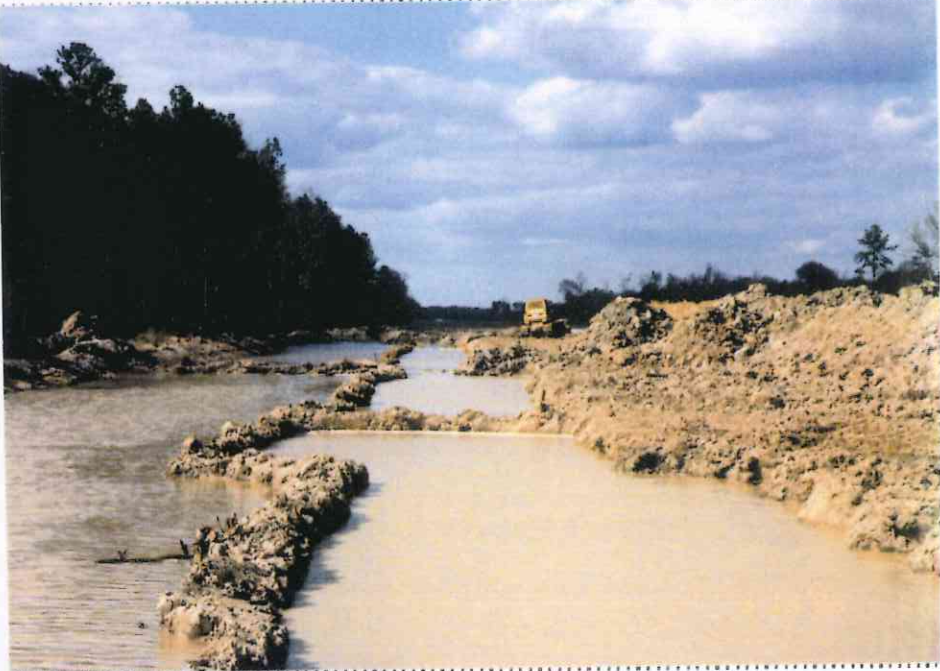
G960032-11-O

11. Southeast arm at station 120+00 looking NW at excavated trench, the walls are left so dryer material may be obtained, the excavation is a little deeper to allow for walls to crumple.

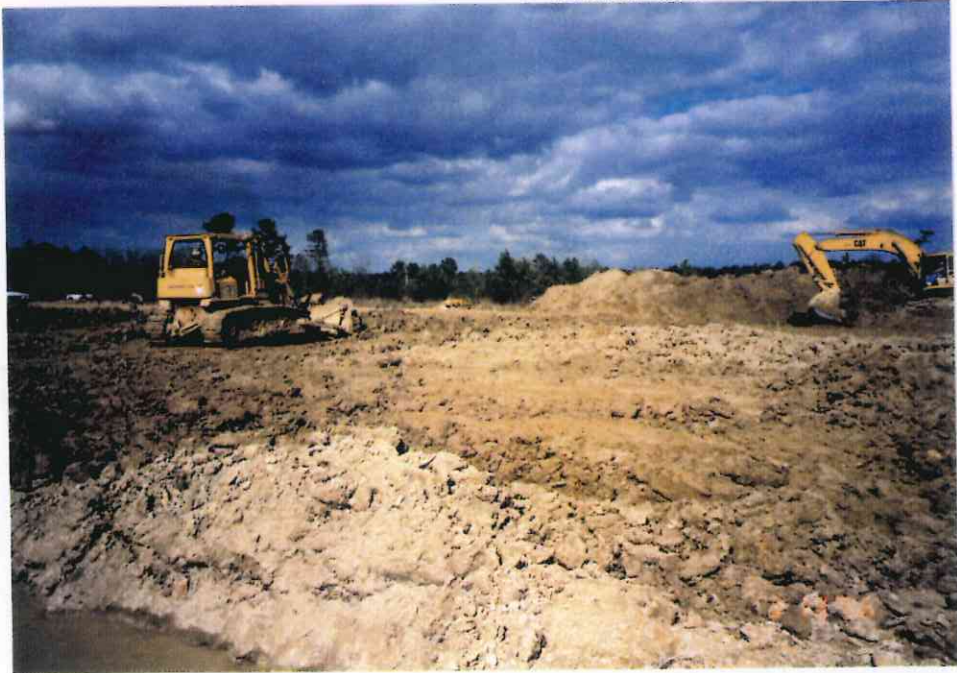
G960032-12-O

12. Southeast arm at station 119+00 showing a dozer moving material from excavated trench to berm area.

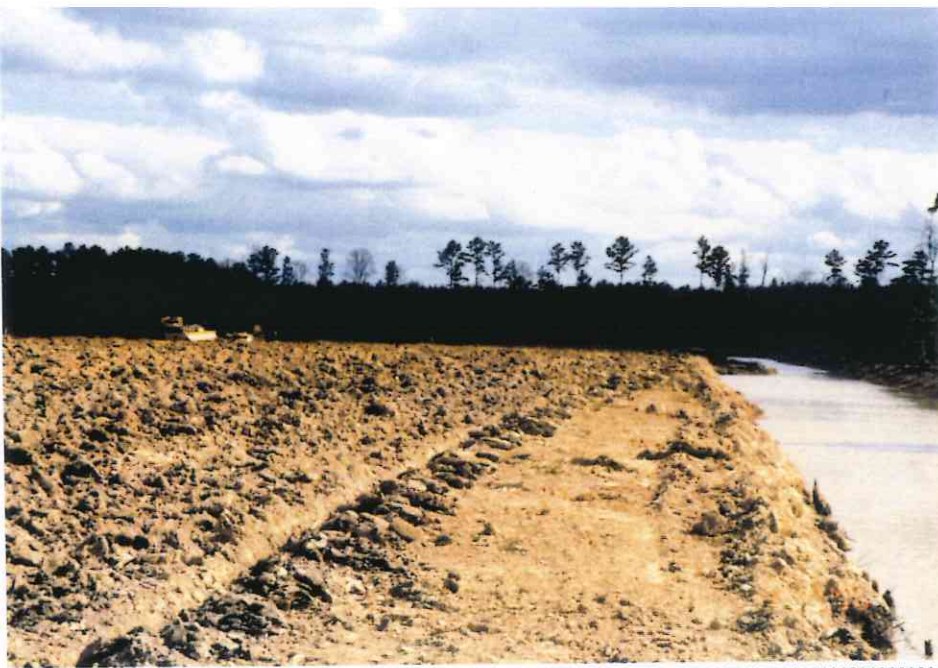
G960032-13-O

13. Southeast arm at station 128+00 showing berm material spread and disked for drying .

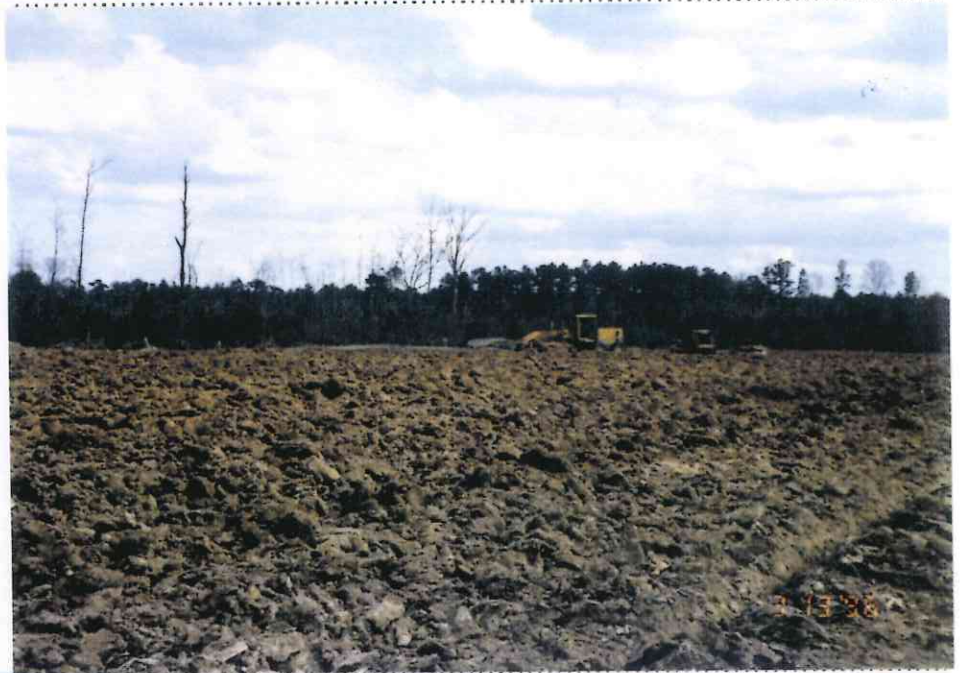
G960032-14-O

14. Southeast arm Station 120+00 foreground disked material drying and a grader rolling material over to expedite the drying process.

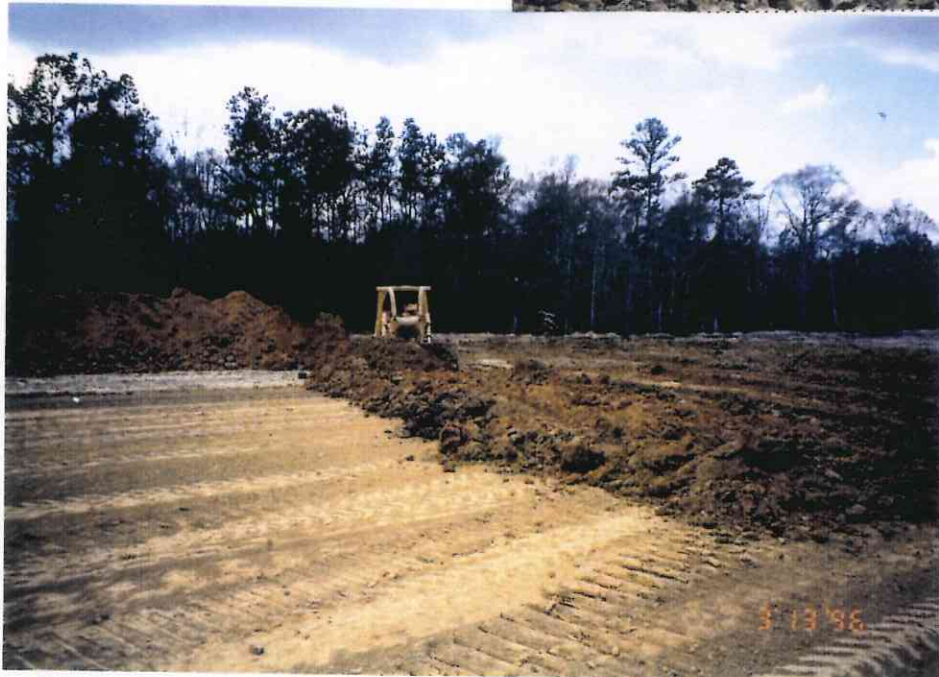
G960032-15-O

15. Southeast arm at station 112+00 a dozer spreading material from the stockpile of material excavated from trench to berm.

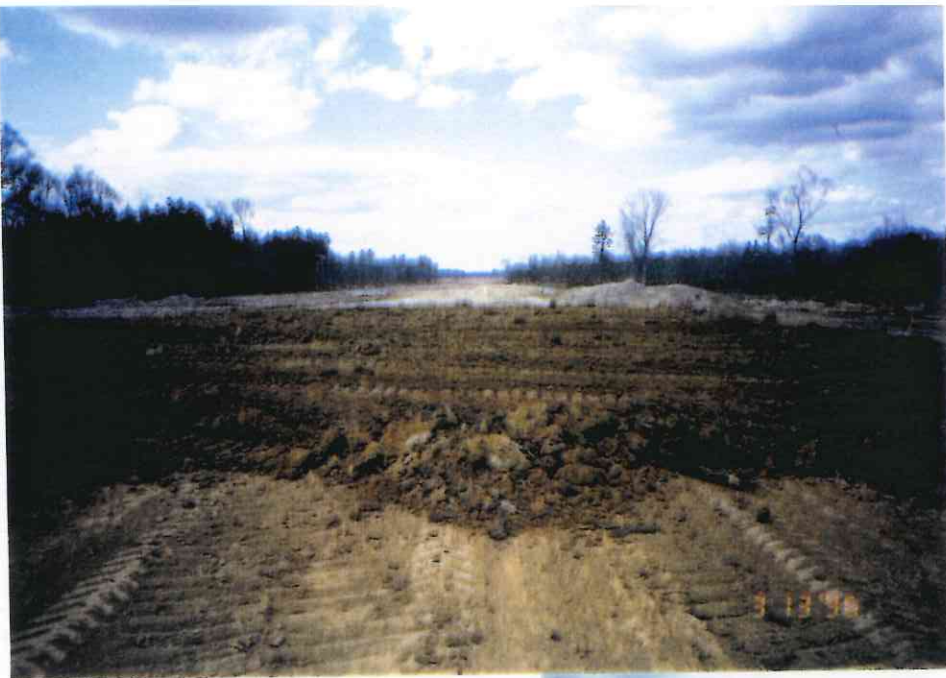
G960032-16-O

16. Southeast arm at Station 110+00 showing a lift of berm fill.

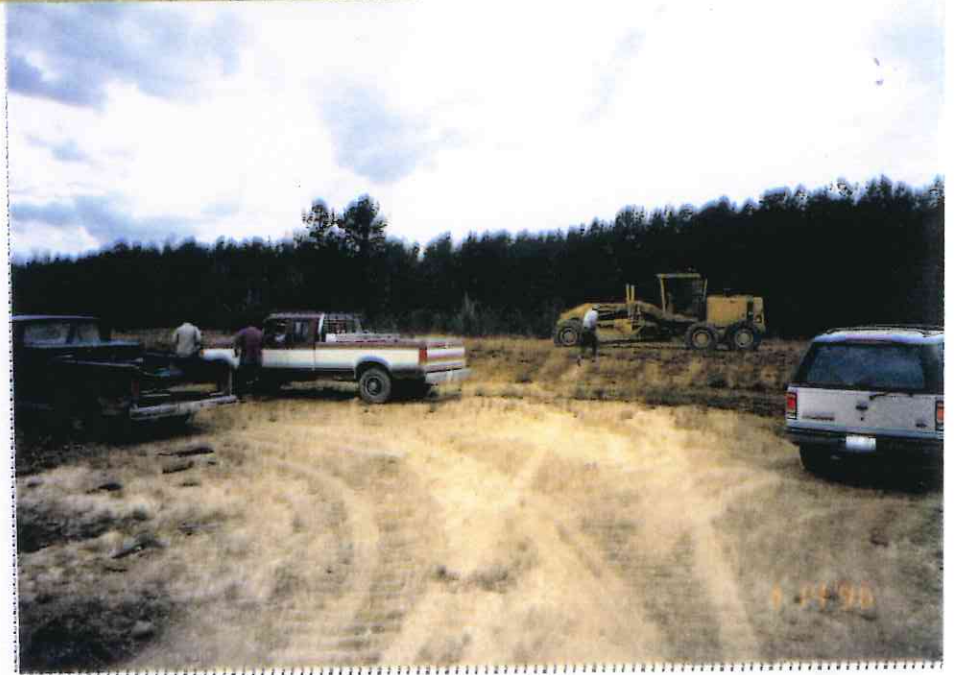
G960032-17-O

17. Southeast arm at station 113+00 showing the elevation of the berm at the date shown.

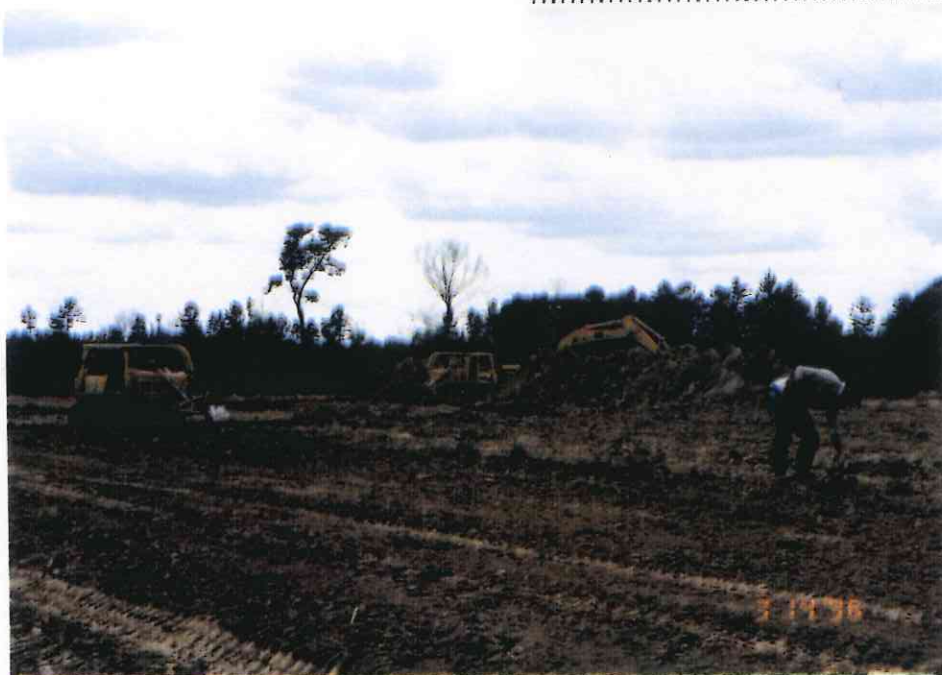
G960032-18-O

18. Southeast arm at station 115+00 Showing excavation of trench & spreading material on berm area.

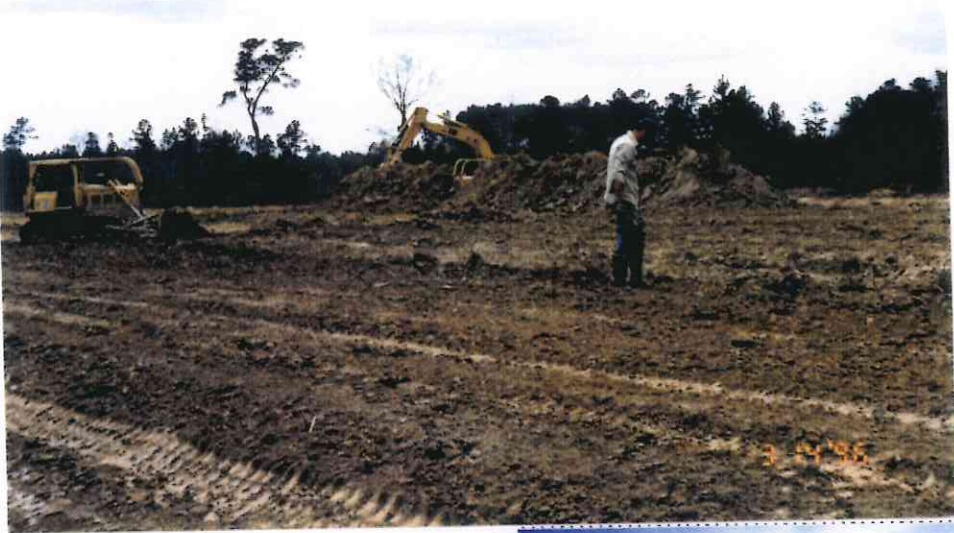
G960032-19-O

19. Southeast arm at station 115+00 showing the removal of tree parts from the berm fill.

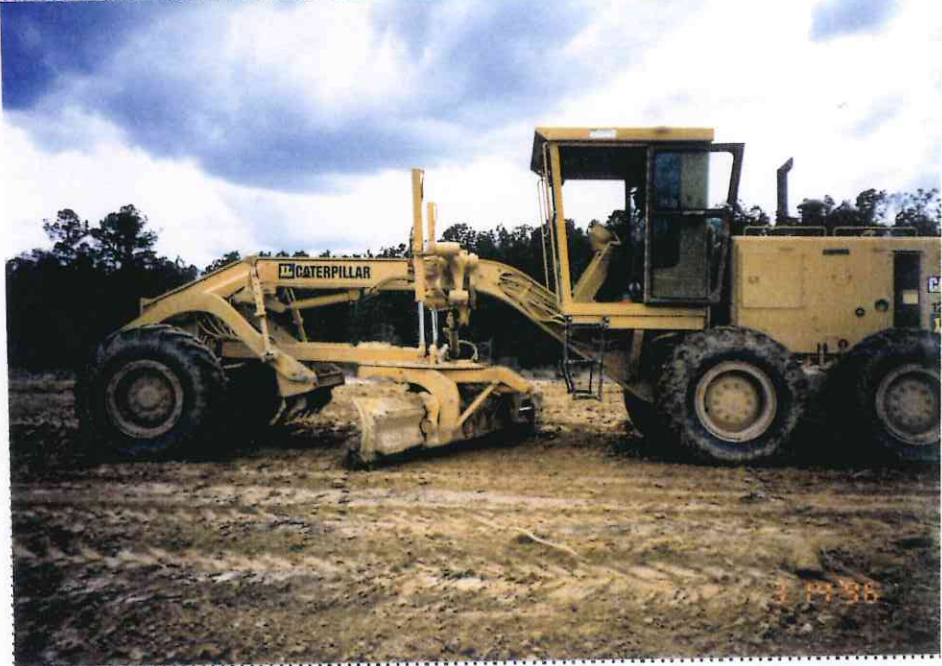
G960032-20-O

20. Southeast arm at station 114+00 grader removing a thin layer of material after a light rain to start a new lift of berm.

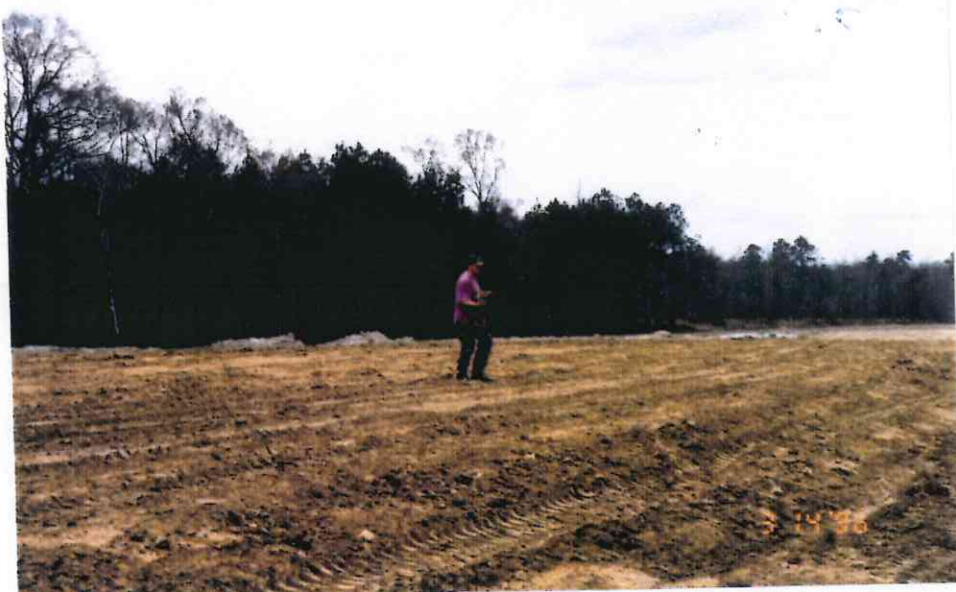
G960032-21-O

21. Southeast arm at station 112+00 showing a stump picker at work.

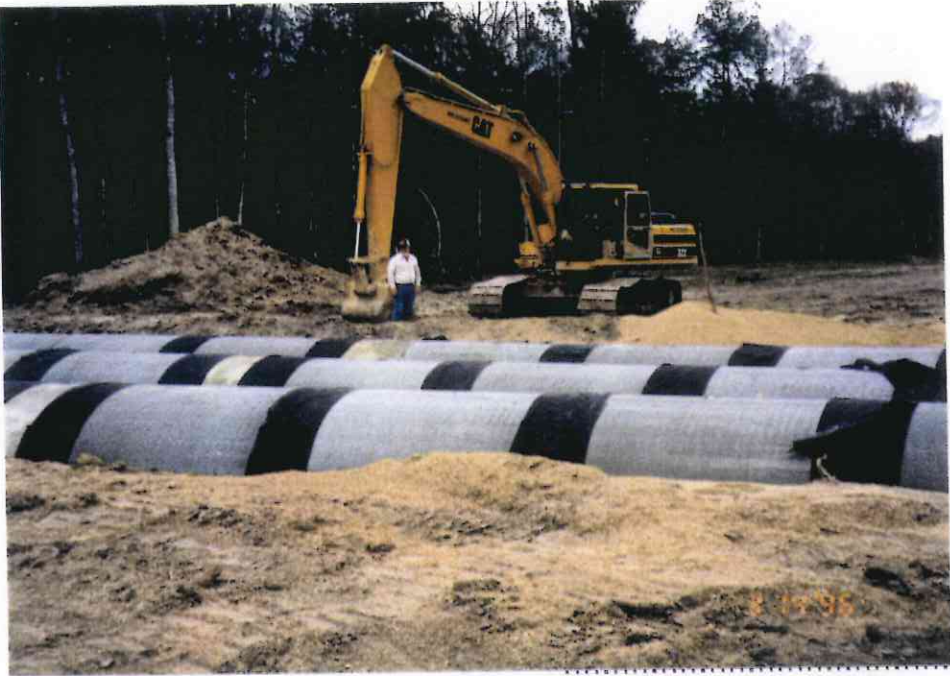
G960032-22-O

22. Southwest arm at station 24+70 showing the culvert pipe ready for backfill .

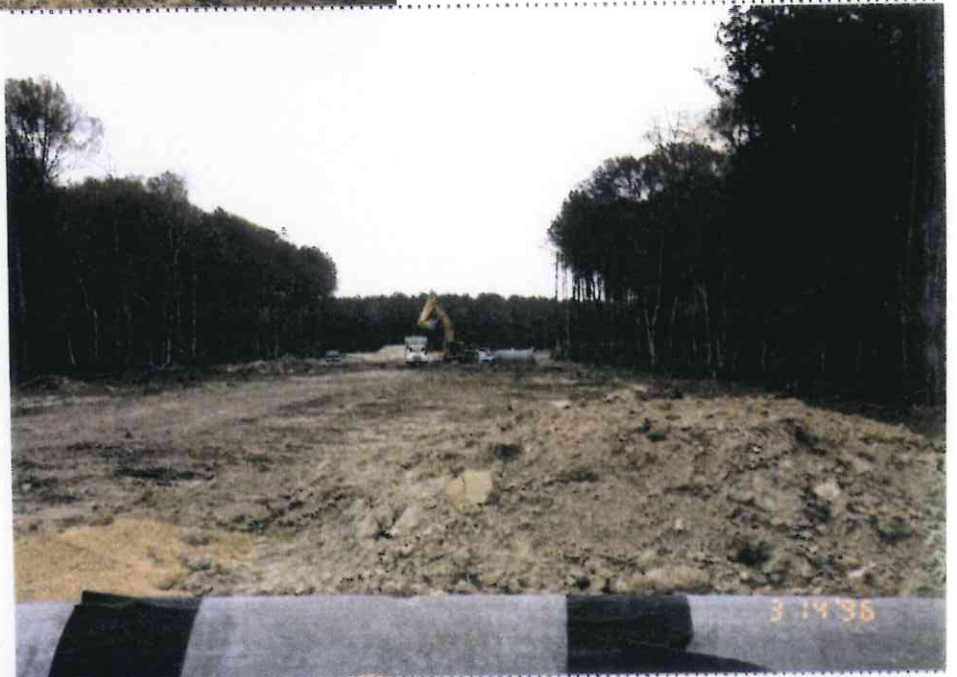
G960032-23-O

23. Southwest arm at station 24+70 culvert crossing looking NE at culvert pipe being off loaded at culvert crossing station 16+40

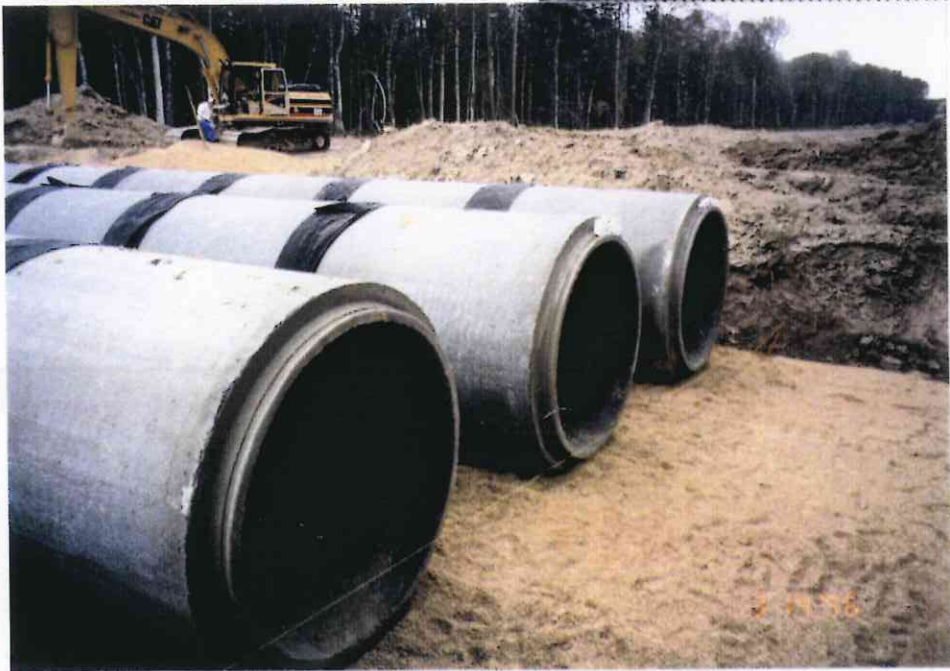
G960032-24-O

24. Southwest arm showing the culvert pipe bedding at station 24+70.
