G960095-

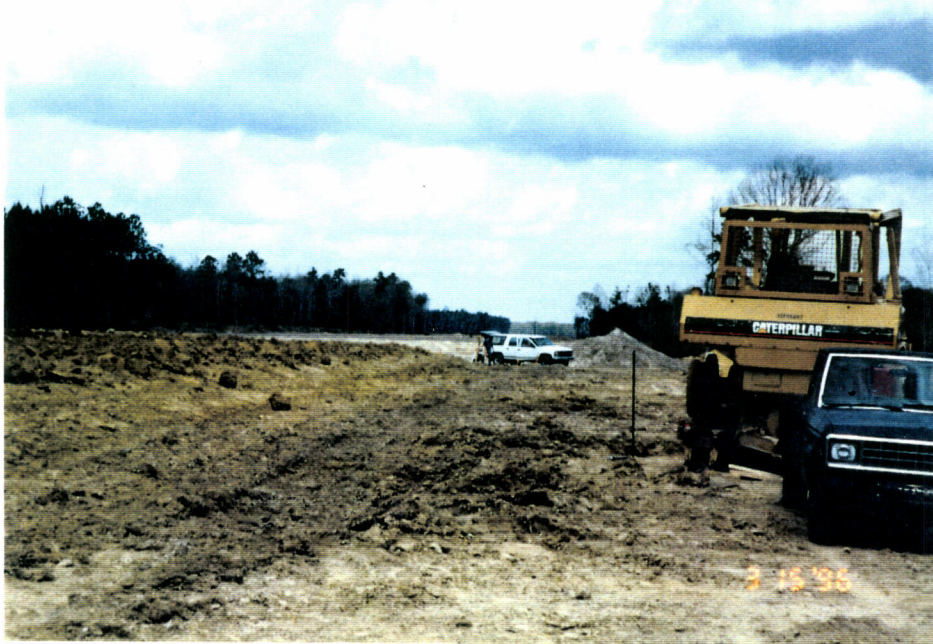
G960095-01-O-P

1. Southeast arm at Station 110+00 looking North at survey crew taking berm fill quantities.

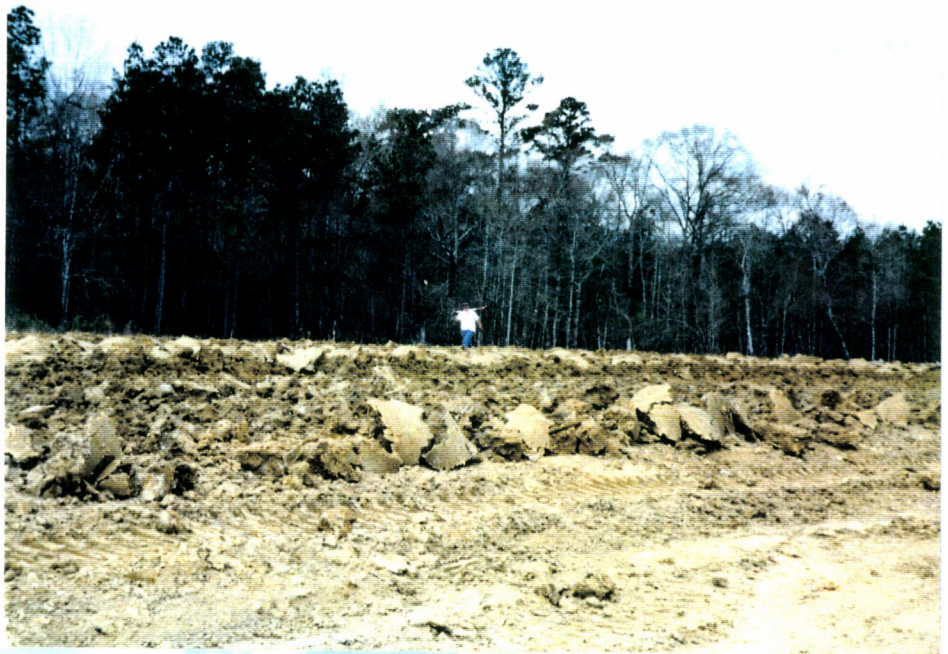
G960095-02-O-P

2. Southeast Arm surveyor working on quantity checks, loose fill factors are considered and agreed to in each measurement.

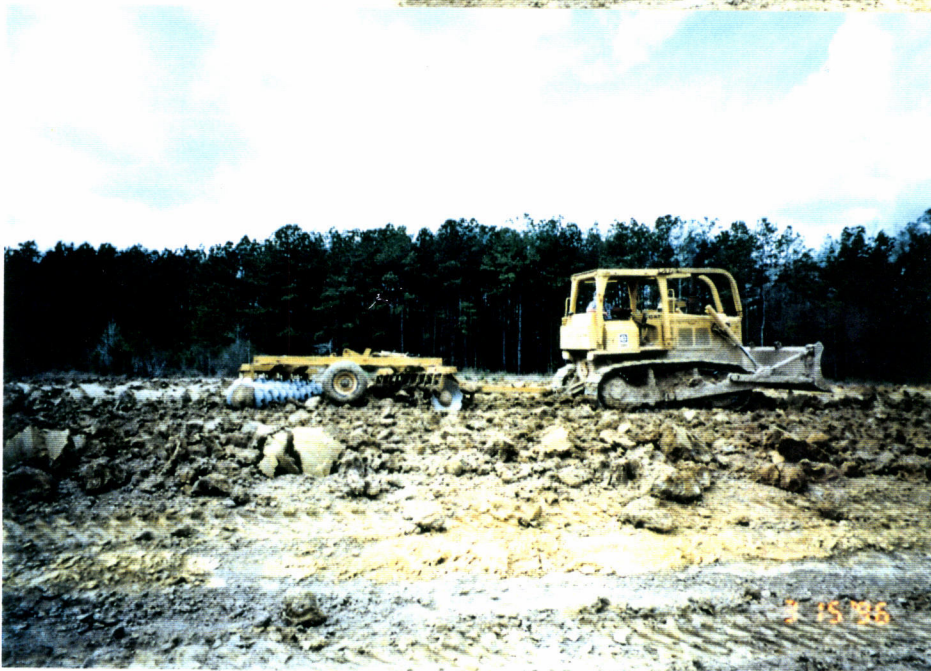
G960095-03-O-PV

3. Southeast arm at Station 115+00 disking berm material to remove moisture.

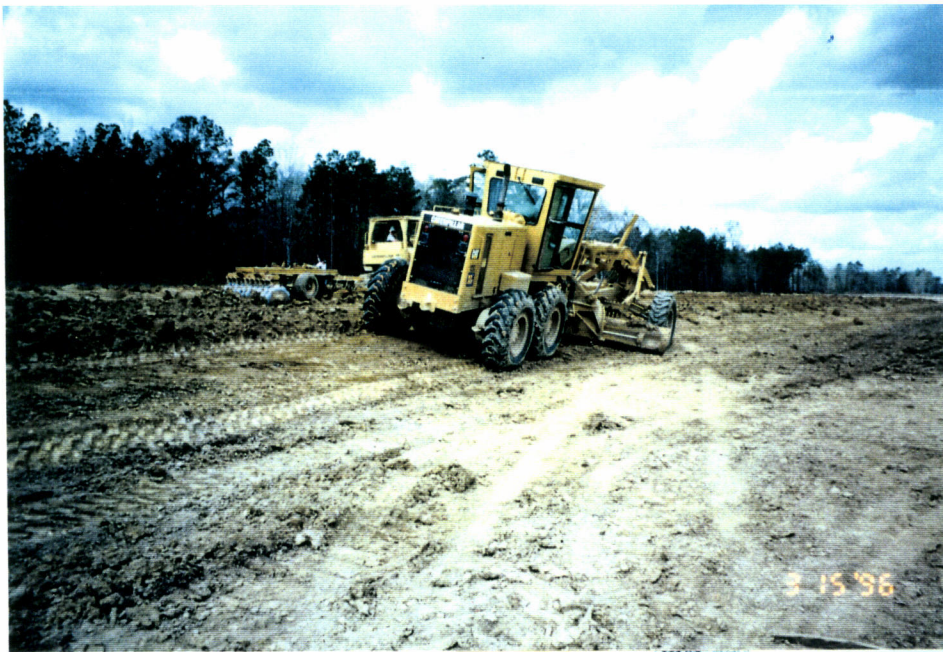
G960095-04-O-PV

4. Southeast arm at station 115+00 shaping the berm slopes.

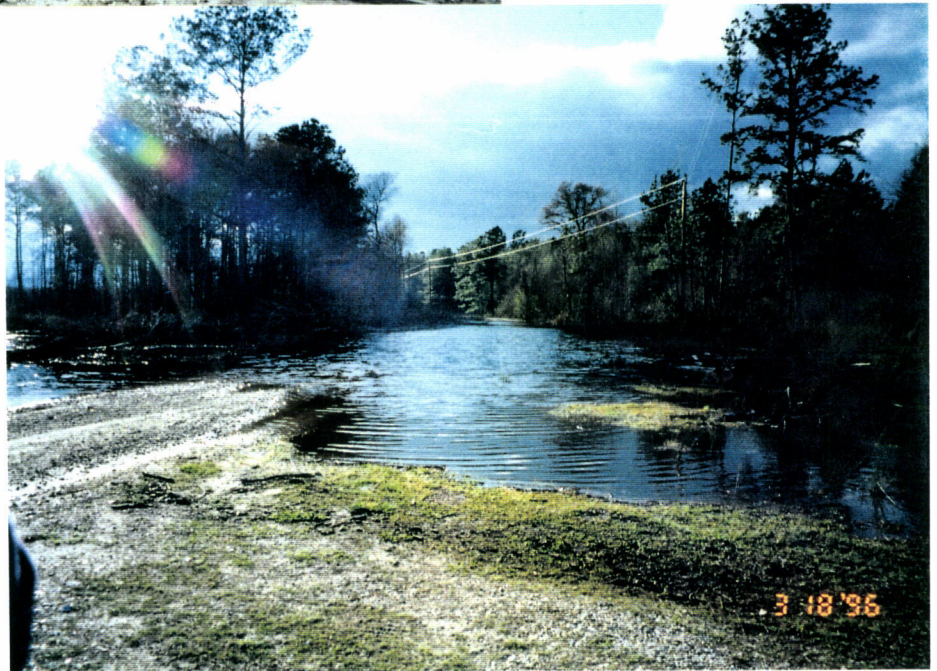
G960095-05-O-P

5. Access road entering site east of bridge , barley visible in the background, taken the morning after the storm the night before. 18" deep +/- .

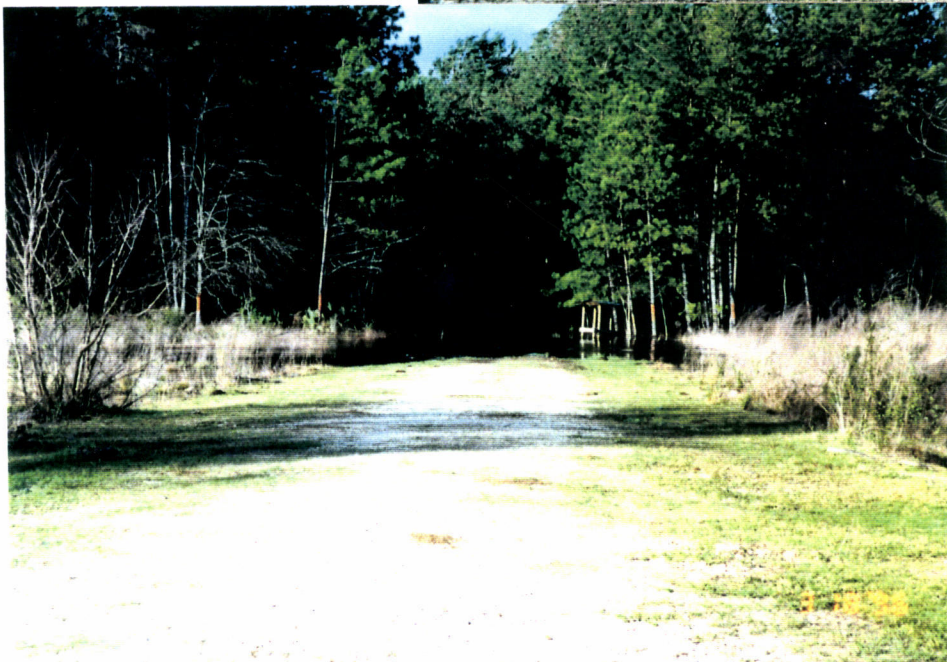
G960095-06-O-P

6. This was taken on the access road , east of bridge at the intersection of the service road looking North.

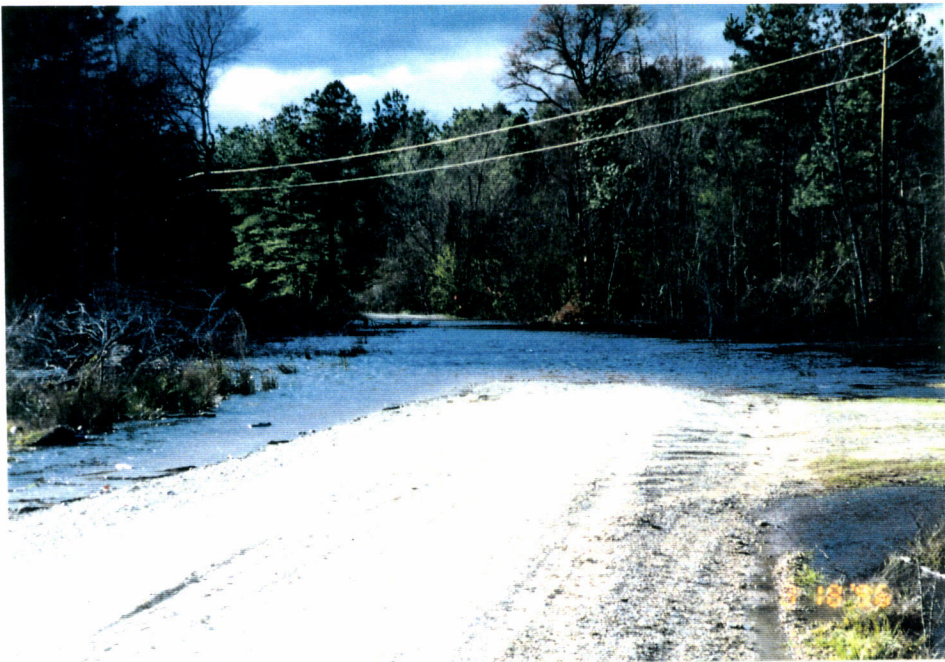
G960095-07-O-P

7. The same location as in # 6 above except looking at bridge in the background.

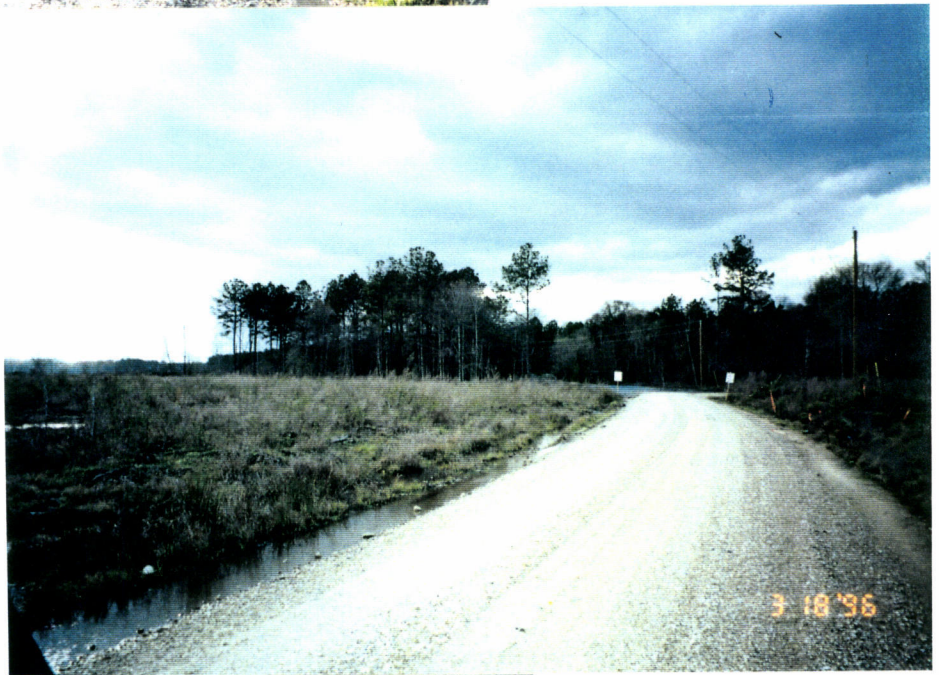
G960095-08-O-P

8. This shot is on the access road looking at the intersection as described in photographs 6&7 above.

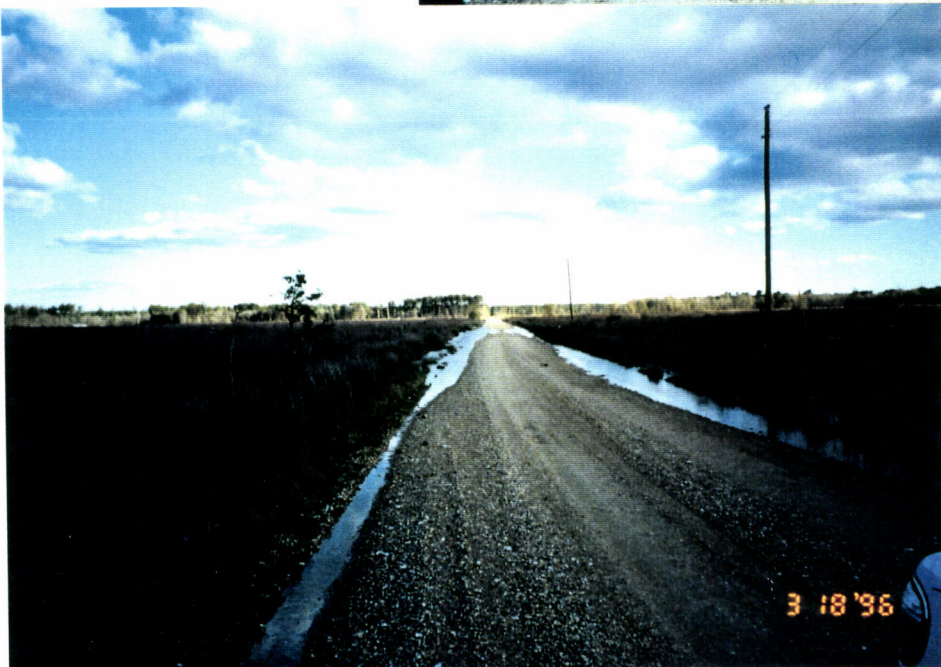
G960095-09-O-P

9. This is on the access road into site showing a small creek backing up over road. The tall trees in the background is where the cattlegaurd is.

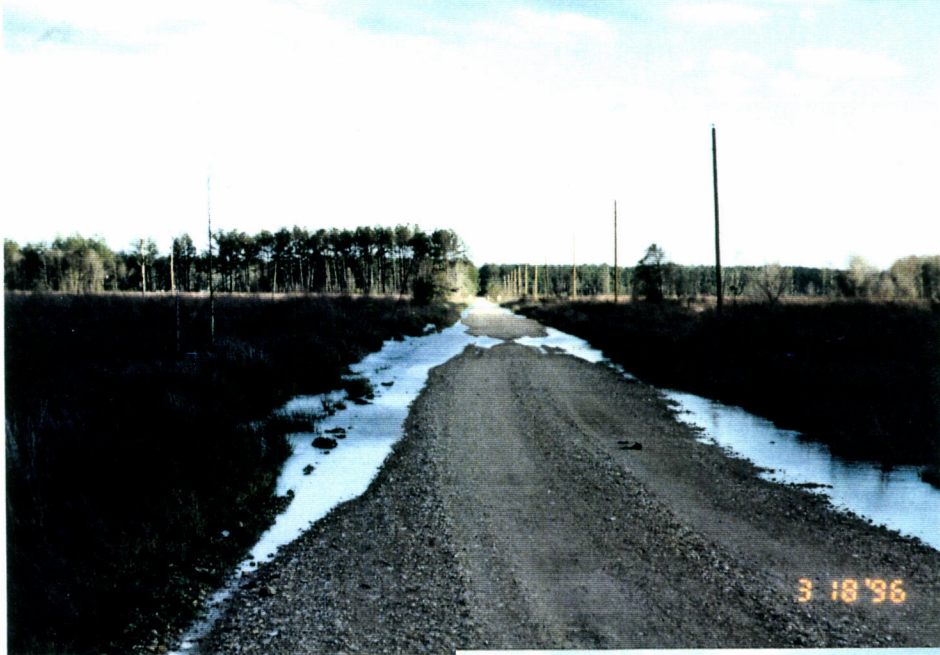
G960095-10-O-P  
10. A closer view of the previous photo showing the small creek back up.

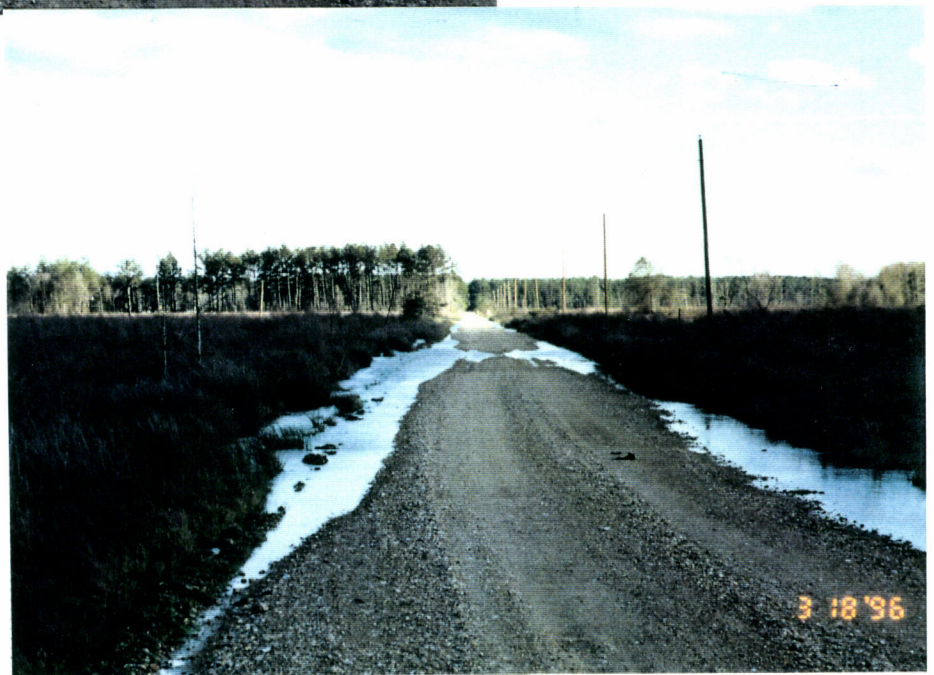
G960095-11-O-P

11. The main access road to the site, showing small drainage ditch overflowing the road, the cattlegaurd at the tall trees.

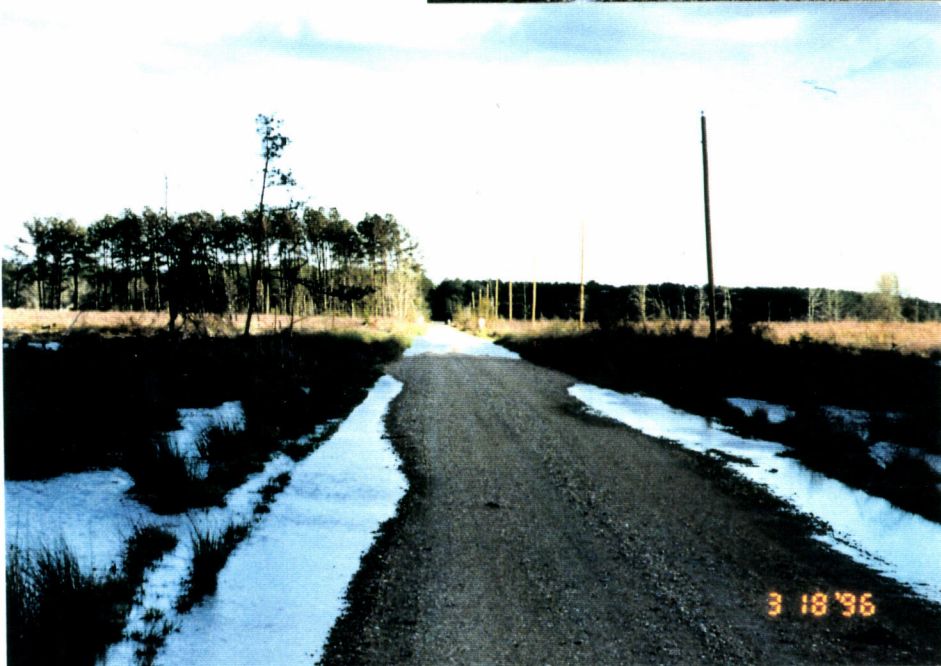
G960095-12-O-P

12. A close up view showing flooding of the road west of the cattlegaurd.

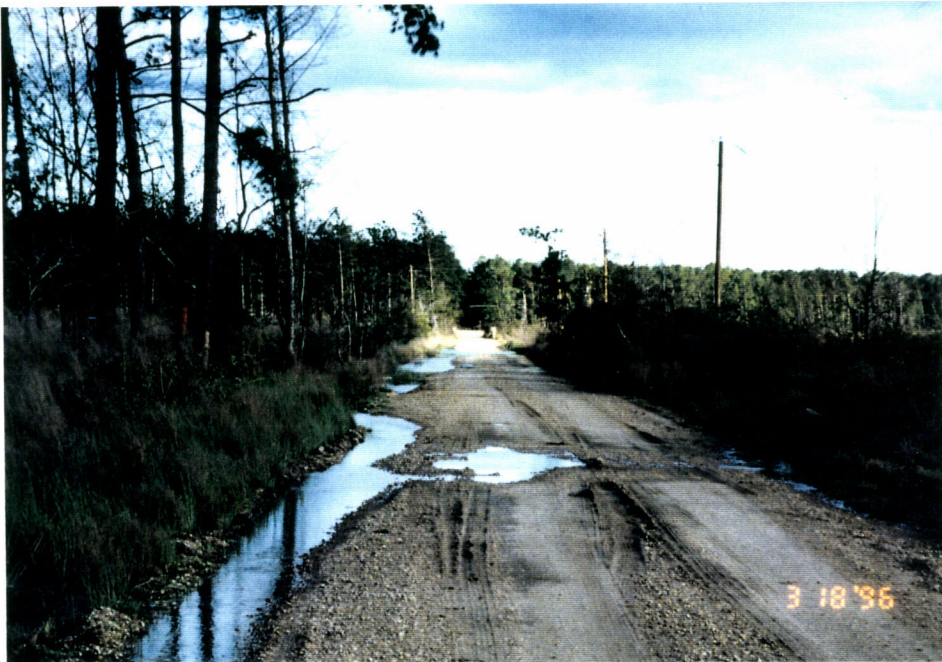
G960095-13-OP  
 13. This is the South entrance road to the end of the Southeast arm , showing flooding of road.

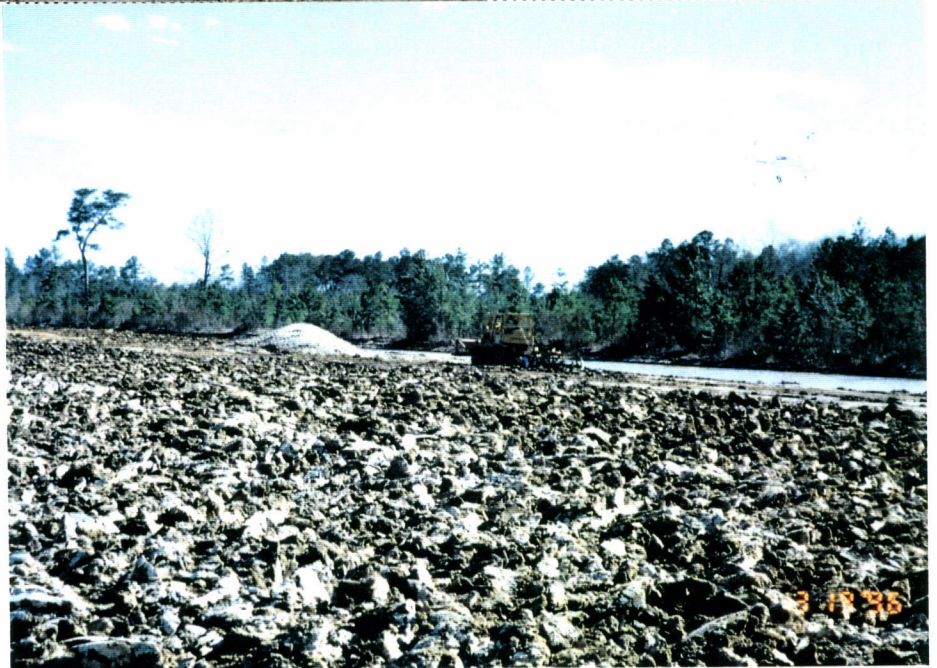
G960095-14-OP  
 14. Southeast arm looking at the disking operation to dry out the soil about station 116+00

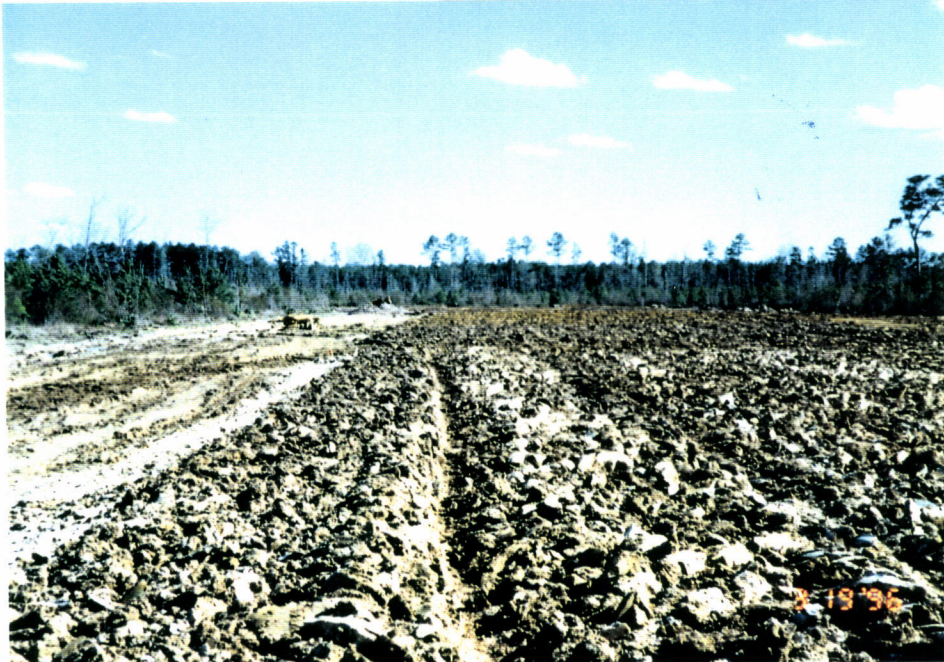
G960095-15-OPV  
 15. Southeast arm at station 115+00 looking at the end of the arm , drying out berm material.

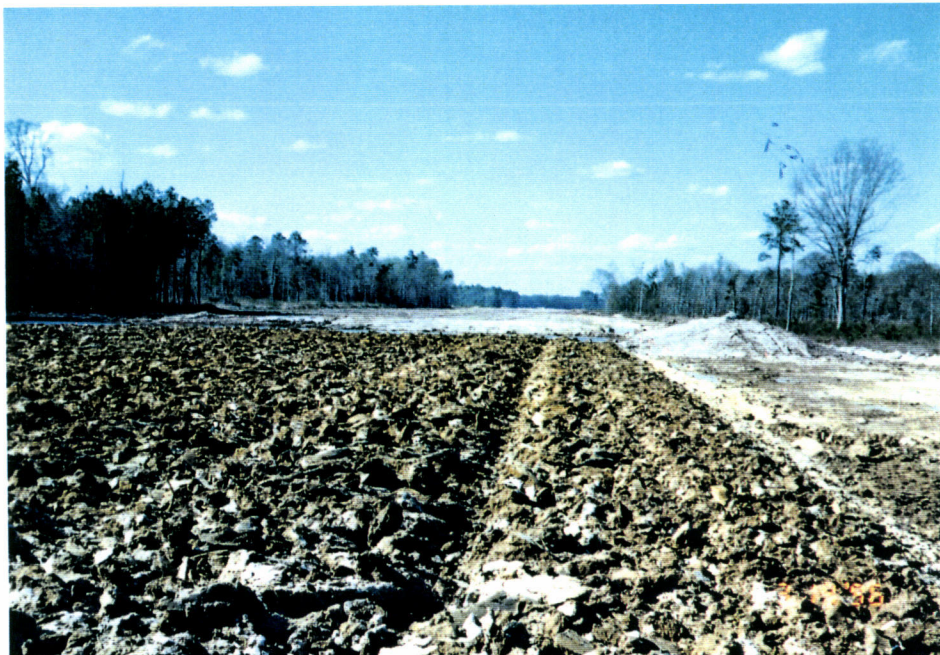
G960095-16 -O-PV

16. Southeast arm at Station 115+00 looking Northwest at culvert crossing 106+00 showing drying of material.

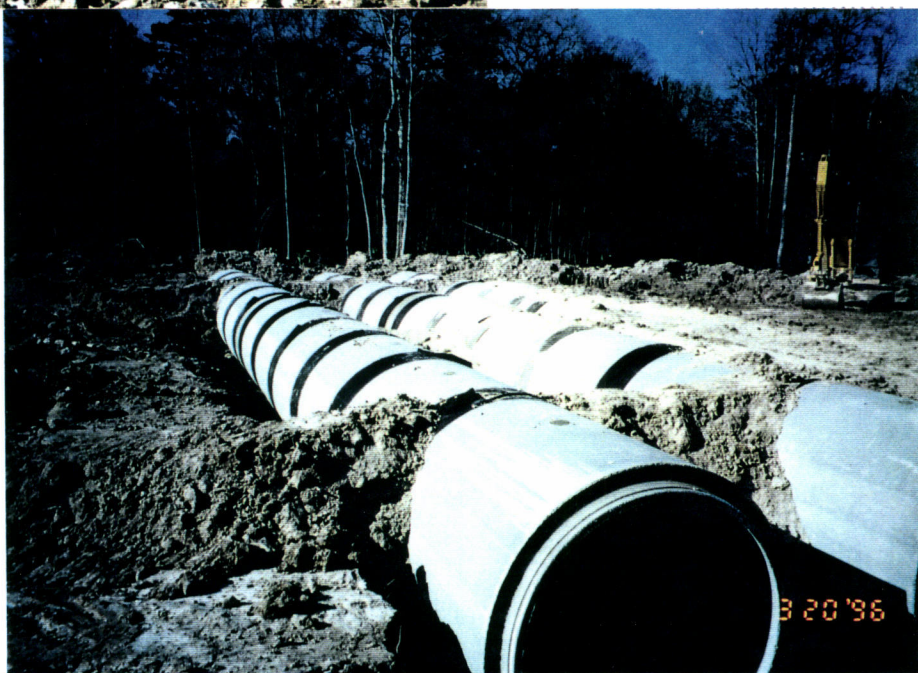
G960095-17 -O-P

17. Southwest arm showing culvert pipe at crossing 24+60 back filling operation.

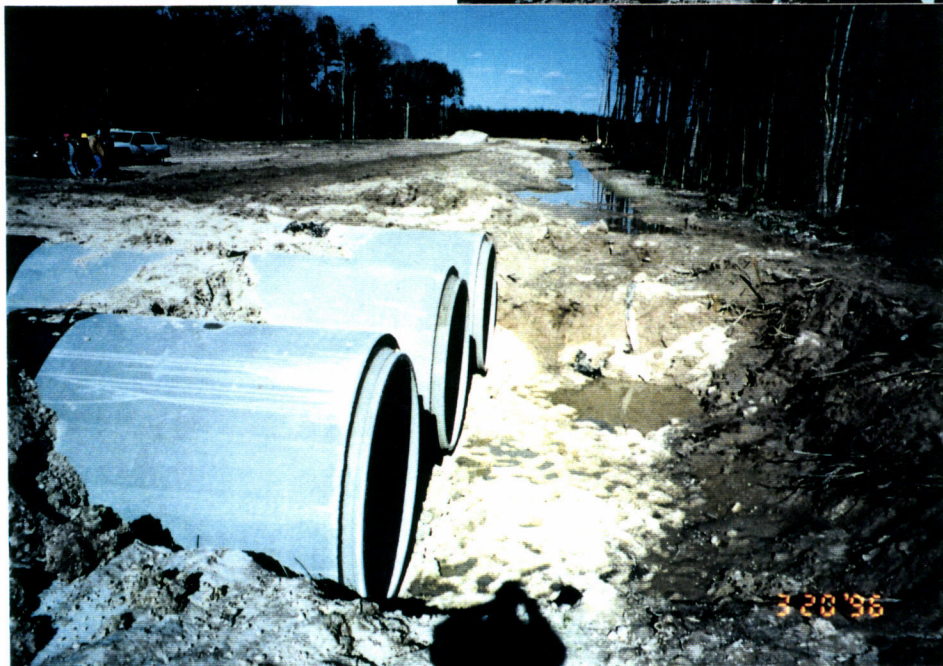
G960095-18 -O-P

18. Southwest arm looking Northeast at culvert crossing 24+60.

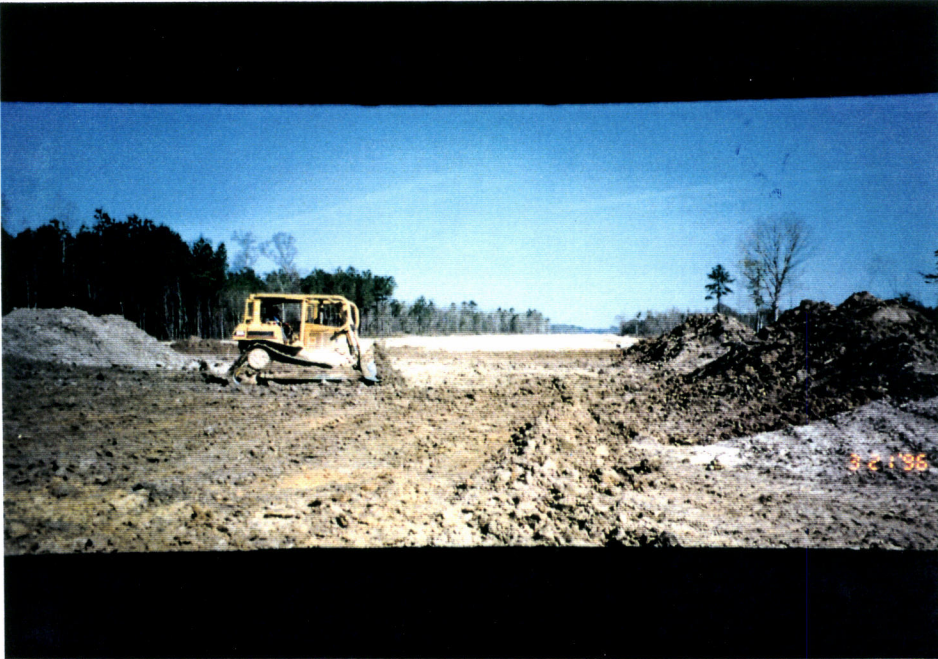
G960095-19 -O-P  
19. Southeast at station 111+00 showing removing of organic soil to be replaced by excavated material.

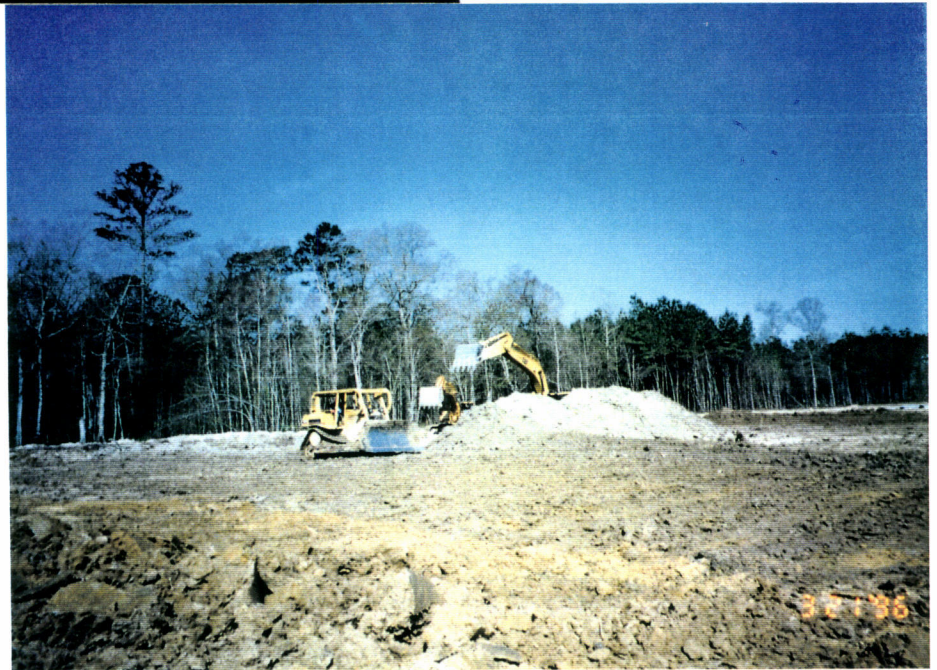
G960095-20 -O-P

20. Southeast arm at station 110+00 showing two excavators removing fill from trench and a dozer spreading fill into place.

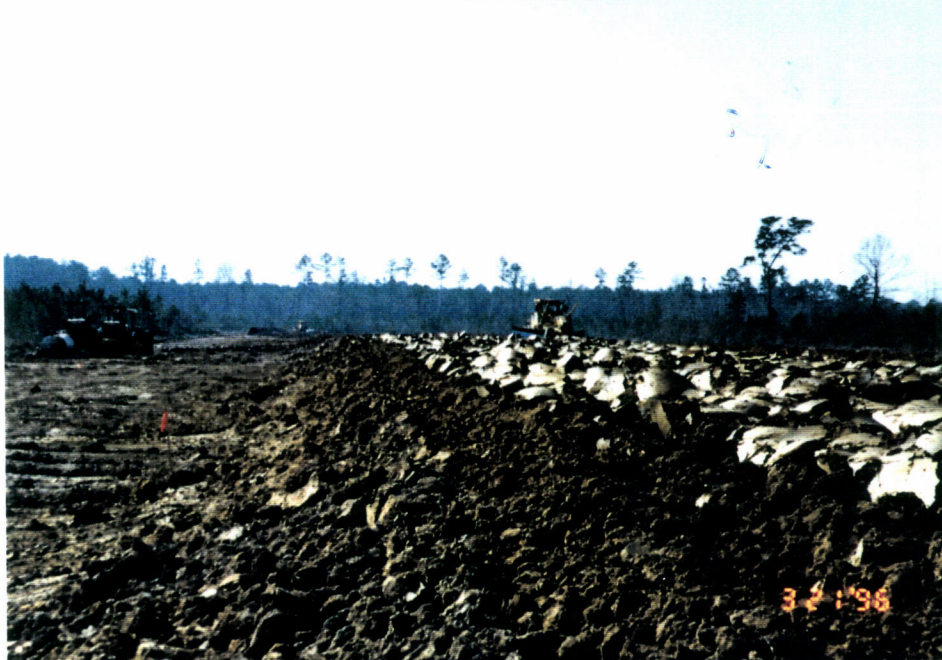
G960095-21 -O-P

21. Southeast arm at station 112+00 showing Grader wind rowing soil to expedite the drying process.

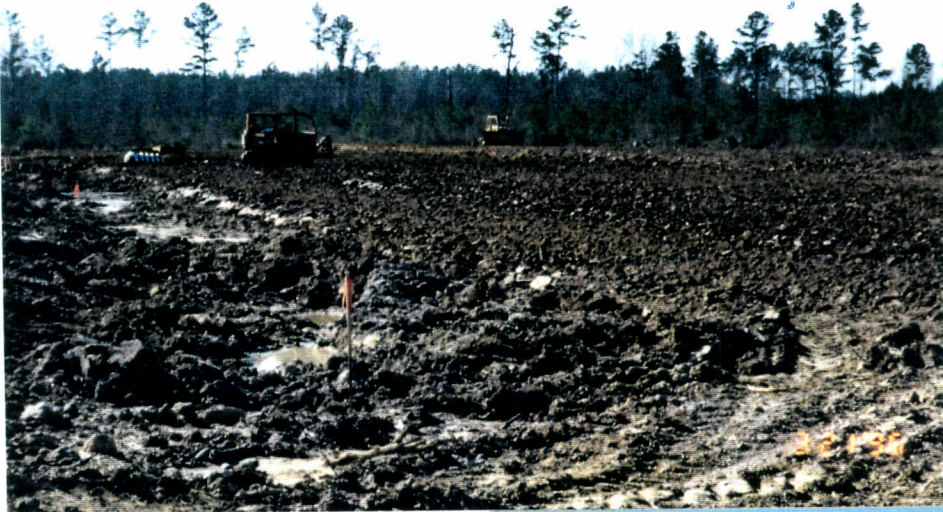
G960095-22 -O-P

22. Southeast arm showing disking operation at station 130+00

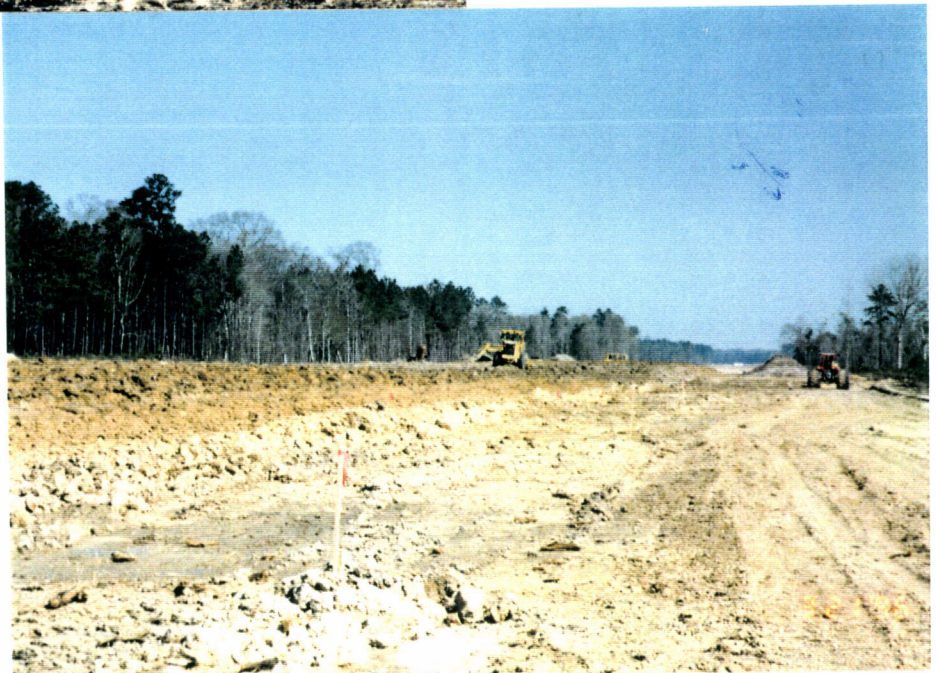
G960095-23-O-PV

23. Southeast arm at station 117+00 showing a road grader windrowing the latest lift to help the drying process.

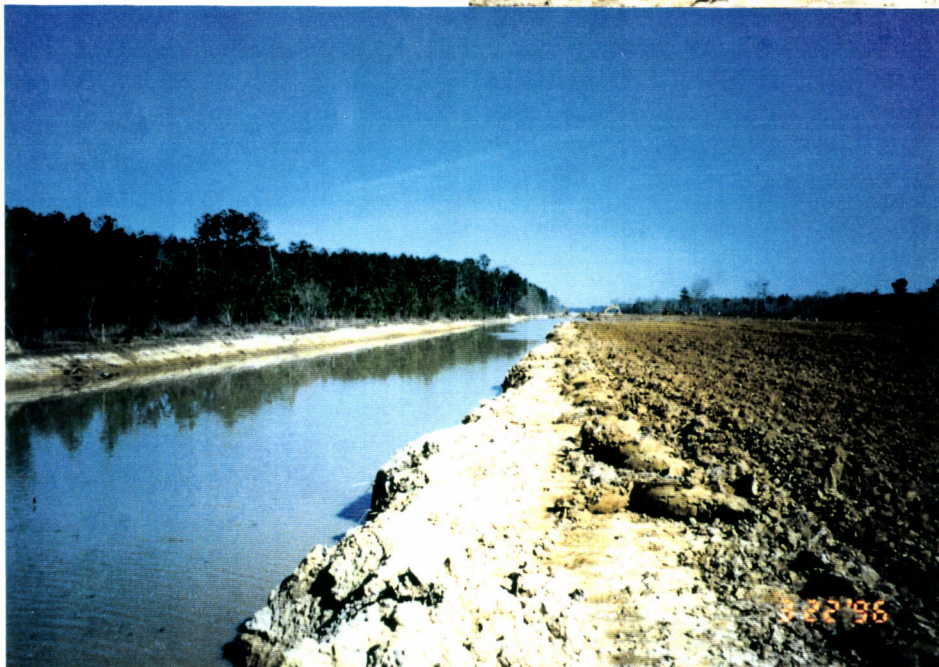
G960095-24-O-P

24. Southeast arm at station 129+00 looking Northwest at the trench on the right and the berm on the left.
