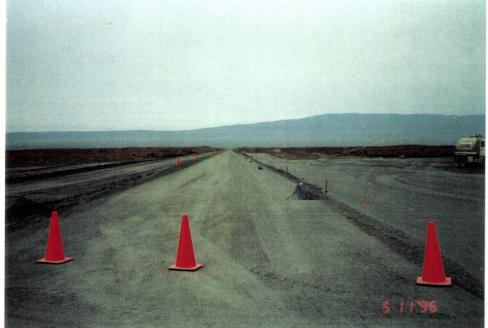
G960124-01-0-P

The subgrade preparation is completed and the southwe arm is ready for the rebar installation.

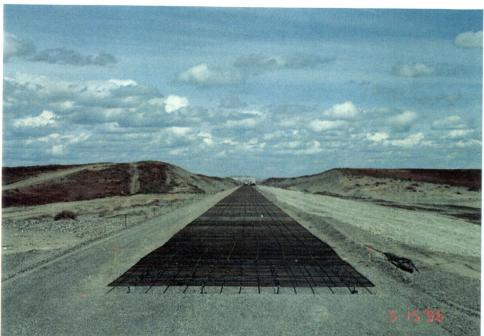
G960124-02-O-P

Typical rebar mats installed along the southwest arm.

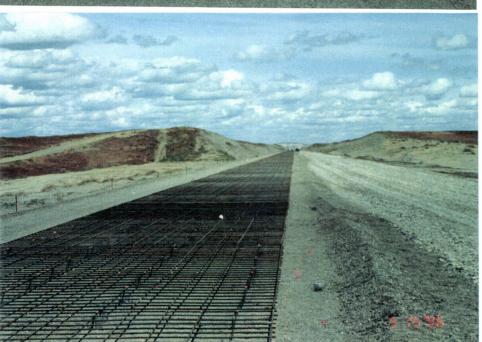
G960124-03-O-P

General process of the rebar mat installation

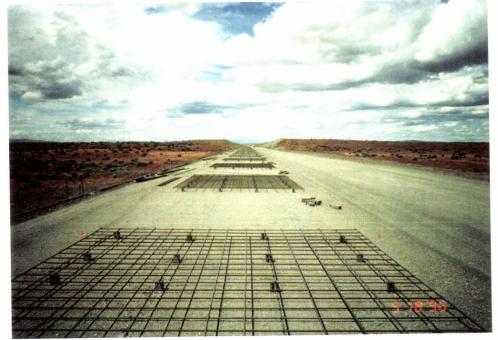
G960124-04-0-P

Placing the rebar for the beam tube enclosure support slab. Alternate sections of mats were placed until the dowel baskets arrived

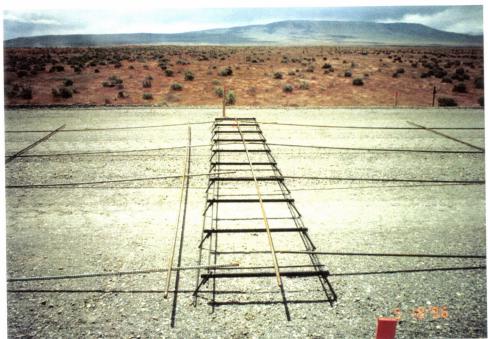
G960124-05-OP

Typical installation of the dowel basked at the slab joint location.

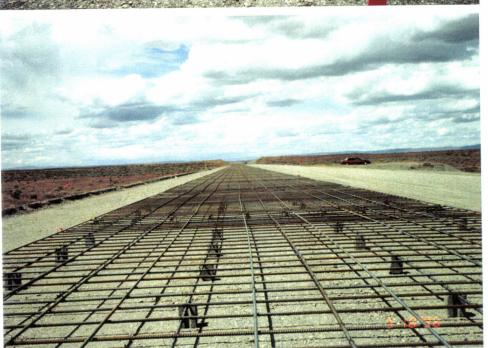
G960124-06-O-P

Completed section of the rebar installed along the southwest arm

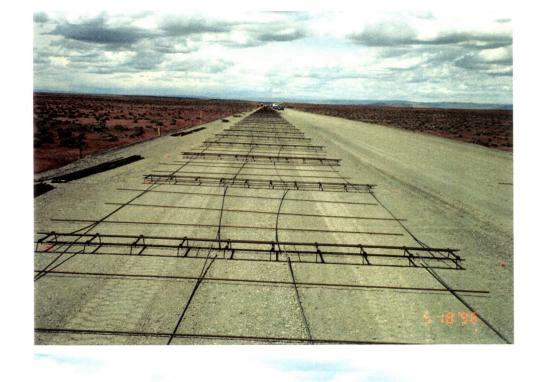
G960124-07-O-P Close-up of the typical rebar mat.

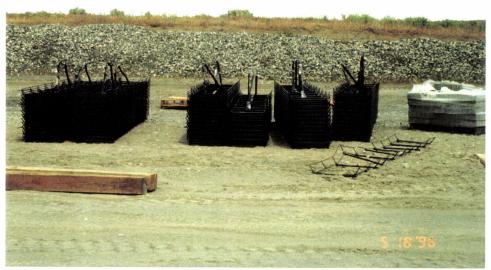
G960124-08-O-P

Dowel baskets arrived assembled and ready for installation.

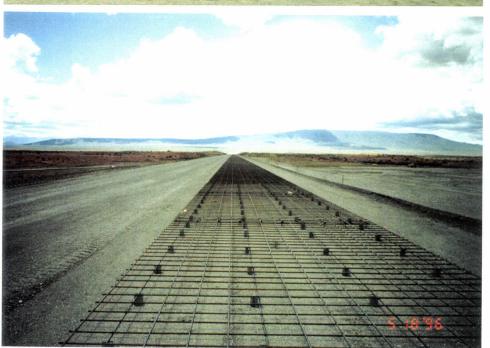
G960124-09-OPV

Another and final view of the installed rebar mats.

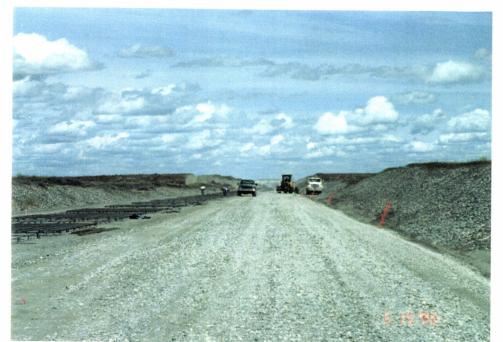
G960124-10-O-P

The beam tube access ro subgrade preparation with of cap rock and 4" of roac base material.

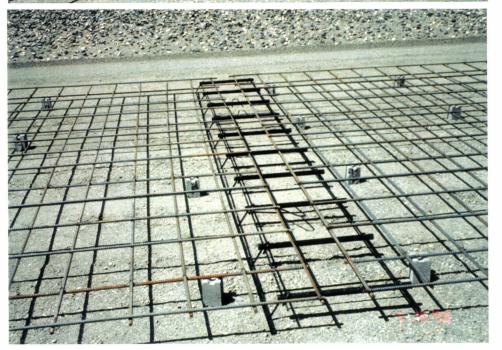
G960124-12-O-P

Close-up of the Dowel basket at a typical beam tube slab joint location.

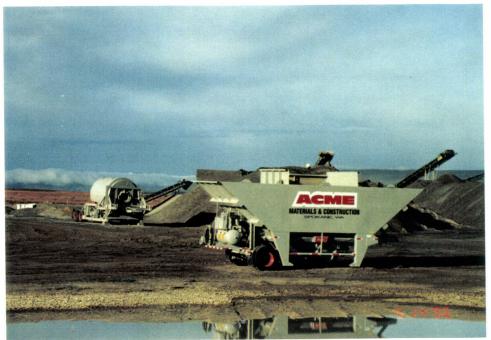
G960124- I4-O-P

Batch plant equipment

arrival.

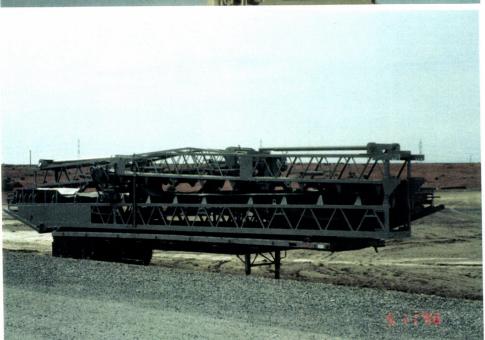
G960124-15-0P

Conveyors for the gravel and sand delivery to the batch plant arrived

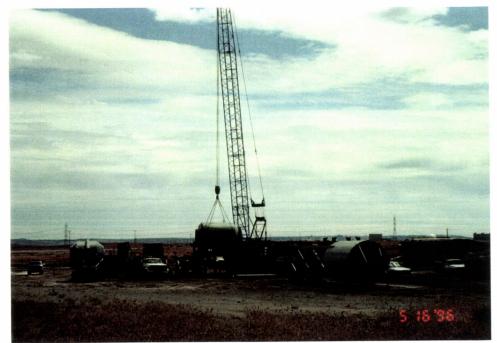
G960124-16-OP

100 ton Lampson crane is assisting in the batch plant erection.

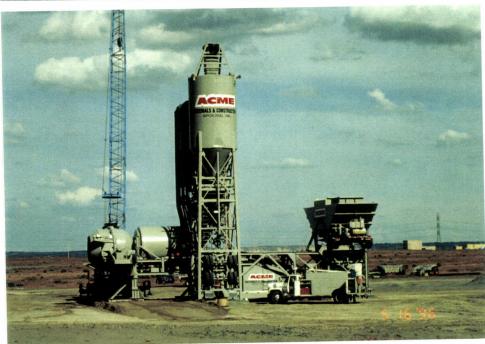
G960124-17-0-P

Batch plant erection continued

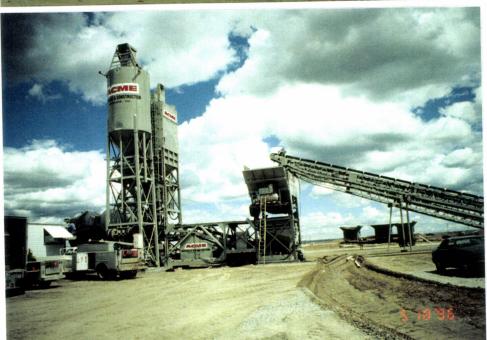
G960124-18-O-P

Batch plant erection virtually completed.

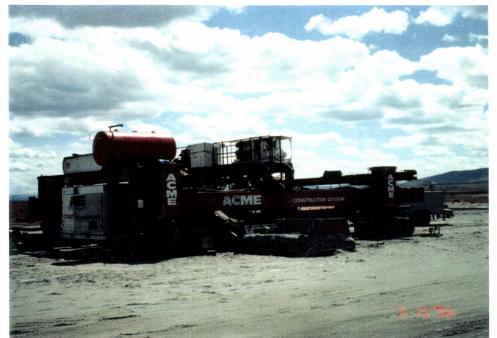
G960124-19-0-P

The assembly of the concrete belt placer continued near the southwest arm end building.

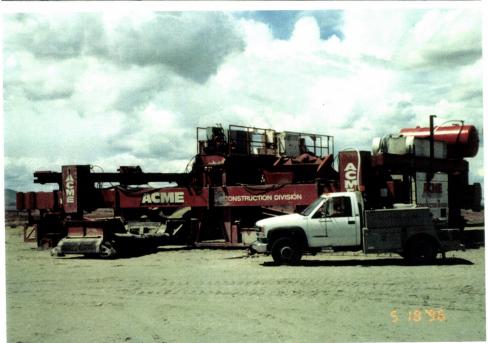
G960124-20-OP

Different view of the belt placer.

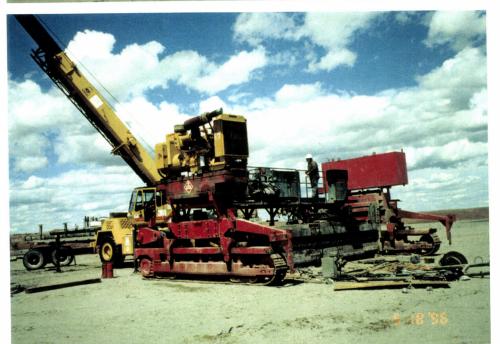
G960124-21 -O-PV

Hydraulic crane is assisting in the assembly of the belt placer

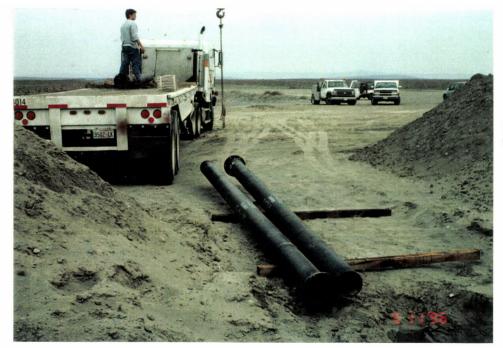
G960124-22-OP

Ductile-iron pipe with mechanical joint arrived.

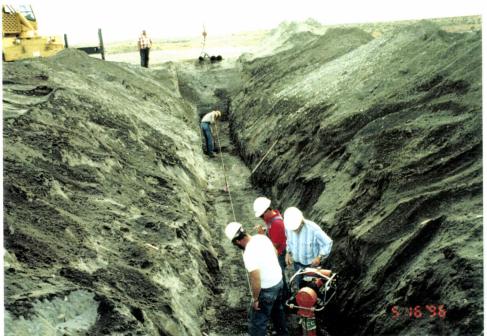
G960124-23 -O-P

Pipe bed preparation for the Ductile-iron underground fire line crossing under the beam tube slab.

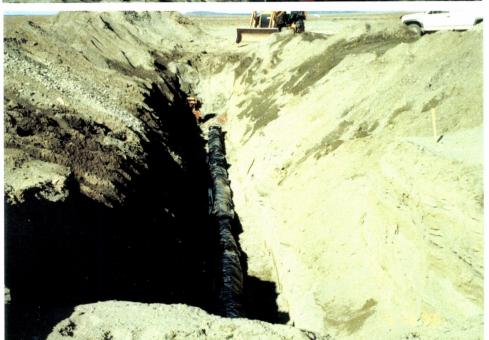
G960124-24-O-P

Fire line installed and ready for hydro test.

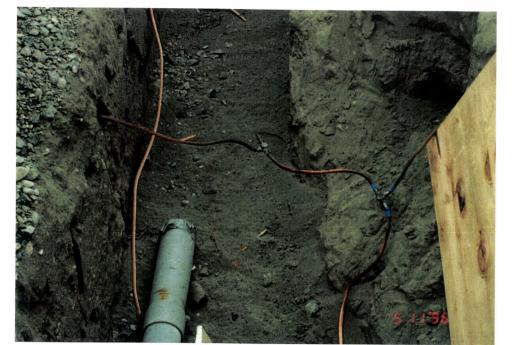
G960124-25-OPV

Duct bank trench . previously damaged grounding cable was repaired.

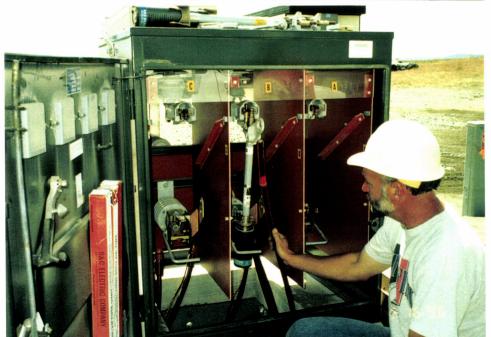
G960124-26-O-PV

Benton PUD installed fuse box near the corner station.

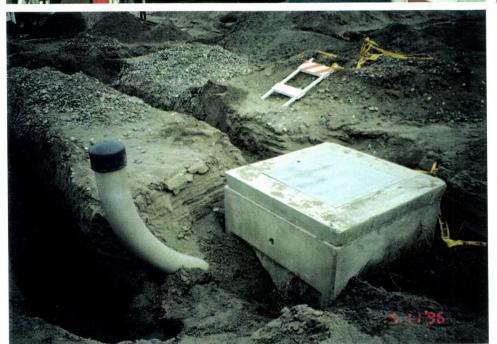
G960124-27-O-PV

Benton PUD installed electrical bake-out vault near the corner station

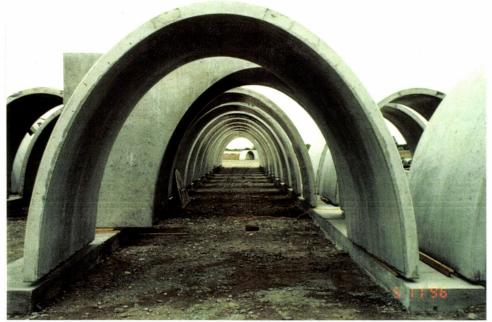
G960124-28-O-P

Completed beam tube enclosure segment at the Acme precast yard

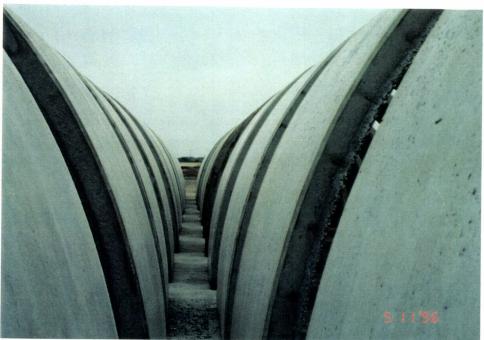
G960124-29-O-P

Exterior view of the beam tube enclosure segments.

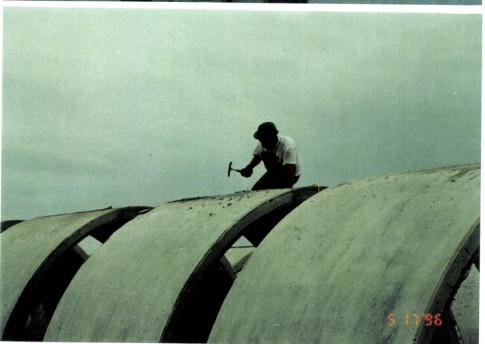
G960124-30-O-P

Q/C work started for the beam tube enclosure segments.

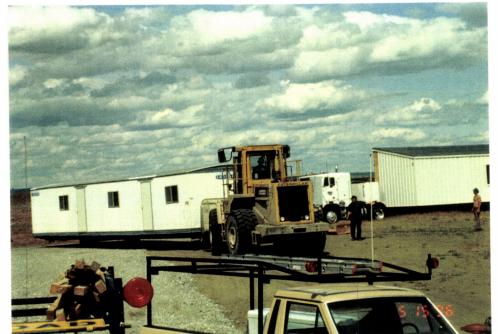
G960124-31-O-P
CBI mobilizing their offices

at site.

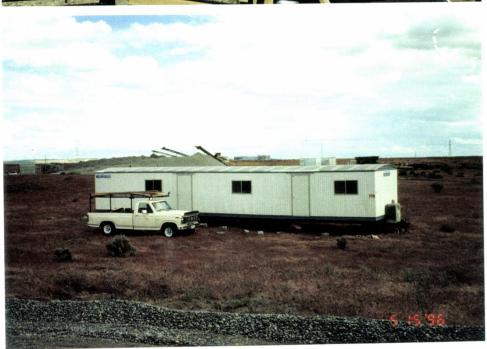
G960124-32-O-P

CBI mobilizing their offices at site.

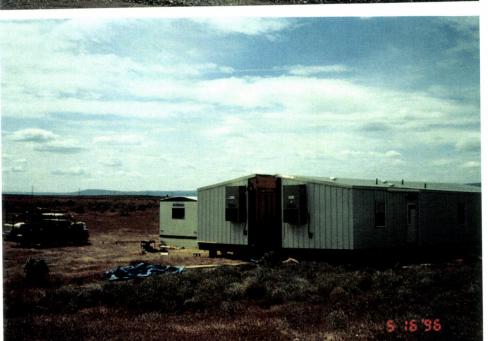
G960124-33-O+P

CBI mobilizing their offices at site.
