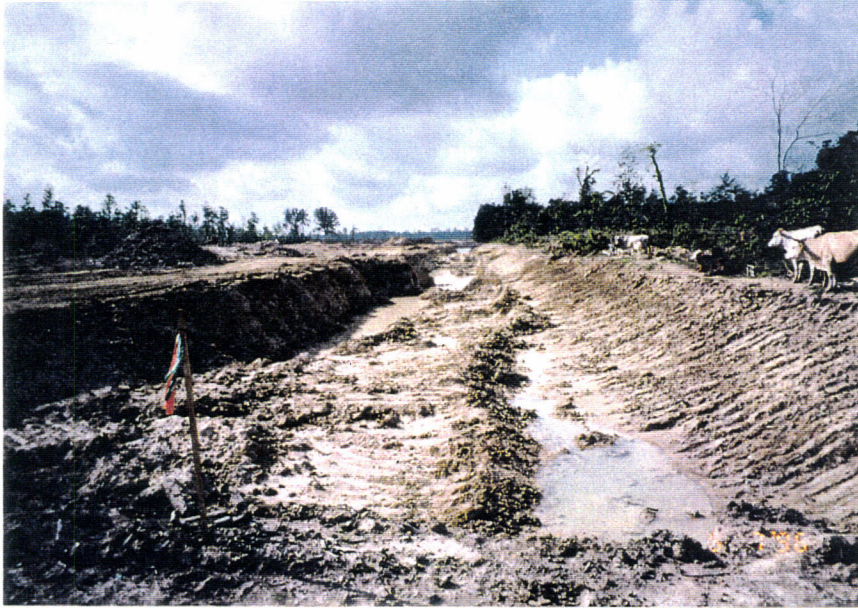
G960142-01-O-PV

1. Southwest Arm at station 36+00 looking SW at trench excavation and spectators.

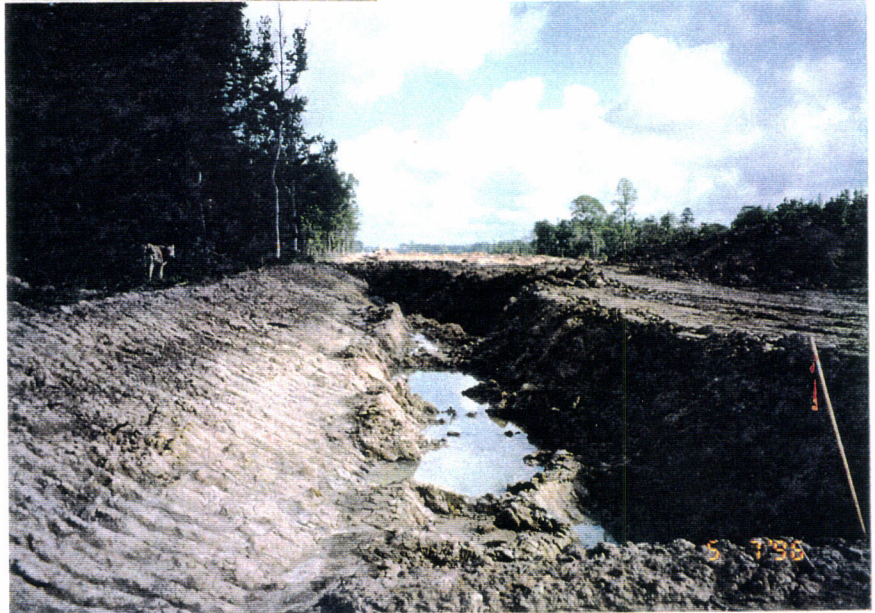
G960142-02-O-P

2. Southwest Arm at station 36+00 looking NE at trench excavation.

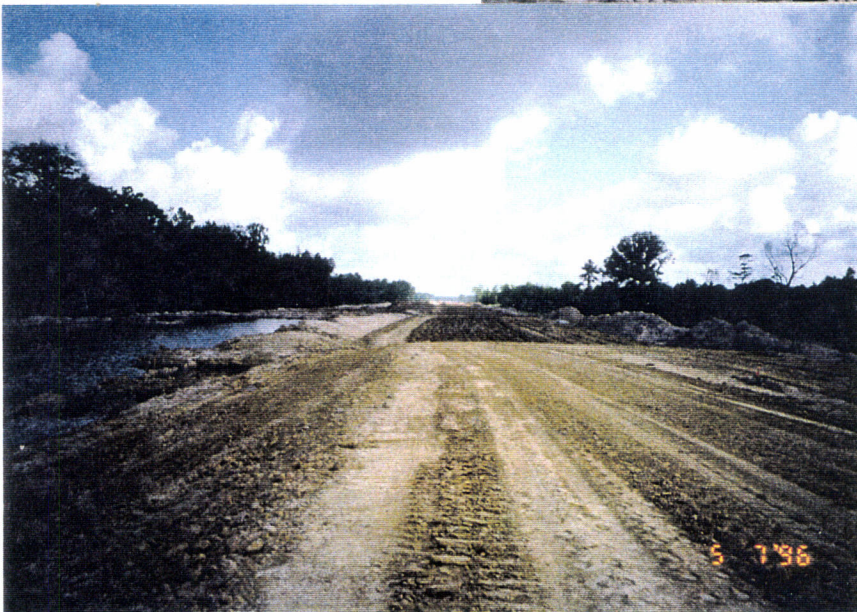
G960142-03-O-P

3. Southeast Arm looking NW at station 110+00

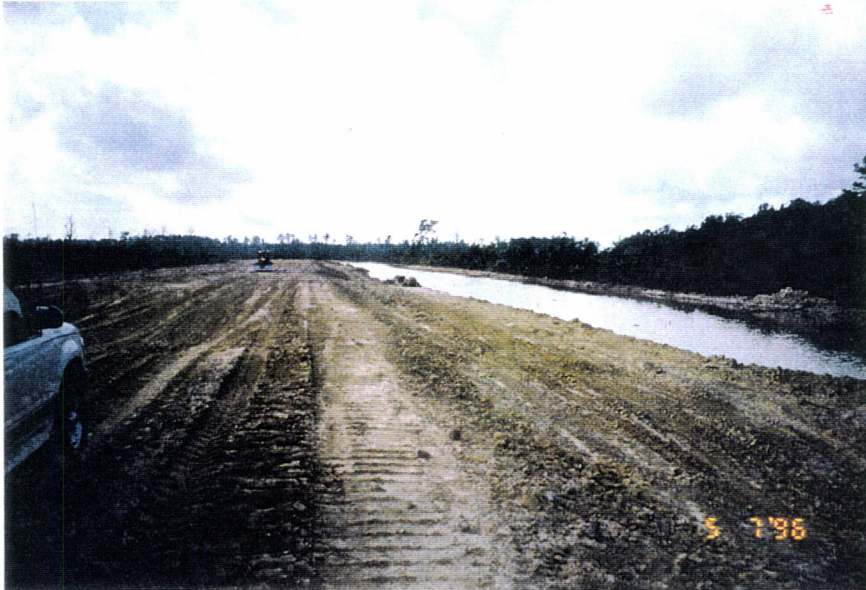
G960142-04-O-P

4. Southeast Arm at station 110+00 looking SW at compaction roller working material to meet Spec.

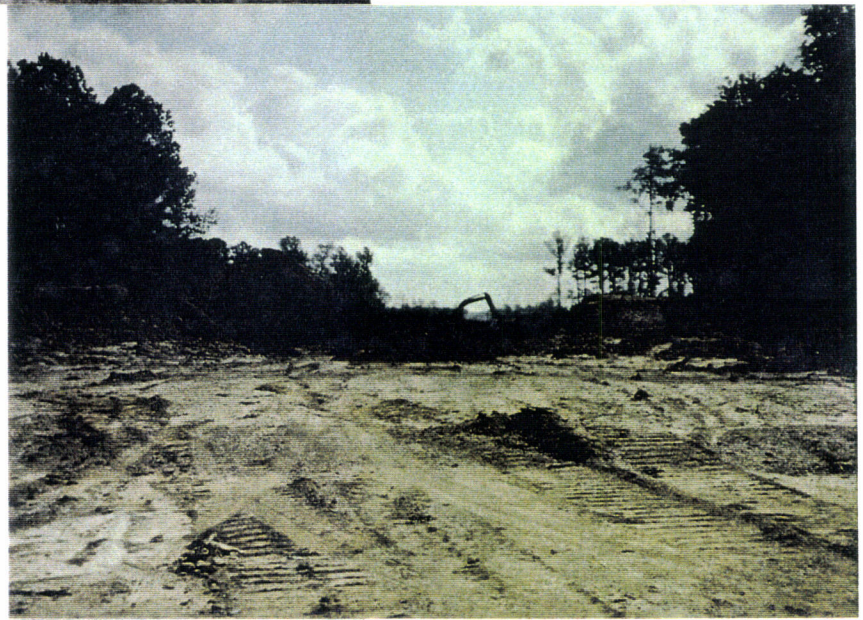
G960142-05-O-P

5. Southwest Arm at station 120+00 showing excavating and spreading berm fill material

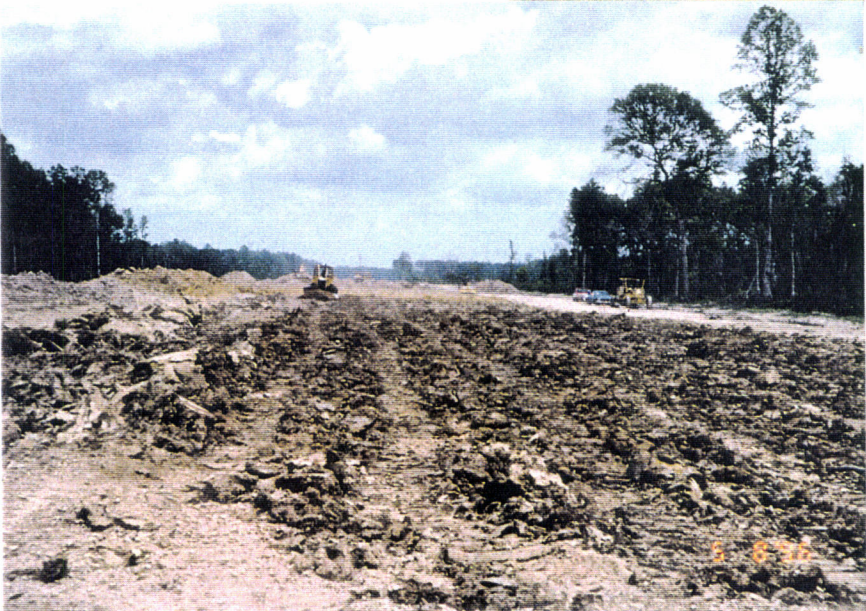
G960142-06-O-P

6. Southeast arm, at station 105+00 looking NW at spreading and drying fill material..

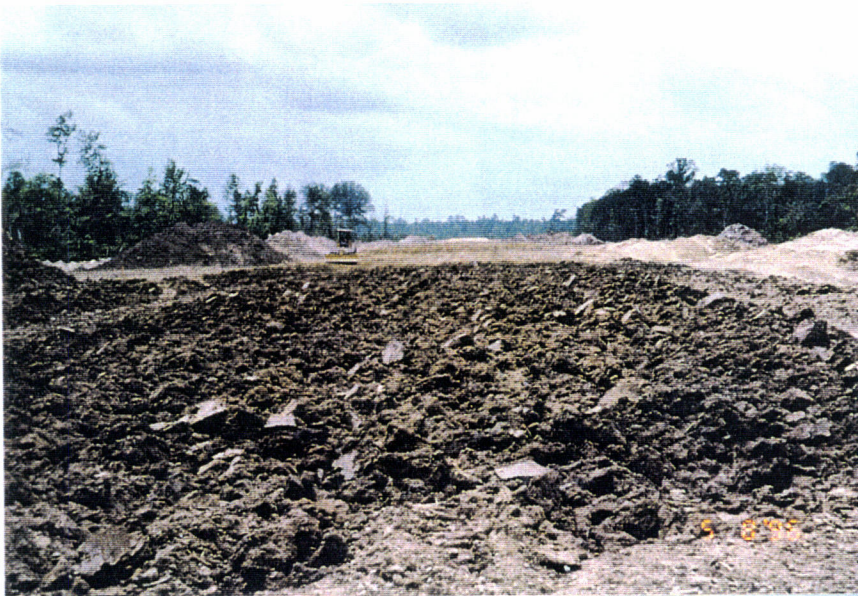
G960142-~~07~~-O-P

7. Southwest Arm at station 119+00 drying a new lift of material.

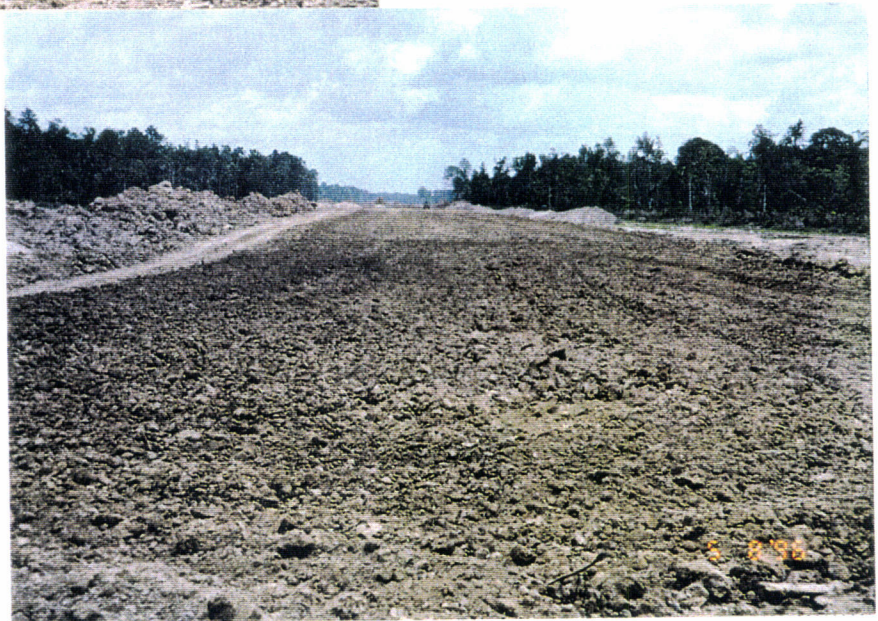
G960142-~~08~~-O-P

8. Southwest arm at station 109+00 showing disked material ready for compaction roller..

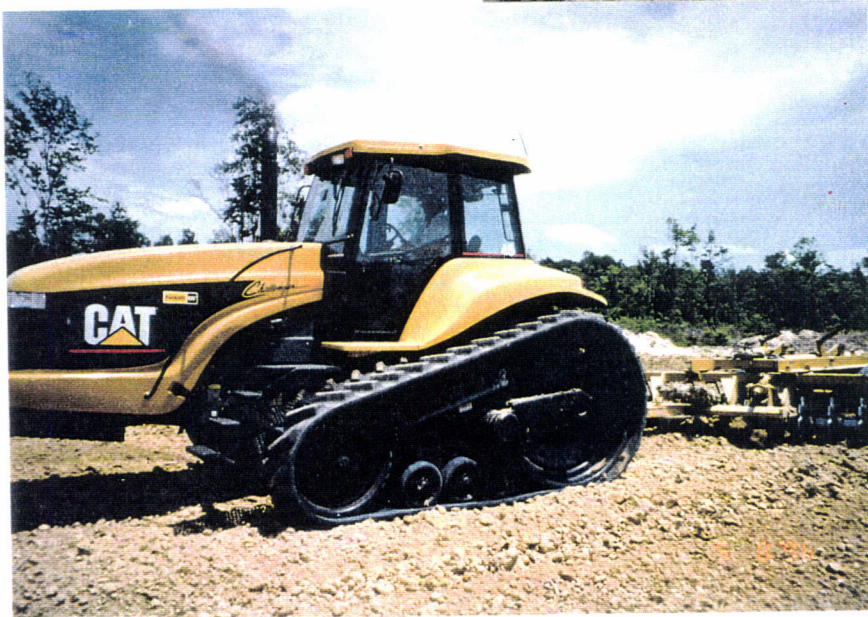
G960142-~~09~~-O-P

9. This is the new Challenger that replaced the dozers for pulling disks. note: the rubber drive train.

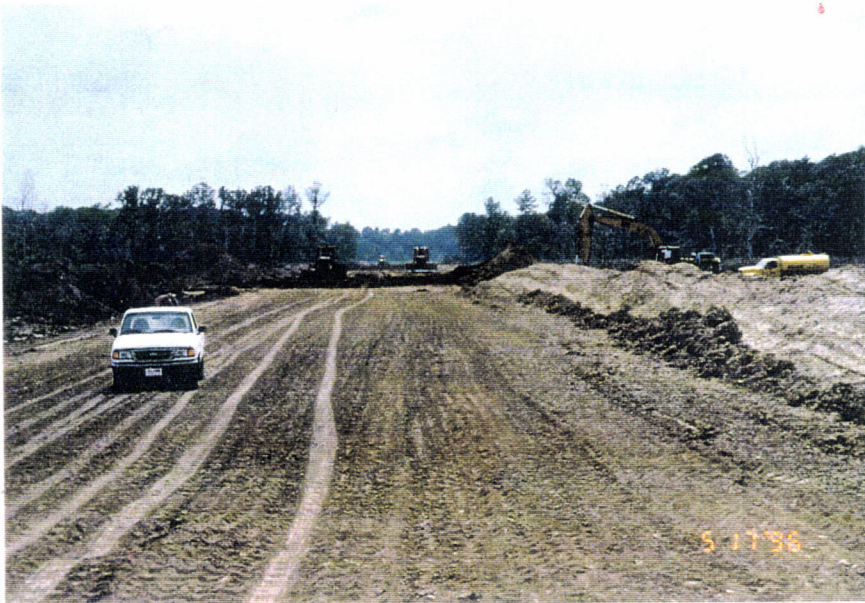
G960142-10 -O-P

10. Southwest arm at station 118+00 Showing preparing for soil compaction test.

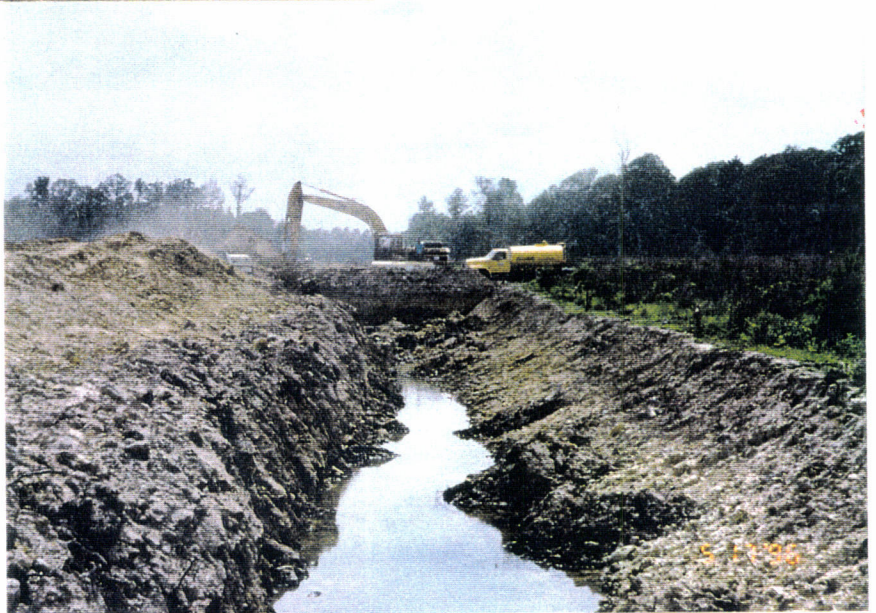
G960142- 11 -O-P

11. Southwest arm at station 109+00 showing excavation of trench for fill.

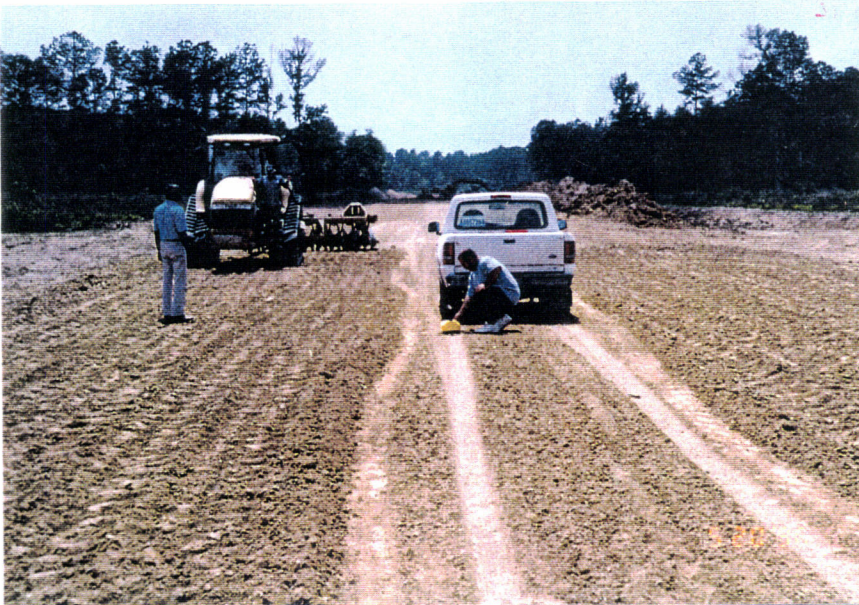
G960142-13-O-~~Q~~V

13. Southwest Arm at station 120+00 conducting soil compaction test.

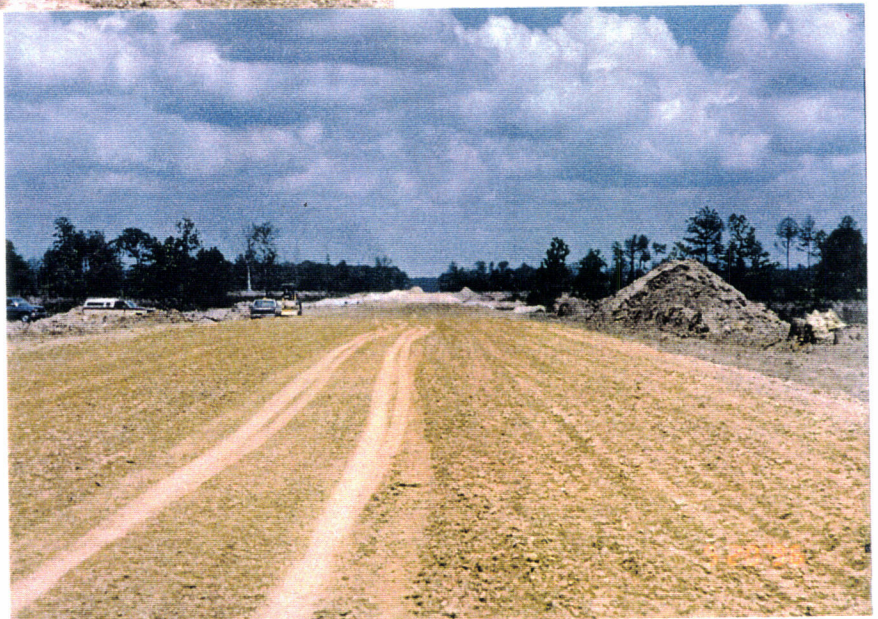
G960142-14-O-P

14. Southwest Arm at station 113+00 looking NE at compacted berm fill.

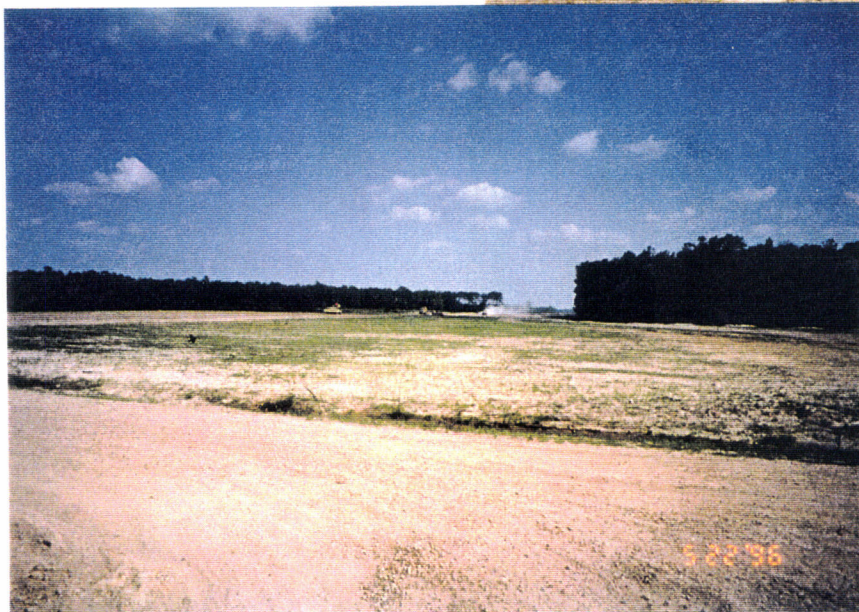
G960142-15-O-P

15. Southeast arm at Apex looking at base prep being done

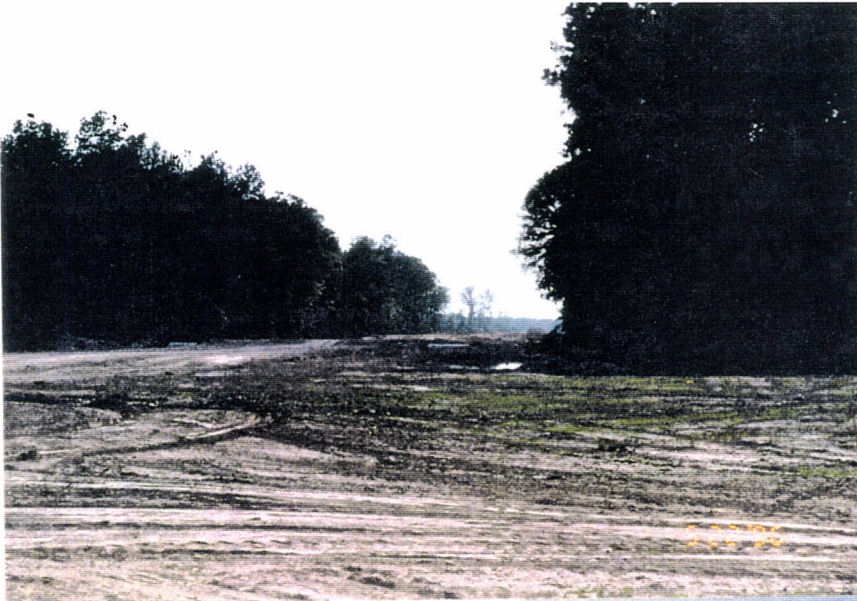
G960142-16-O-P

16. Southwest Arm at Station 2+00 looking SW at berm as it enters apex area.

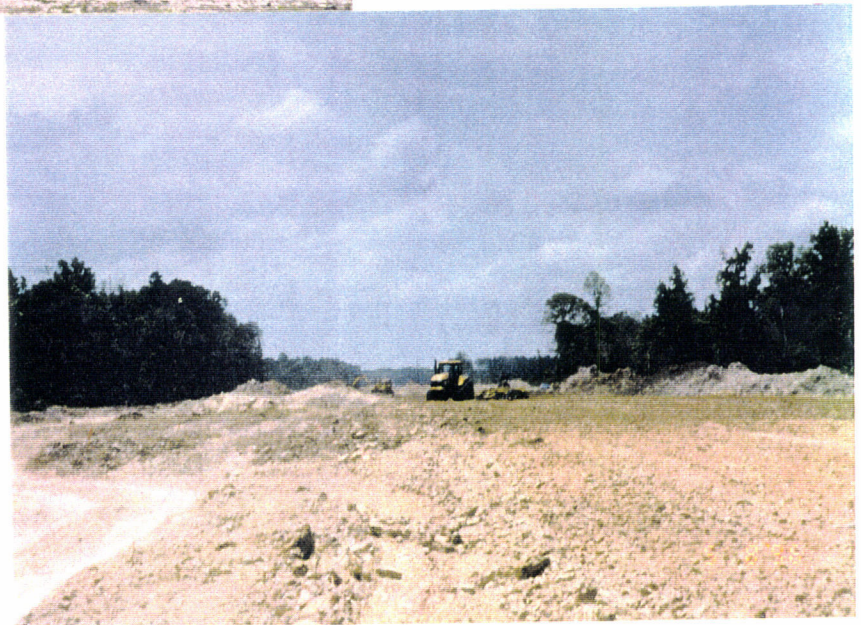
G960142-17-O-P

17. Southeast Arm at Station 108+00 looking NW at Challenger disking moist material.

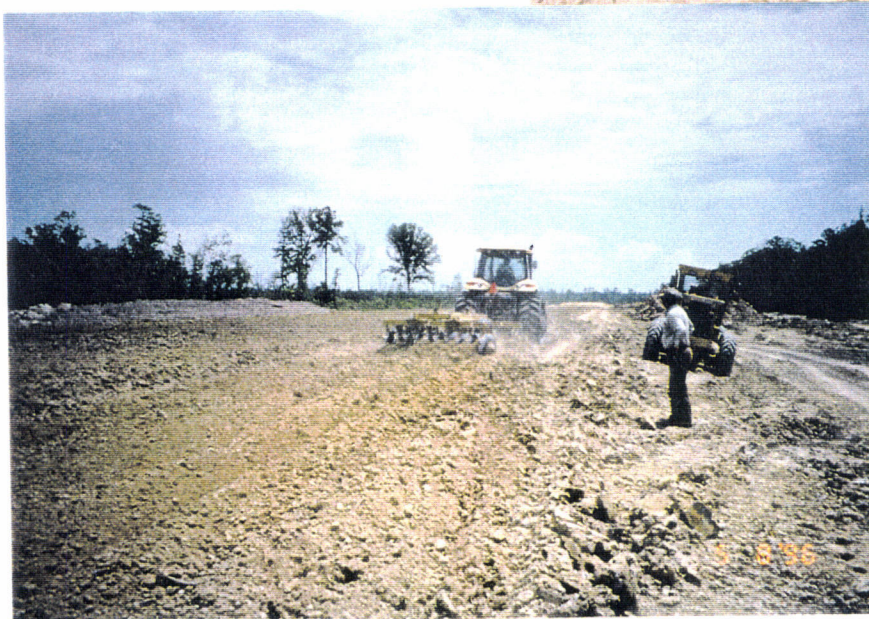
G960142-18-O-P

18. Southeast Arm at station 96+00 showing disking operation

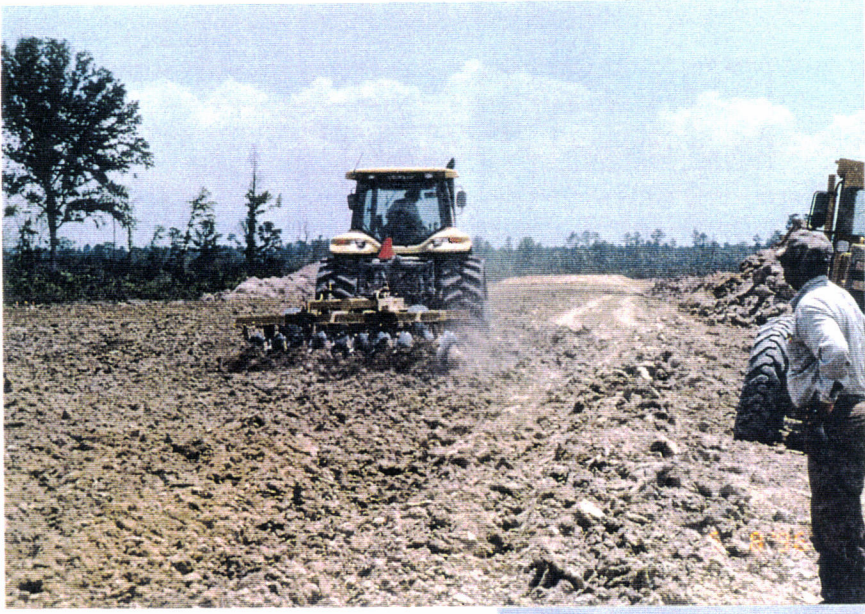
G960142-19-O-PV

19. Southeast arm showing the fine material flying from disk which enhances the drying process

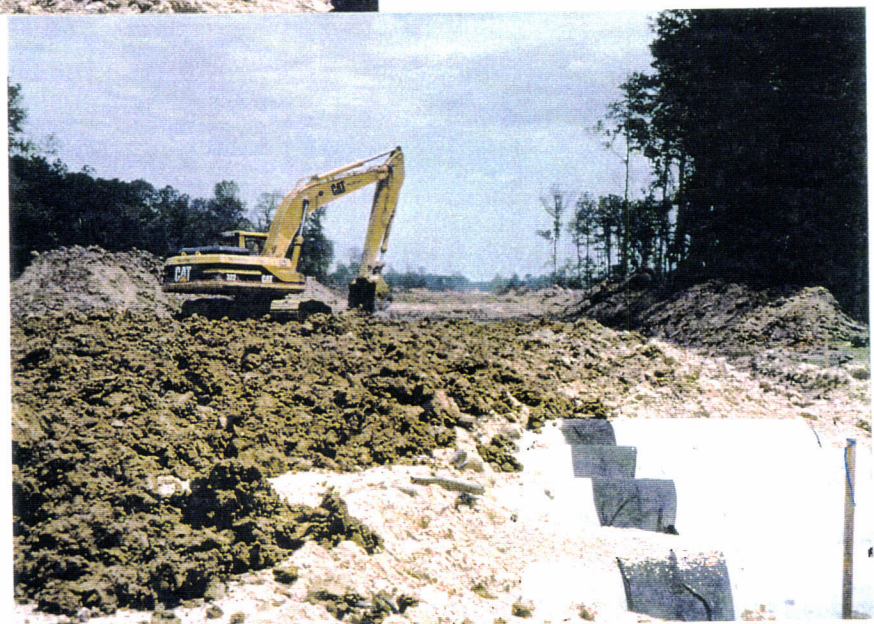
G960142-20-O-PV

20. Southwest Arm at Station 126+00 showing berm material being spread , another lift!

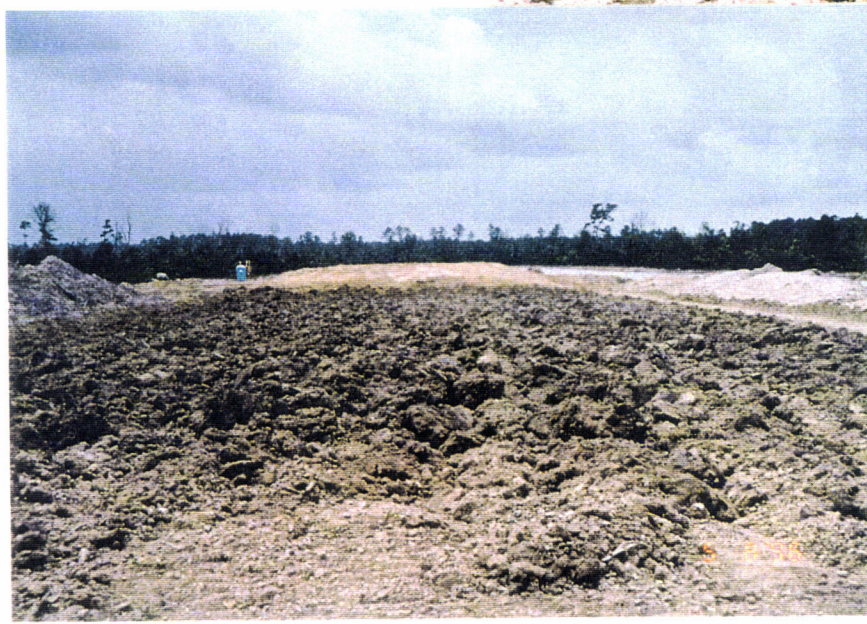
G960142-21-O-P

21. Southeast arm at station 108+00 looking SE . showing another lift being placed.

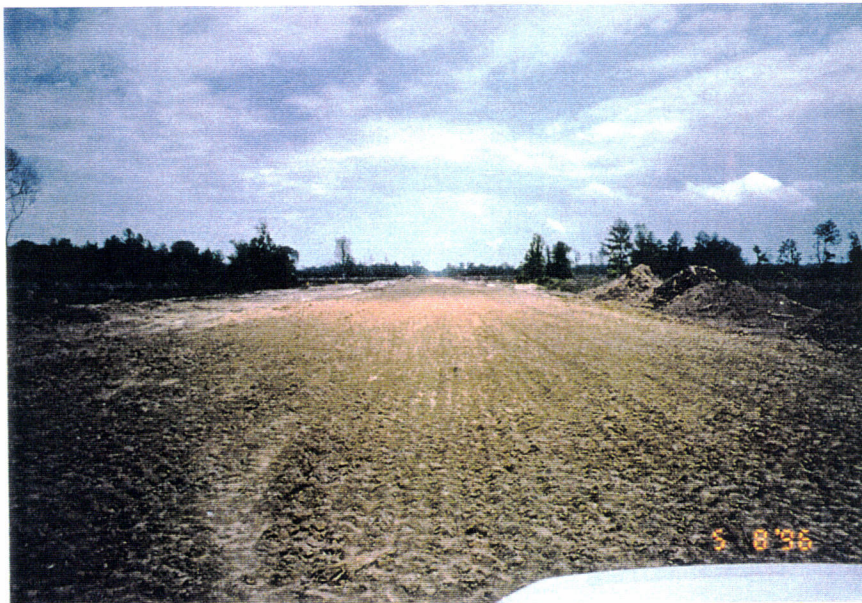
G960142-22-O-P

22. Southwest arm at station 76+00 looking SW at compacted berm fill just prior to compaction test.

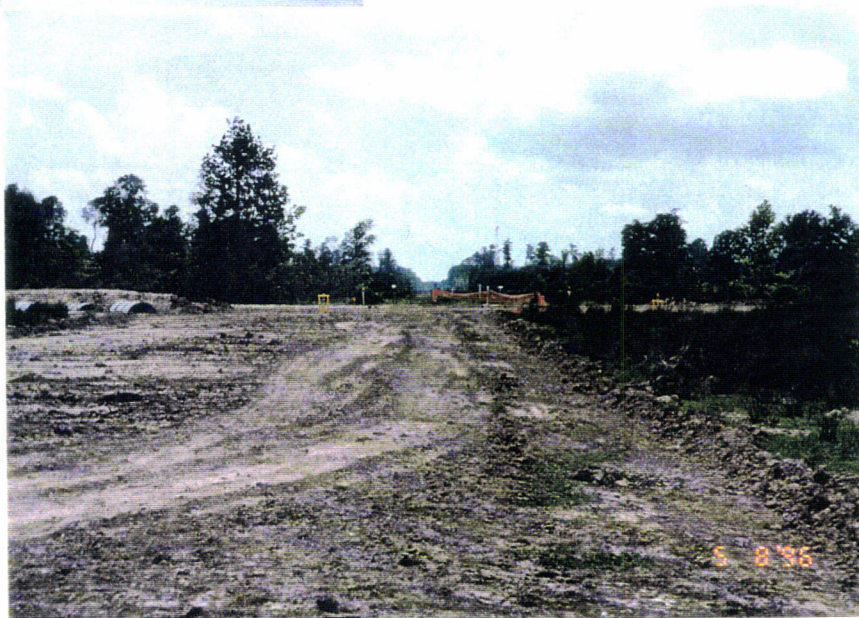
G960142-23-O-P

23. Southwest Arm at the pipeline crossing looking south as pipeline intersects the berm.

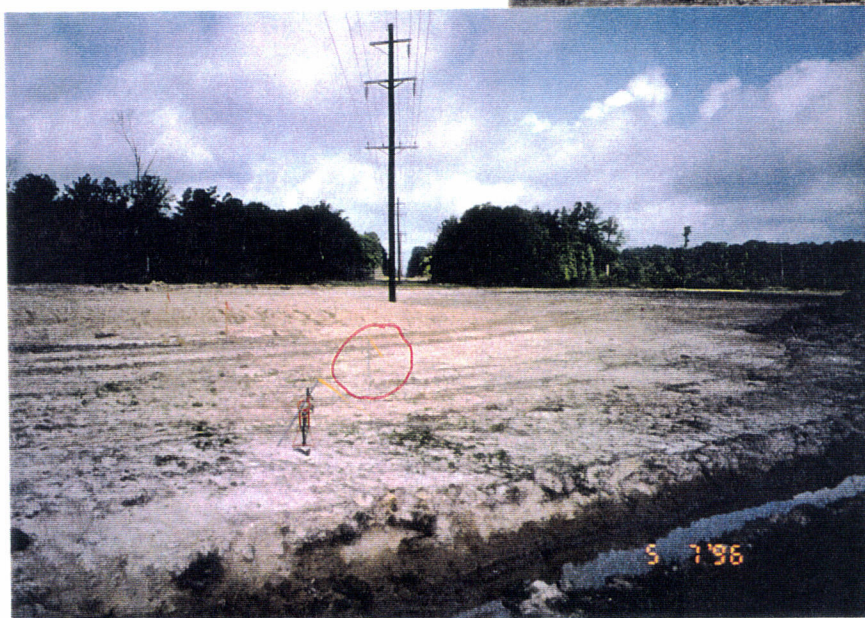
G960142-24-O-P

24. Southeast Arm at Dixie Power line crossing showing new location of 80 ft. pole to make more room for construction. (see red circle)
