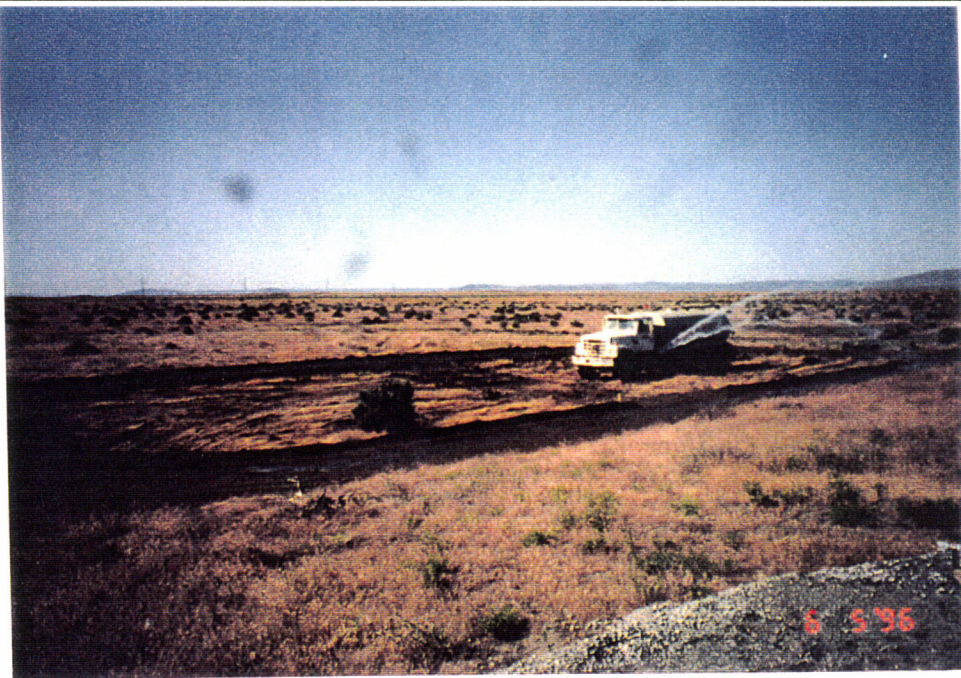
G960143-06-O-PV

Preparation of the
CB&I temporary
access and lay down
area.

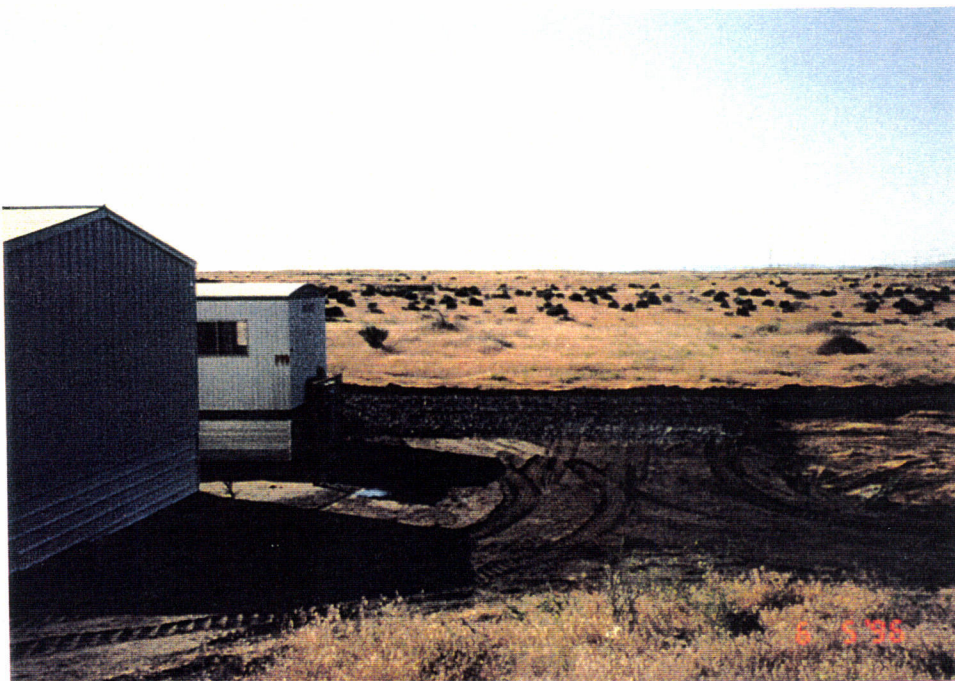
G960143-05-O-PV

Another view of the
CB&I temporary yard

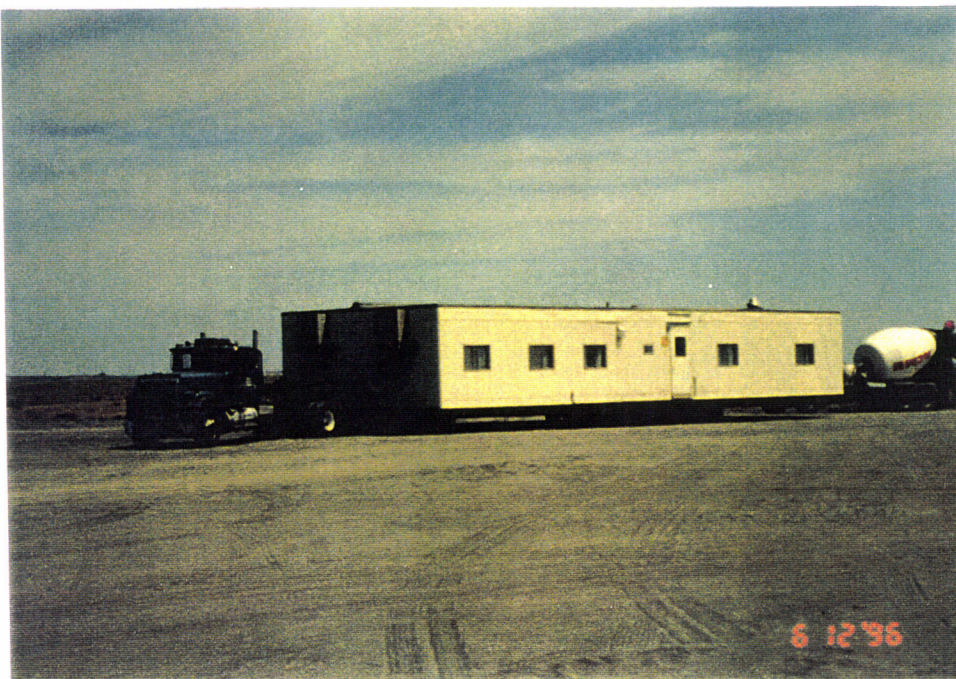
G960145-14-O-P

Delivery of the new
LIGO office.

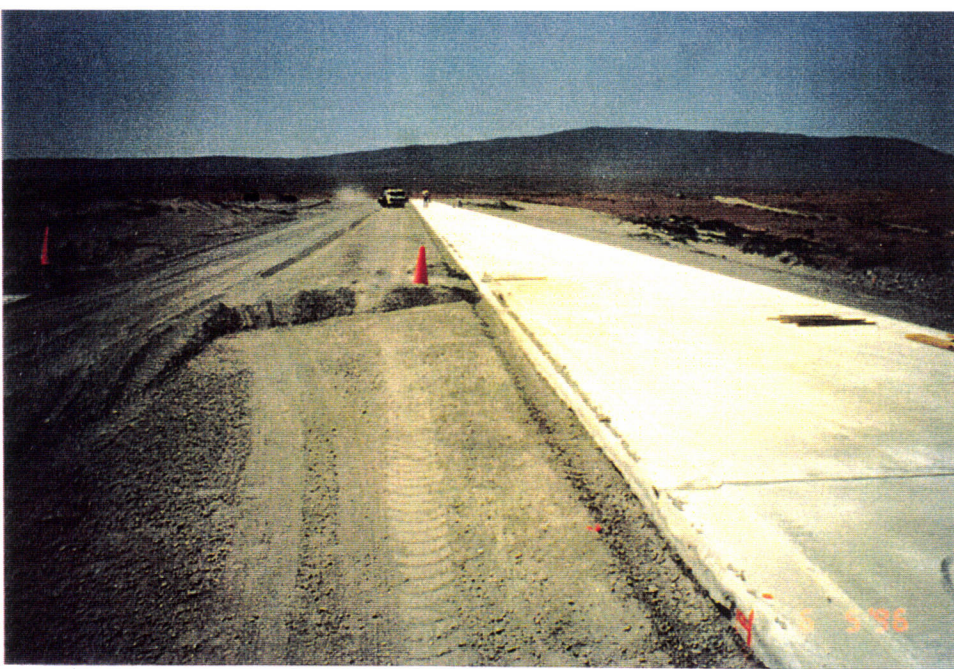
G960143-12-O-PV

Fine grading activities preparing the beam tube access road for bituminous treatment.

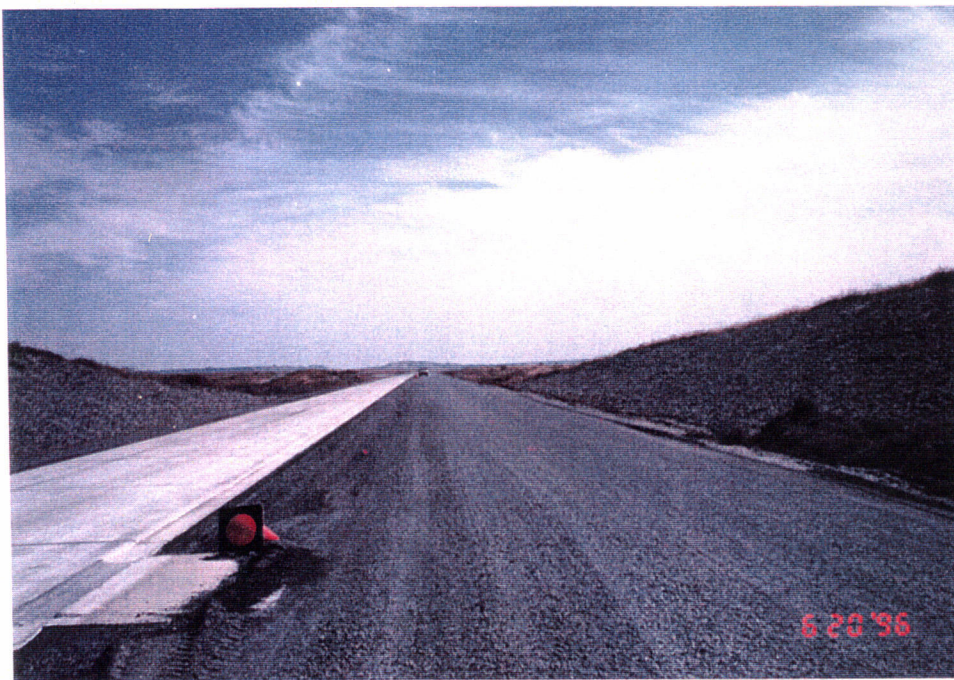
G960144-02-O-PV

View of the completed beam tube access road base installation prior to bituminous treatment.

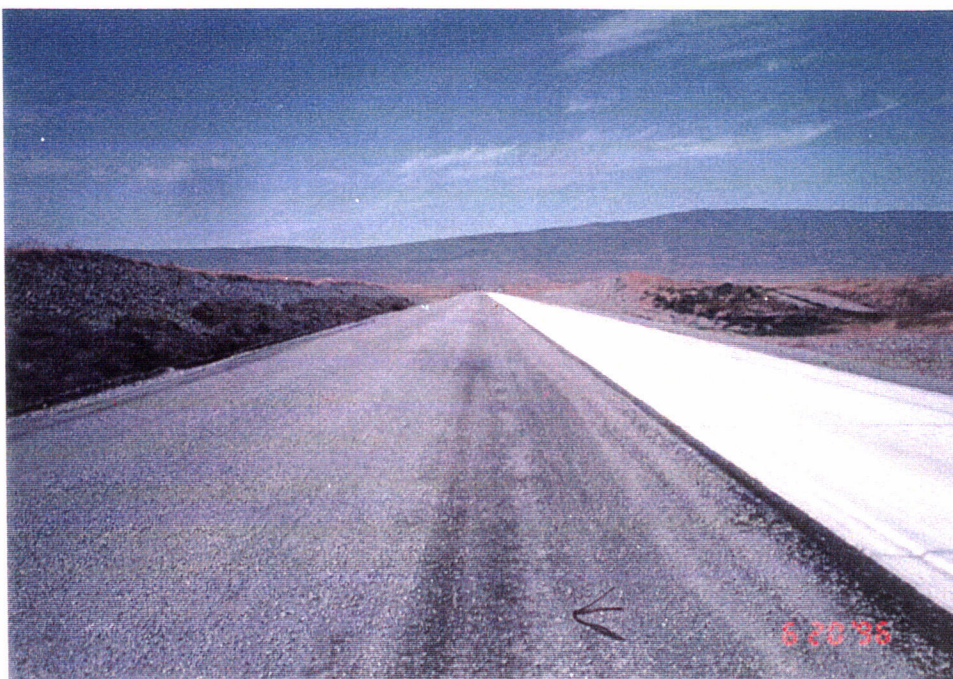
G960144-14-O-P

Another view of the completed access road prior to bituminous treatment.

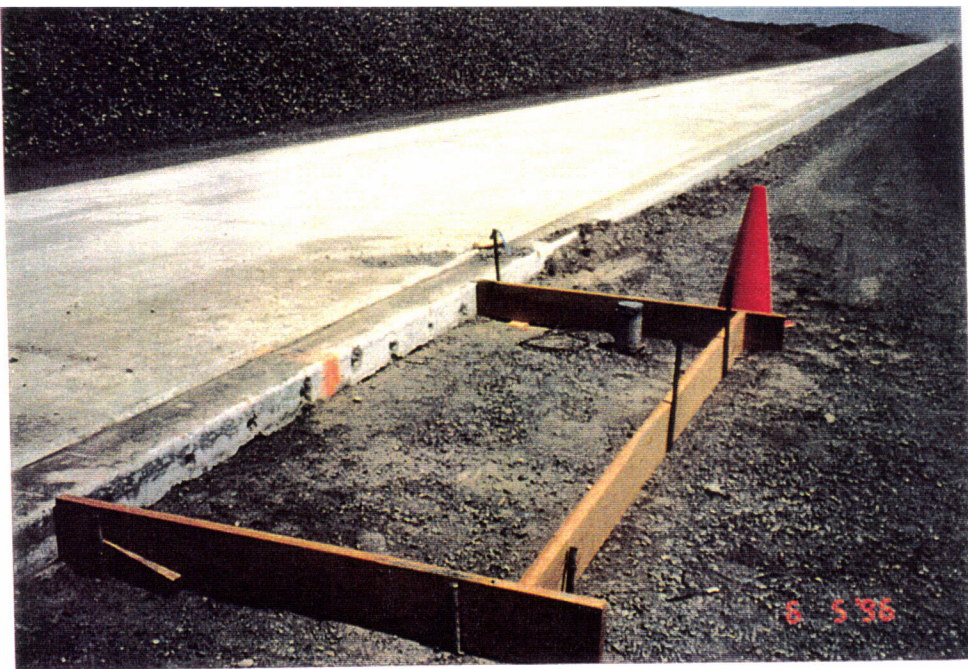
G960143-16-O-PV

Typical beam tube service entrance form.

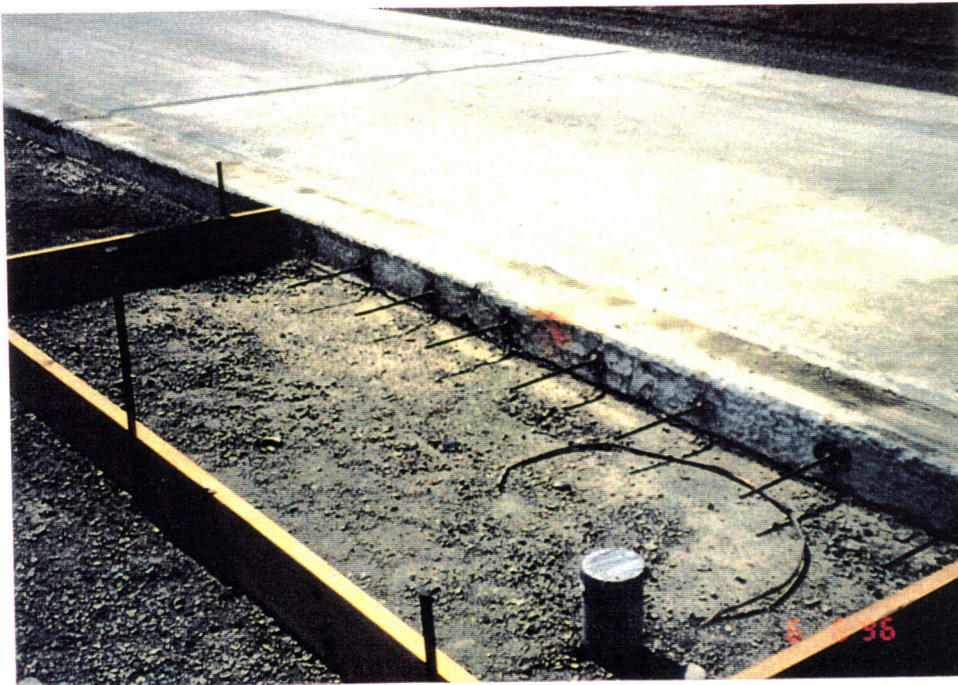
G960143-25-O-PV

The dowels were placed in epoxy grout material.

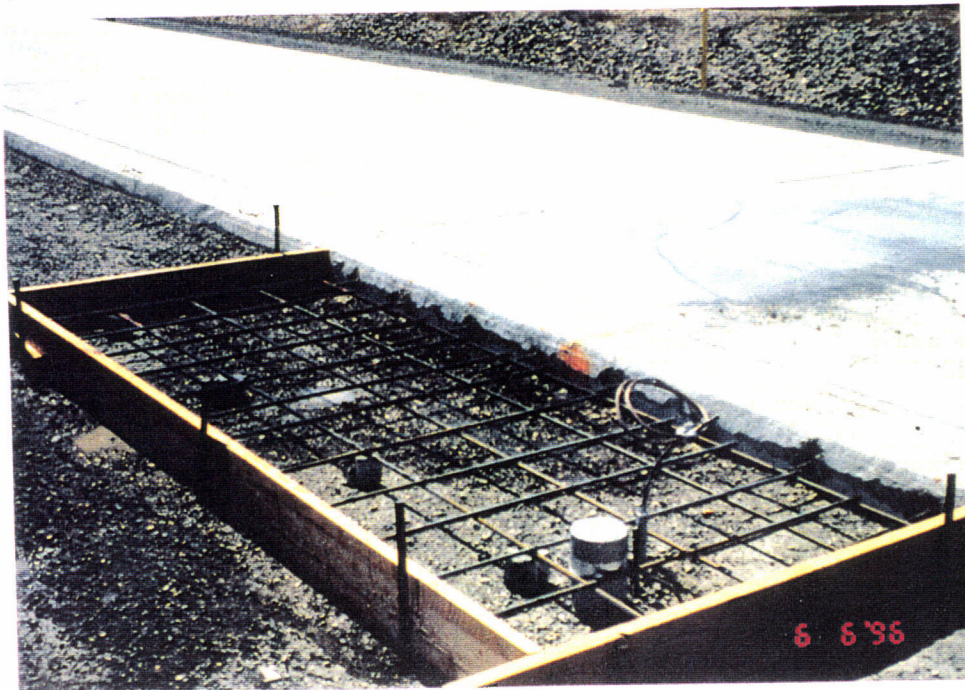
G960143-03-O-PV

The rebar is placed and the slab is ready for placing concrete.

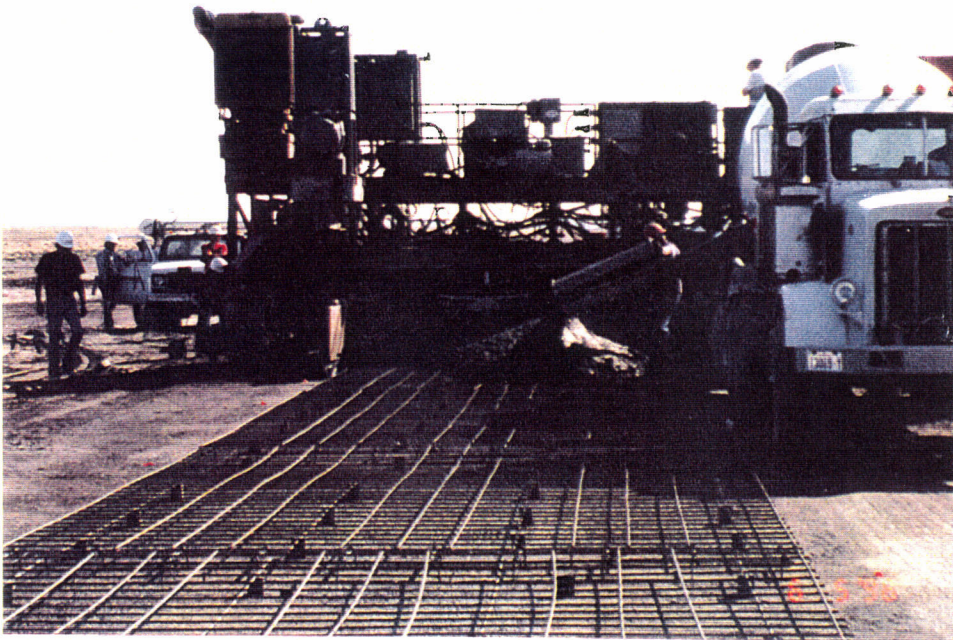
G960143-04-O-PV

Acme decided to mechanically place the final 60 feet of beam tube support slab at the location where underground installations had not been completed in time, when the slab for the southwest arm was placed.

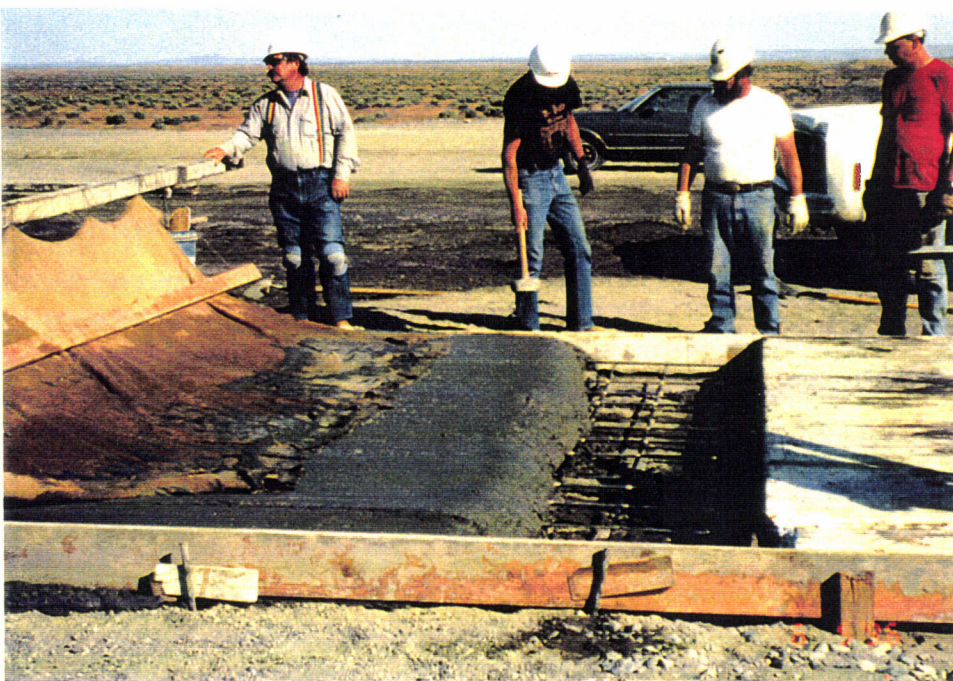
G960143-07-O-PV

The first of paving section where the slip forming interfaces with the anchor slabs is accomplished by manual application.

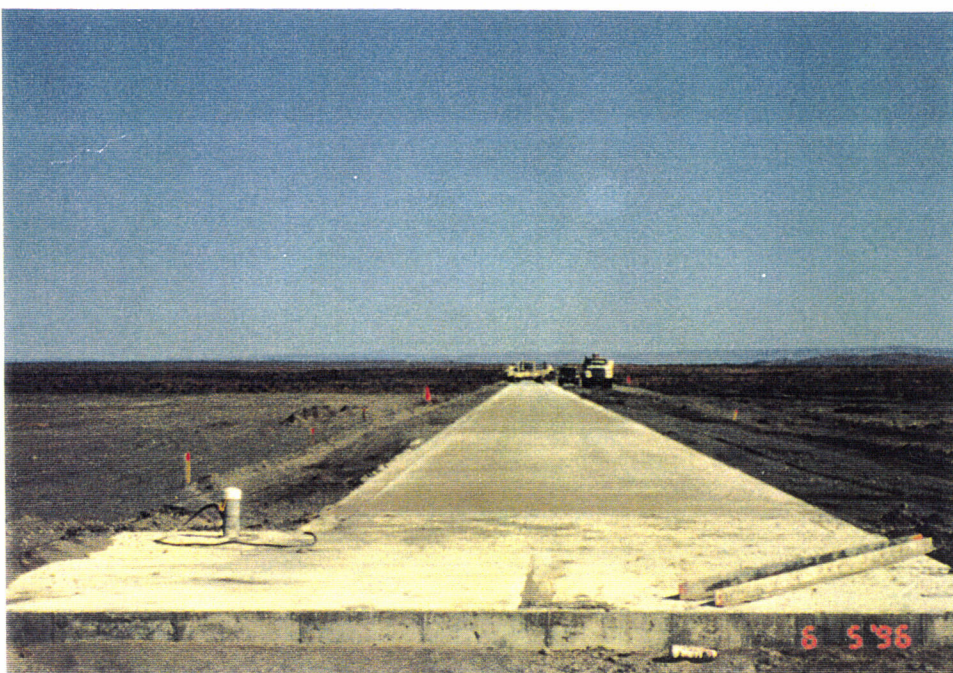
G960143-09-O-PV

View of the completed and final slip forming activities at the southwest arm Corner Station on June 5, 1996

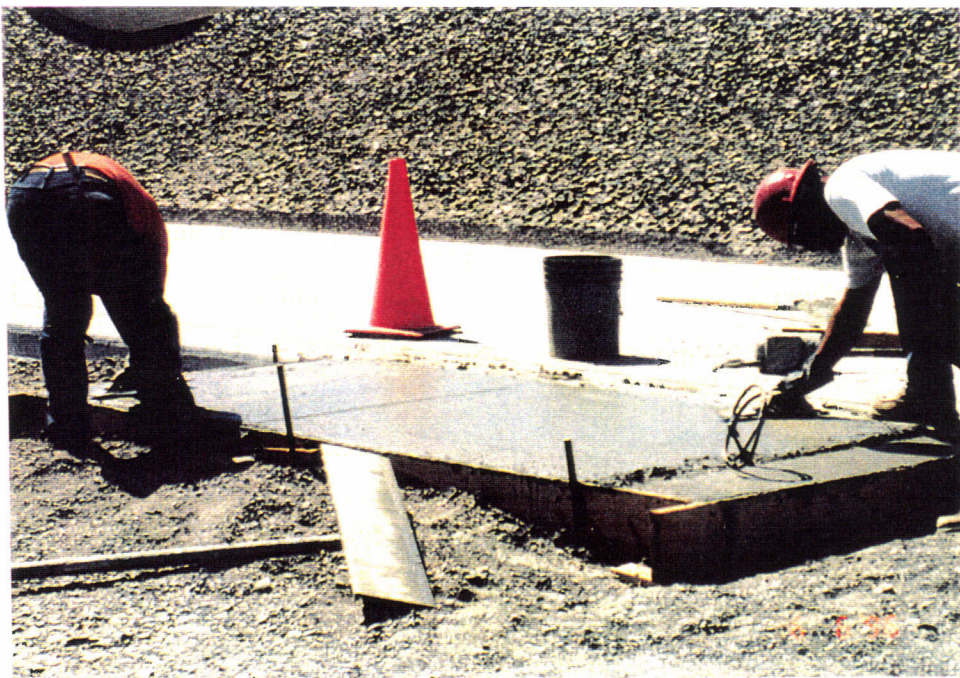
G960143-21 -O-PV

Concrete is placed for the service entrance. The finishers are providing the final touch for the Type "A" enclosure module alignment groove.

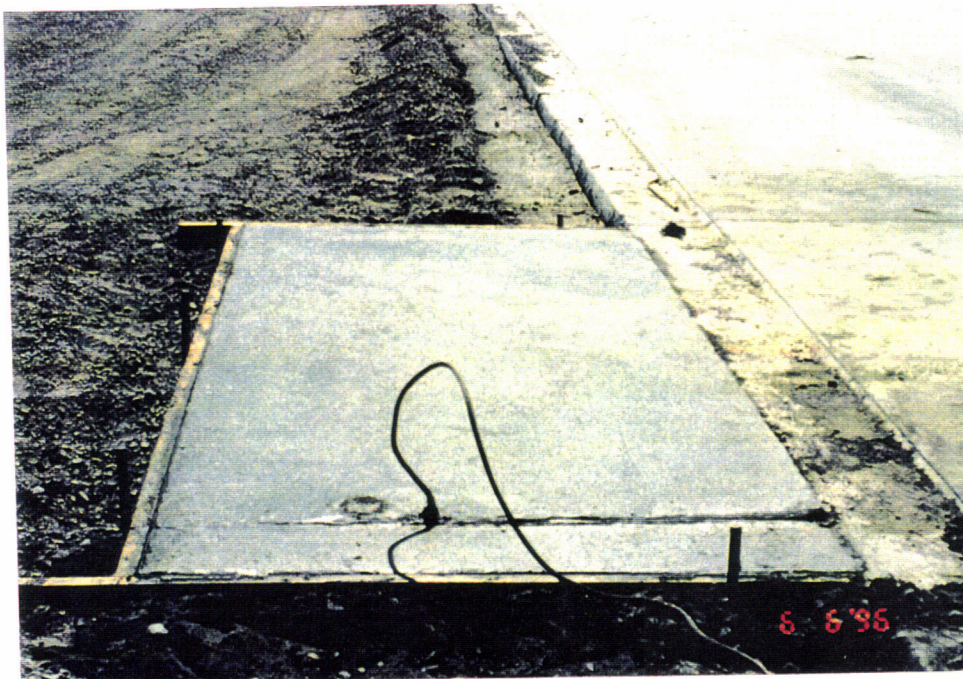
G960143-17 -O-PV

Typical completed service entrance slab.

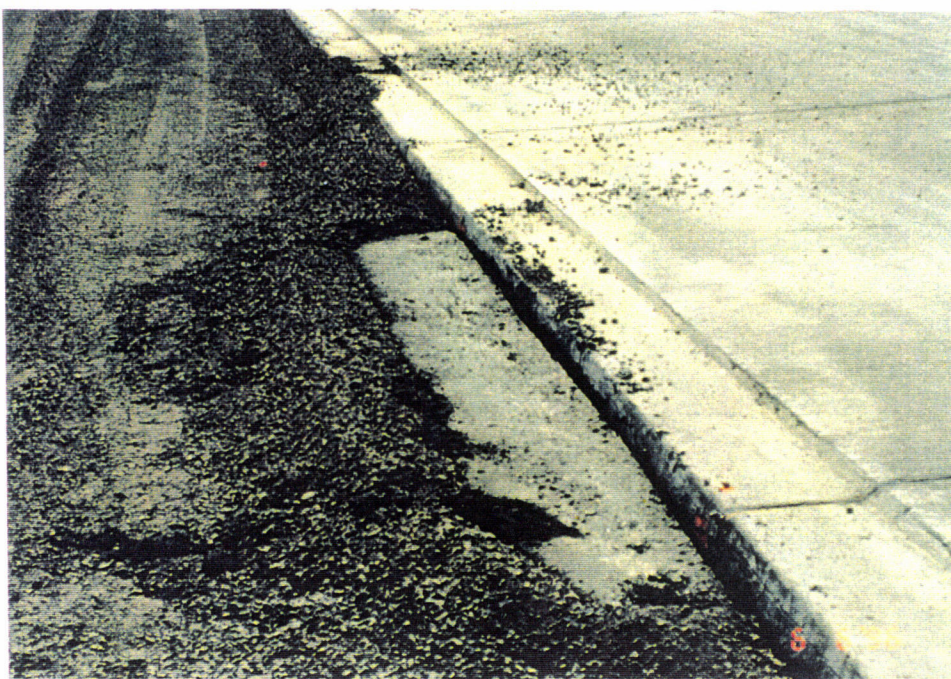
G960143-23 -O-PV

Picture shows some remedial work that was necessary at the alignment groove along the southwest arm where the paver caused some undermining.

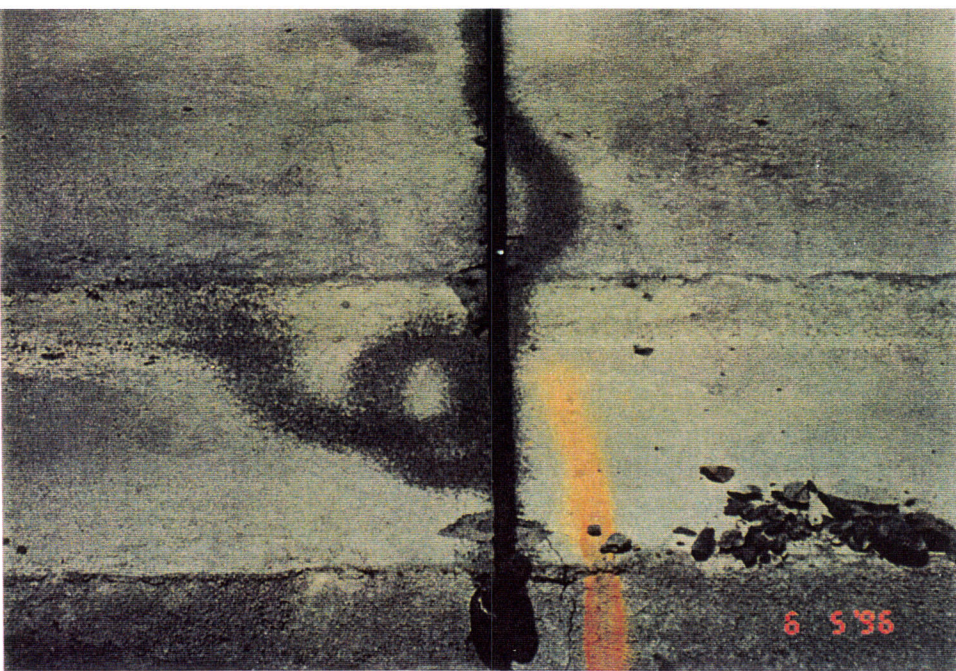
G960143-18 -O-PV

Foam Backer Rod is installed into the clean joint.

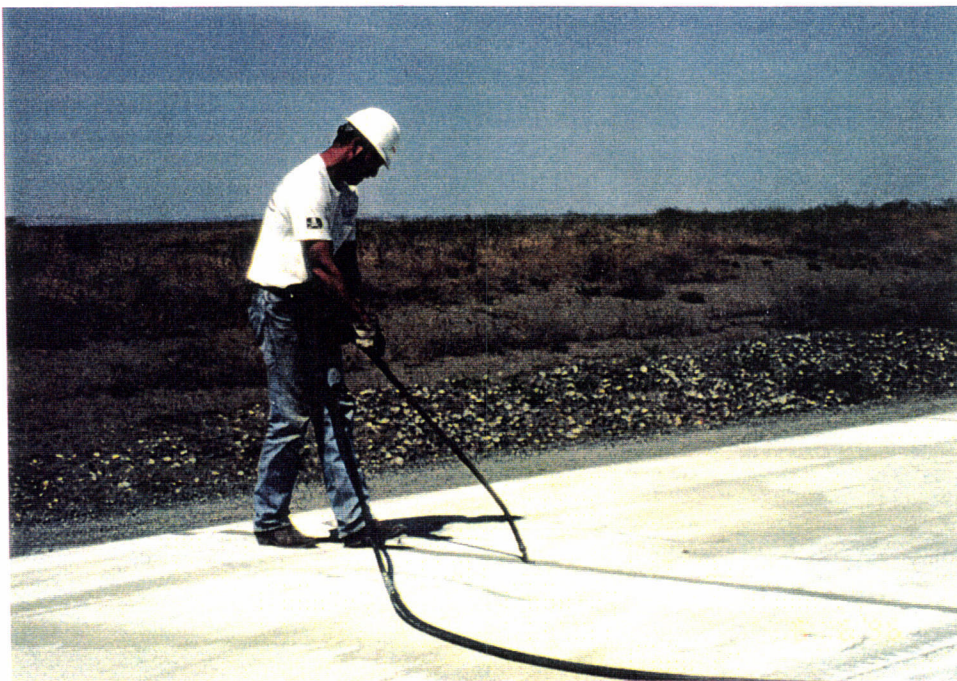
G960143-19 -O-PV

The joints are filled with a flexible sealing compound.

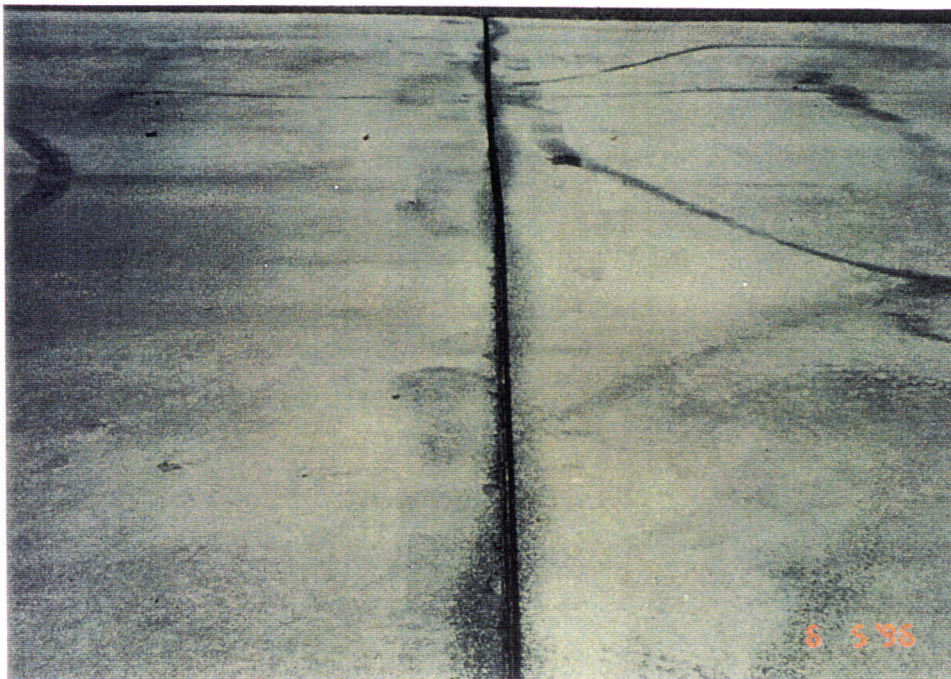
G960143-10 -O-PV

View of a typical completed sealed joint.
