G960151-

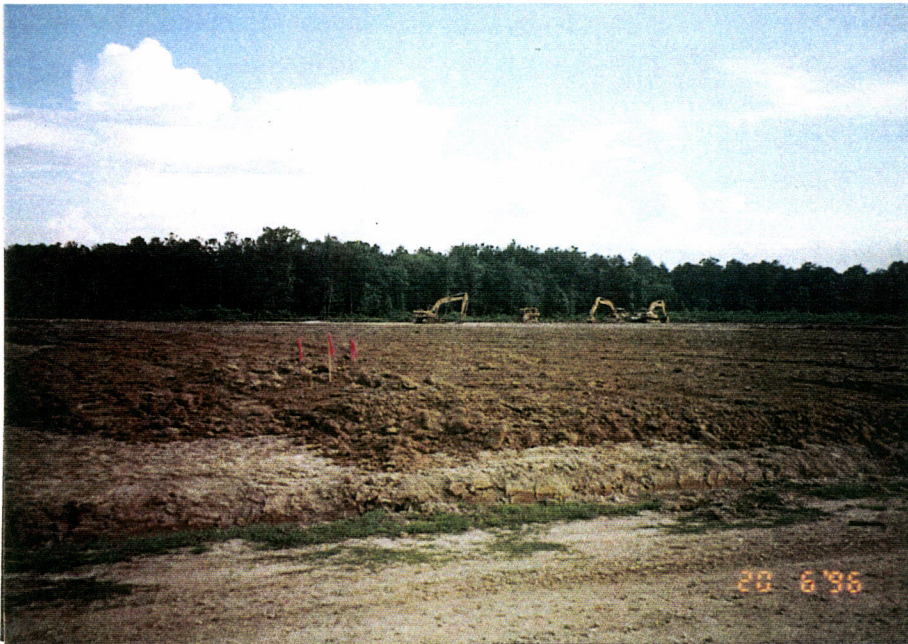
G960151- 01 - O-P

1. Center of Corner Station looking South.
Loose fill of 1st lift.

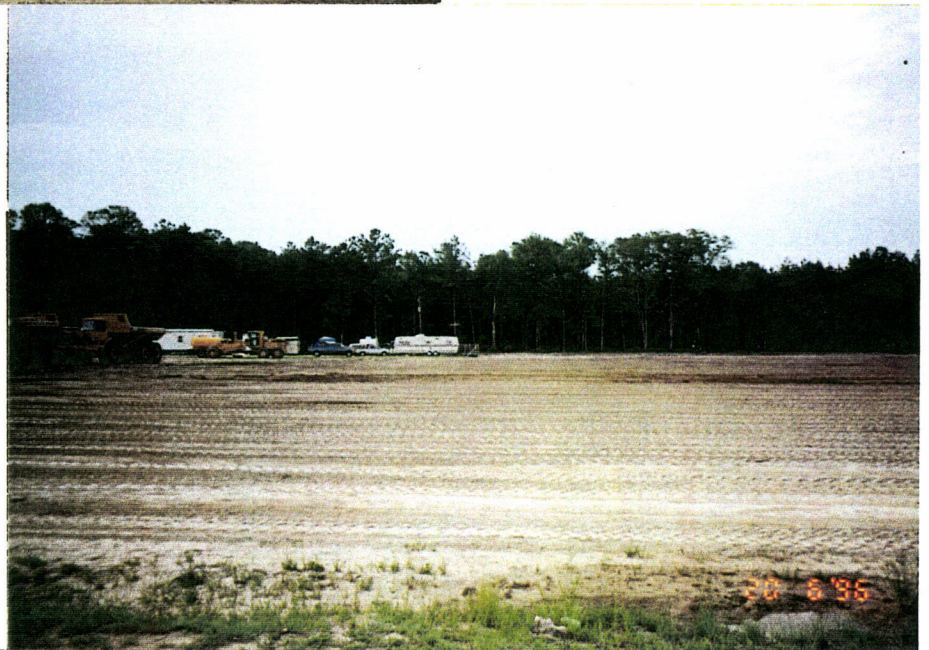
G960151- 02 - O-P

2. South side of Corner Station looking East.
Compacted soil at grade.

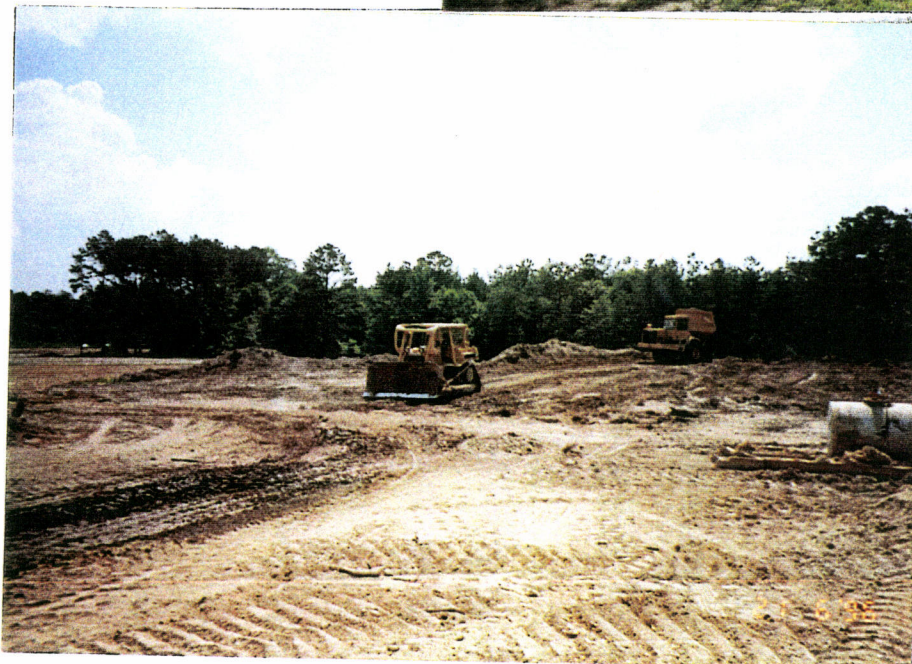
G960151- 03 - O-P

3. Northwest side of Corner Station looking West. Unusable topsoil being spread over future laydown area.

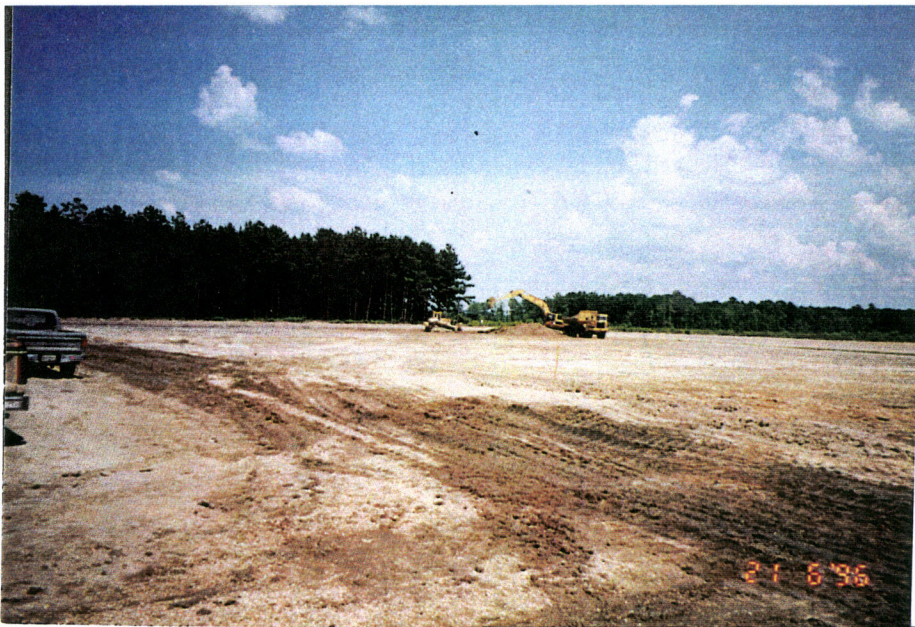
G960151- 04 - O-P

4. Northwest side of Corner Station looking East. Unusable topsoil being loaded for removal from Corner Station.

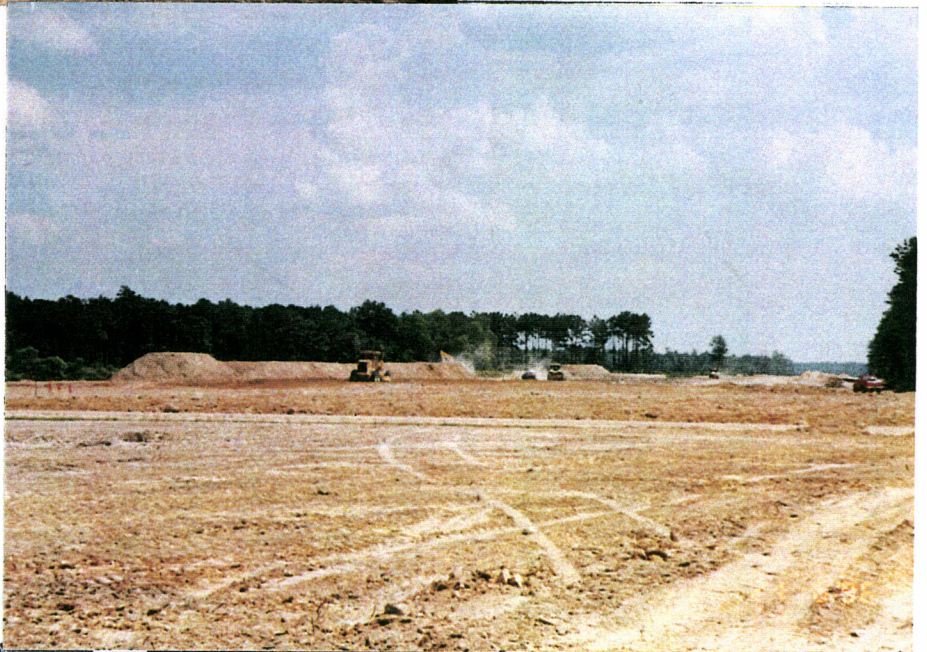
G960151- 05 - O-PV

5. North side of Corner Station looking South. 1st lift at grade being disked and compacted on South side of Corner Station.

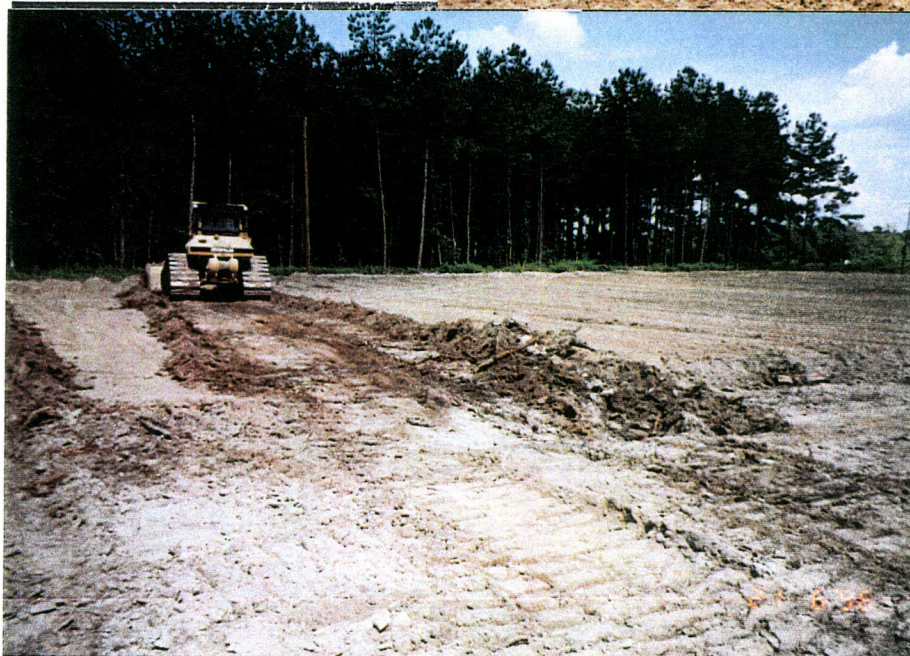
G960151- 06 - O-P

6. Northeast side of Corner Station looking East. Unusable topsoil being excavated for removal.

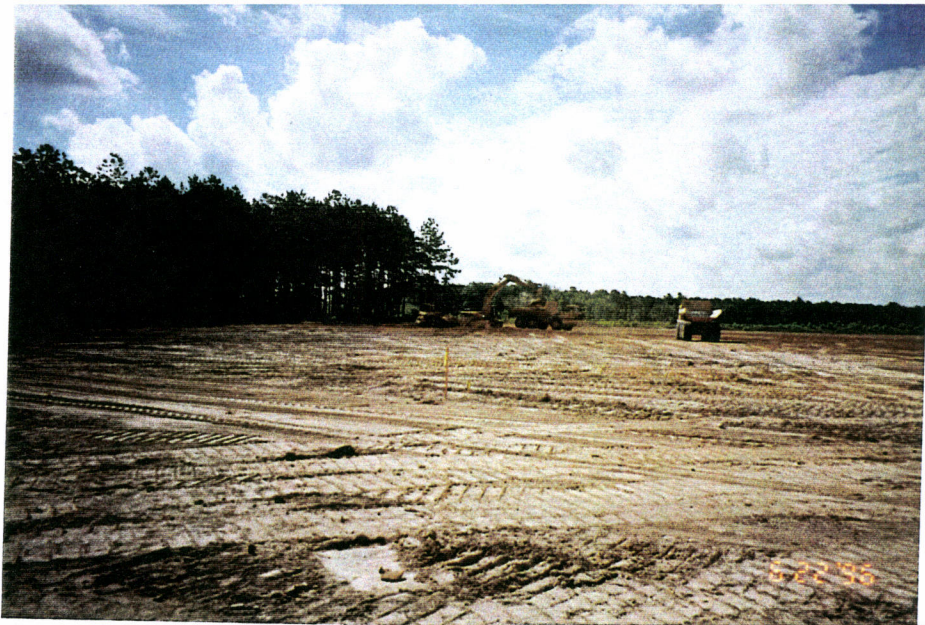
G960151- 07 - O-P

7. North side of Corner Station looking East. Unusable topsoil being removed from east side of Corner Station.

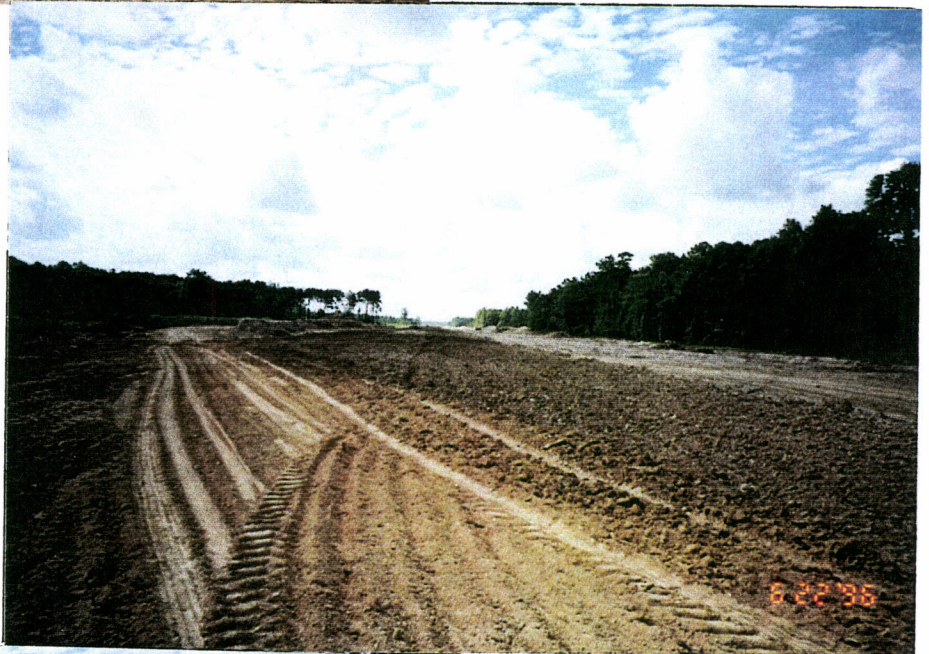
G960151- 08 - O-P

8. Southeast arm looking South at Sta. 5+00. Disking of fill for aeration.

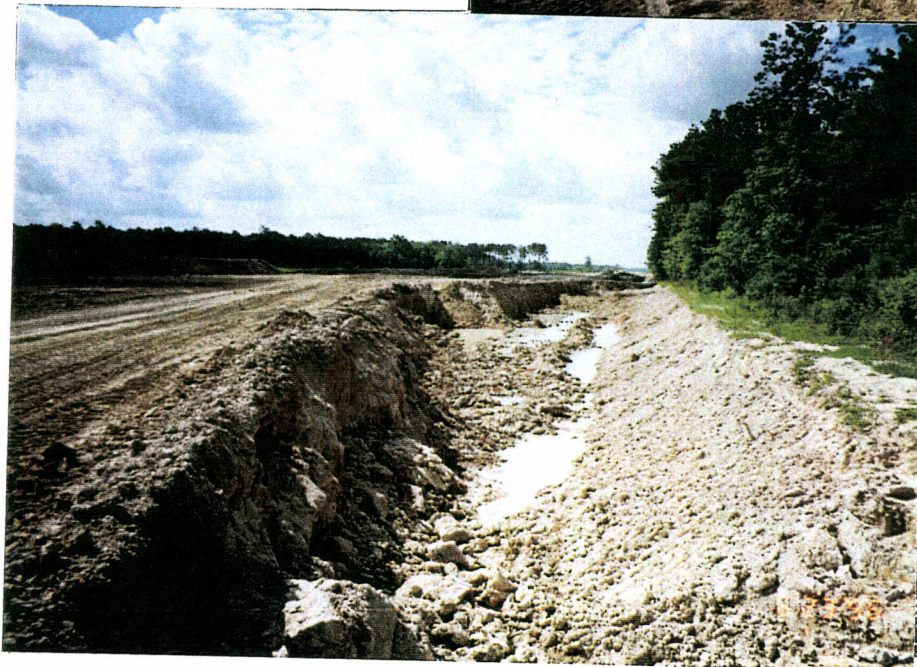
G960151- 09 - O-P

9. Southeast arm looking South at Sta. 3+00. Borrow pit for beam fill material.

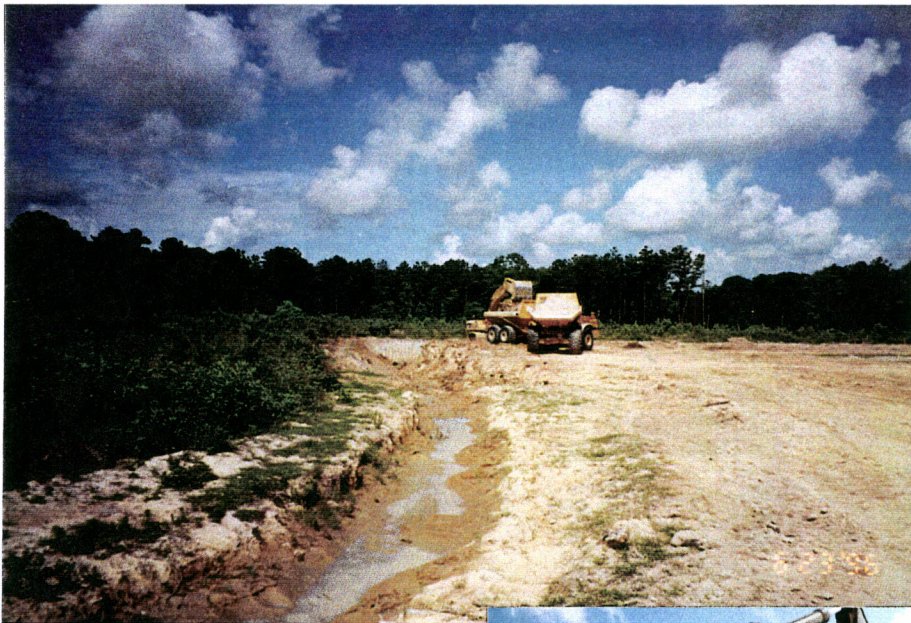
G960151- 10 - O-P

10. Southwest side of Corner Station looking West. Fill material being excavated and loaded.

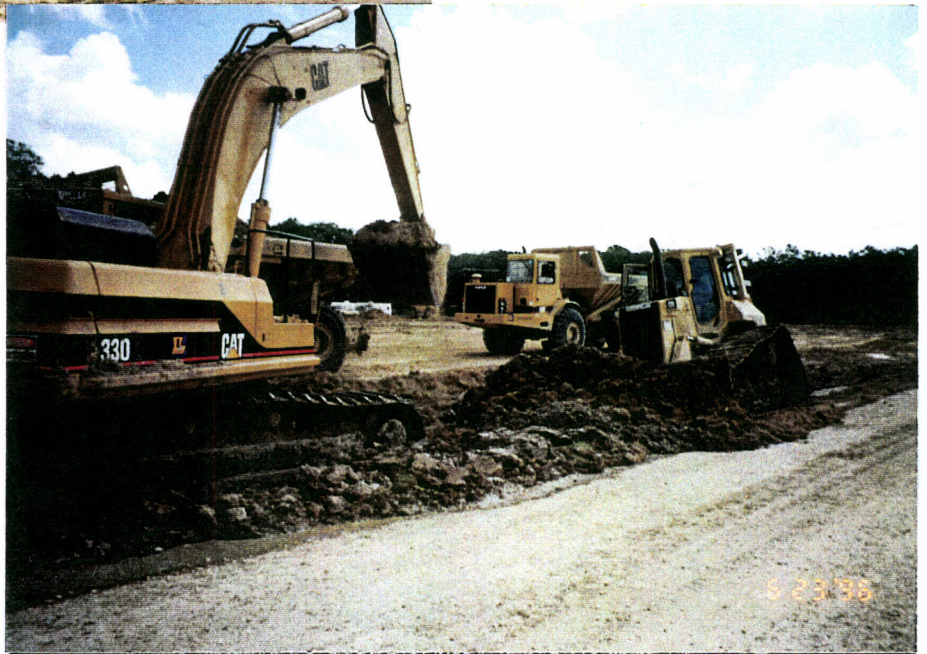
G960151- 11 - O-P

11. Center of Corner Station looking Northeast. Unusable material being removed from original site access road.

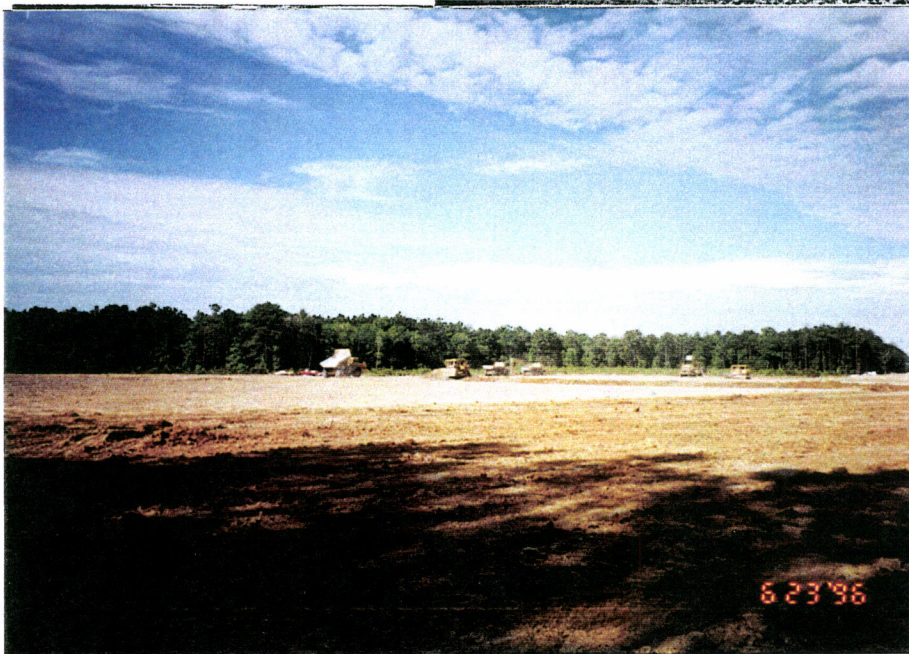
G960151- 12 - O-P

12. Center of Corner Station looking Southwest. Excavating fill from bottom pit on SW side of Corner Station.

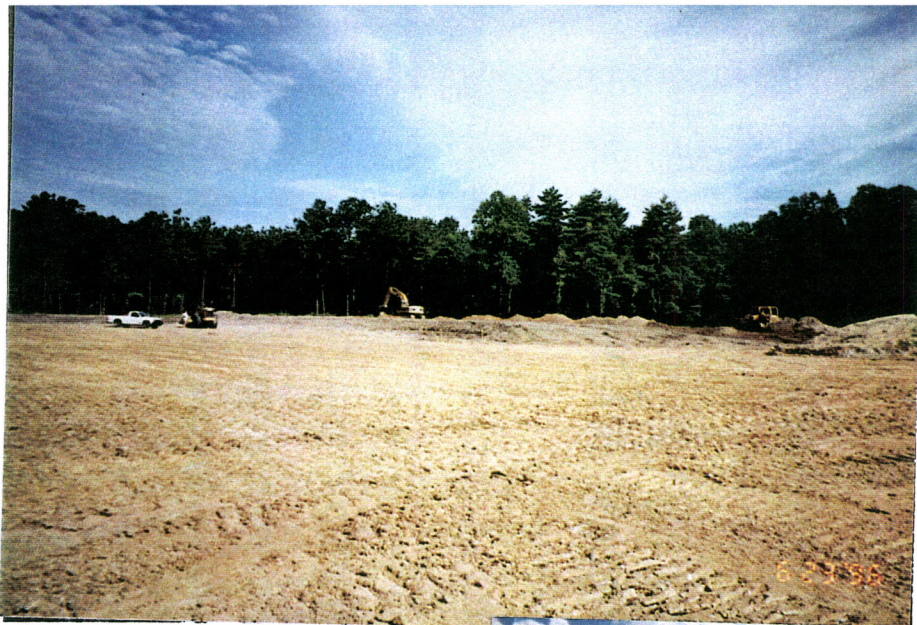
G960151- 13 - O-P

13. North side of Corner Station looking West. Fill spread and ready for compaction.

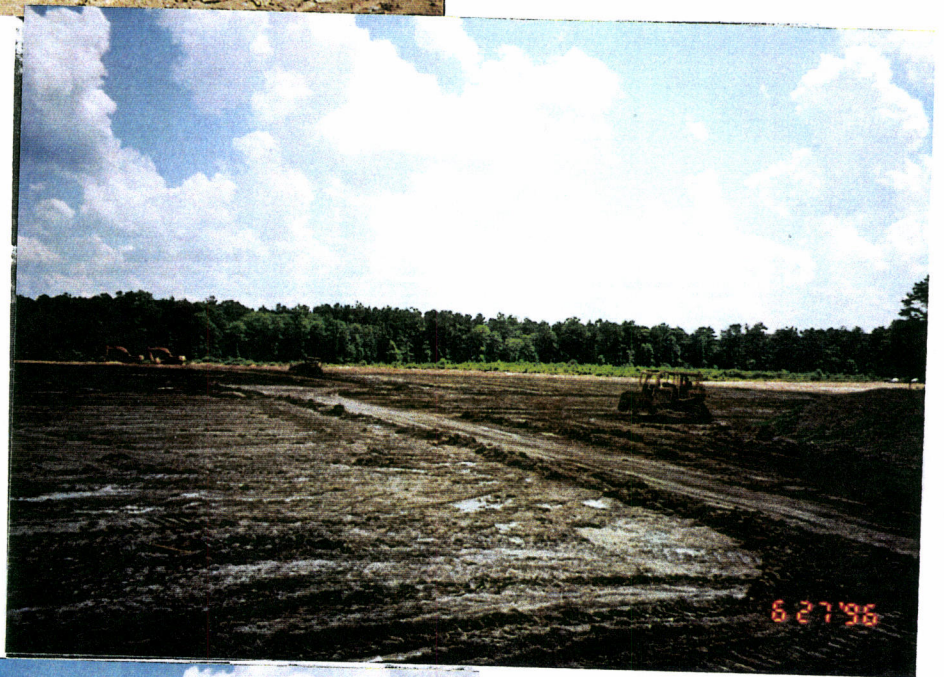
G960151- 14 - O-P

14. North side of Corner Station looking Southwest. Dewatering after heavy rain.

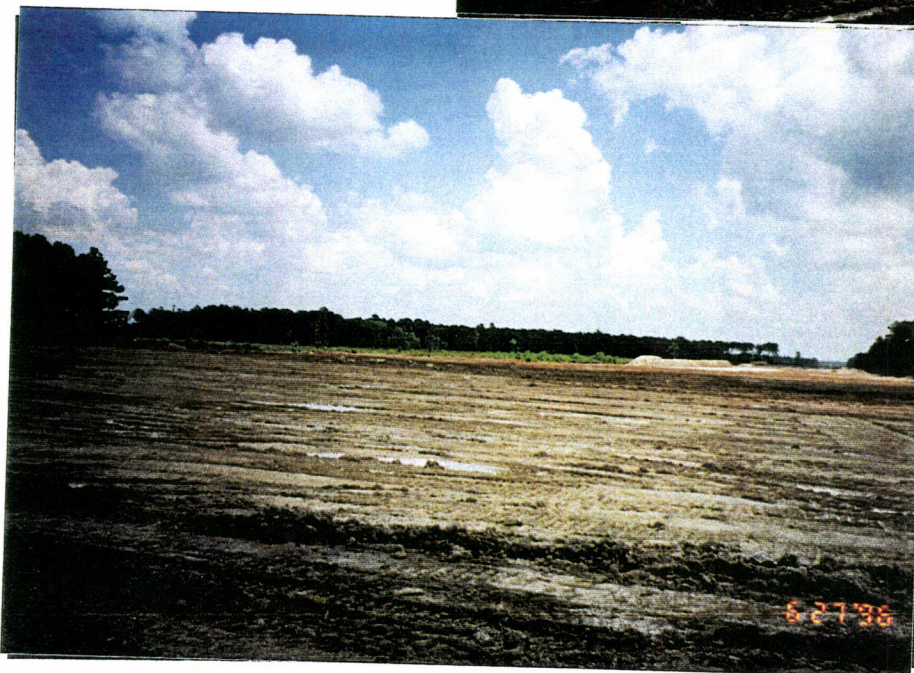
G960151- 15 - O-P

15. North side of Corner Station looking South after rain storm.

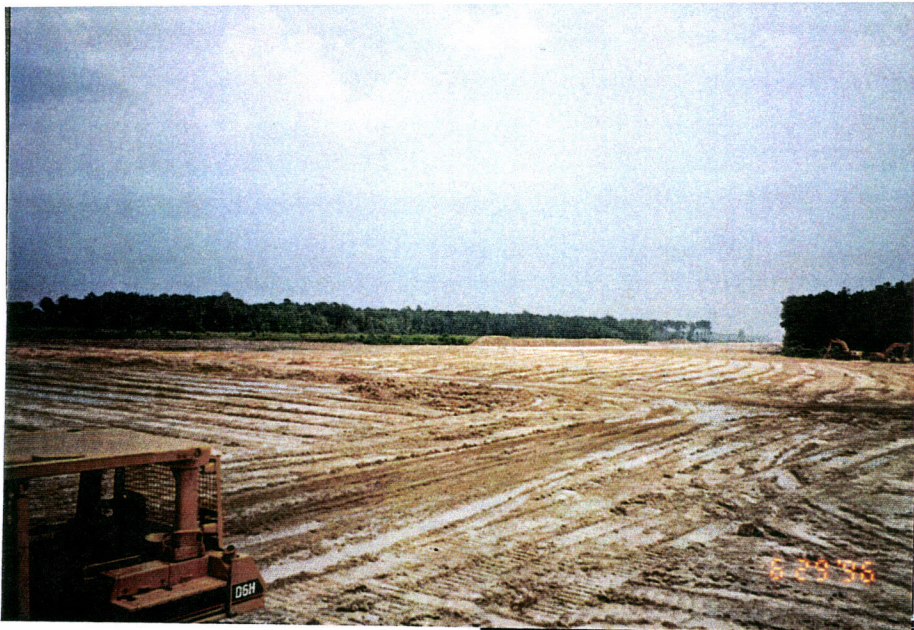
G960151- 16 - O-PV

16. Northwest side of Corner Station looking Southeast. Standing water from rain on June 27th.

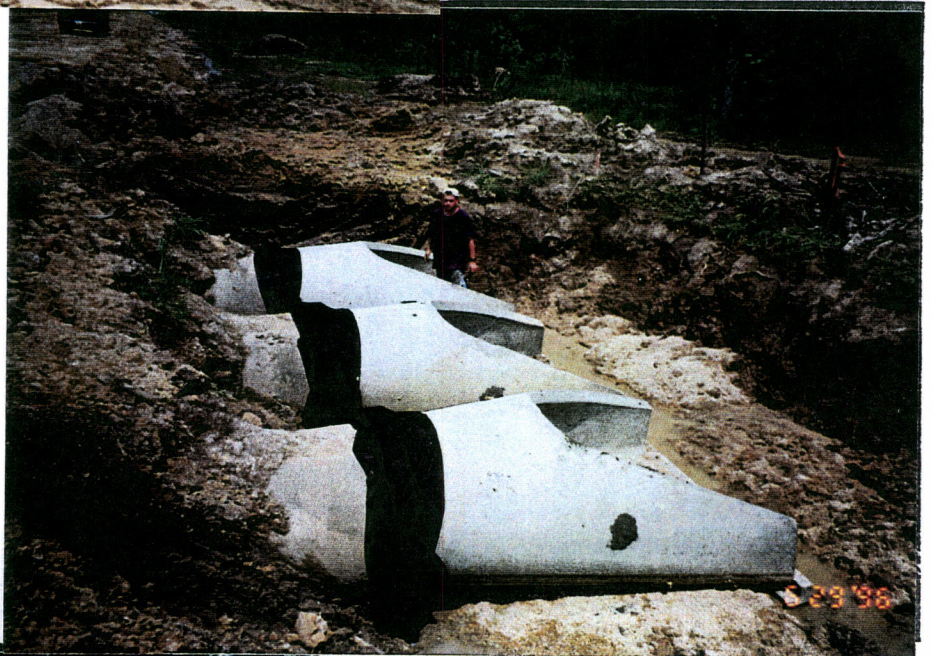
G960151- 17 - O-P

17. Southwest Arm looking East. Flared ends of culverts at Sta. 60+00 being installed.

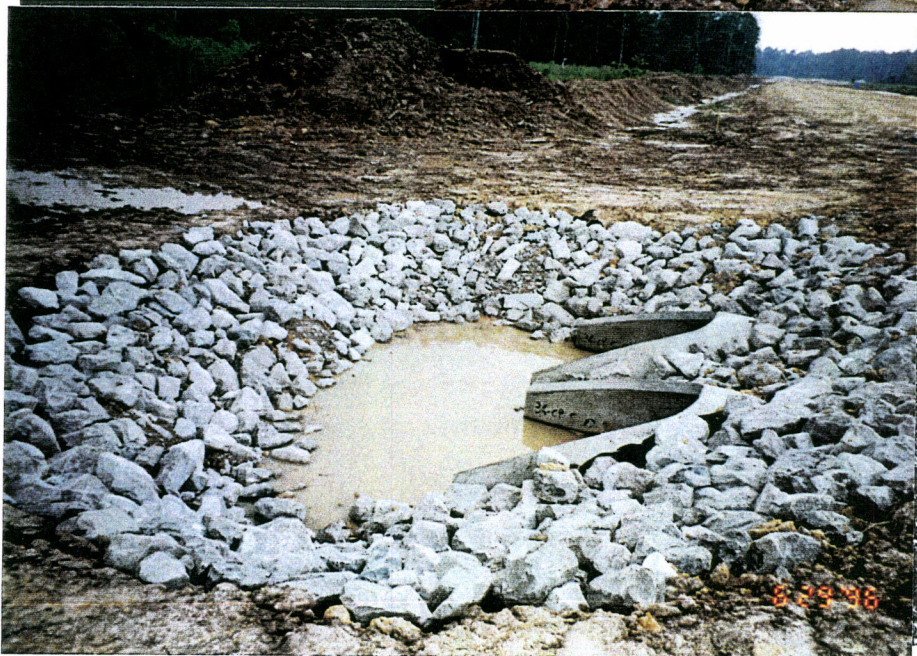
G960151-18 - O-PV

18. Southwest Arm looking West. Rip-rap installation at flared ends of culverts at Sta. 111+00.

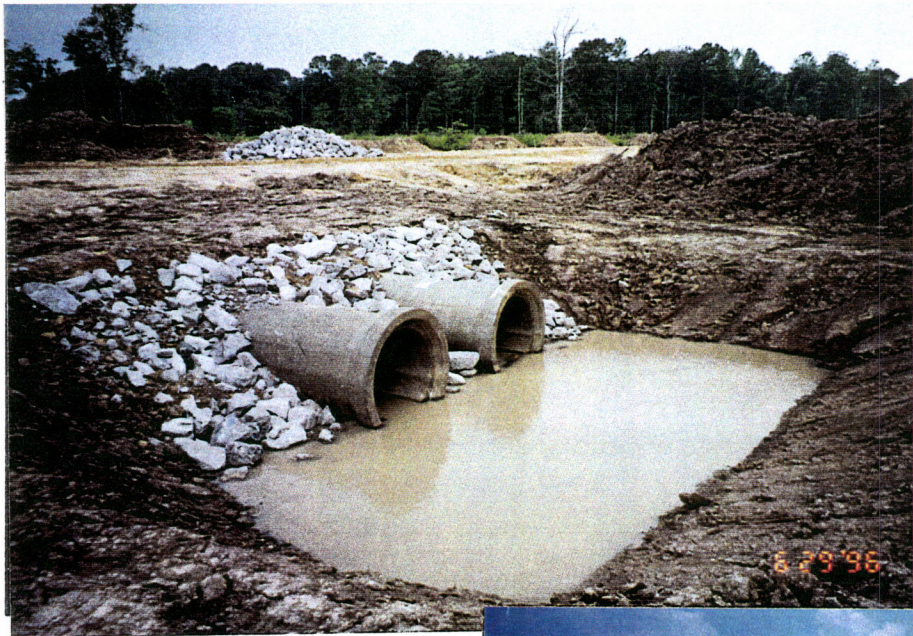
G960151- 19 - O-P

19. Southwest Arm looking Southwest. Rip-rap around culverts at Sta. 111+00.

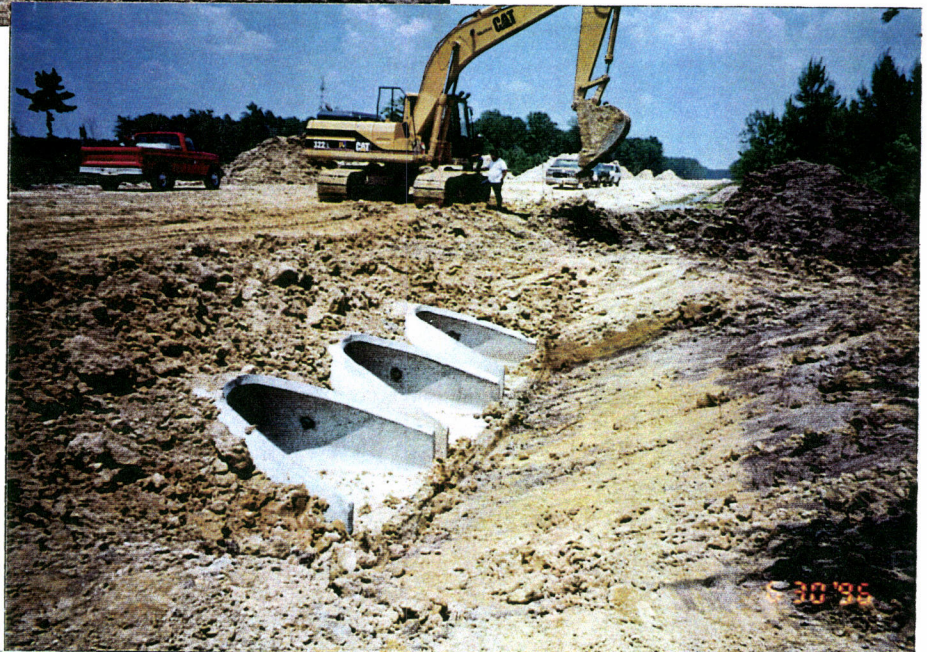
G960151- 20 - O-PV

20. Southwest Arm looking East. Flared ends of culverts at Sta. 60+00.

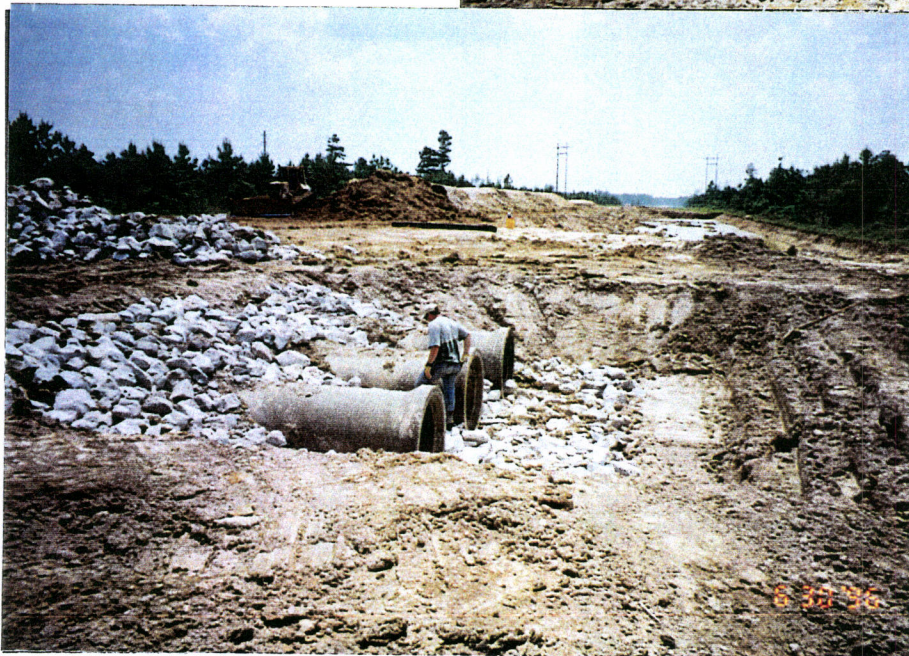
G960151- 21 - O-P

21. Southwest Arm looking West. Rip-rap being installed on 3'-36" dia. culverts at Sta. 60+00.

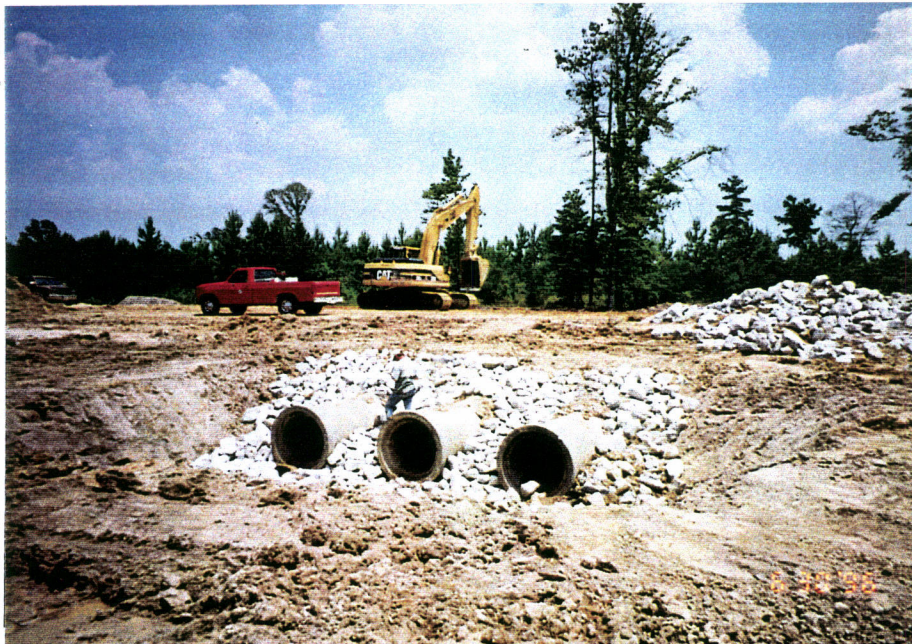
G960151-22 - O-P

22. Southwest Arm looking South. Rip-rap being installed on inlet side of culverts at Sta. 60+00.

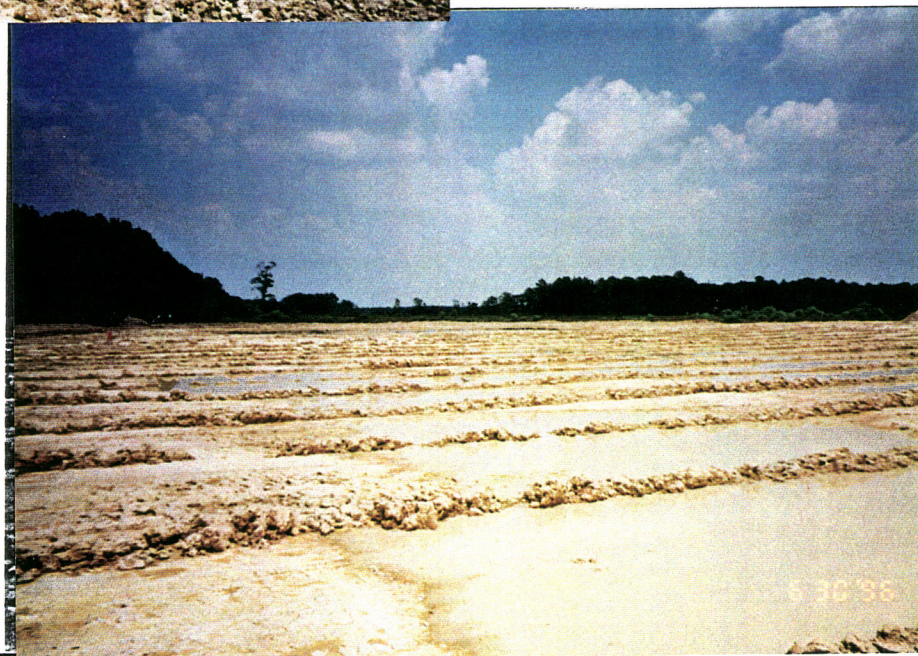
G960151-23 - O-P.

23. Center of Corner Station looking East. Water remaining from rain on June 27th.

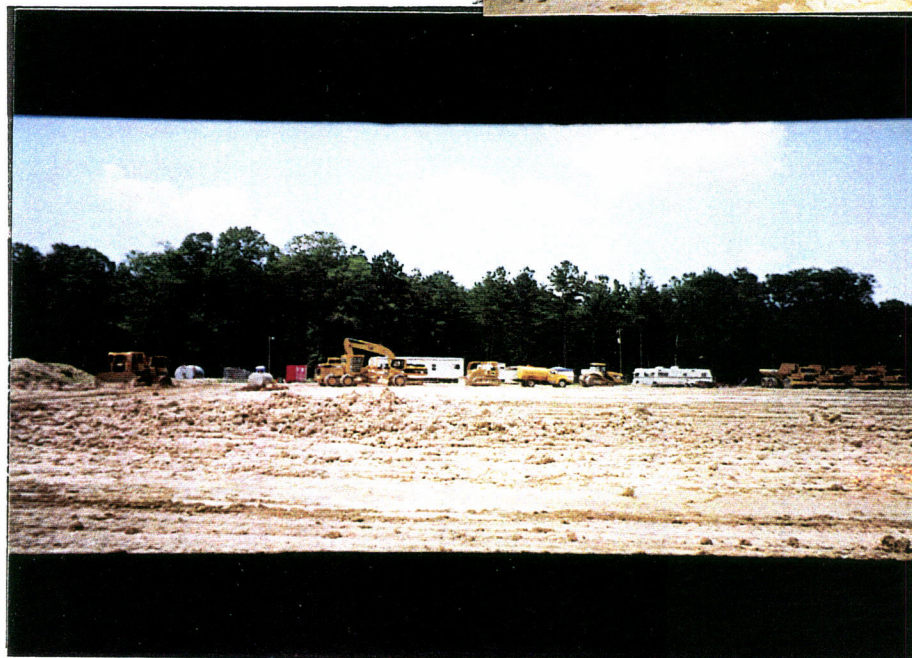
G960151-24 - O-P

24. Panoramic view from center of Corner Station showing equipment idled by wet conditions.
