G960155-01 - O-P

1. Installation of fired ends on 72" culverts at Sta. 16+40 on Southwest Arm.

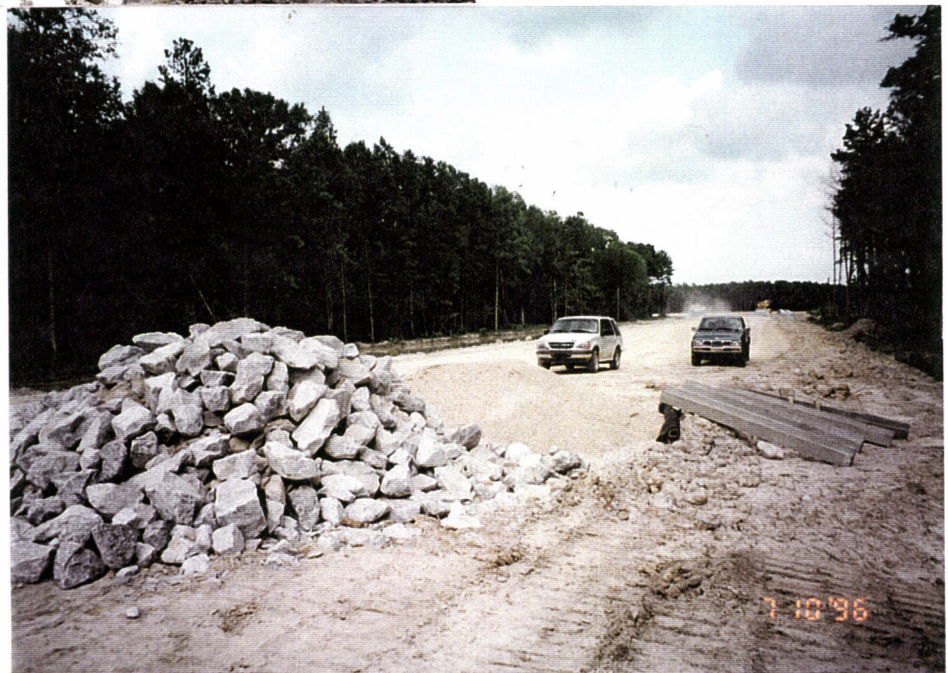
G960155-02 - O-P

2. Stockpiled riprap and precast concrete cutoff walls for culverts at Sta. 16+40 on Southwest Arm.

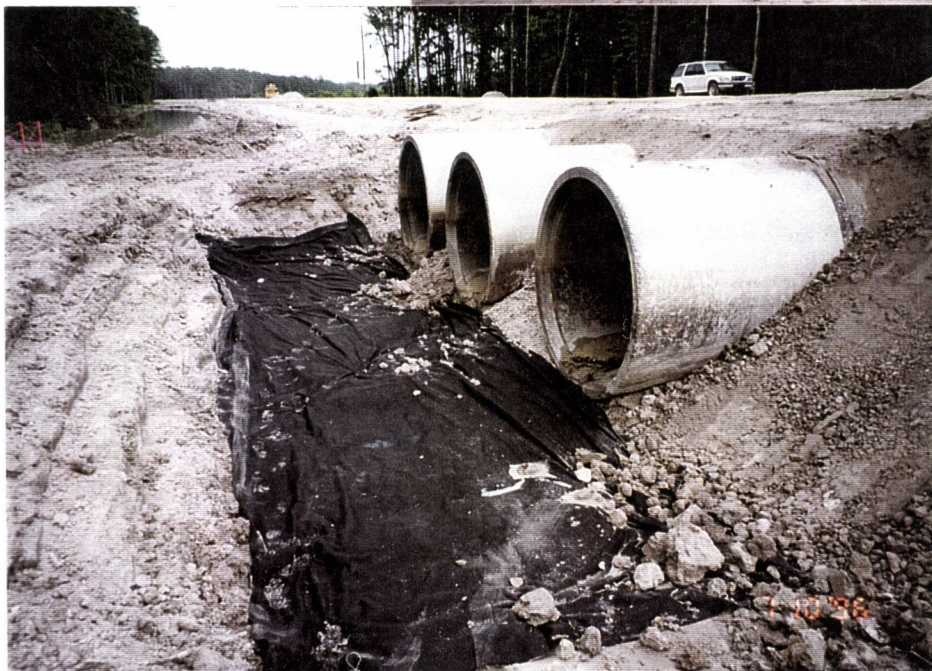
G960155-03 - O-P

3. Application of geotextile fabric on inlet side of culverts at Sta. 16+40 on Southwest Arm.

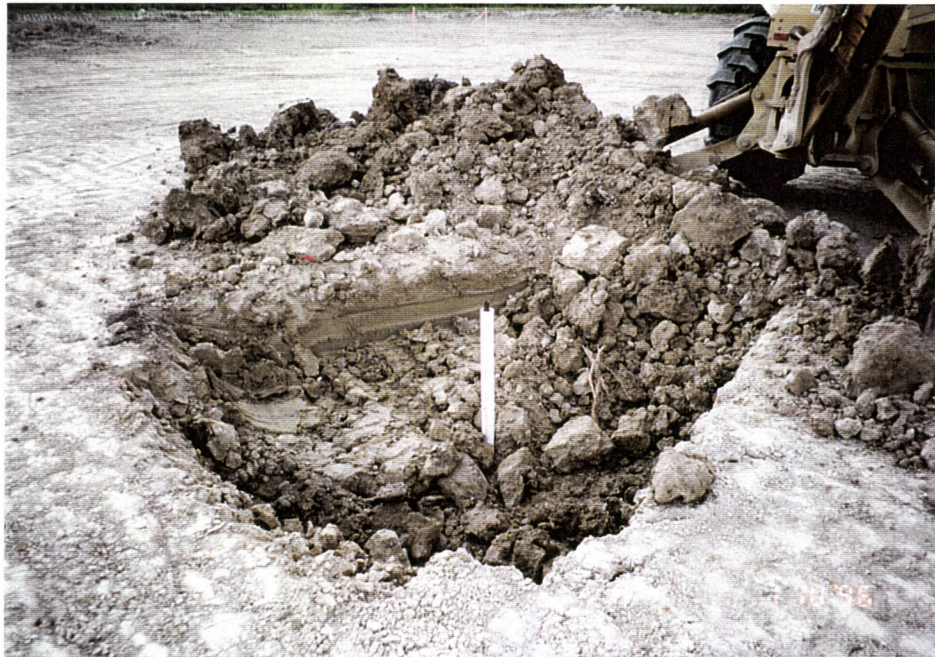
G960155-04 - O-P

4. Settlement monitoring plate being installed on Southeast Arm End Station. {Placed at elev. 51.0'}.

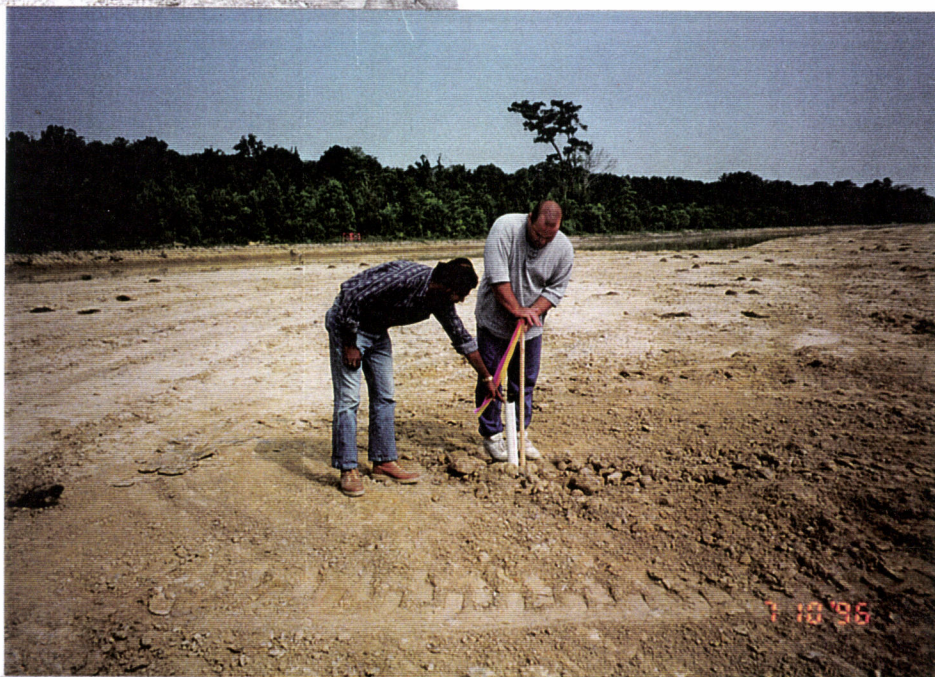
G960155-05 - O-P

5. Settlement monitoring plate on Southeast End Station. (Partially backfilled).

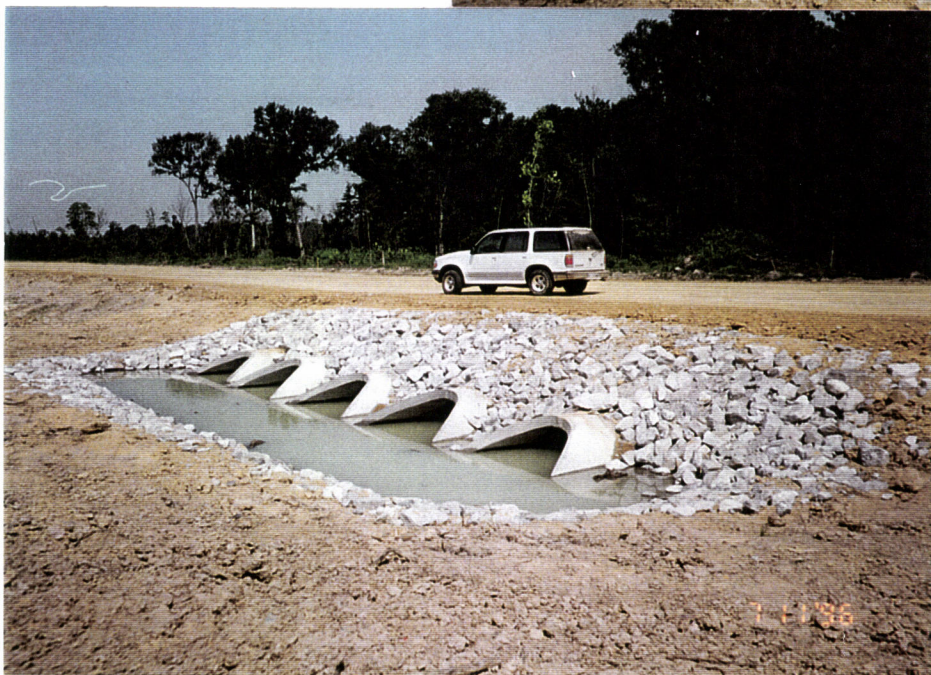
G960155-06 - O-P

6. Completed installation of culverts (outlet end) at Sta. 44+60 on Southwest Arm.

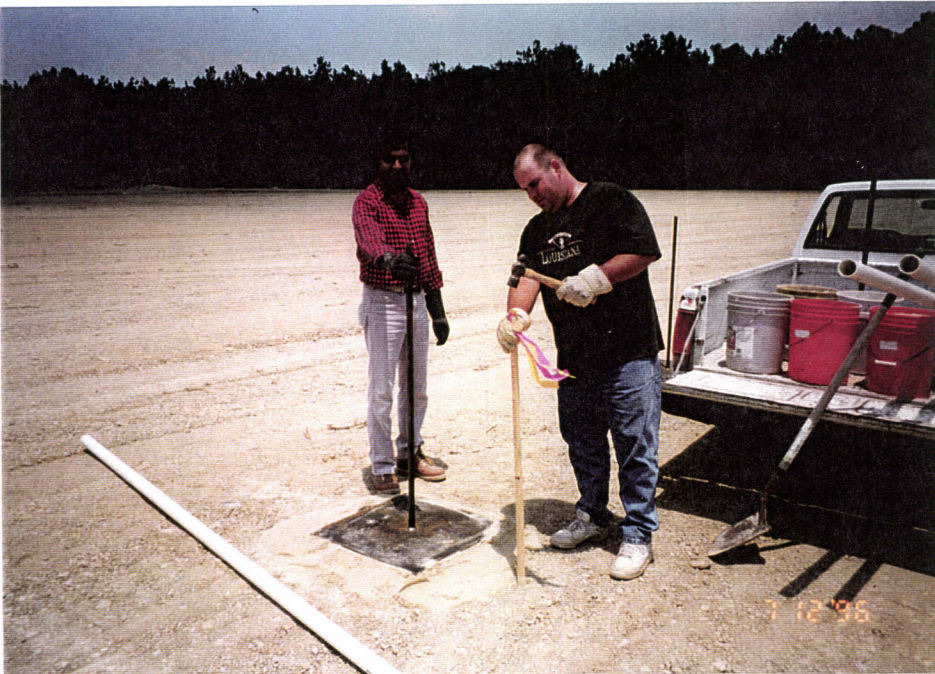
G960155-07 - O-P

7. Installation of settlement monitoring plate at Corner Station.

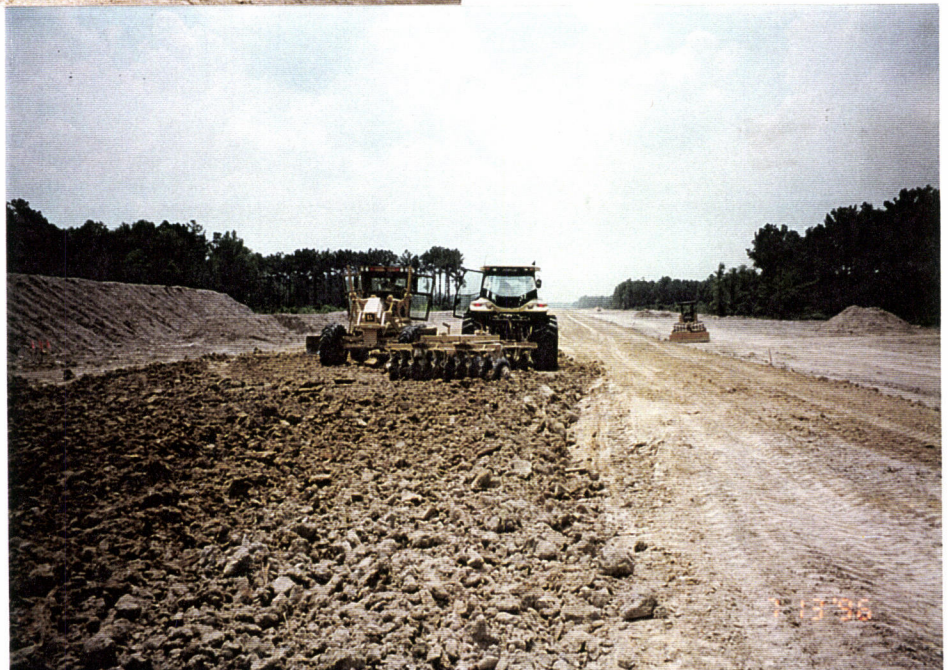
G960155-08 - O-P

8. Disking of fill at Sta. 5+00 on Southeast Arm.

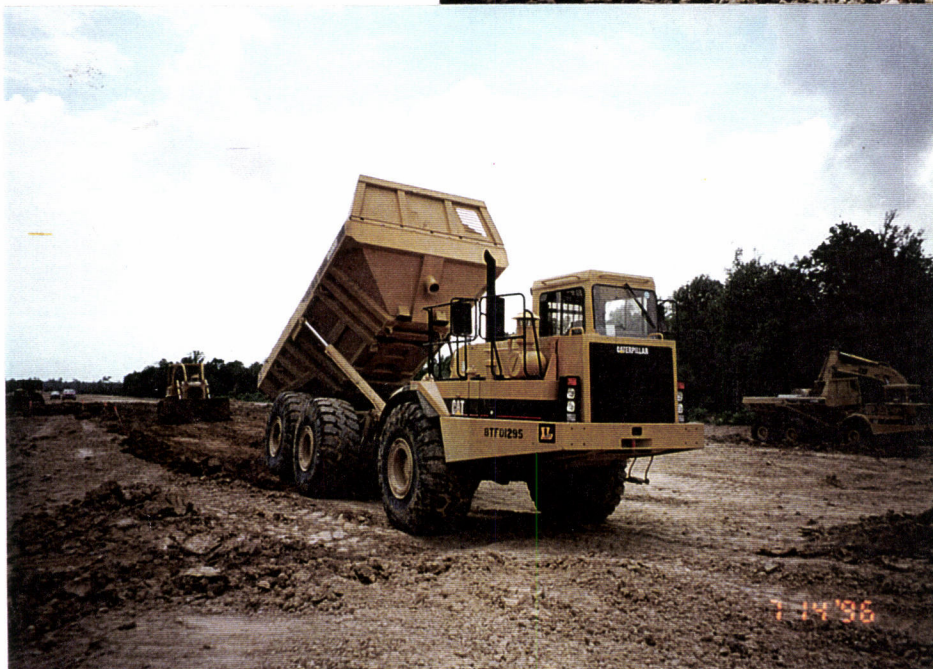
G960155-09 - O-P

9. Excavating, placing and spreading fill material at Sta. 82+00 on Southeast Arm. (Looking South).

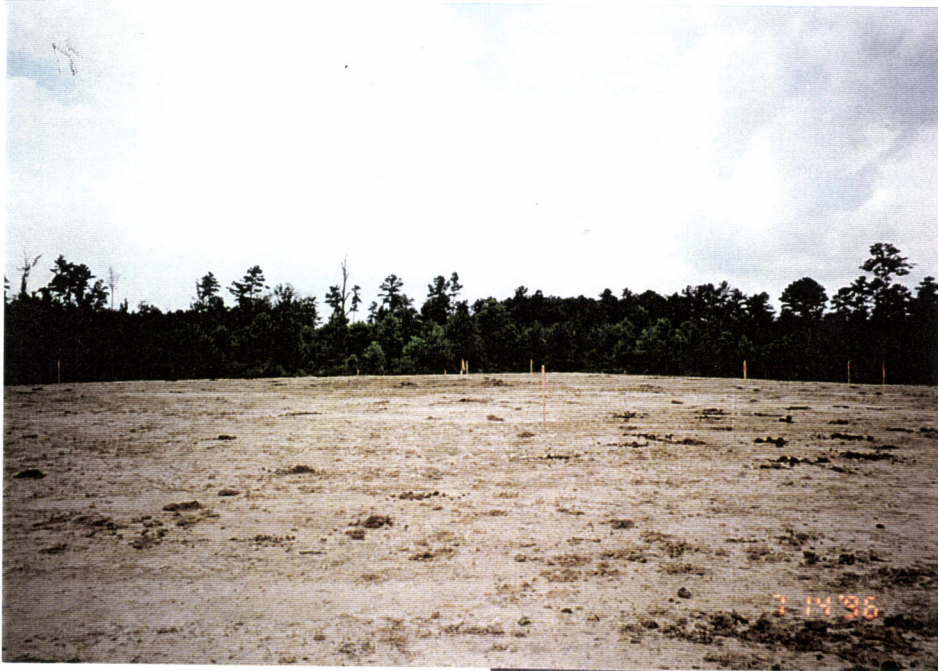
G960155- 10 - O-P

10. Looking South on Southeast Arm End Station. Finish grade stakes set.

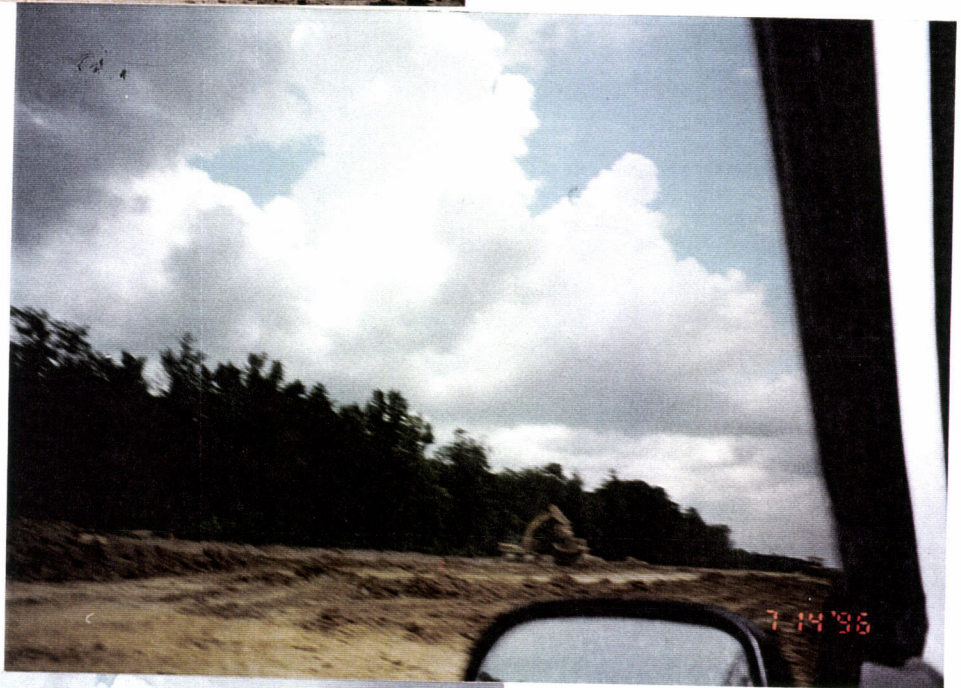
G960155- 11 - O-P

11. Rain clouds building!!

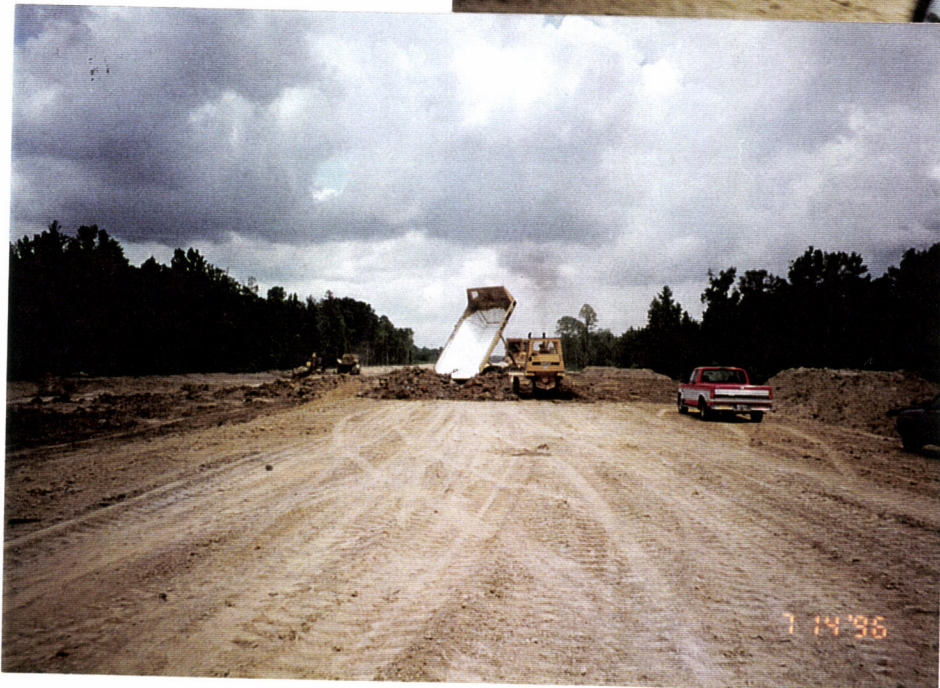
G960155- 12 - O-P

12. Dumping and spreading fill at Sta. 86+00 on Southeast Arm. (Looking North).

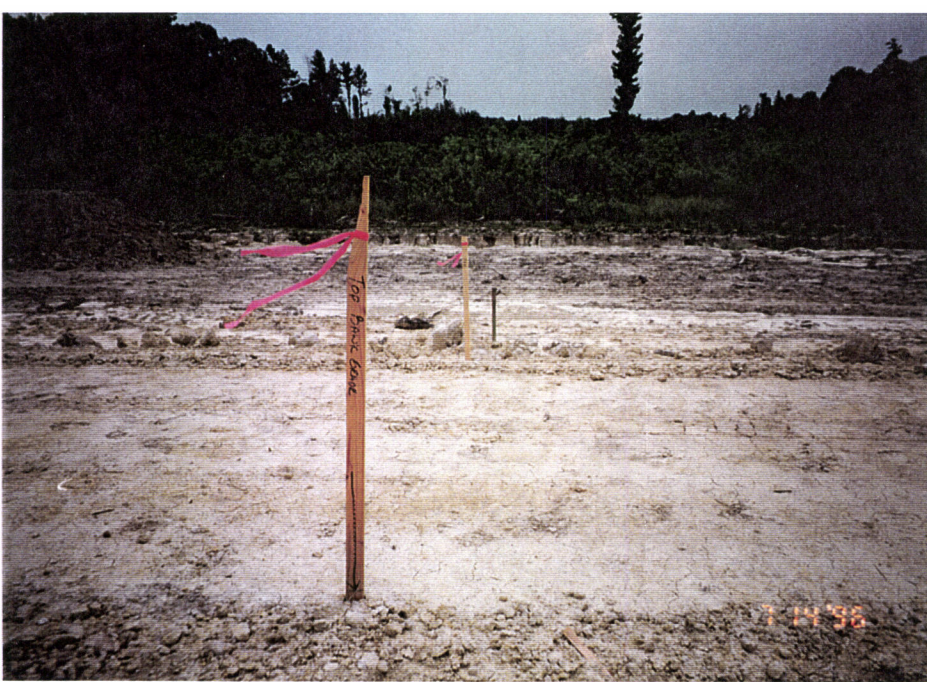
G960155-13 - O-P

13. Grade stake at Sta. 68+00 on Southeast Arm. (Fill at finish grade).

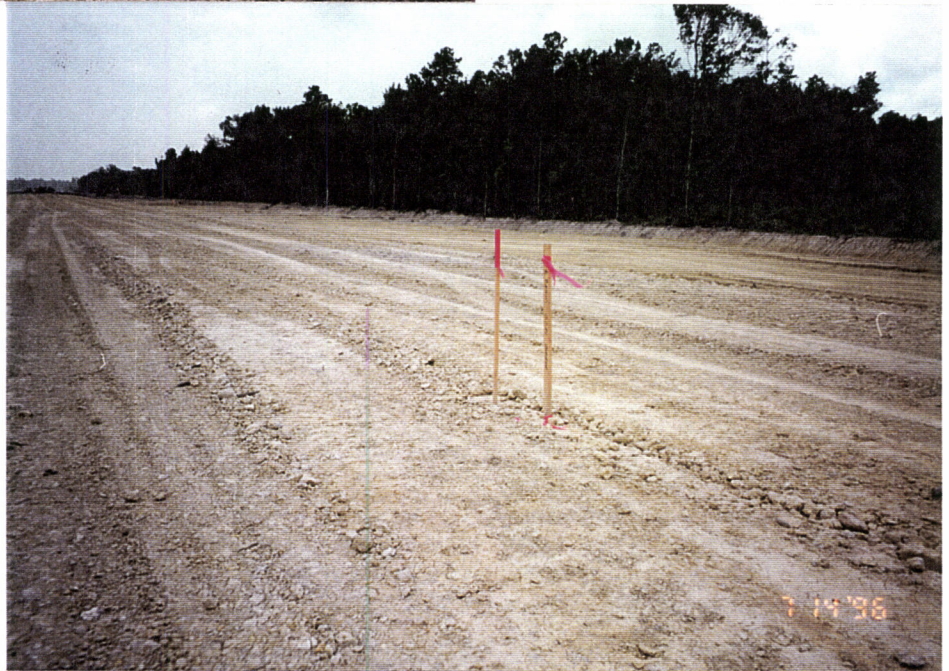
G960155-14 - O-P

14. Grade stakes at Sta. 70+00 on Southeast Arm. (Fill at finish grade).

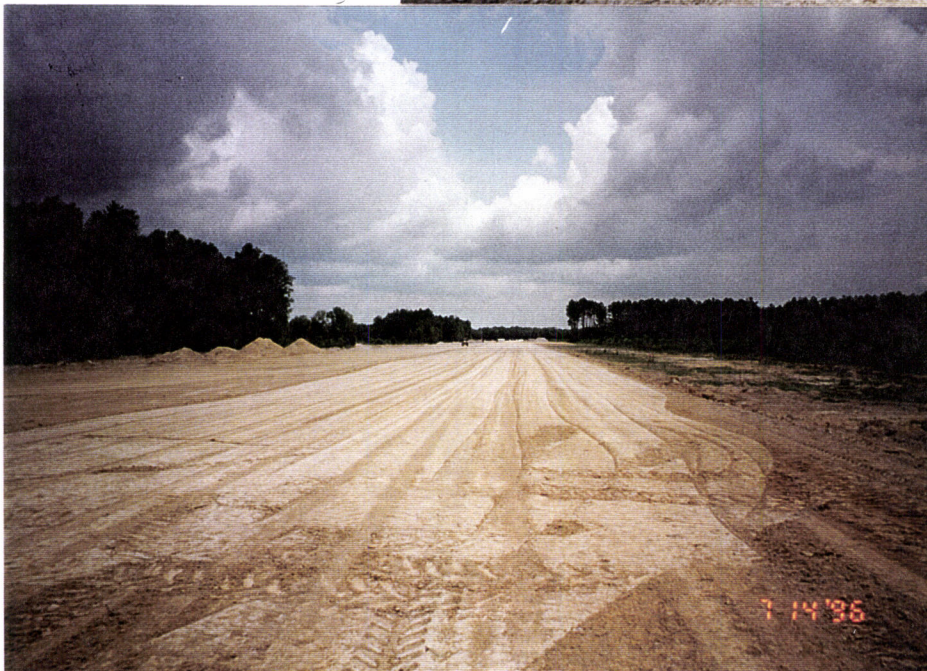
G960155-15 - O-P

15. Looking North on Southeast Arm at Sta. 60+00. Fill smooth rolled to seal surface before imminent rain.

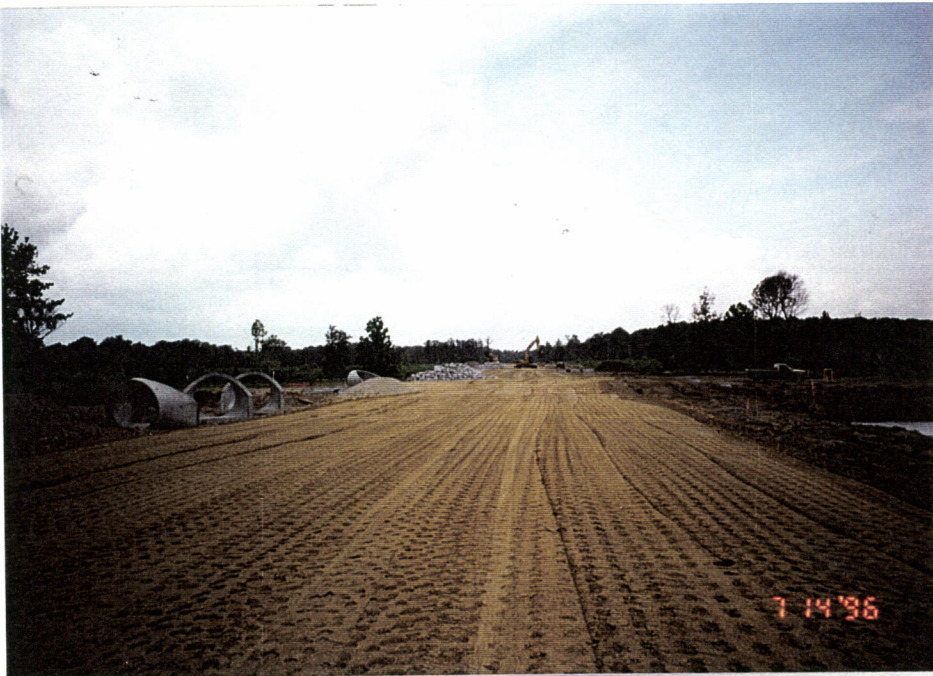
G960155- 16 - O-P

16. Fill compacted by sheepsfoot roller at Sta. 85+00 on Southwest Arm. (Looking West).

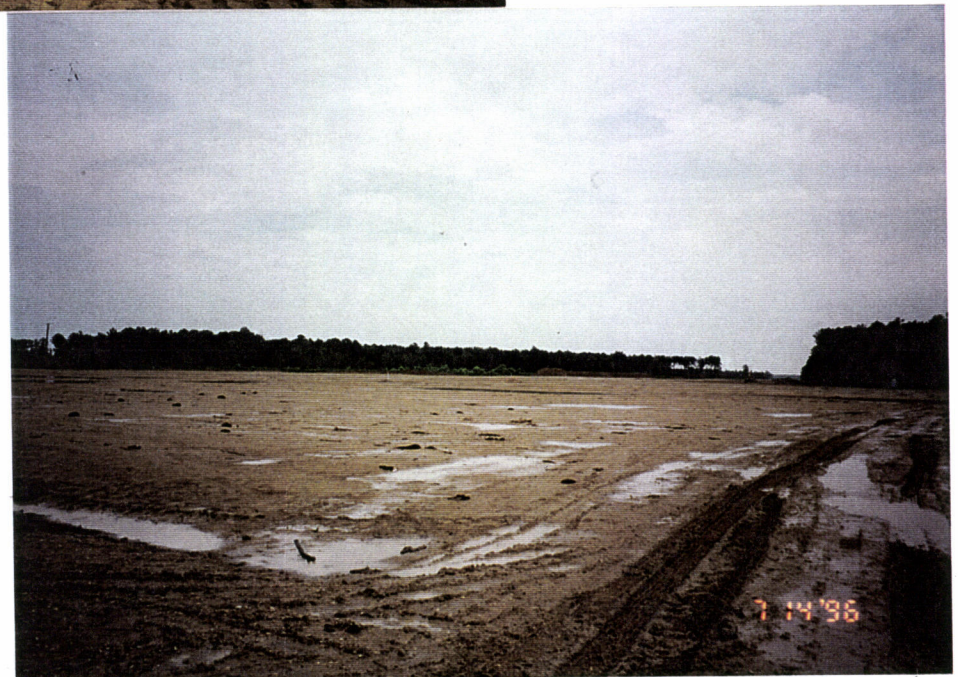
G960155-17 - O-P

17. View from North side of Corner Station looking South after rain.

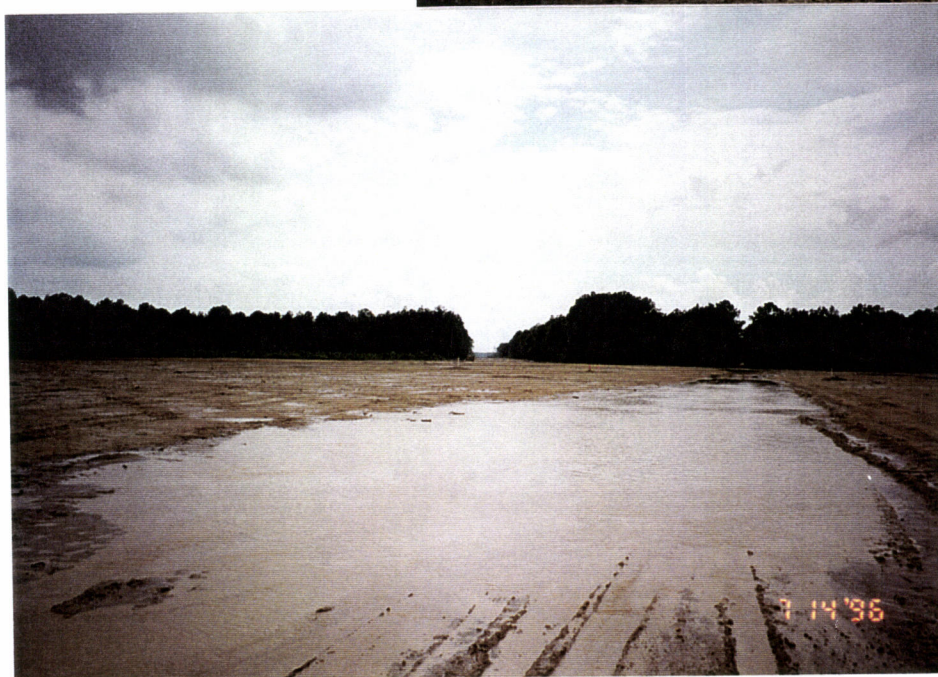
G960155- 18 - O-P

18. View from East bank of Lake LIGO. (Former site access road at Corner Station).

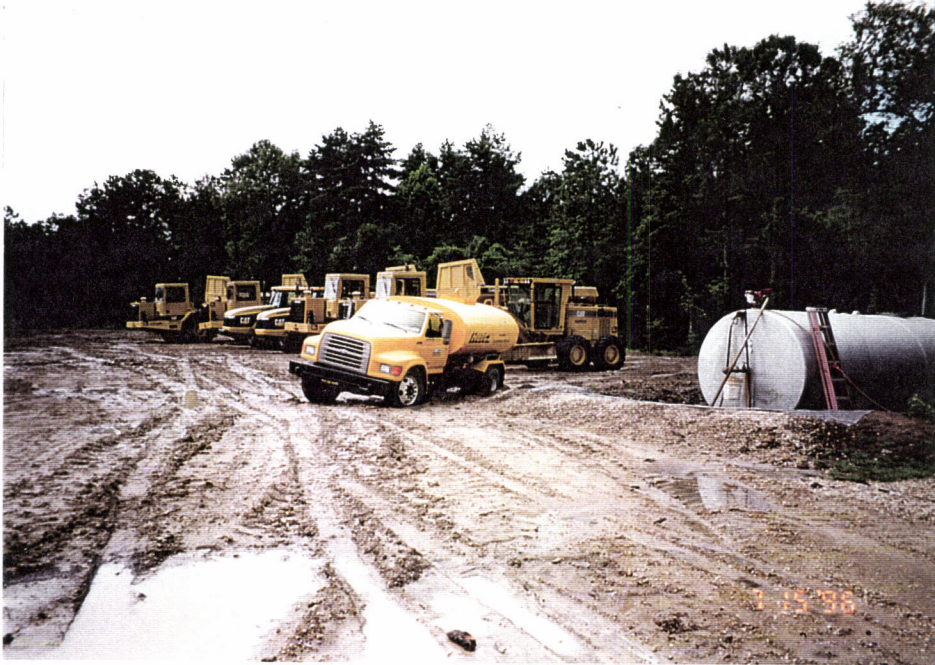
G960155- 19 - O-P

19. Idle equipment.
"Stuck" water truck
presently not needed.

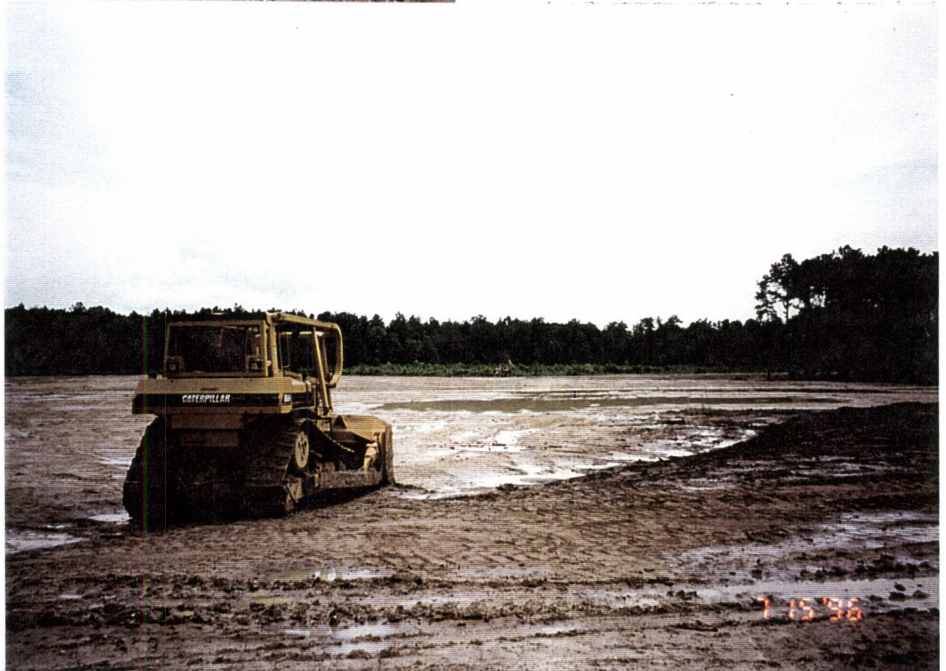
G960155- 20 - O-P

20. Looking Southwest
across Corner Station
after another rain.

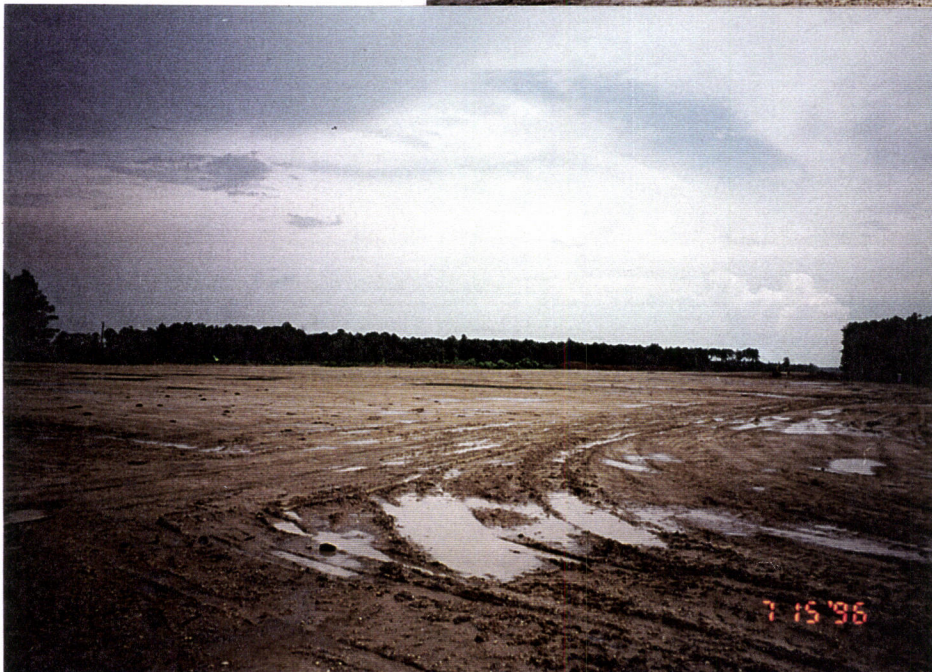
G960155- 21 - O-P

21. Looking Southeast
from North side of
Corner Station.

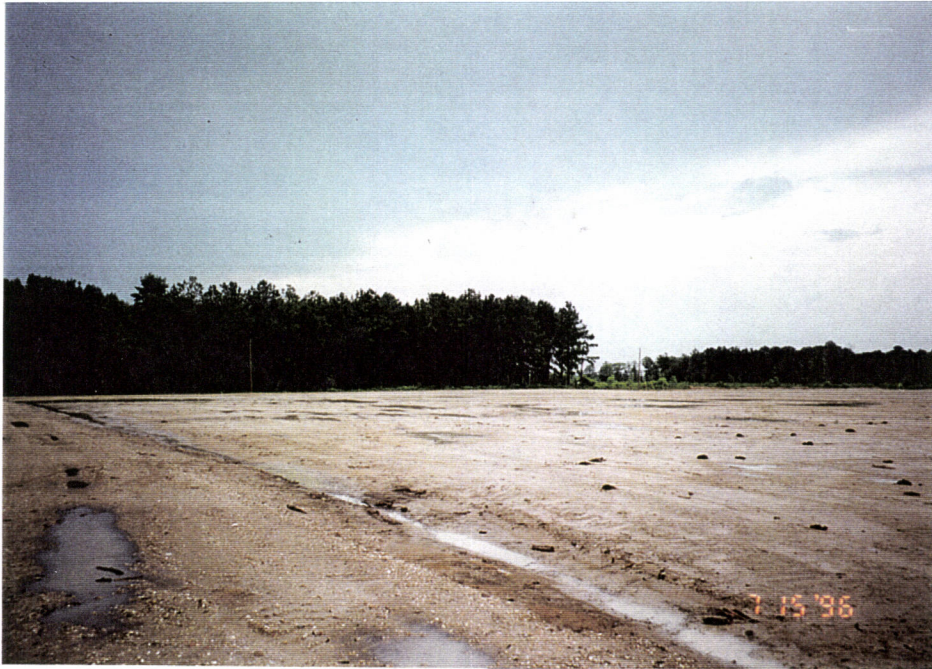
G960155-22 - O-P

22. A view of wet conditions from North side of Corner Station looking East.

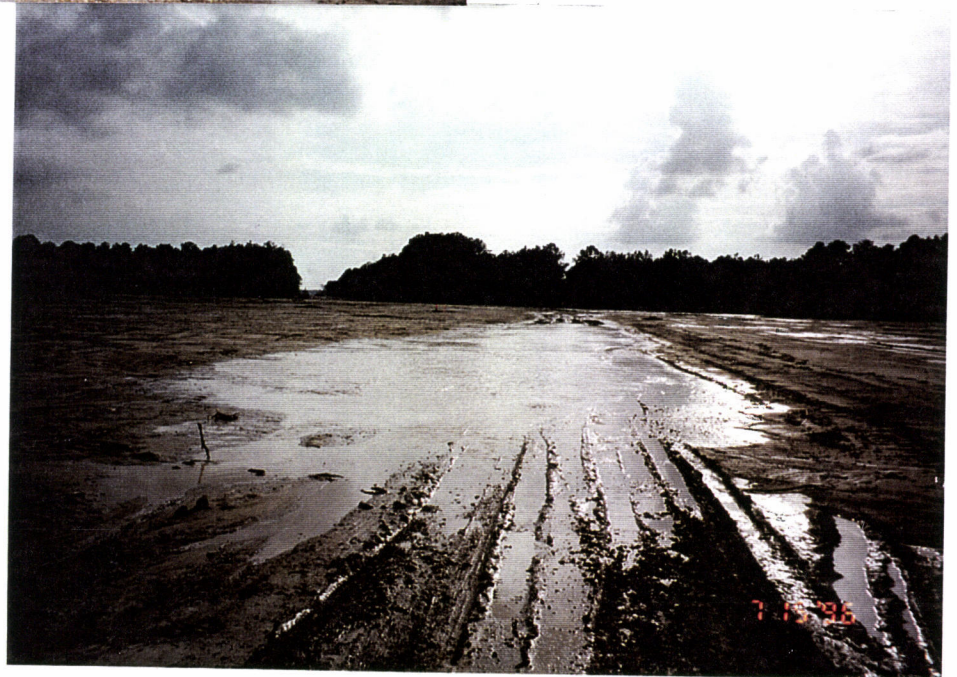
G960155- 23 - O-P

23. Looking West at access road through Corner Station. (Tide still in).
