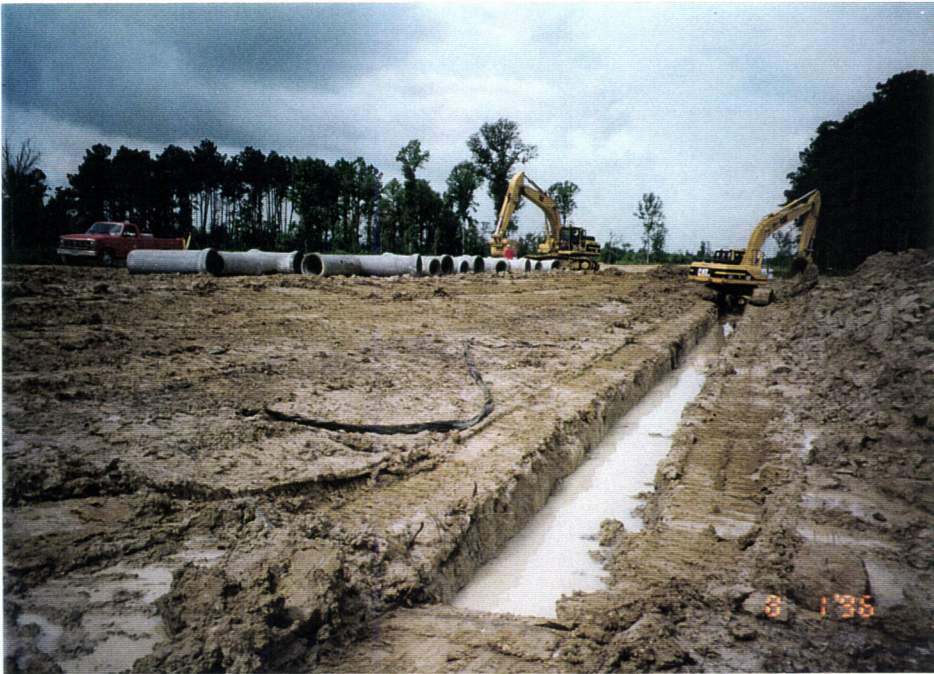
G960166- 01 - O-P

1. Southwest Arm at station 38+00 Installing 24in. RCP Pipe balance line between ditches.

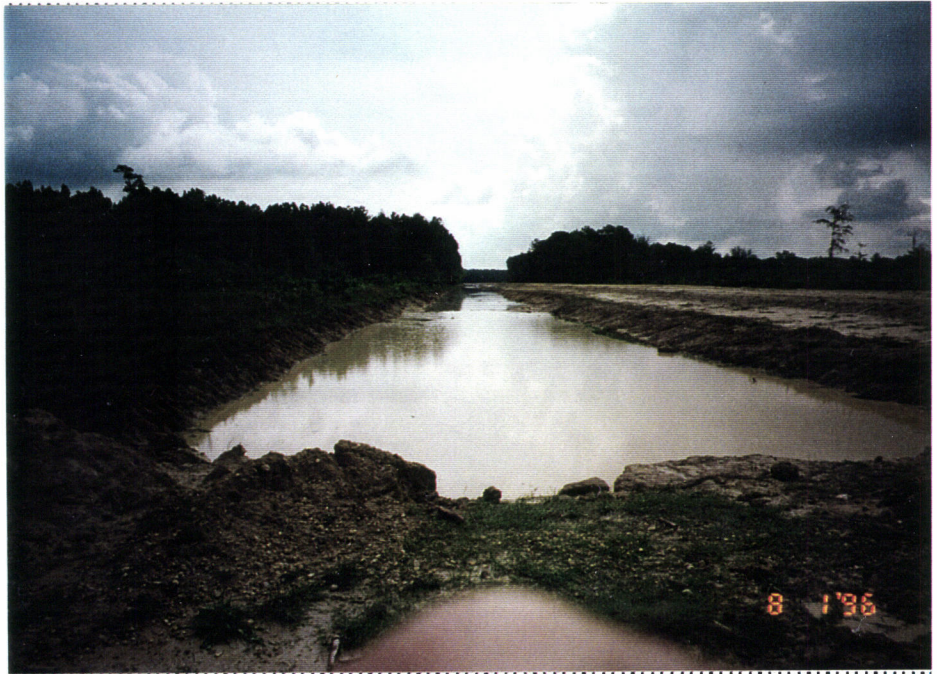
G960166- 02 - O-P

2. Southwest Arm at Station 38+00 looking northeast at trench.

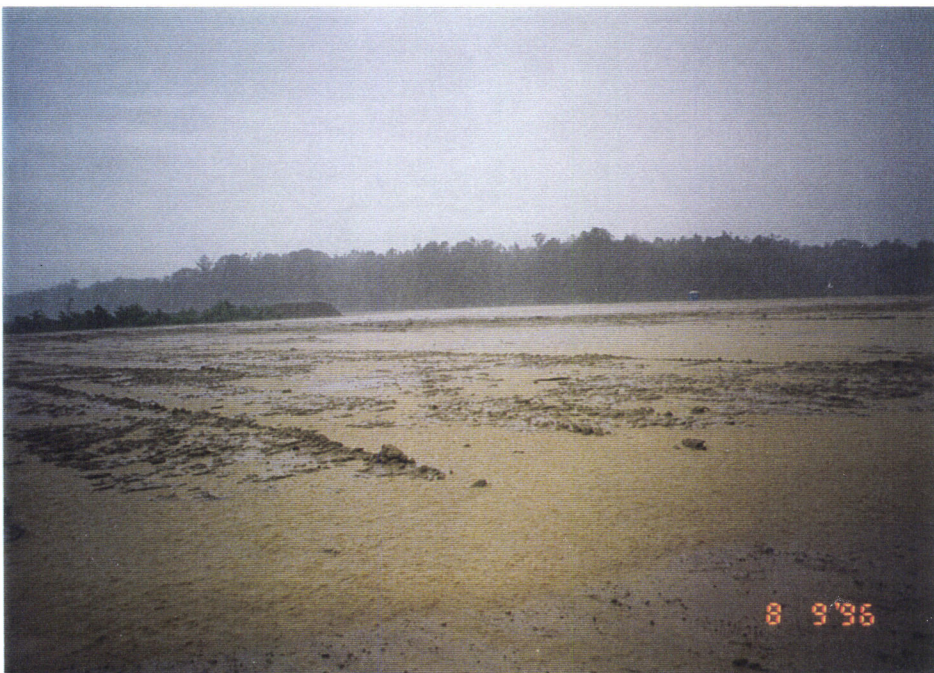
G960166- 12 - O-P

12. More rain.
