LASER INTERFEROMETER GRAVITATIONAL WAVE OBSERVATORY

LIGO-T1200551-v2

Feb. 1, 2013

## Optical-lever installation interferences at LHO

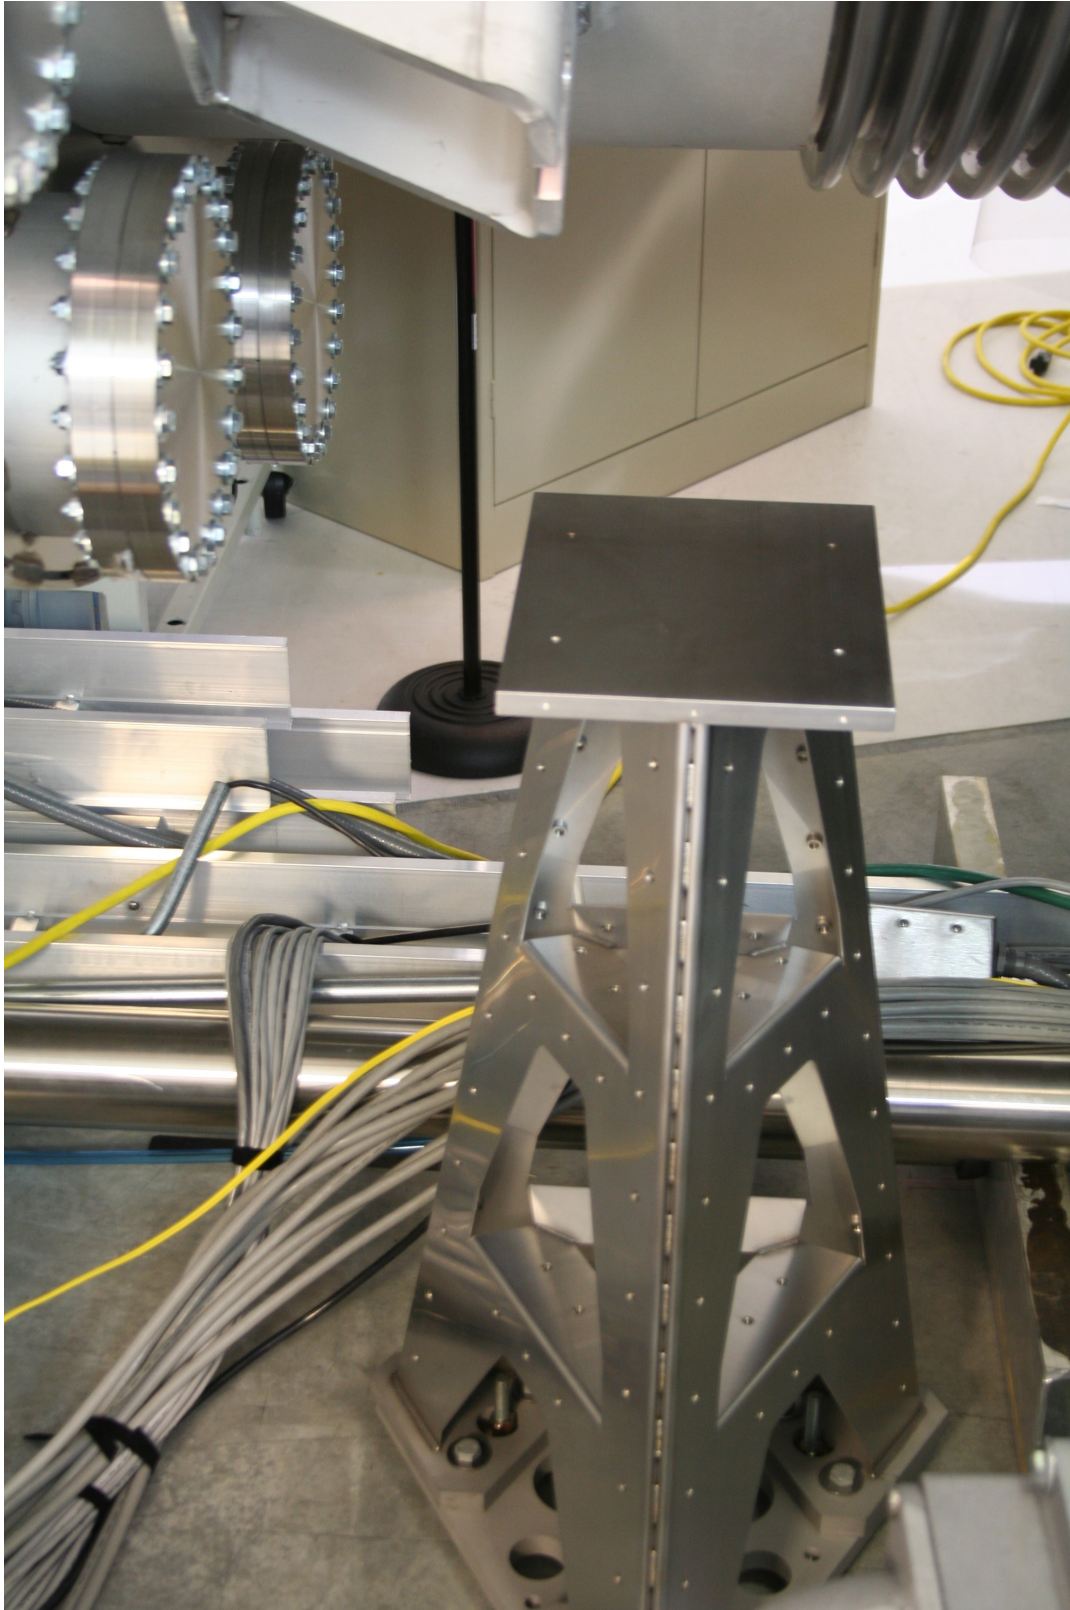
Notes: This transceiver was installed on the wrong side of the beam tube. It faces viewport VP7 whereas the design called for it to look into VP5. There is no interference with the pylon in this incorrect spot, but there is in the correct location.

**Figure 1: HAM3 Oplev transceiver as installed by WAMCA1, looking into VP7.**

Recommendation: As long as there is no interference inside the vacuum chamber, leave it the way it is. The reflecting mirror on the HAM table will have to be rotated laterally (in yaw) by about four degrees to return the beam, but since this mirror sits on the near edge of the table this should not be a problem. It is my understanding that there is a hole in the beam-tube baffle that would allow the oplev beam to come in and out of VP7.

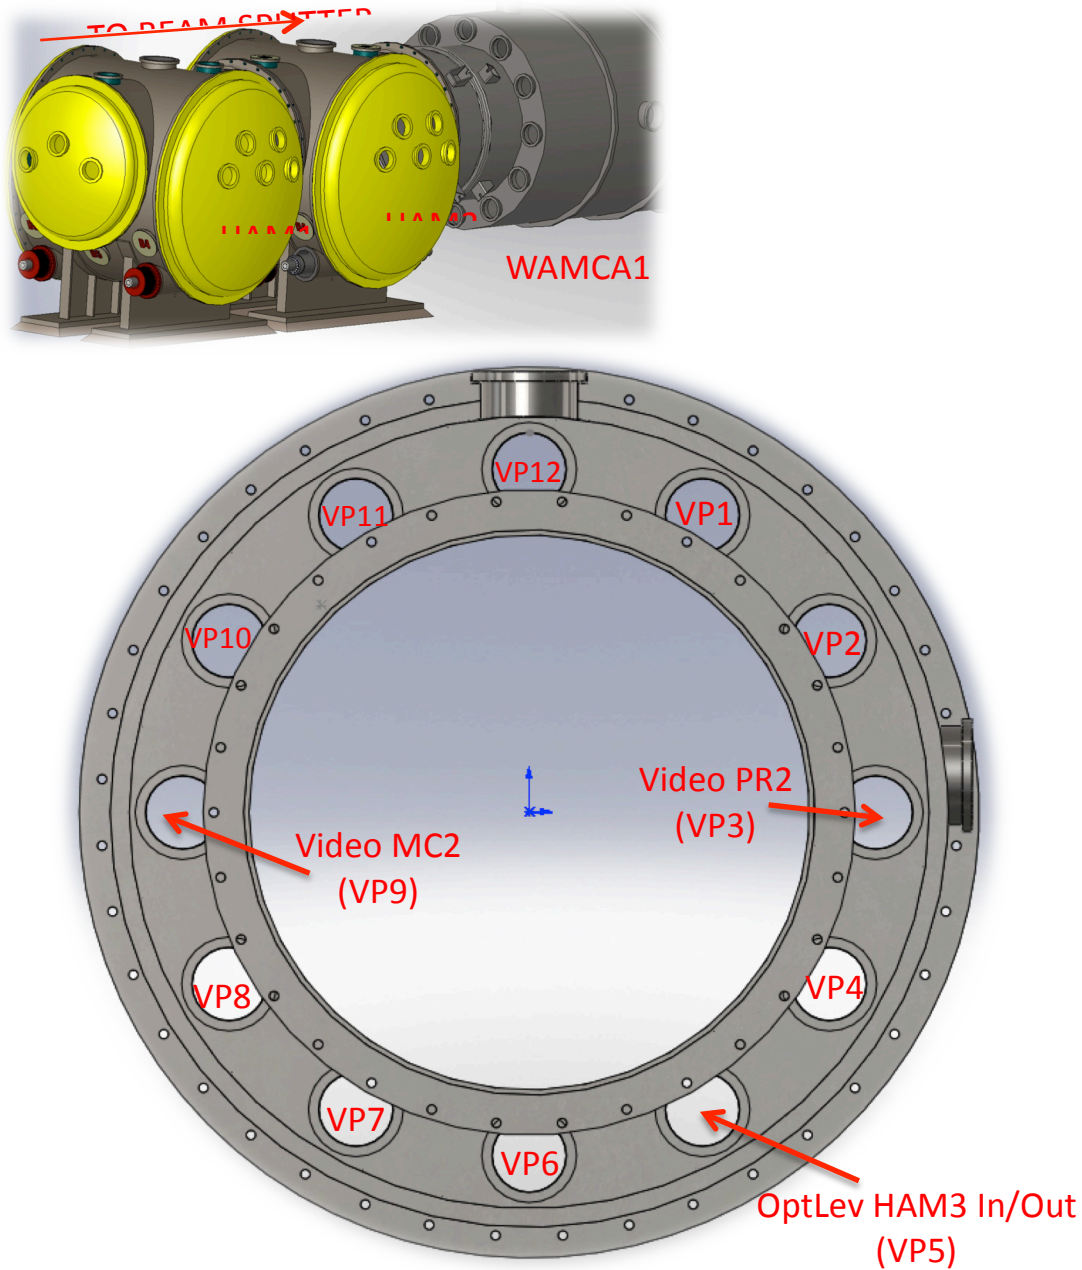
**Figure 2: Viewport configuration from Figure 37 of T1000746-v7, Viewport Final Design. HAM3's optlev should look in VP5 but was installed looking into VP7.**

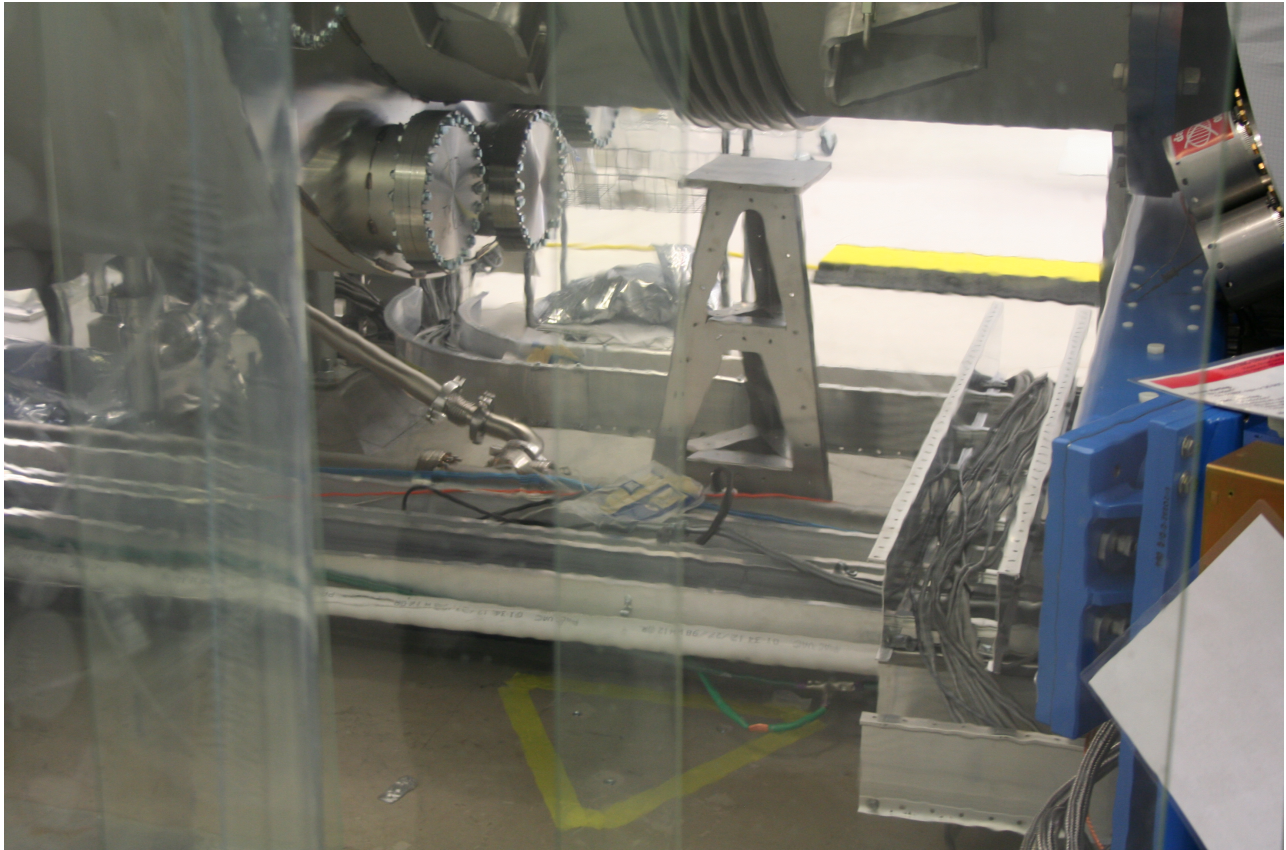
Notes: Only one piece of pvc pipe is in the way here. The holes have been drilled in the wrong orientation, according to the floor-occupancy diagram. According to G1000740, the triangle should point into the beam-tube axis, and as shown in the photo below, it is now pointing out. This would be the correct orientation for LLO, according to G1000700, and may be just fine for LHO.

**Figure 3: PR3 transmitter-pylon floorplate footprint, bounded by yellow tape in the foreground.**

Recommendation: Re-route or remove pvc pipe. Leave orientation the way it is. UPDATE 1/30/13: John Worden and I pushed the pvc pipe out of the way and installed this pylon. As long as Richard McCarthy signs off on the close contact with the cable tray, we're done here.

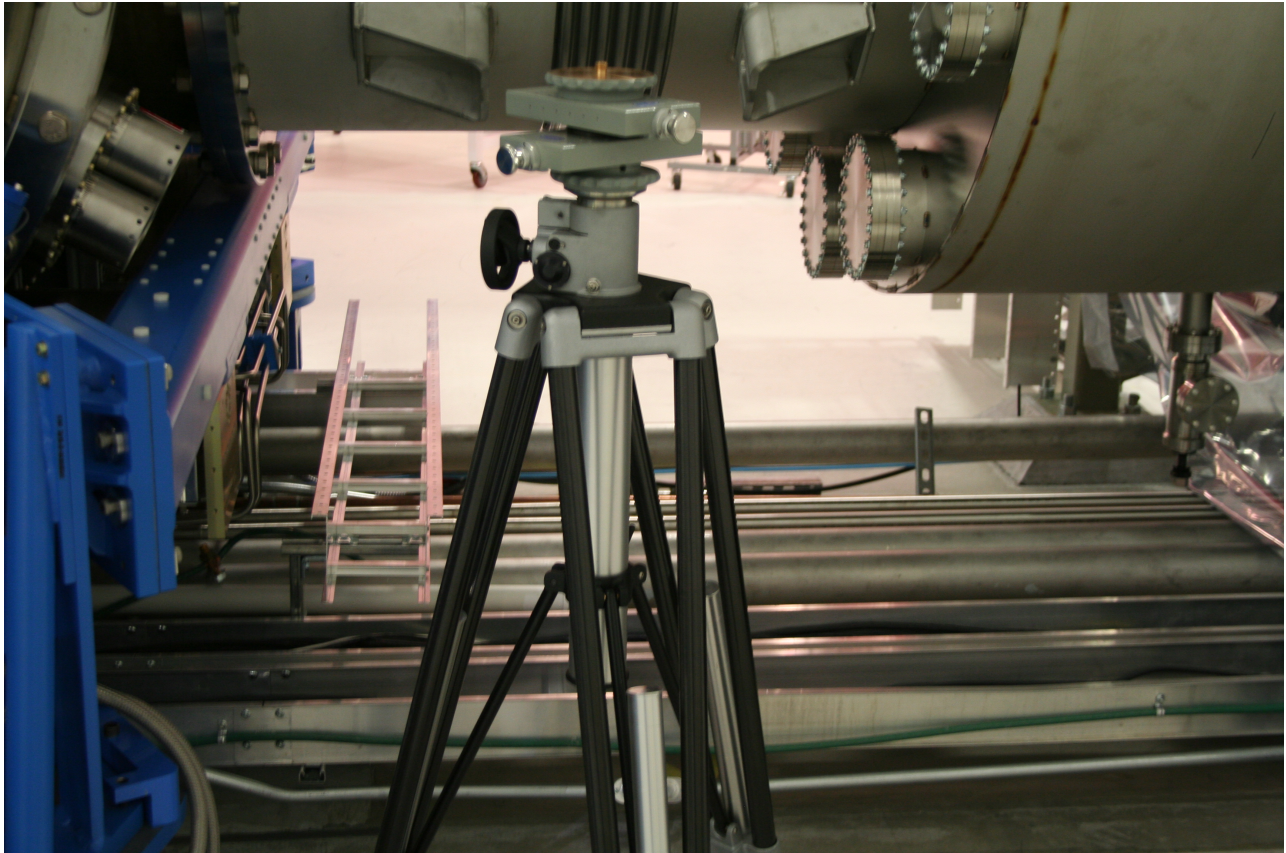
**Figure 4: SR3 location.**

Notes: Significant interference. See photo. As of this writing, we are measuring to see if we can get away with just moving the cable trays, or if we need to move pipes as well. Even if we don't need to move pipes for this one, they will almost certainly need to be moved for the HAM5 transceiver.

Type: HAM Transceiver  
 Location: Under HAM4, looking into VP7 of WAMCB2  
 Notes: Significant interference. See Figures 4 and 5.

Recommendation: Re-route purge-air pipe. Re-route cable tray.

Recommendation: Trim pylon so that vacuum foreline can pass through. *Note: Modeling should be performed and verified before installation, drilling, or cutting is done.*

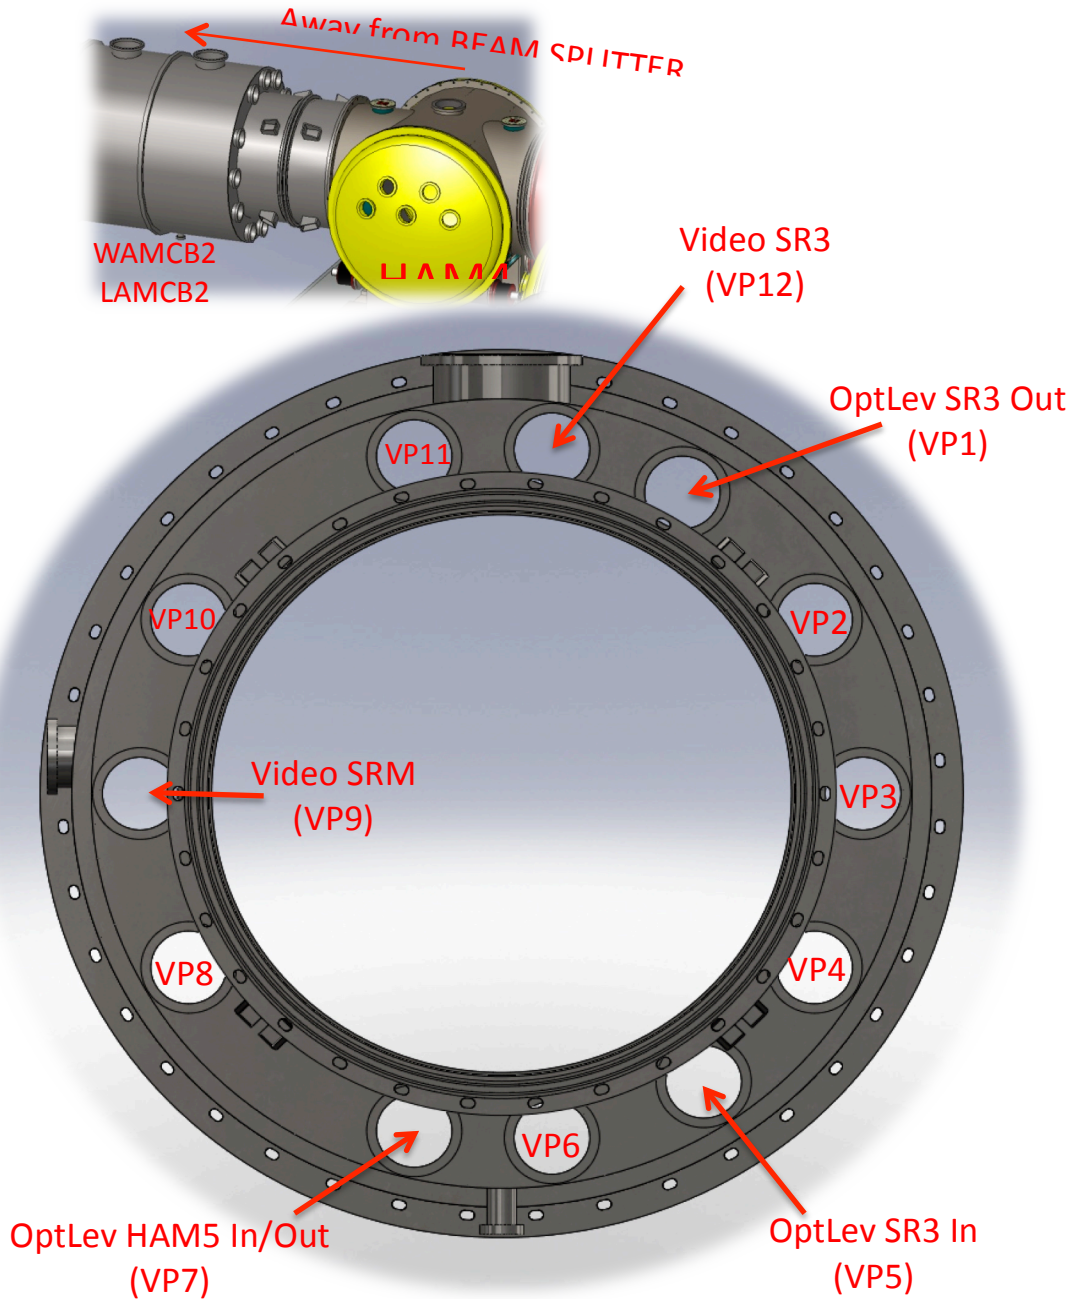
**Figure 5: Viewport locations for HAM5 and SR3 oplevs, taken from Figure 40 of T1000746, Viewport Final Design. The photo in Figure 4 views this flange from the right.**

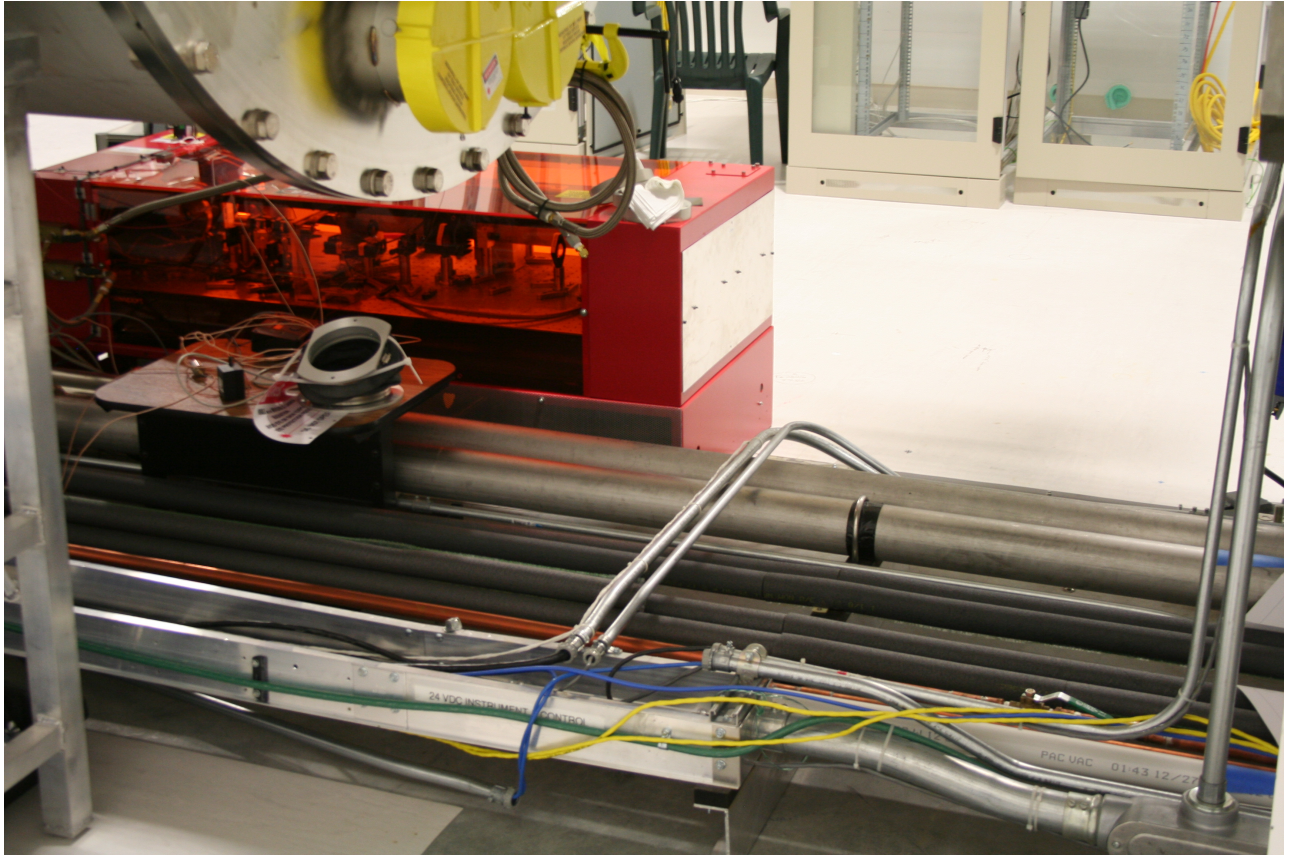
Notes: Significant interference. See figures below.

**Figure 6: ITMX location, from the opposite side of the beam tube from the transmitter. The dwarf is supposed to sit next to the red TCS table. There are lots of pipes in the way.**

Recommendation: Re-route or remove interfering pipes. Mount initial-alignment monument LV7 on leaner’s baseplate. Translate leaner parallel to beam axis as needed.

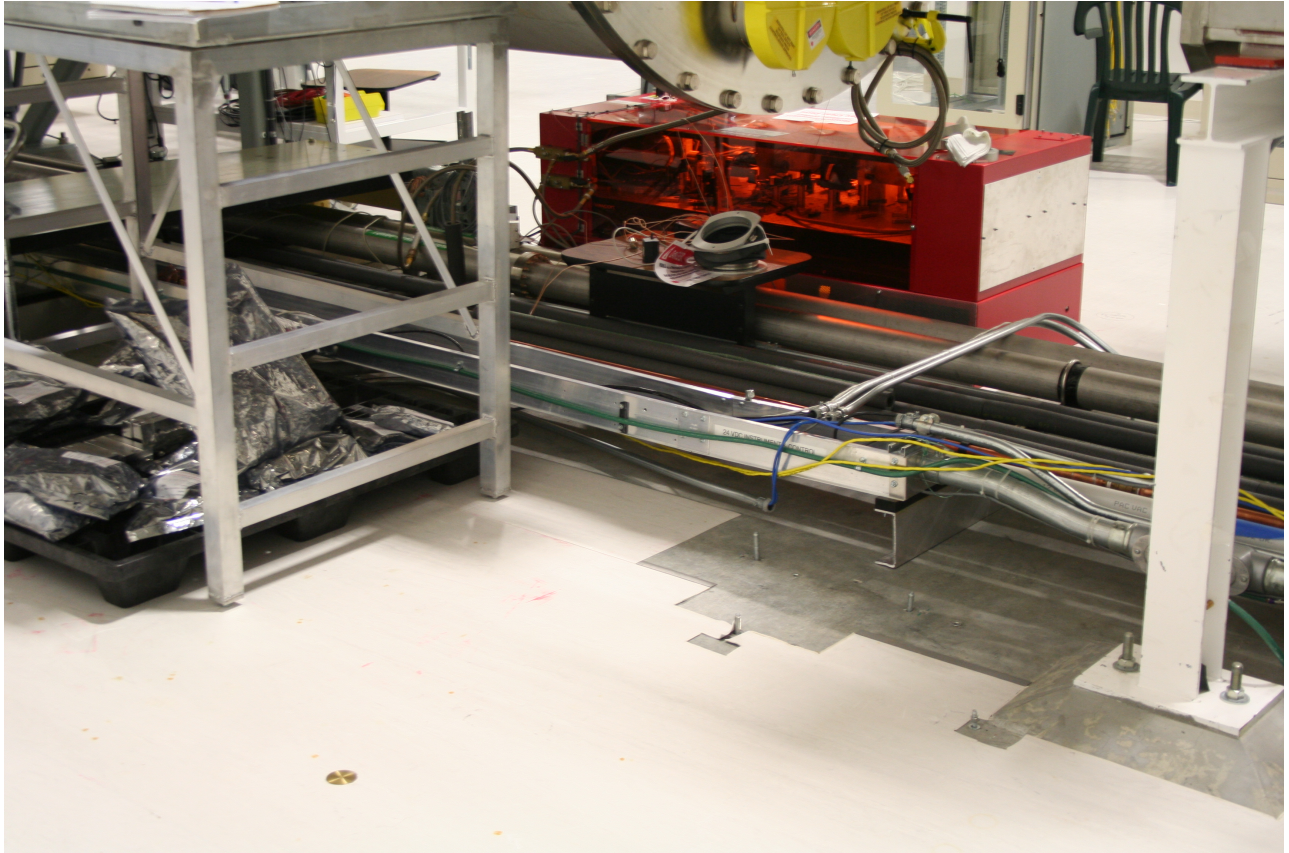
**Figure 8:** The receiver pylon (leaner) is supposed sit in the foreground of this picture, probably occluding the brass-disk monument set into the floor for initial alignment.

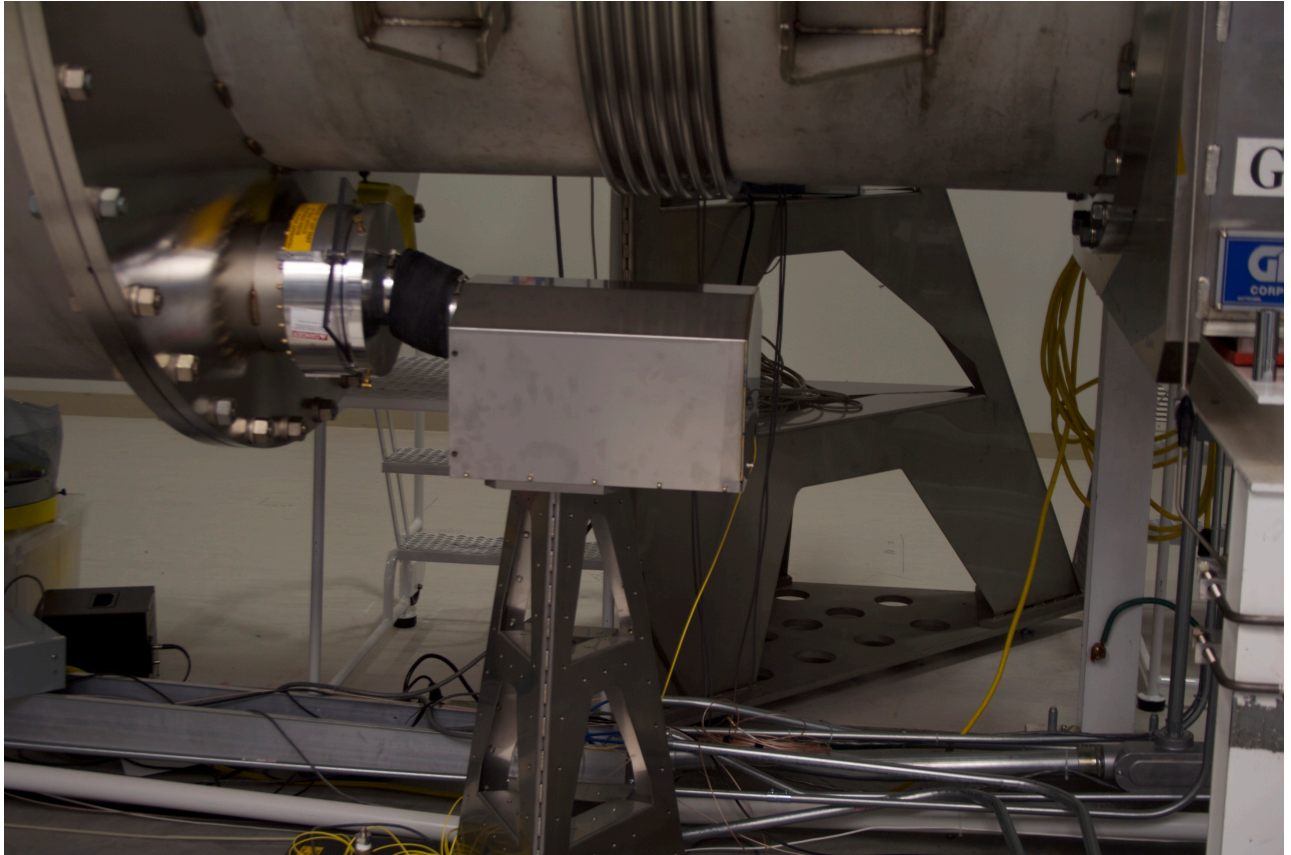
**Figure 10: ITMY launching platform looking into VP4.**

Notes: Installed, but occludes initial-alignment monuments LV17, LV18, and LV19.

Recommendation: Mount initial-alignment monuments on pylon baseplates. Adjust pylon positions along beam axis and rotate transmitter by  $180^\circ$  as necessary.

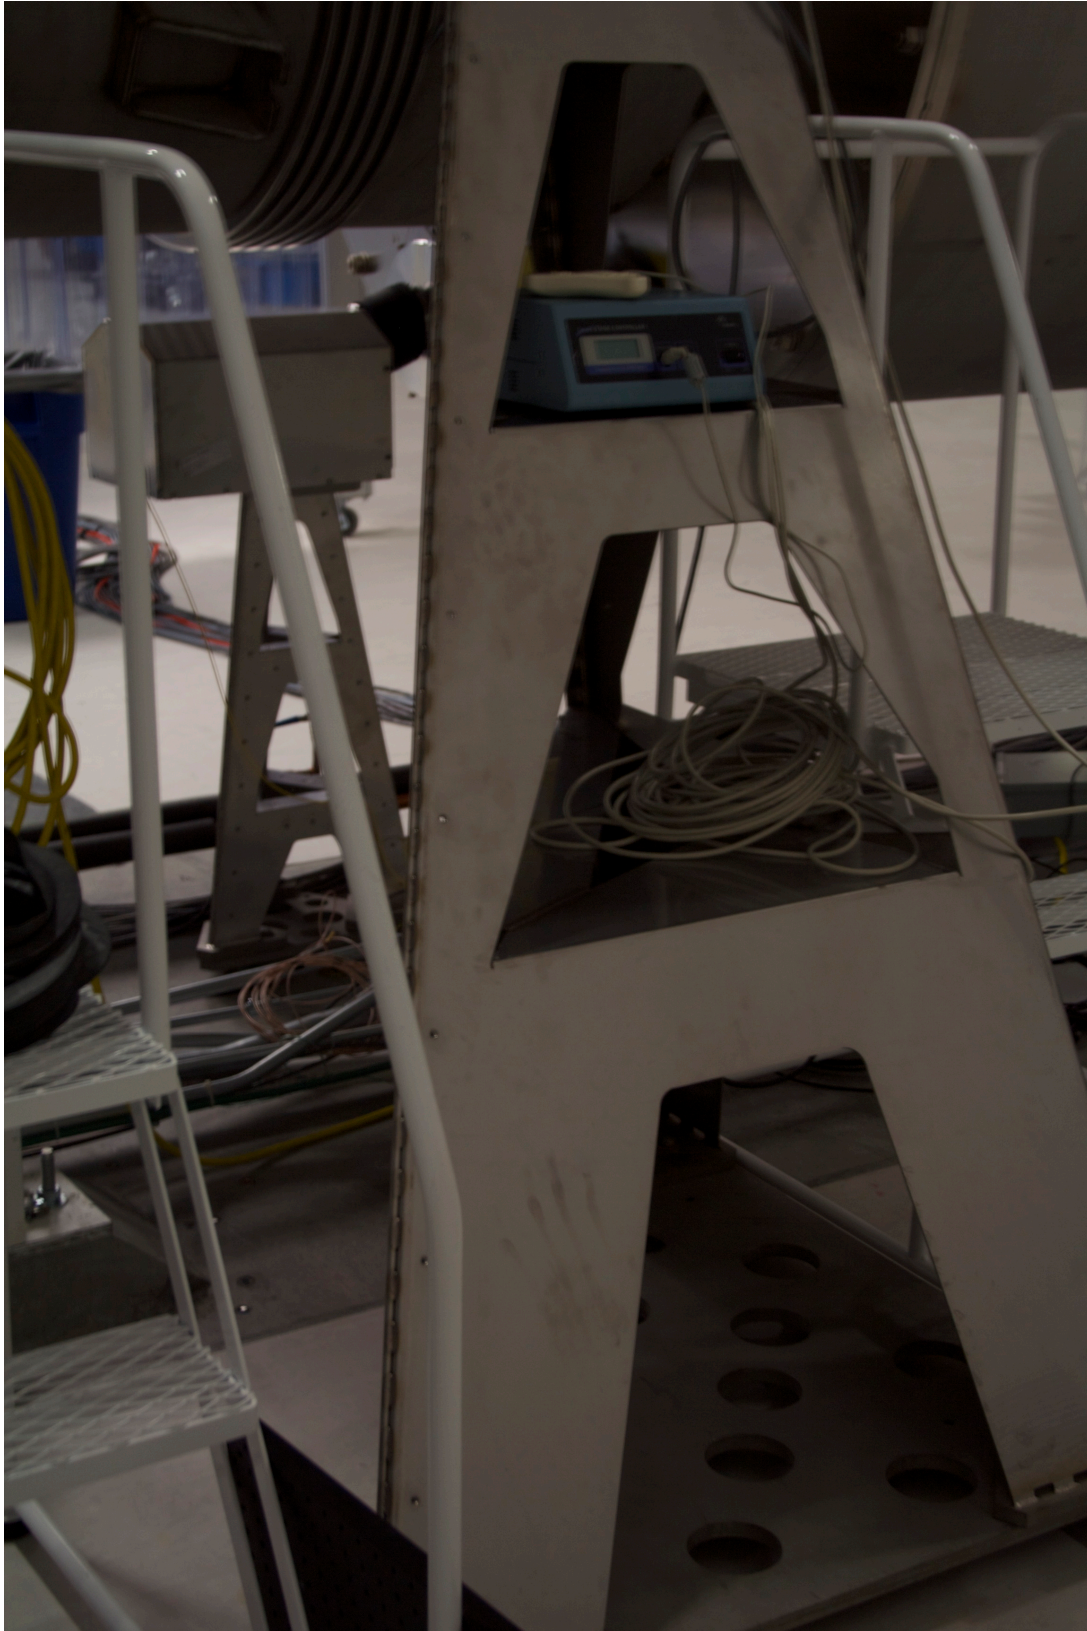
**Figure 11: ITMY receiver (leaner) in the foreground, with launcher (dwarf) in the background.**

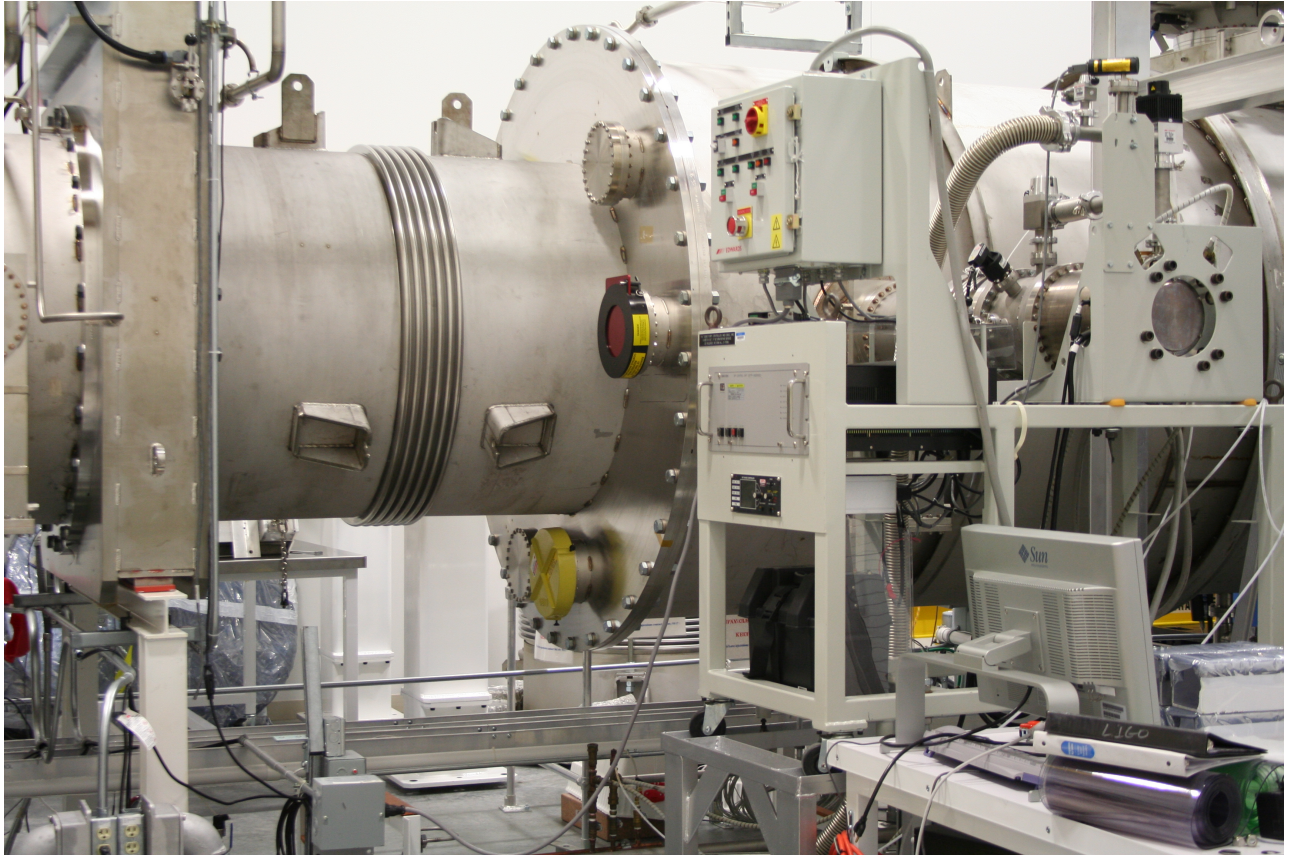
Notes: Significant interference here for both the transmitter and receiver. There is a turbo pump in the way of the leaner, and the dwarf will probably occlude a survey monument used for initial alignment.

**Figure 13: Turbo pumping station on AUX cart, where the ETMX leaner should go.**

Recommendation: Re-position AUX cart to clear space for leaner. Translate launching pylon back ~3.5" and mount monument inside baseplate.

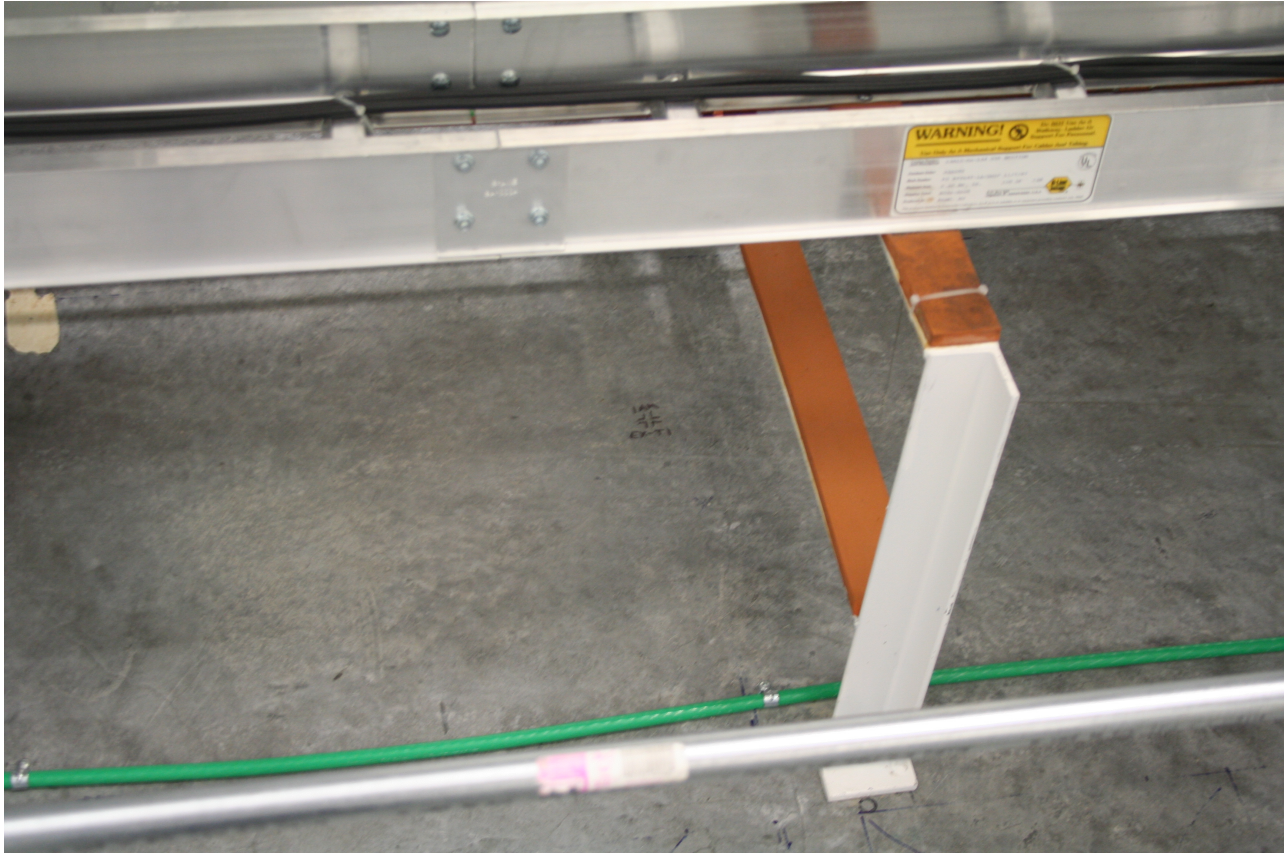
**Figure 15: Monument under VP4, where the dwarf transmitter should go.**
