Summary of information on the leak in the y arm at the LIGO Livingston site

R. Weiss and M. Zucker Jan 28,2013

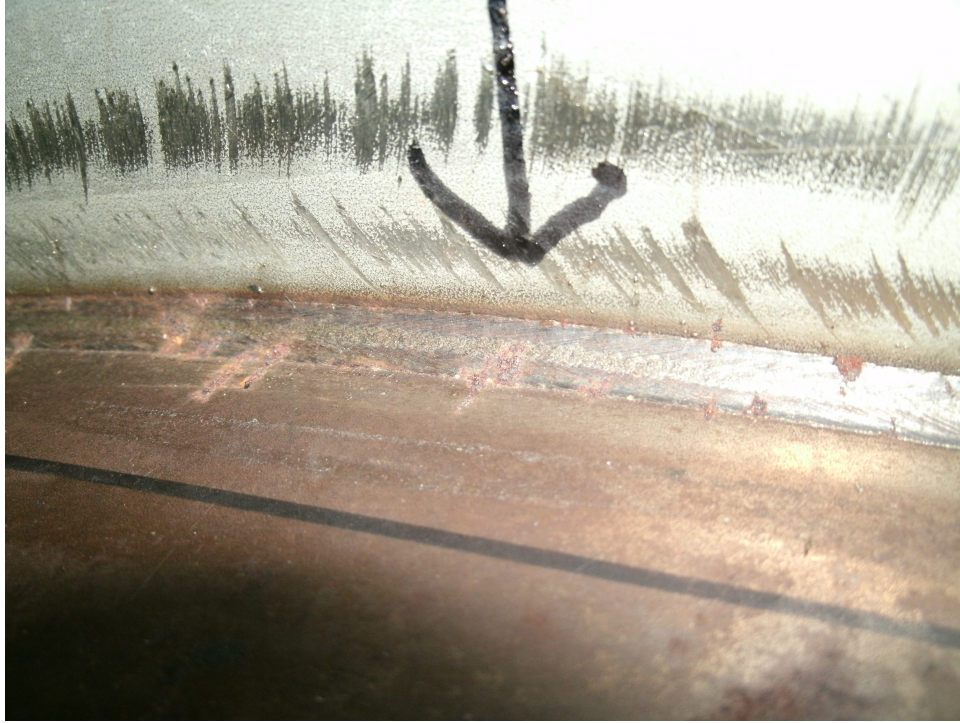
A leak of approximately the estimated value was found with helium at 2258 meters. The leak was on a stiffener ring fillet weld near the top of the tube (**Figure 1** and **Figure 2**). The region around the leak including an adjacent spiral tube weld was found to be contaminated with mouse urine and feces. X ray photoelectron spectroscopy was done on rags that had wiped the tube surface and compared with clean rags (**Appendix 1**). The dirty rags showed chlorine and bismuth peaks.

Near the location of the leak there is evidence of an arc-gouge and a manually repaired section of the spiral weld.

Figure 1: The location of the arrow is a likely place for the original leak on the continuous weld between the stiffening ring and the tube. The brown discolorations are assumed to be due to mouse urine.

The leak was repaired initially with epoxy but this was not as successful as using a lower viscosity silicone leak repair called "Vacseal". Once the "Vacseal" was applied the pressure in the tube began to decrease. Once the region had been cleaned there was no obvious place which could be seen to indicate the exact location of the leak. Within several hours after cleaning and the application of heat by a heat lamp to cure the "Vacseal", a second leak three times large than the original one opened

The leaking section of spiral weld was cleaned and "Vacseal" was applied. Helium testing showed that the region was now leak tight to 10^{-6} torr liters/sec or smaller.

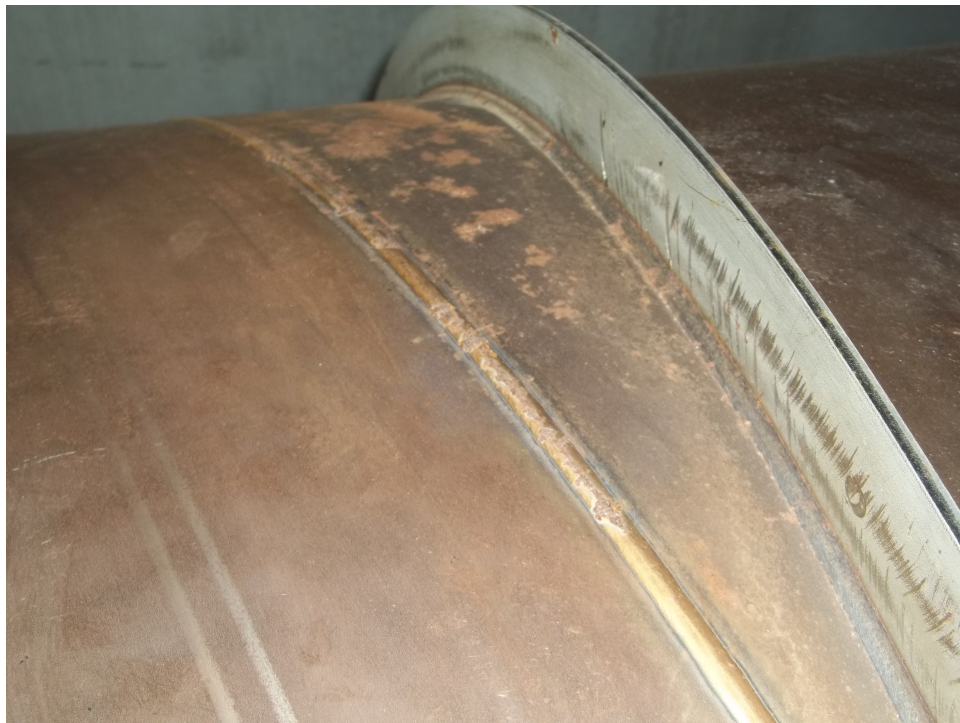
Figure 2: A larger view showing the stiffening ring and the spiral weld. The spiral weld is covered with mouse feces which comes off easily. The mouse urine has discolored the tube in patches between the spiral weld and the stiffening ring. The background brown color of the tube is due to the air heating of the tube material before fabrication to reduce the dissolved hydrogen in the steel.

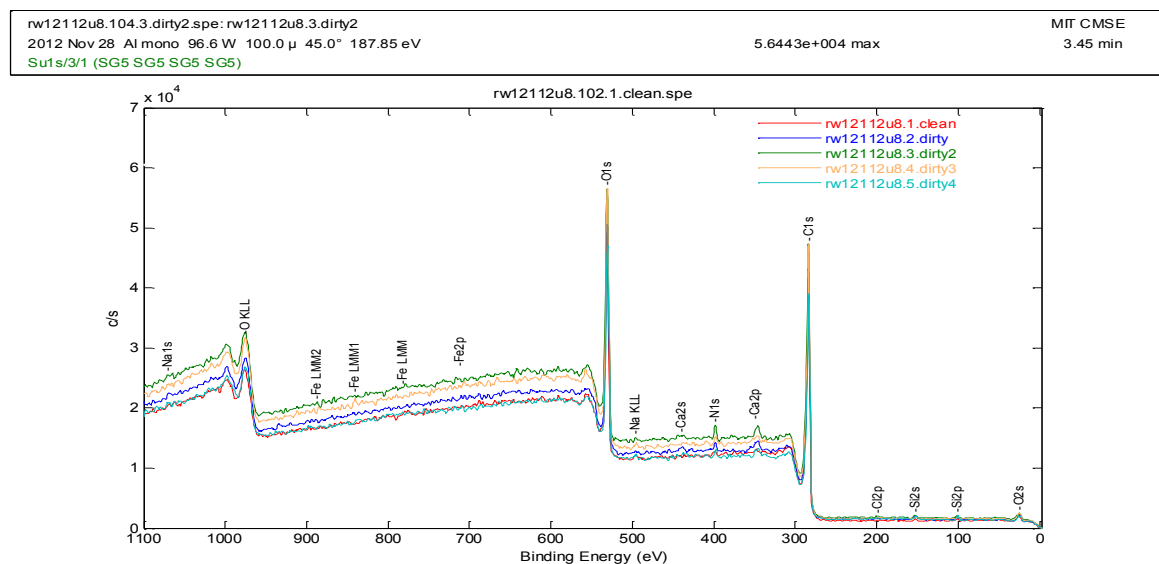
C and O major components, Ca, Na, and Si very minor components
Fe and Cl were not detected in these 3.5 minute survey scans

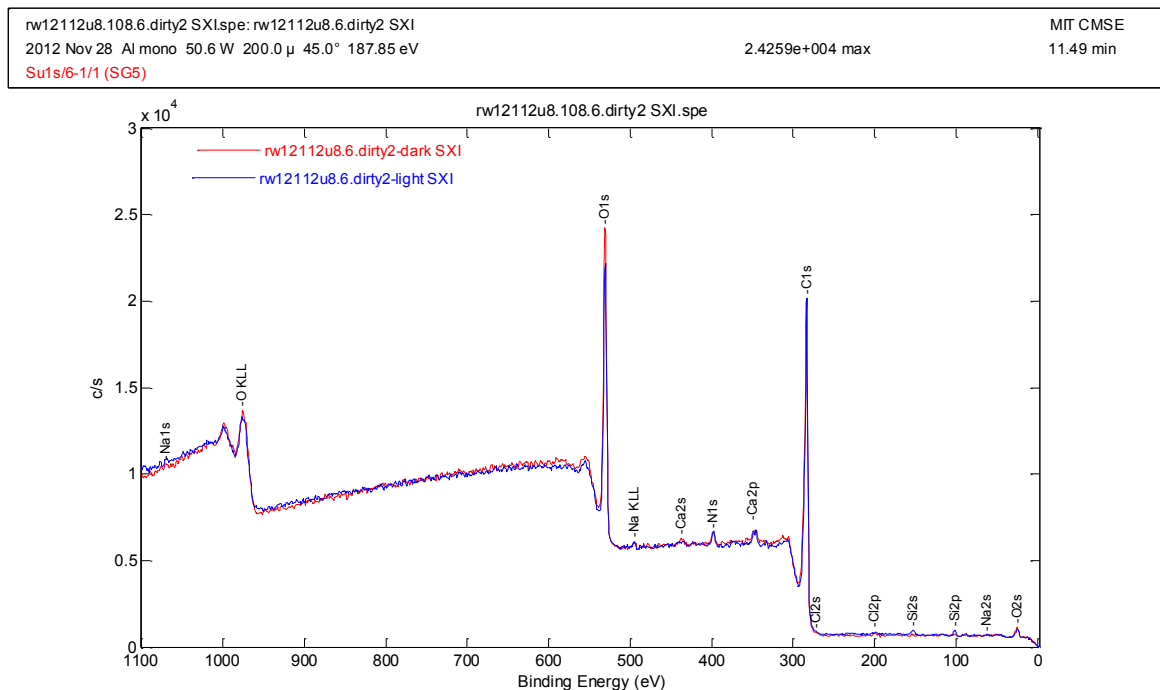
Dirty2 hole (dark) and Dirty2 fibers (light)
analysis areas 200 μm diameter

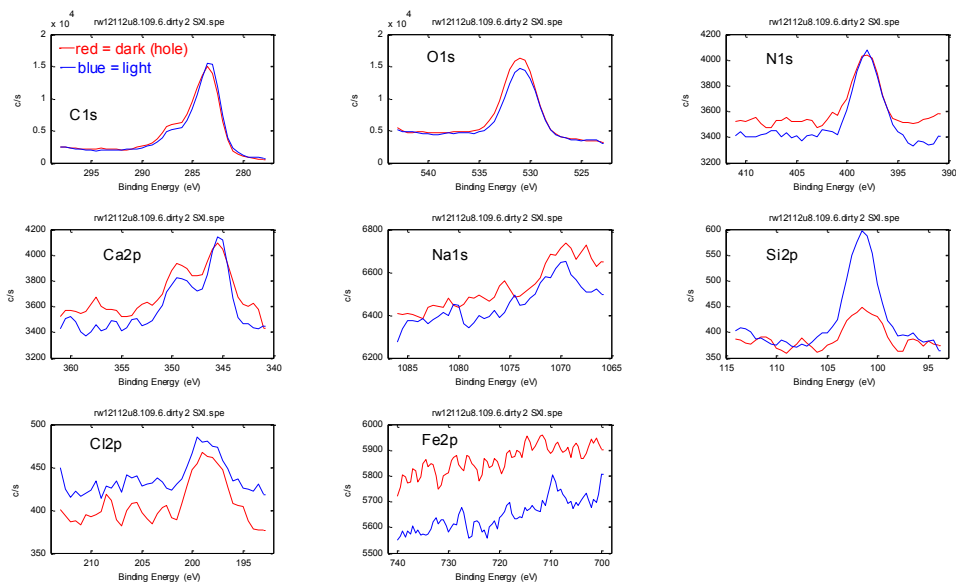
Possible hint of iron on fibers (blue) , none on hole (red).

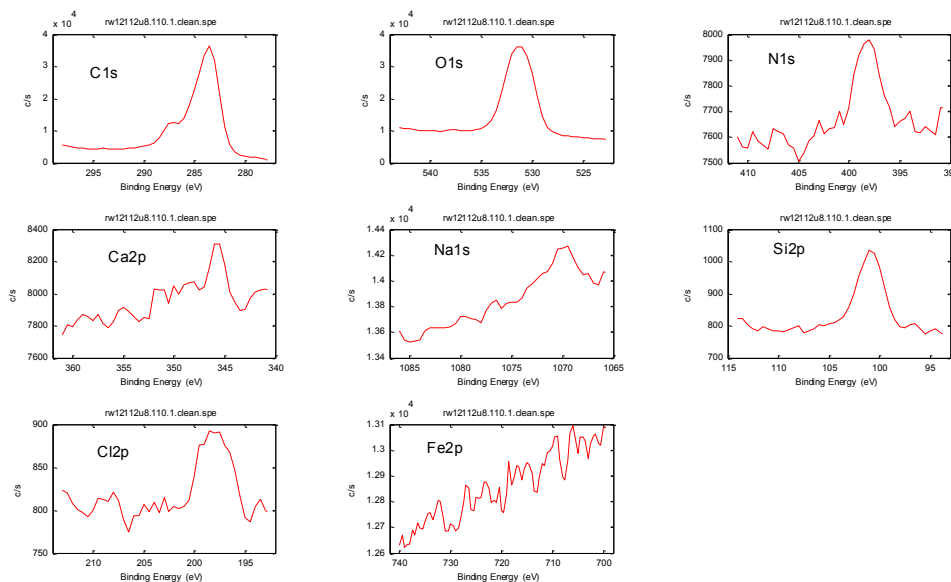
60 sweeps Cl2p and Fe2p
no hint of iron on clean fabric

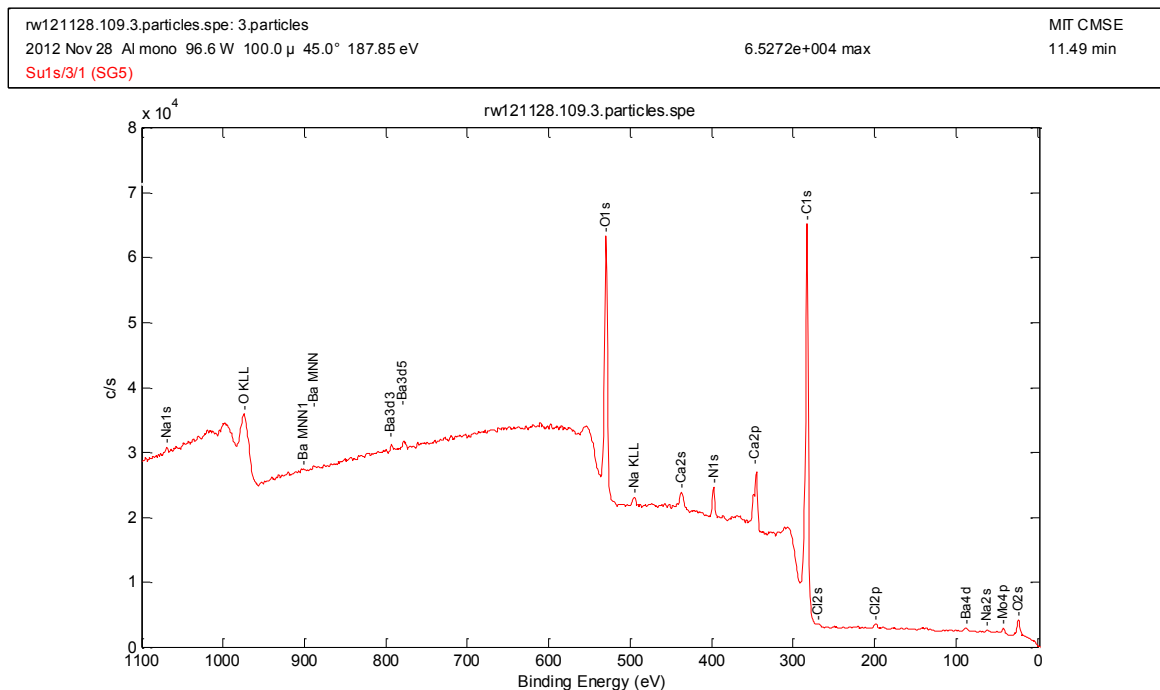
Survey spectrum
particles collected from fabric
analysis area 100 μm x 1300 μm
no Fe detected, Ba unambiguously detected
