external
stress
corrosion
cracking

ESCC of Stainless Steel

W. G. Ashbaugh

Union Carbide Corporation
Texas City, Texas

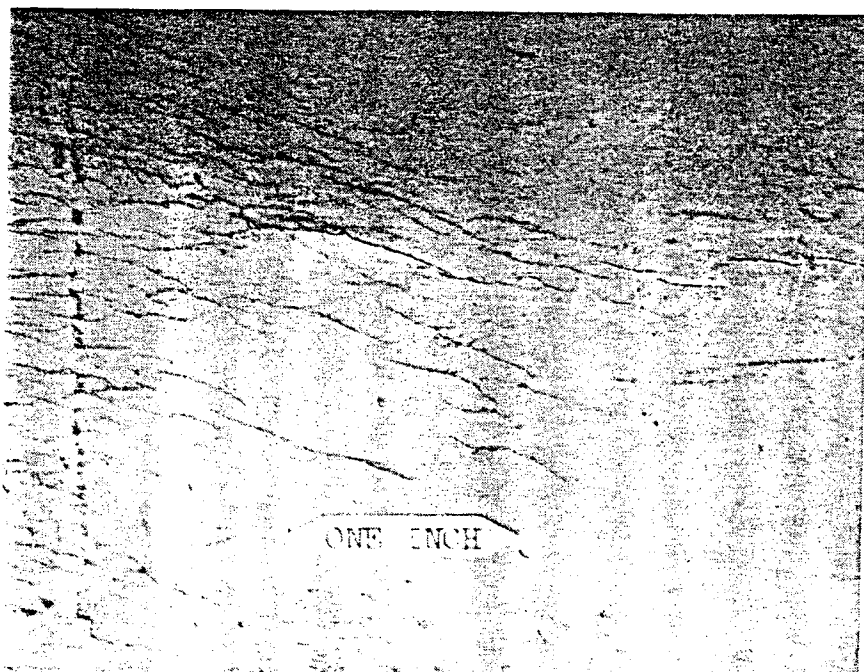
A recent series of ESCC failures at Union Carbide's Seadrift plant was investigated. The cause was cracking resulting from an anti-abrasive coating applied to the inside surface of a non-wicking insulation material (Figures 1 and 2). In efforts to solve this problem, a laboratory test was developed to determine if the insulation material in question would cause stress corrosion cracking of stainless steel. Once perfected, the test was extended to all the common insulation materials which are used in the company's Chemicals Division to determine if any others also were dangerous from an ESCC standpoint. Tests were run to evaluate protective coatings for the metal as well.

Figure 1—External stress corrosion cracking of Type 316 stainless steel on a distillation column. This cracking was caused by an anti-abrasive coating applied to the underside of a non-wicking insulation material. The cracking occurred in less than six months.

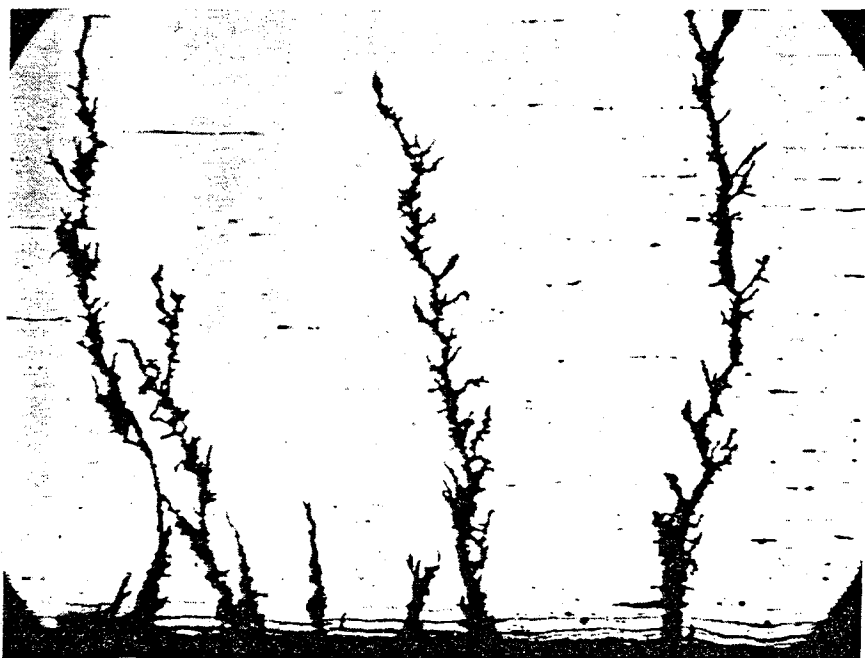
Metallographic examinations of several cracked specimens confirmed that the defects noted were typical trans-

Figure 2—These transgranular, branched cracks are metallographic evidence that the cracking seen in Figure 1 is chloride stress corrosion cracking. (Electrolytic oxalic acid etch, 75X)

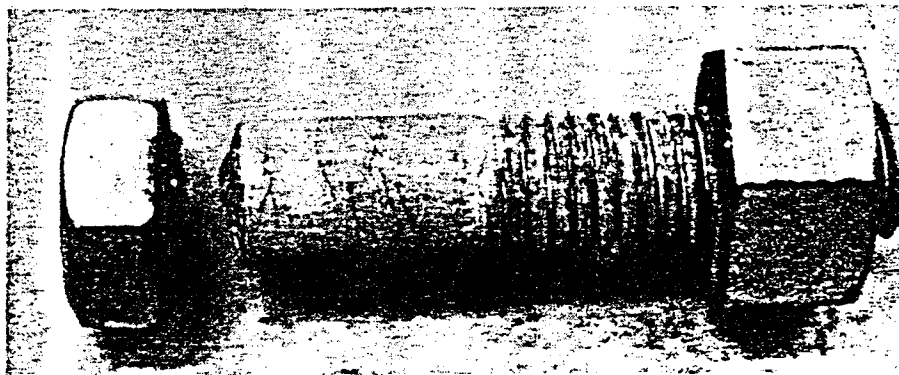
Another case of ESCC which is quite common and occurs without the benefit of insulation is the failure of Type 302 stainless bolts (Figure 8). Here again, chlorides collect on the hot flanges and bolts and are trapped in the bolt hole crevice, resulting in stress cracking.

Figure 8—Chloride stress cracking of this ½-inch Type 303 stainless bolt occurred in less than four years. Atmospheric chlorides accumulated in the flange bolt holes, resulting in widespread cracking.
