## MEMORANDUM

TO: ISC team  
FROM: Daniel Sigg, Koji Arai  
SUBJECT: EOM/AOM Diver Modifications  
Refer to: LIGO-E1500353-v3

This modifications apply to [D0900761-B](#), [D0900847-B](#), [D0900848-C](#) and [D1000216-B](#) to bring them to revisions C, C, D and C, respectively.

The affected serial numbers are S1500117 to S1500128.

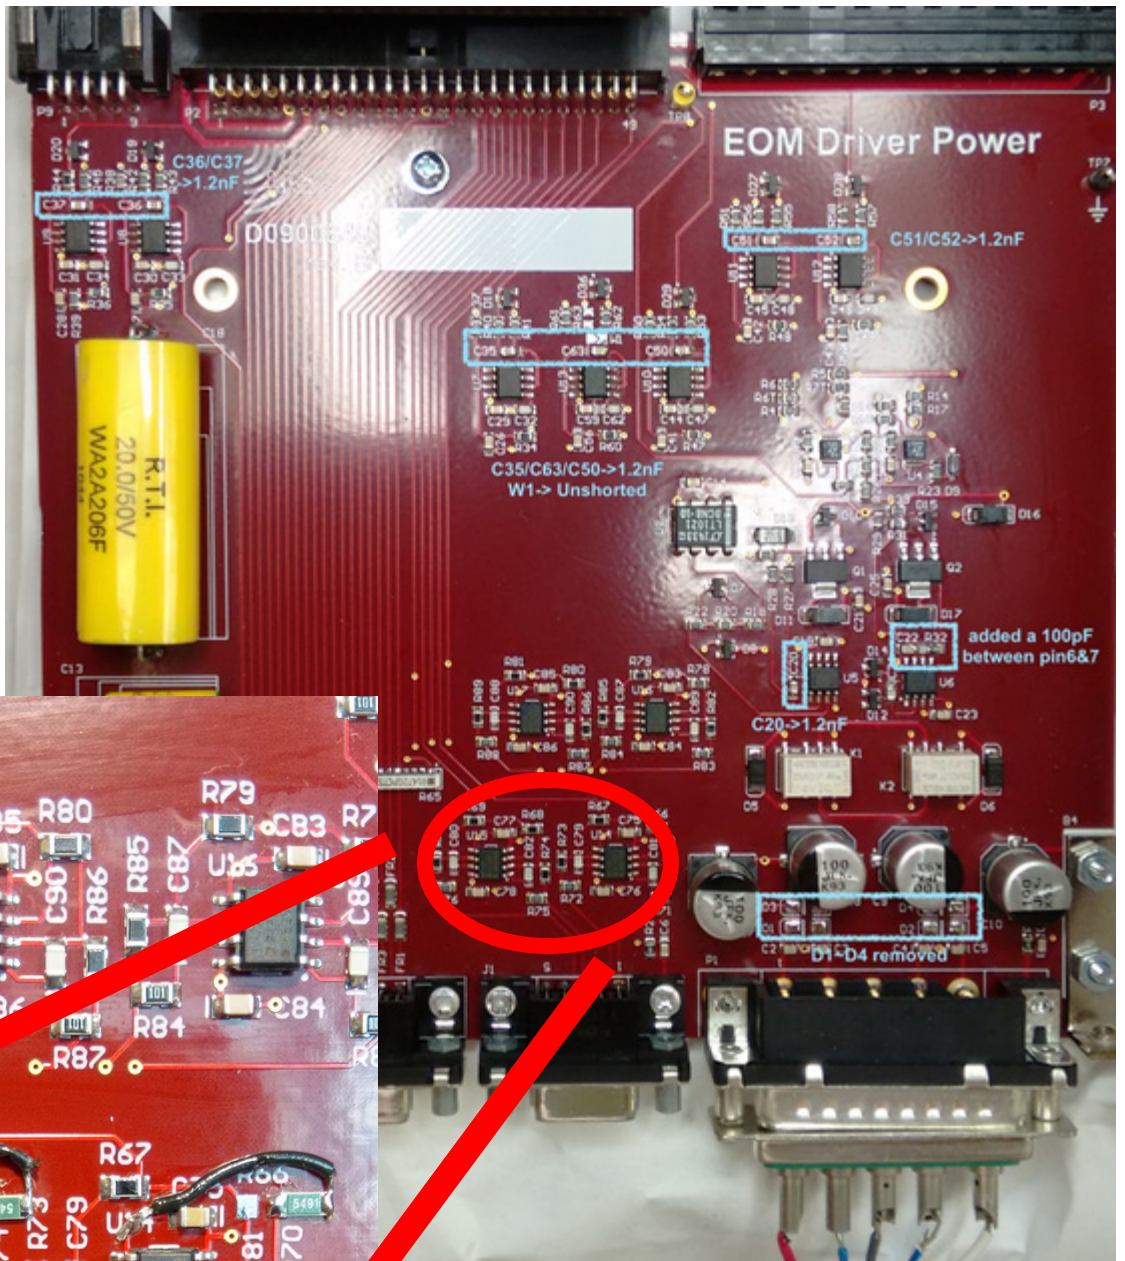
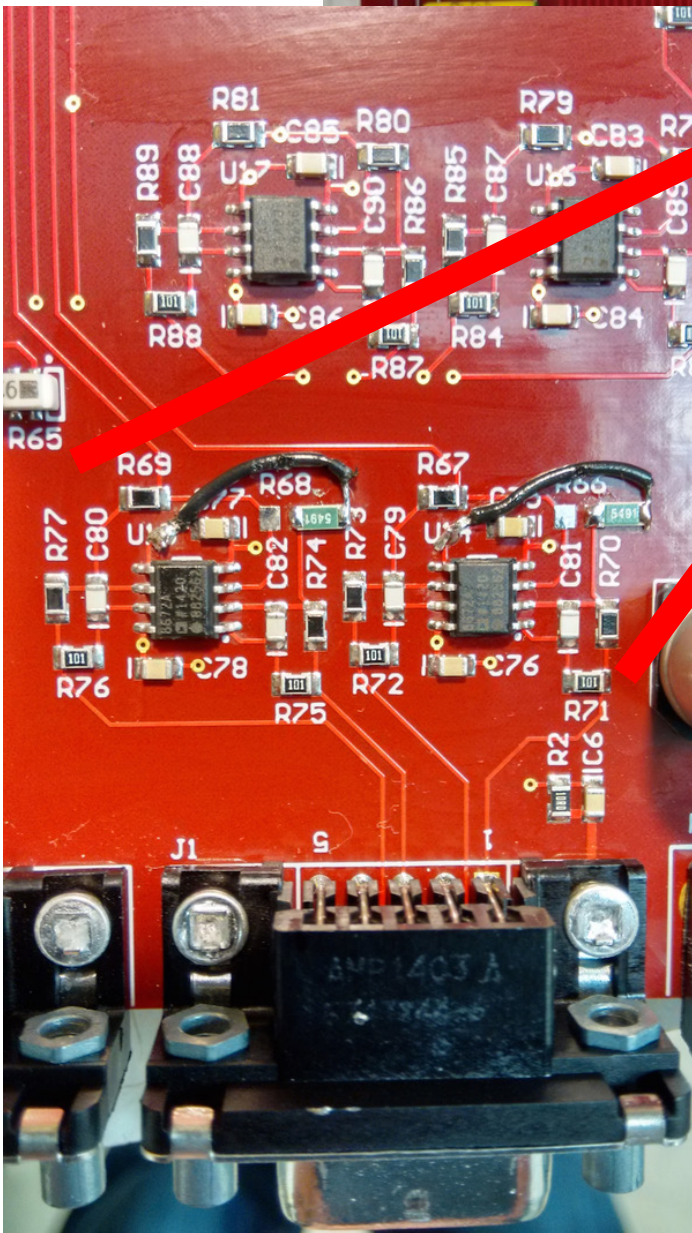
## Change 3:

Fix the gain in the differential output stages.

R66, R68 → 5.49K, shift and use only the pad above R70 and R74

J1, J2 → add a jumper wire from the free end to ground (see pic)
