LIGO- T1500492-V1

17 September 2015

**Information regarding the two failed PSL
Pre-mode cleaners (PMC's) at LLO**

Matthew Heintze

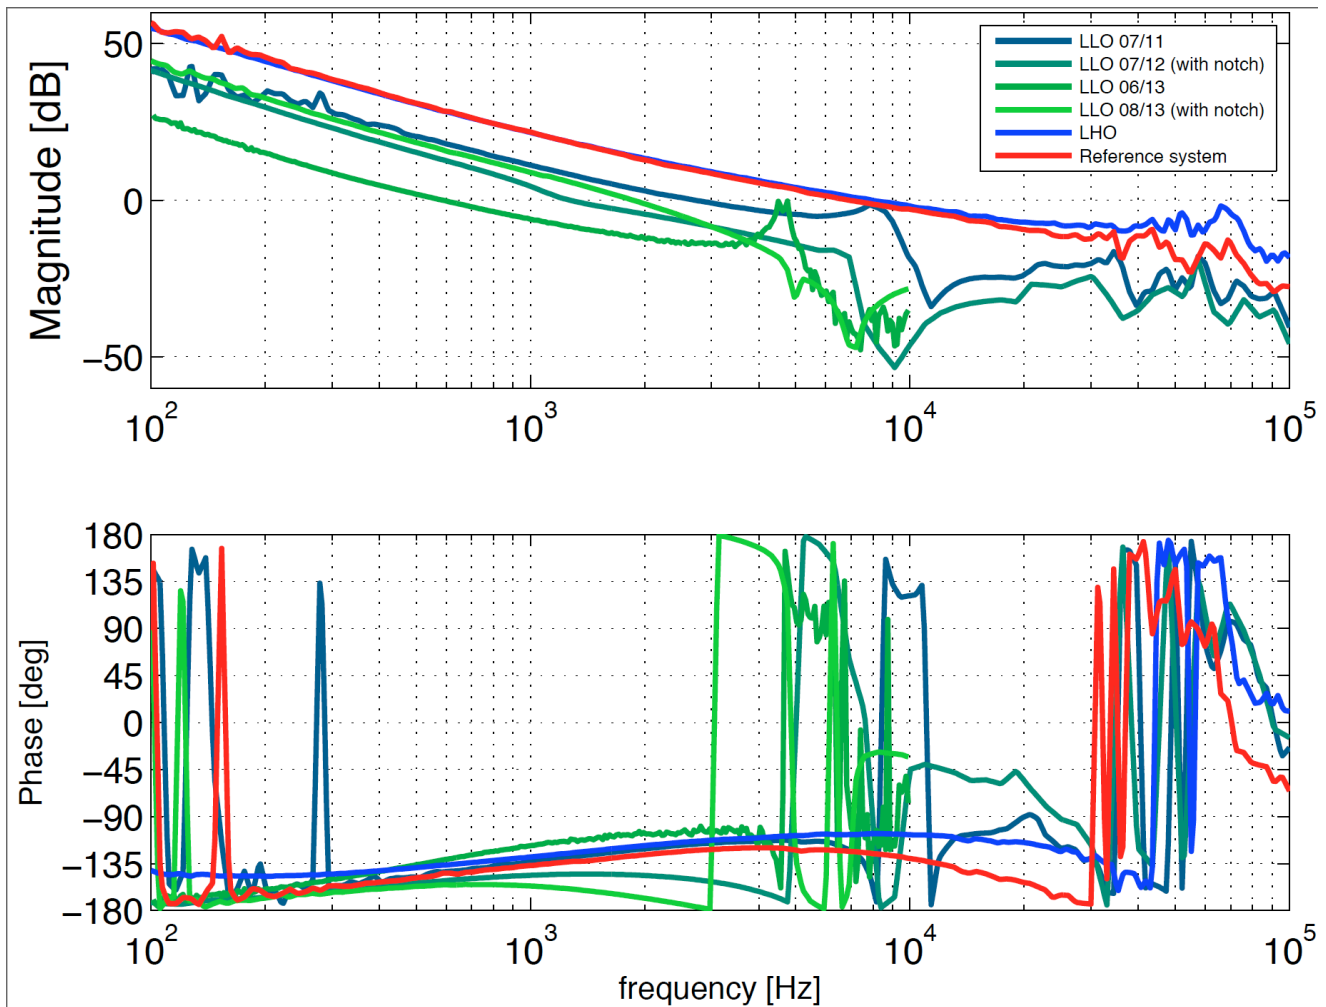
In November 2014, Rana reported ([LLO alog15751](#)) on suspicions about the performance of the originally installed PMC (T1000430 S/N: 08, S1102964). On 8 Dec 2014, Dennis M reported ([LLO alog 15986](#)) that they found in the DARM spectrum “a growing intensity noise from 100Hz to 1000Hz and a bump around 4000Hz”. It was suspected that the PMC caused this intensity problem. The Detector Characterization group also reported ([see LLO alog 16082](#)) of glitches that they associated at the time with the PMC PZT high voltage supply. Gabriele Vajente also confirmed ([see LLO alog 16202](#)) the significant coherence of PMC signals to DARM noise at ~ 1.5 kHz. The plots in Figure 1 (plots provided to me by Janeen R, unknown who produced the plots) show that the LLO PMC issue could be seen as far back as July 2011.

All this pointed to a faulty PMC PZT.

Figure1: Curves comparing the LLO PMC to the PMC at LHO and AEI showing the issue at LLO has been present as far back as July 2011

The decision was made to swap out PMC unit S/N: 08 (with the suspected faulty PZT) with the LLO spare PMC unit S/N: 10. This was implemented on the 18 December 2014 ([see LLO alog 16186](#)).

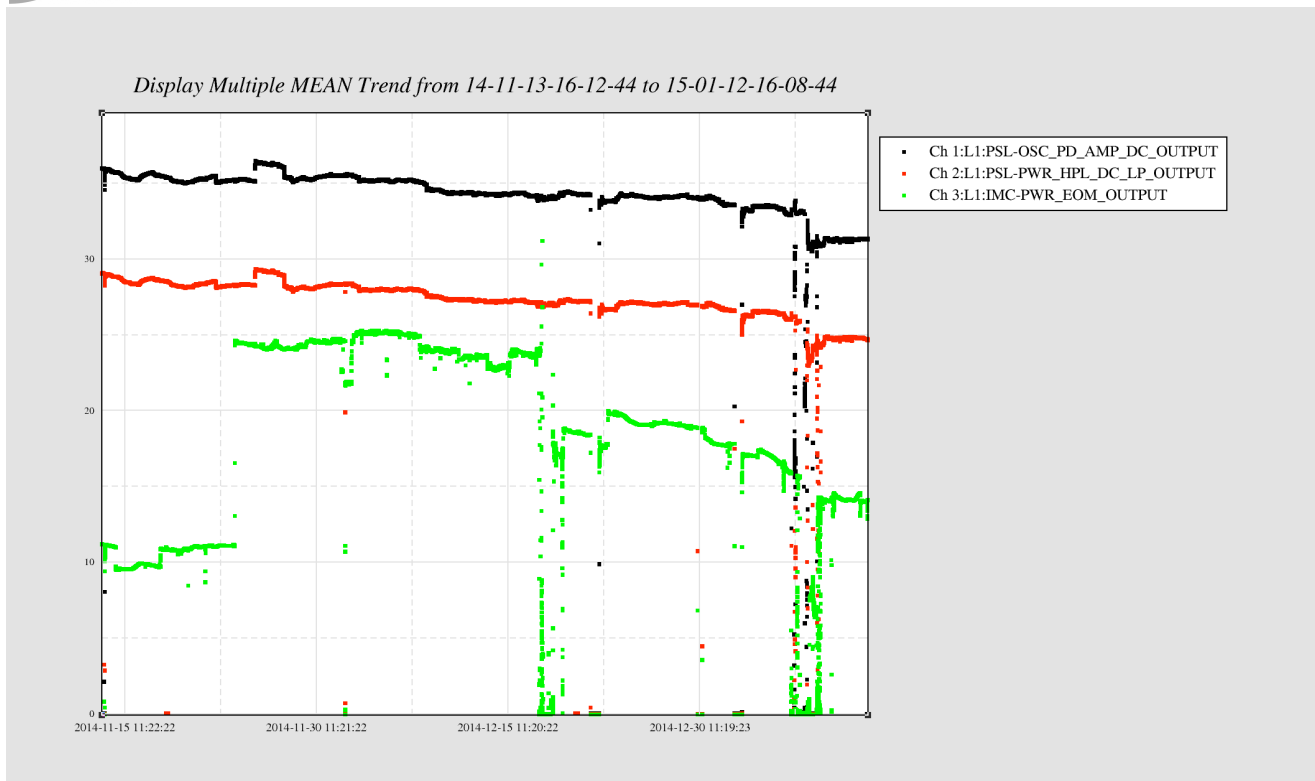
On 12 January 2015 Valera reported (see [LLO alog 16338](#)) on the trend of the powers at three points of the PSL. Out of the front end amplifier, after the HPO and after the PMC. It could be seen that the rate of decay after the PMC was a lot greater than at the other two locations (see Figure 2).

A power budget measurement was performed on the PSL system (see [LLO alog 16380](#)), especially focusing on the PMC, and the visibility was measured to be ~85%, however the throughput was only ~60.5%. This indicated that the newly installed PMC (unit S/N: 10) had become quite lossy in only a month of operation.

Figure 2: The decay of the power after the PMC compared to out of the front end and the HPO in the PSL.

On the 21 January 2015 the LHO spare PMC unit (S/N:12) was installed into the LLO PSL (see [LLO alog 16482](#)). This unit has been running fine up to the point that this report was written (17 September 2015).
