### Required Modifications (Oct 13, 2015 Koji Arai, Oct 29, 2015 Daniel Sigg)

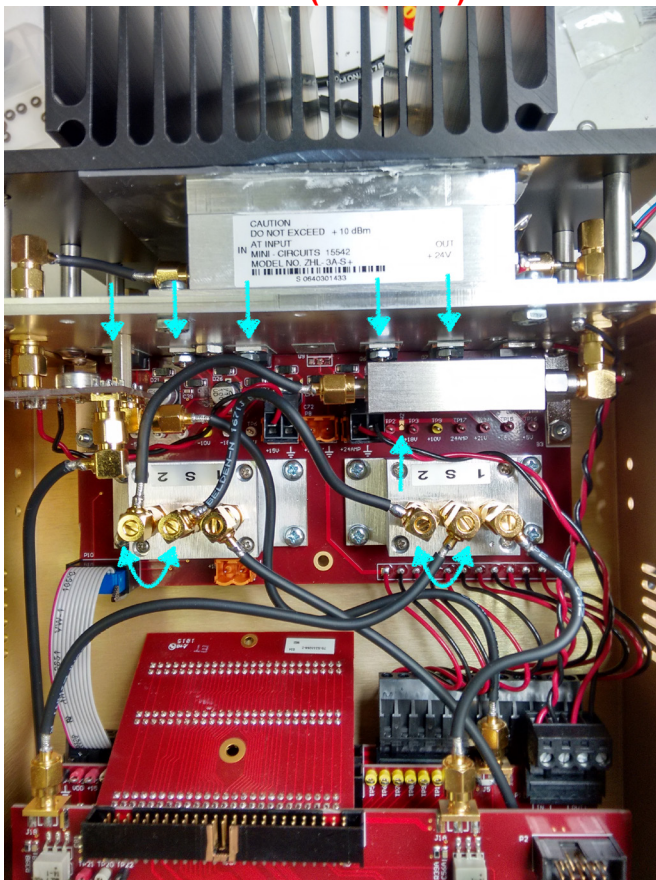
**Before (Incorrect)**

4. The internal RF connections are incorrect. They should be corrected as shown in the following photo.
