# Visual Catalog of LLO ETM Inspection Images from Mid-O3 Vent

GariLynn Billingsley, Danny Sellers, Marie Kasprzack, Stephen Appert  
ETMX Inspection 3-4 October 2019  
ETMY Inspection 7-8 October 2019

T1900696-v1

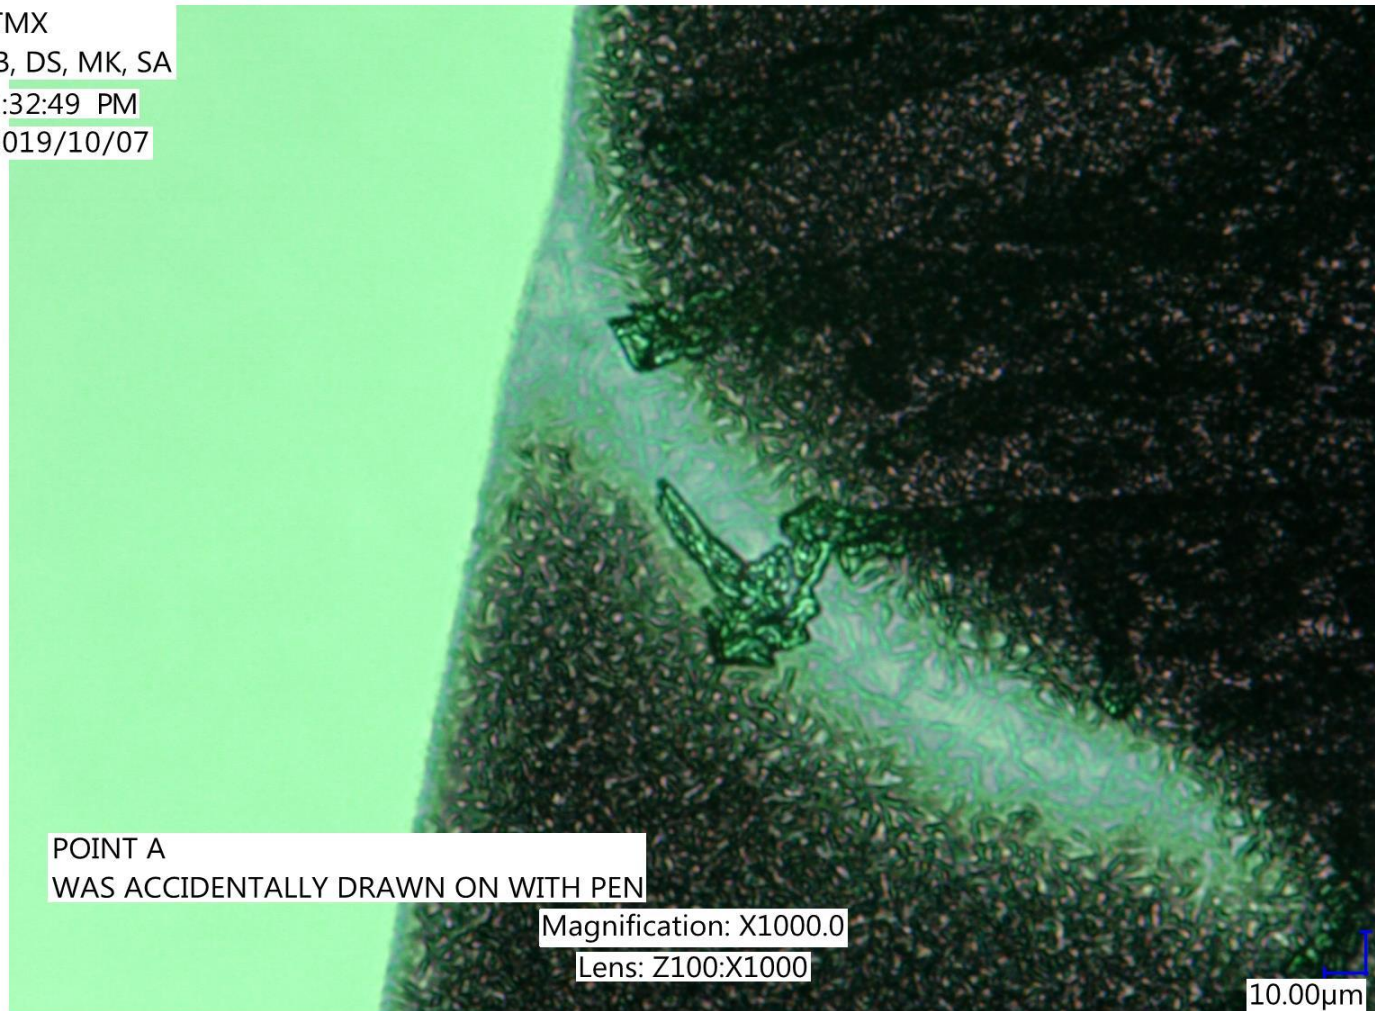
## Point A

Particulate

Accidentally drawn  
on with pen

POINT A  
WAS ACCIDENTALLY DRAWN ON WITH PEN

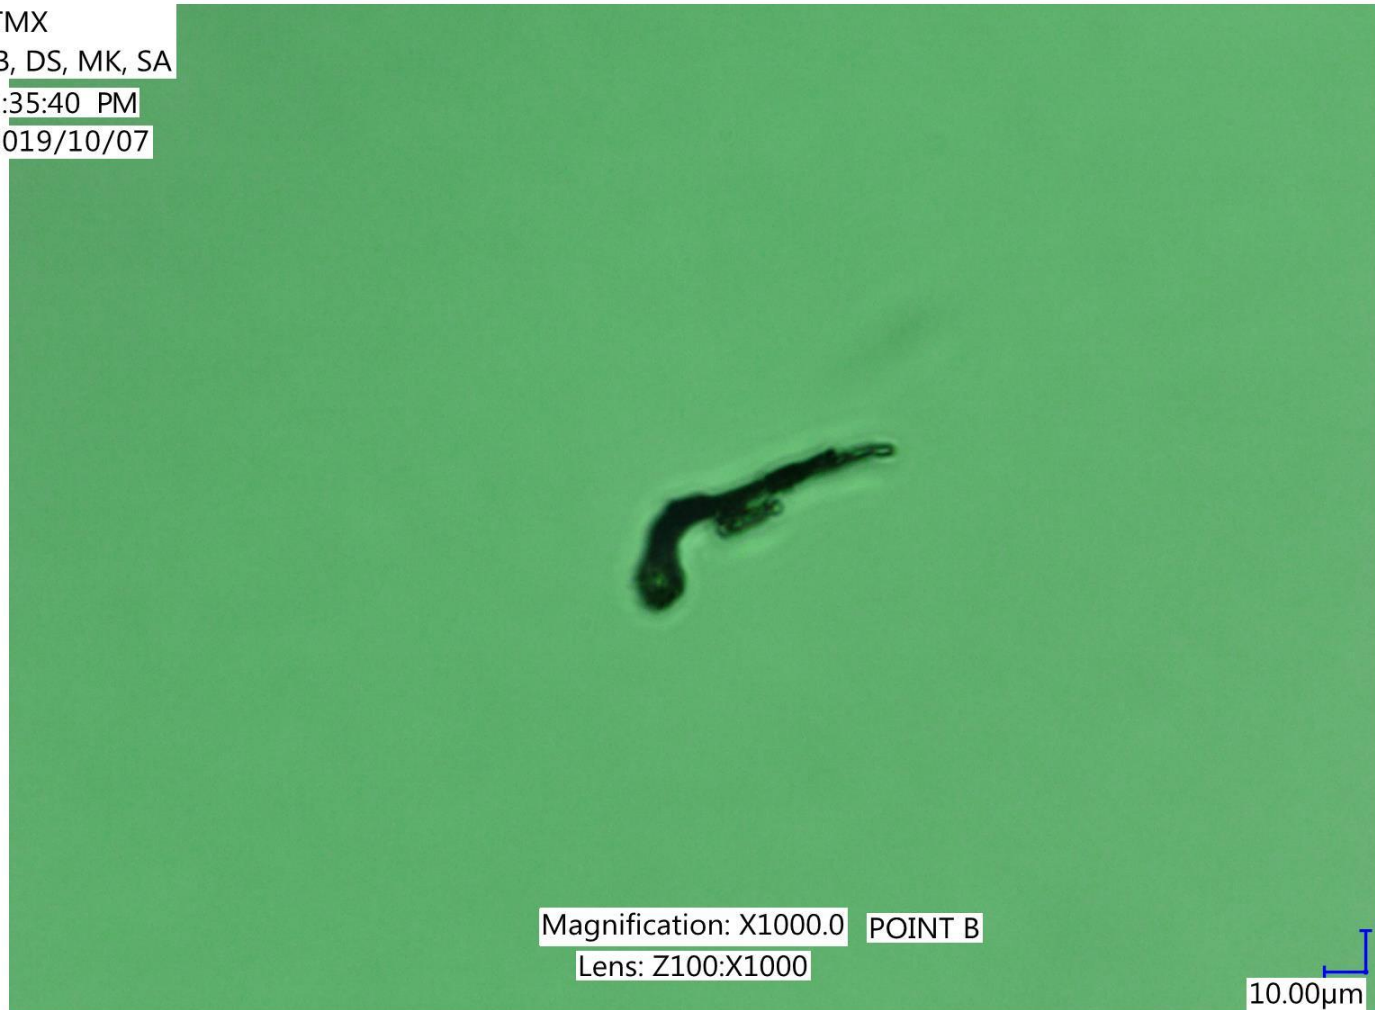
## Point B

Debris

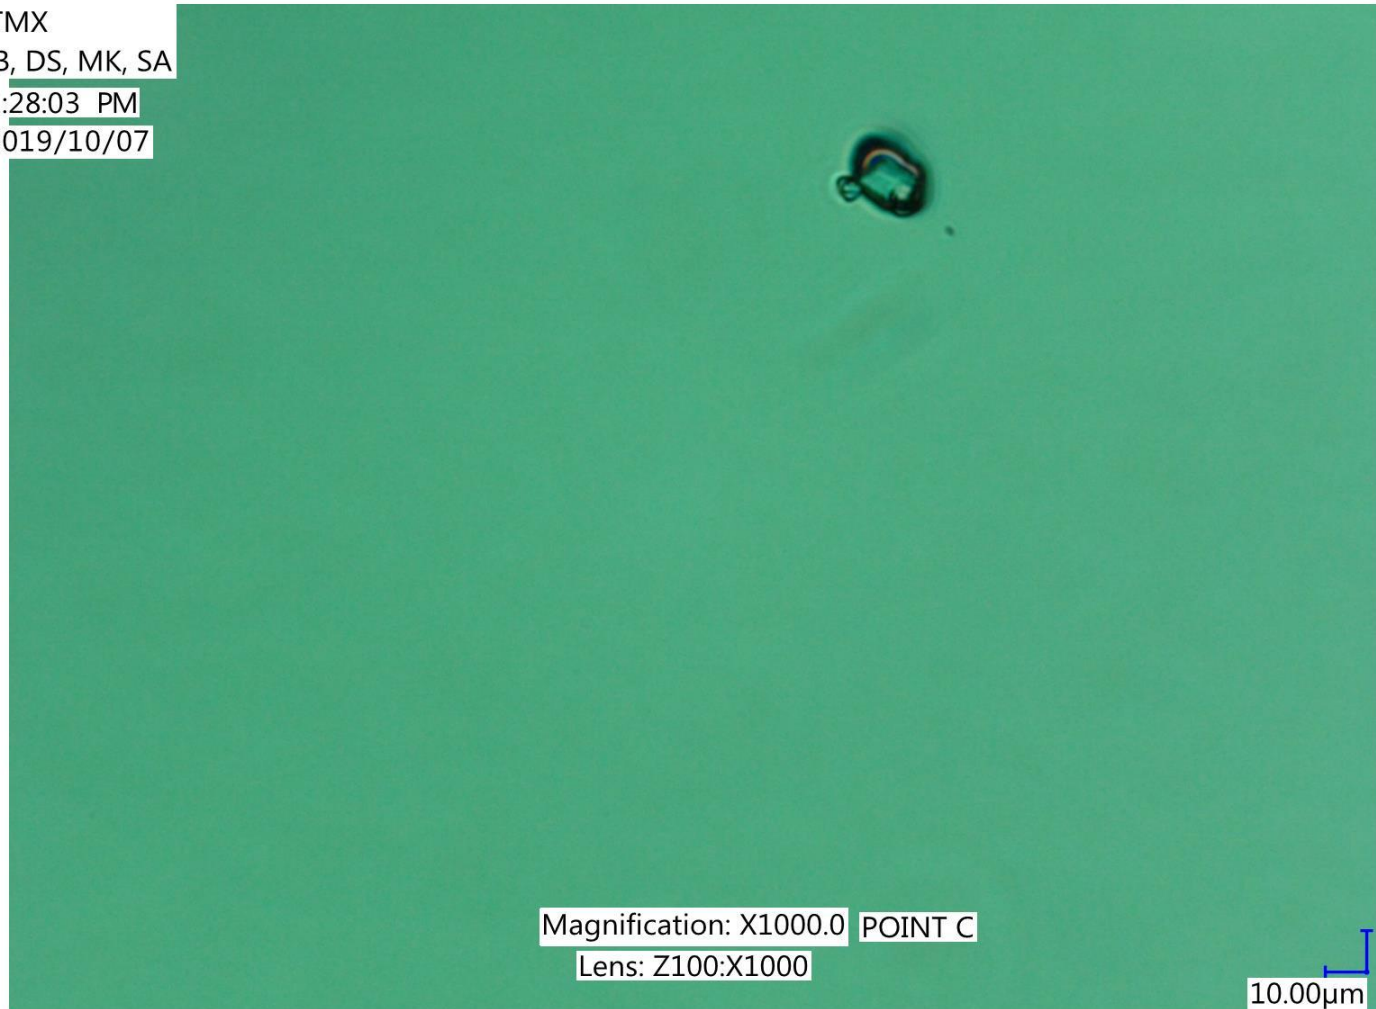
## Point C1

Coating Void

2 points in region

Transmitting  
illumination from  
green flashlight in  
this image

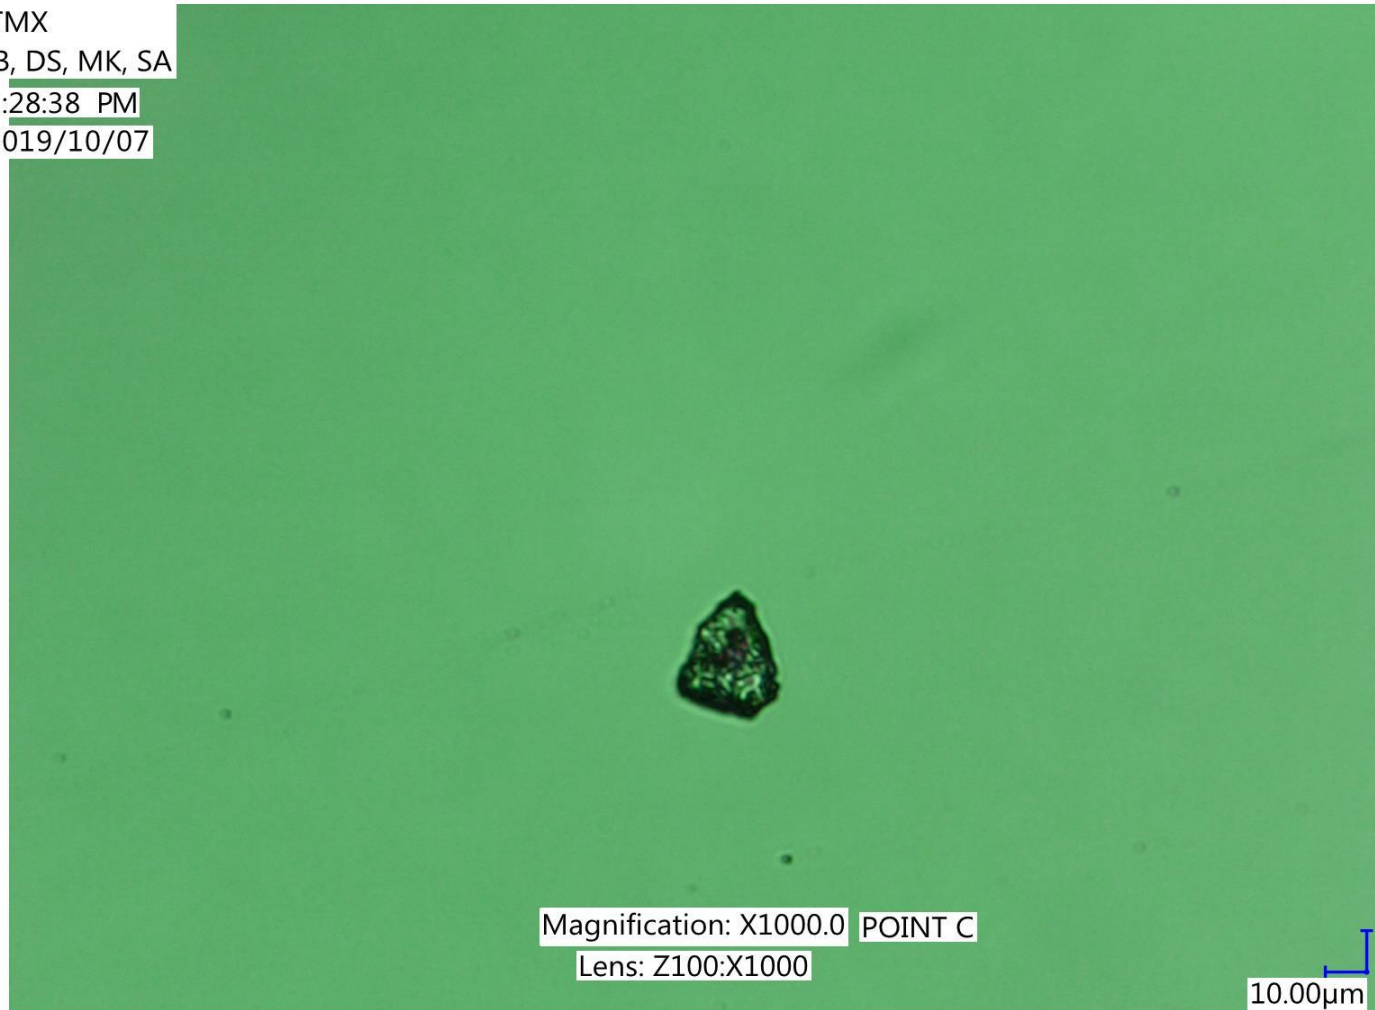
# Point C2

Debris

2 points in region  
C

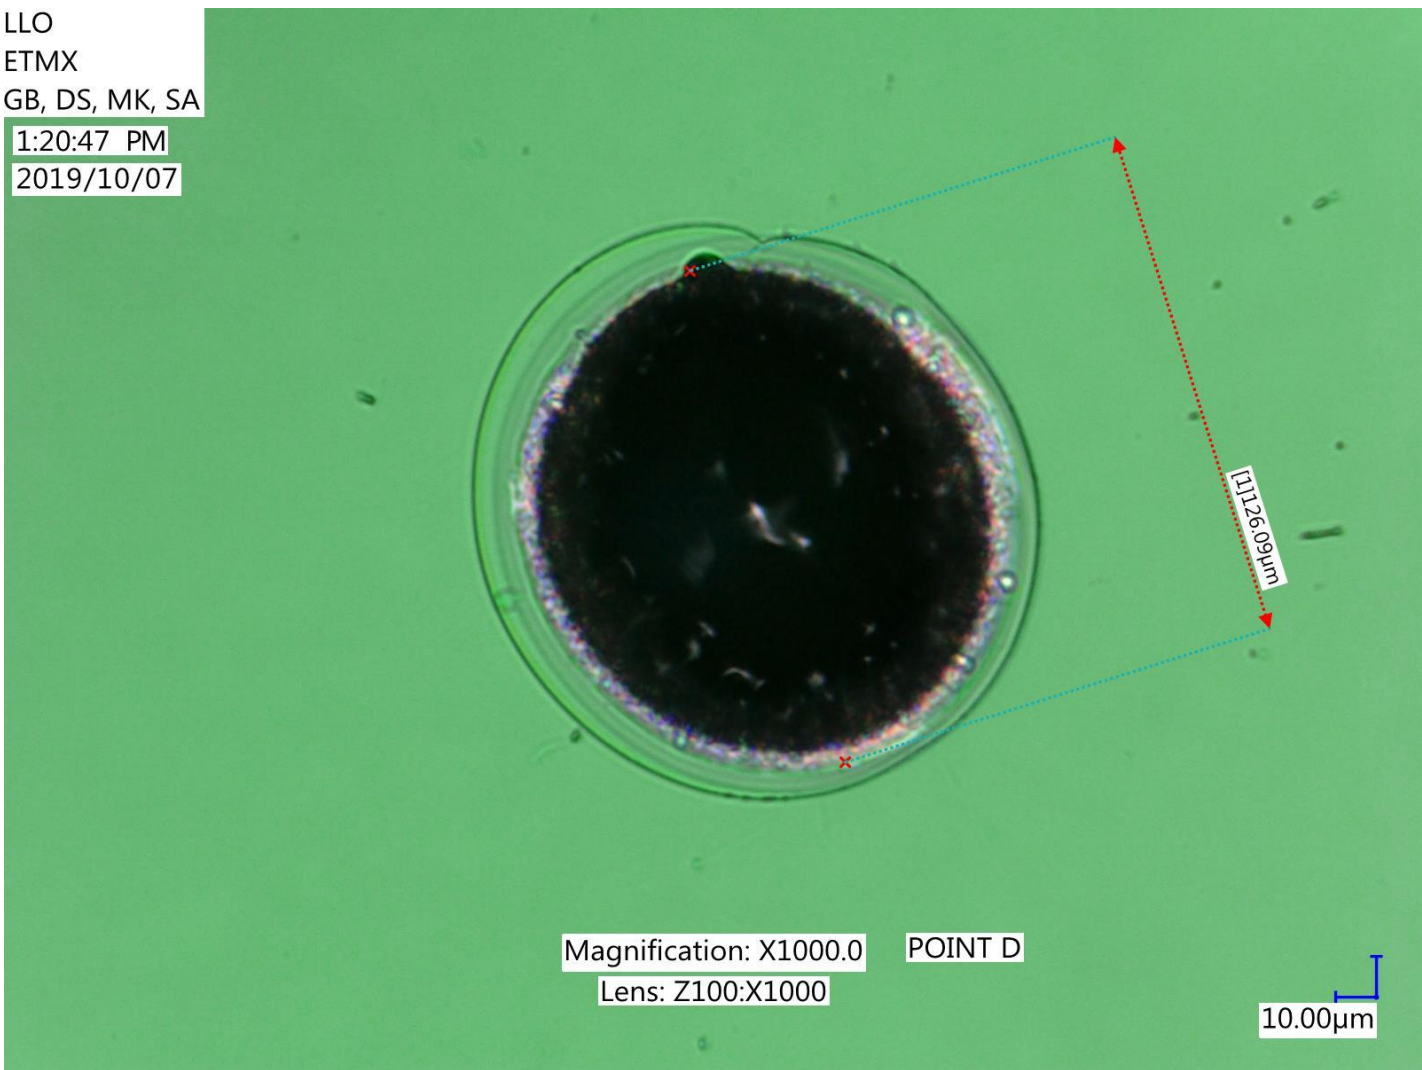
## Point D

Point D is measured at 126  $\mu\text{m}$  and is shown in the file ending ... 212 location (-54, -27) from center

Damaged Absorber

Point absorber appears to have been damaged

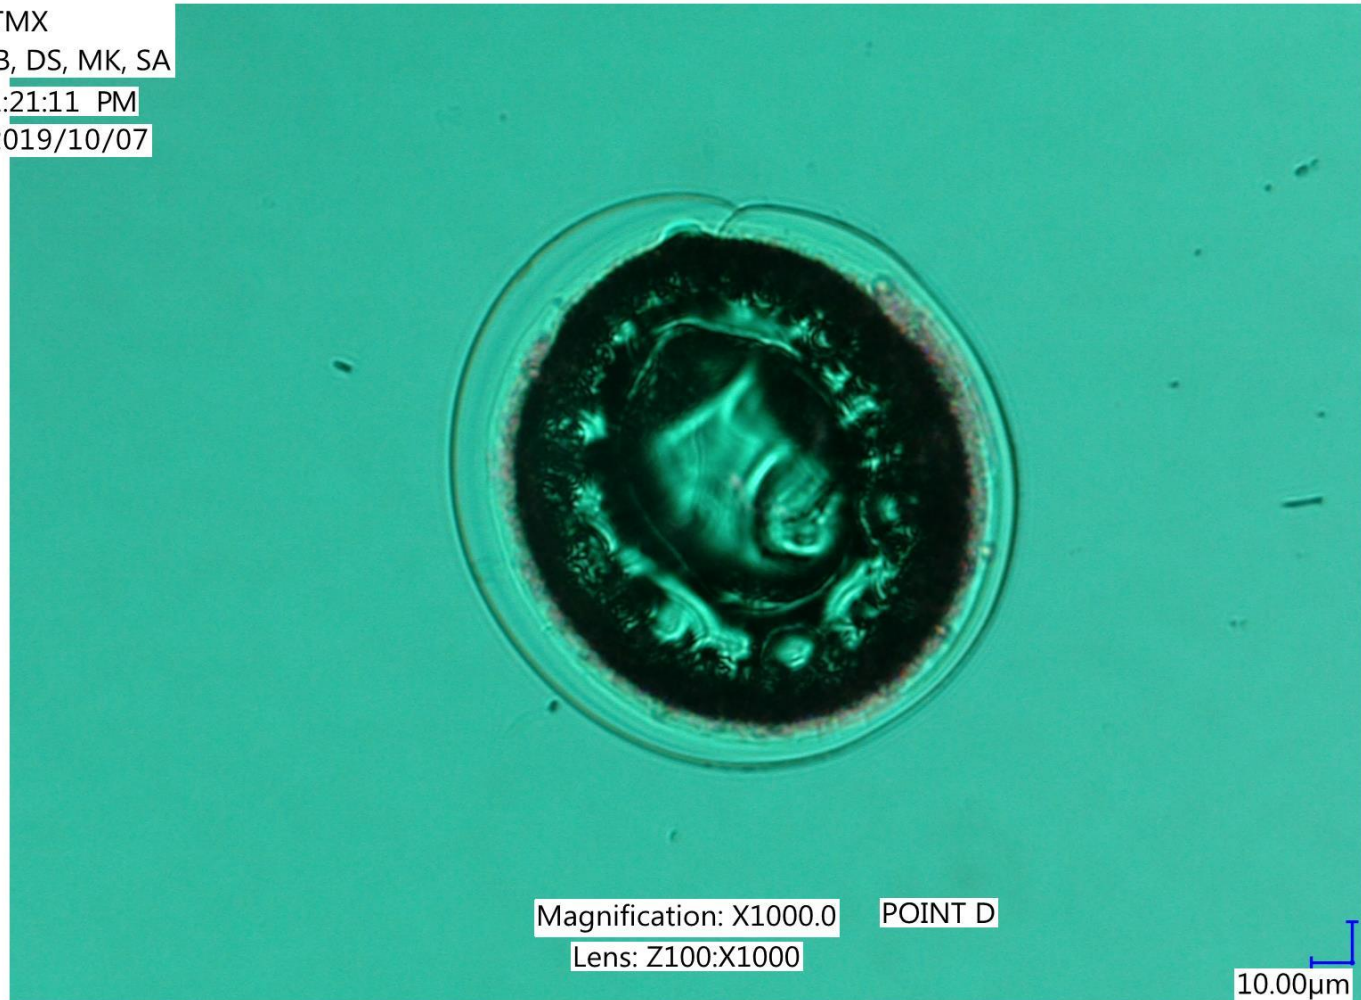
## Point D (green)

All three points transmit green light, implying that the coating is missing in that location.

Damaged Absorber

Transmitting illumination  
from green flashlight in  
this image

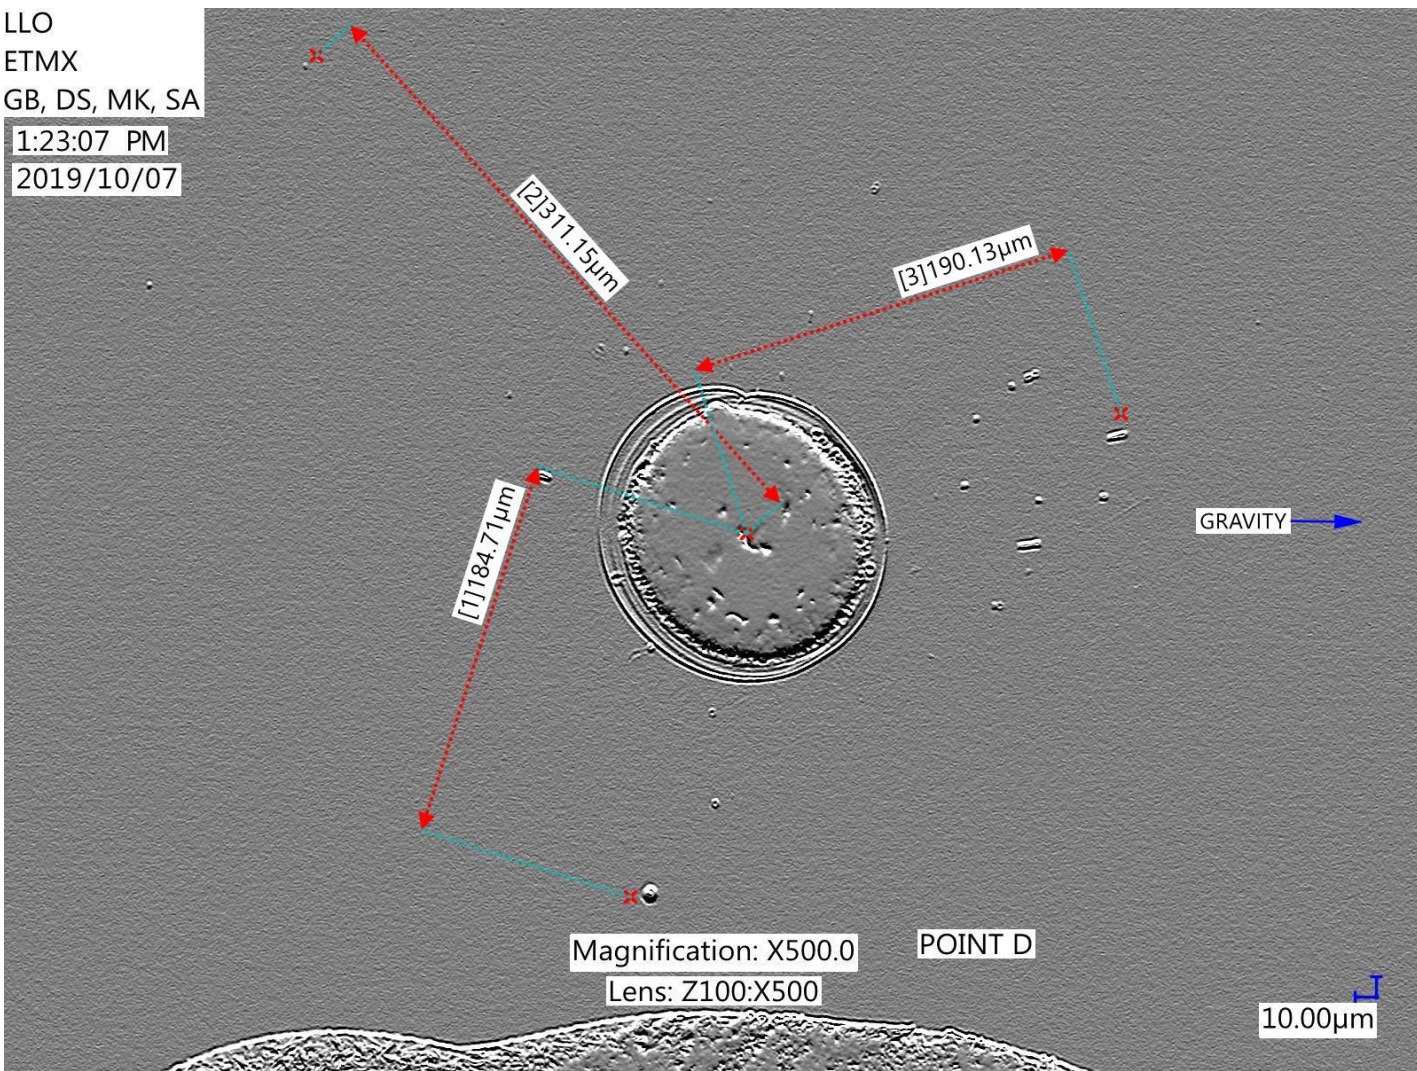
## Point D

Damaged Absorber

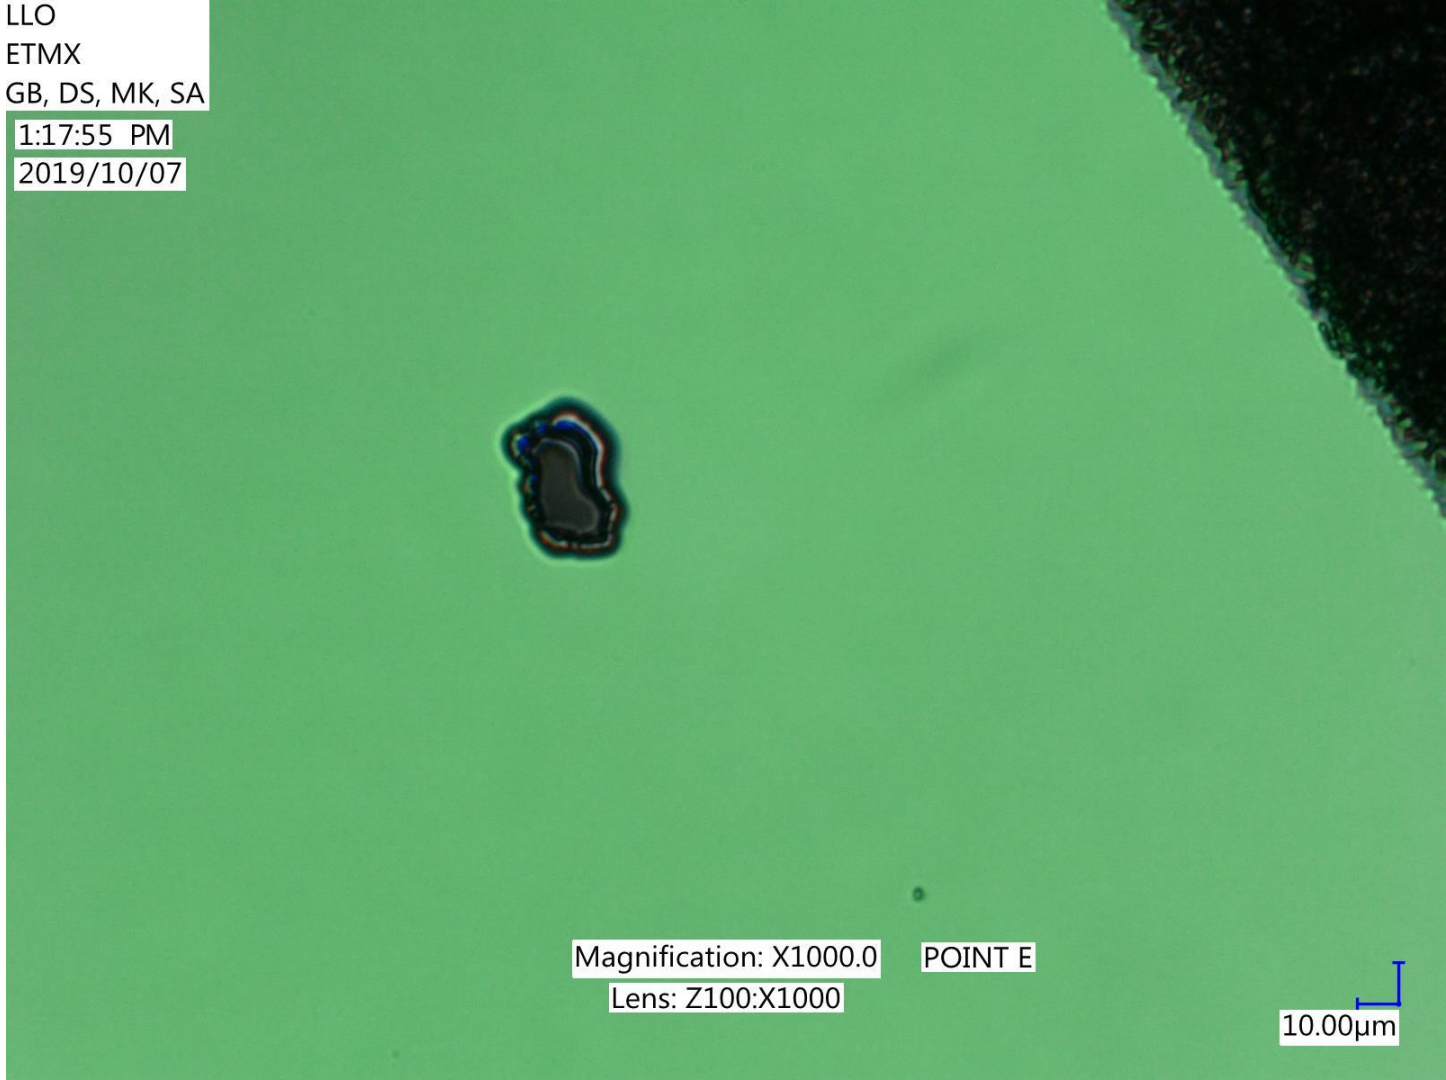
# Point E

Coating Void

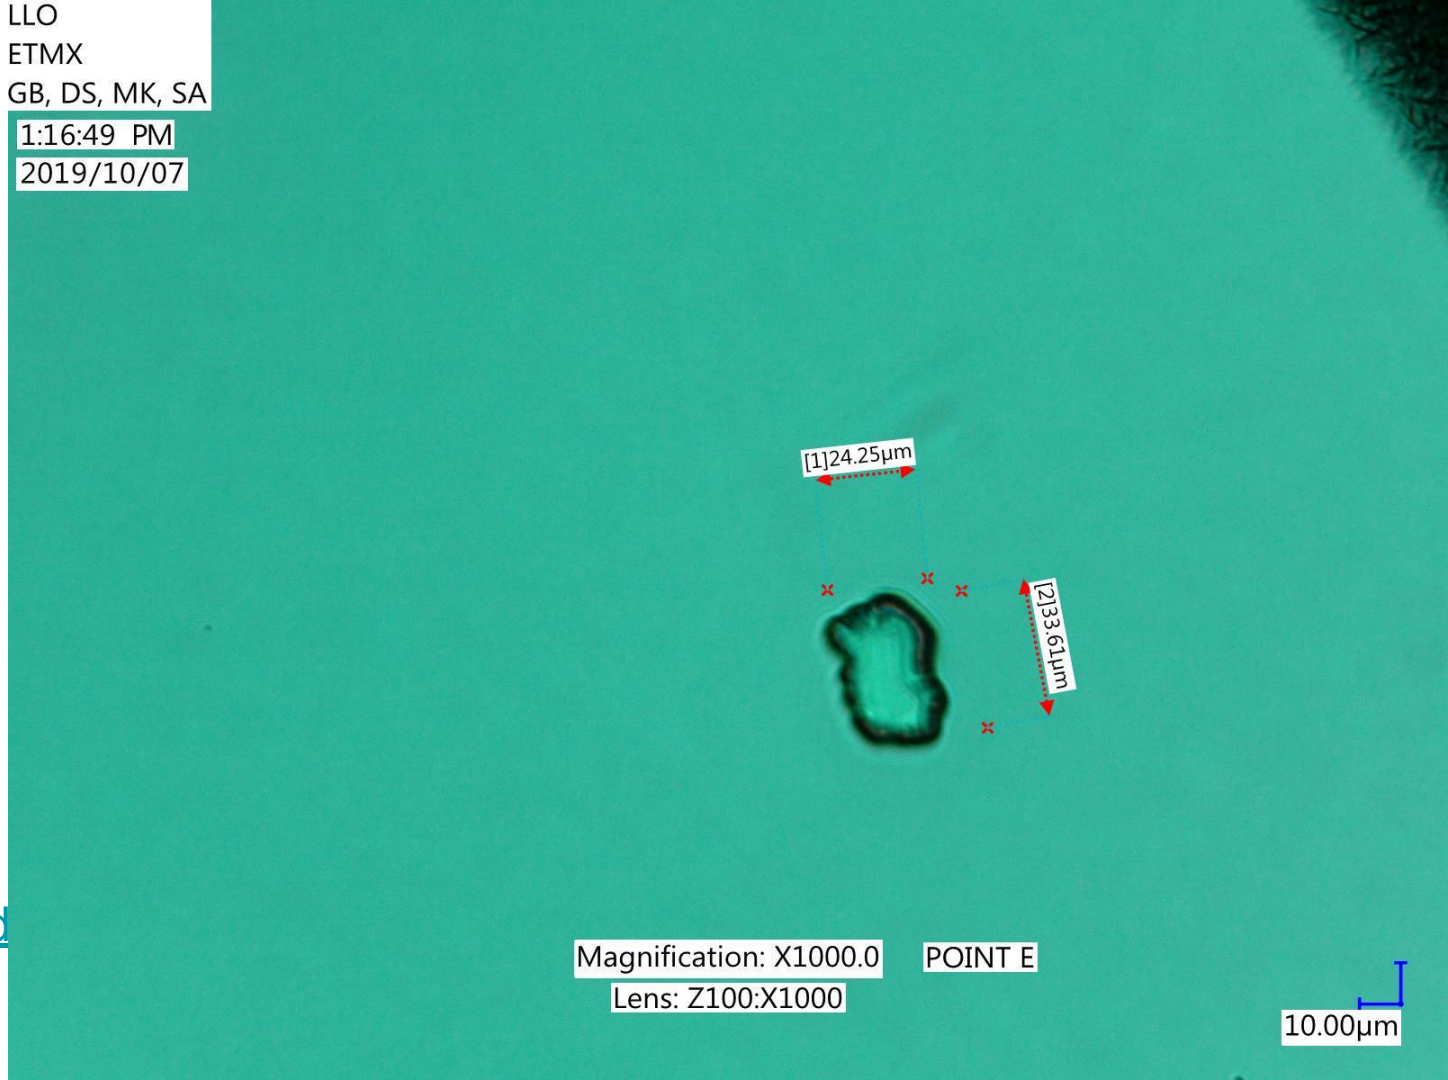
## Point E (green)

Coating Void

Transmitting illumination from green flashlight in this image

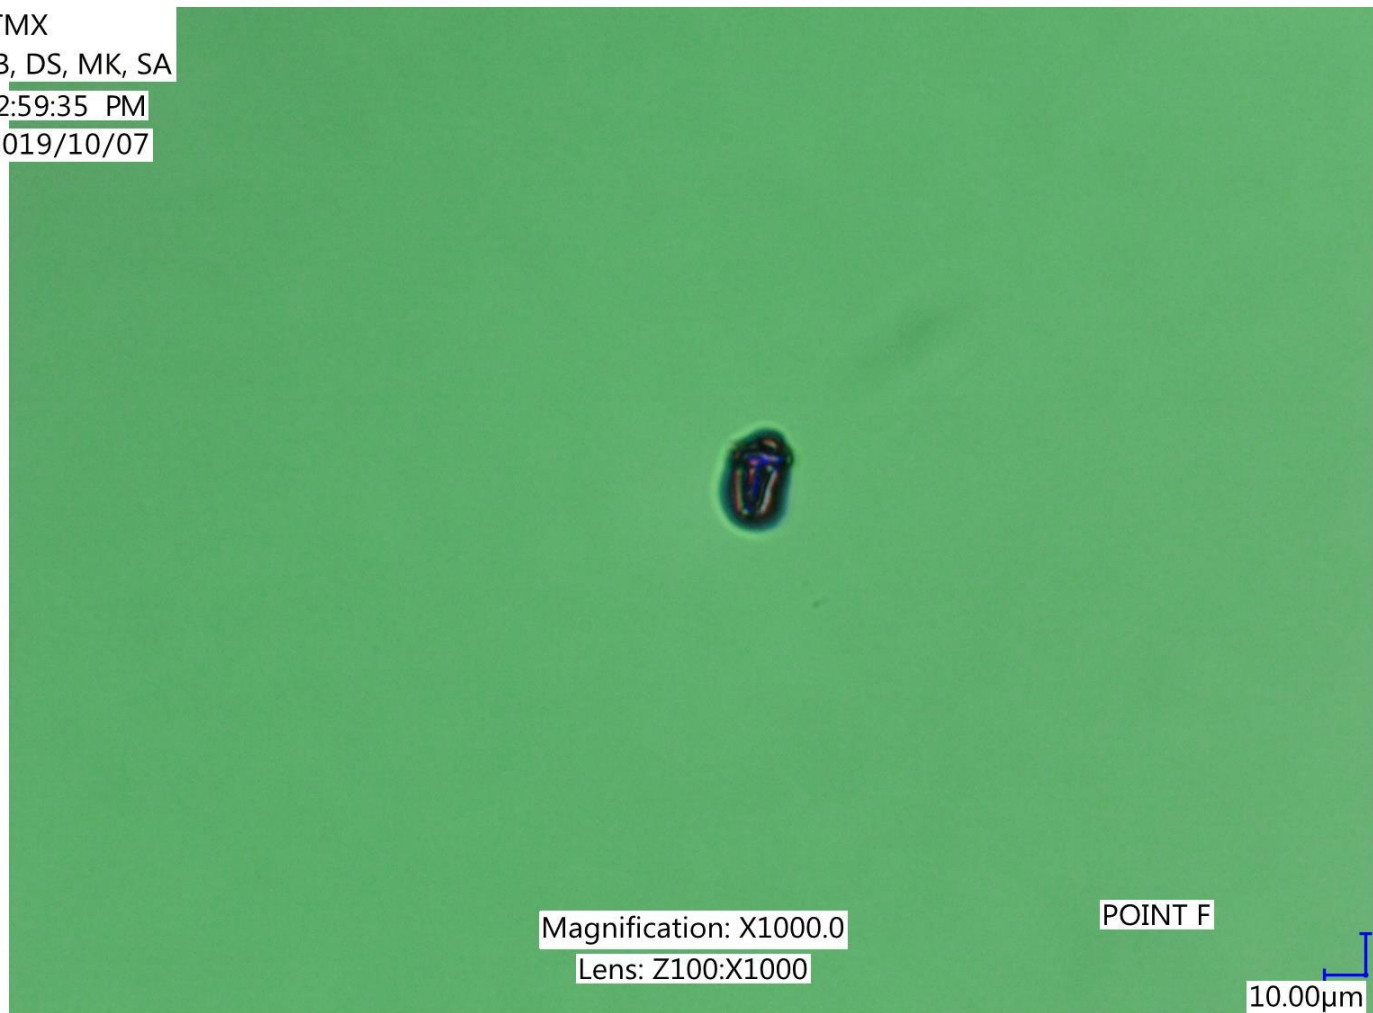
# Point F

Unknown

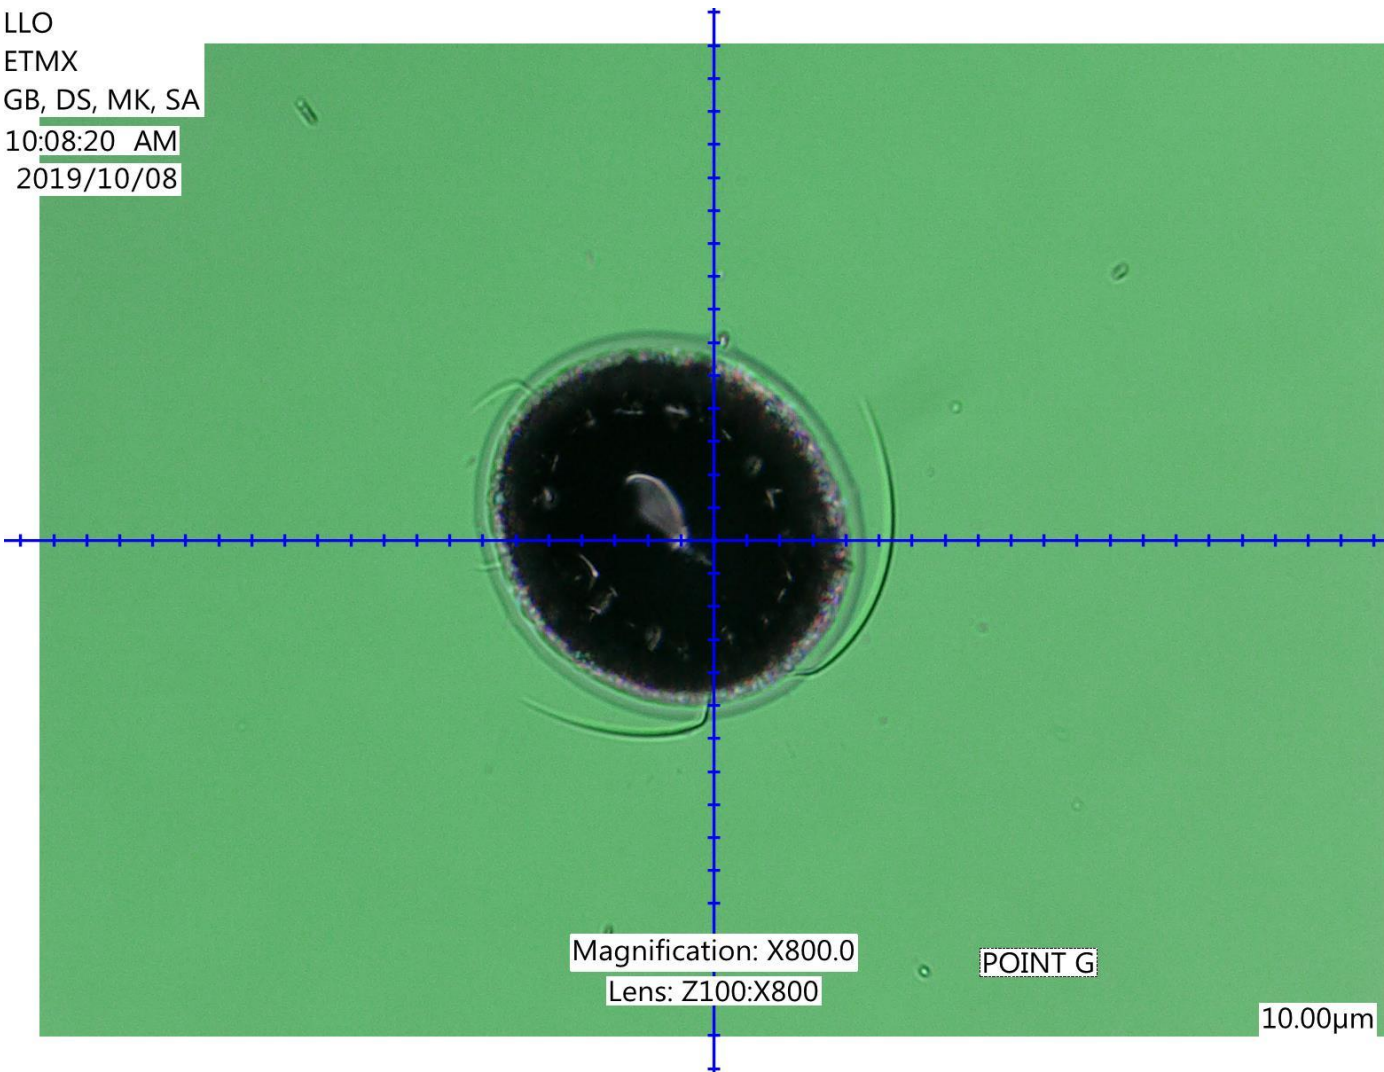
## Point G

Point G is not yet measured, though similar to D, and is shown in the file ending ... 201 location (11, 12) from center

Damaged Absorber

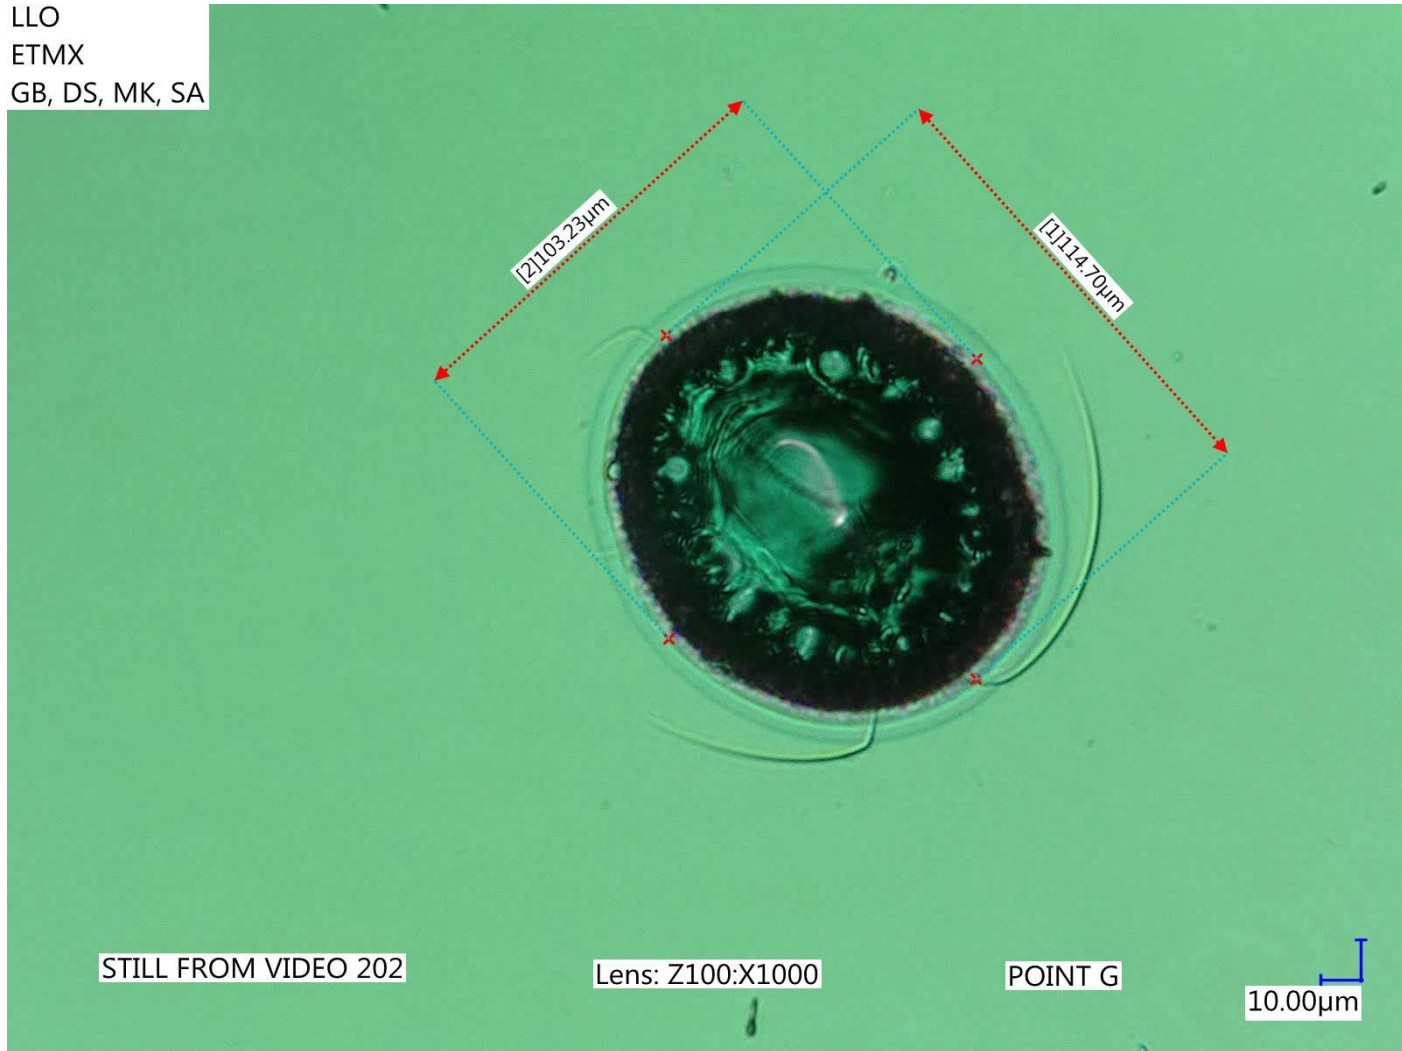
## Point G (green)

Damaged Absorber

Transmitting illumination  
from green flashlight in  
this image

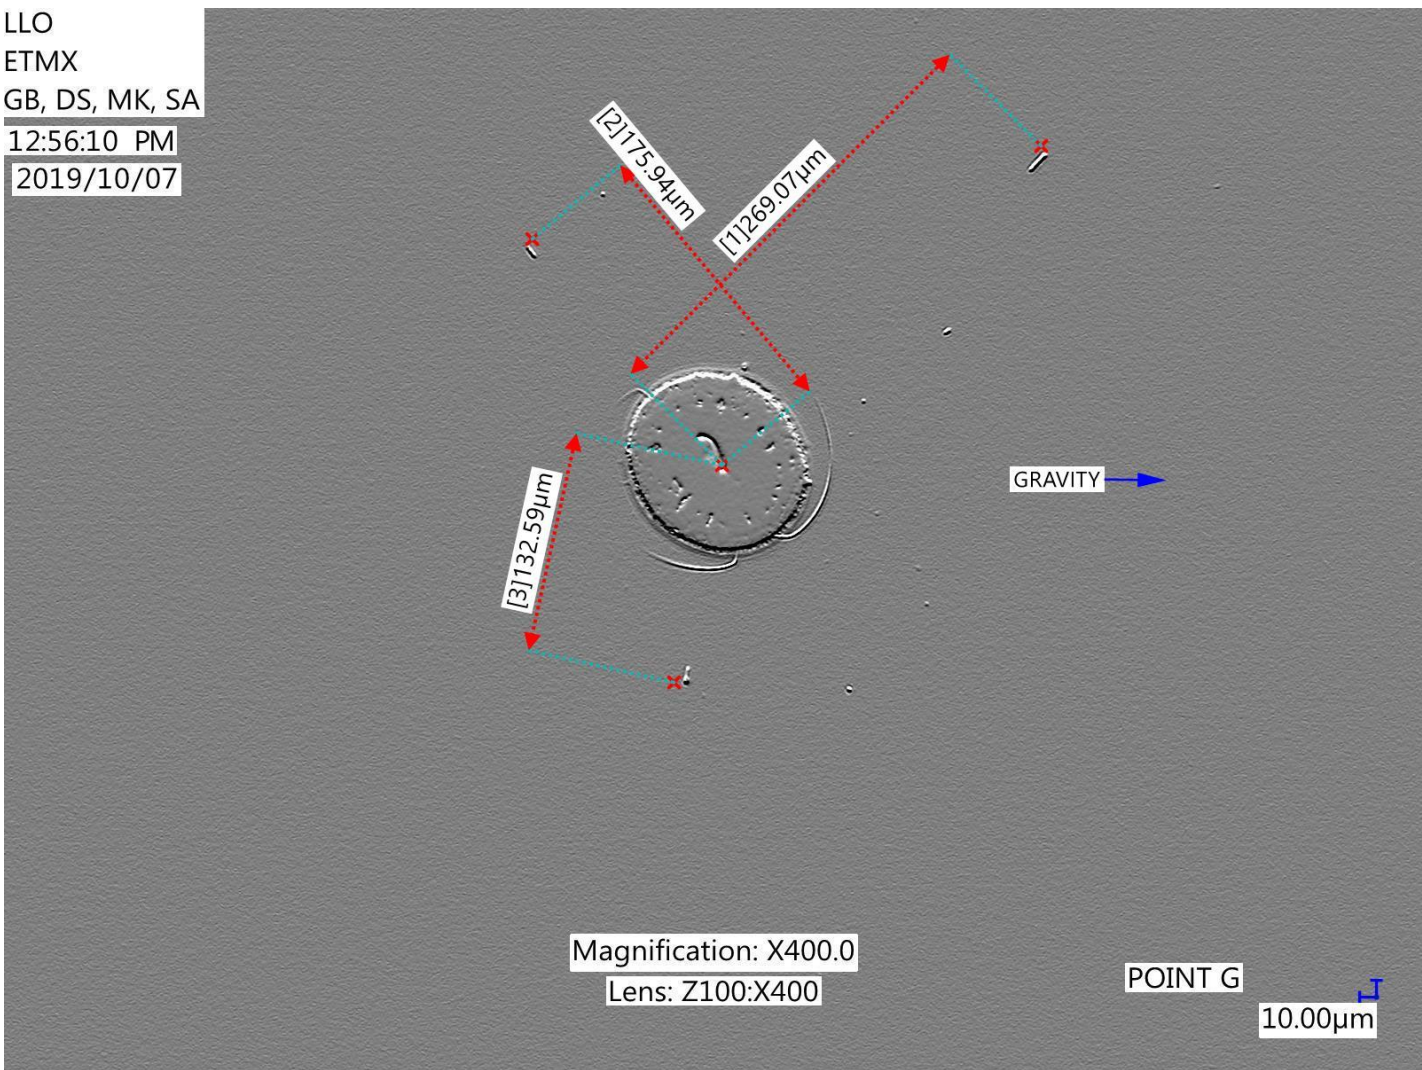
# Point G

Damaged Absorber

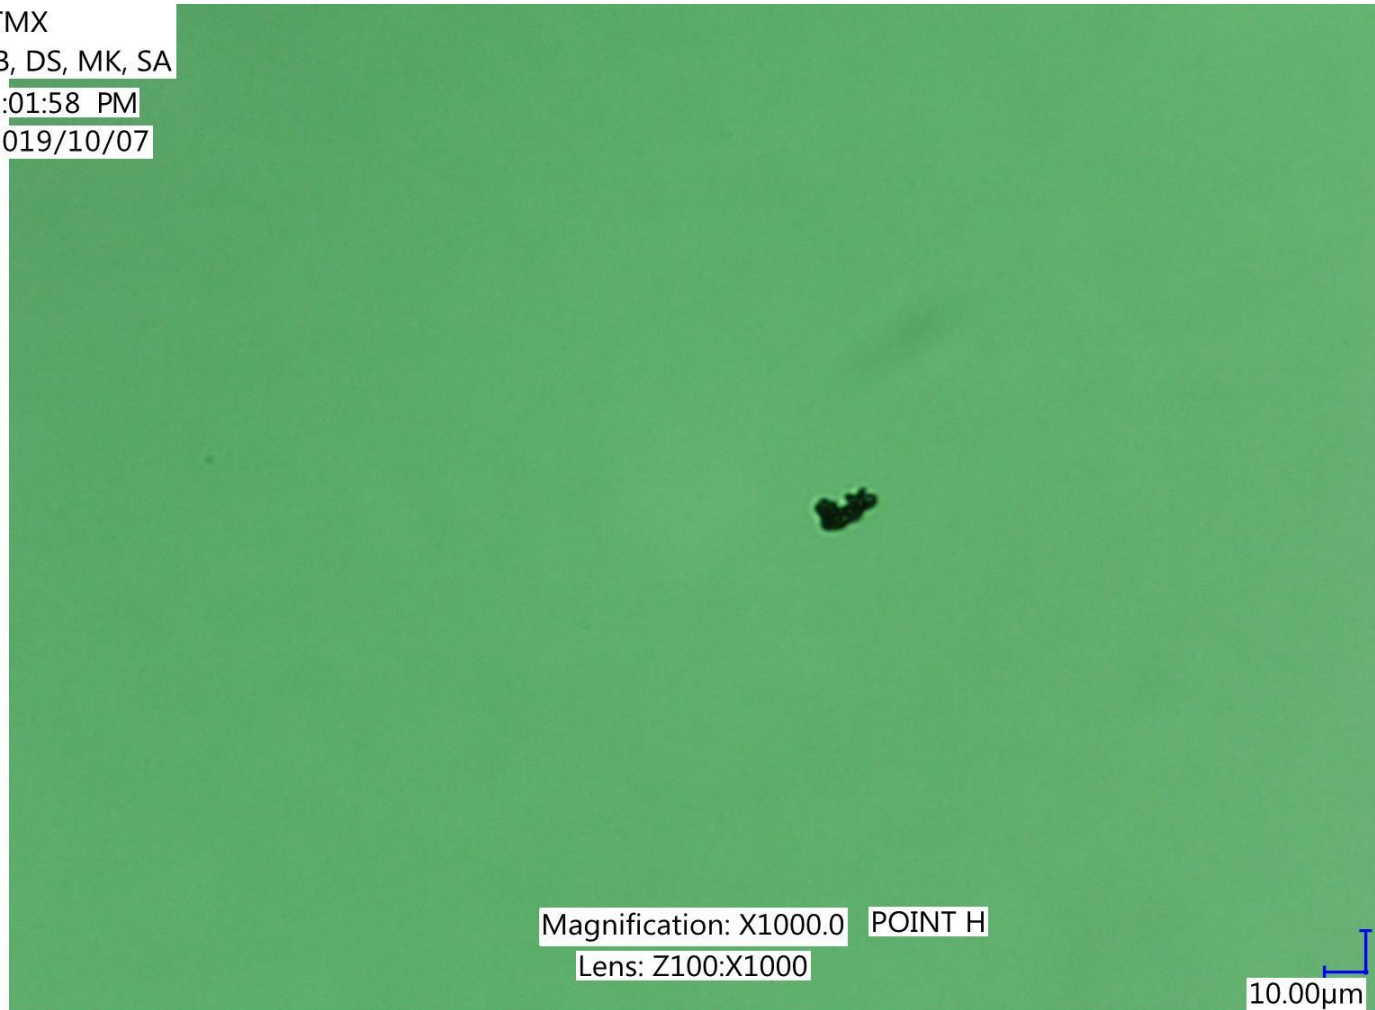
# Point H

Debris

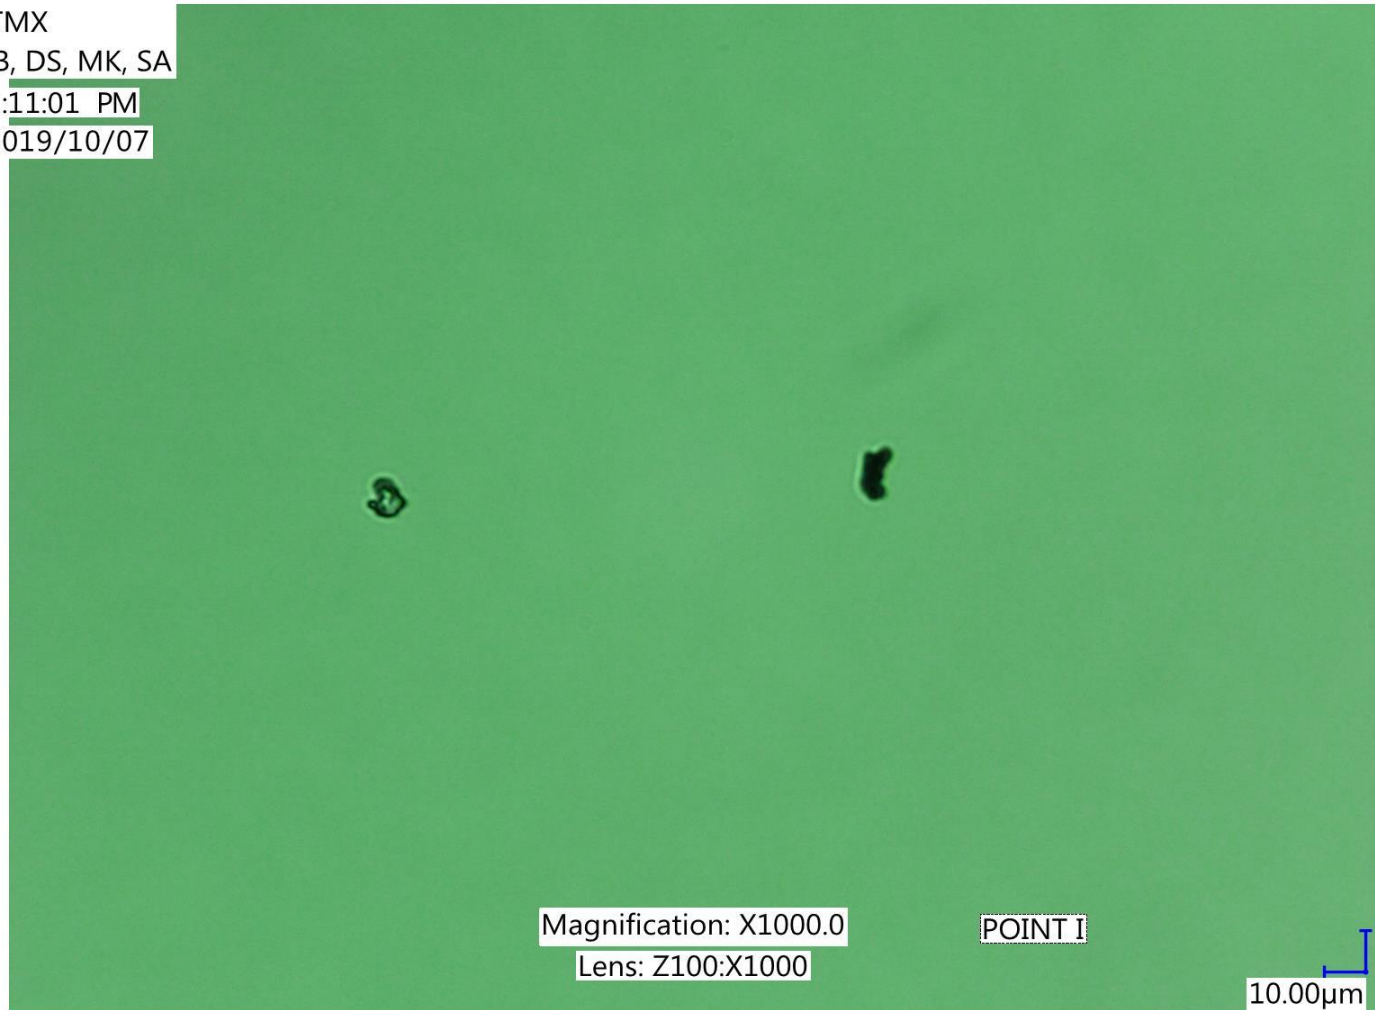
# Point I

Debris
