# Visual Catalog of LLO ETM Inspection Images from Mid-O3 Vent

GariLynn Billingsley, Danny Sellers, Marie Kasprzack, Stephen Appert  
ETMX Inspection 3-4 October 2019  
ETMY Inspection 7-8 October 2019

T1900696-v1

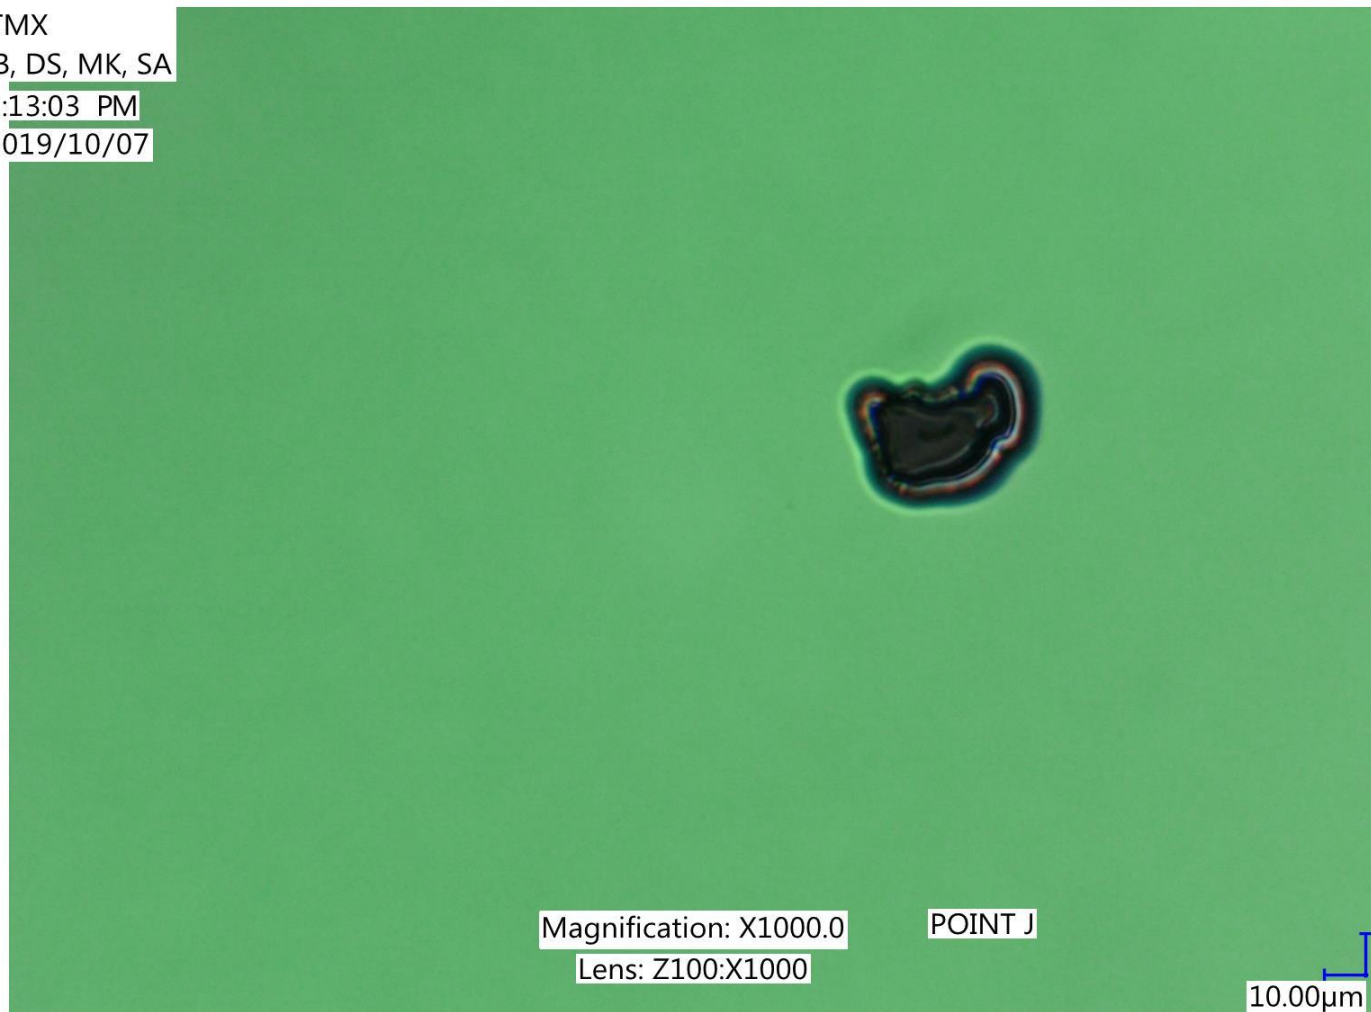
# Point J

Coating Void

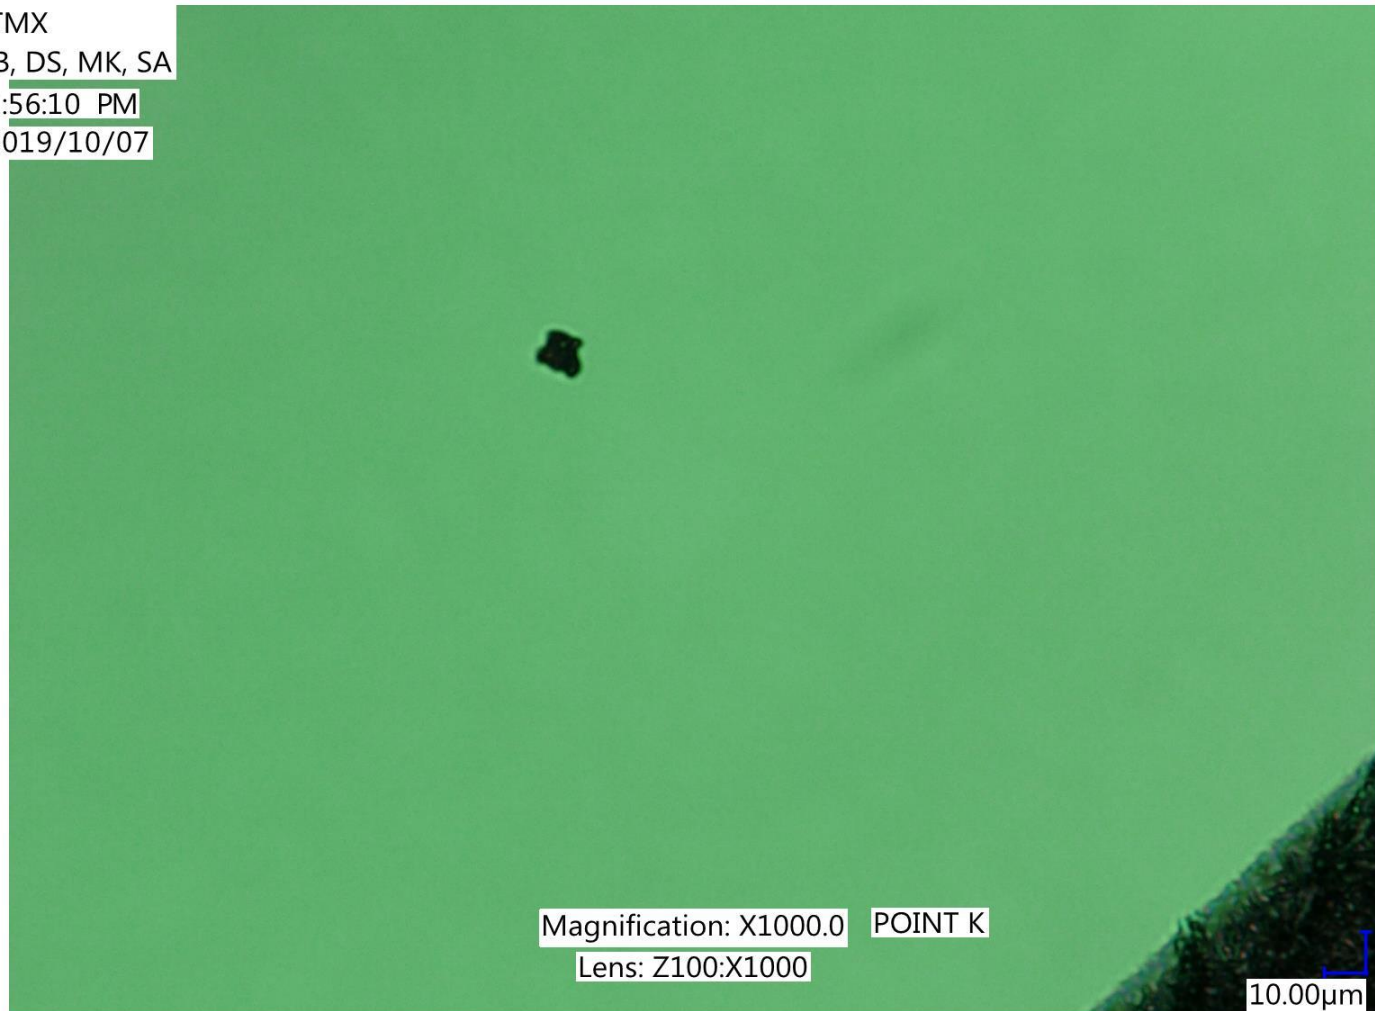
# Point K

Debris

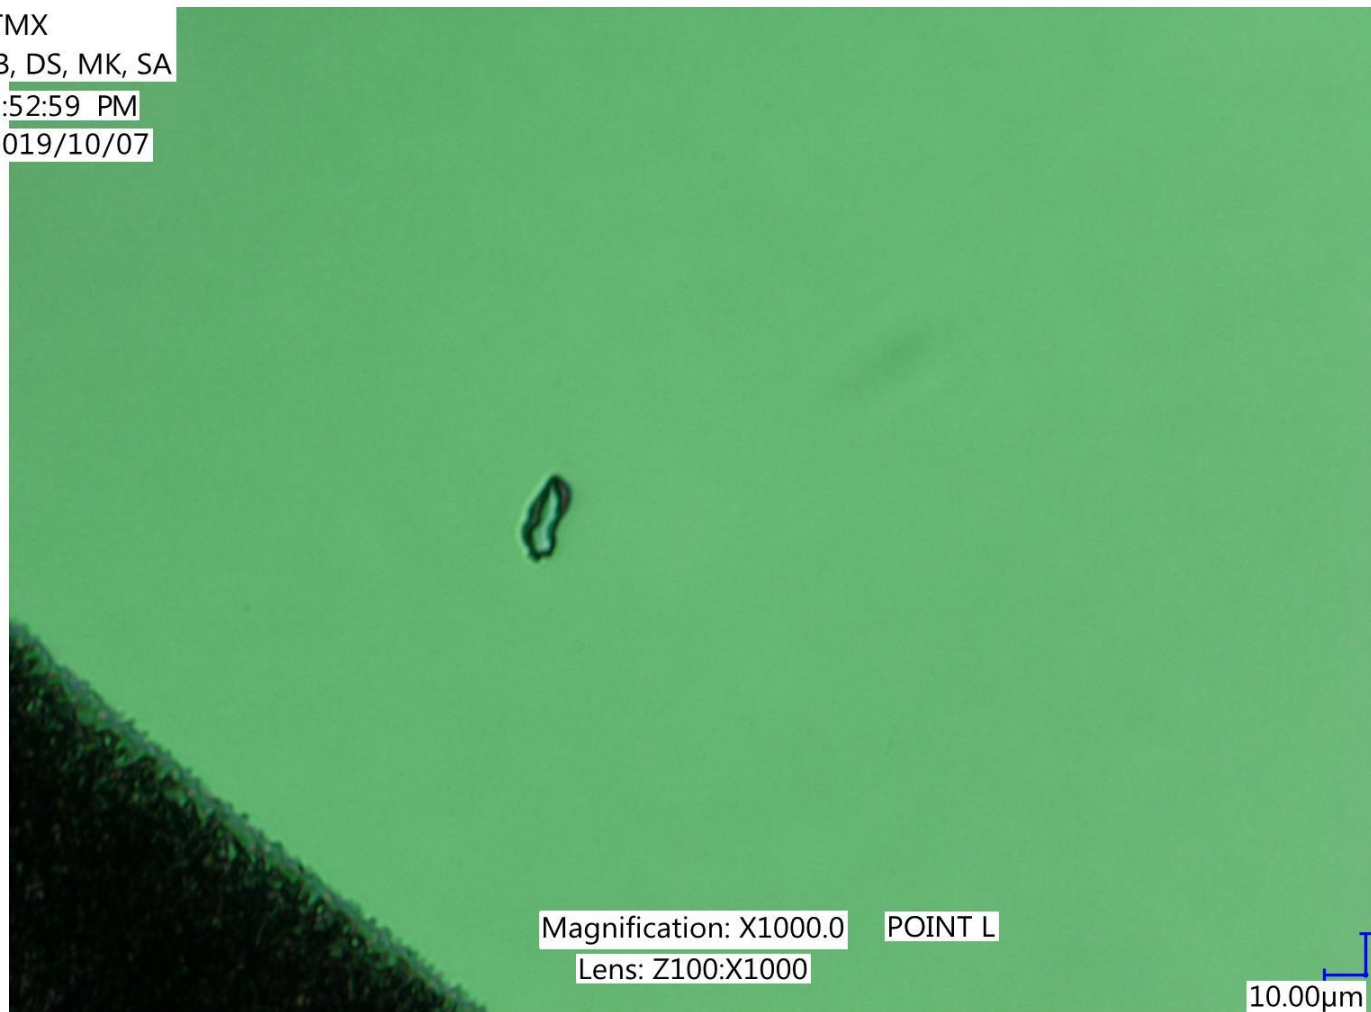
Point L

Coating Void

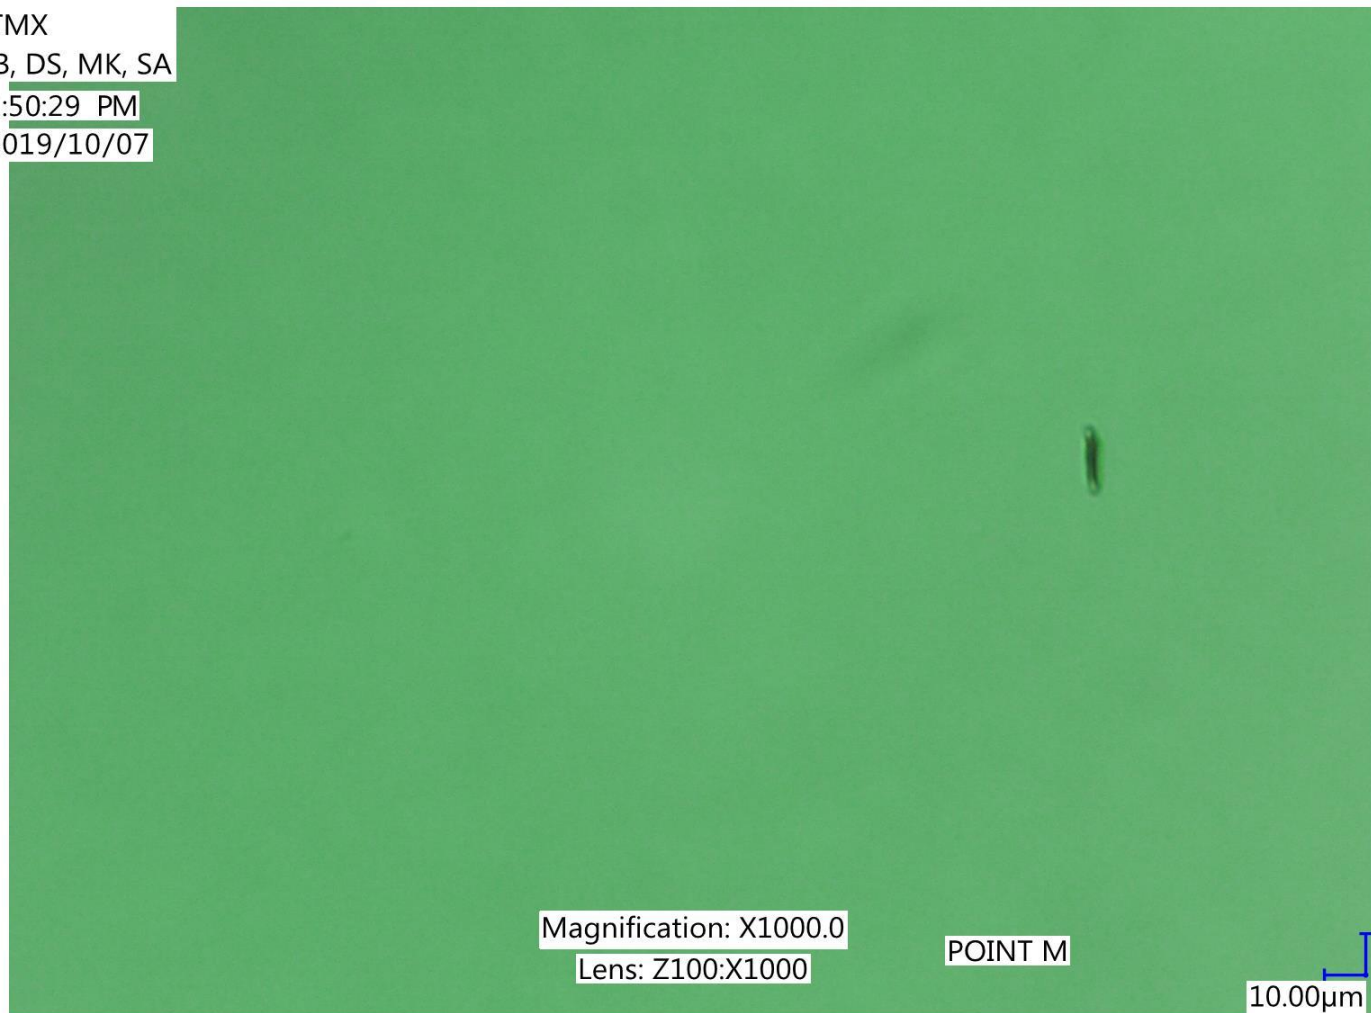
# Point M

Coating Void

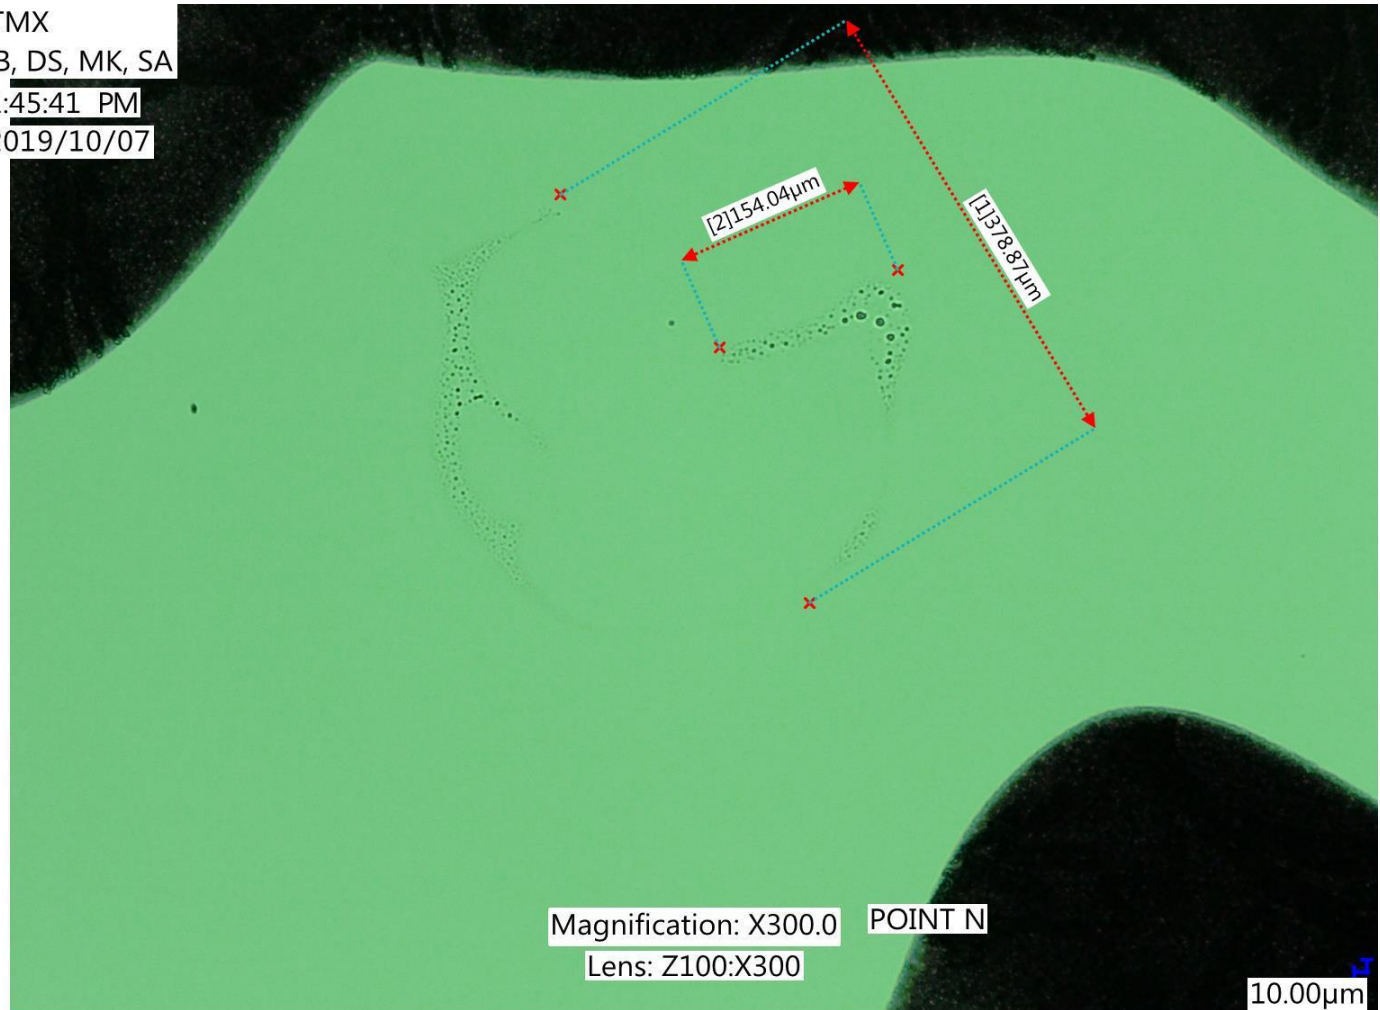
Point N

Halos

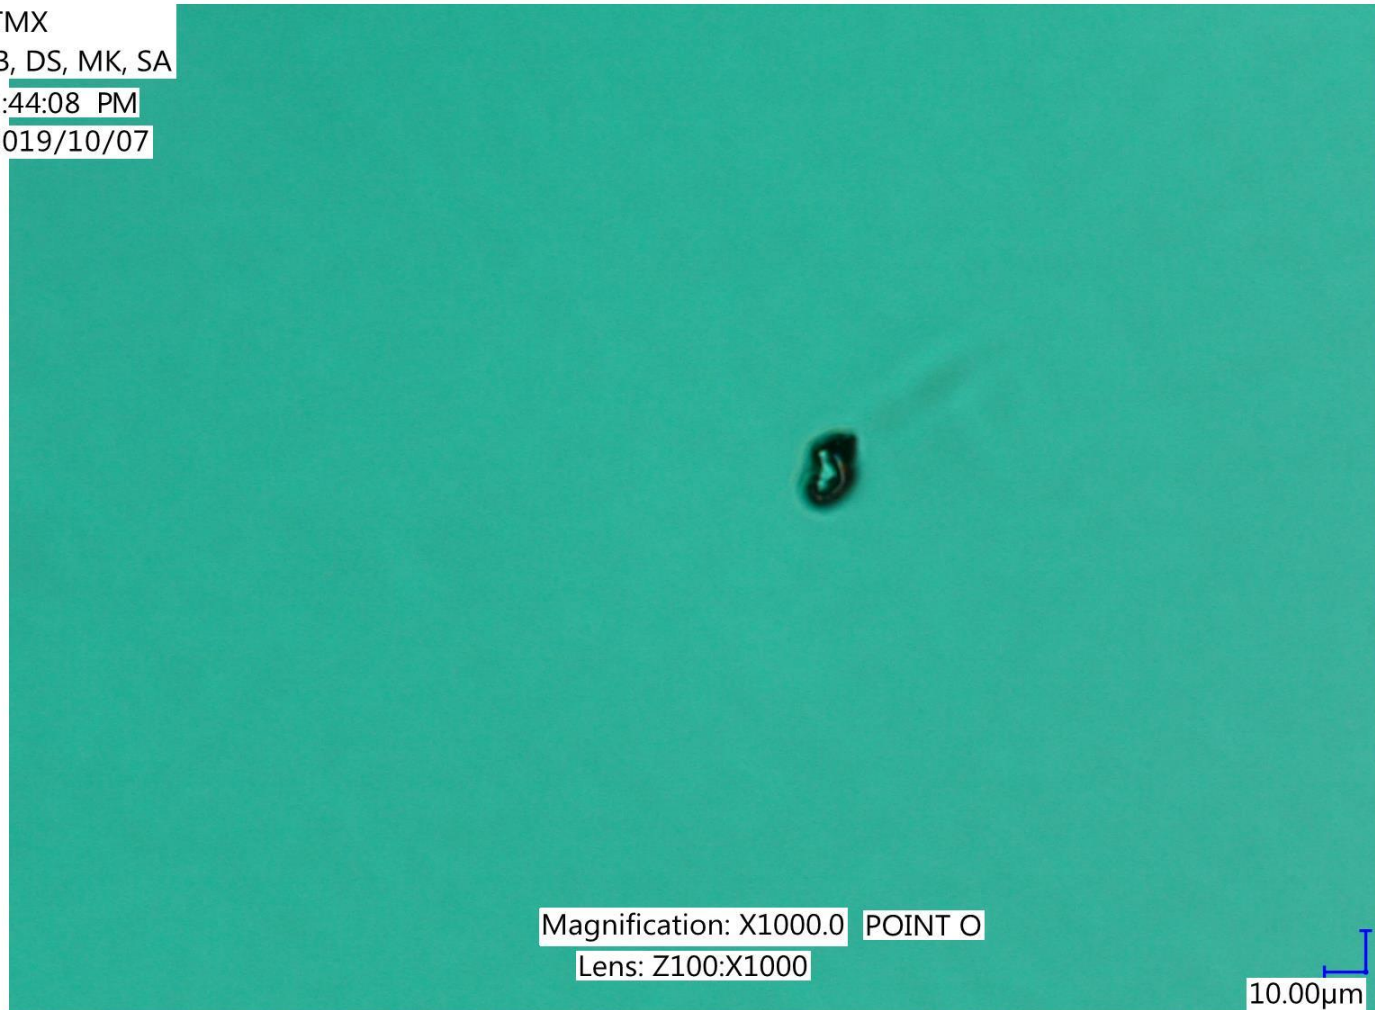
# Point O

Coating Void

Transmitting illumination  
from green flashlight in  
this image

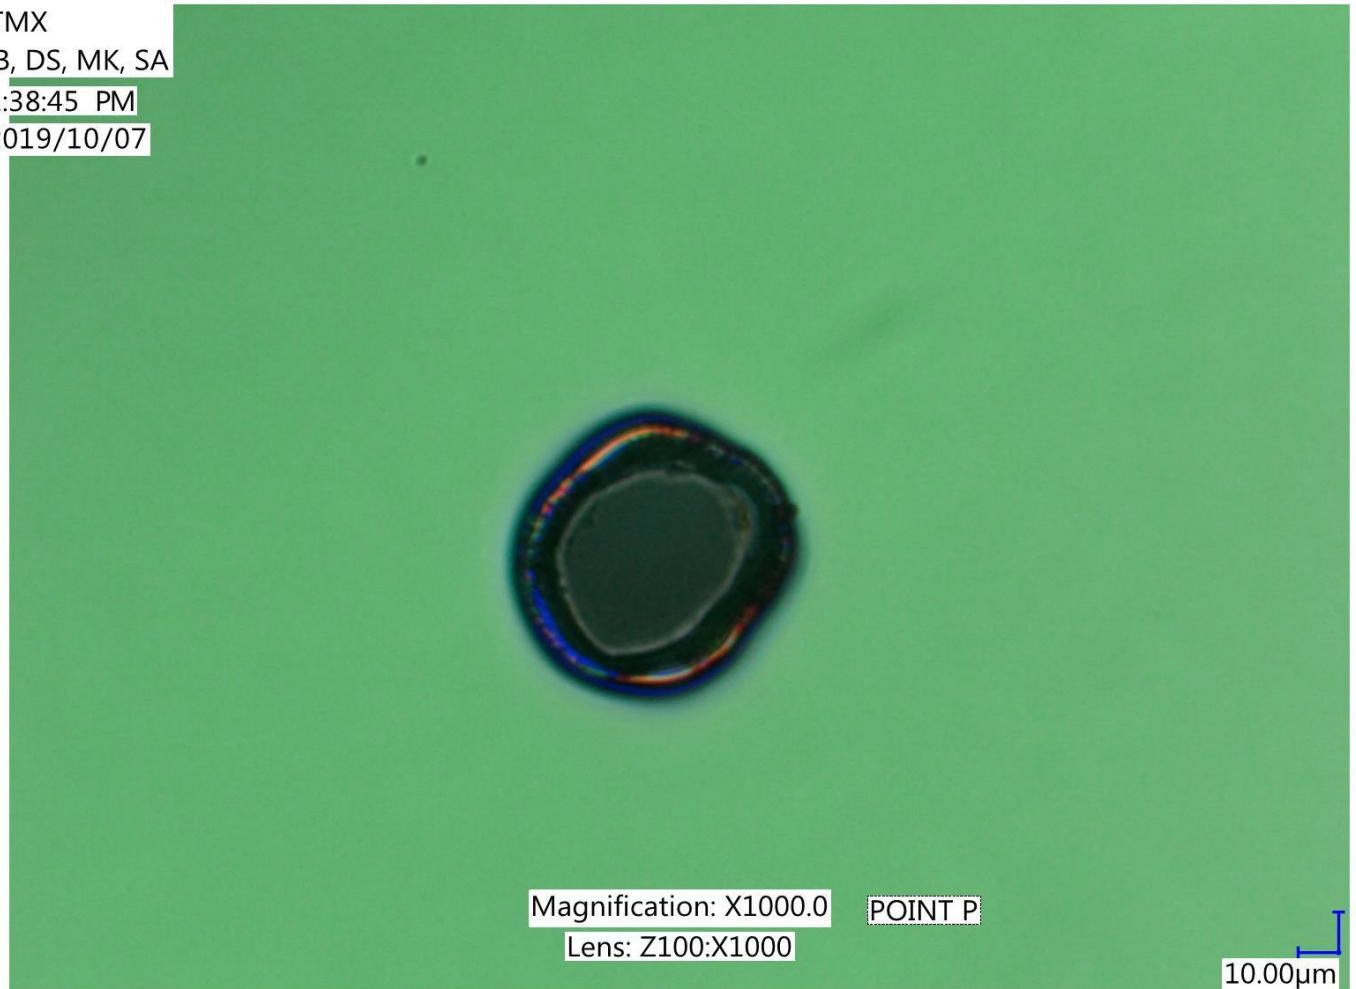
## Point P

Point P is measured at 73  $\mu\text{m}$  and is shown in the file ending ... 221 location (27, 4) from center

Point P is interesting in that there is only one dot that may be a splash, and there are no fractures evident in the coating nearby. This may not be the same type of feature as D&G.

Damaged Absorber

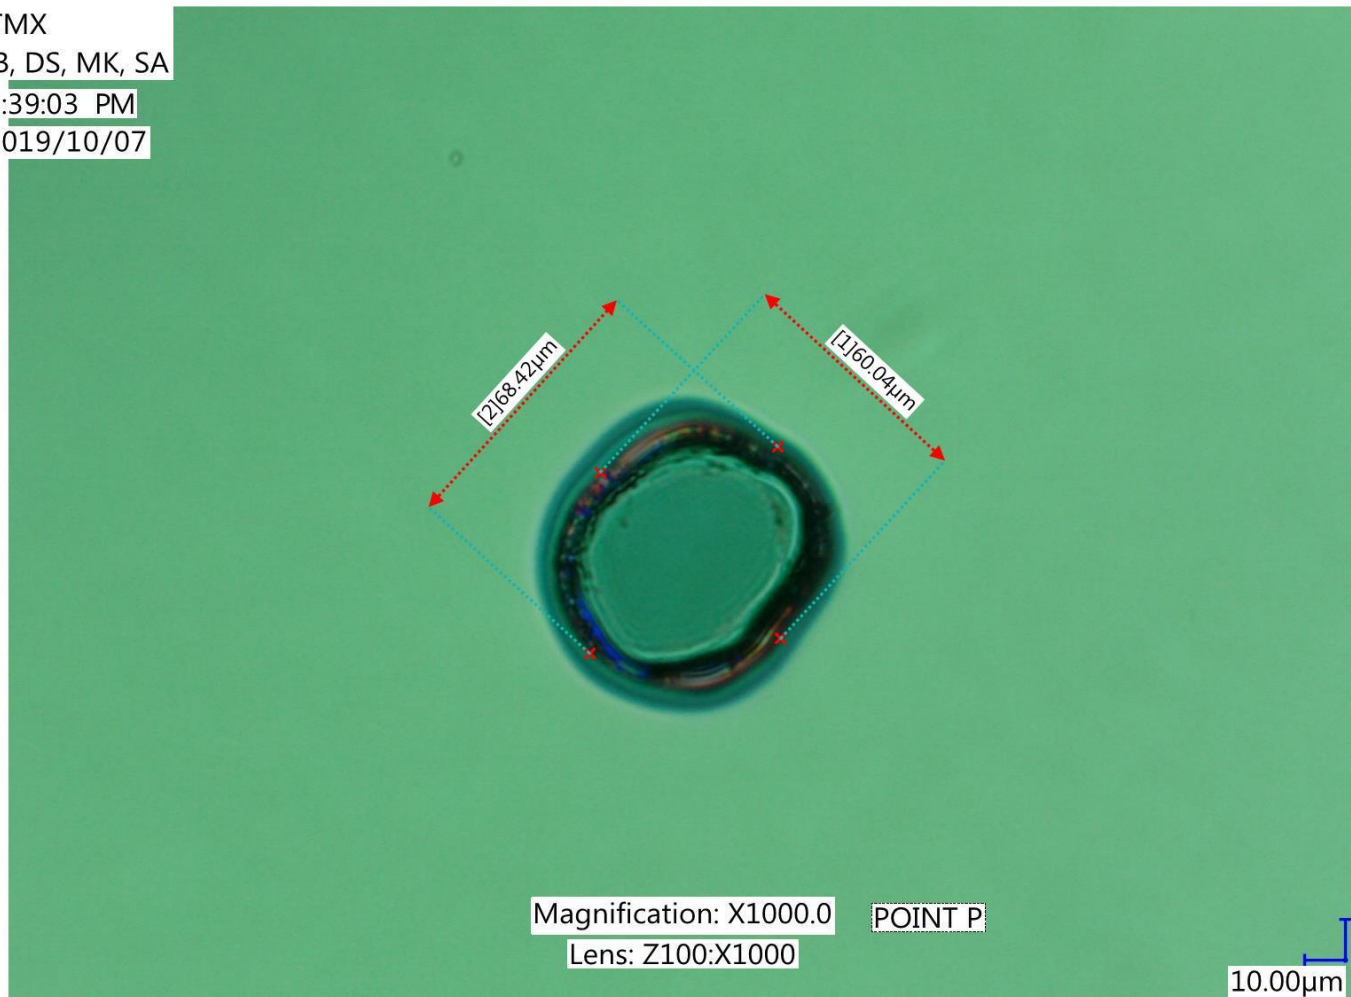
Point P<sub>(green)</sub>

Damaged Absorber

Transmitting illumination  
from green flashlight in  
this image

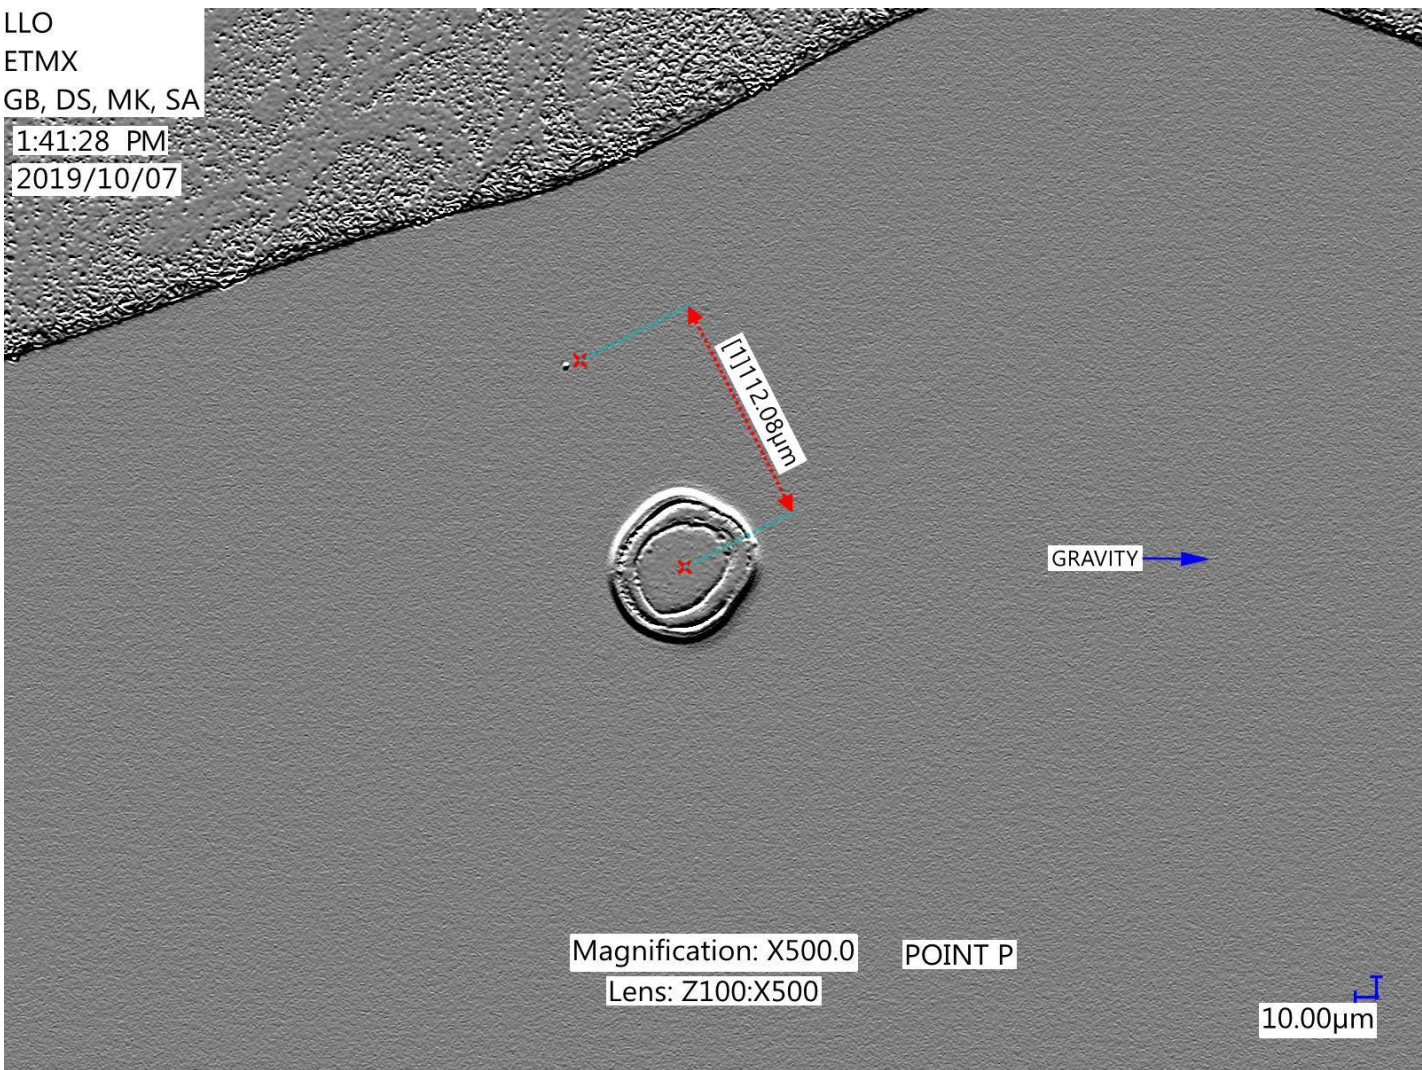
## Point P

Damaged Absorber

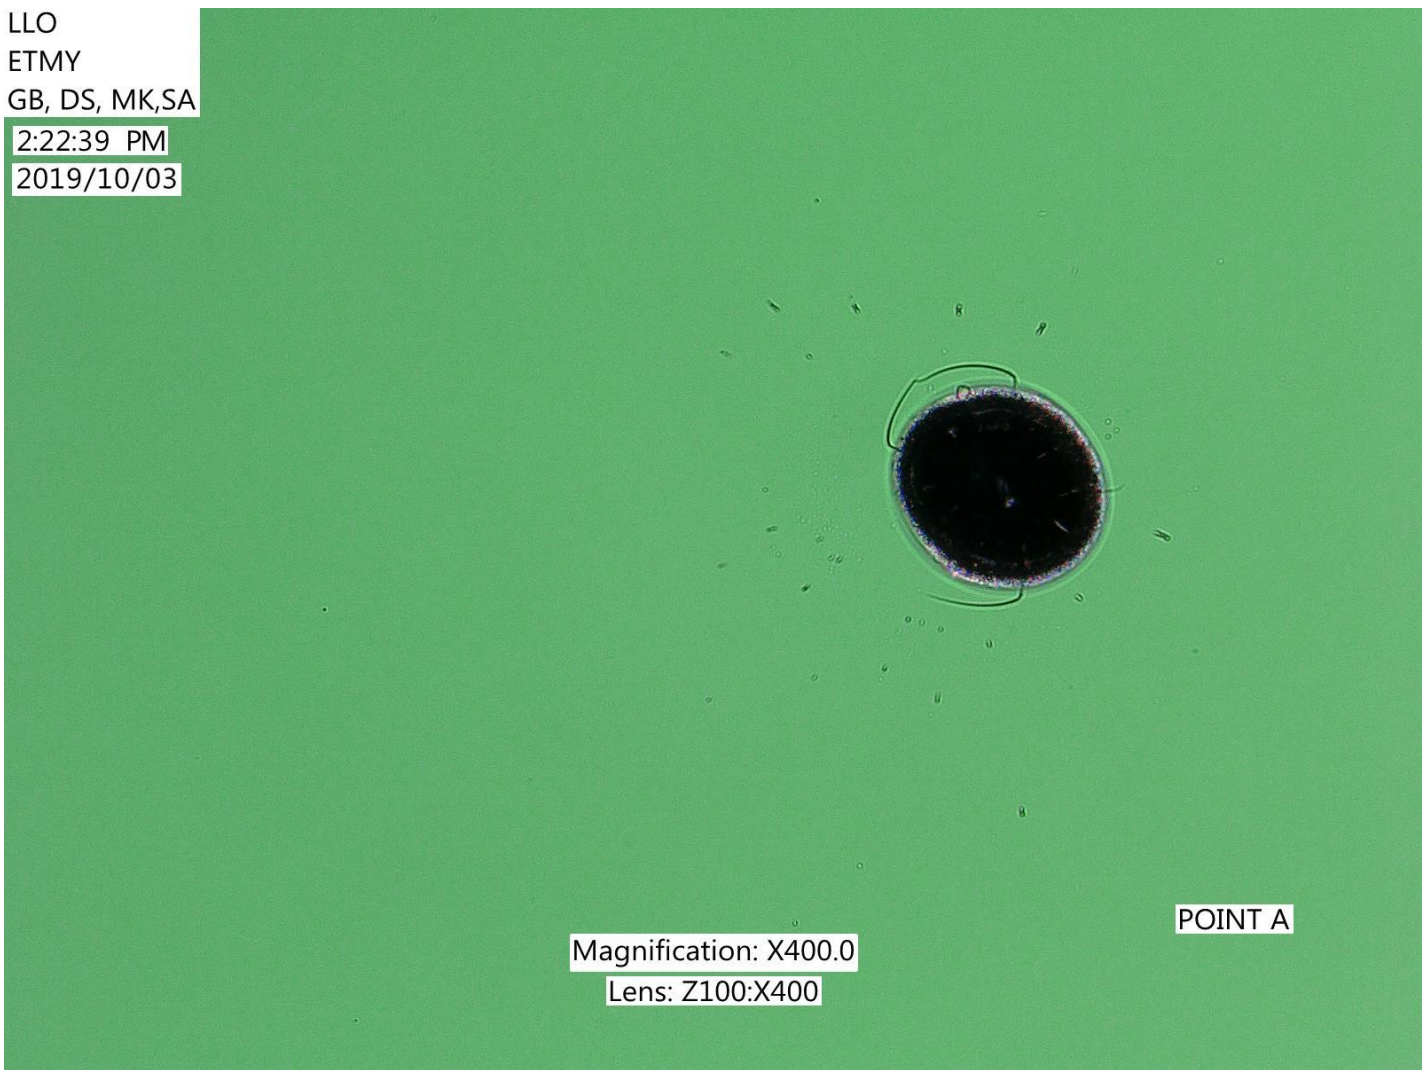
# Point A

It appears that we had an absorbing particle that exploded in the presence of the beam which has left molten "glass" (or molten coating material) in a circular pattern surrounding a crater. I believe there is no coating remaining in the center of the hole (ETM coatings are 6  $\mu\text{m}$  thick.)

The feature appears as a hole  $\sim 128 \mu\text{m}$  across with a droplet field  $\sim 0.5 \text{ mm}$  at the farthest separation. We shone a green flashlight from the back, which transmitted well, however the coating should not transmit green light. The appearance is a nice clean, round hole with several droplets visible in bright field. Unfortunately, we didn't have a dark field capability with us, so we can't see the extent of any fine spray from the explosion. There were fracture zones evident in the coating immediately surrounding the hole. It is possible that the original point absorber is evident in both the scatter and transmission data from the RTS measurements pre-installation: [E1500335](#) and [E1500301](#). At least the location is coincident.

Damaged Absorber

Before First Contact  
cleaning effort

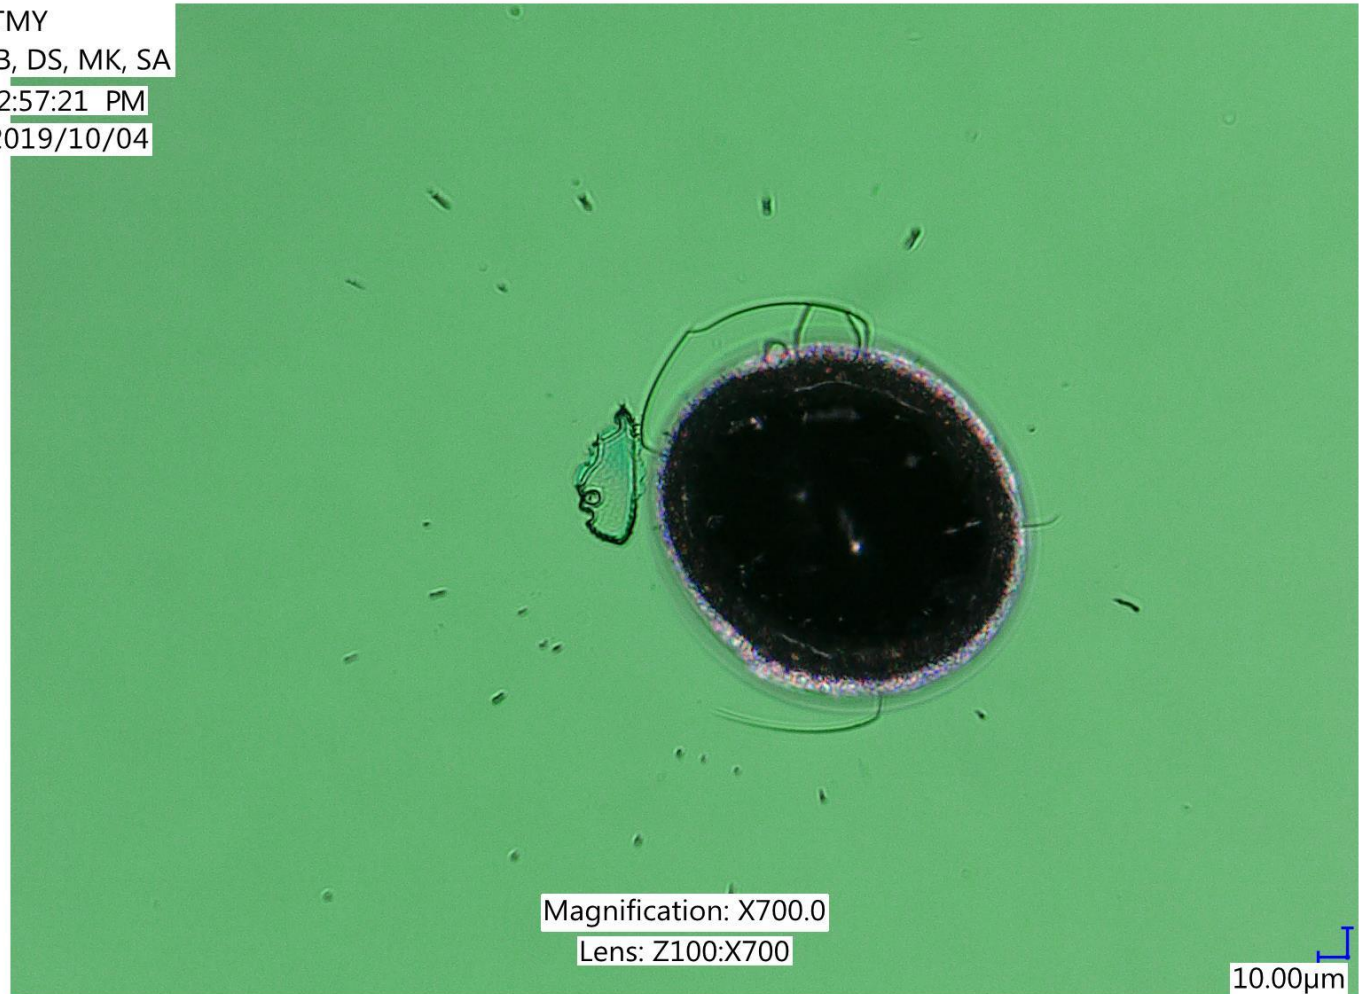
Point A (after FC  
cleaning)

On October 4th the center 75 mm was painted with first contact then examined. A second round of imaging on the point absorber showed some first contact clinging to the edge of the crater. I know of no way to prevent this - it could be treated with an acetone wipe after first contact but there is a risk of increased scatter.

Damaged Absorber

After First Contact  
cleaning effort

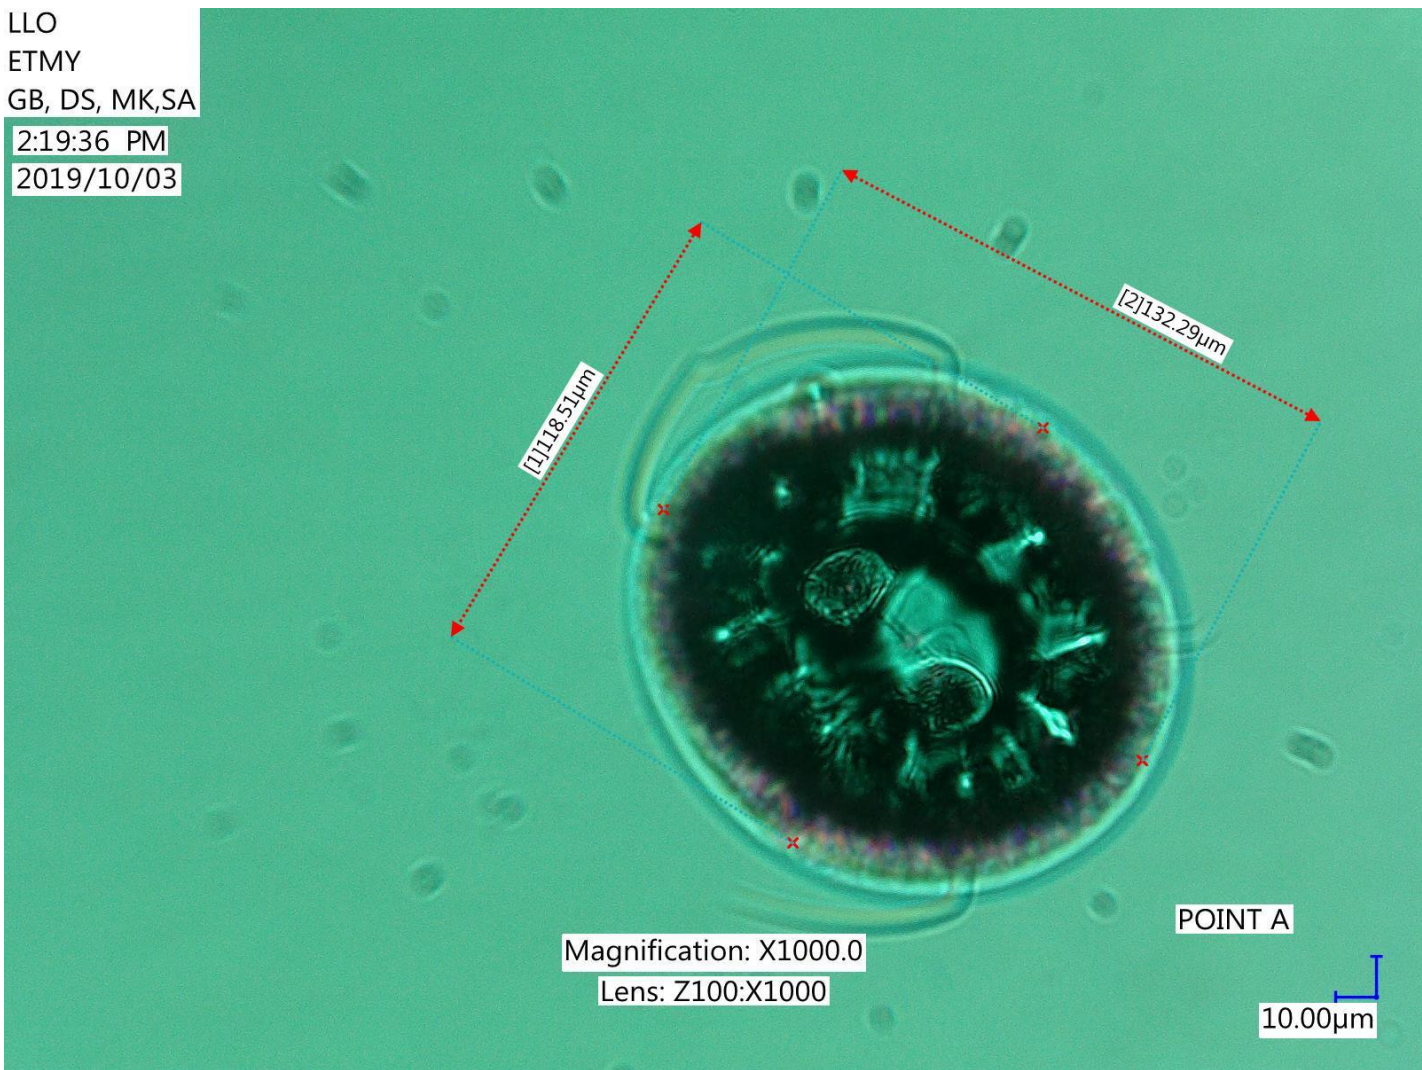
Point A<sub>(green)</sub>

Damaged Absorber

Transmitting illumination  
from green flashlight in  
this image

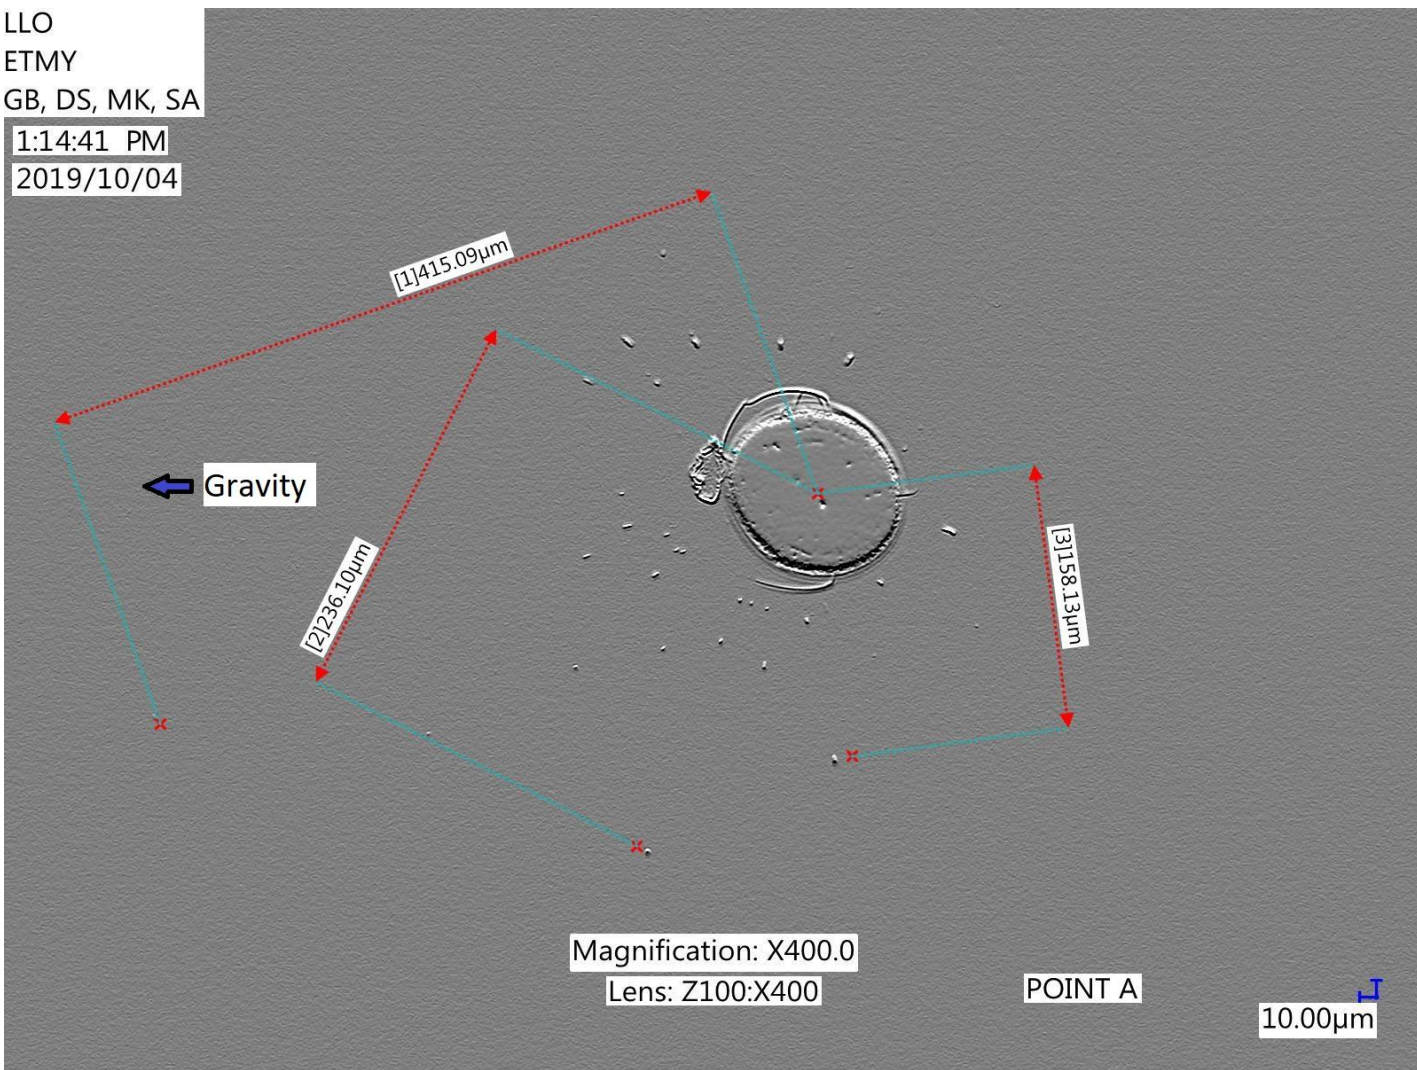
## Point A (overview)

Damaged Absorber

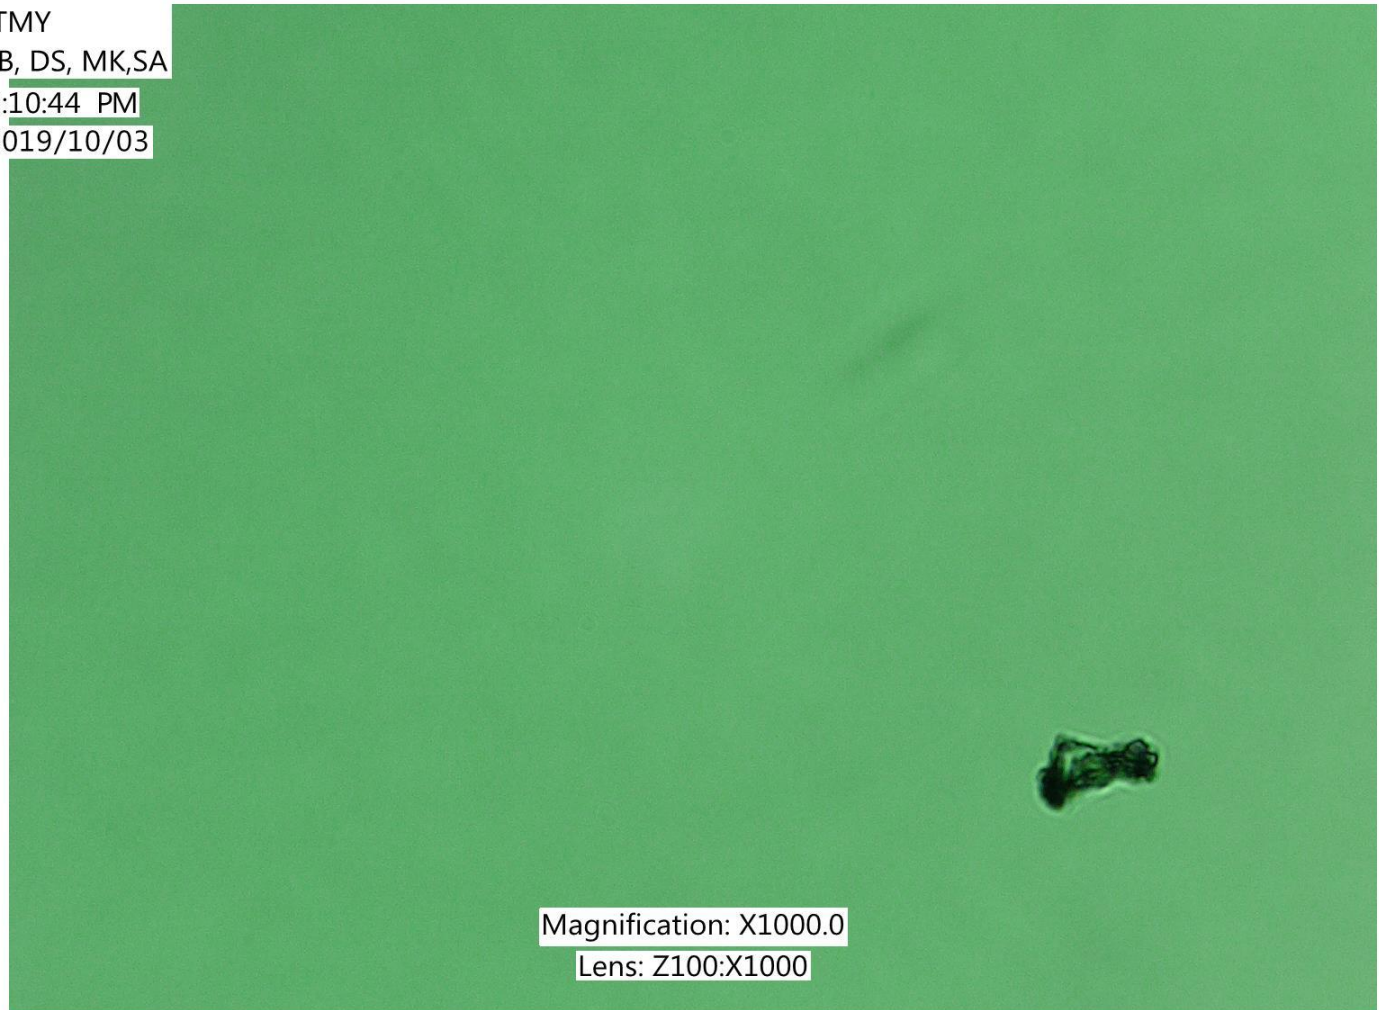
## Point B

Debris

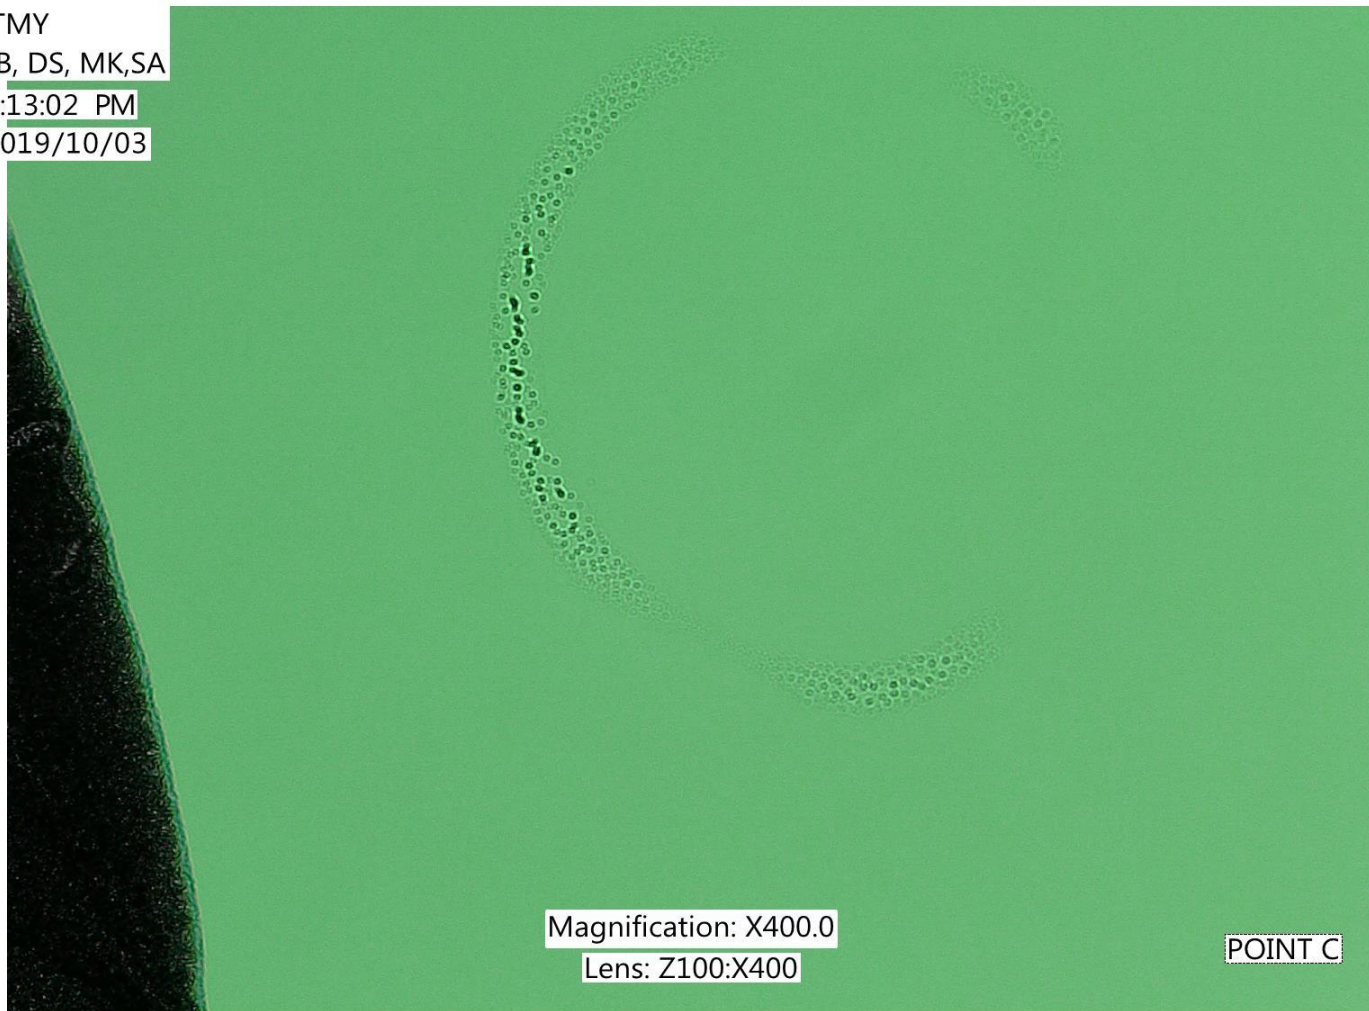
# Point C

Halos

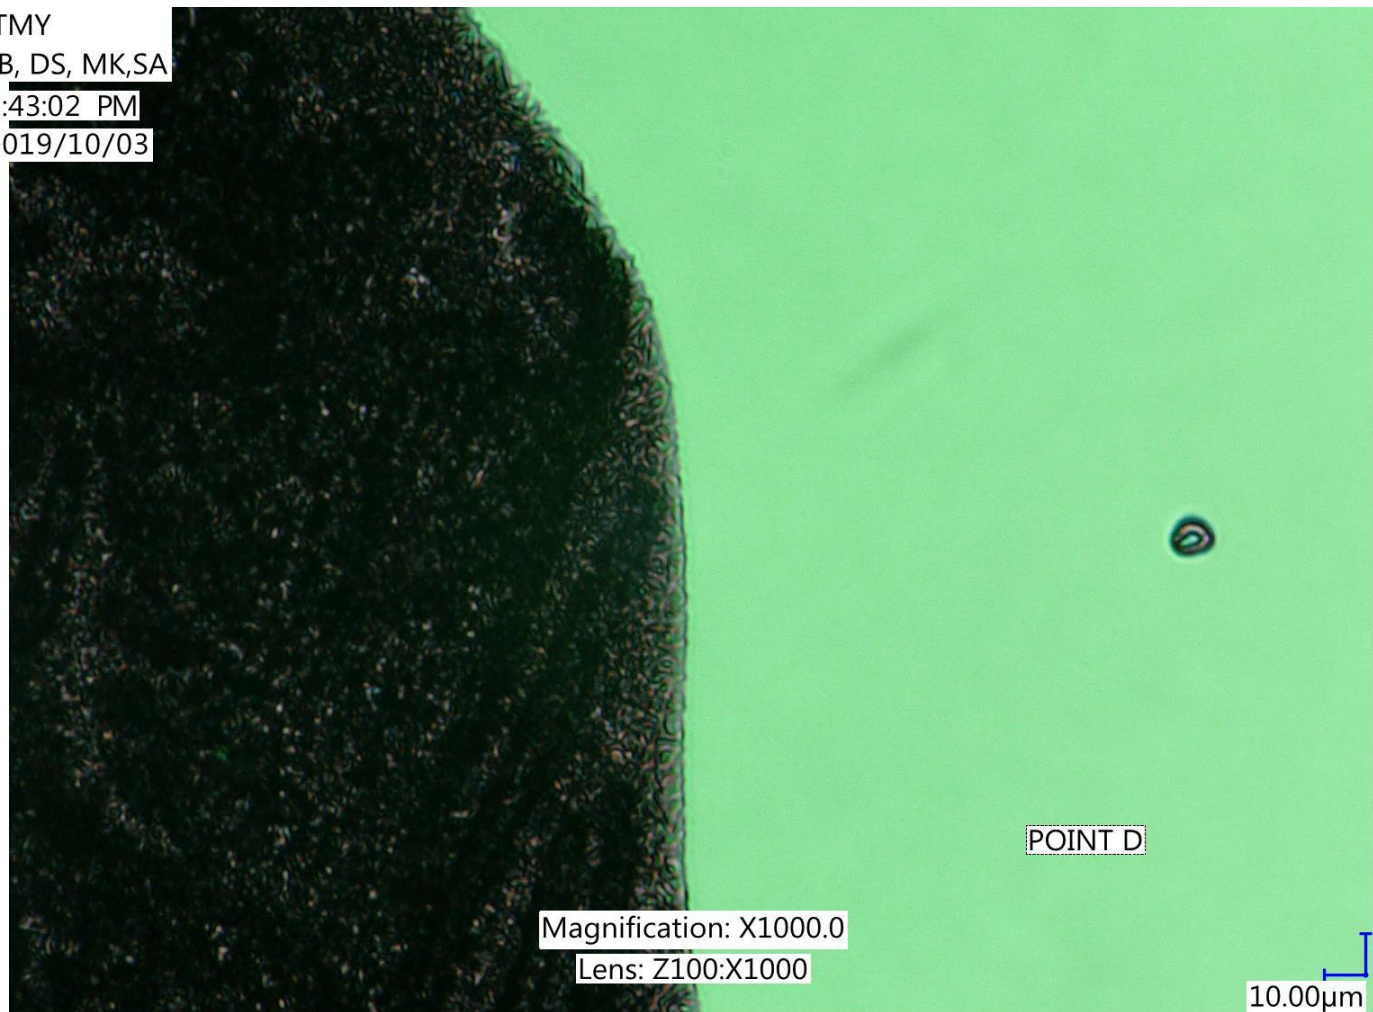
# Point D

Unknown
