# Visual Catalog of LLO ETM Inspection Images from Mid-O3 Vent

GariLynn Billingsley, Danny Sellers, Marie Kasprzack, Stephen Appert  
ETMX Inspection 3-4 October 2019  
ETMY Inspection 7-8 October 2019

T1900696-v1

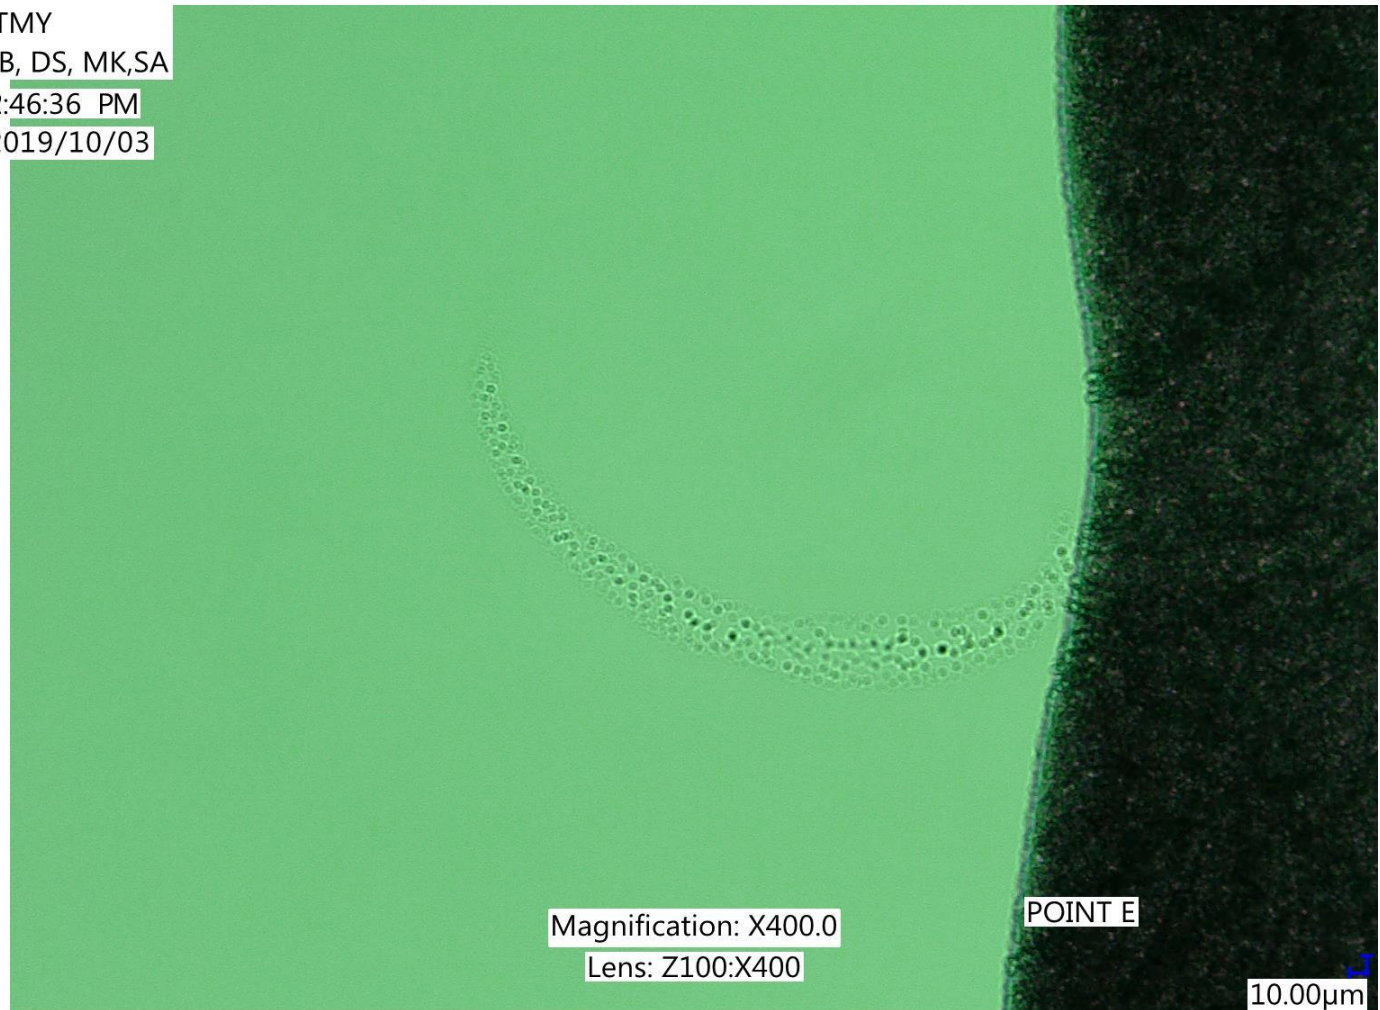
# Point E

Halos

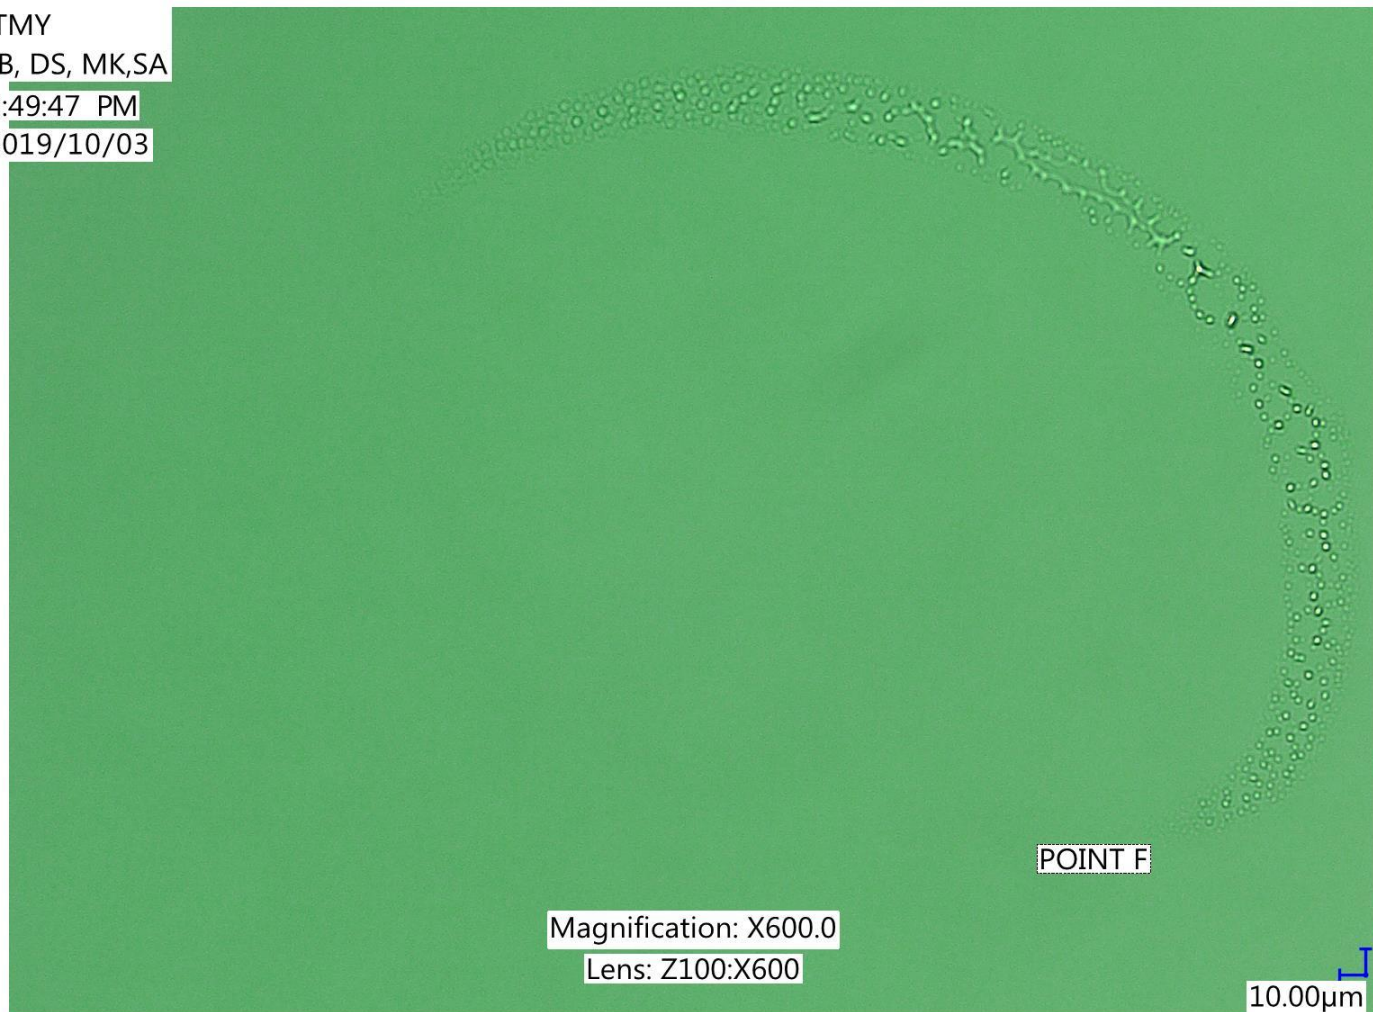
# Point F

Halos

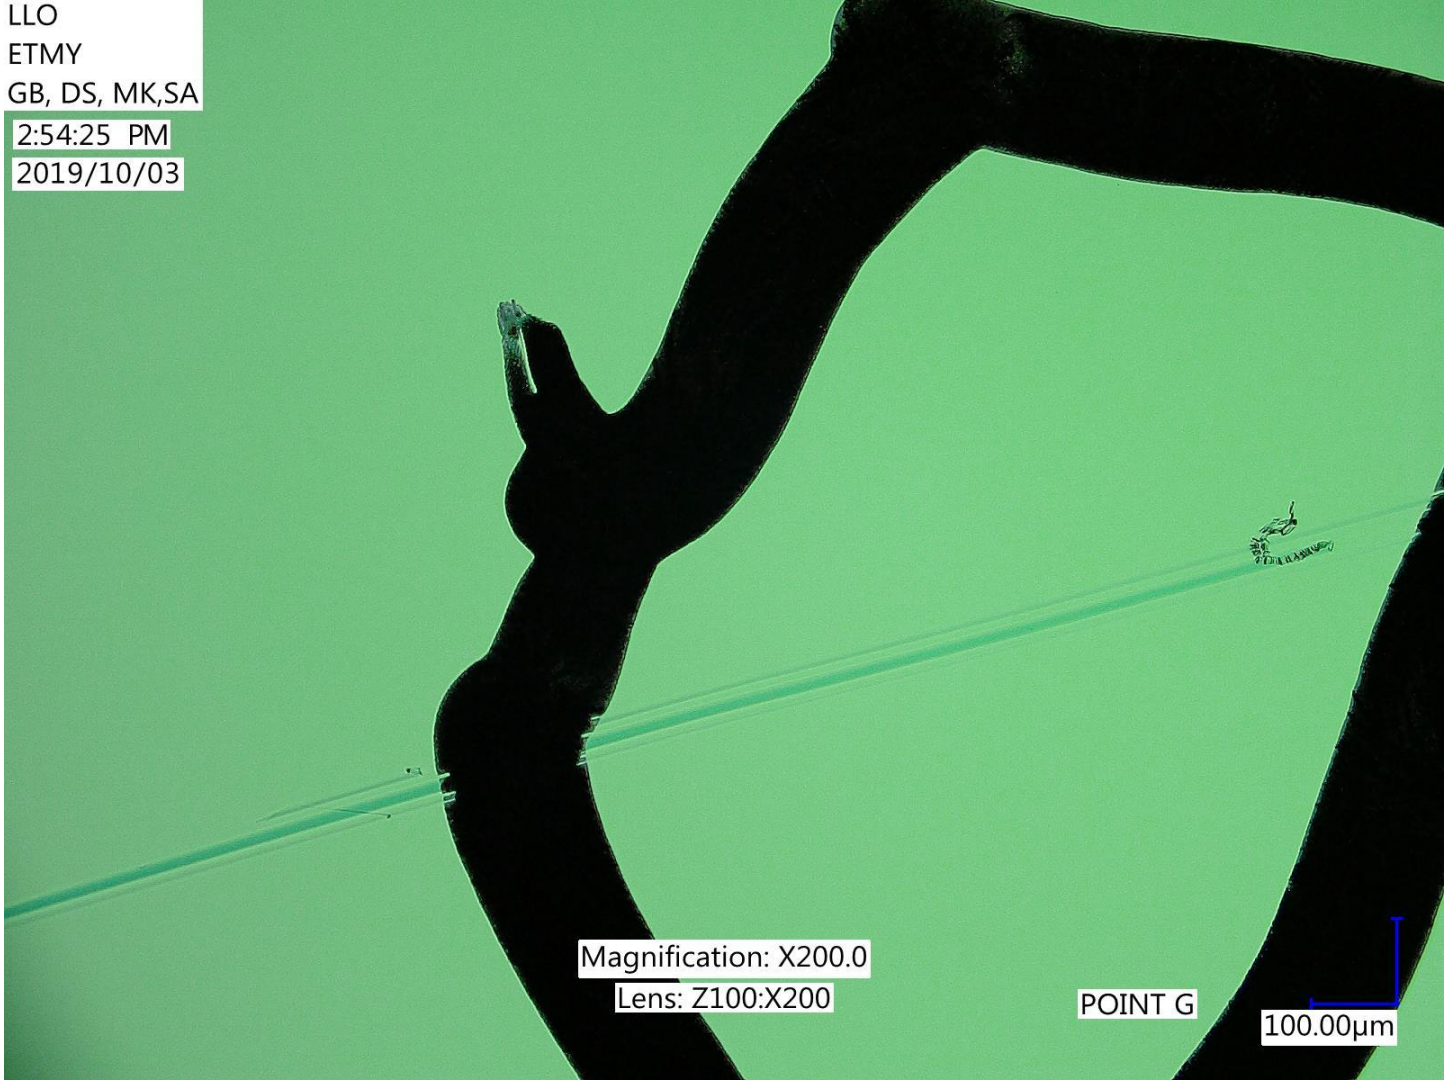
# Point G

Debris

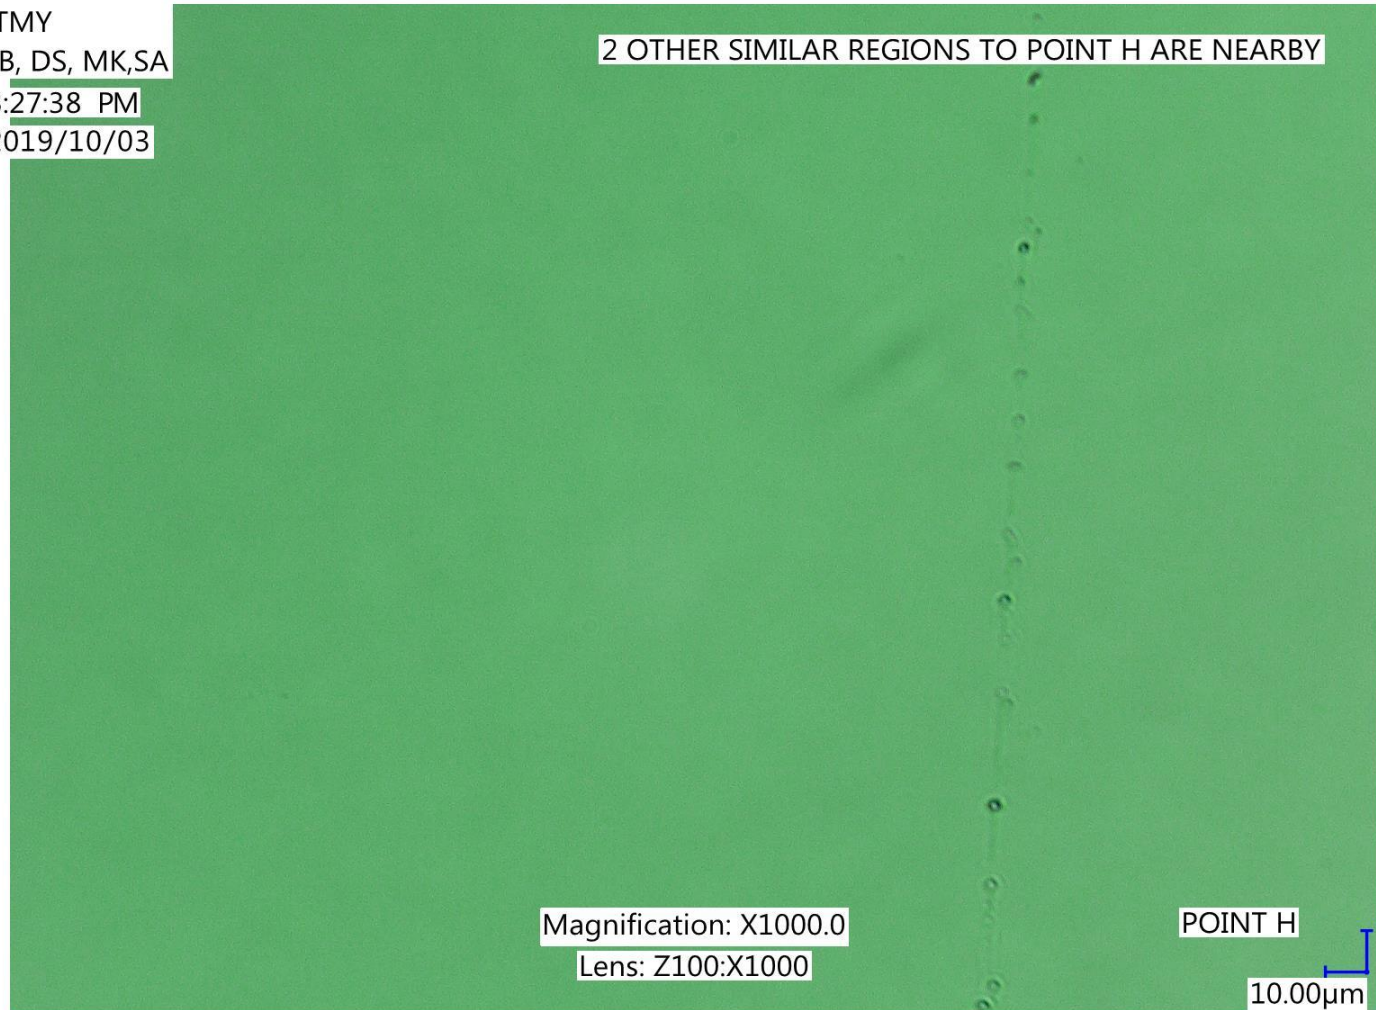
## Point H

Unknown

3 Lines which  
extend > 1mm

2 OTHER SIMILAR REGIONS TO POINT H ARE NEARBY

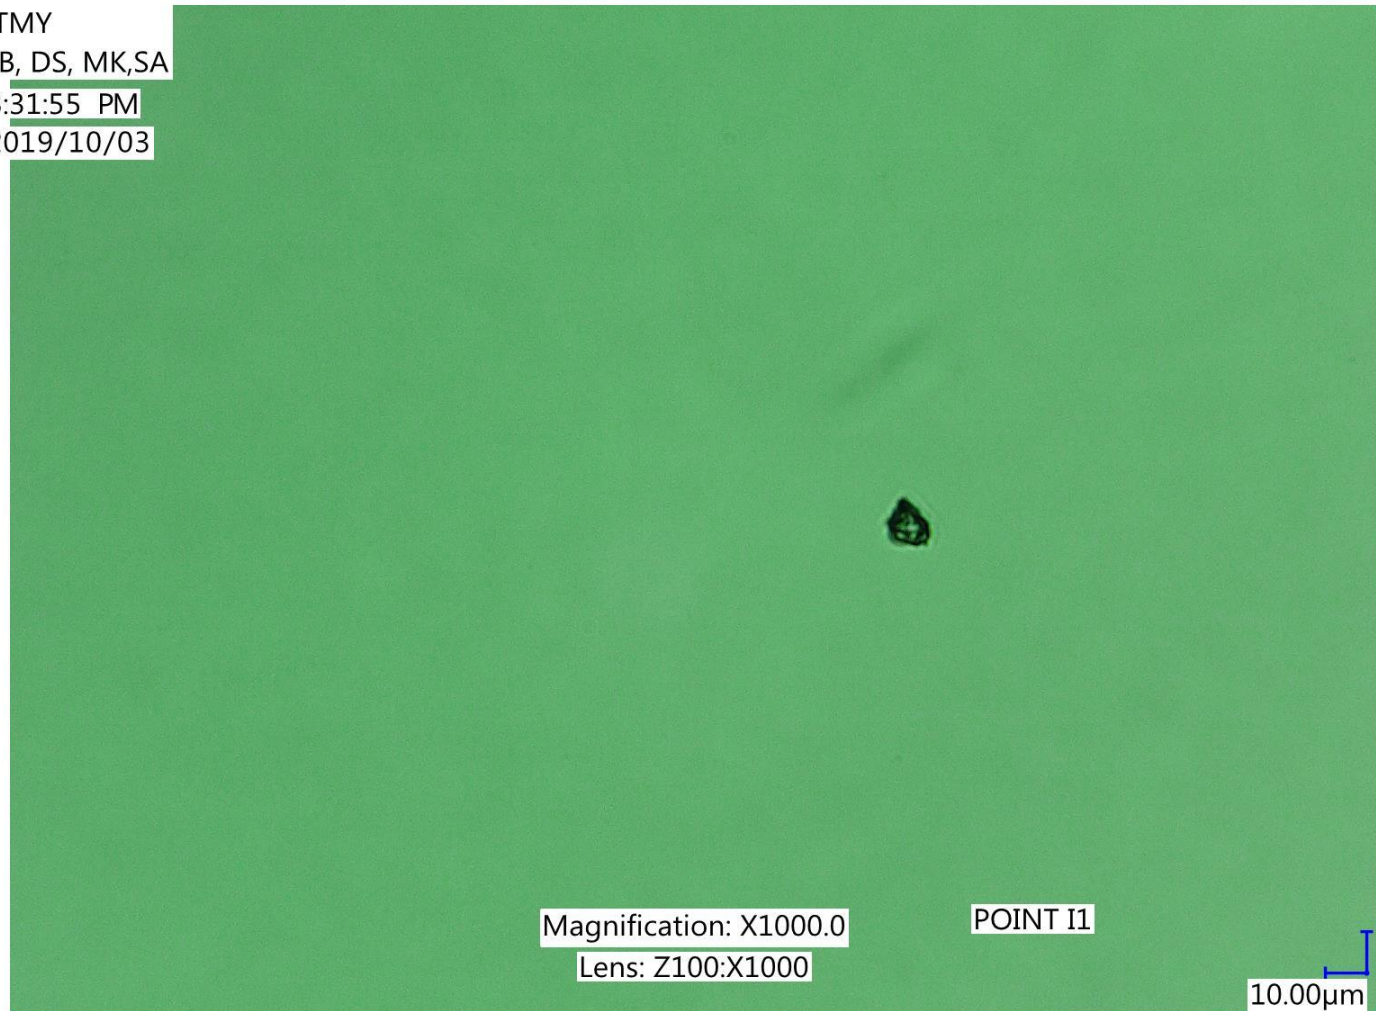
# Point I1

Debris

Separated from I2  
by > 2mm

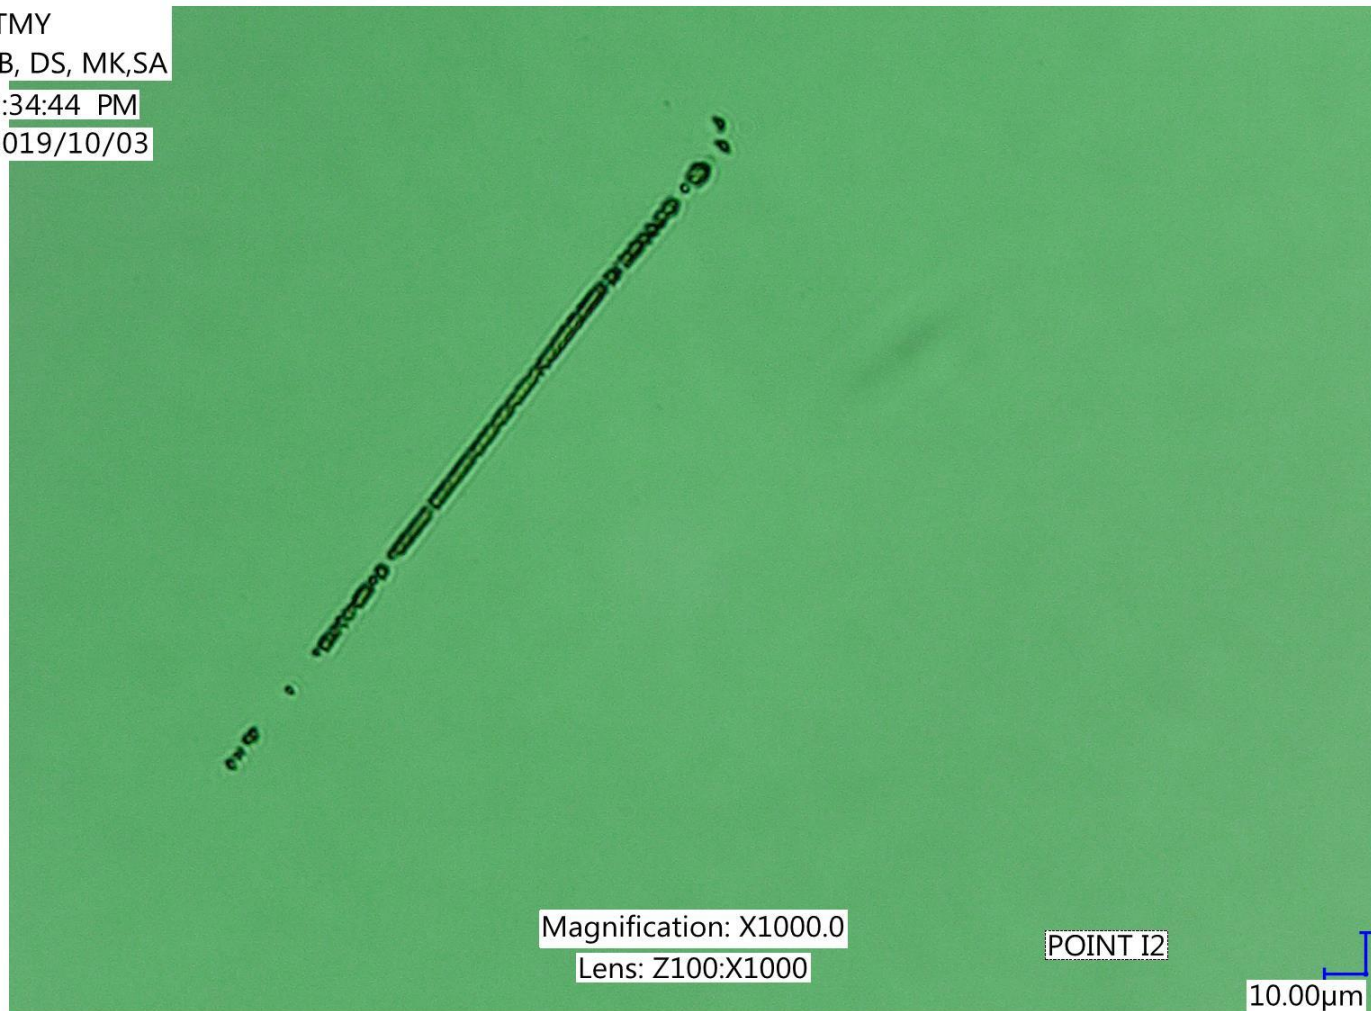
## Point I2

Unknown

Separated from I1  
by > 2mm

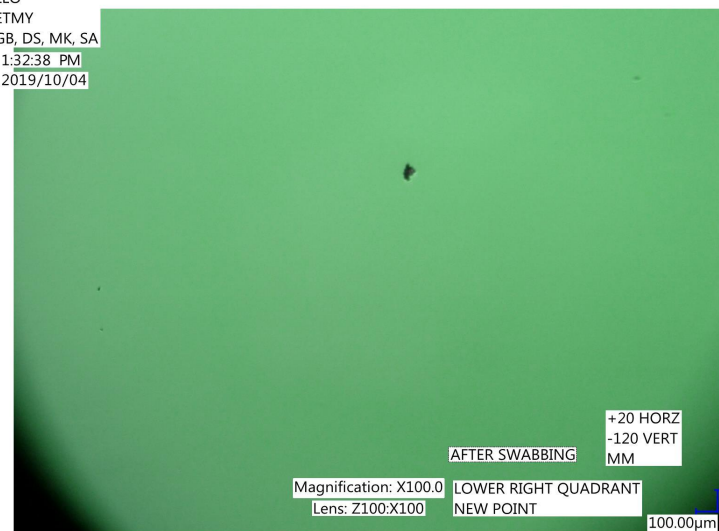
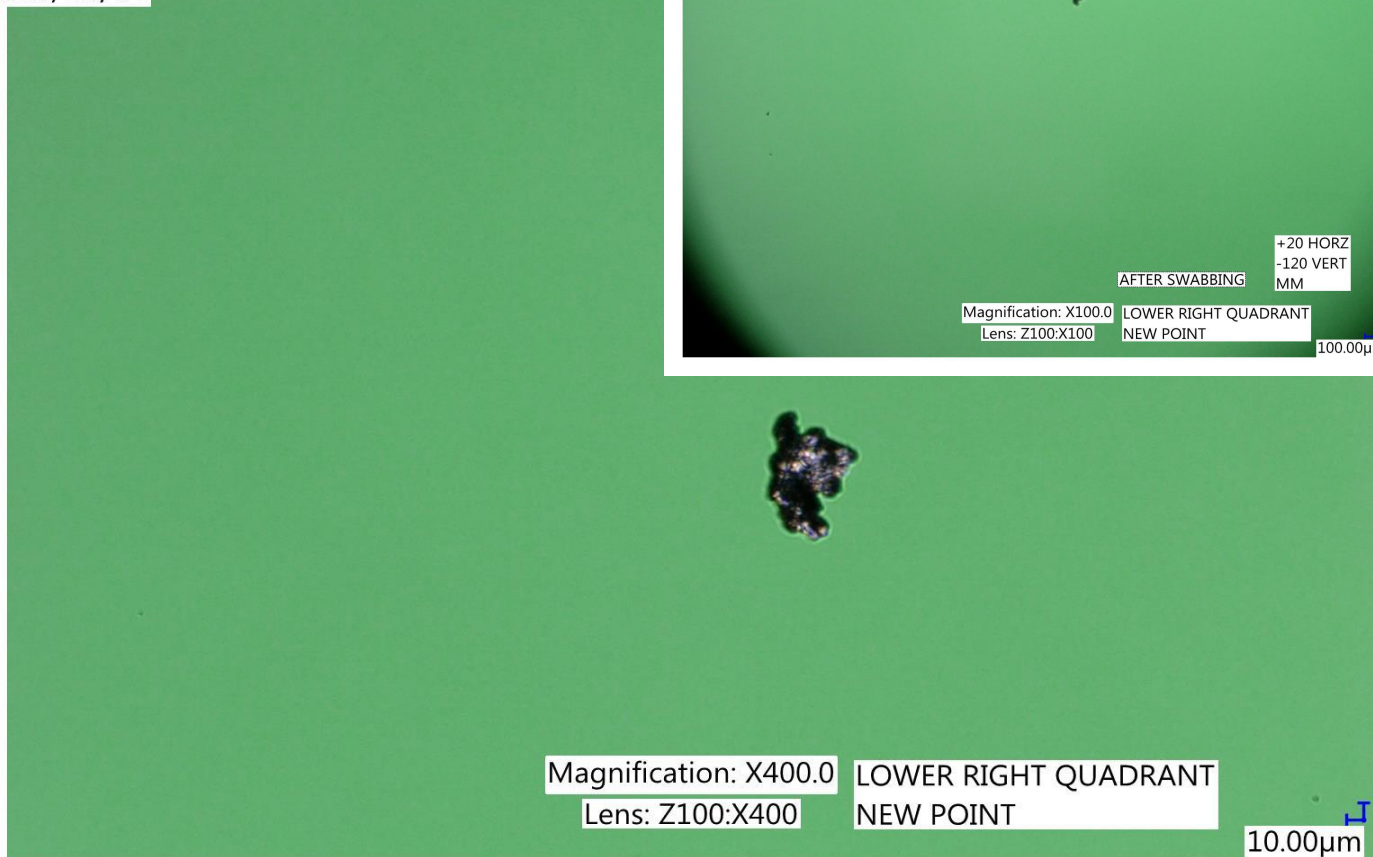
## Point LRQ NEW

### Unknown

Apparent debris but still present after swabbing (see inset)

Approx location from center  
+20 mm horizontal, -120 mm vertical

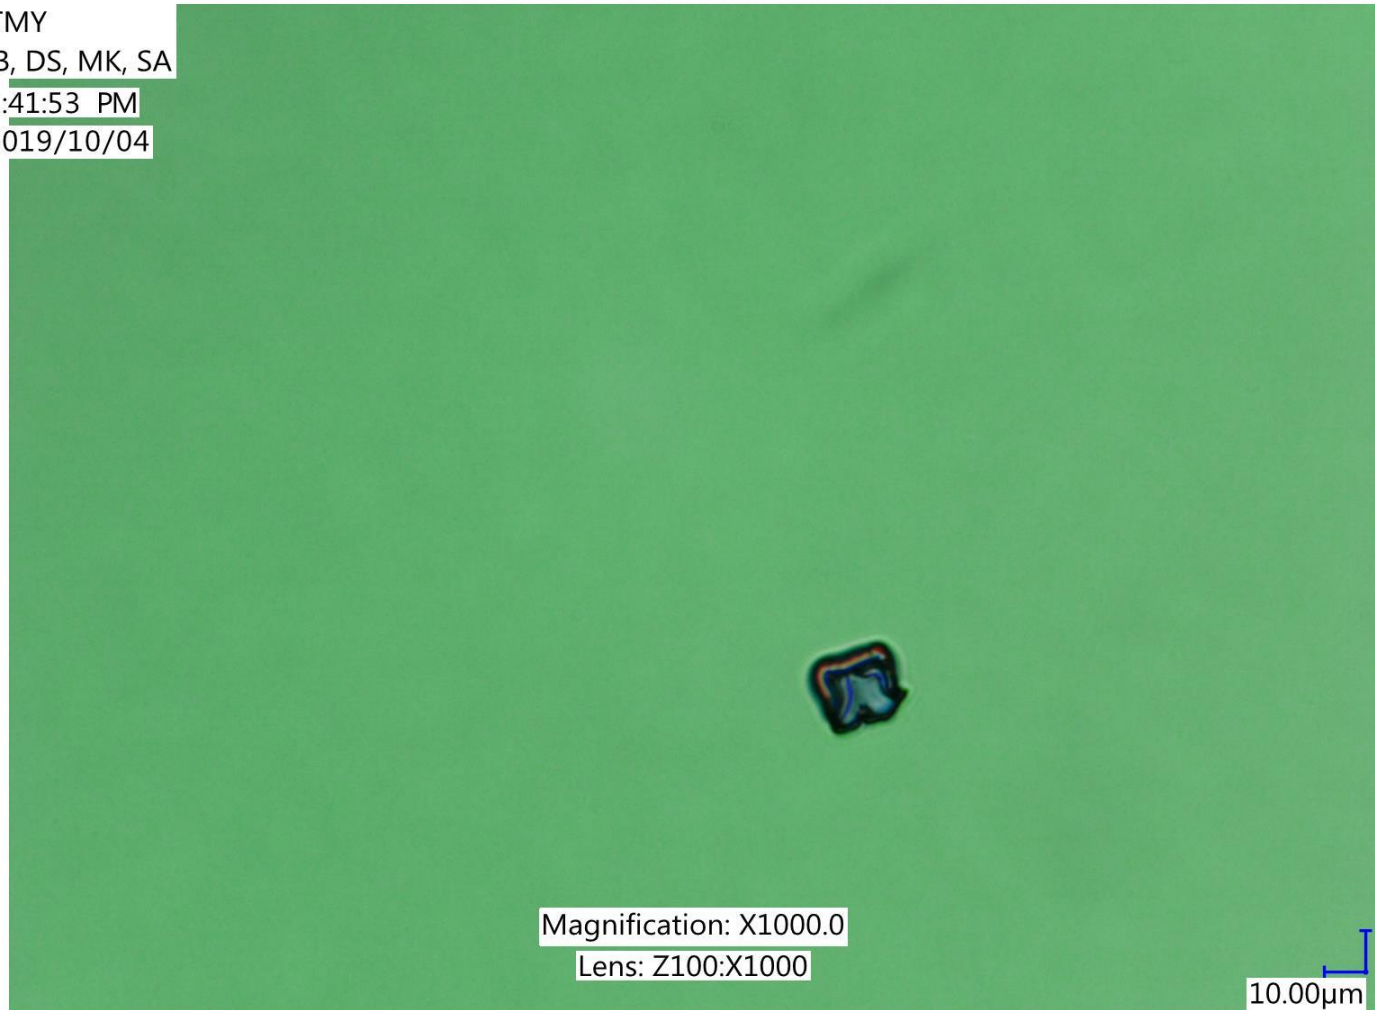
Point NEW

Unknown

Approx location from center  
+9 mm horizontal, +20 mm  
vertical

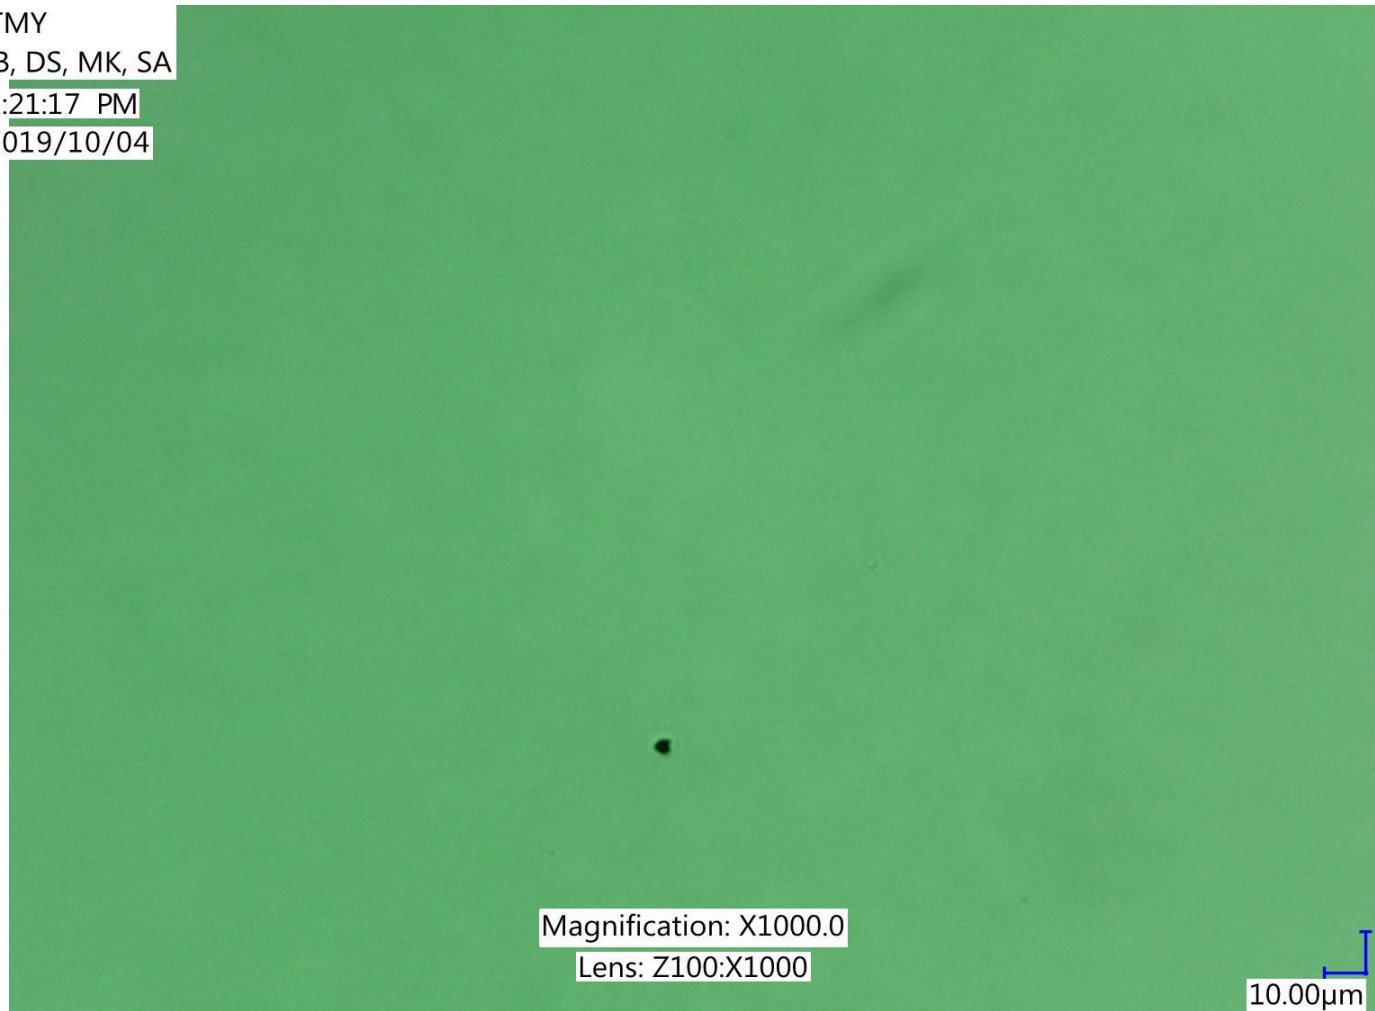
Point DOT

Unknown

Approx location from center  
+10 mm horizontal, +5 mm  
vertical

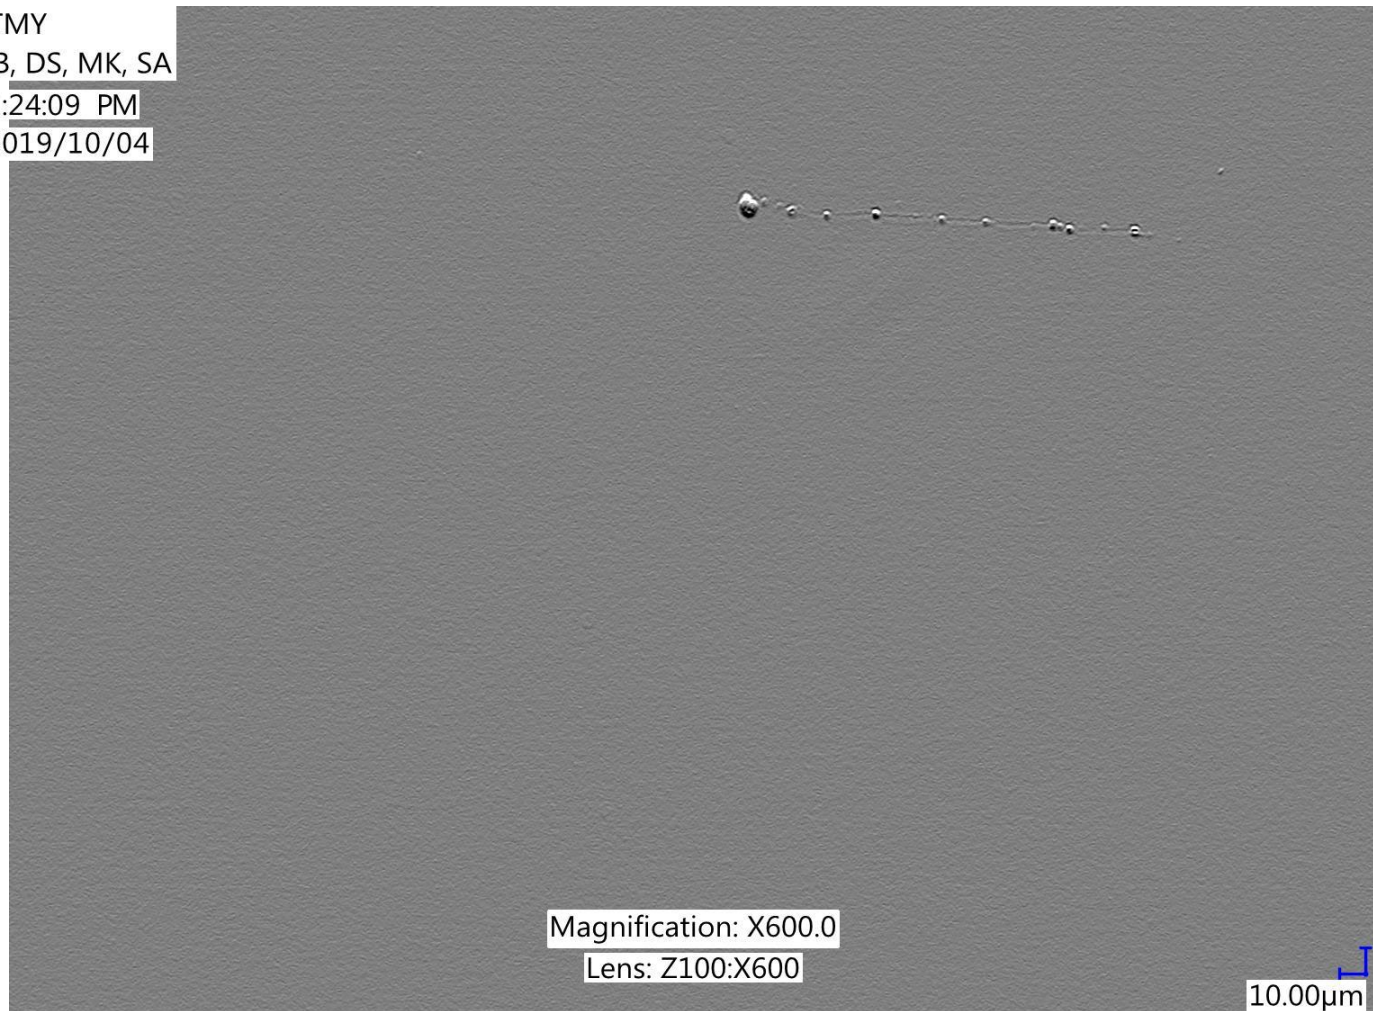
Point HORZ STREAK

Unknown

Approx location from center  
+10 mm horizontal, +5 mm vertical

Visually similar to [ETMY](#)
