Absorption Test

ITM03/11 Witness sample

LMA Run Reference C13074/13

Microscopy/absorption test/Microscopy

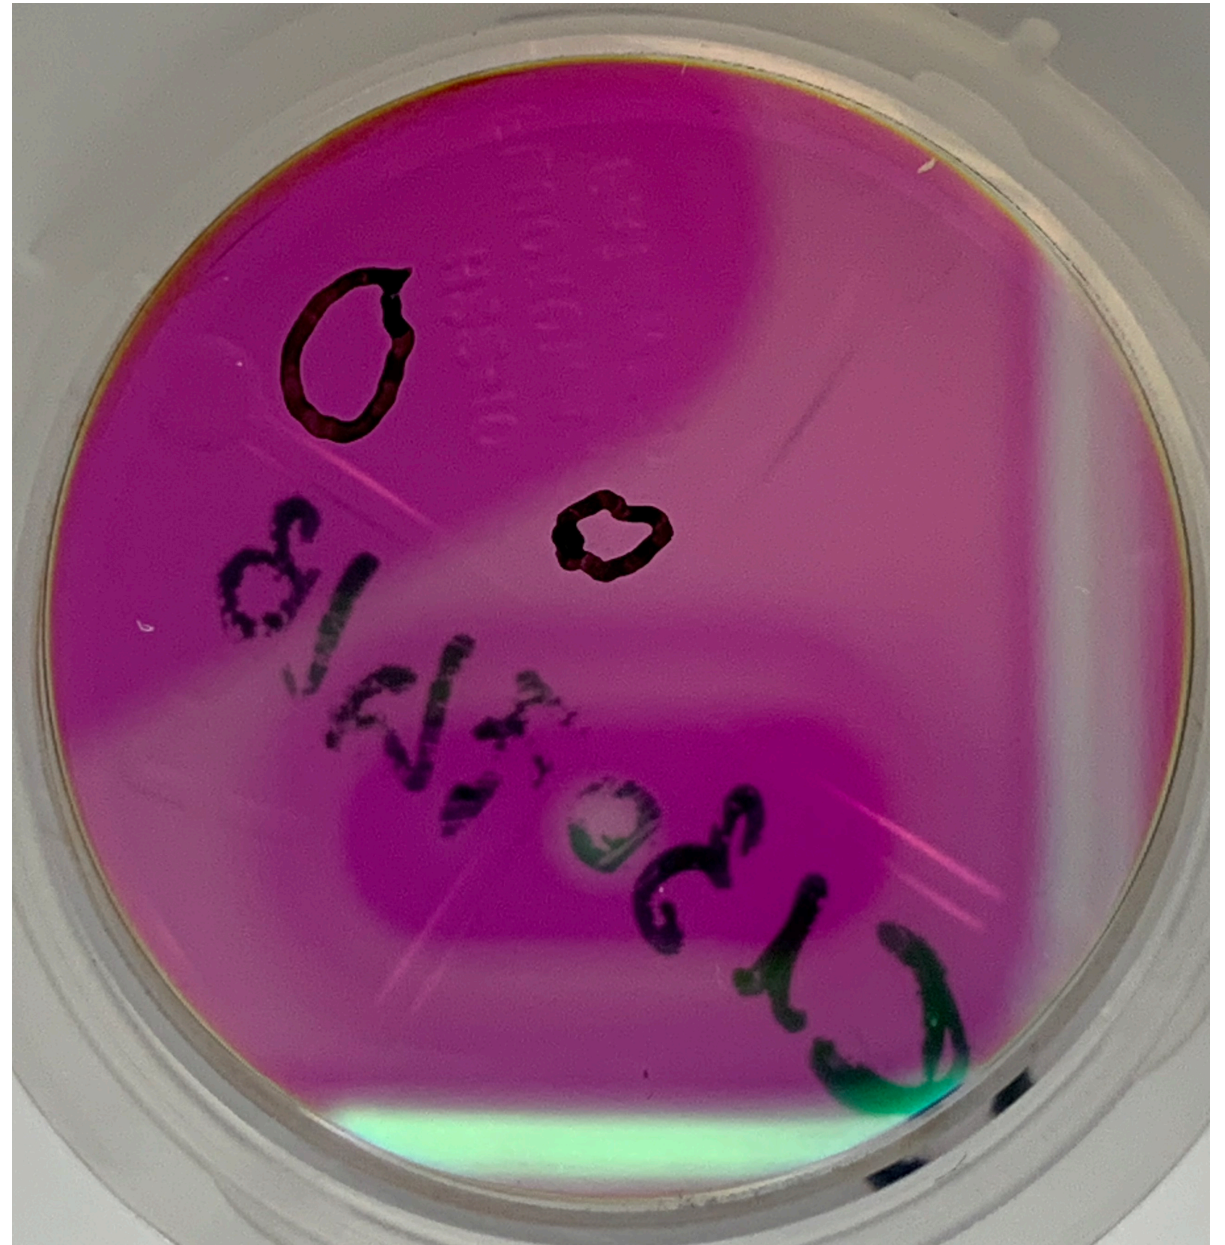
Absorber is located in the
large circle.

Non-absorber in the small
circle

Image S1, Arrow down.

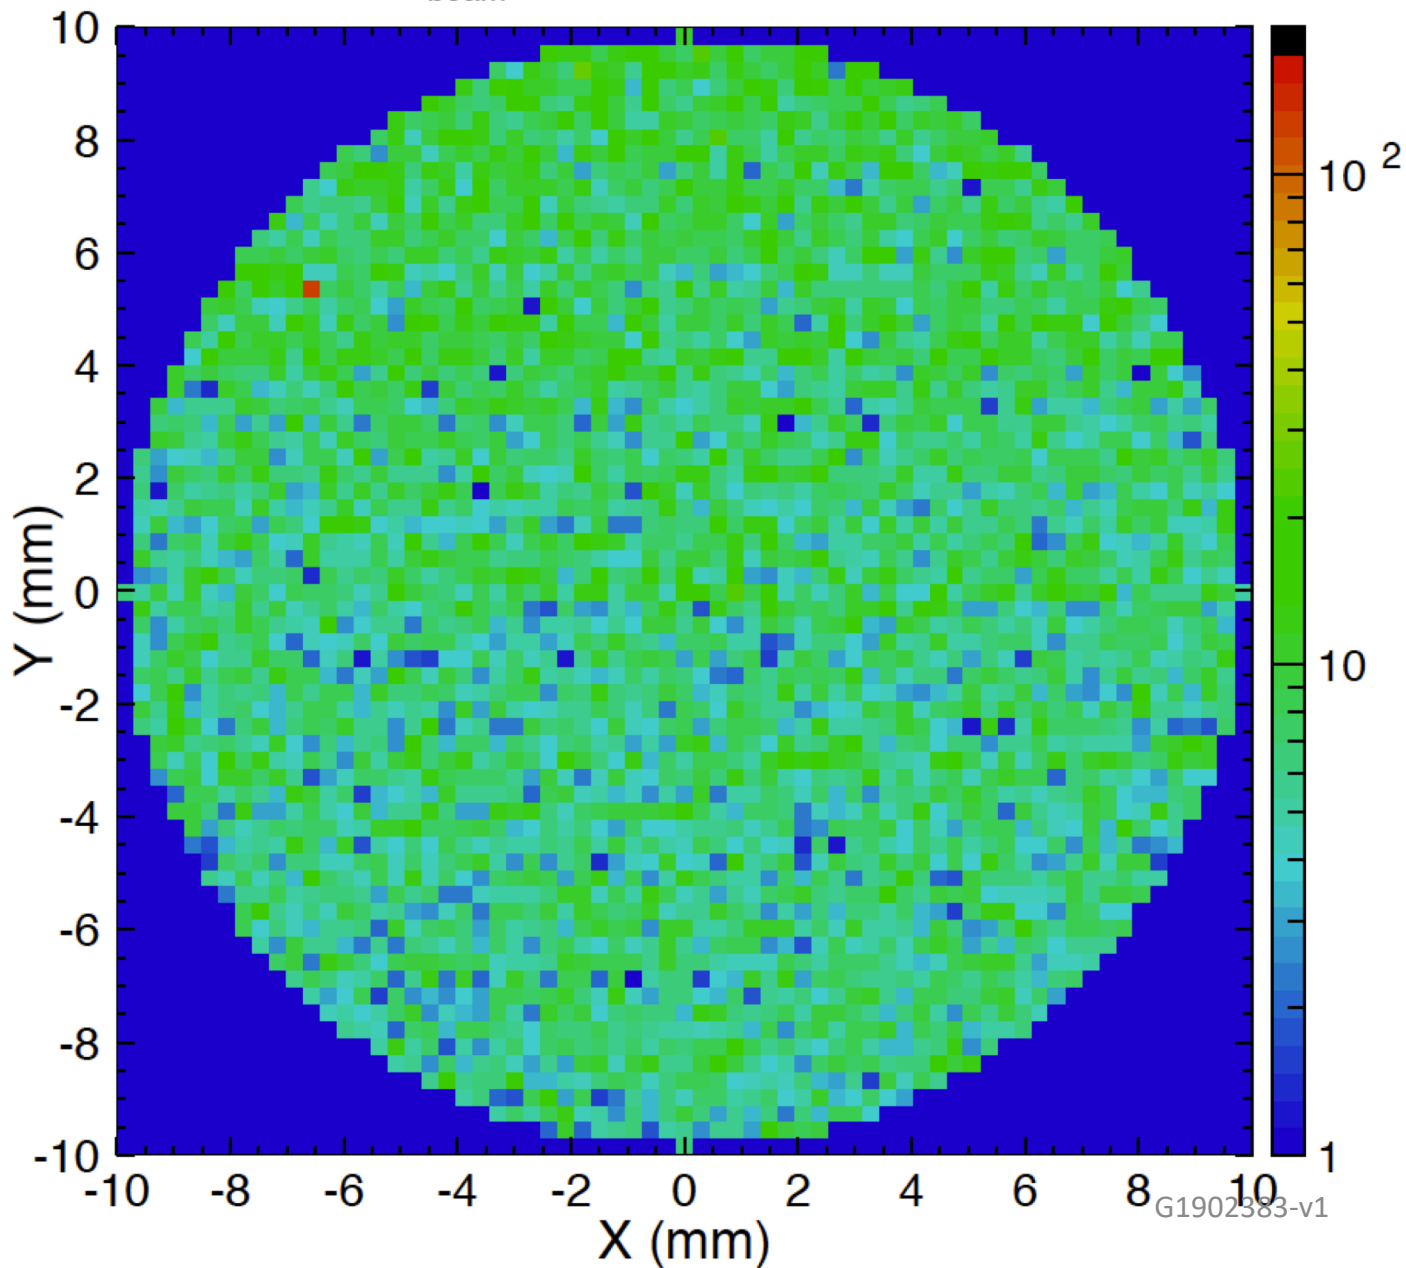
C13074/13 witness (sn:1549, ↑@-Y)

HR absorption ($\phi_{\text{beam}} = 0.3 \text{ mm}$, Step= 0.3 mm)

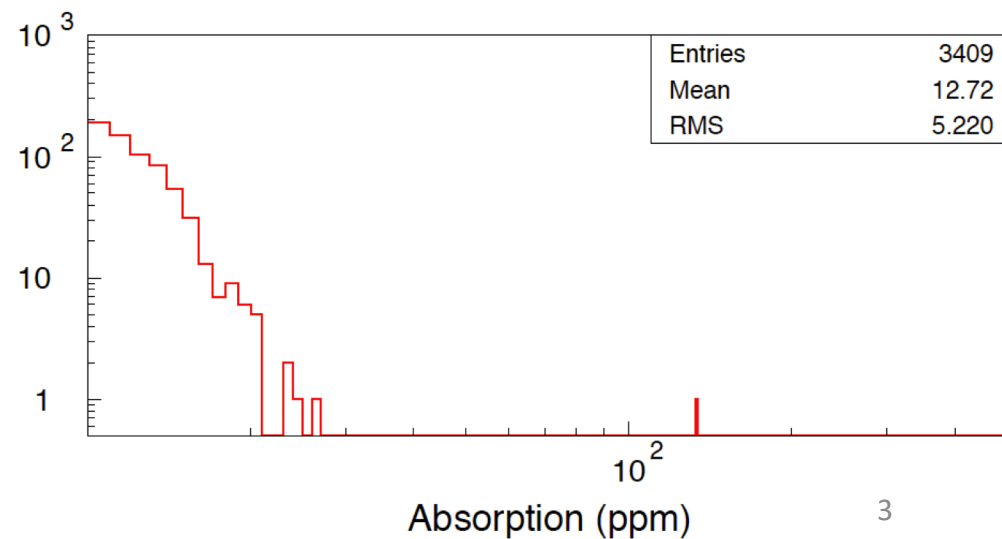
Image arrow at -Y

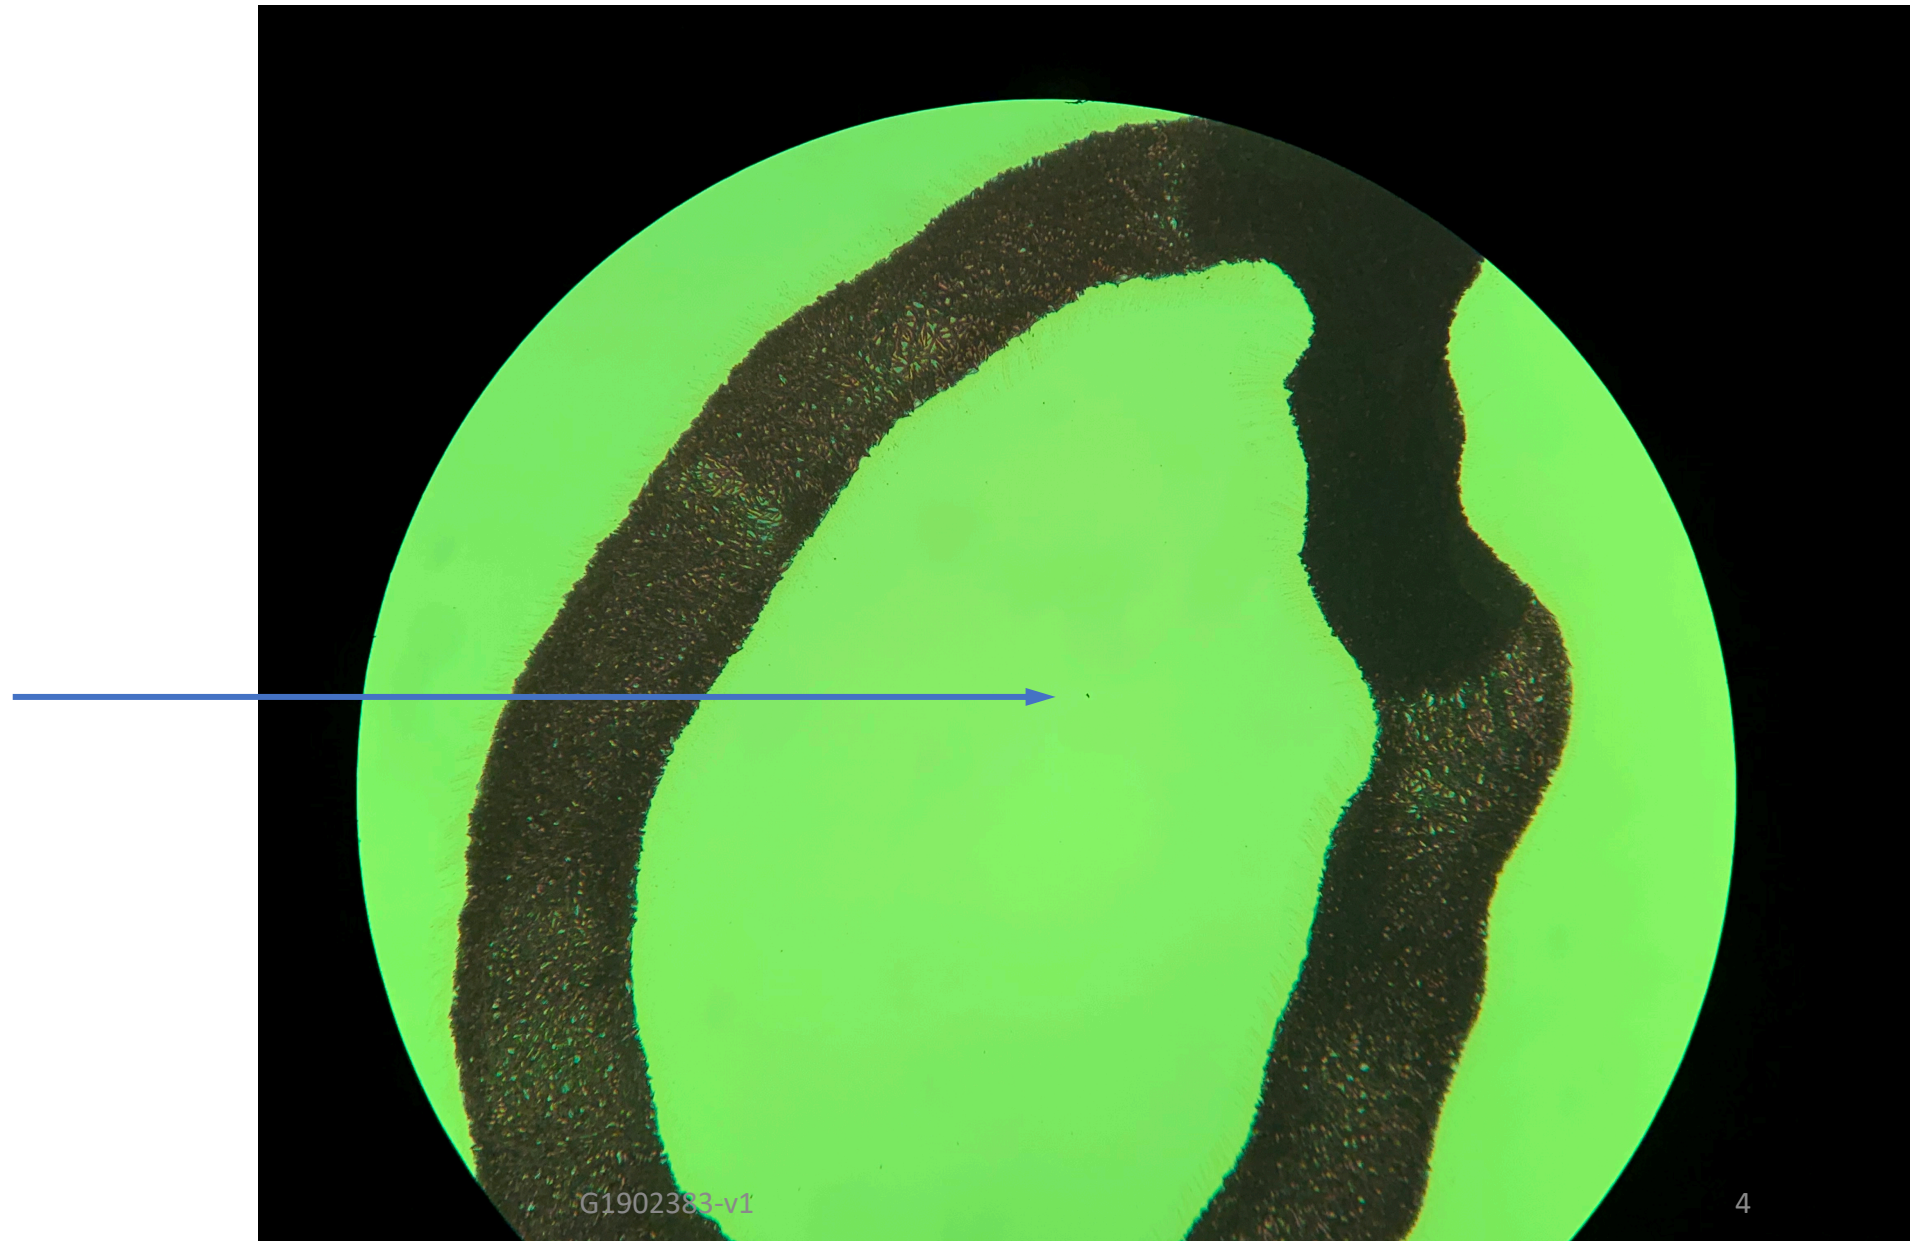
Close up of absorber circle/position

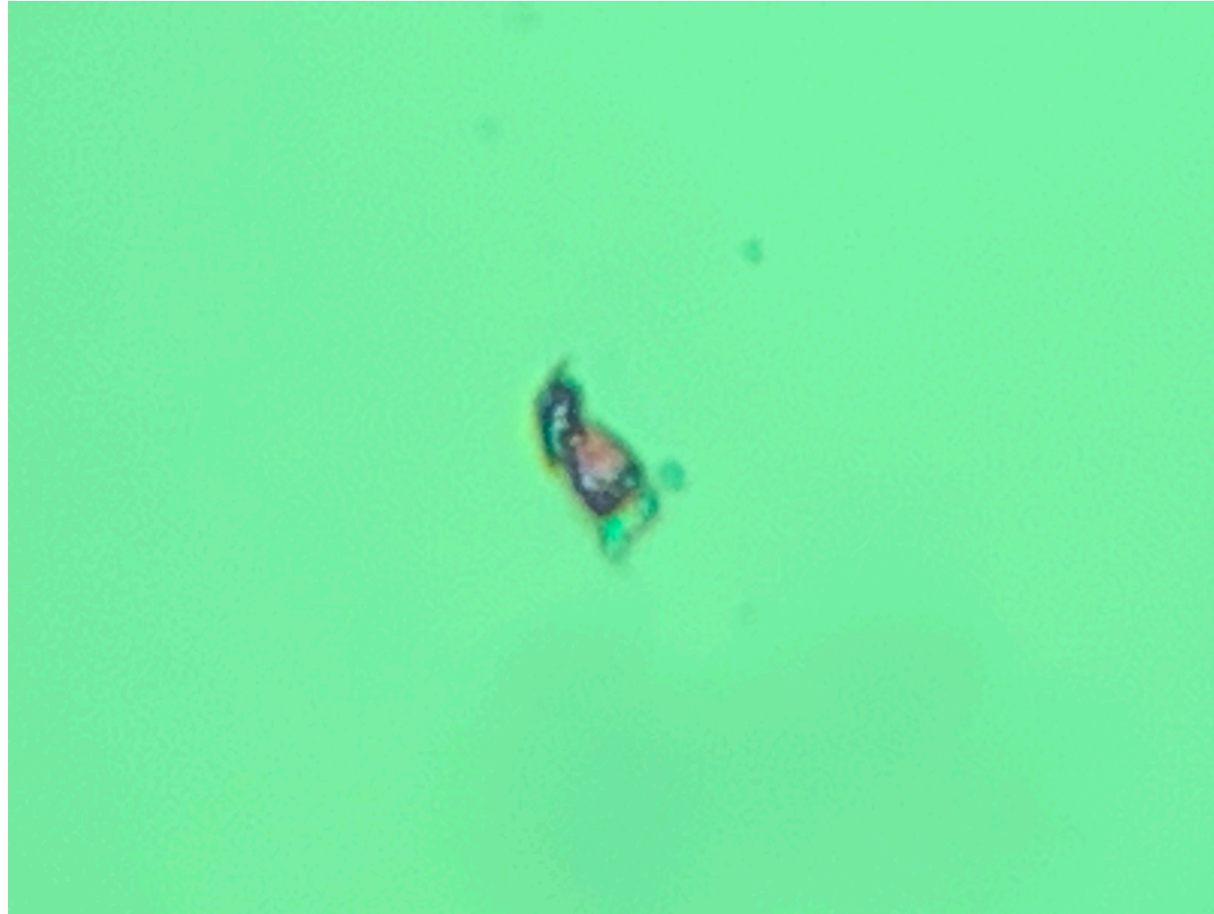
Absorber $\sim 13 \mu\text{m}$ long

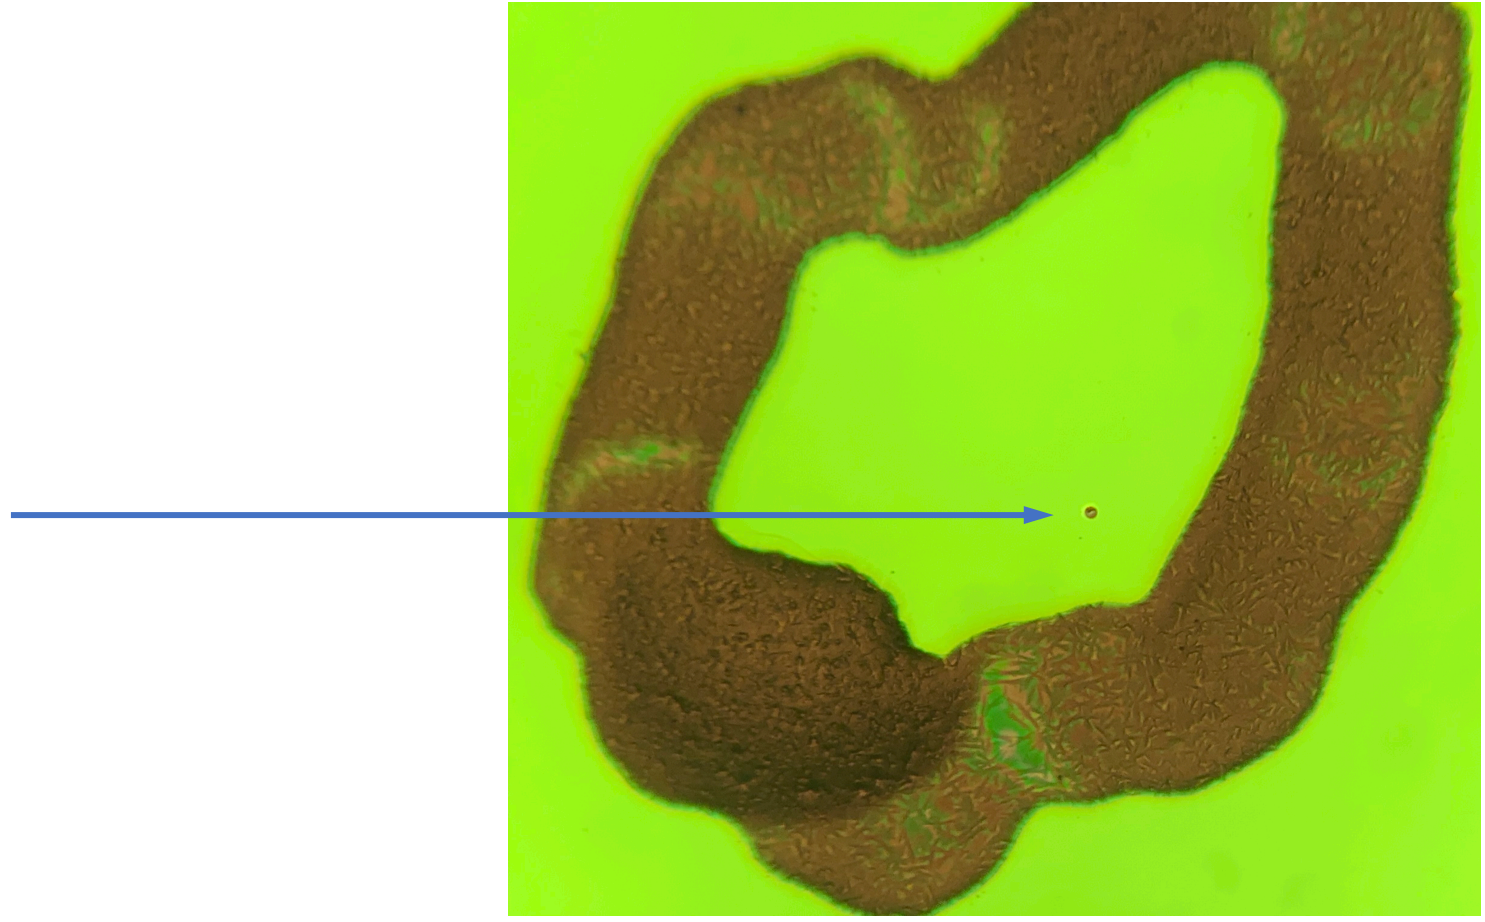
Location of the “bubble” non-absorber inside the smaller circle

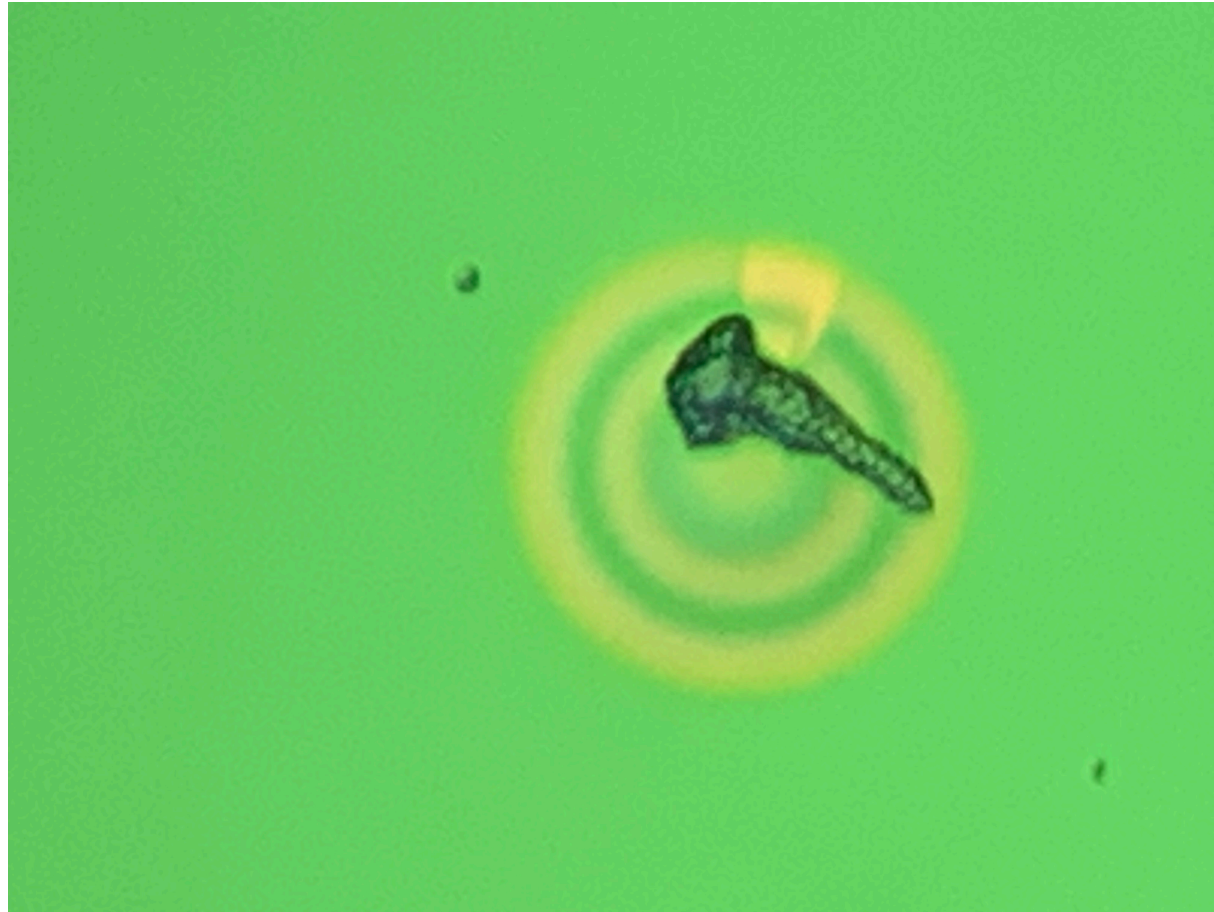
Non absorbing roughly 25 μm long no change in appearance before/after Abs. scan

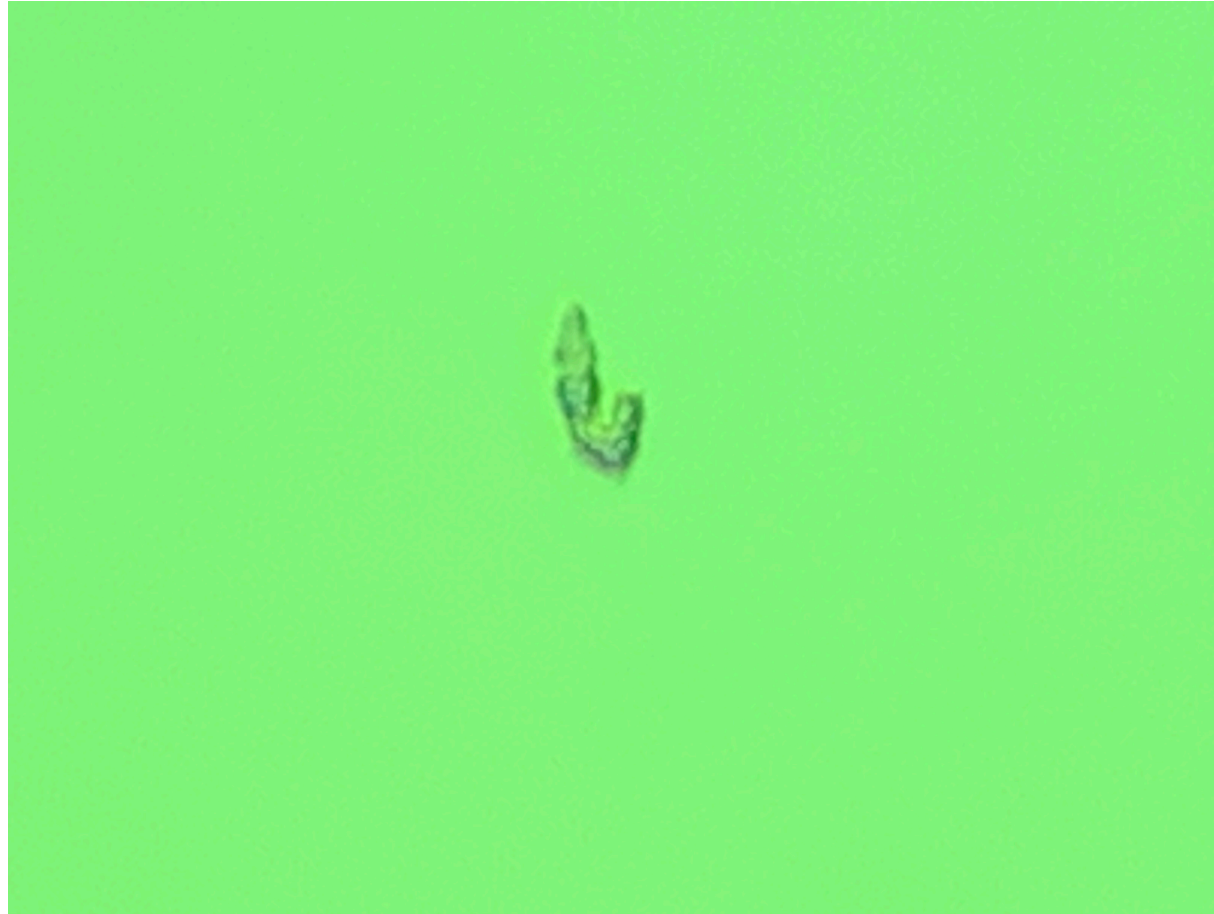
Non Absorbing. Roughly $10\mu\text{m}$ long

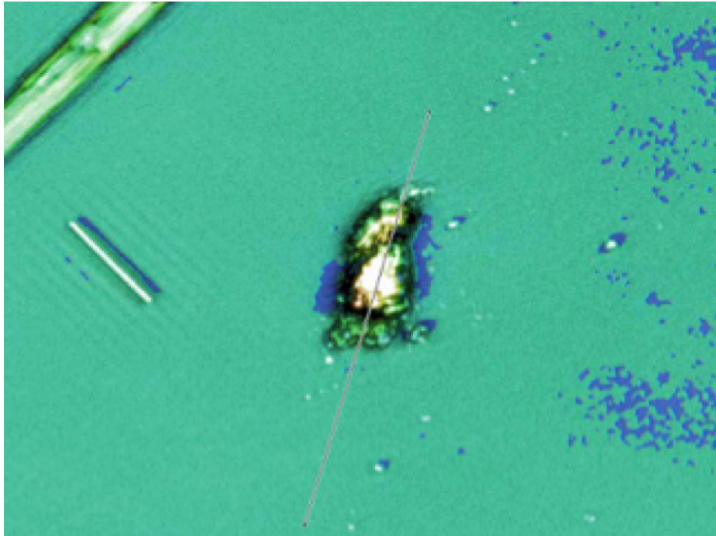
- Absorber Before

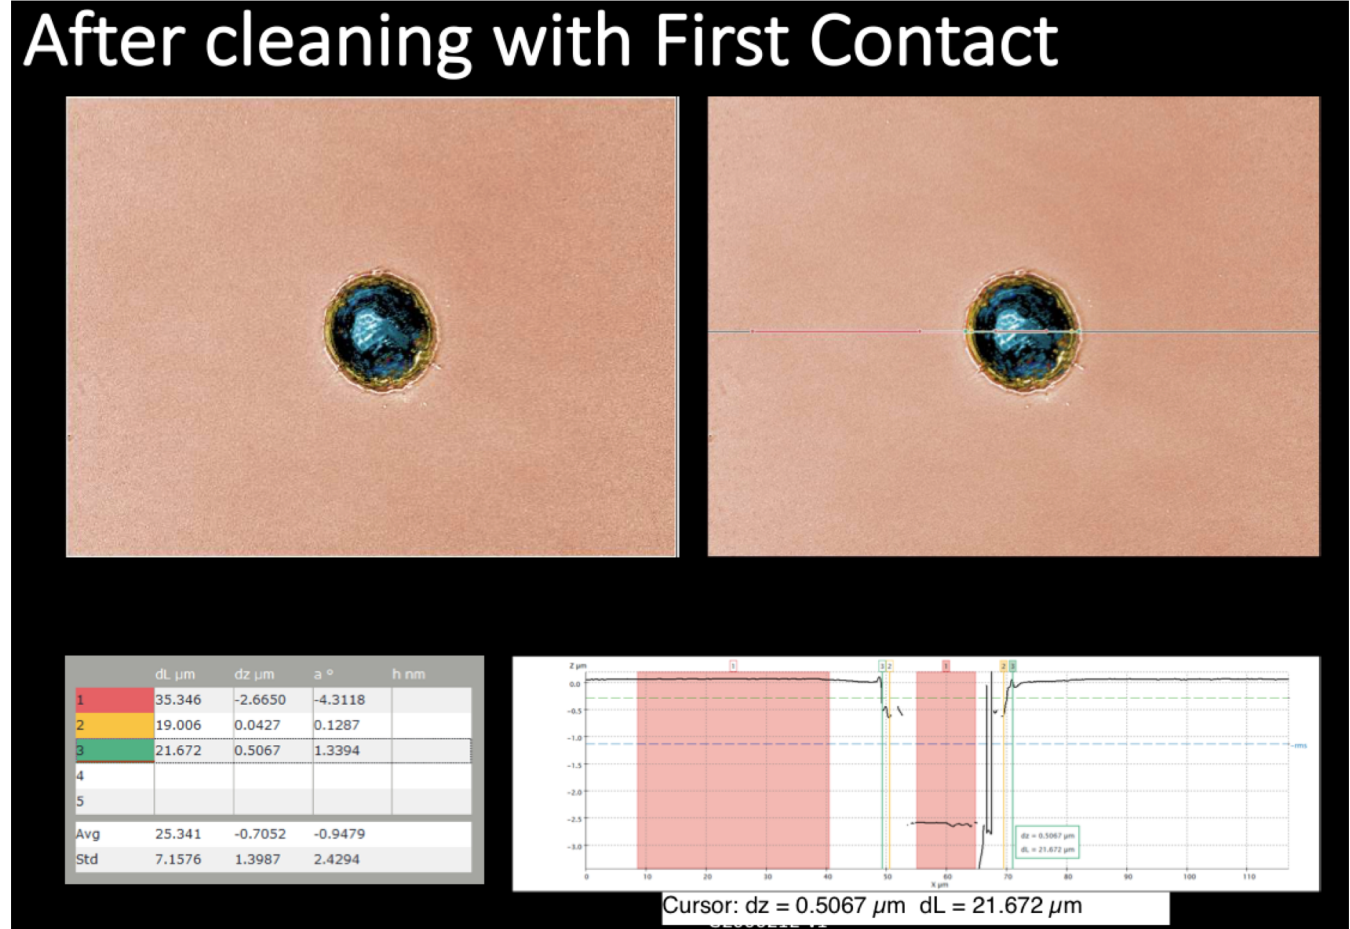
- Absorber after →

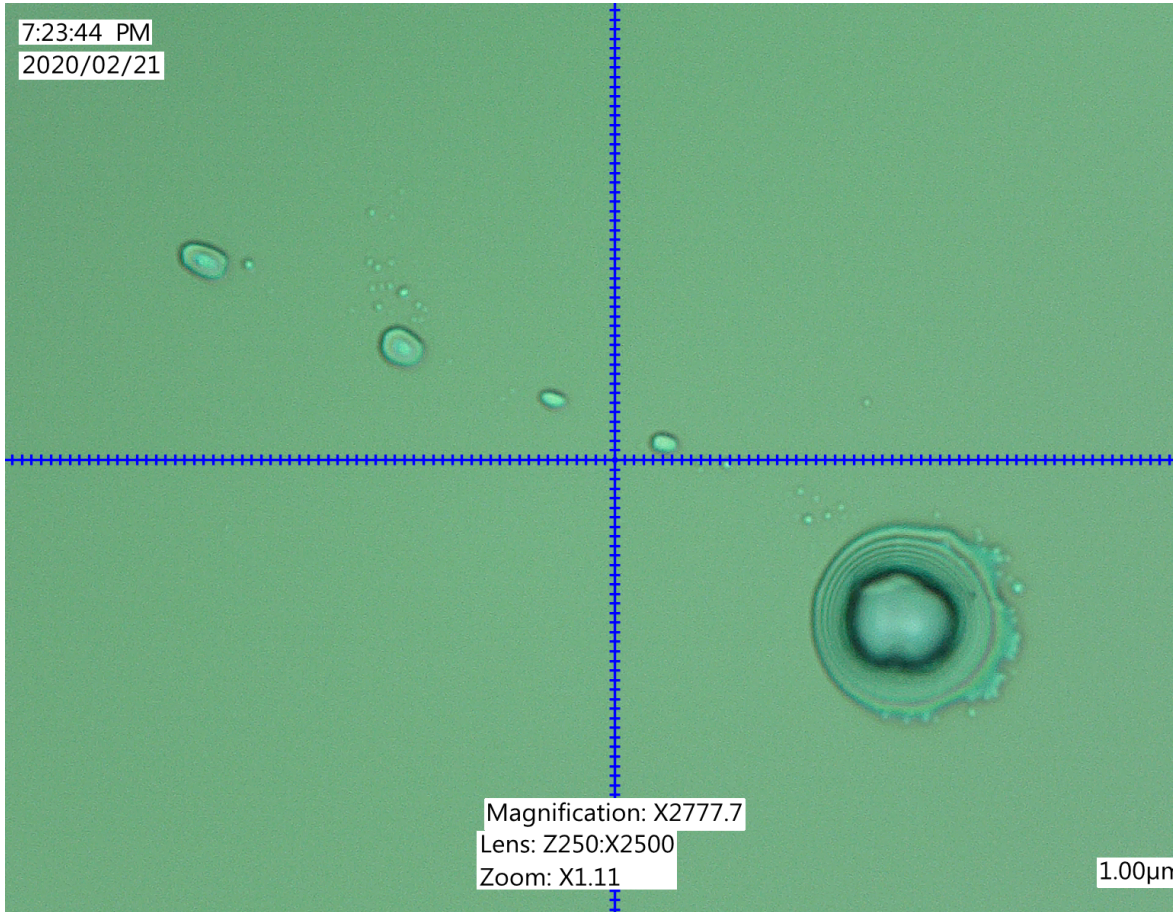
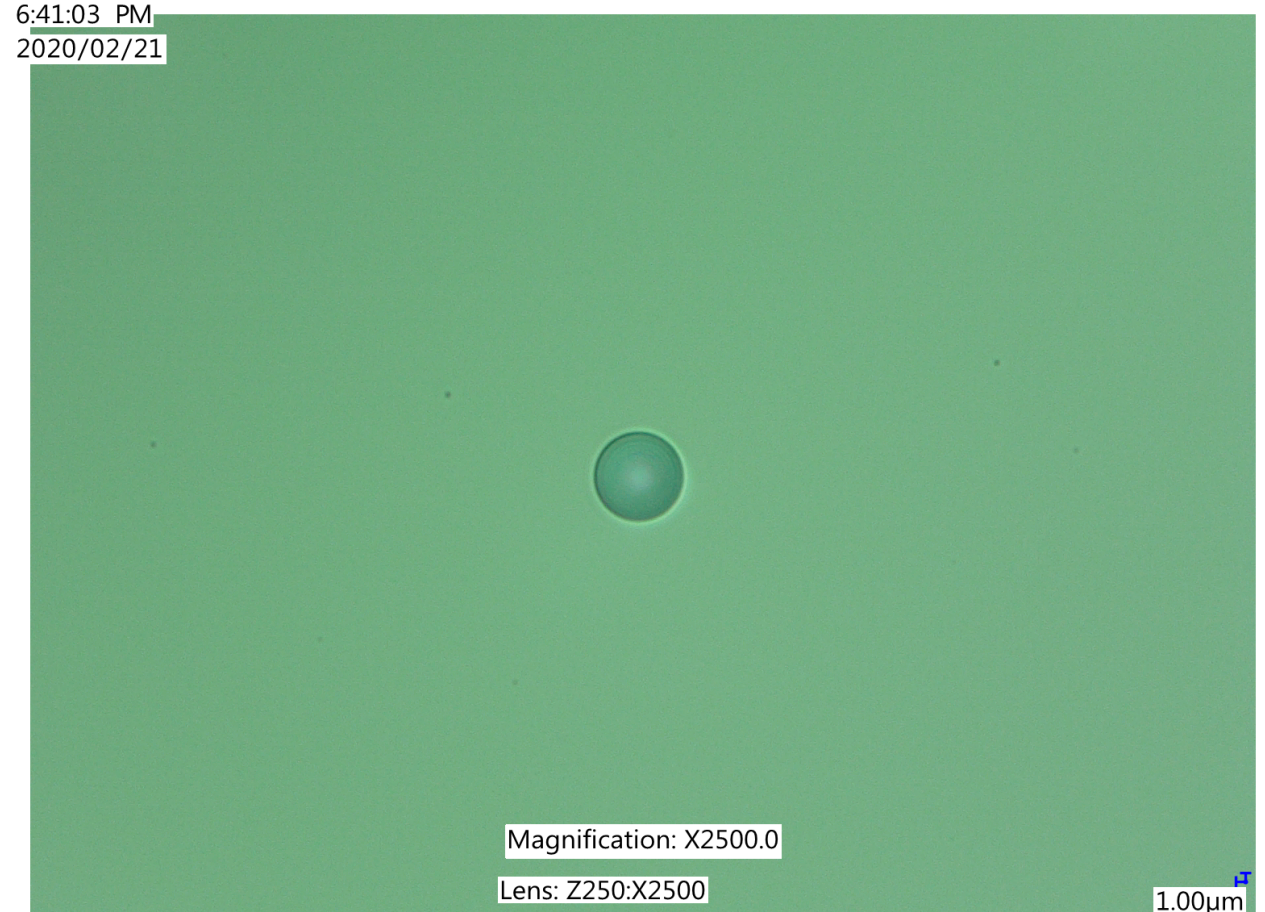
Also found near the arrow

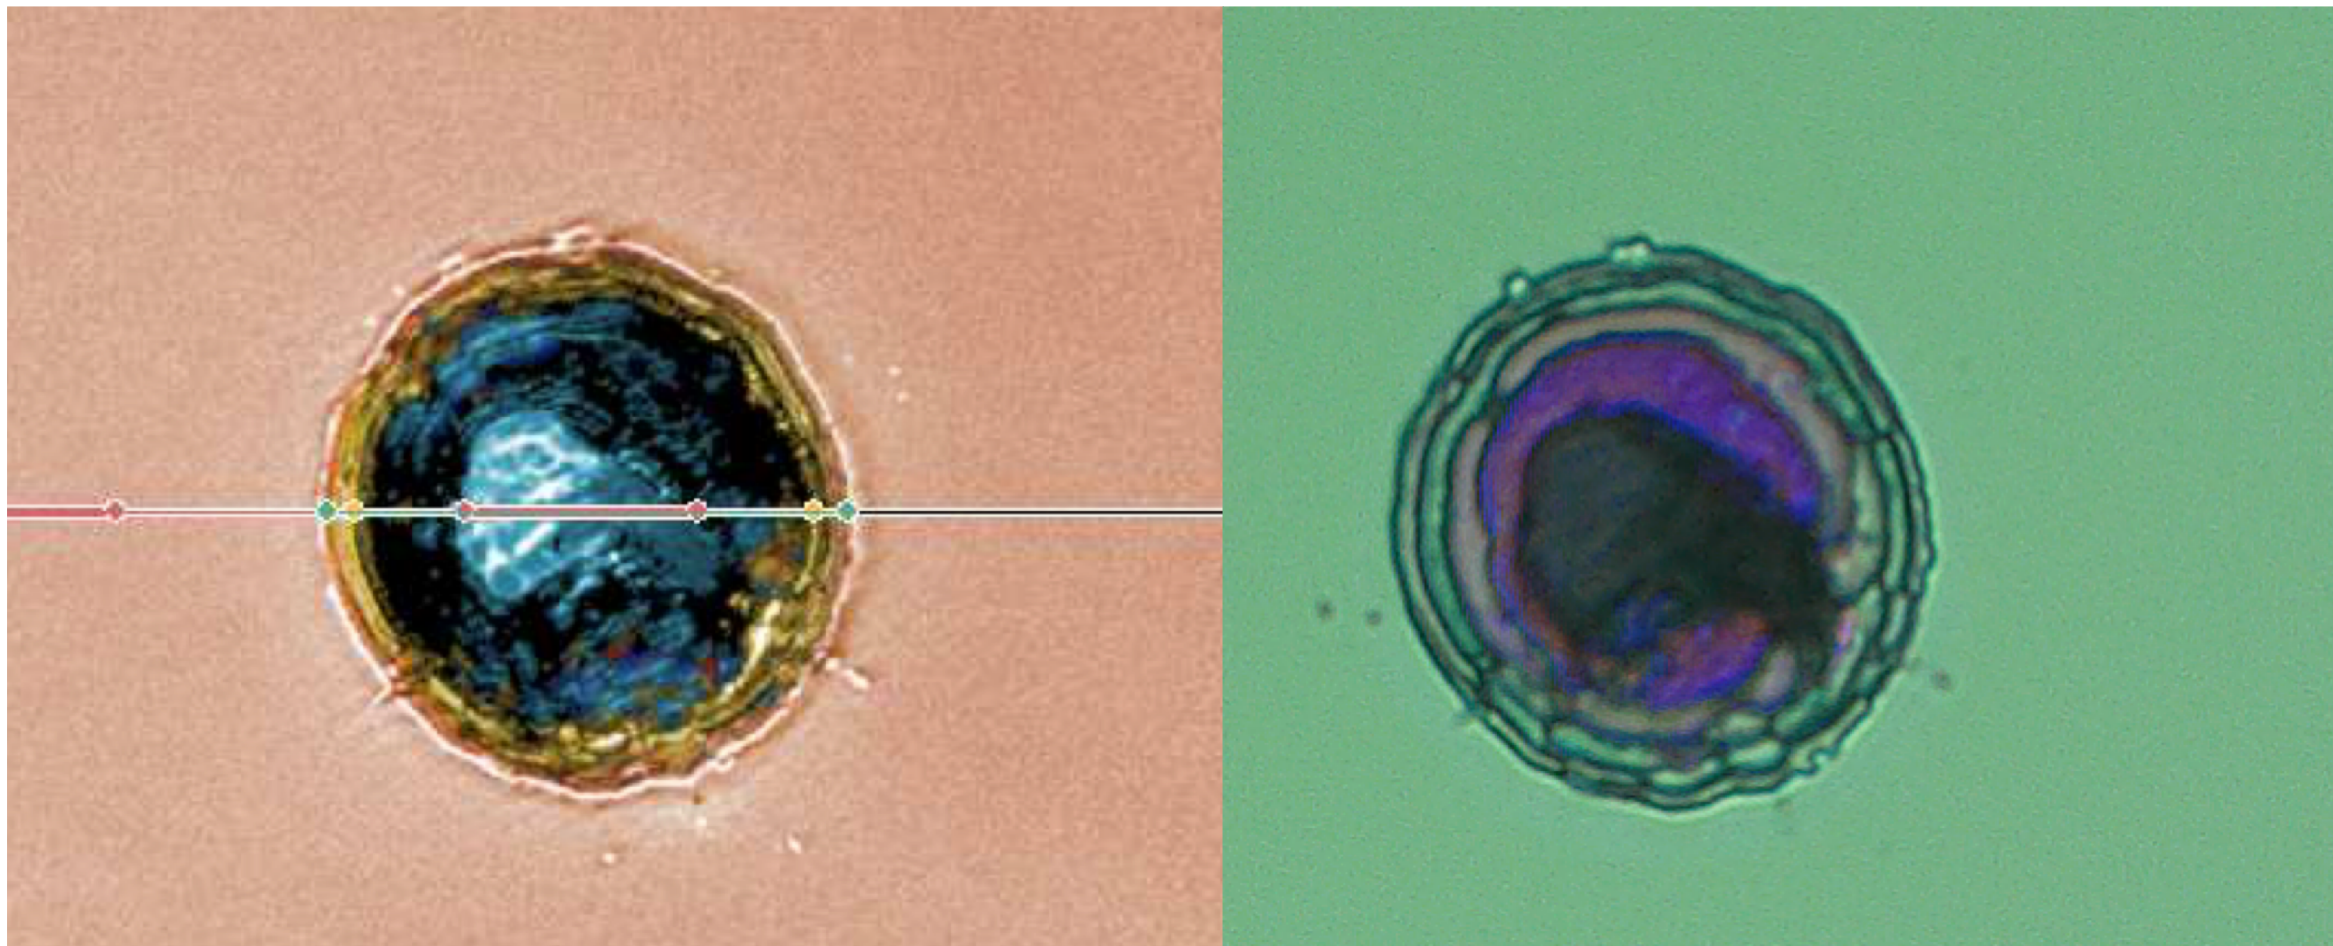
Large spot found in the zone where the absorber was.

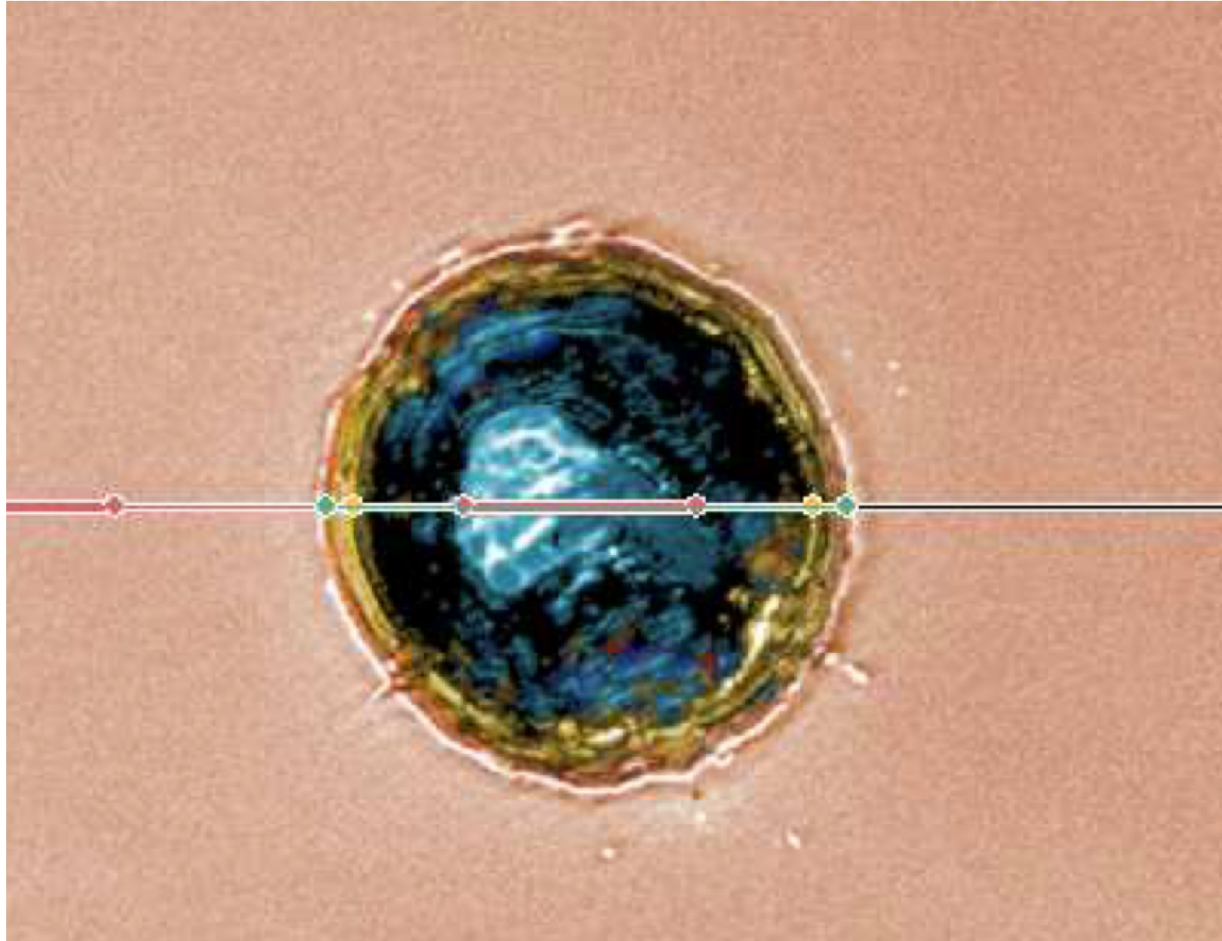
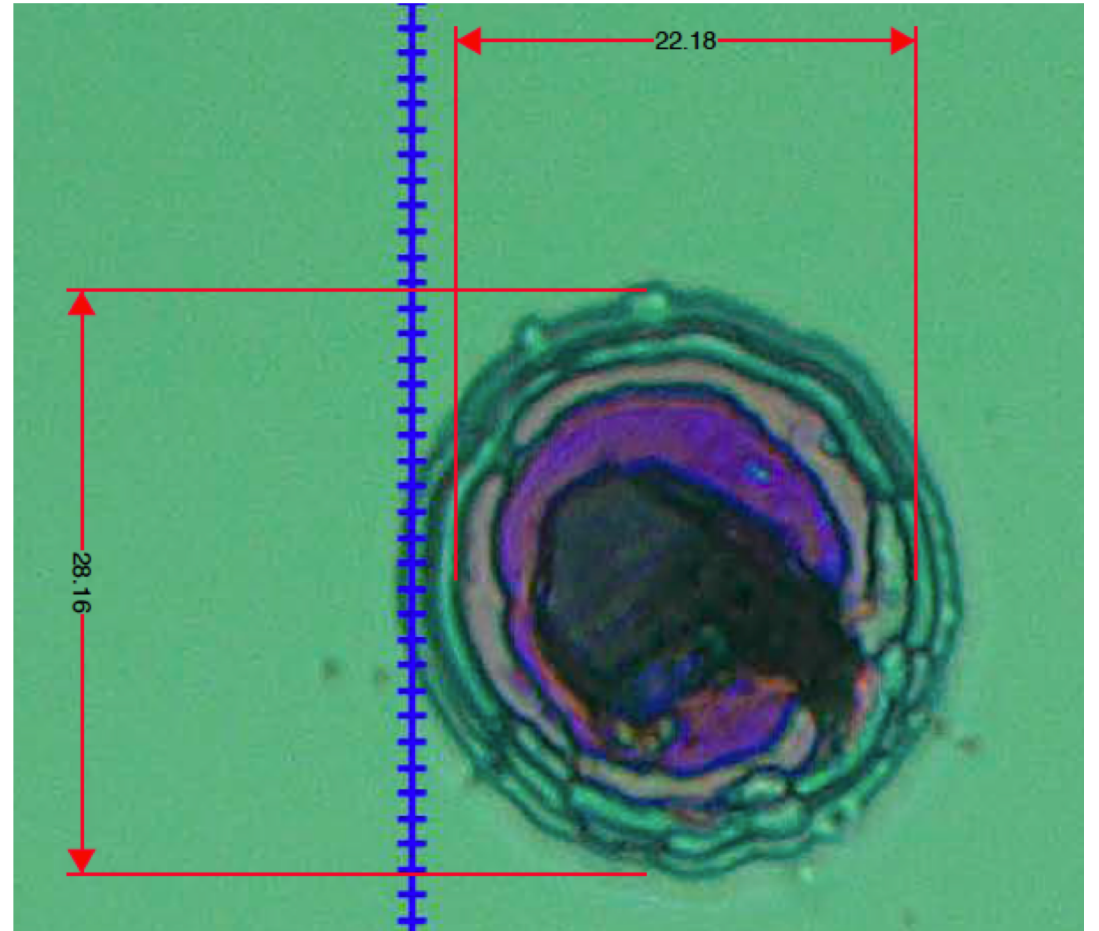
21.67 μm green dots, 22.16 μm horizontal on Keyence

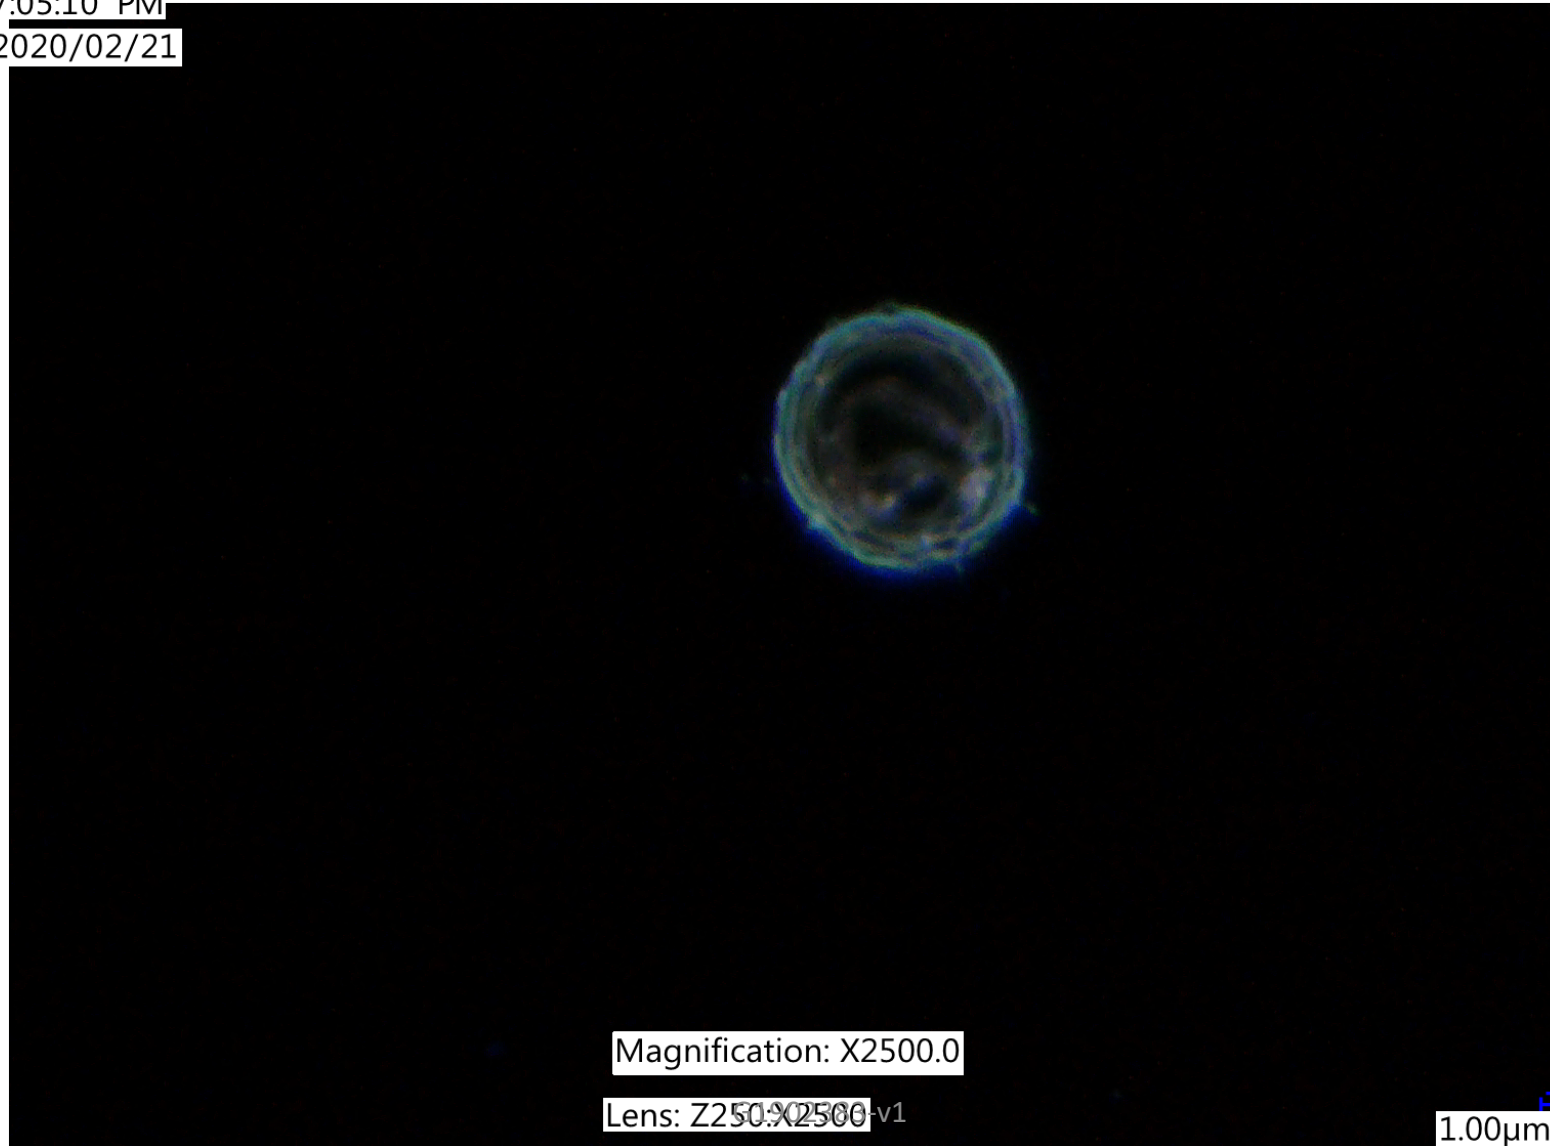
No surrounding scatter appears in dark field view
