T2000526 Ink and First Contact Damage test

[Sample SN 0919](#)

Zhang, Billingsley

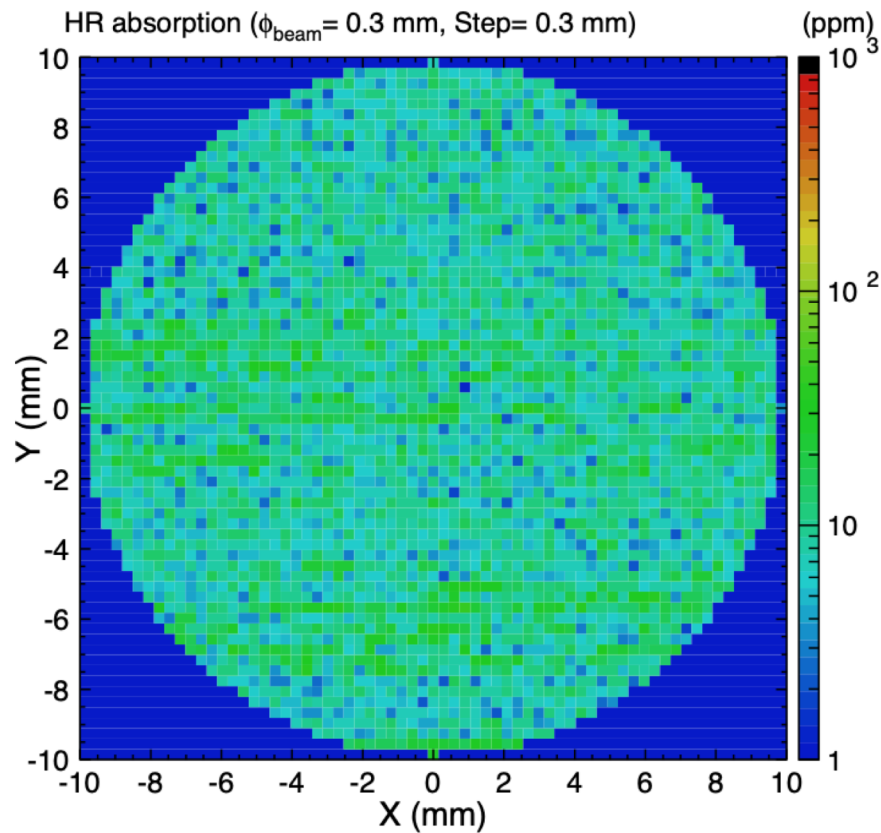
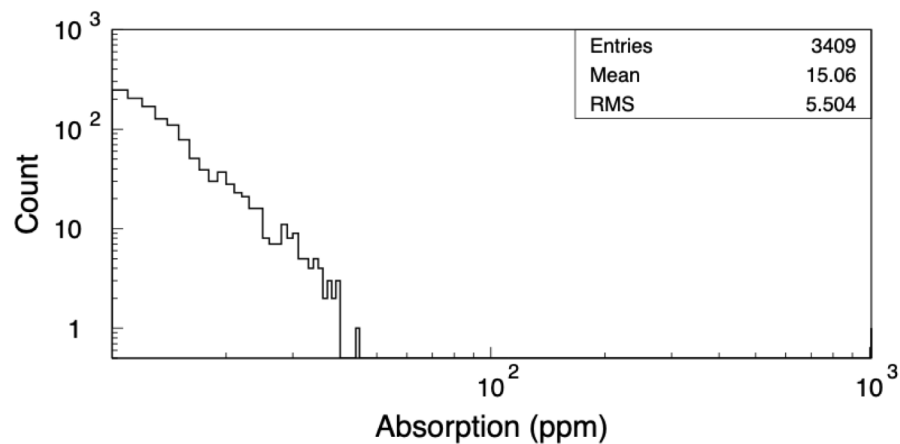
Witness sample 0919 ITM-type HR witness sample, Initial Absorption Scan, no absorbers found

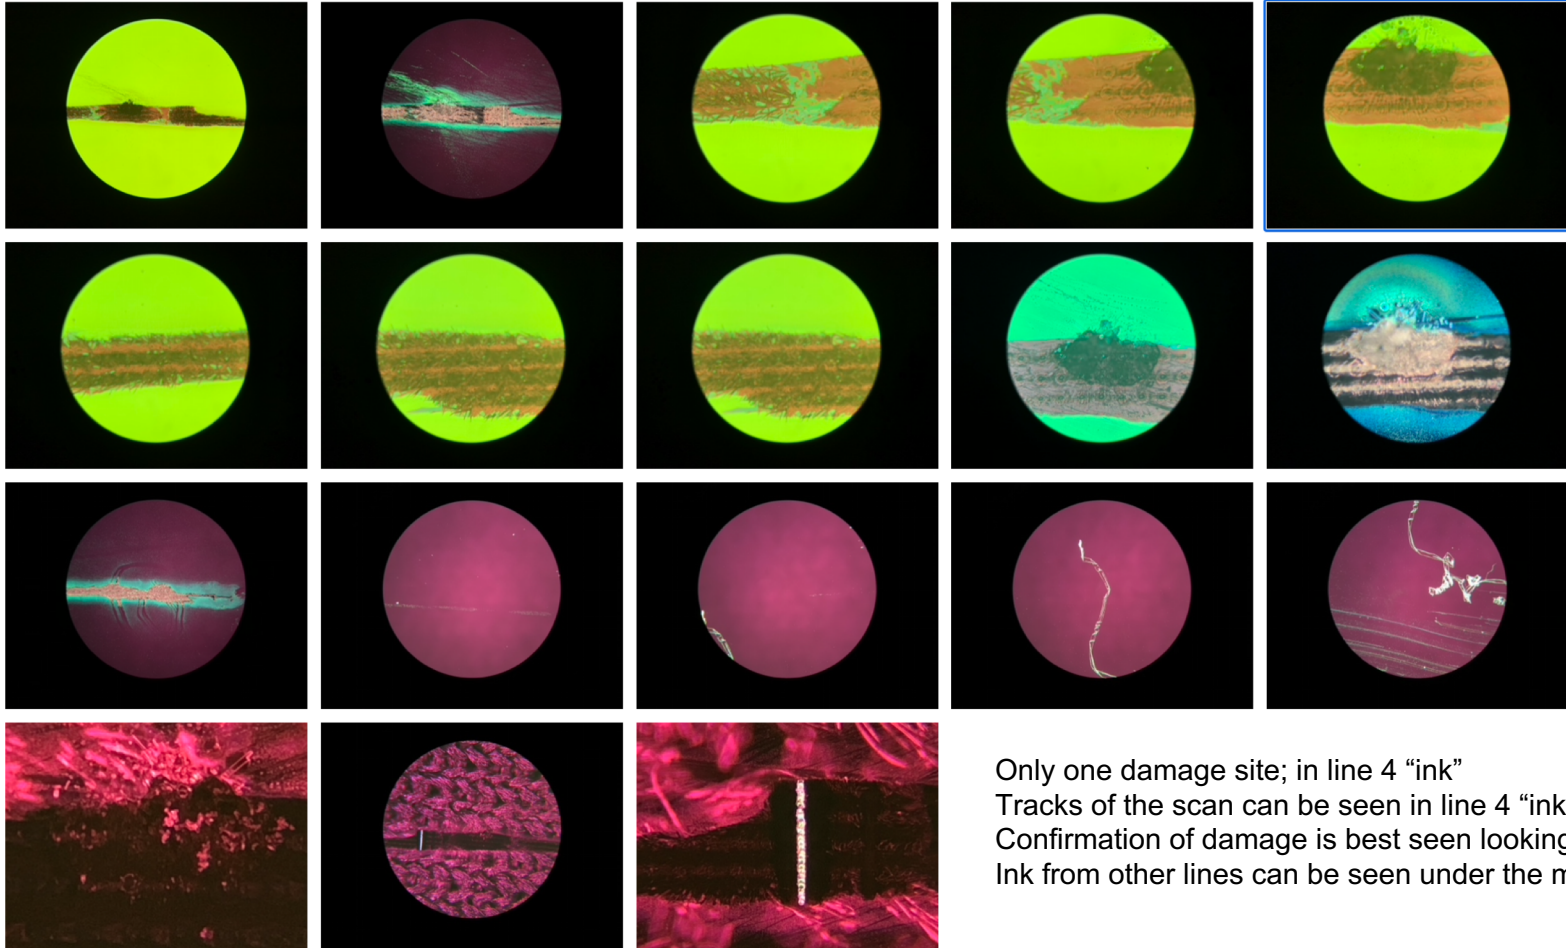
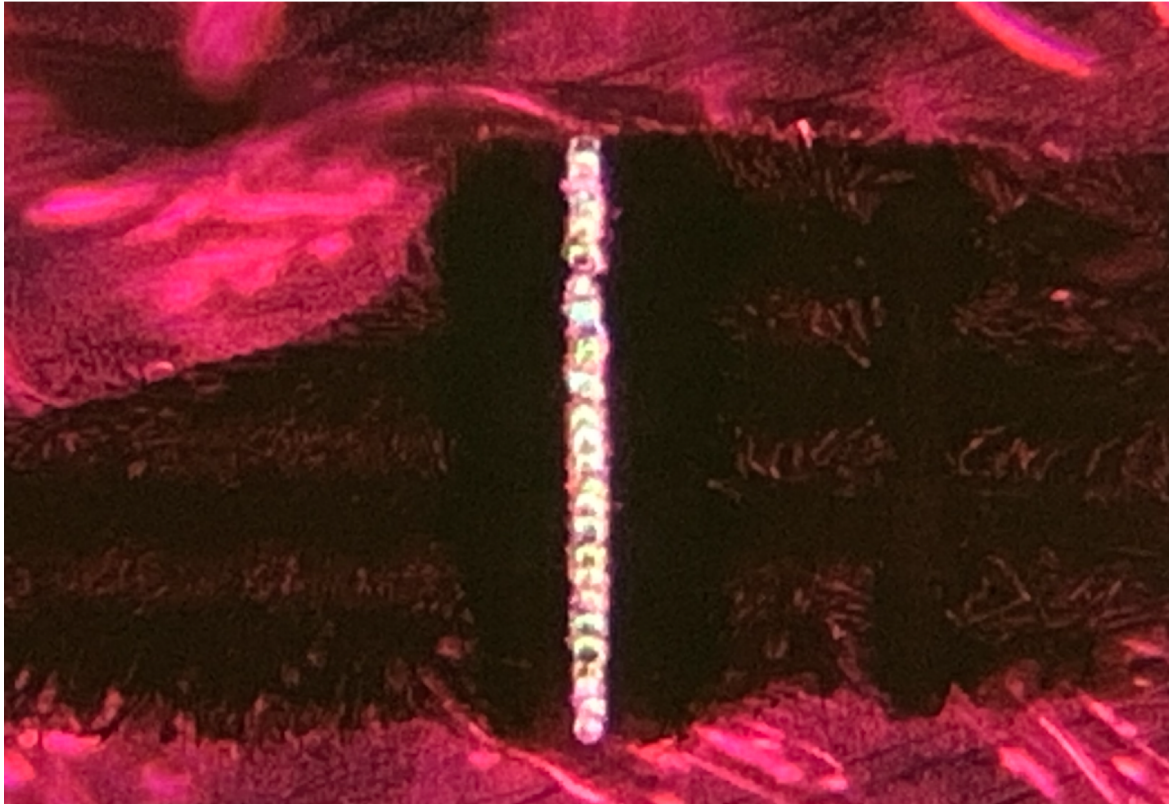
Inspection after 2 W/mm²

Only one damage site; in line 4 "ink"
Tracks of the scan can be seen in line 4 "ink"
Confirmation of damage is best seen looking through the optic.
Ink from other lines can be seen under the microscope

Damage found at $2\text{W}/\text{mm}^2$ in one location. Easiest to see when viewed through the optic
Possibly at another power level, done during stage movement.

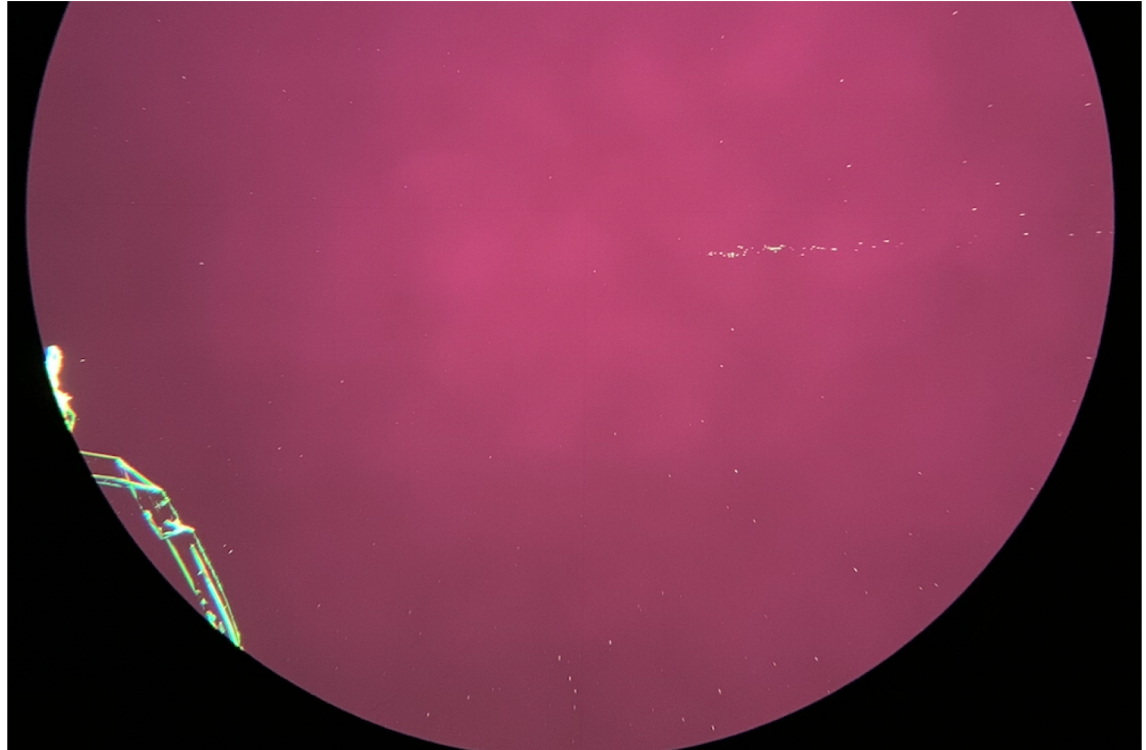
The ghost of line one

A ghost of the first ink line can be seen near some First Contact shards

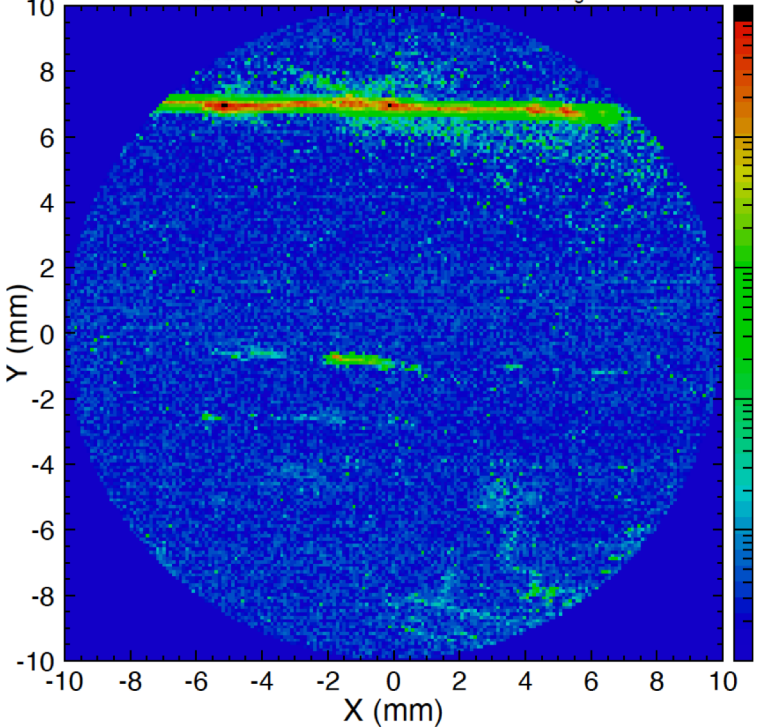
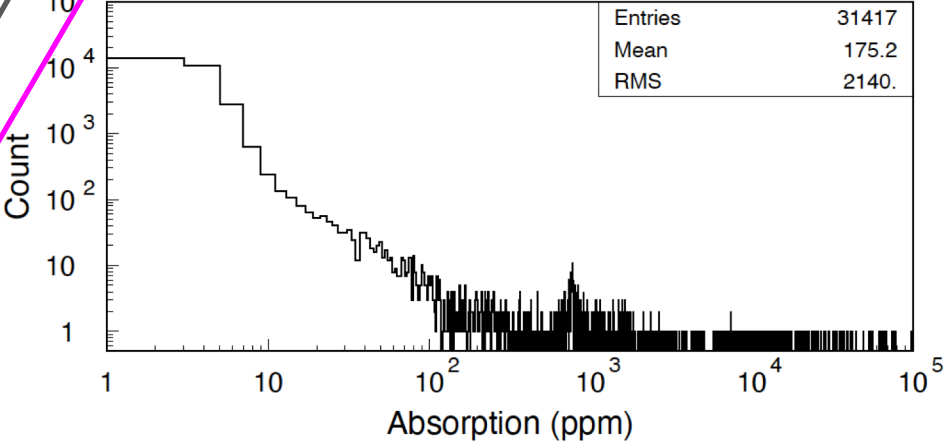
Scan at 20 W/mm²

The four lines can be seen
The first contact can be seen

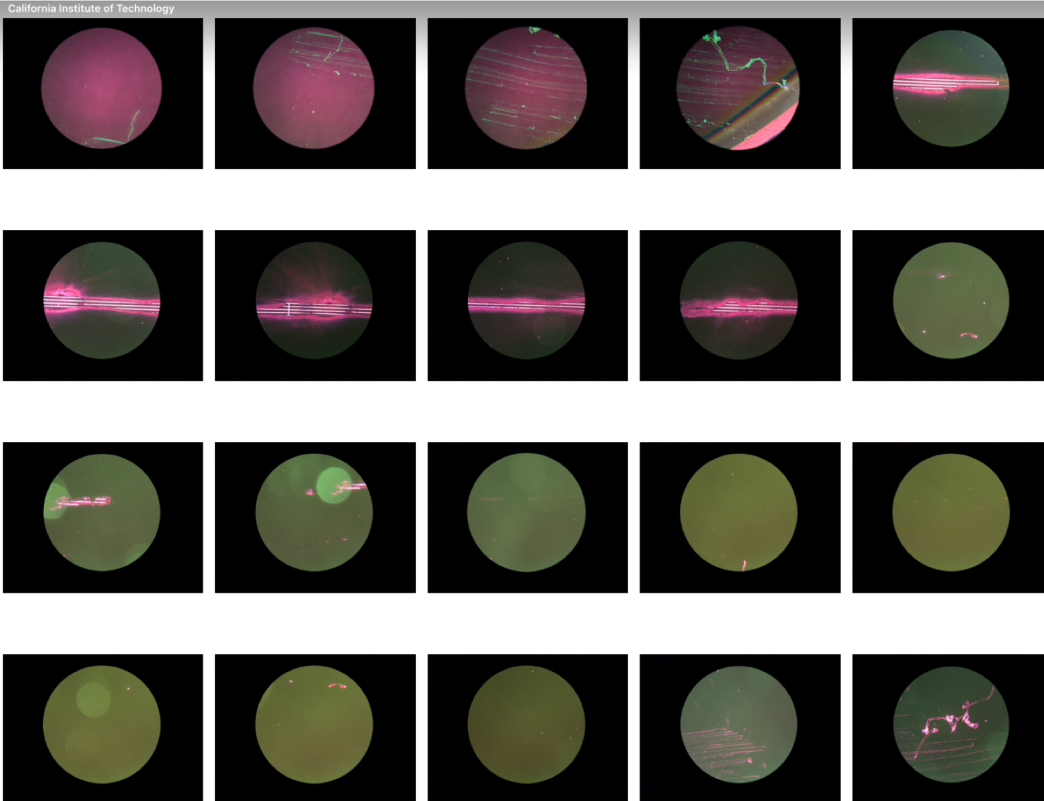
Inspection after 20 W/mm²

Excessive Damage on line 4- Ink
Damage on lines 2 and 3
No Damage on line 1
No Damage in First Contact

Perhaps one damage site that was not on a line? We usually clean before this type of test, but the sample is getting quite dirty. (below)

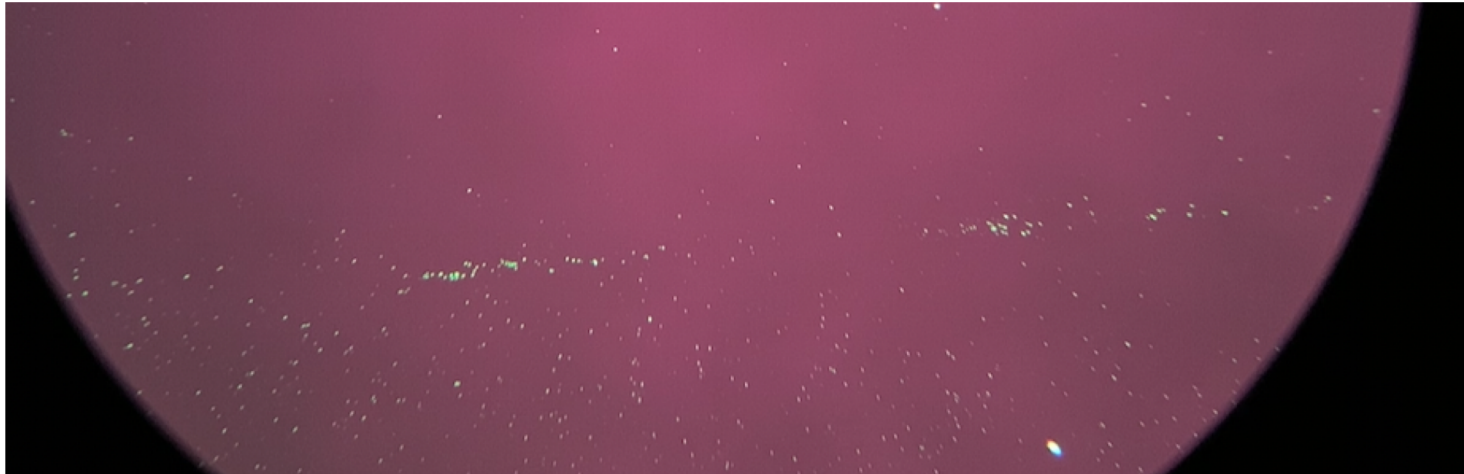
No damage in line 1,

The remaining,
visible part of
line 1 - no
damage

Viewed on the
front of the optic
in dark field.
Cannot be seen
through the optic
(in DF)

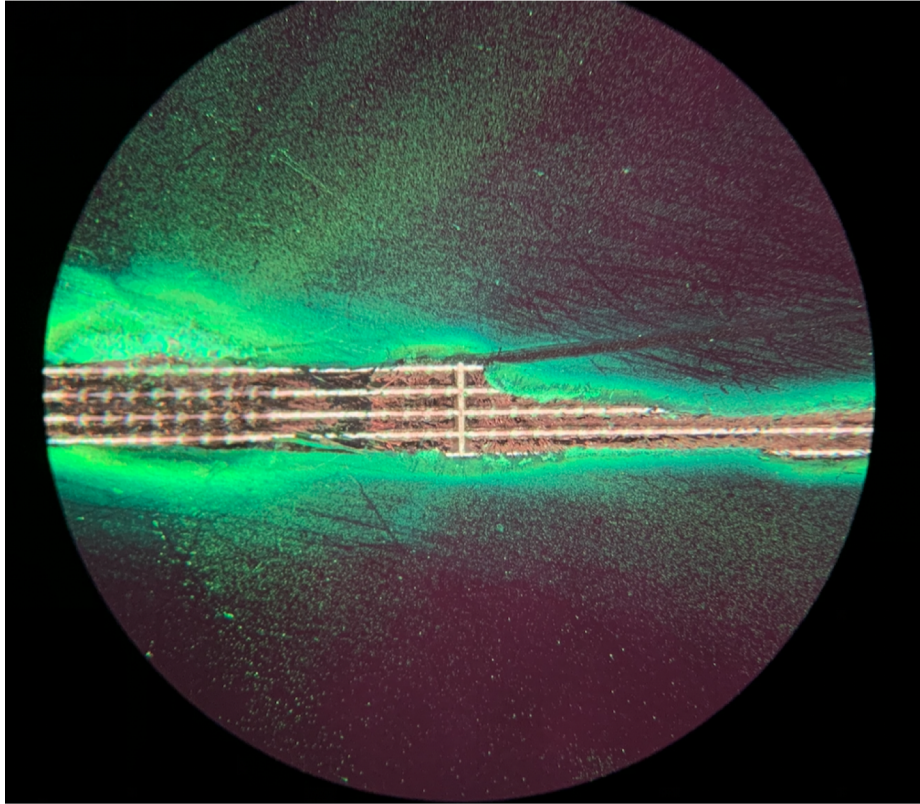
Viewed through the optic in dark field

Small damage site in line 2

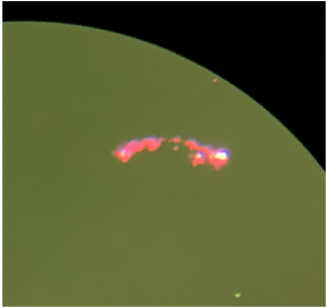
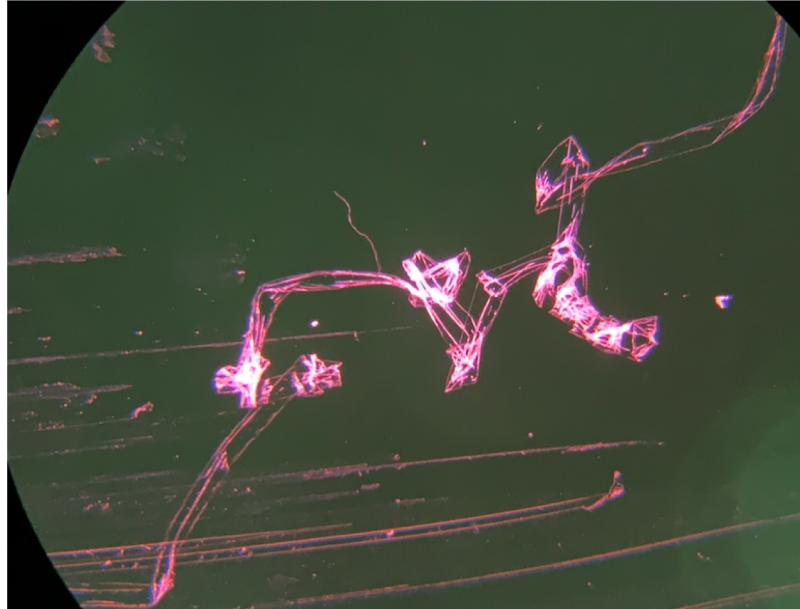
First contact shard shows no damage

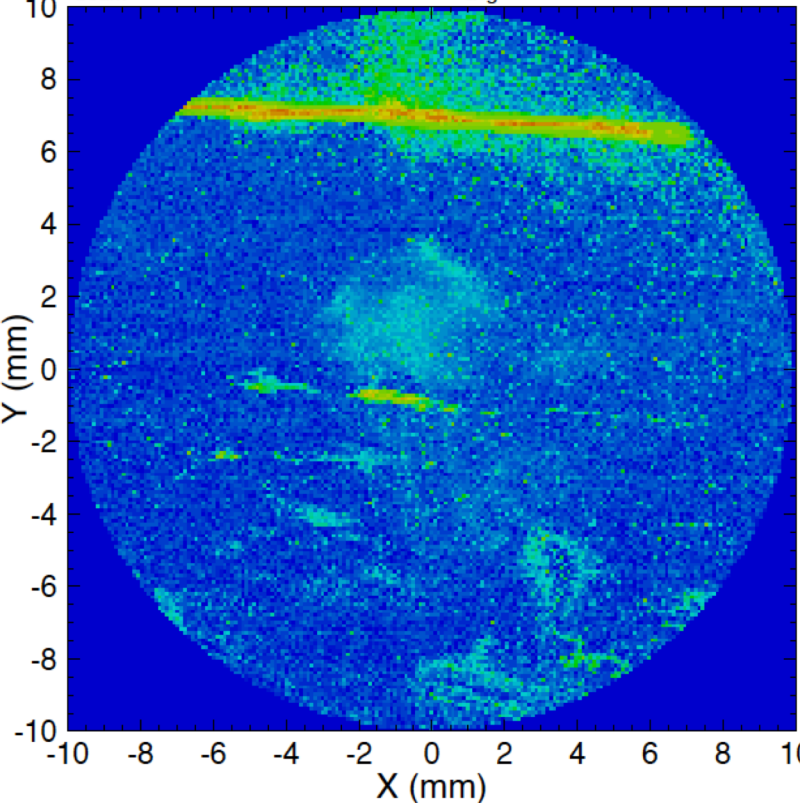
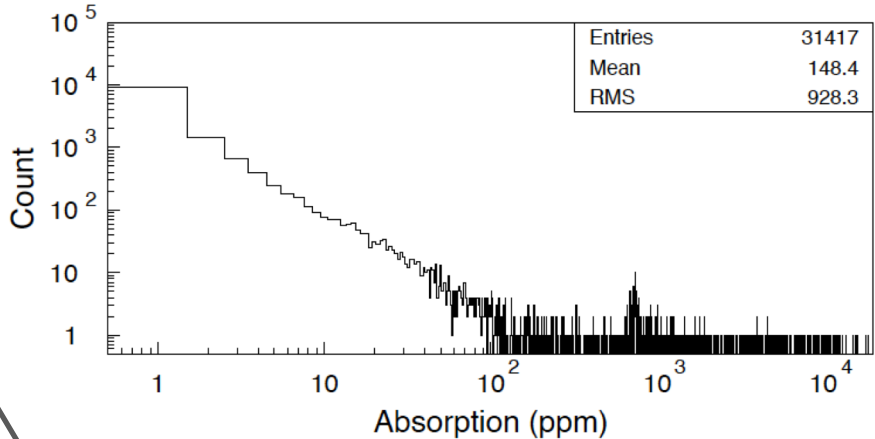
Scan at 200 W/mm²

The optic is quite dirty at this point.
The four lines can be seen
The first contact can be seen

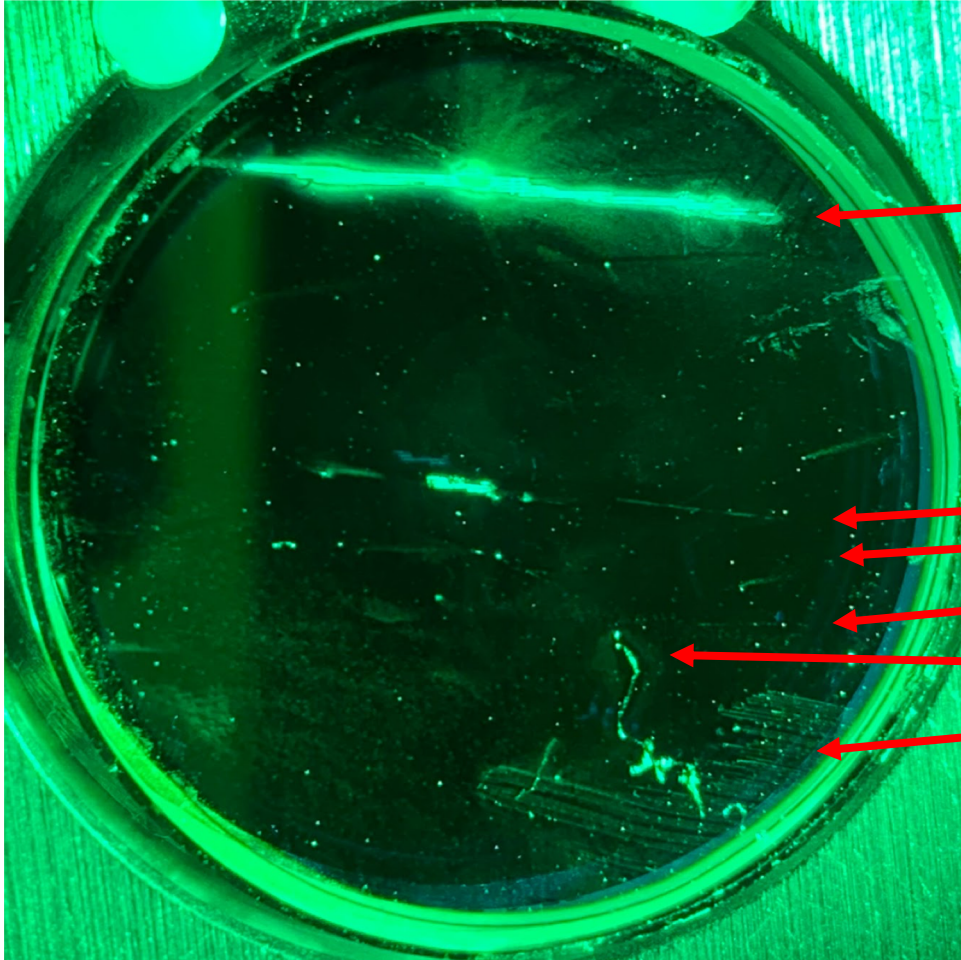
How it actually turned out - after all damage runs

All lines are at least partially visible, even with the high background from the mount and the damage

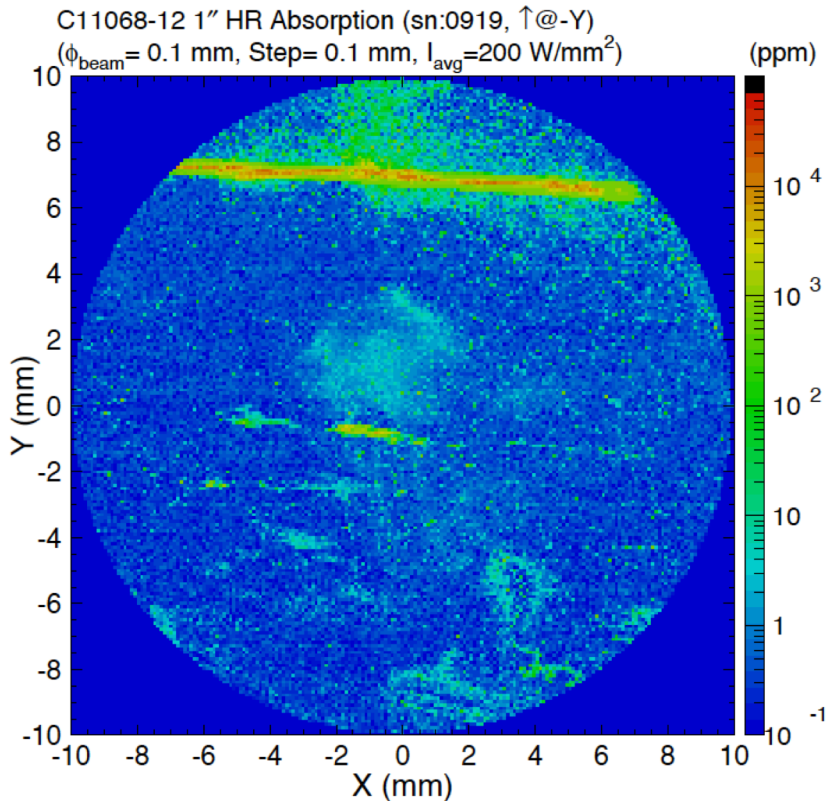
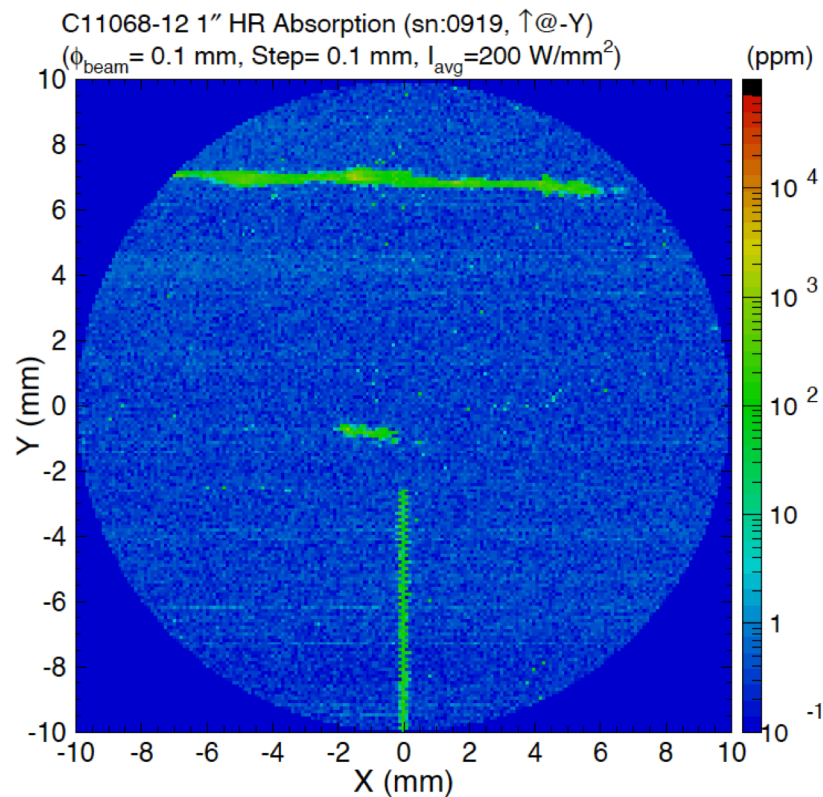
Comparing before/after cleaning

Accidental damage occurred after cleaning at (0,-y) when irradiated with 2000 w/mm^2 Not clear if there is still absorption, or if the signal comes from distortion

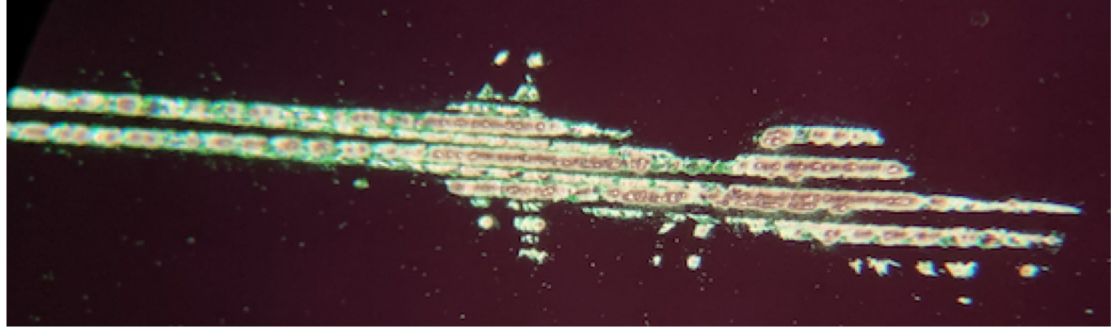
Damage filled with first contact after cleaning

Attempted Cleaning:

1. Acetone Soak in ultrasonic bath ~ 1 hour
 - a. No noticeable change
2. First Contact thinner in ultrasonic bath ~ 1 hour
 - a. No noticeable change

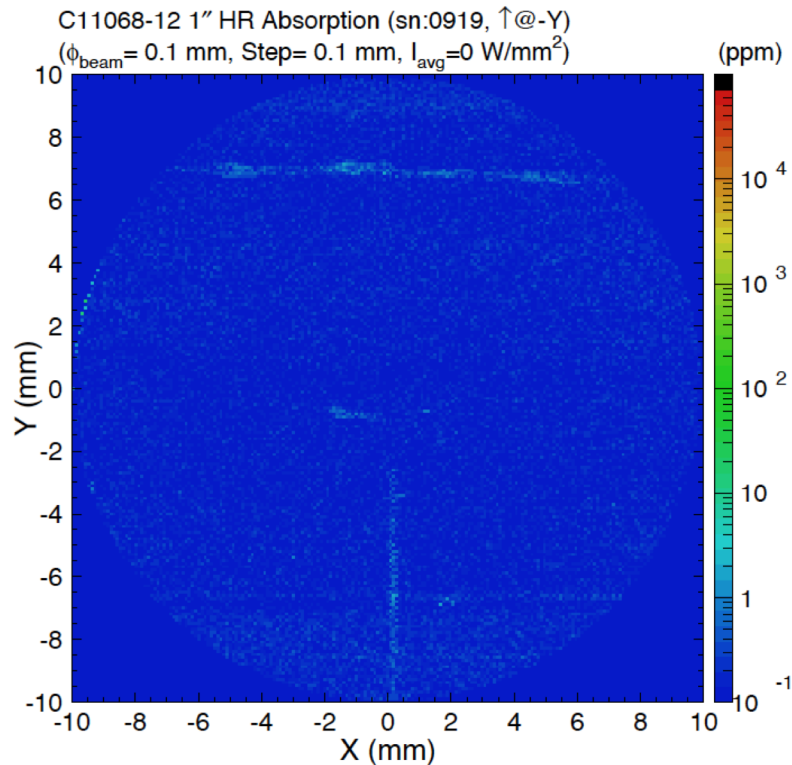
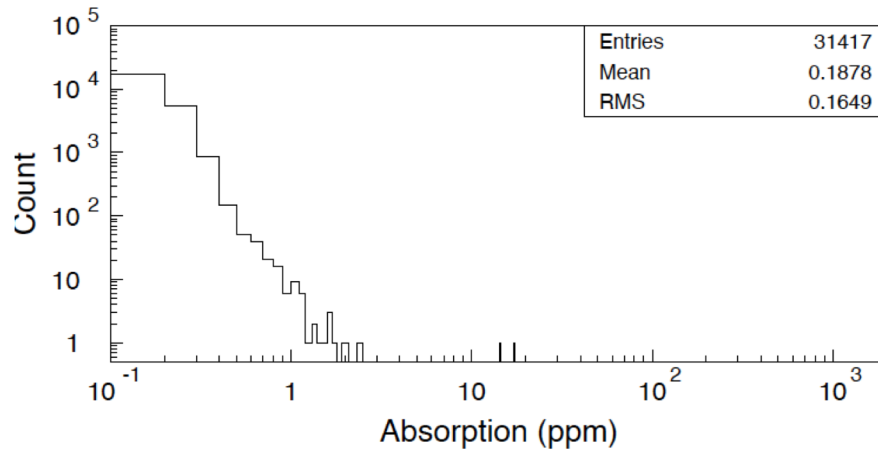
An RTS scan with the IR (pump) beam off.
A slight increase of the background at the damaged points is due to lower He-Ne transmission, making the noise equivalent absorption appear larger.

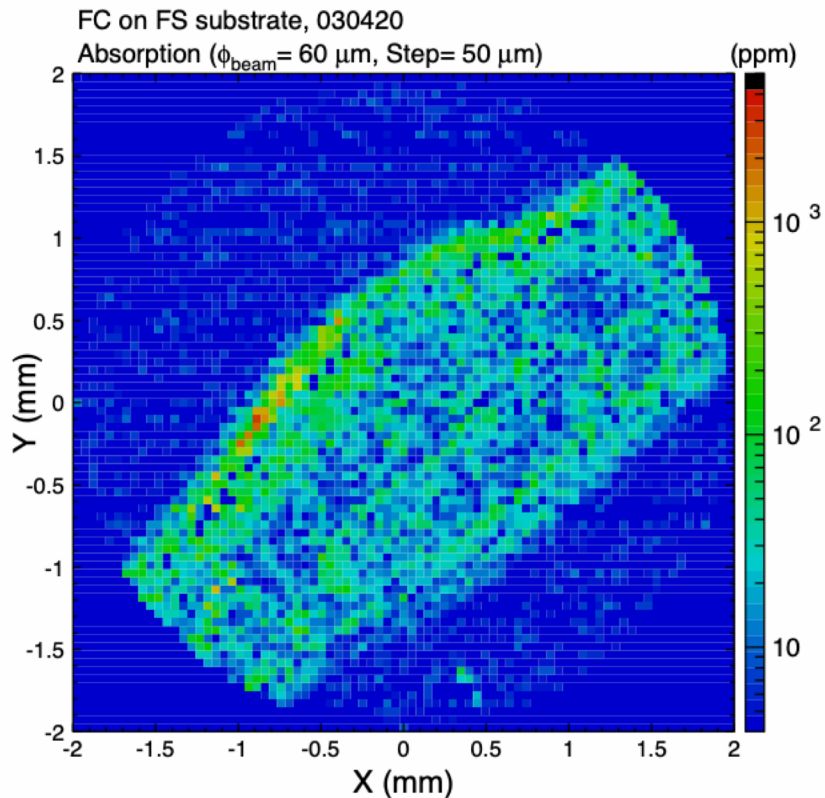
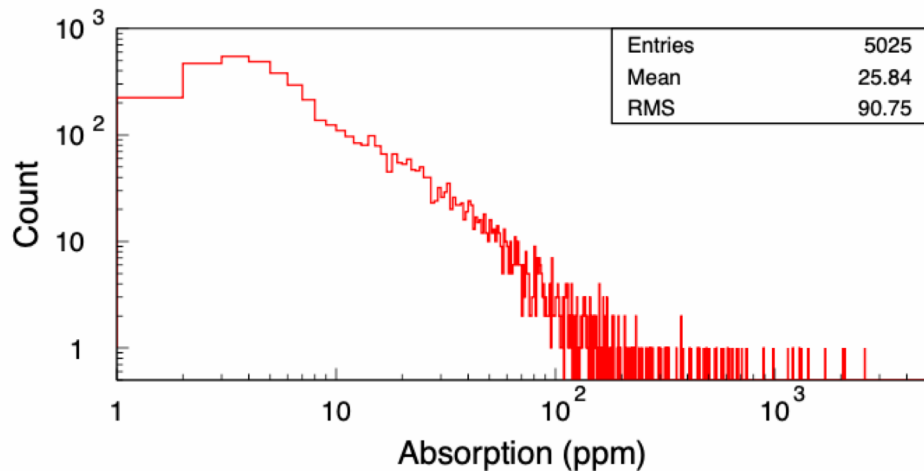
First Contact absorption on an uncoated optic 60W/mm²

No damage identified after FC removal
