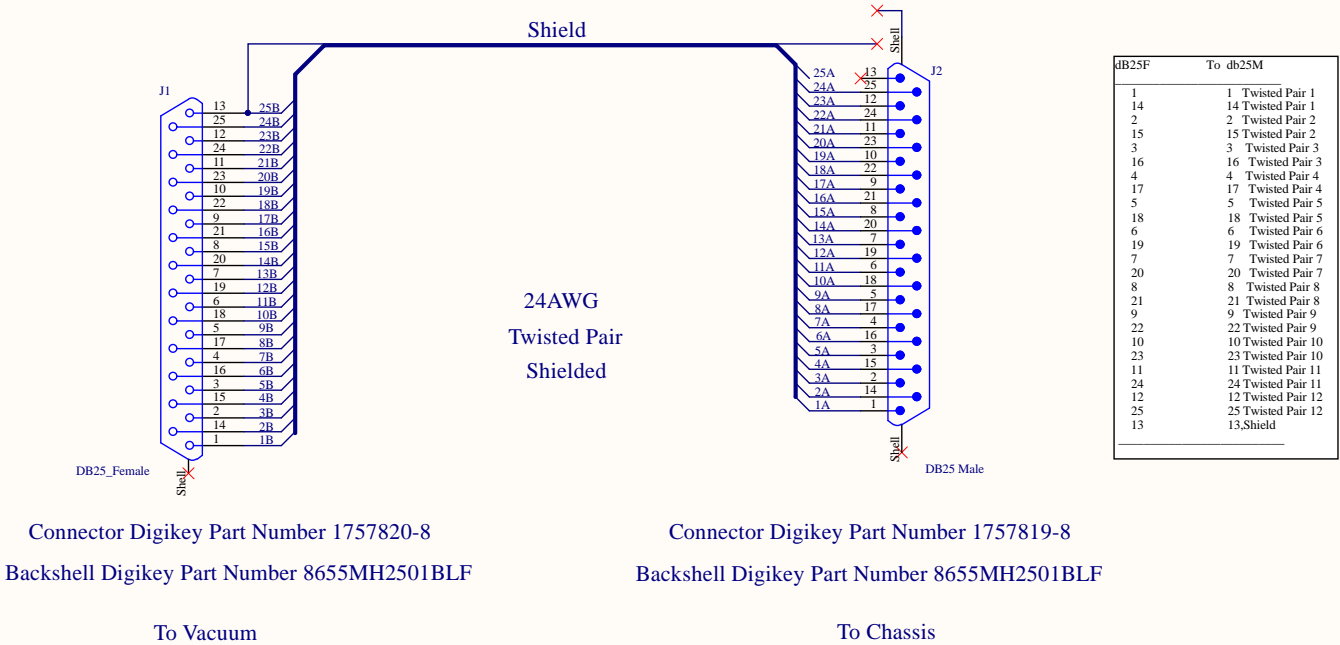
For A+ BOSEM connections, On male connector pin 13 was extracted and the shield was removed, to prevent a BOSEM-C gnd loop.  
LHO cables affected are:  
SUS\_FC1\_001, SUS\_FC1\_002  
SUS\_ZM1\_001, SUS\_ZM2\_001, SUS\_ZM3\_001, SUS\_ZM4\_001 and SUS\_SQ\_002.  
LLO cables affected are:  
SUS\_FC1\_001, SUS\_FC1\_002  
SUS\_ZM1\_001, SUS\_ZM2\_001, SUS\_ZM4\_001 and SUS\_SQ\_002.

E2100504 shows the fix.  
T2100465 describe the gnd loops in BOSEM-C.  
D2000202 shows the HAM7 wiring diagram concept.
