Point Absorber Update NSF Review June 2022

Addressing Charge 2.D

Absorber Summary

LIGO-G2200853

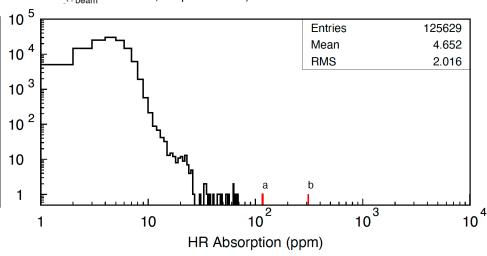
ETM08 HR Absorption, 052722 (\uparrow @Y+) (ϕ_{beam} =0.30 mm, Step=0.20 mm)

First Result is "good enough" – ETM08

- 2 PA found on RTS using gentle absorption on 80 mm ø
 - a. \emptyset 3.2 µm, r = 24 mm
 - b. \emptyset **5.4 µm**, r = 25 mm
- Max allowed "equivalent diameter" 12.6 µm
 - Assumes 100% absorption by defect

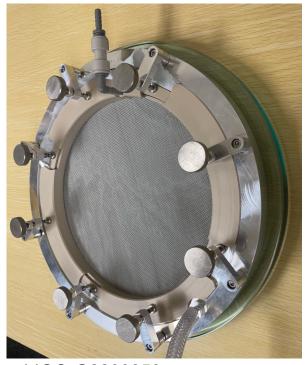
Improved cleaning

Vertical pour of First Contact Thicker layer = better cleaning Better layer removal

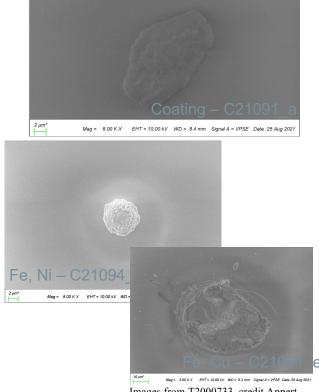
- Composition has been investigated for features on 15+ optics from a wide range of coating runs.
 - O Cataloged at T2000733
- Many absorbers are
 Aluminum, many have Carbon, and we have also seen
 Titanium, Copper, Iron, Nickel.
- Many absorbers appear to have compositions similar to coating layers.
