Abstract:

The purpose of this document is to depict a general set of needs & ideas, and to support dialog, regarding provision of necessary floor & elevation space for the proposed LHO aLIGO Optical Lever and Photon Calibrator installations.

LIGO-G1000103-v2

Advanced LIGO

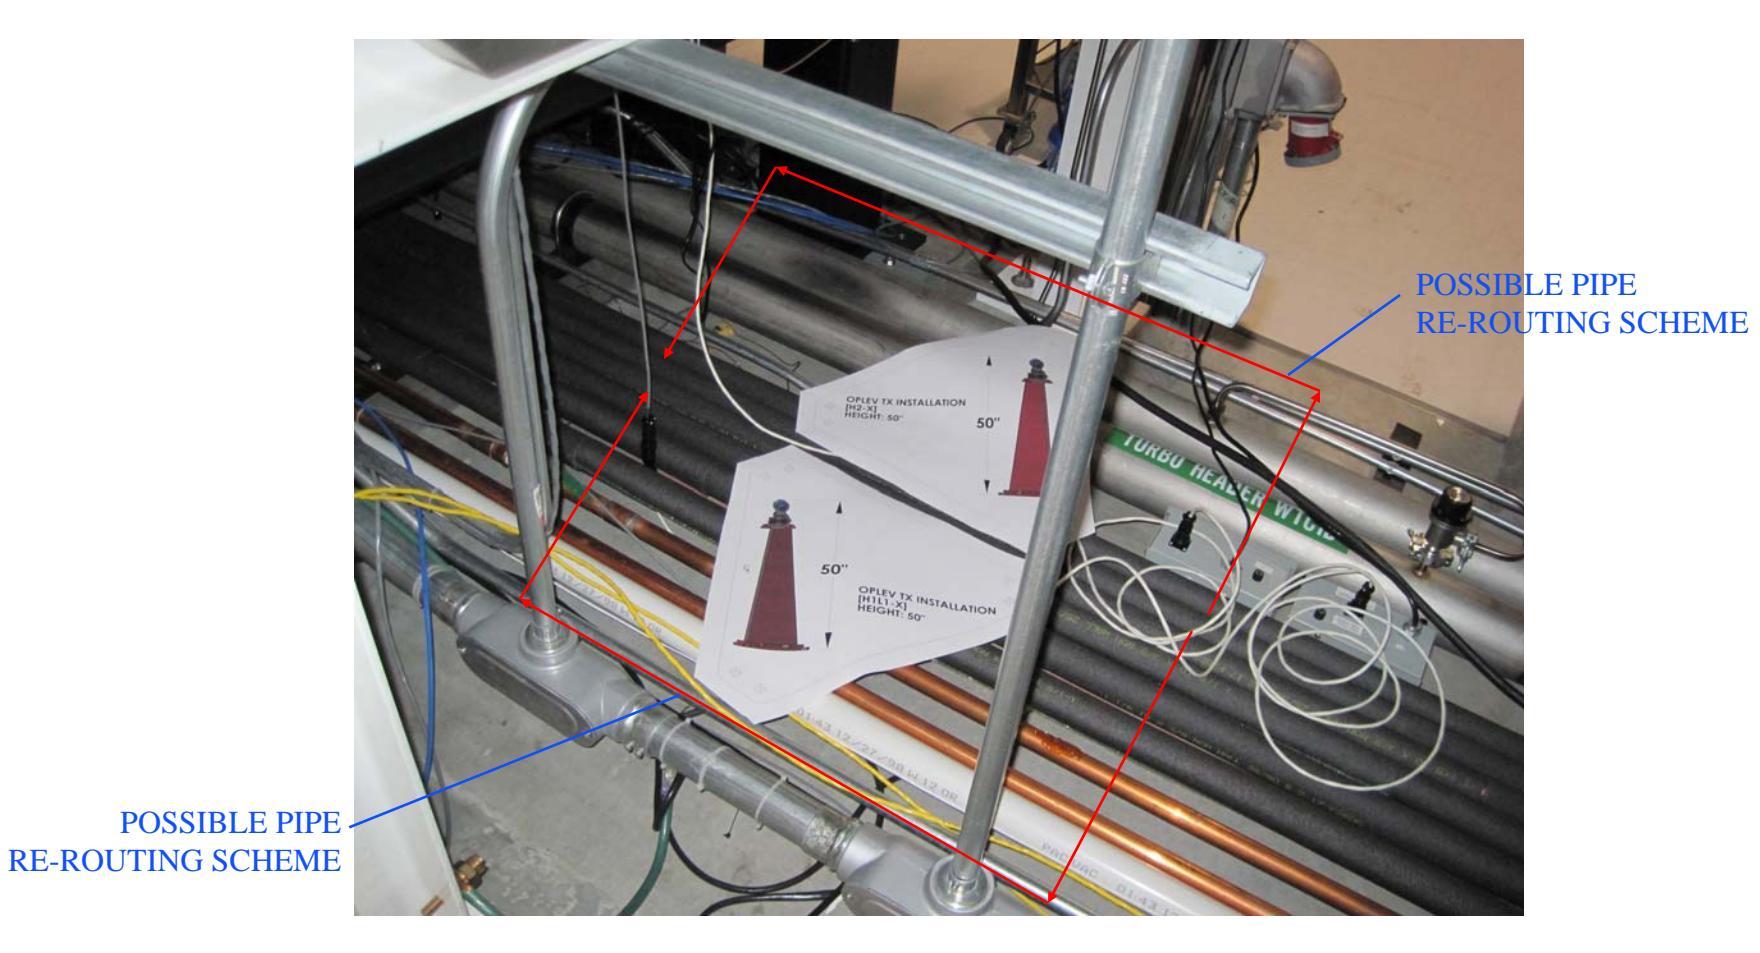
The following photos depict the problems facing the LHO X-arm ITM Optical Lever installation. These involve piping and possibly aLIGO TCS camera installations.

The preceding page photo depicts the floor plans (with embedded elevation views) of the LHO H1&2 ITM-X Optical Lever launchers. They are placed about 2 ft. longitudinally right of the design location WRT/the beam tube. The current-LIGO Optical Lever installation is at the design location. As can be seen, the new installation will necessitate local re-routing of at least eleven pipes including 4" & 6" vacuum/clean air pipes. The re-routing will need to preserve space for the new receiver installations with leaning piers on either side of the manifold end section. Pipes may need to be arranged vertically in some places.

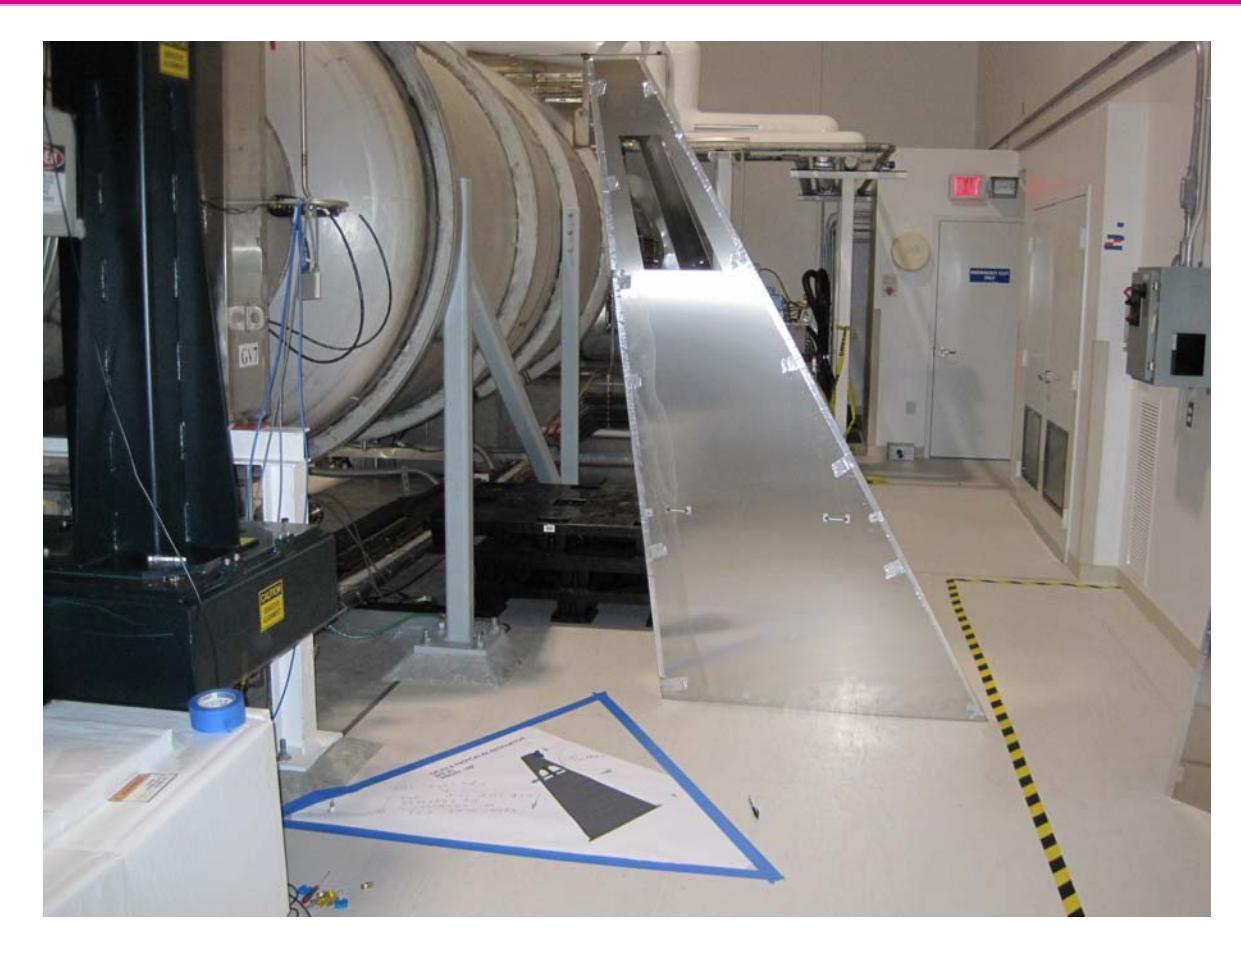
The preceding photo shows a left hand receiving pier mock-up. On the floor is a footprint & elevation view offset longitudinally ~2 ft. in the direction of LHO GV7. The green current-LIGO Optical Lever installation can be seen at the design position. A current-LIGO TCS installation is shown at the left of the frame with the camera near the top.

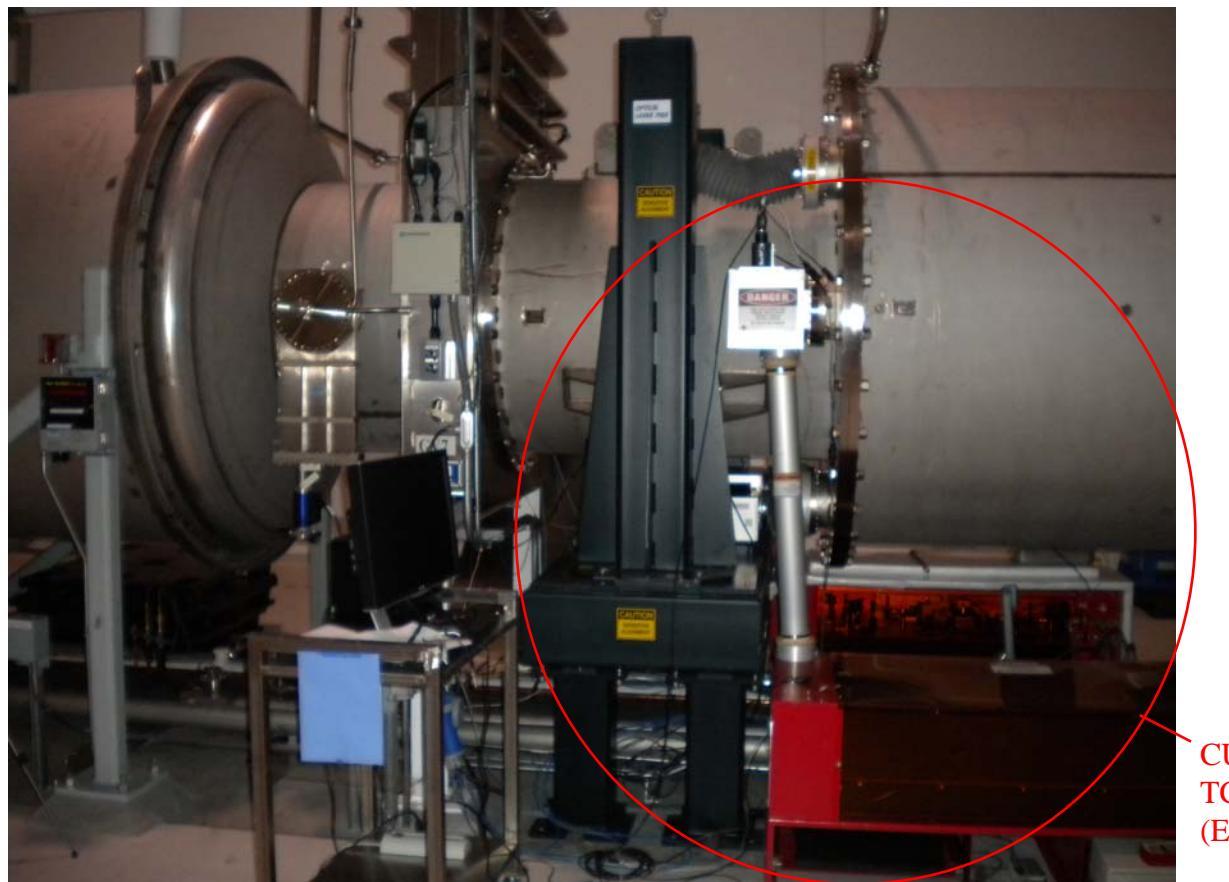
CURRENT-LIGO TCS SYSTEMS (EACH SIDE OF ARM)

The following page shows a current-LIGO TCS installation on the H2 side of the of the arm in the same general location discussed. As mentioned, the yet TBD aLIGO TCS installations may conflict with space for Optical Lever receivers, which use the next higher viewport above the TCS camera shown.
