ELIGO 35W PSL Report

Anamaria Effler, LIGO Hanford Observatory

G0900223 LVC Meeting Mar 2009

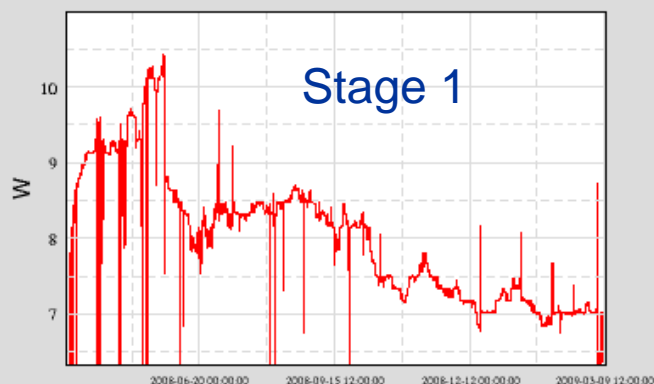
Ch 3: H1:PSL-AMP_PWR1

- We installed our own PD for laser output
- Pickoffs drifted out of calibration immediately
- Table Power measurements:
 - 35.5 W Mar 08
 - 34.8 W Jul 08
 - 33.0 W Dec 08
 - 31.7 W Mar 09
- Output power 10% down
- New water-cooled power meter

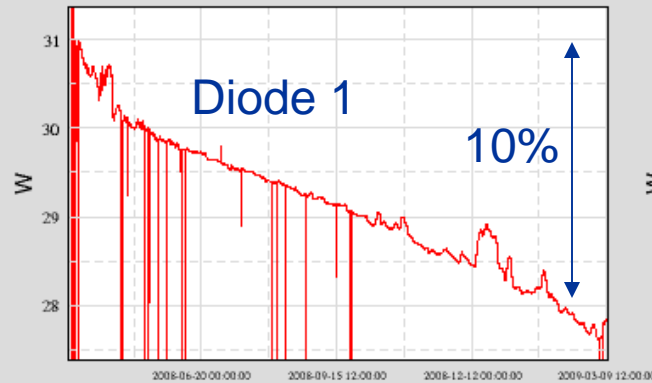
Ch 10: H1:PSL-AMP_D1PWR

- The pump diode powers have trended down ~10%
- No change in diode currents (47 amps)

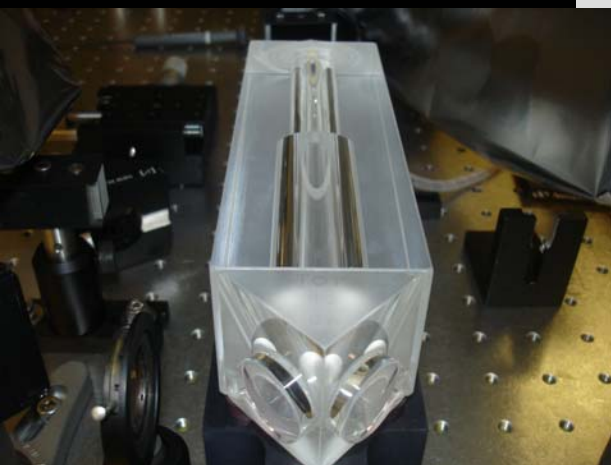
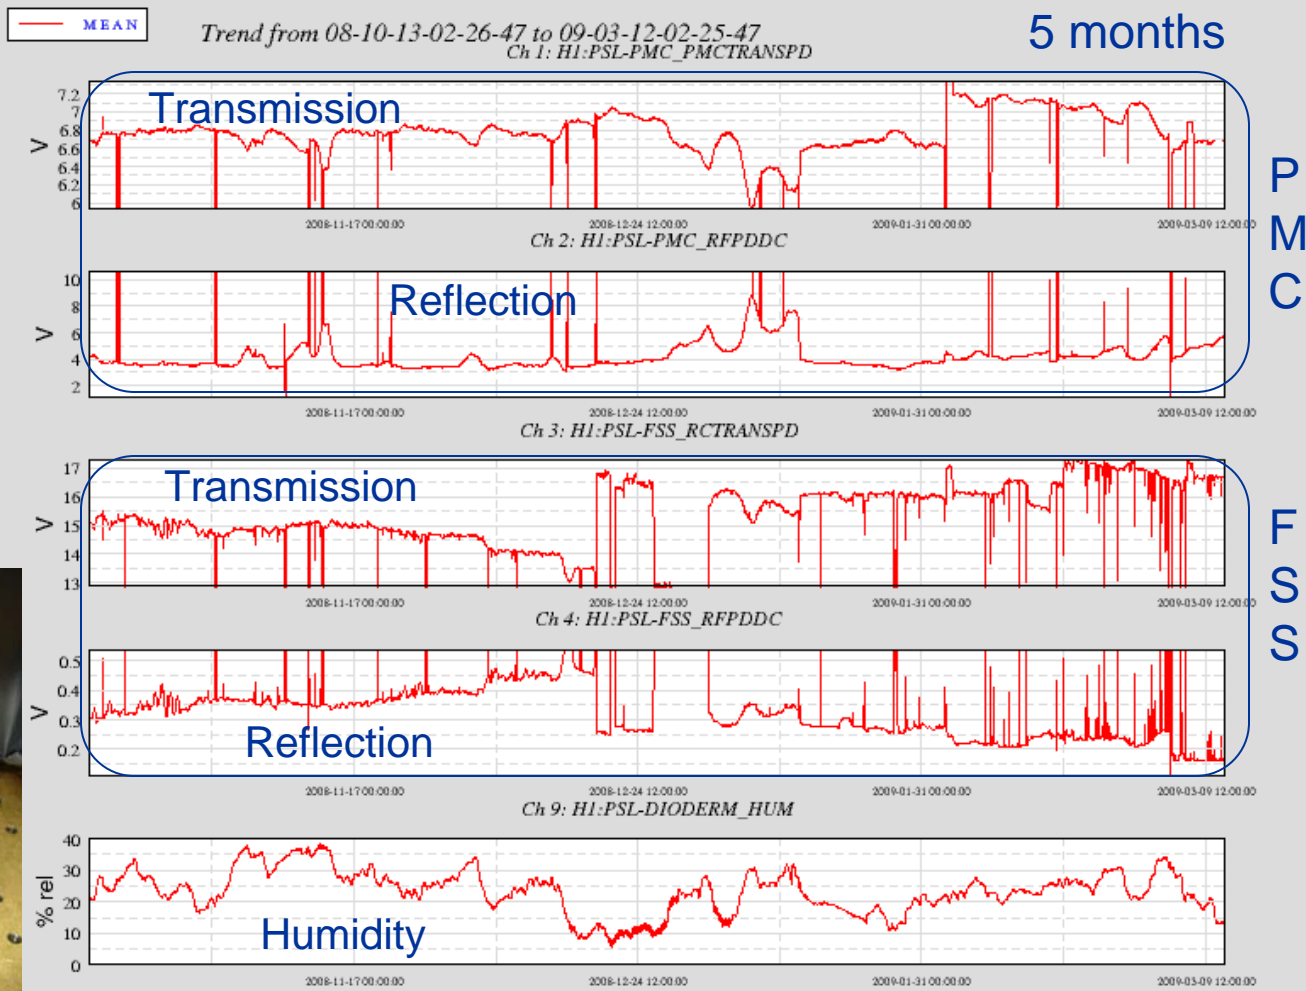
- PMC output power varies by up to 10% over ~week periods – correlated with relative humidity

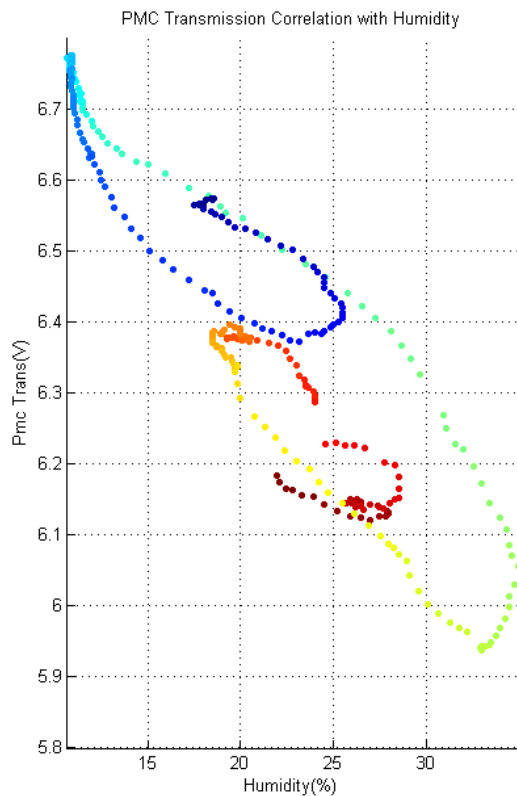
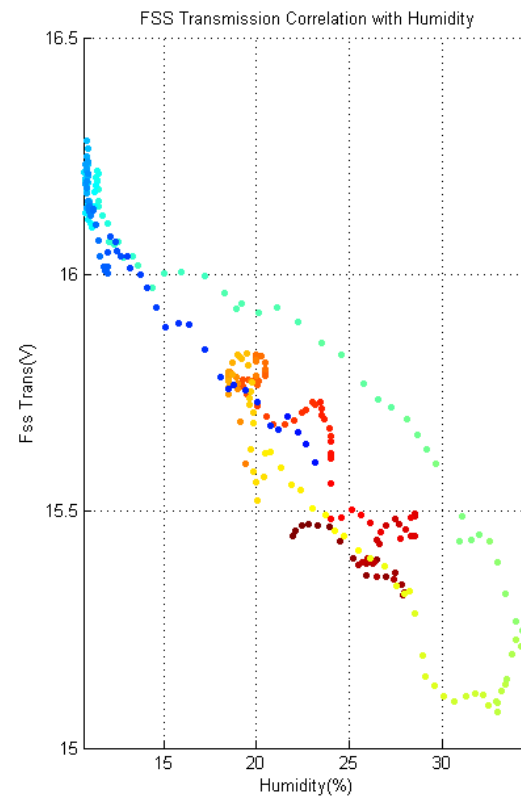
- Scatter plot of PMC trans and FSS trans versus humidity before polarizer replacement

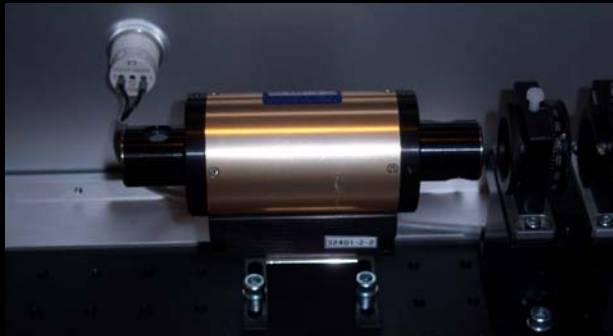
- LZH identified glue in polarizers in the Faraday isolator as source of pointing variations

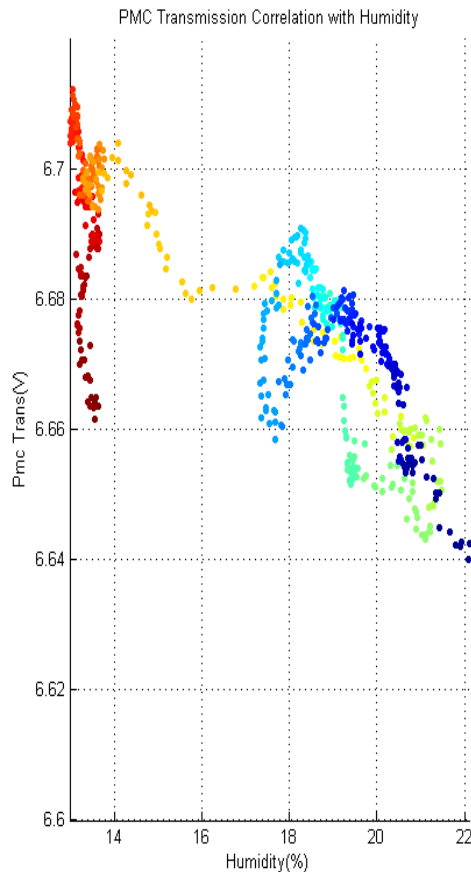
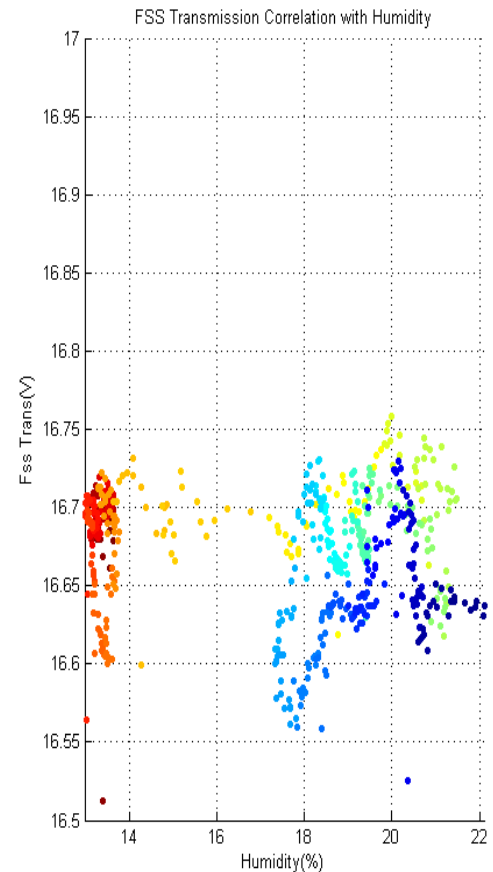
- Scatter plot of PMC trans and FSS trans with humidity after polarizer replacement

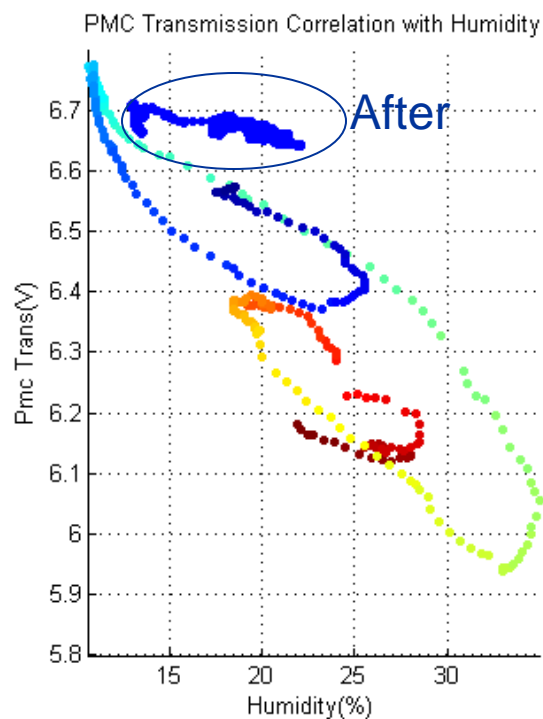
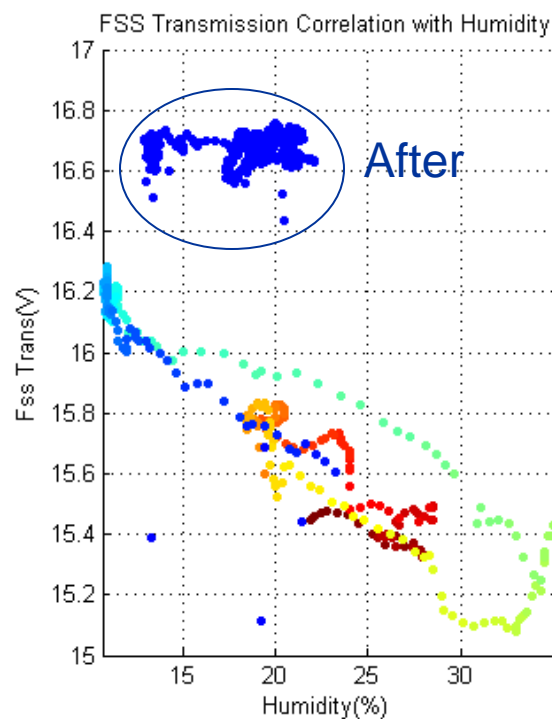
- Before and after on same plot
- Notice decrease in slope
- Not enough data yet for more analysis

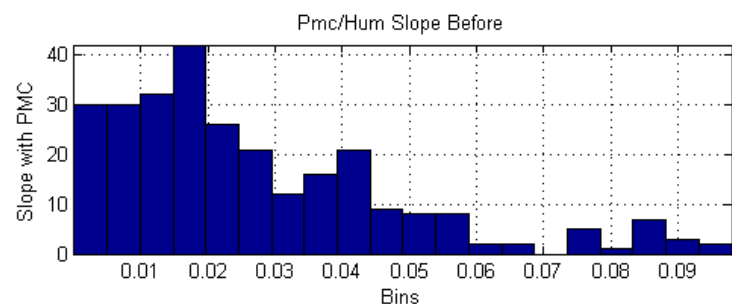
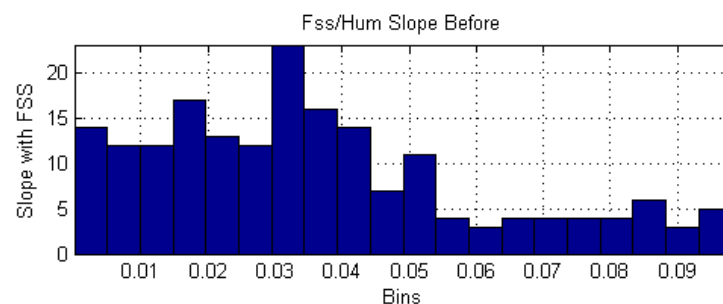
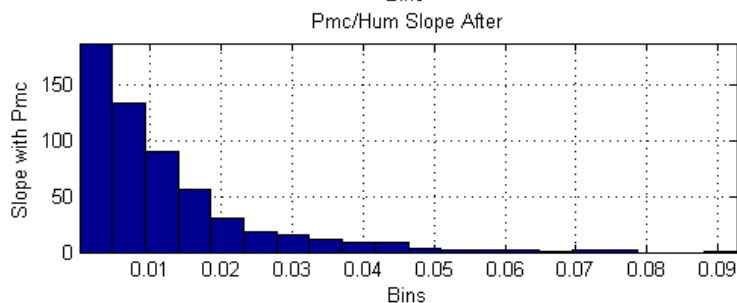
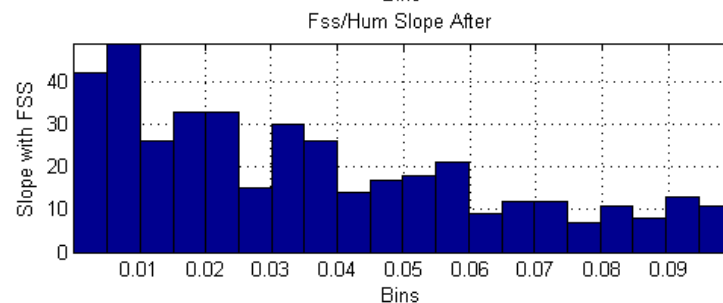
- Try to calculate a slope over 4 points of the data shown
- Bin it to see change before and after
- Not very clear for FSS, but smaller for PMC correlation

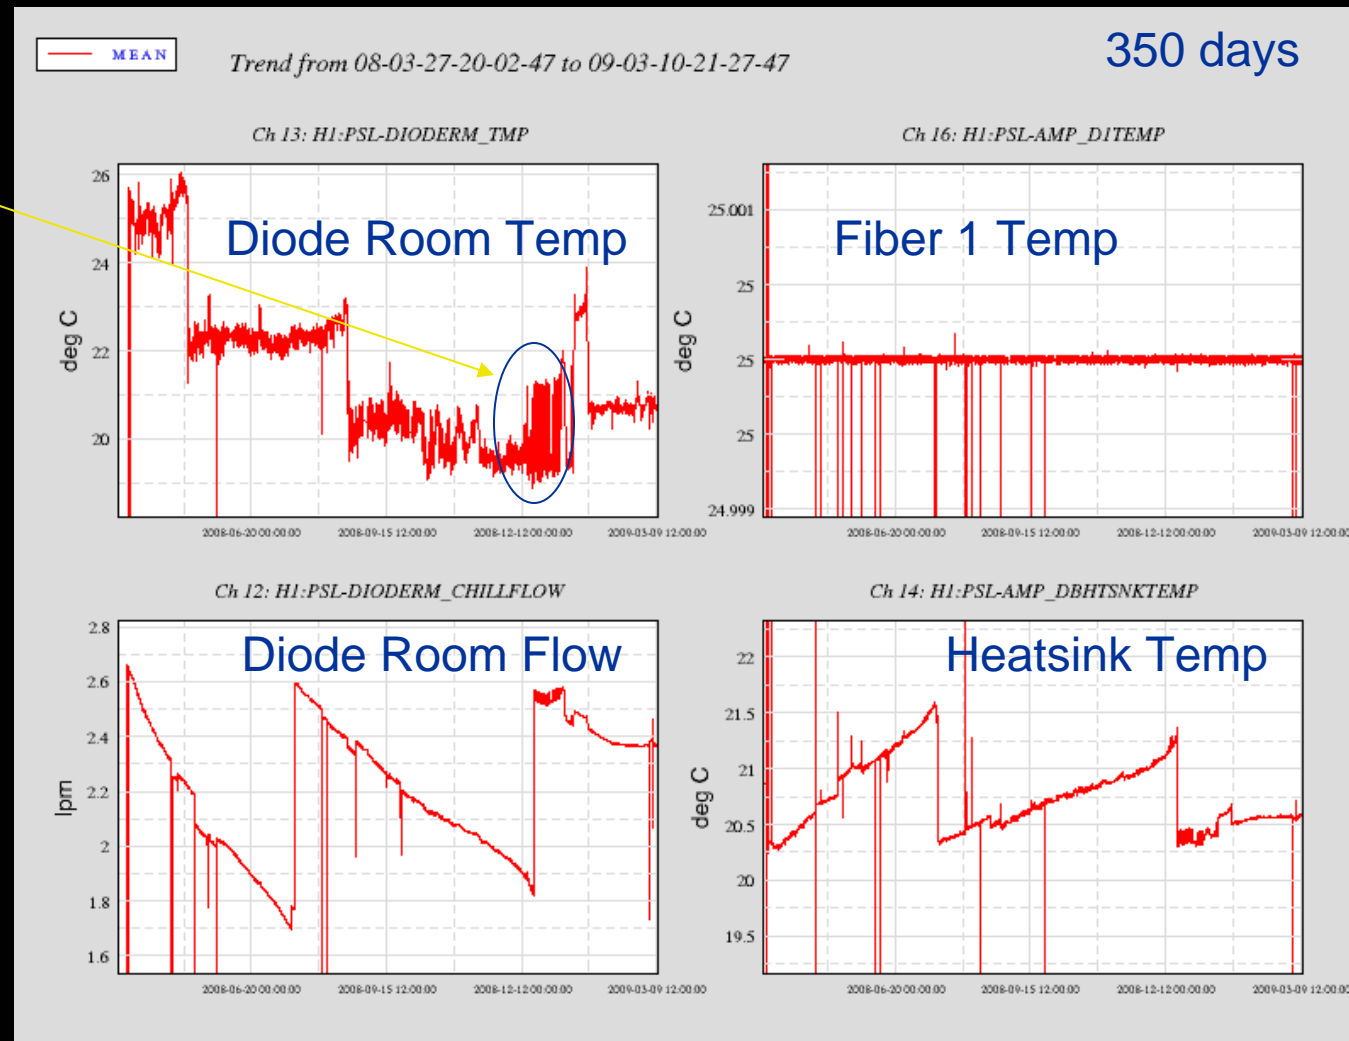
- Diode room air temperature fluctuates sometimes possibly due to a low heat load
- Negligible effect on diode temperatures

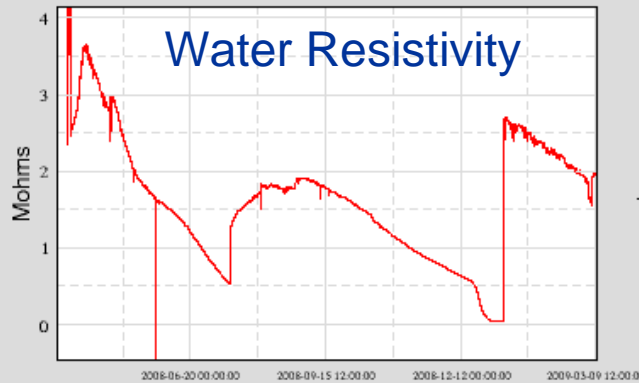
Ch 9: H1:PSL-TABLE_CHILLCND

- Water pressure and flows dropping monotonically
- Changed DI filter twice
- Changed water filter twice (carbon shedding in pump?)
- Reset flows to “nominal” values
