## T020179-00-E HEPI Actuator 2 Assembly Oct 24 2002

### [Directory 1](#)

### [Directory 2](#)

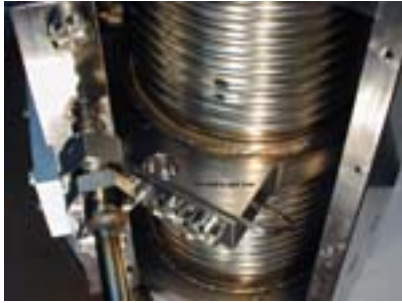
[No2 Leak Area 1.jpg](#)

Attached are pics of the bellows leak area showing the weld assist inner band.

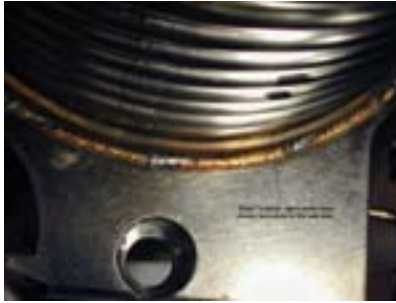
[No2 Leak Area 3.jpg](#)

Small "original" weld assist band shown here close to the leak area.

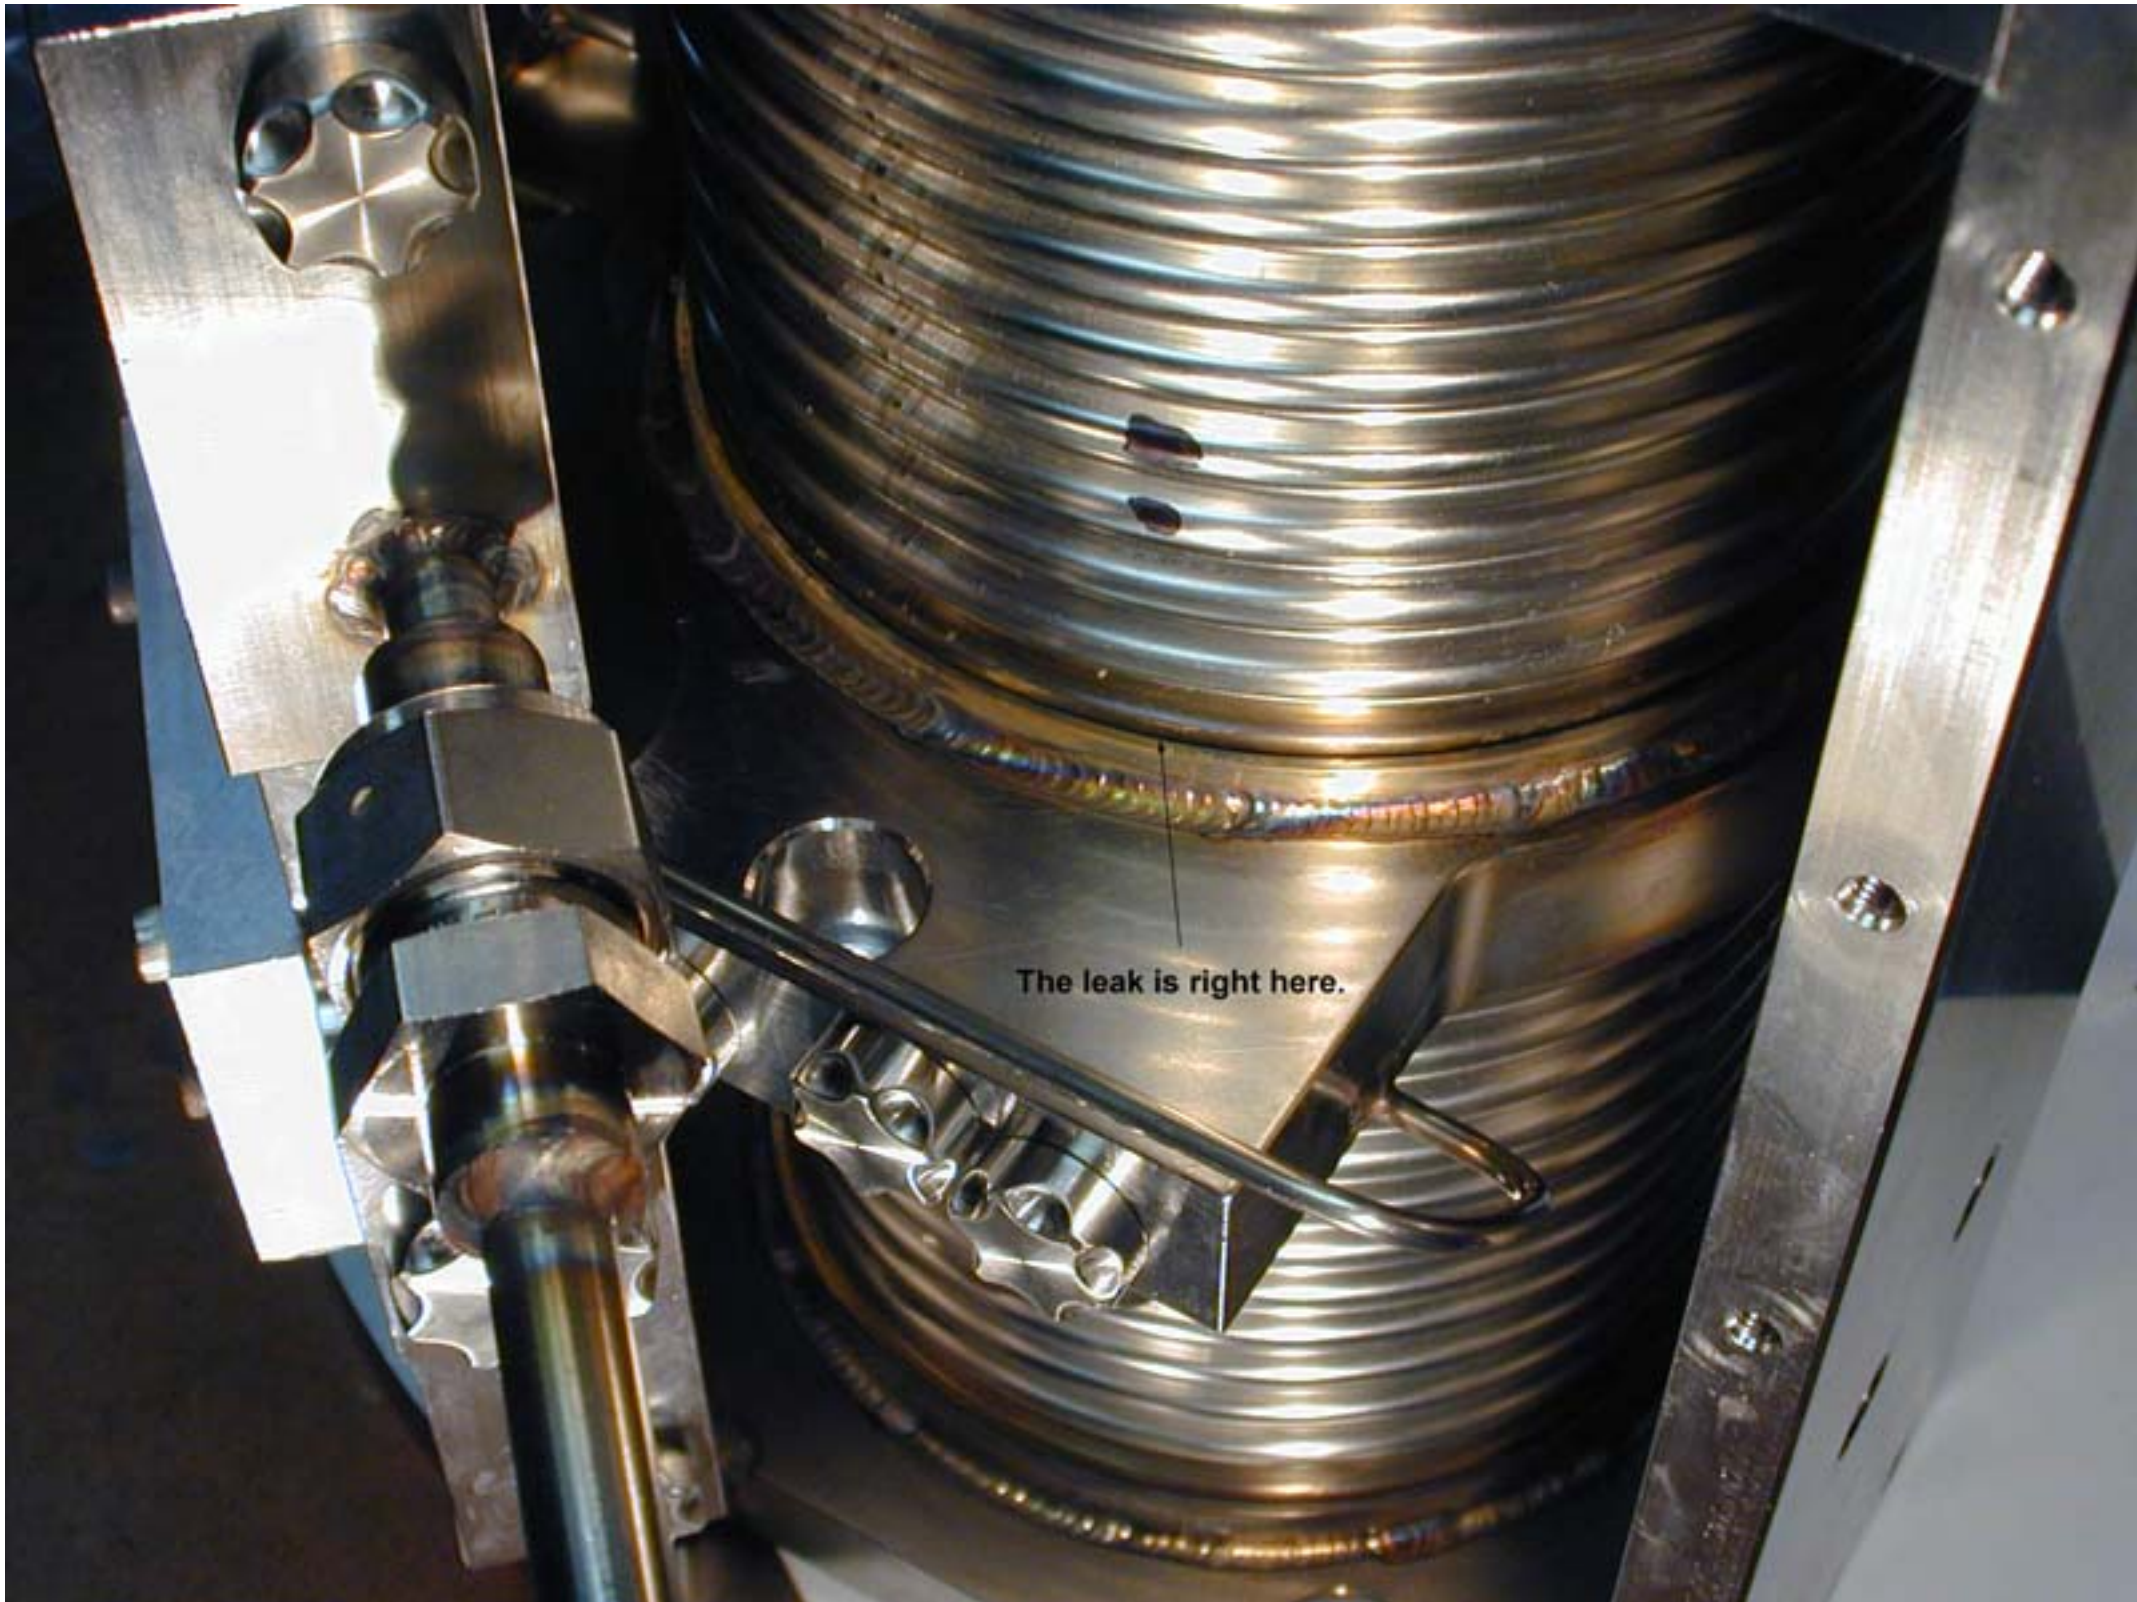
No2 Leak Area 1.jpg

Attached are pics of the bellows leak area showing the weld assist inner band. / No2 Leak Area 1

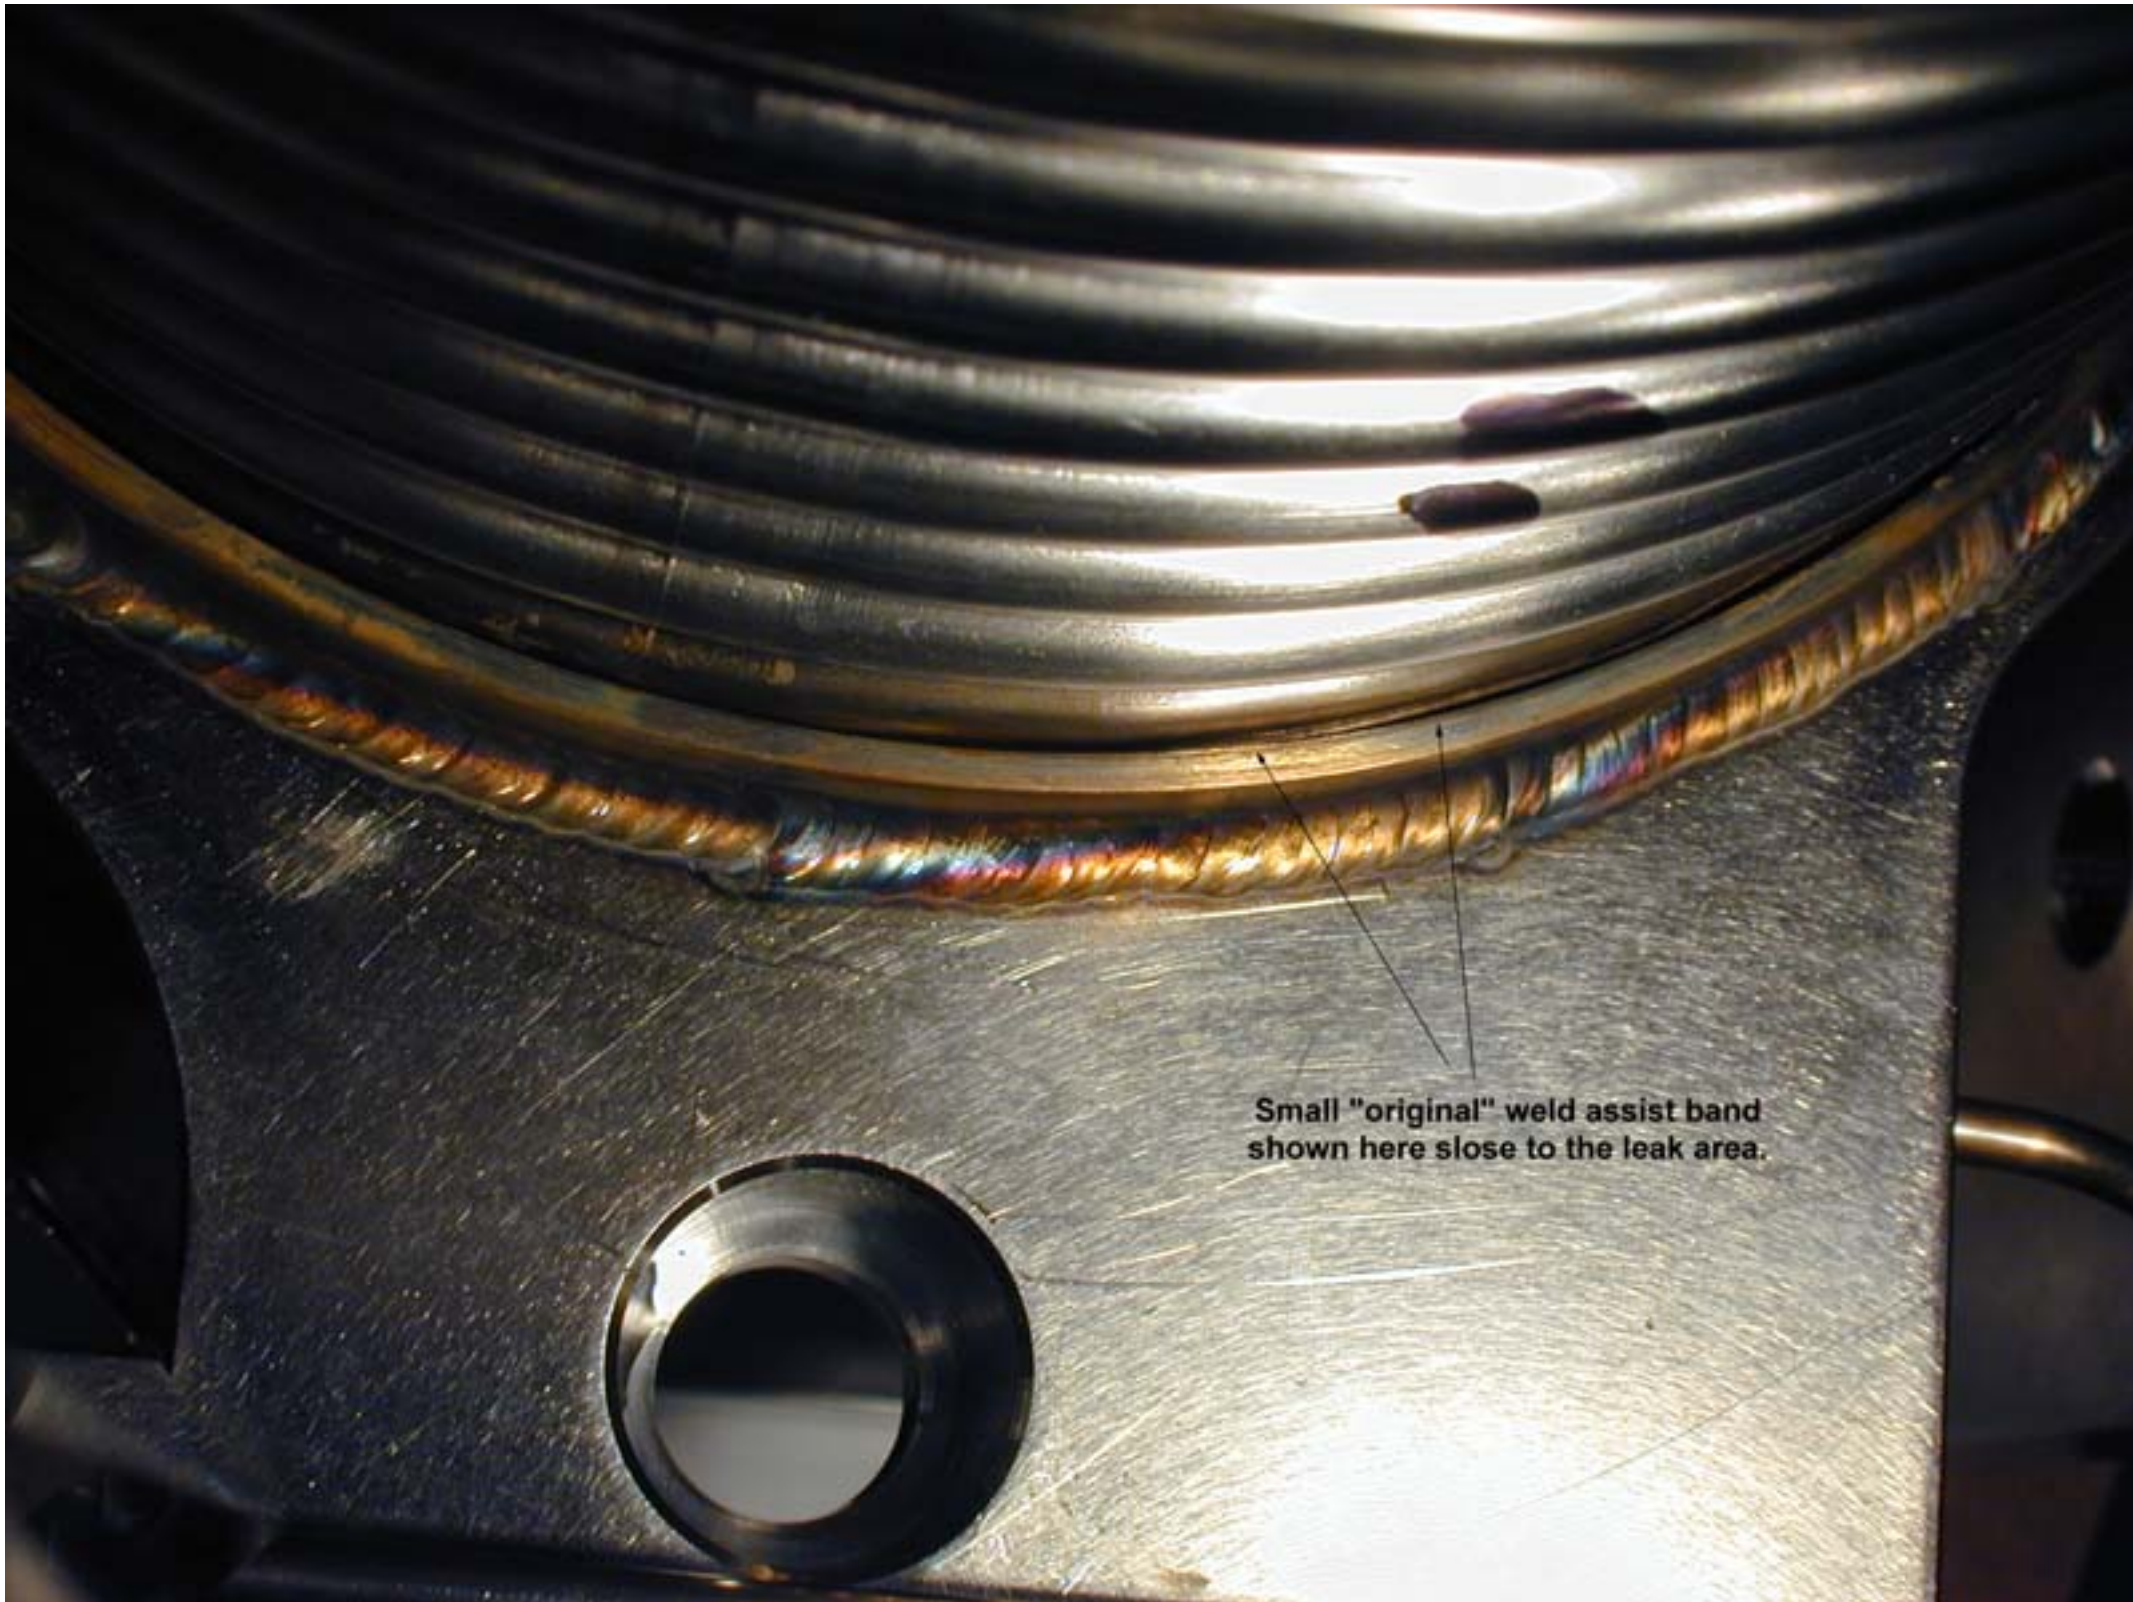
No2 Leak Area 3.jpg

Attached are pics of the bellows leak area showing the weld assist inner band. / No2 Leak Area 3

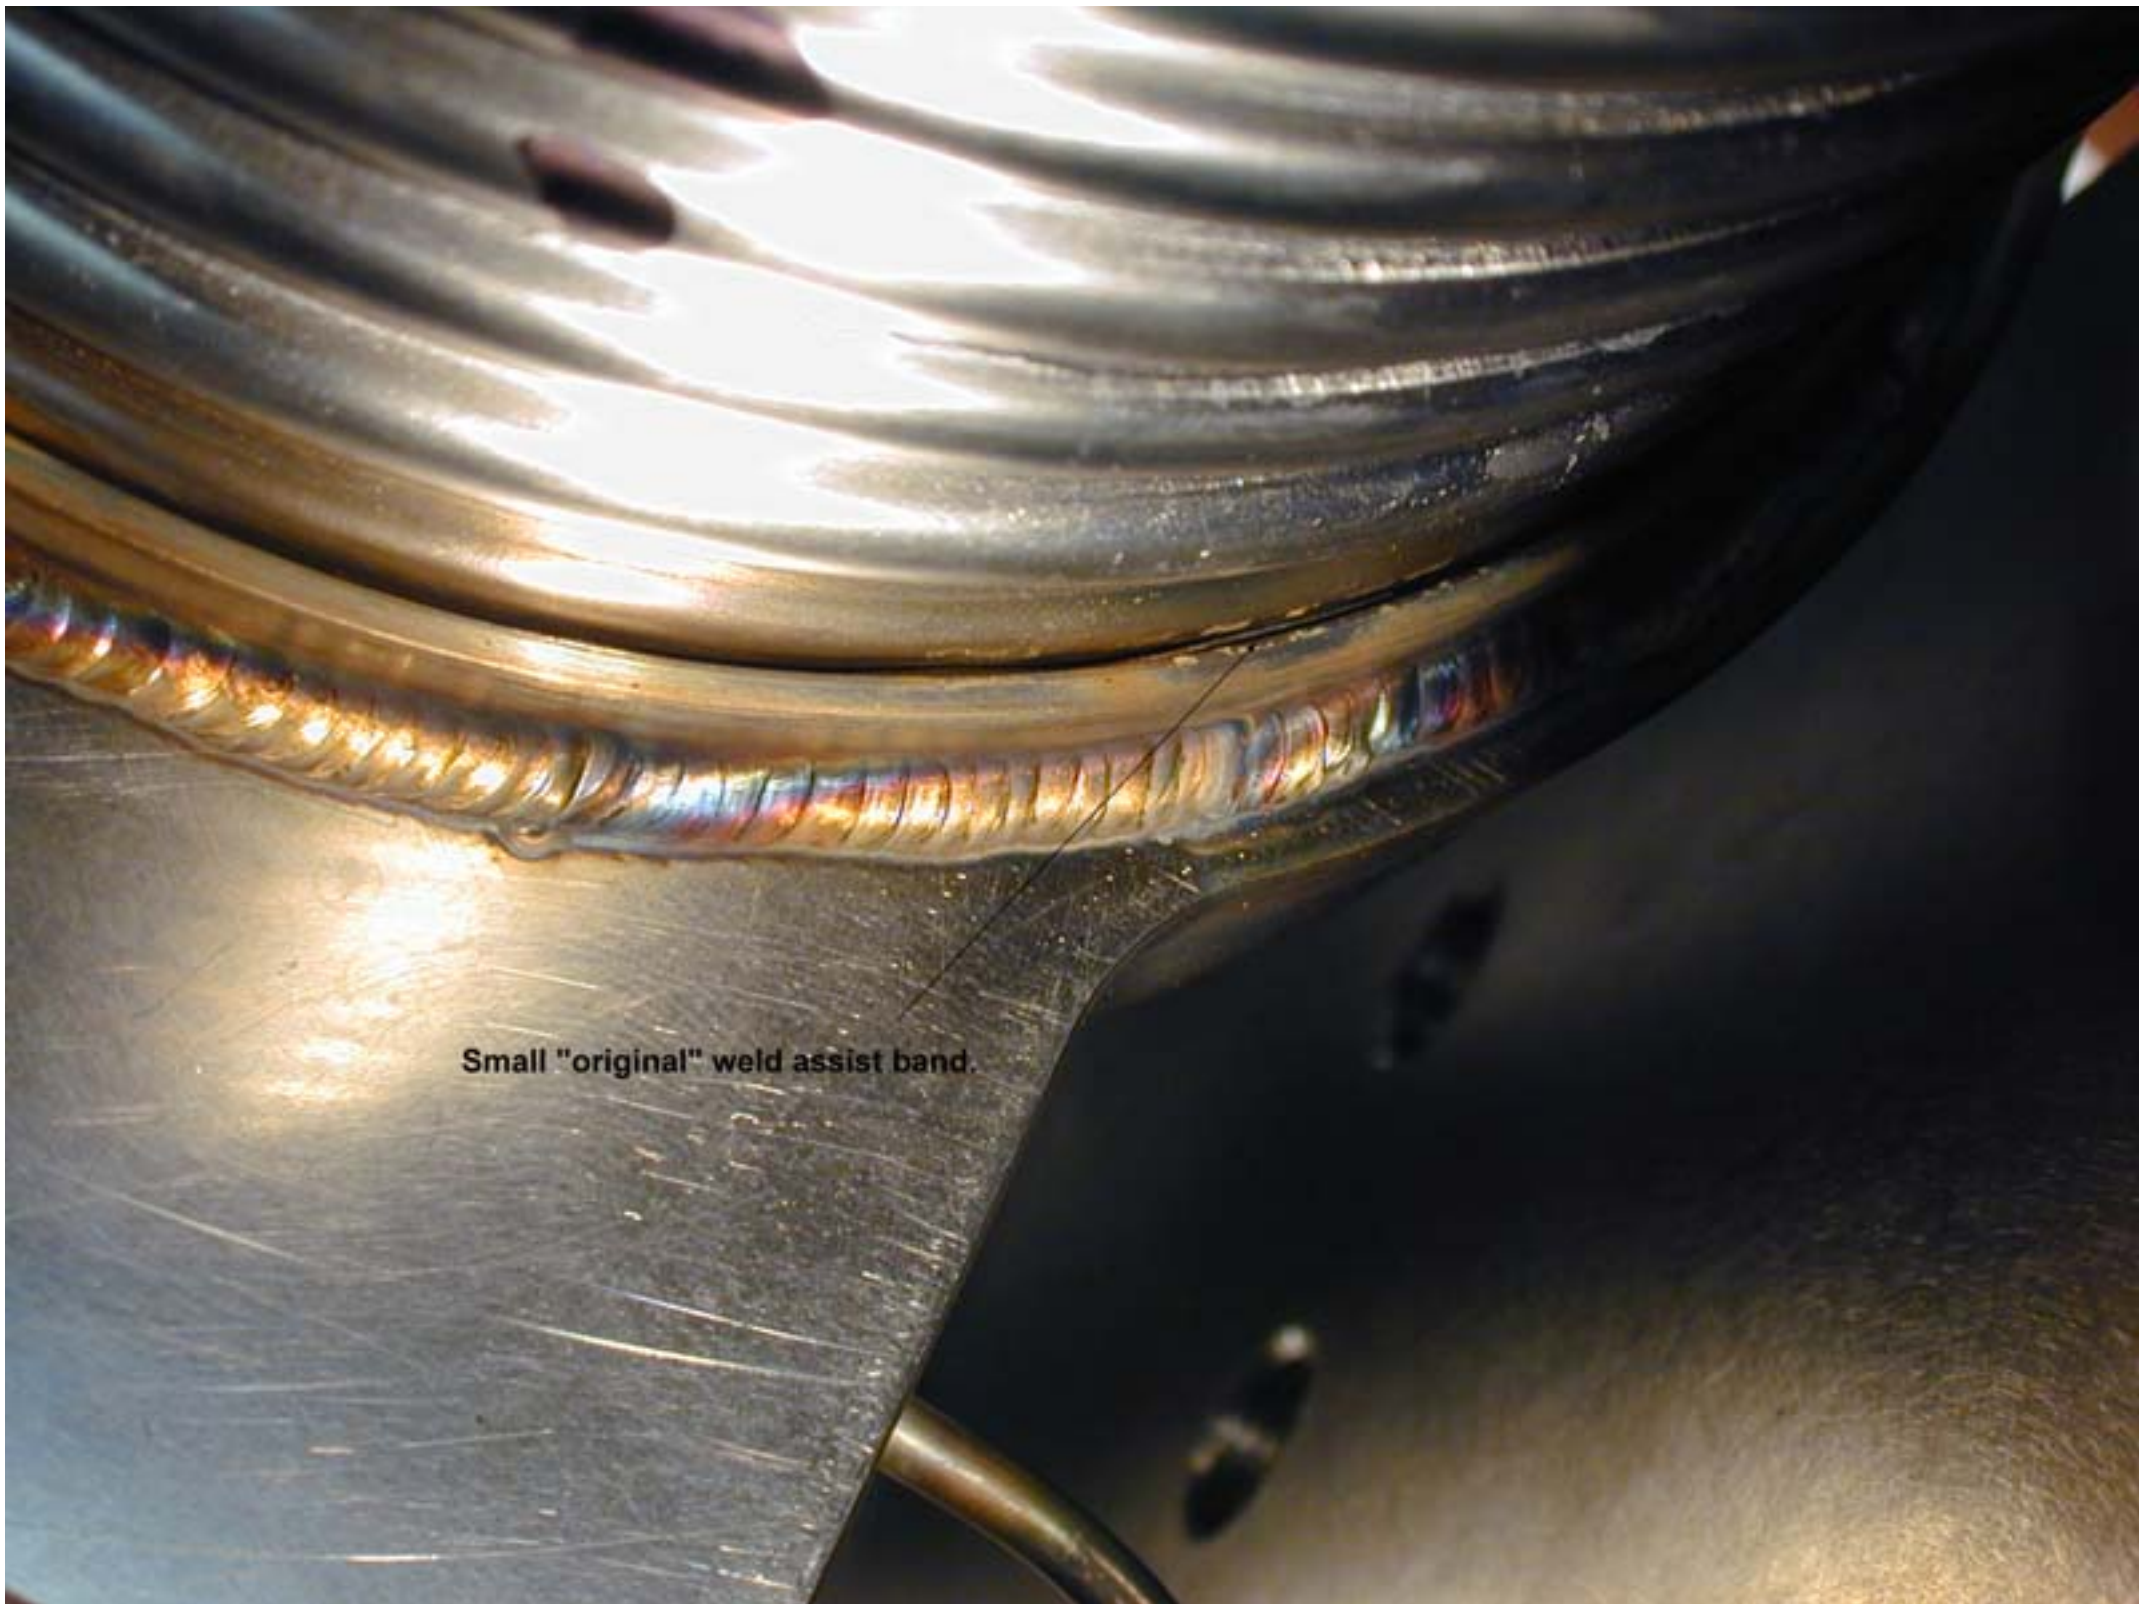
No2 Leak Area 4.jpg

Attached are pics of the bellows leak area showing the weld assist inner band. / No2 Leak Area 4

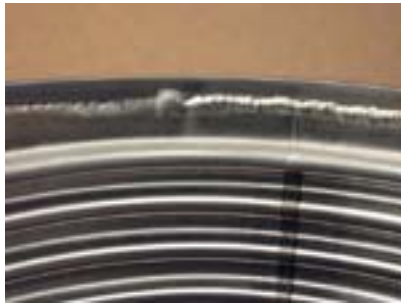
[Suspect Weld 2.jpg](#)

Here are some more pics of a Hyspan bellows that has many very questionable features. Some areas look like the welding proceeded well but there are areas that appear to have needed quite a lot of filler rod. Or it could have been areas that were welded and then needed to be repaired after it leaked. It would be very hard to tell which was the case.

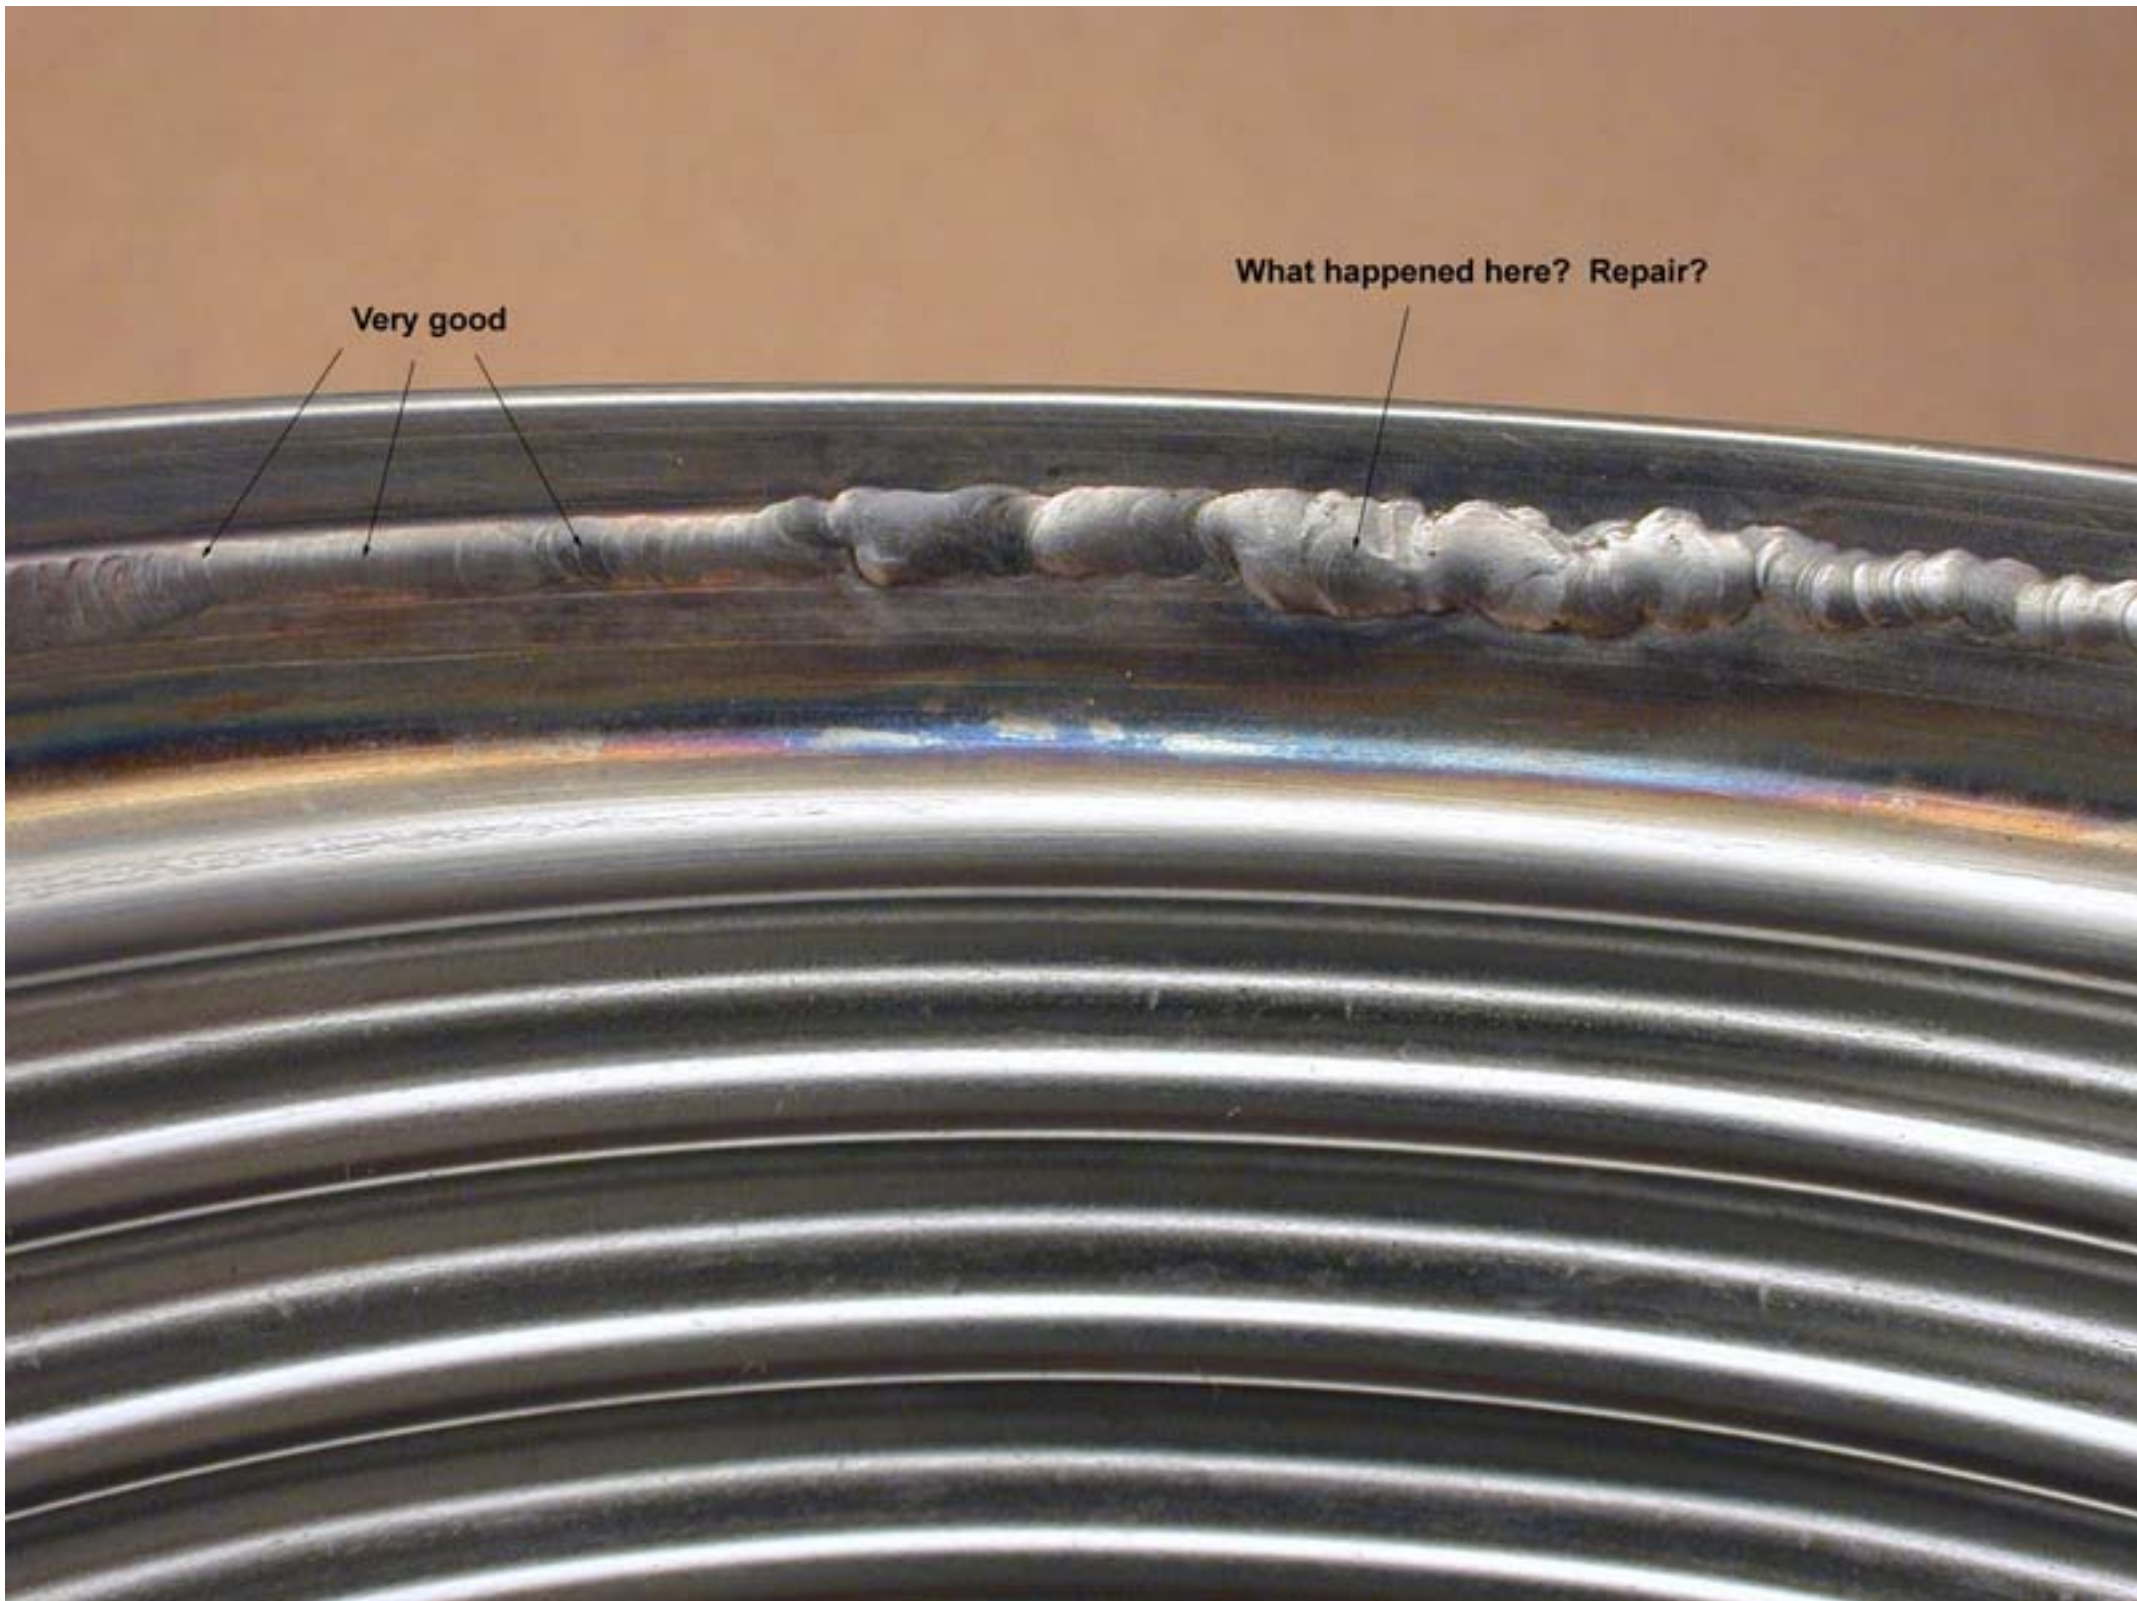
Suspect Weld 1.jpg

What can't be shown by a photograph is the waviness of the convolutions. This might not be a problem, but reflects the quality of the part.

Here are some more pics of a Hyspan bellows that has many very questionable features / Suspect Weld 1

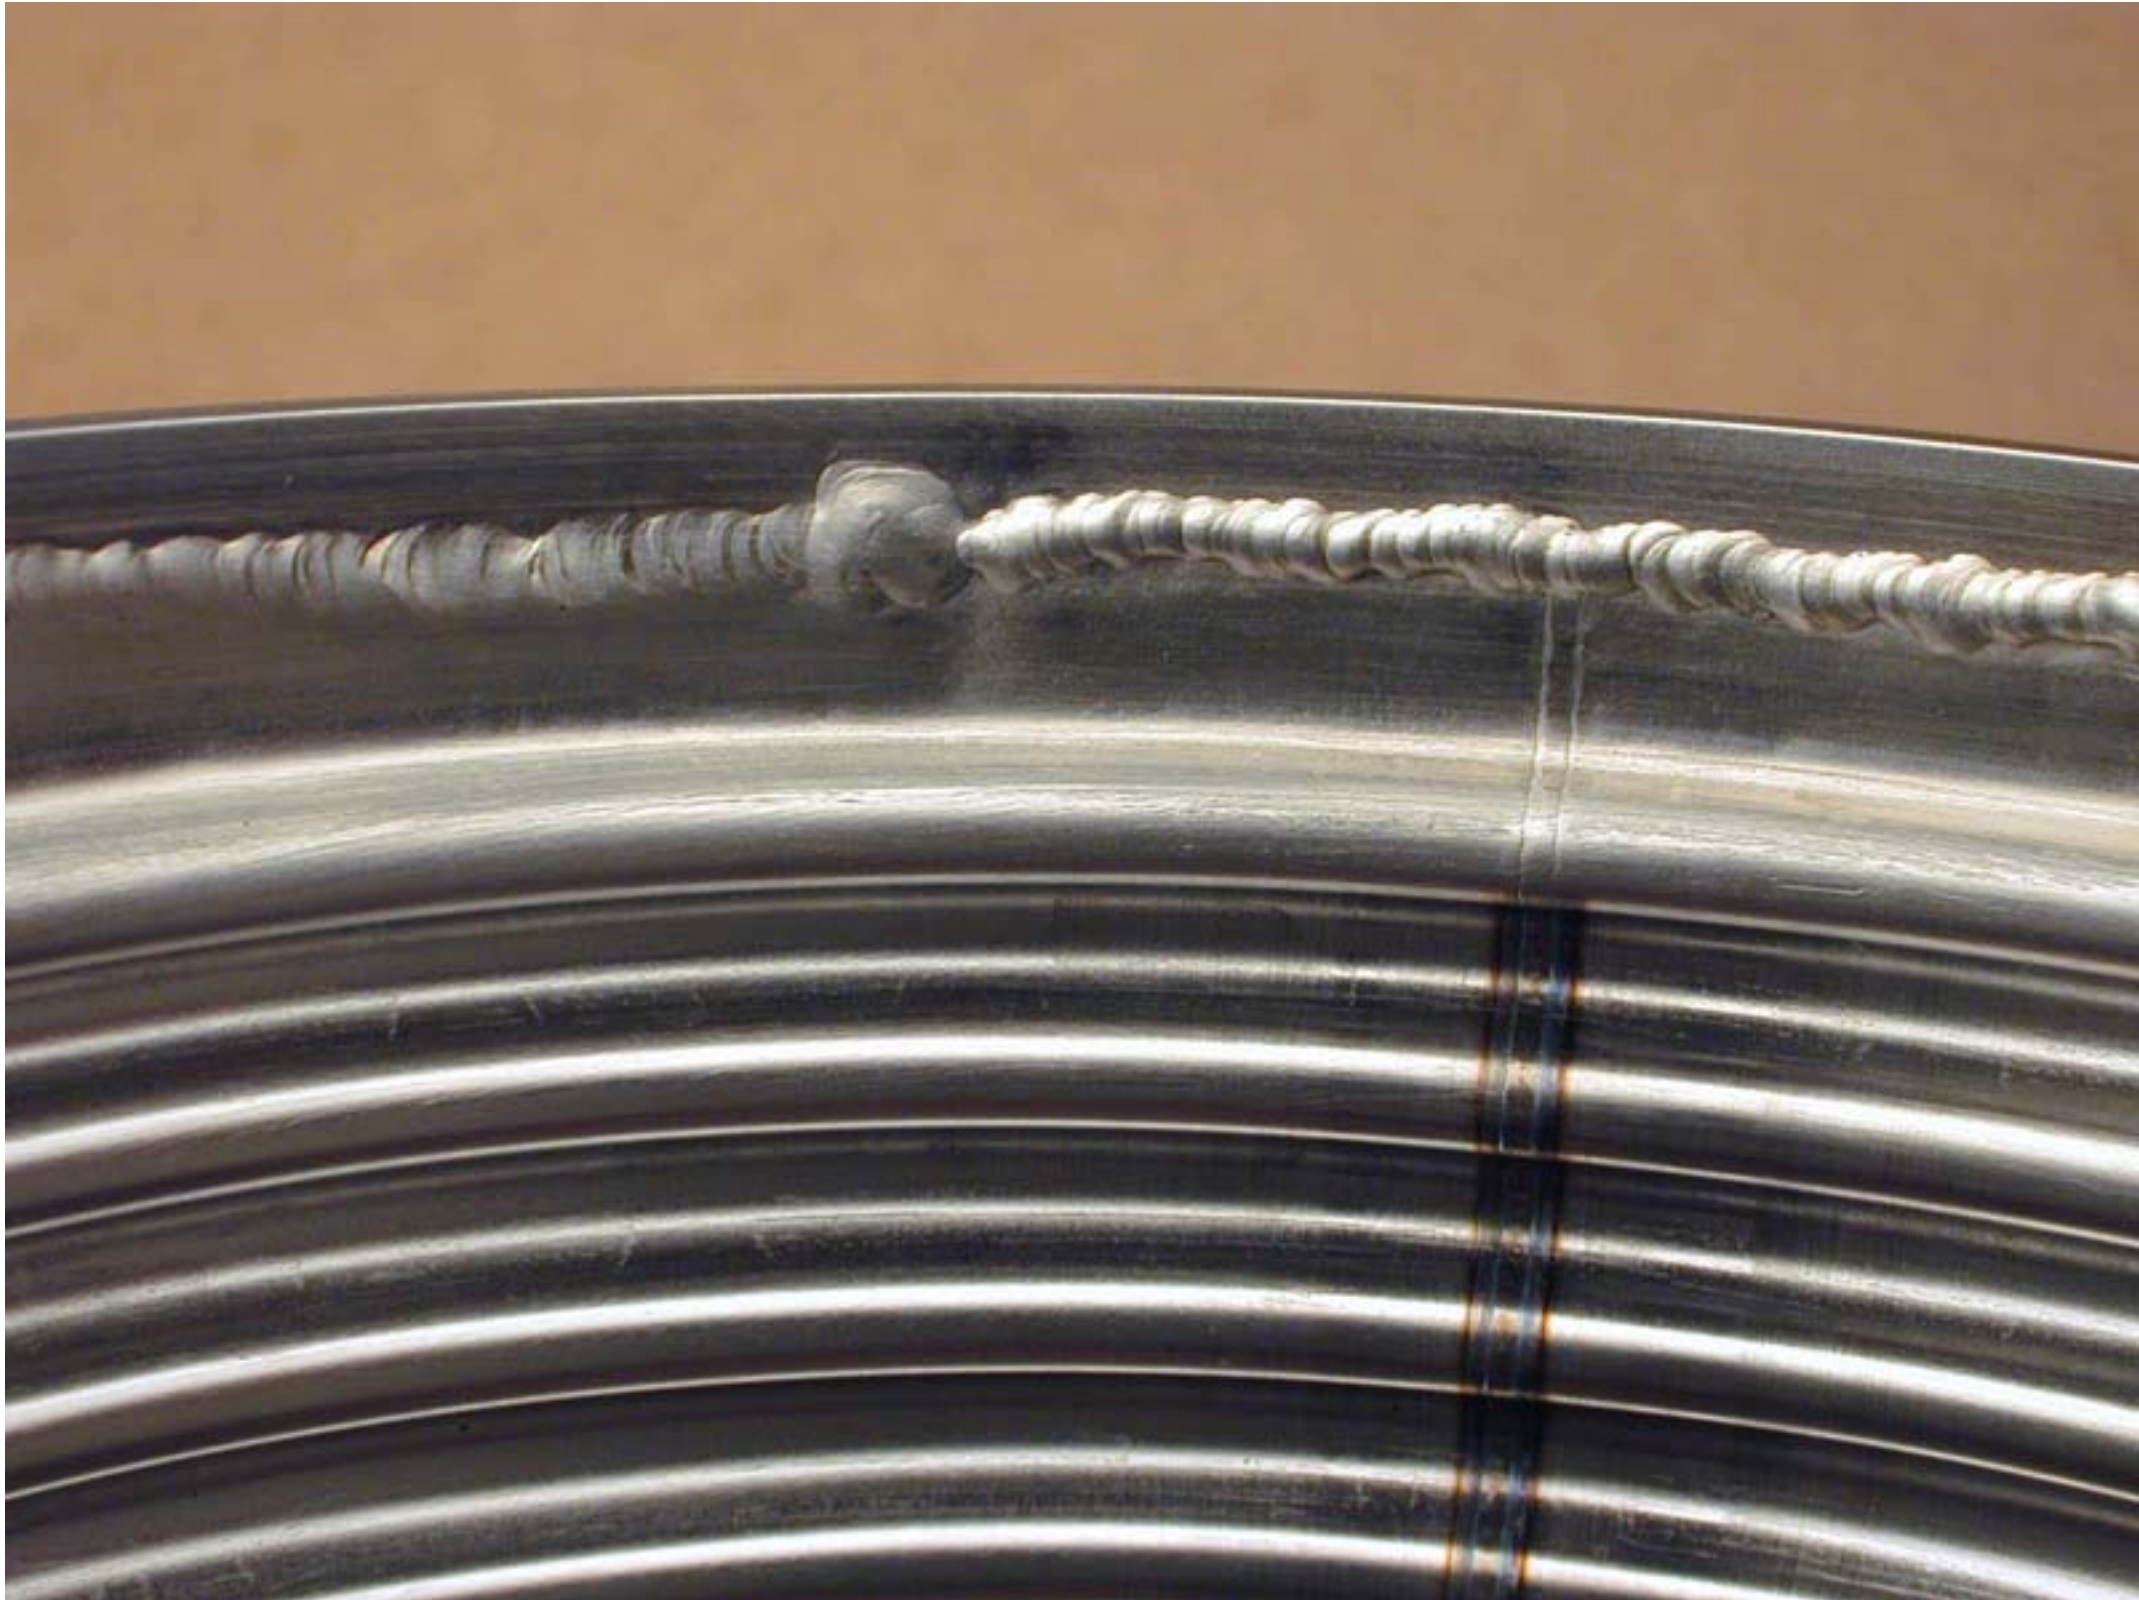
Suspect Weld 2.jpg

Here are some more pics of a Hyspan bellows that has many very questionable features / Suspect Weld 2

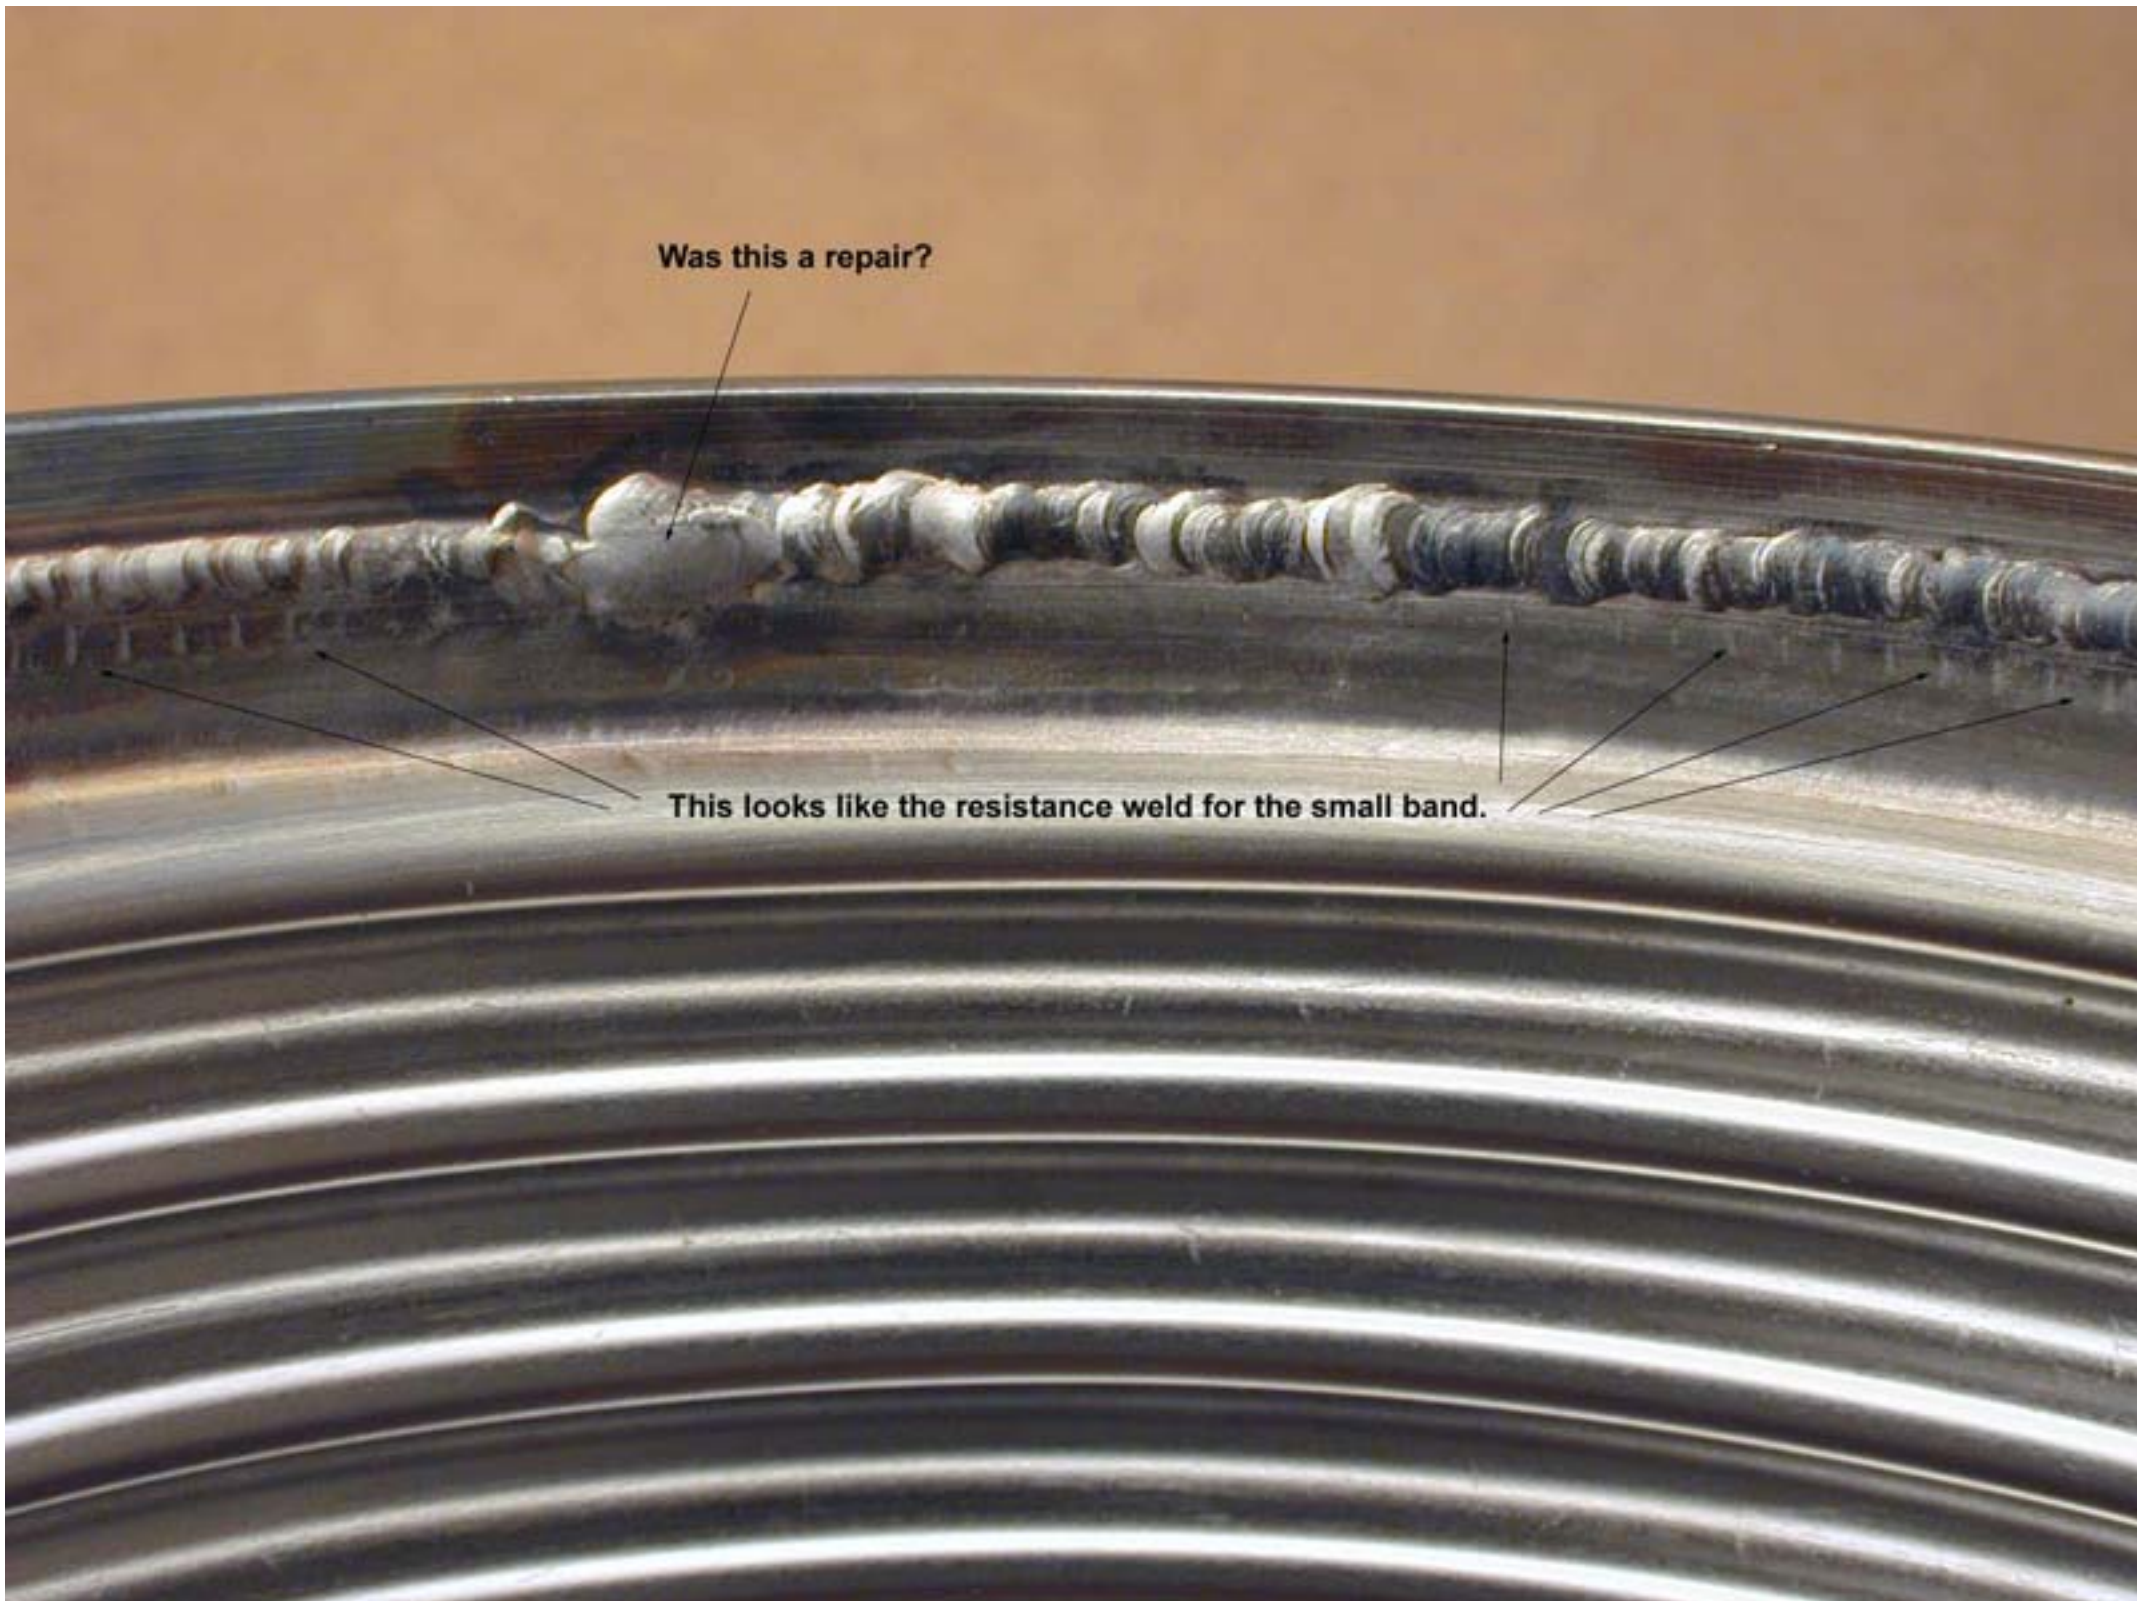
Suspect Weld 3.jpg

Here are some more pics of a Hyspan bellows that has many very questionable features /  
Suspect Weld 3
