## T020179-00-E HEPI Actuator 2 Assembly Oct 24 2002

### [Directory 1](#)

### [Directory 2](#)

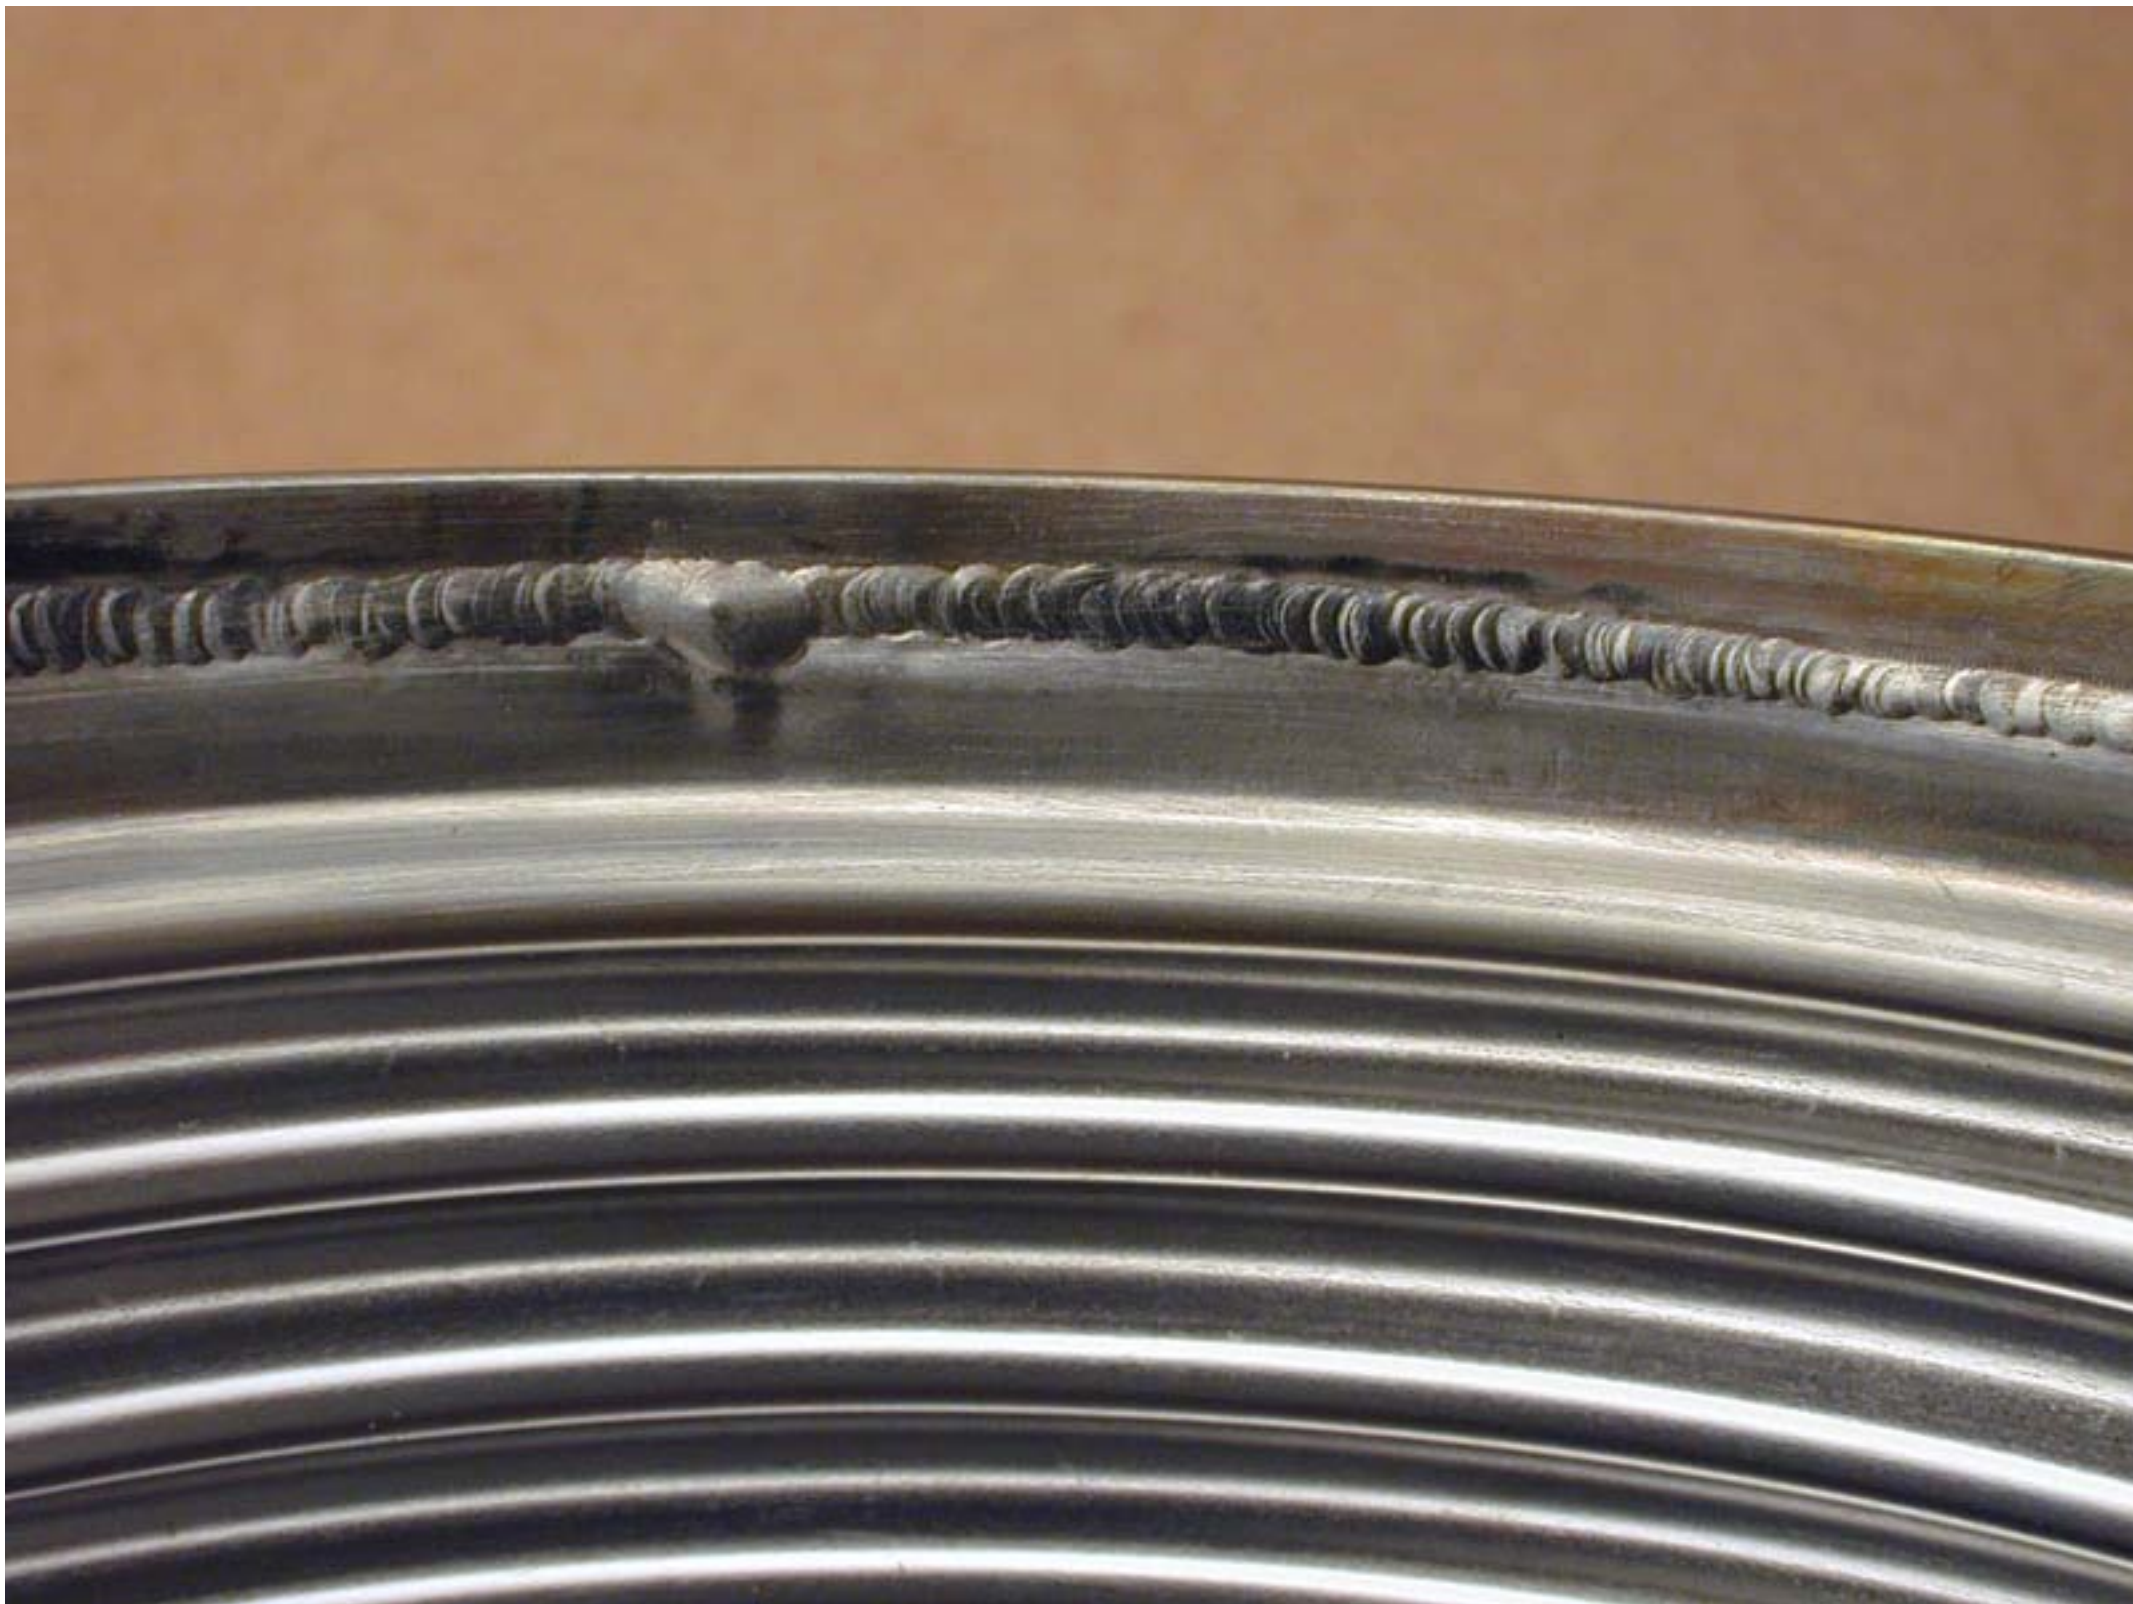
Suspect Weld 4.jpg

Here are some more pics of a Hyspan bellows that has many very questionable features. Some areas look like the welding proceeded well but there are areas that appear to have needed quite a lot of filler rod. Or it could have been areas that were welded and then needed to be repaired after it leaked. It would be very hard to tell which was the case.

Here are some more pics of a Hyspan bellows that has many very questionable features /  
Suspect Weld 4

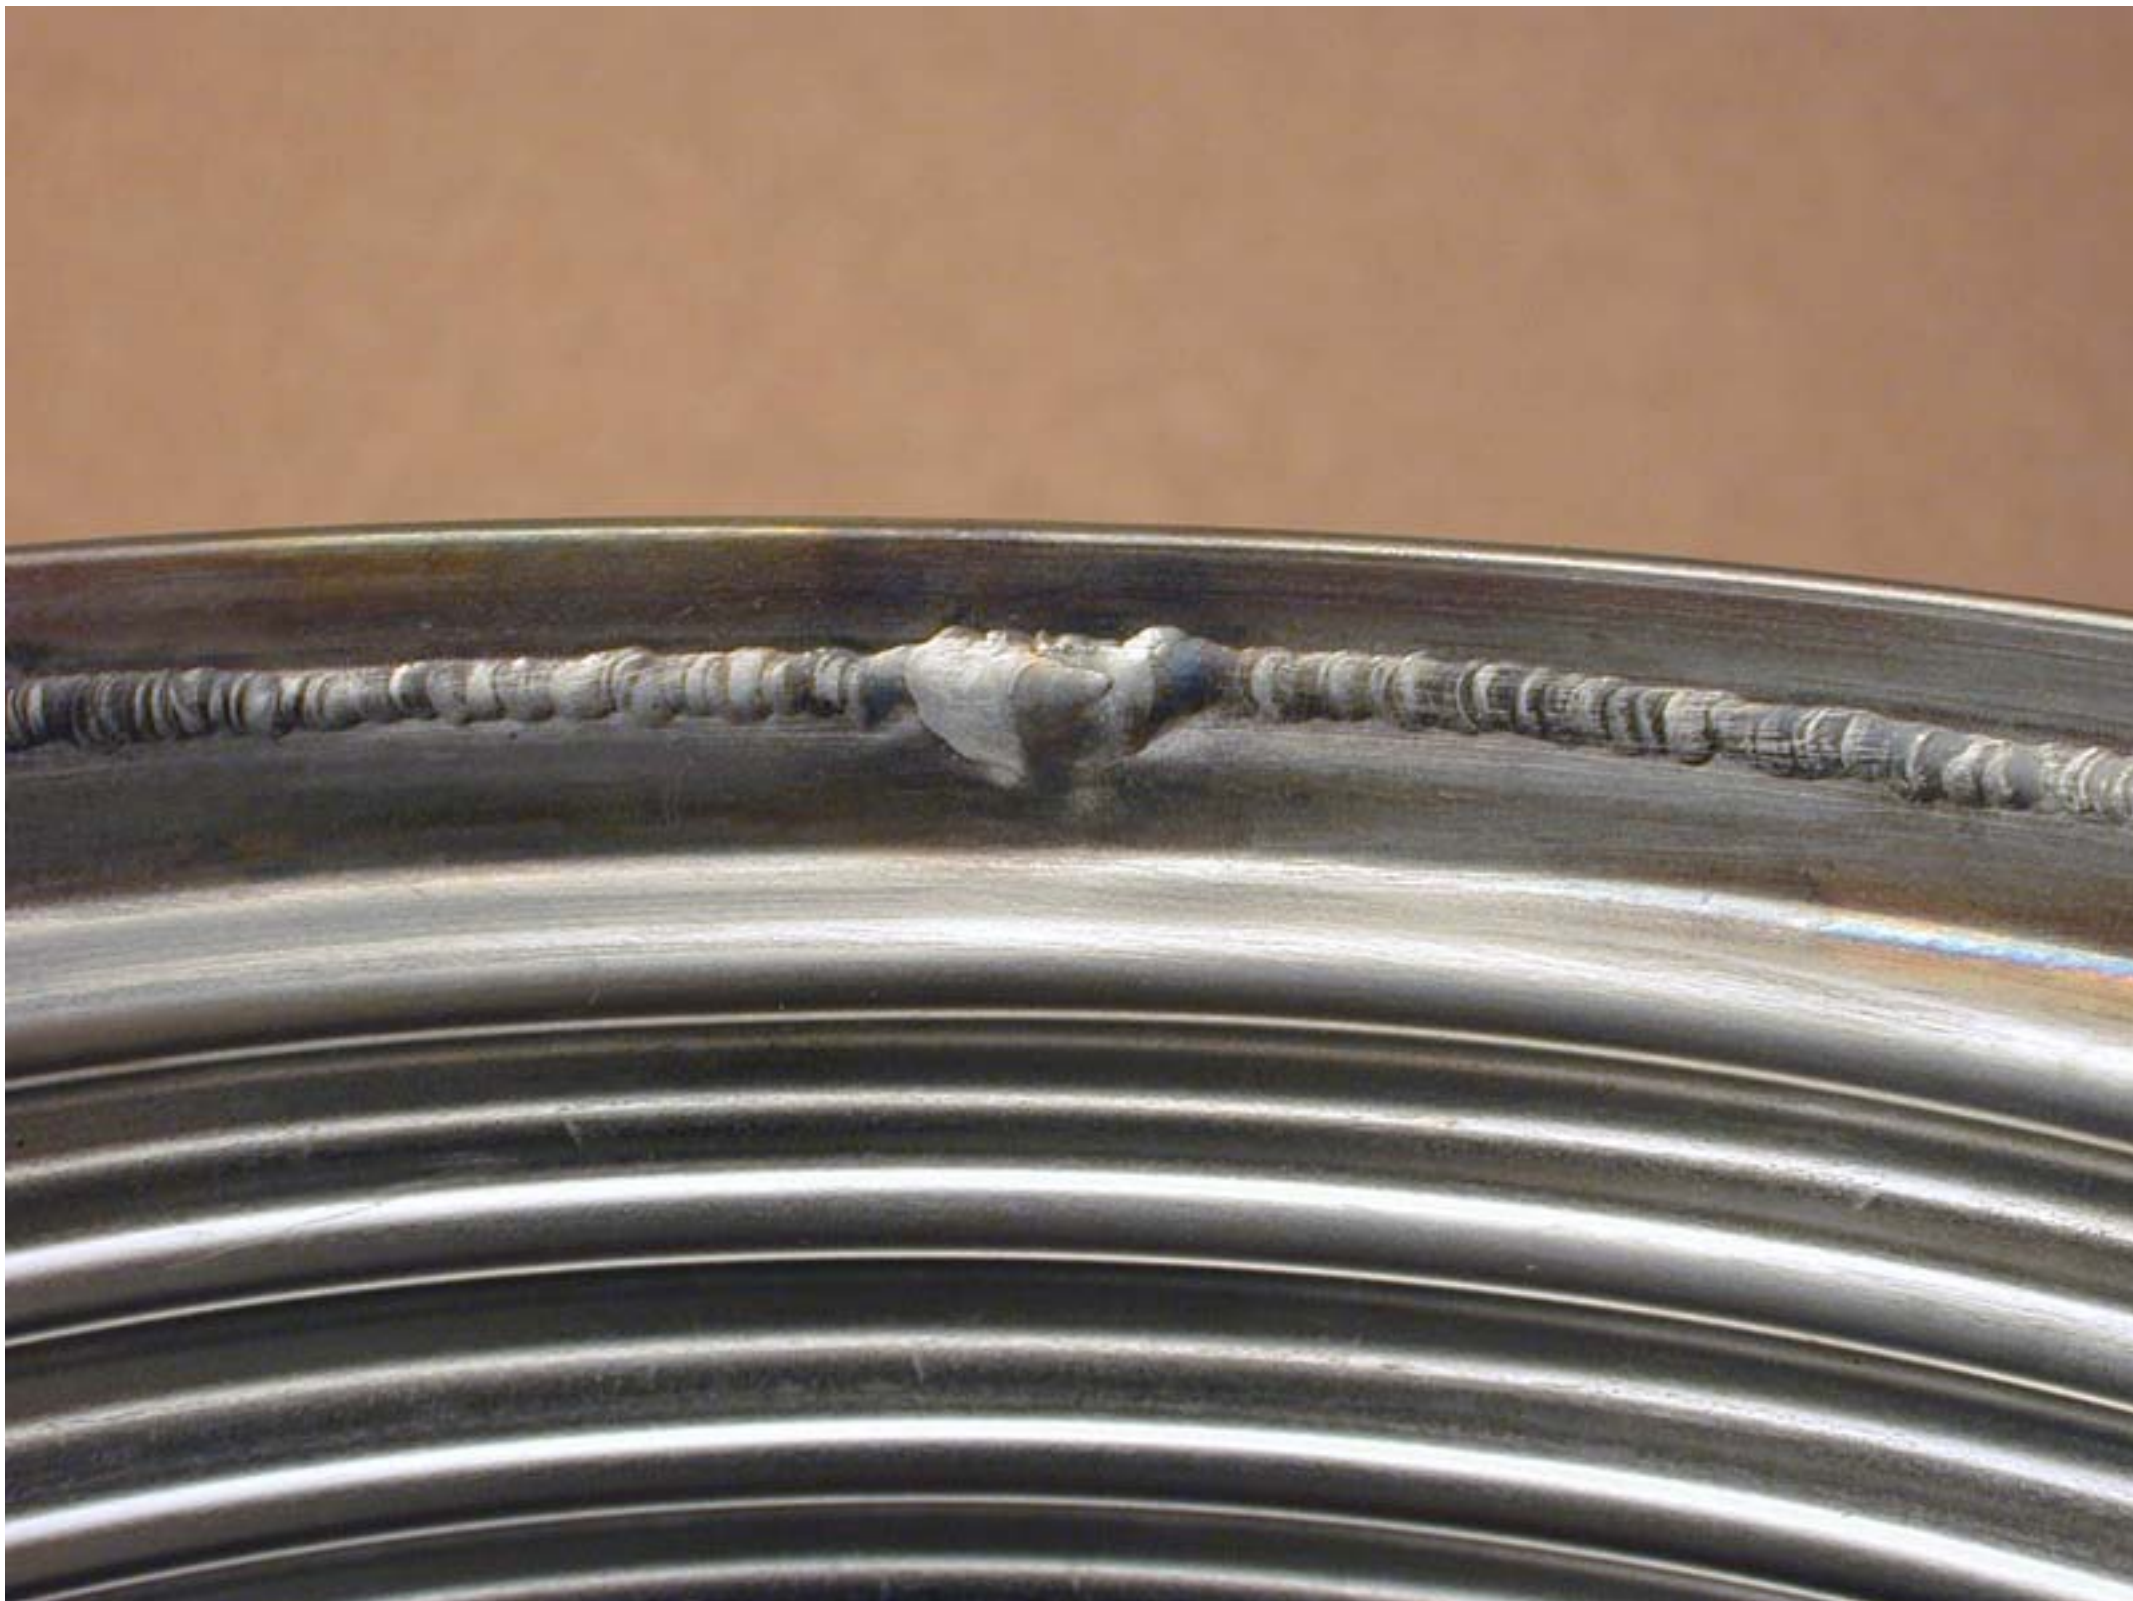
Suspect Weld 5.jpg

What appears to be the resistance weld of the small weld assist band can be seen on the inside of the bellows as shown.

Here are some more pics of a Hyspan bellows that has many very questionable features /  
Suspect Weld 5

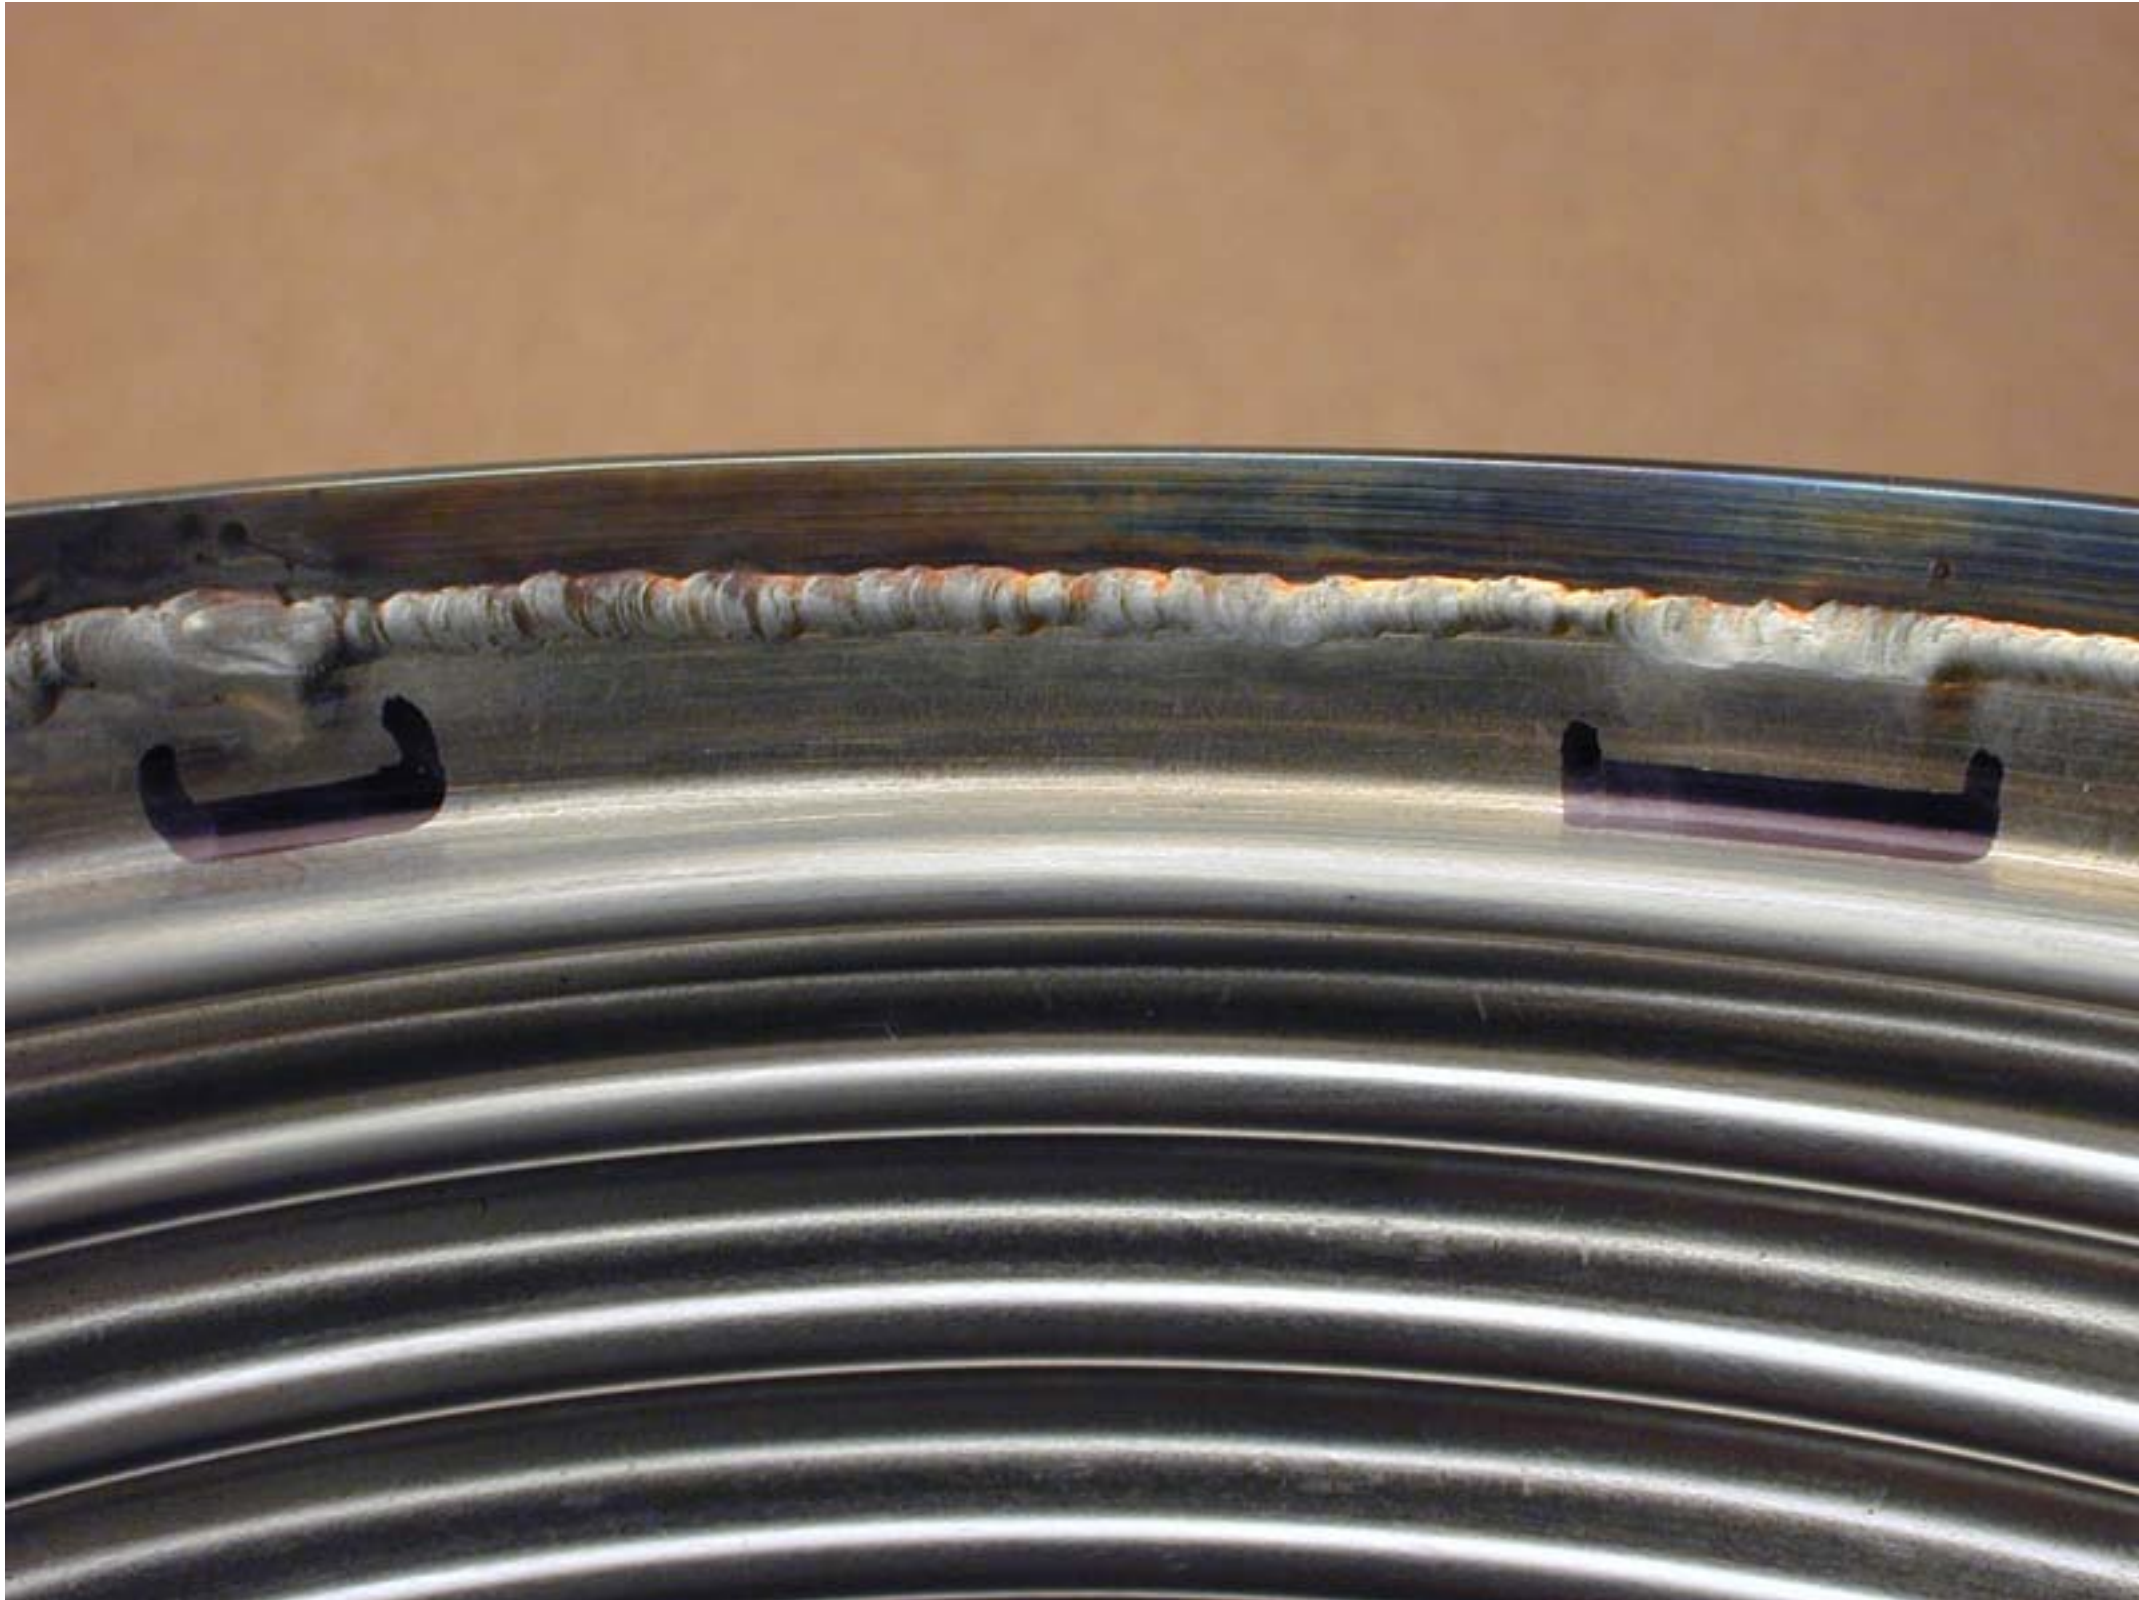
Suspect Weld 6.jpg

Note the inner weld assist band between the bellows and the large weld assist ring.

Here are some more pics of a Hyspan bellows that has many very questionable features /  
Suspect Weld 6

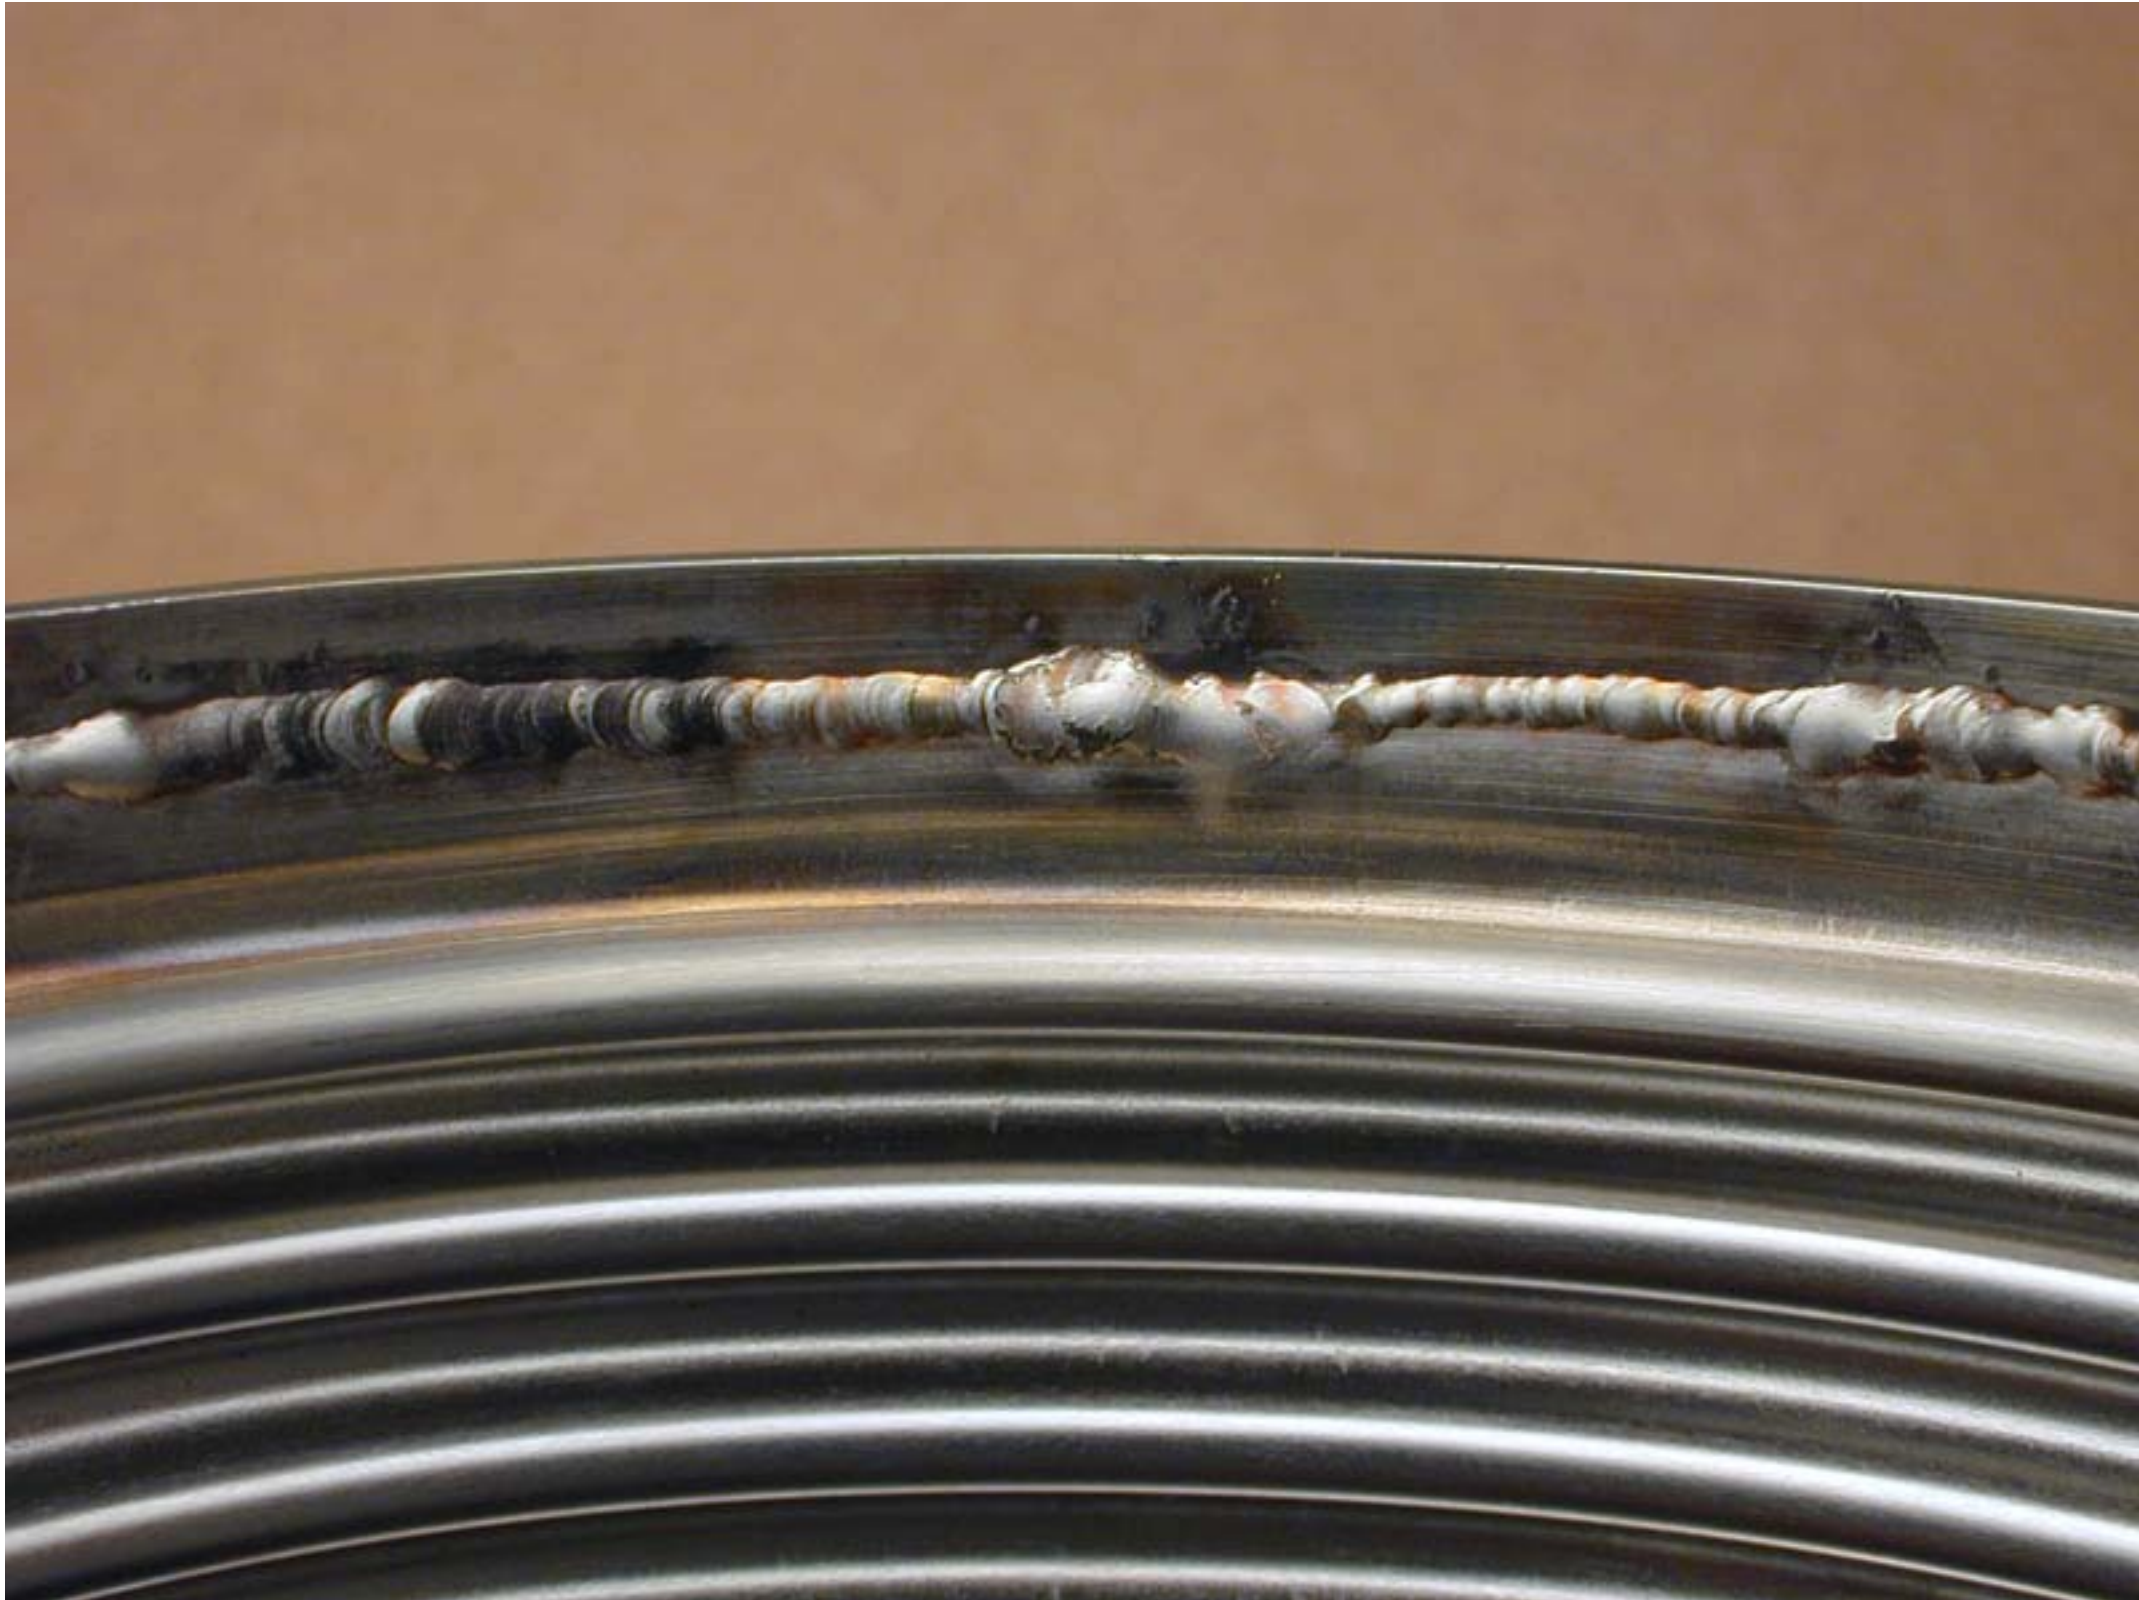
Suspect Weld 7.jpg

Also note the several places where the bellows does not sit flush with the surface by the weld.

Here are some more pics of a Hyspan bellows that has many very questionable features /  
Suspect Weld 7

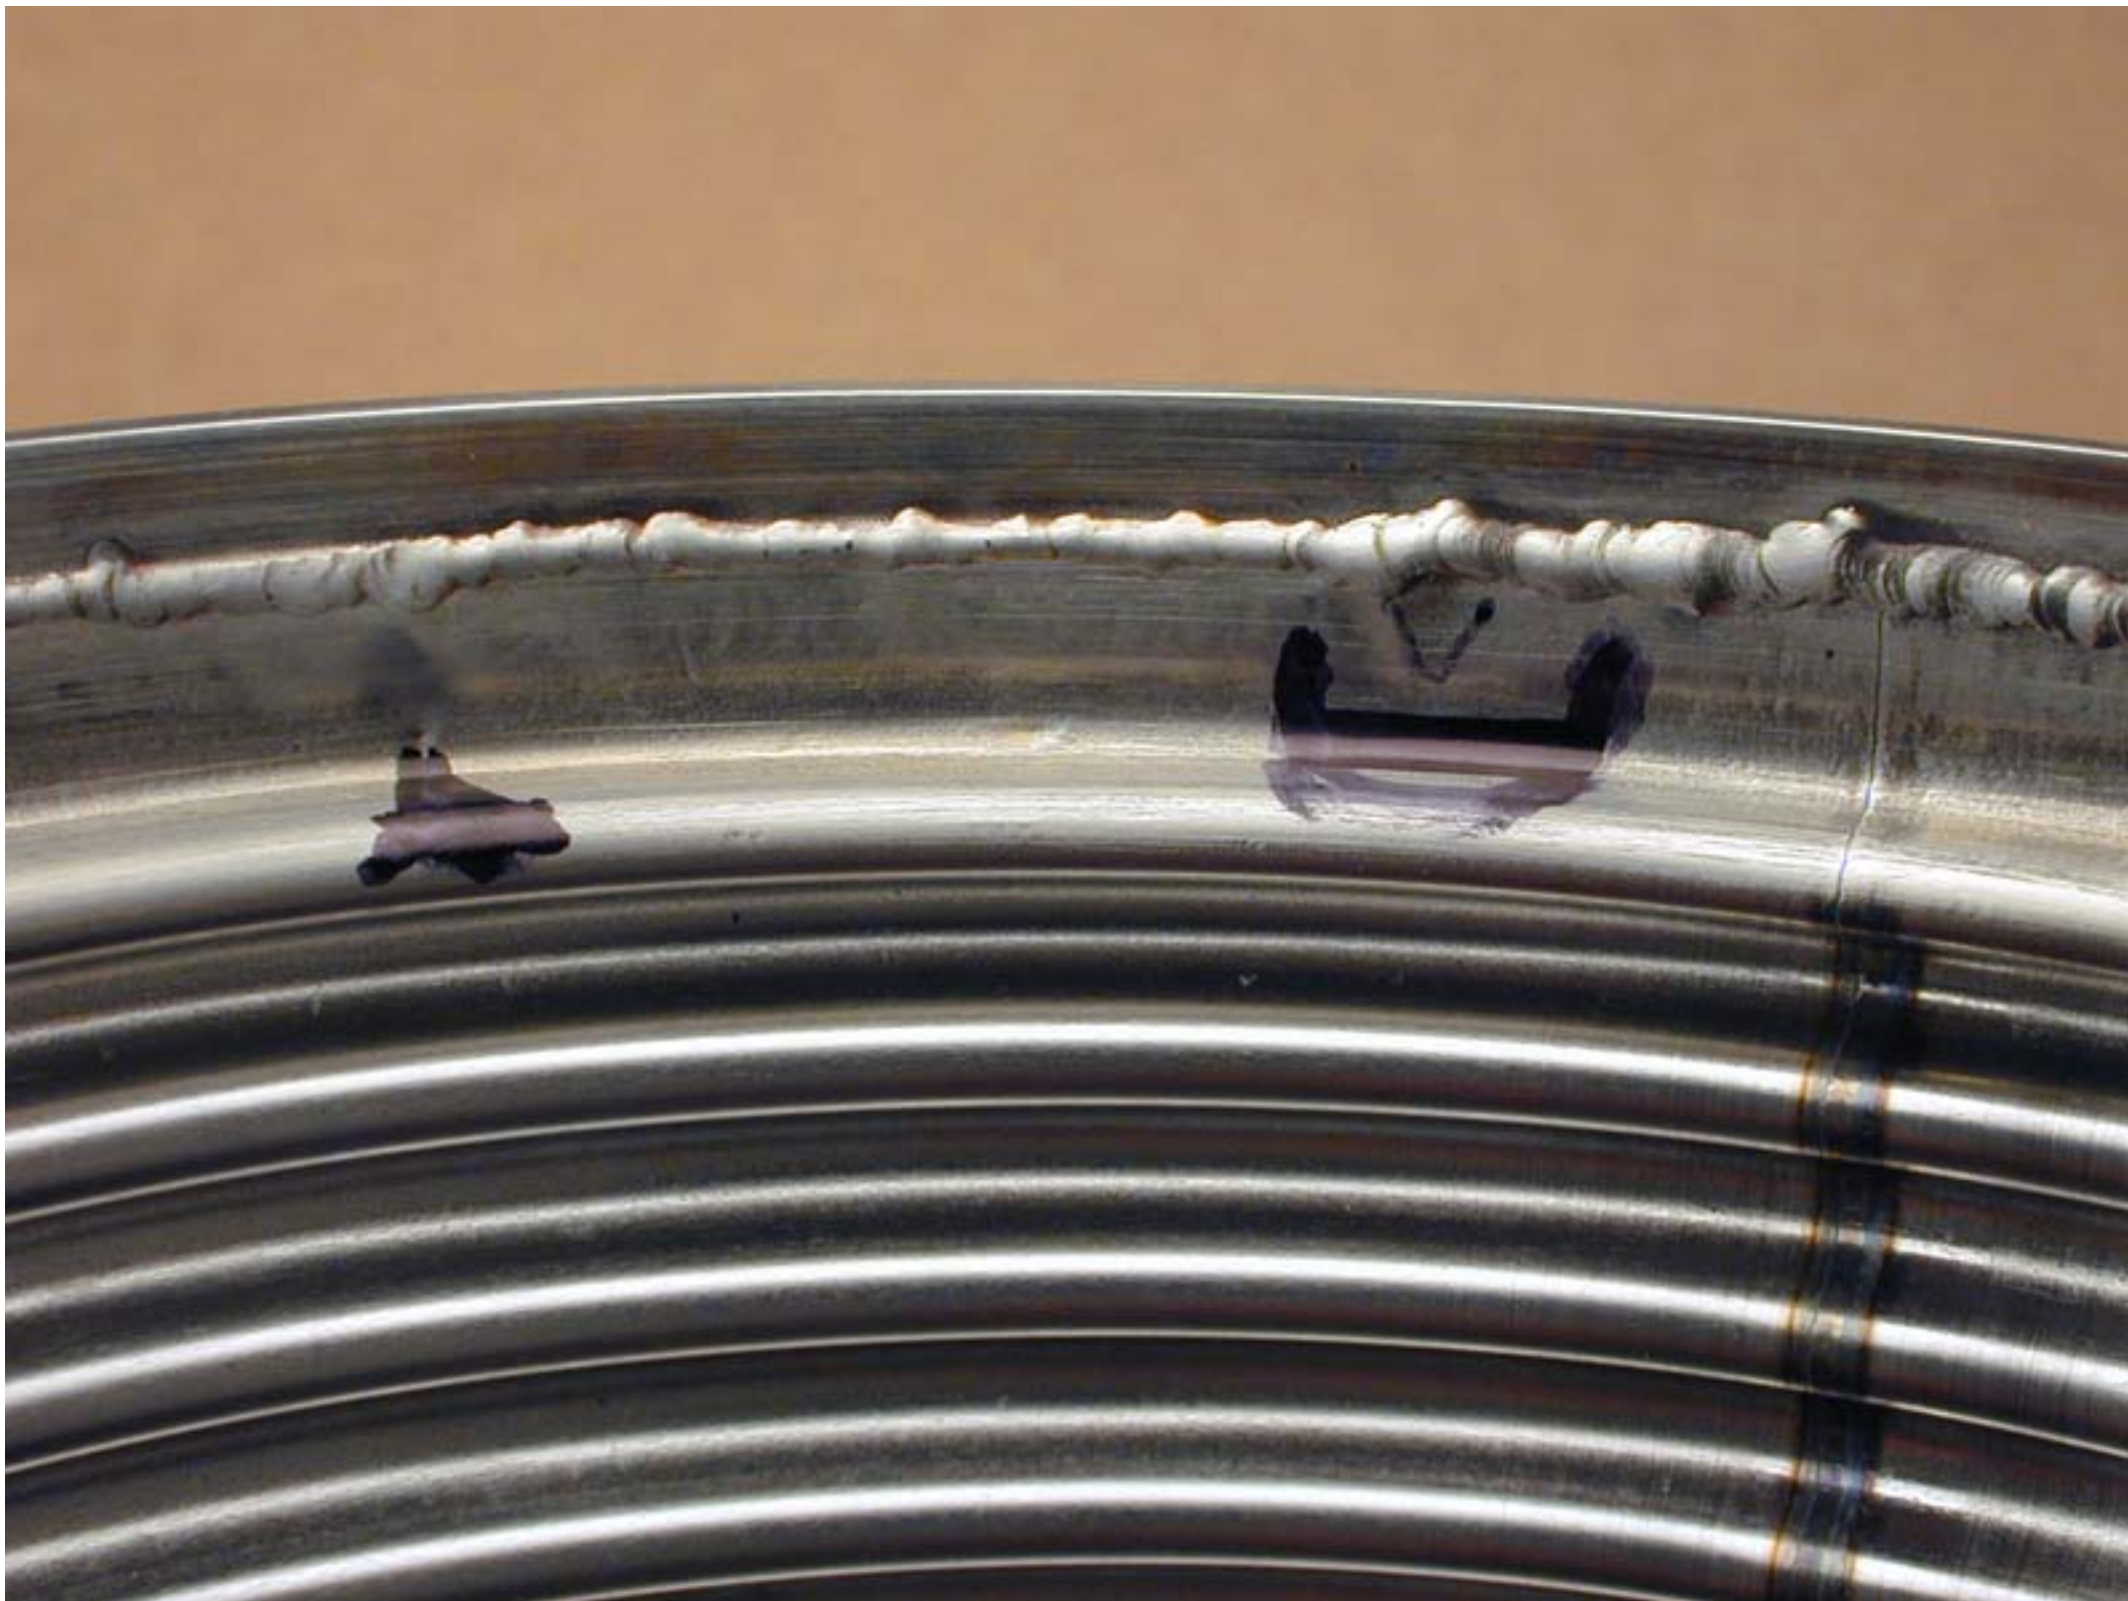
Suspect Weld 8.jpg

Here are some more pics of a Hyspan bellows that has many very questionable features /  
Suspect Weld 8

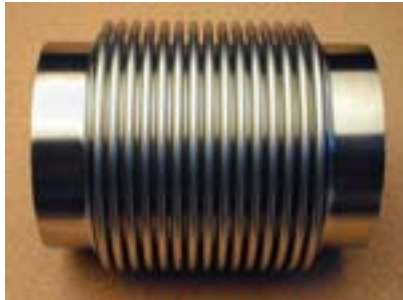
[Ameriflex Bellows 1.jpg](#)

Here is some pics of the Ameriflex bellows that Jim Edwards sent overnight after talking to him yesterday evening at 6:30 CDT. I received it this morning at 9:00. This isn't Hyspan.

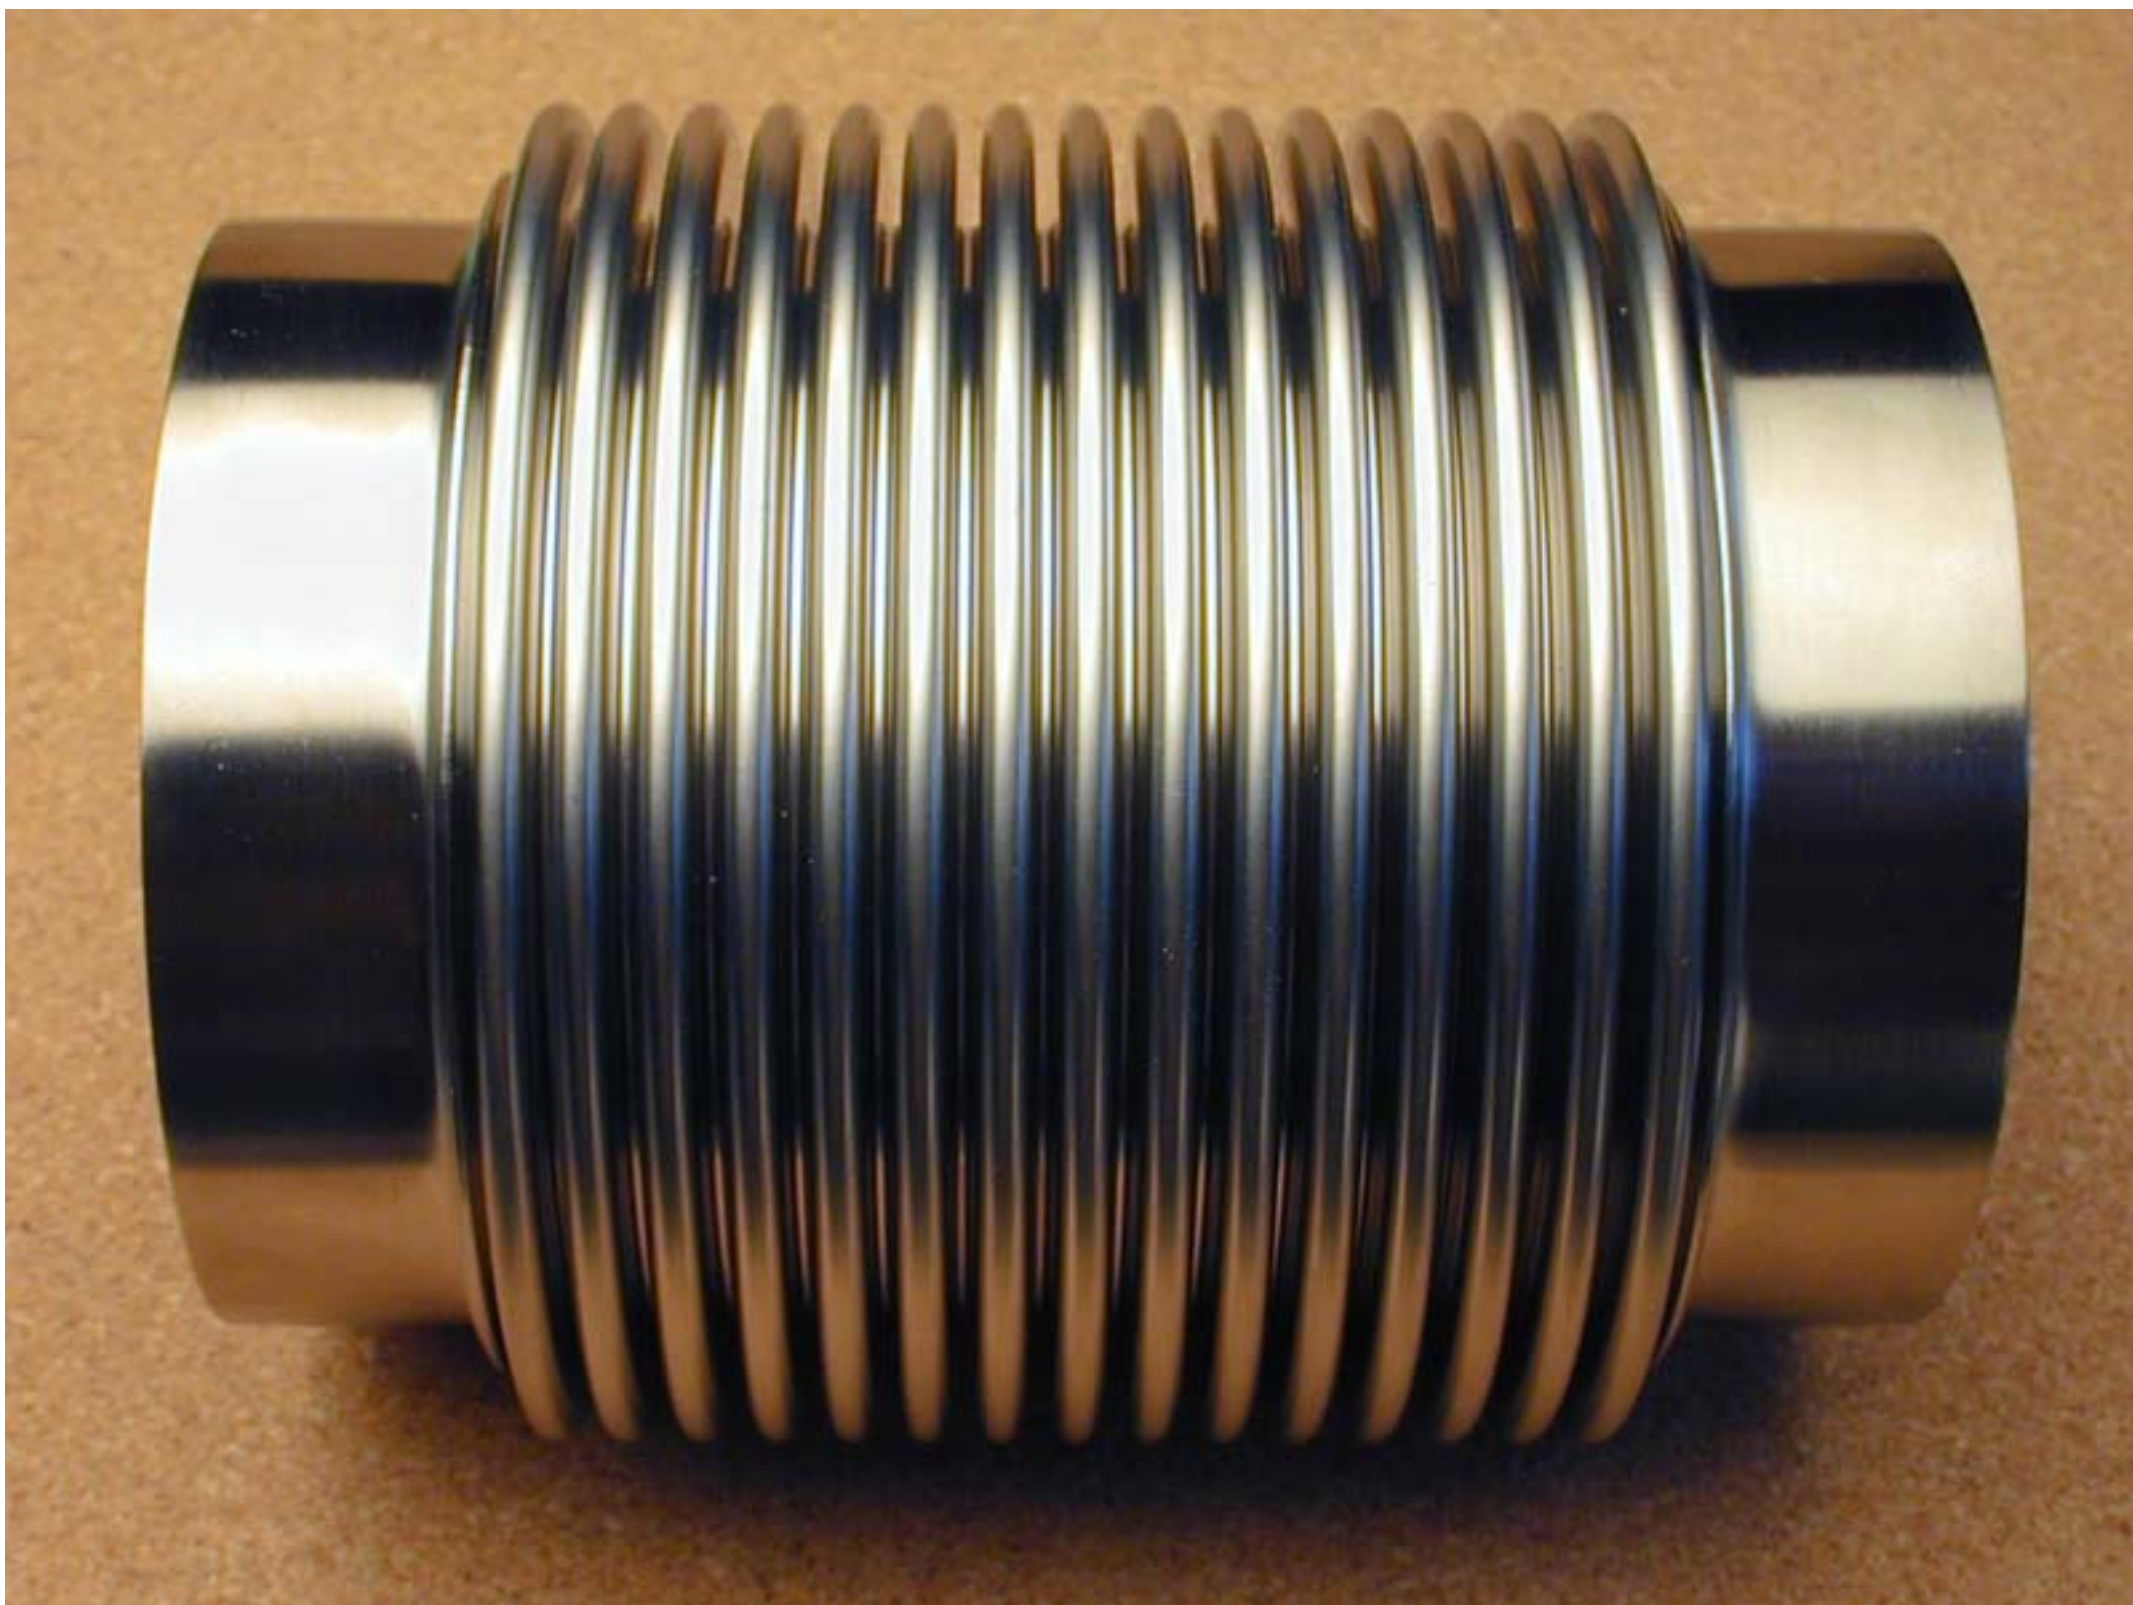
Ameriflex Bellows 1.jpg

The Ameriflex bellows have their weld assist flange made in such a way that any welding on the flange will not stress the bellows to flange joint much. Notice the flair and how nice the weld is.

Here is some pics of the Ameriflex bellows / Ameriflex Bellows 1

When welding the weld assist band to the Actuator plate, the weld will pull the weld assist band and make it larger. Because of the design of the bellows to weld assist band joint, this could be putting unacceptable stress on the internal Hyspan weld. There may also be some rotation of the joint in cross section when the weld cools and pulls outward on the top of the ring. I will try to measure this today. This is our best guess at this time as for the cause of the three leaks we have had.
