## T020179-00-E HEPI Actuator 2 Assembly Oct 24 2002

### [Directory 1](#)

### [Directory 2](#)

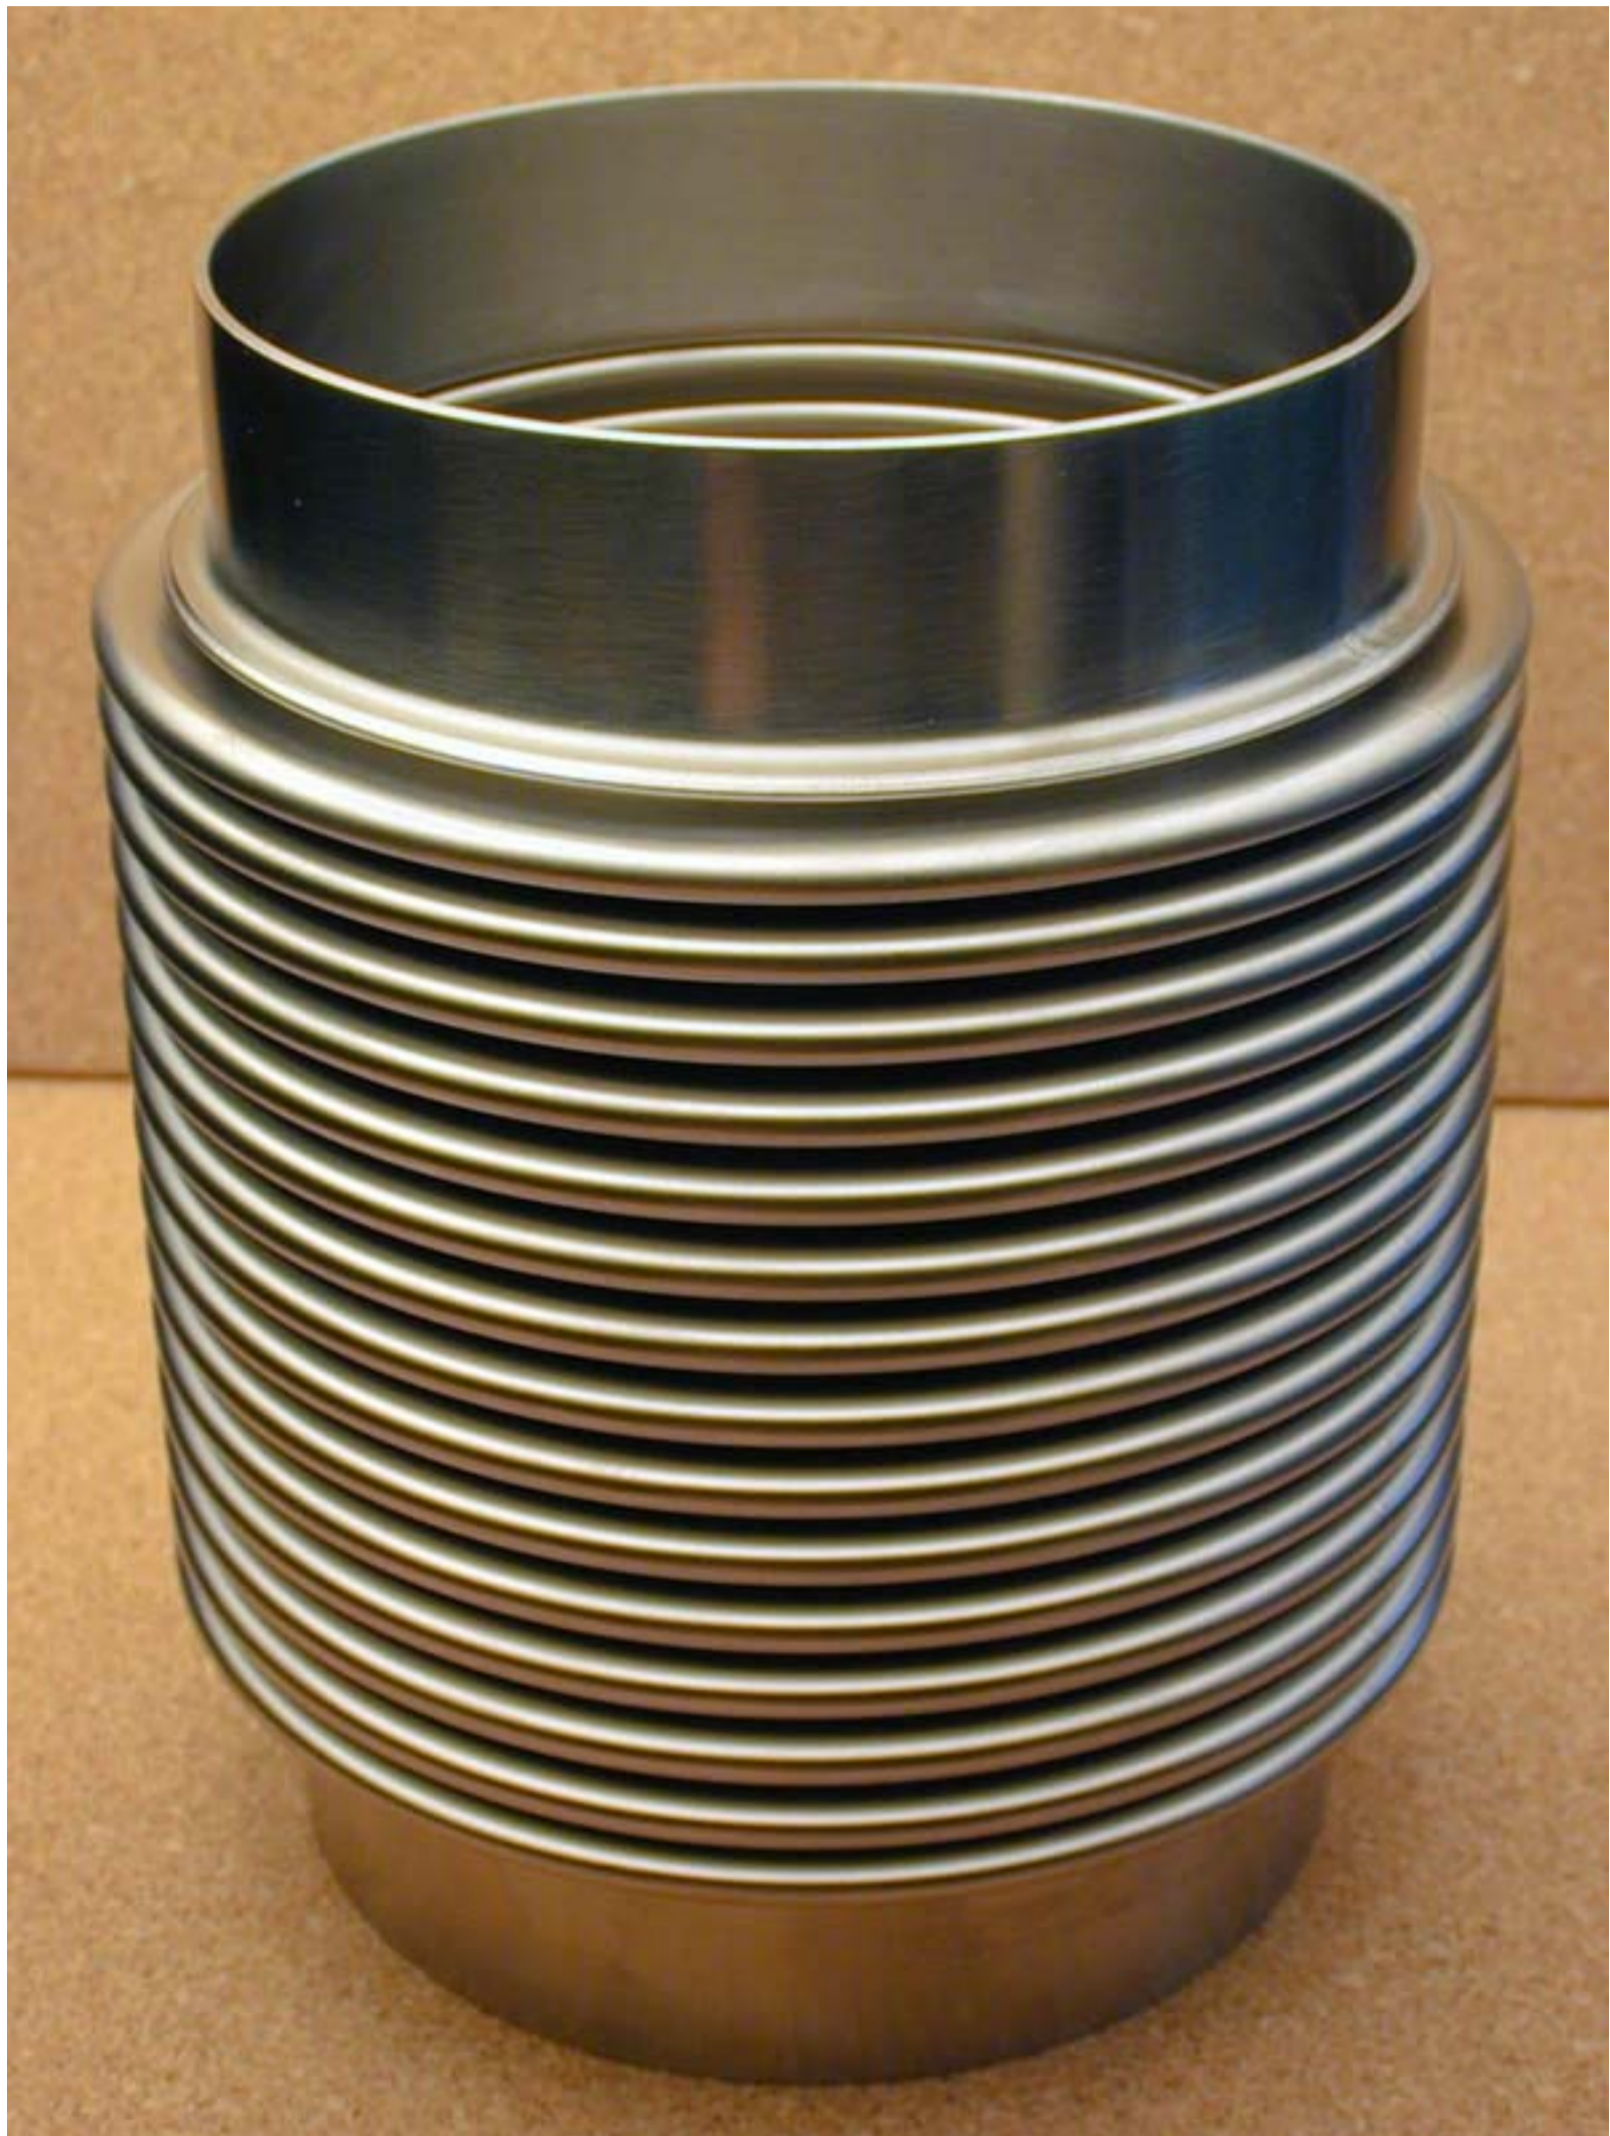
Ameriflex Bellows 2.jpg

The Ameriflex bellows have their weld assist flange made in such a way that any welding on the flange will not stress the bellows to flange joint much. Notice the flair and how nice the weld is.

Here is some pics of the Ameriflex bellows / Ameriflex Bellows 2

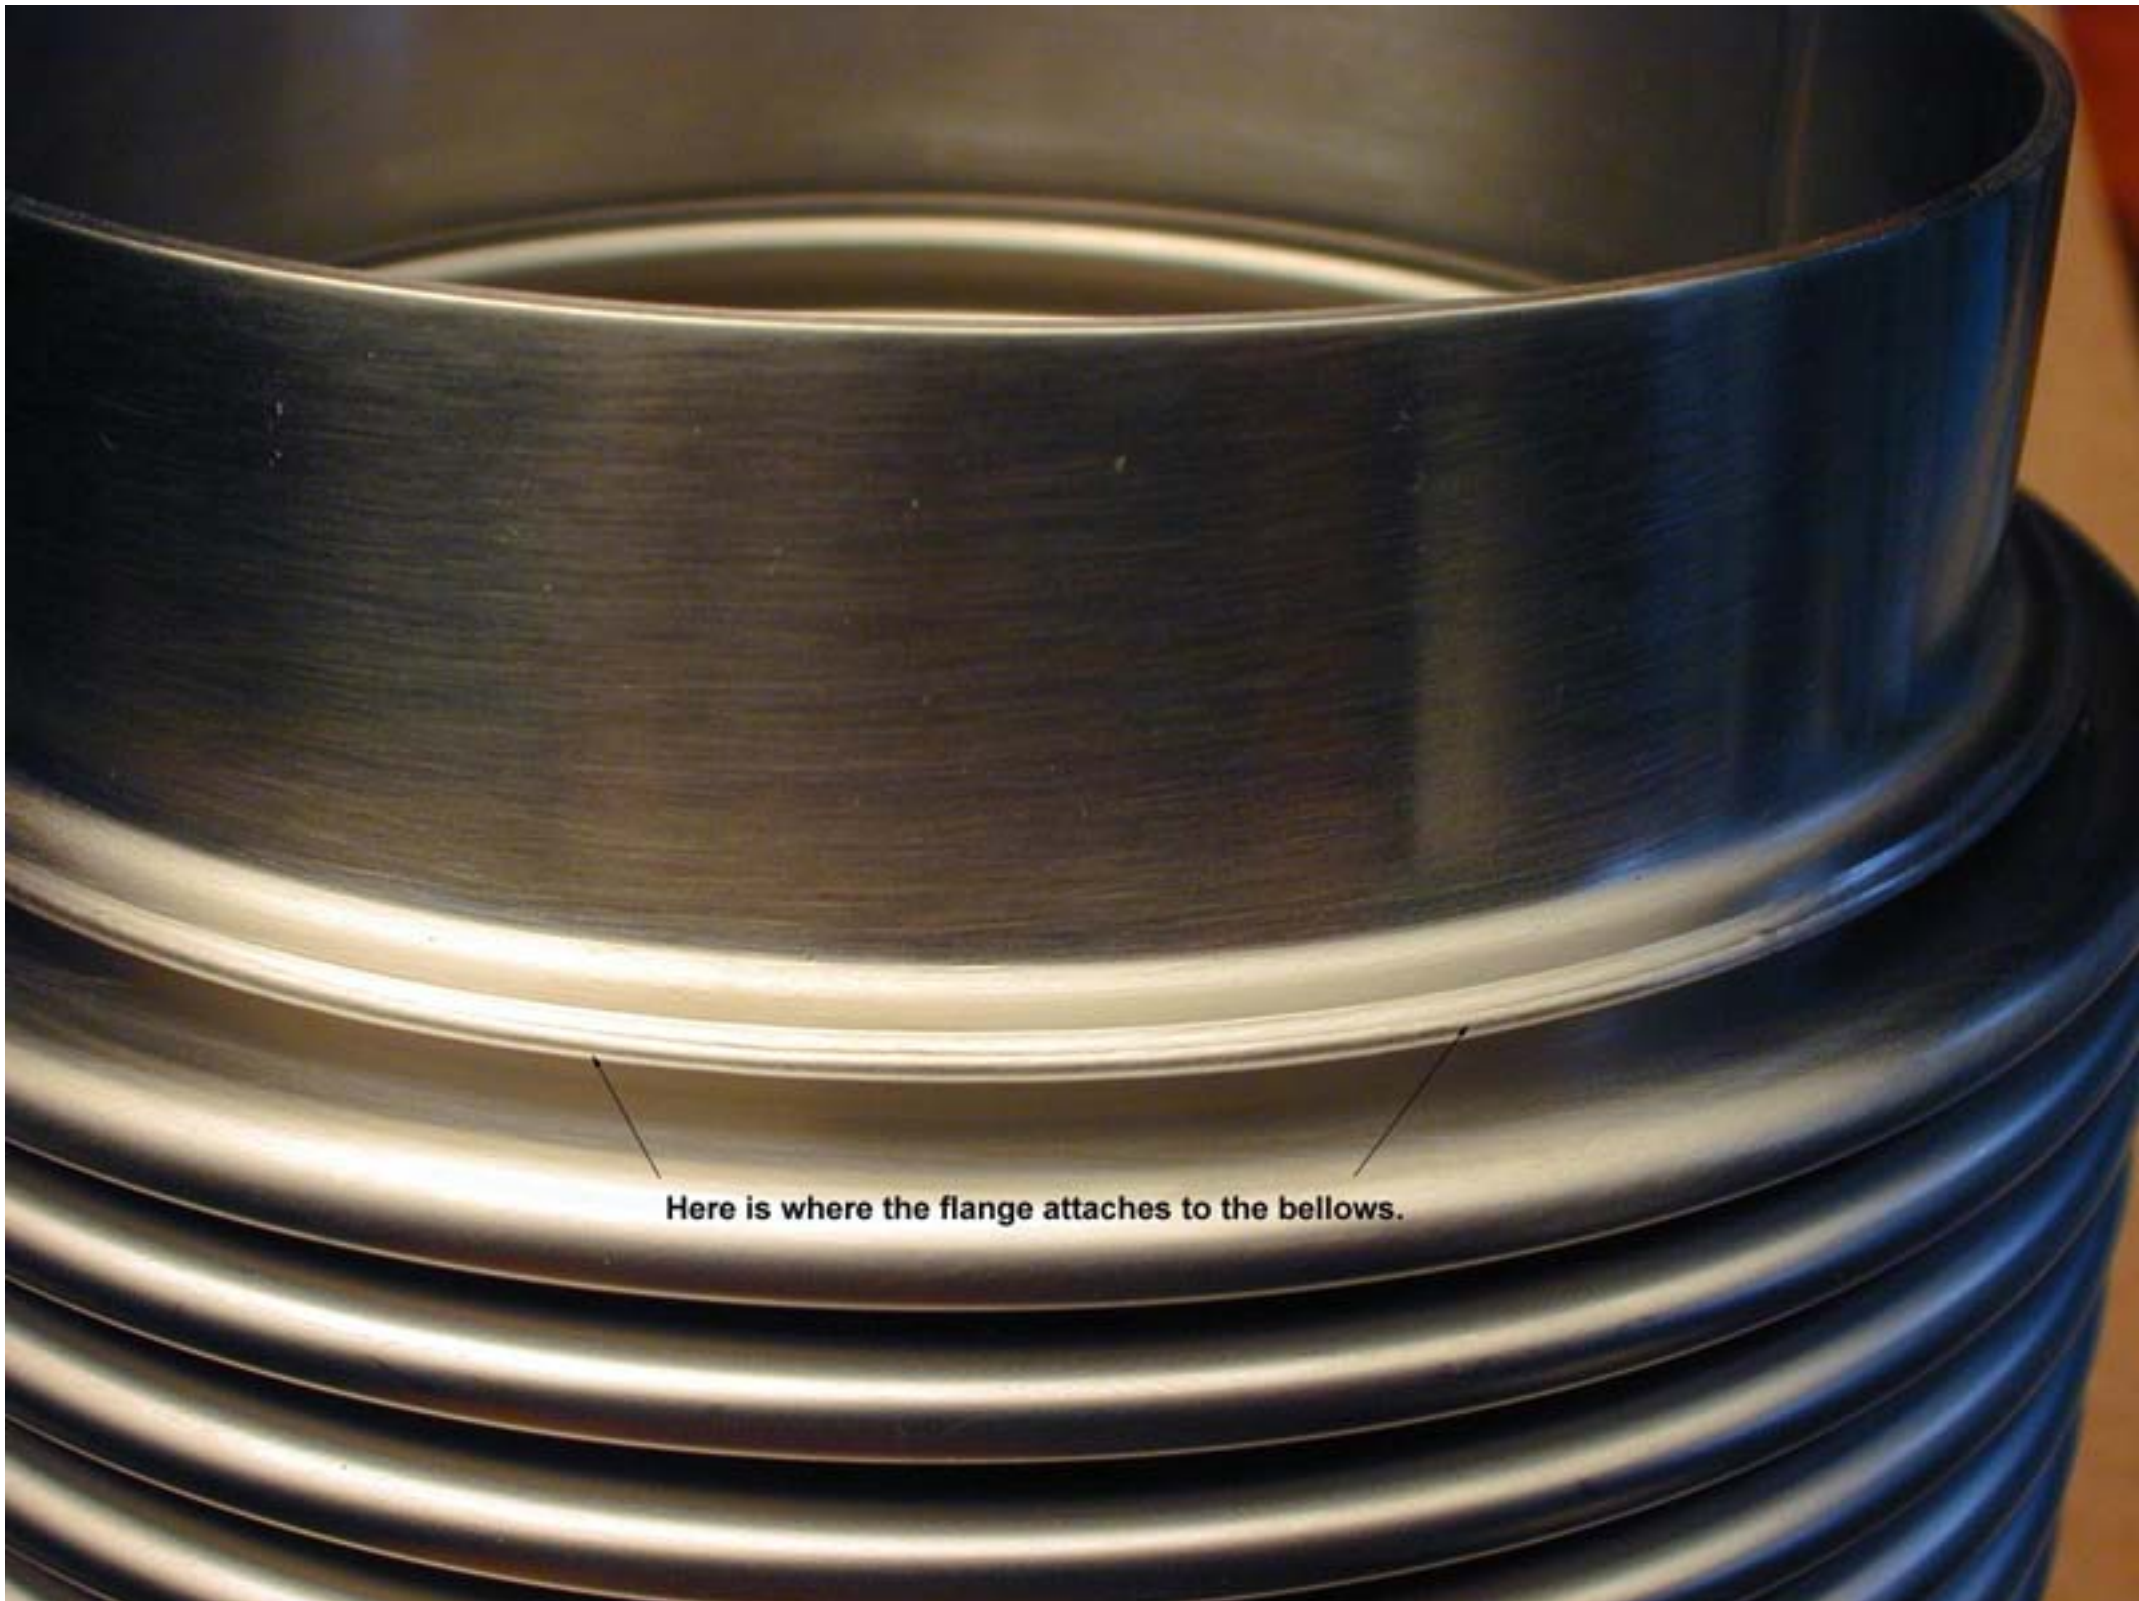
Ameriflex Bellows 4.jpg

Here is some pics of the Ameriflex bellows / Ameriflex Bellows 4

**Here is where the flange attaches to the bellows.**
