LIGO- LIGO-T060109-00-D

Preliminary Weld Tests, mid May 2006

Stefano Molesti, Marcello Berchiolli, Yumei Huang, Riccardo DeSalvo

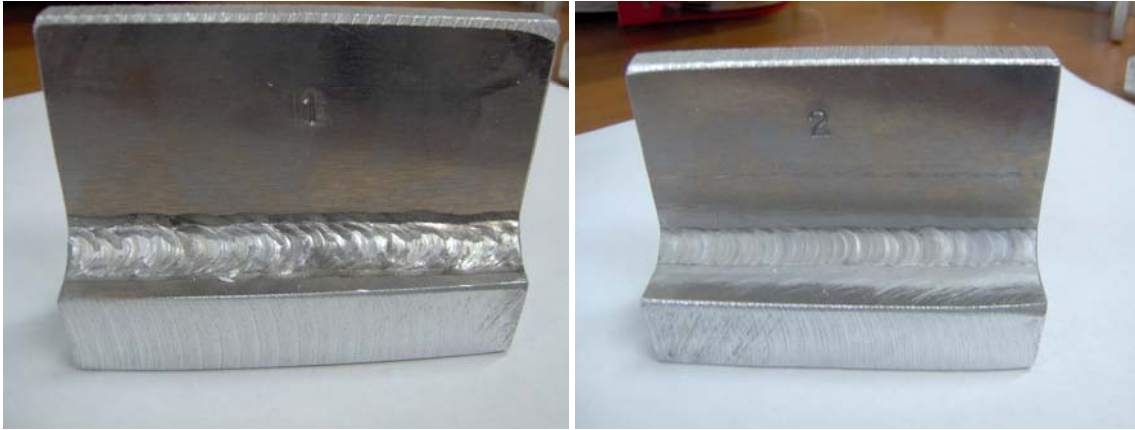
The T-welds labeled 1-2 and 3-4 (figure 1,2 and 3) appear at first sight to be quite good samples. The welds in the saw cuts appear compact and uniform.

Weld 1 looks the best, quite uniform and little waving, weld 3 and 4 are similar between themselves, the only problem is what appear as a bubble or small inclusion in weld 3 right under the 3 label (see figure 2).

Figure 1: welds of sample 1.
Weld 1 MIG, He25%-Ar75% mix ,cold sample
Weld 2 TIG, He-Ar mix, sample pre-heated by MIG

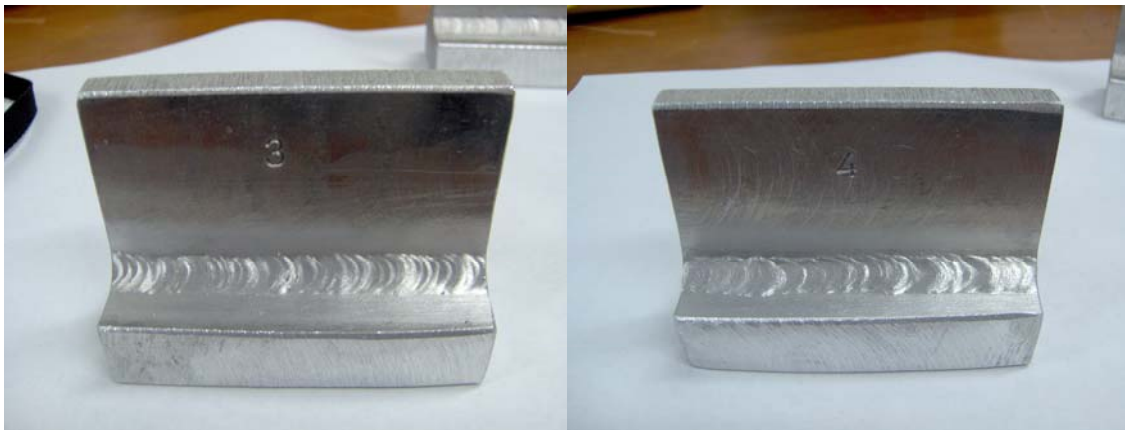
Figure 2: Welds of sample 2
Weld 3 TIG, Ar, sample pre-heated by MIG
Weld 4 MIG, He-Ar mix, cold sample

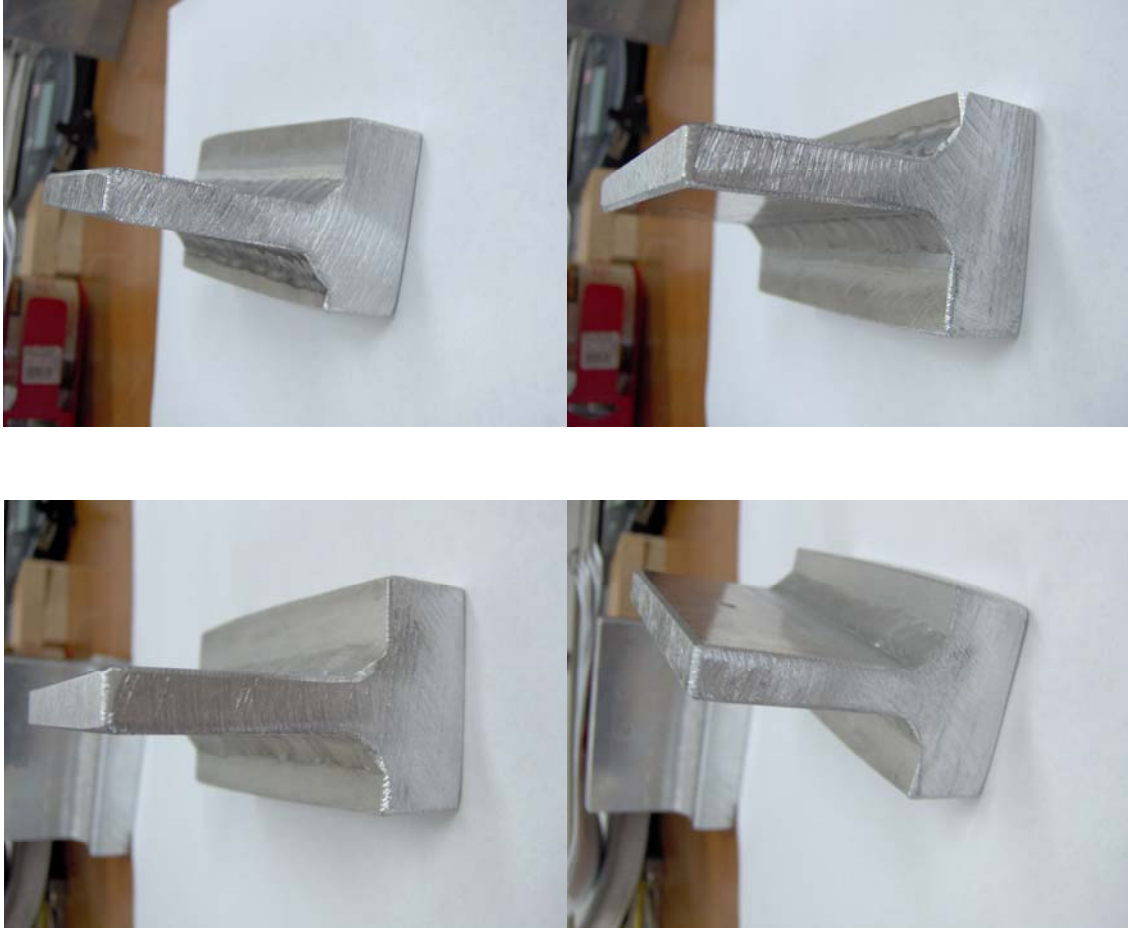
Figure 3: Weld saw-cut view of samples 1 and 2
Weld 1 MIG, He-Ar mix ,cold sample
Weld 2 TIG, He-Ar mix, sample pre-heated by MIG

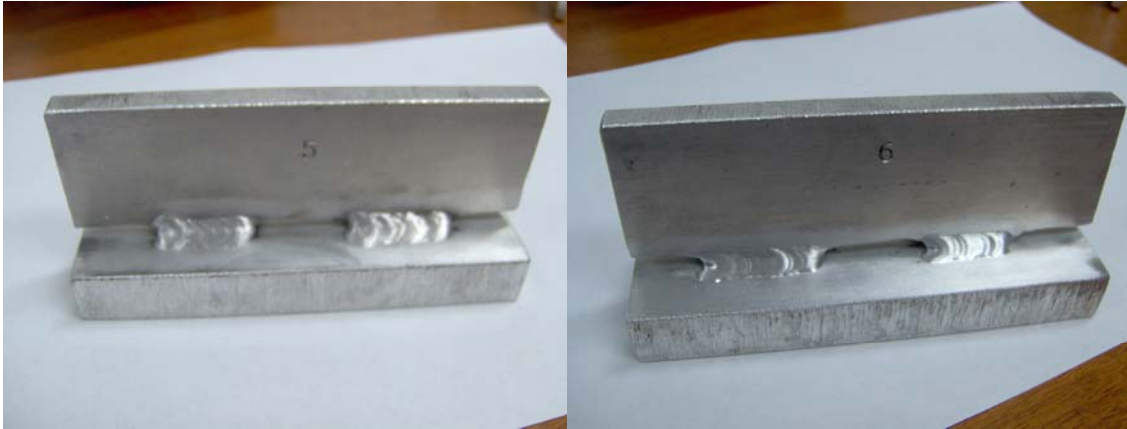
The scalloped T-weld labeled 5 and 6, along the length appear quite acceptable along the weld length, with weld 6 looking better than weld 5, see figure 4.

Figure 4 side view of scalloped T-weld
Weld 5 MIG, He-Ar mix ,cold sample
Weld 6 TIG, He-Ar mix, sample pre-heated by MIG

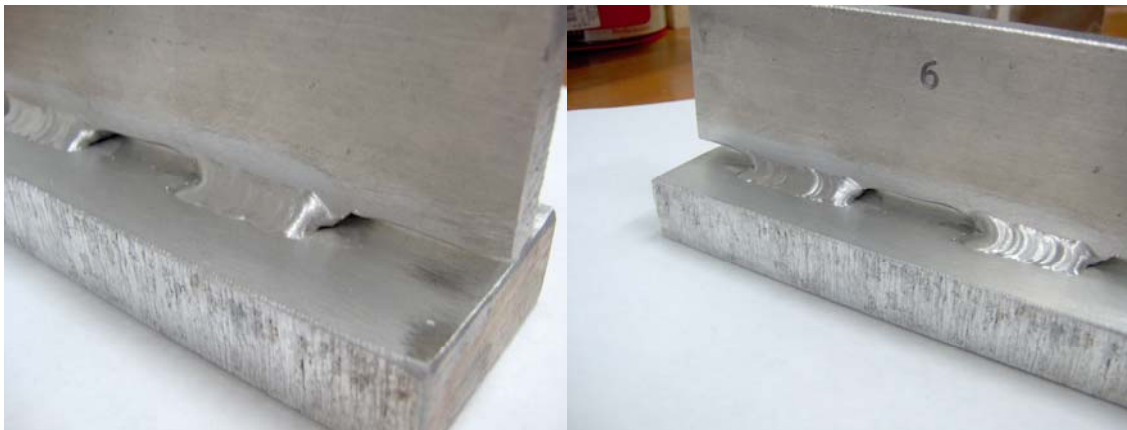
The problem comes from the ends where, see figure 5, deep crevasses are left at the end of the weld. Machining oil that would certainly get in there by capillary action, and stay there. No cleaning technique could remove it. In vacuum the oil would start evaporating and damage the mirrors. This sort of crevasses is totally unacceptable.

Figure 5 View of the ends of welds 5 and 6
Weld 5 MIG, He-Ar mix ,cold sample
Weld 6 TIG, He-Ar mix, sample pre-heated by MIG

Perhaps, if we were to open the scalloping much wider, the weld could be completed all around and full penetration of the weld achieved, making the weld acceptable.

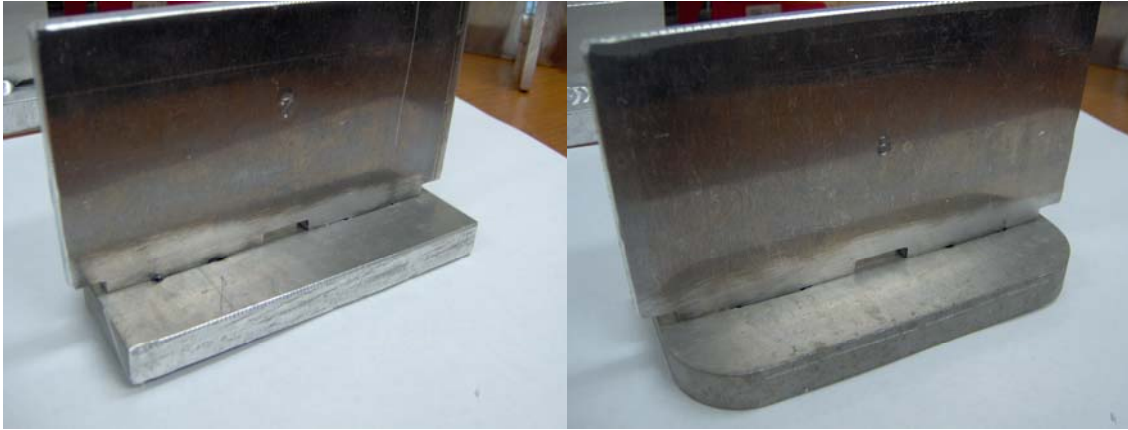
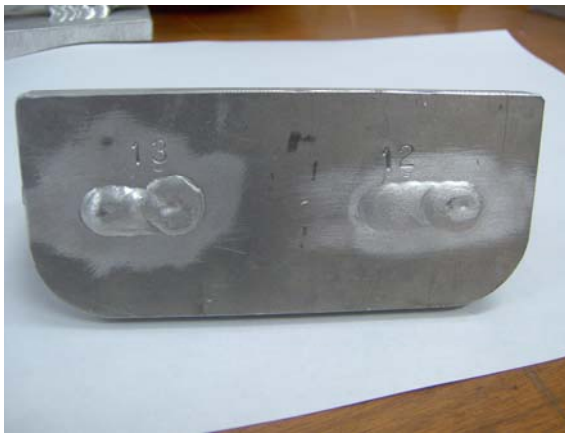
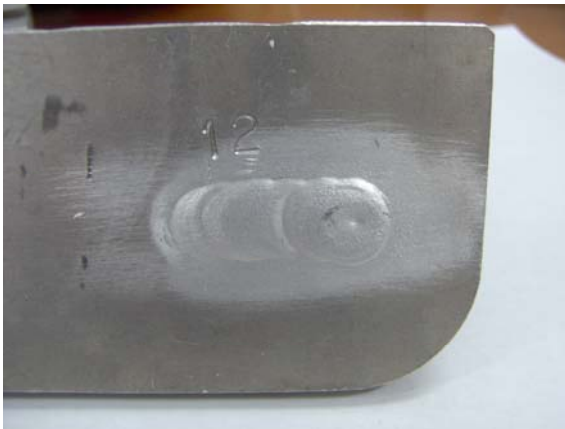
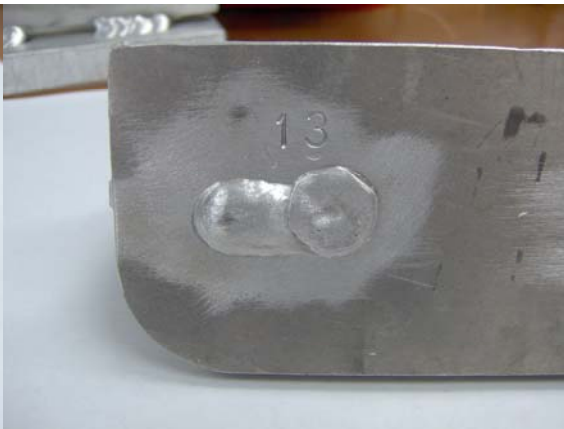
Plug T-welds, figure 6, on the bottom side the plug 12 looks better than the 13, but on the top side, deep crevasses are totally unacceptable. Again deep scalloping and all-around welds may make it acceptable if deep penetration was achieved.

Figure 6, Plug T-welds
Weld 12 TIG, He-Ar mix, sample pre-heated by MIG
Weld 13 MIG, He-Ar mix, cold sample

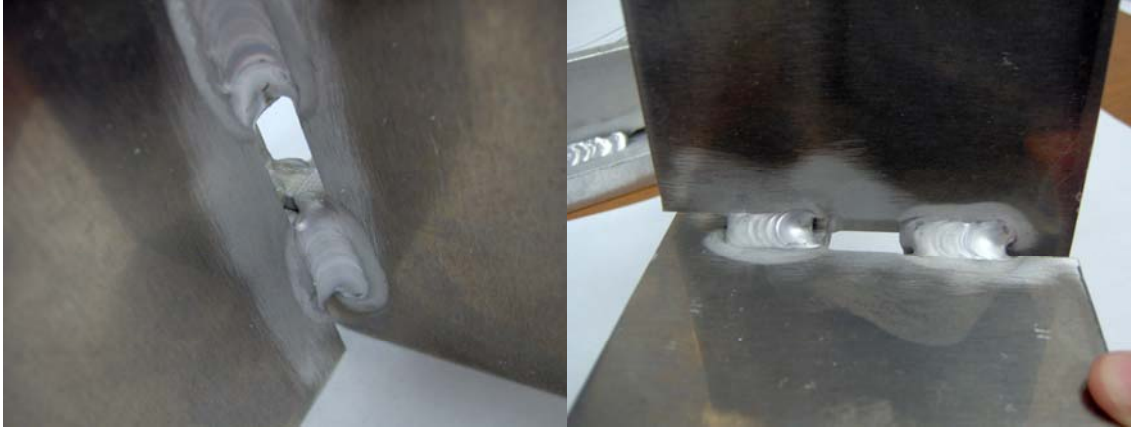
Similarly the welds in the egg-crate cross weld, labeled 11, look OK along the length, but crevasses are present at the ends.

Figure 7 view of cross welds and crevasses.
Weld 11 TIG, Ar, cold sample

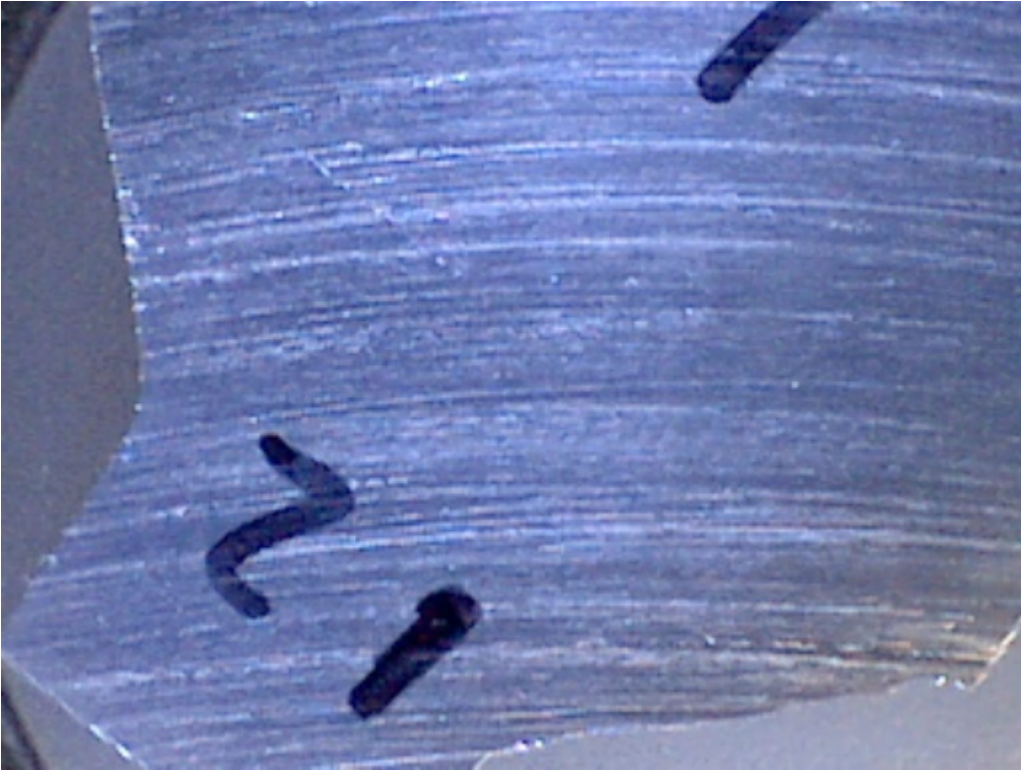
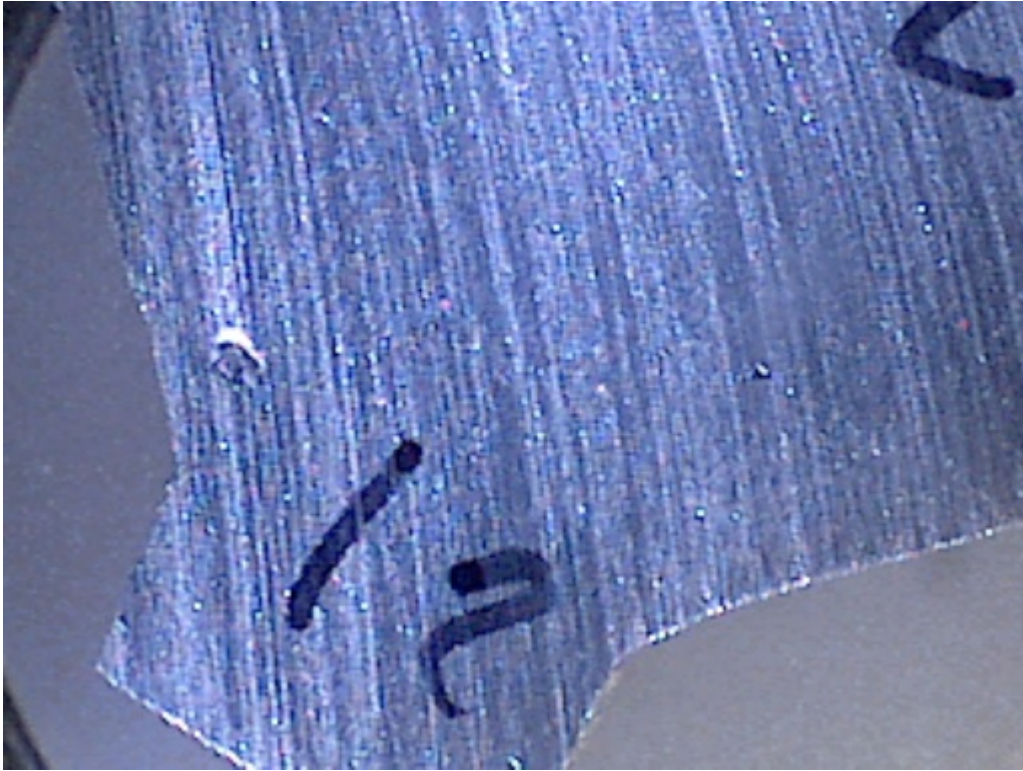
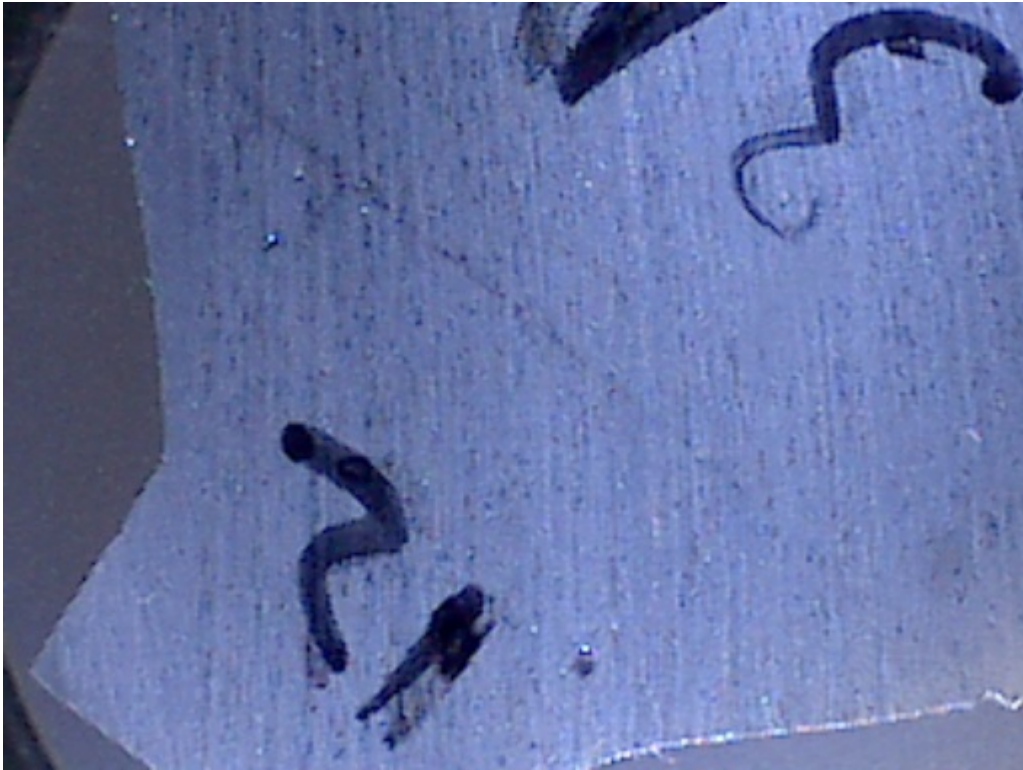
Indeed the welds appear to be quite compact, with only some small isolated bubbles of little concern.

The problem comes from the hairline cracks visible in many, but not all sections.

The crack marks the boundary between the two parts welded together, and indicates that full penetration welding was not achieved. The lack of hairline crack in some welds indicated that occasionally full weld was achieved.

Unfortunately these long cracks have little chance of being completely isolated inside the aluminum welded body and would absorb machining oils and then produce virtual leaks by out-gassing in the vacuum.

In the cuts it appears that the boundary between the two parts in welds 1, 2, 3, and 4 never melted significantly.

It appears to be a slightly larger gap on the TIG side, not surprising, given the fact that the MIG was the first cut and in cooling it has more than likely pulled the samples, lifting the other end.

Likely if the contact surface had been reduced drastically by heavy chamfering, full depth welding would have probably achieved.

TIG appears to be the best choice in all cases, and it is clear that welding from both sides does not appear to be of interest, especially seen the pulling effect that lifts the other end. The contact area between parts before welds should be as thin as possible.
