LIGO- T060128-00-D

Cross weld tests

Stefano Molesti, Marcello Berchiolli, Chiara Vanni, Riccardo DeSalvo

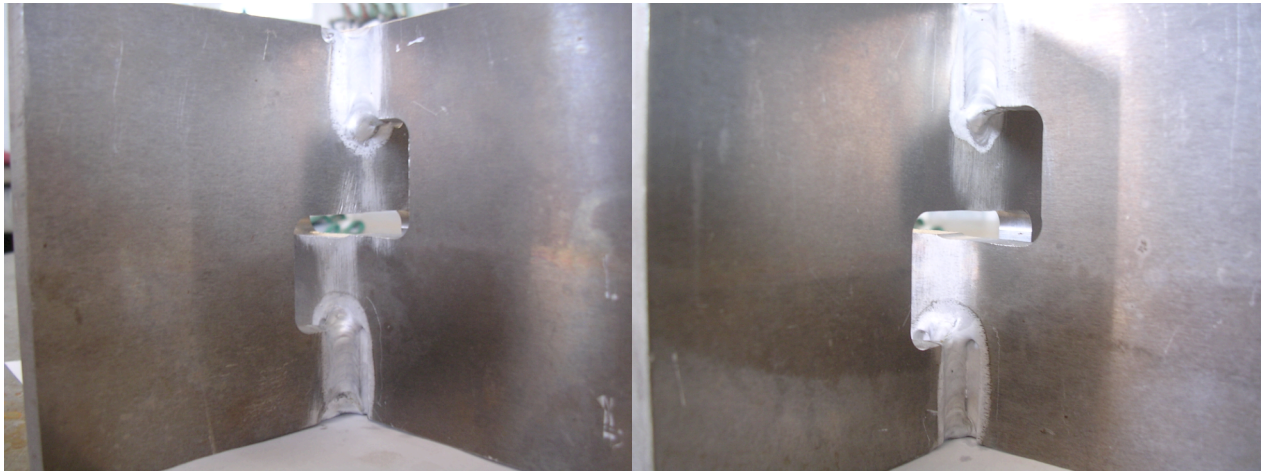
These results are illustrated in the following photos

The first four show the four sides of the cross welds.

The fifth is a zoom in what, in the photo, appears as a crack. It is the remnant of the machined trench wall, molten and dragged by surface tension on the two sides. At close inspection it does not present the risk of a virtual leak, but better design of trenching will be done to avoid even this visual problem.

The sixth photo shows an inclined view of the cross and the turn around point between two weld tracts.

Although not perfect, it was a visually satisfactory weld test.

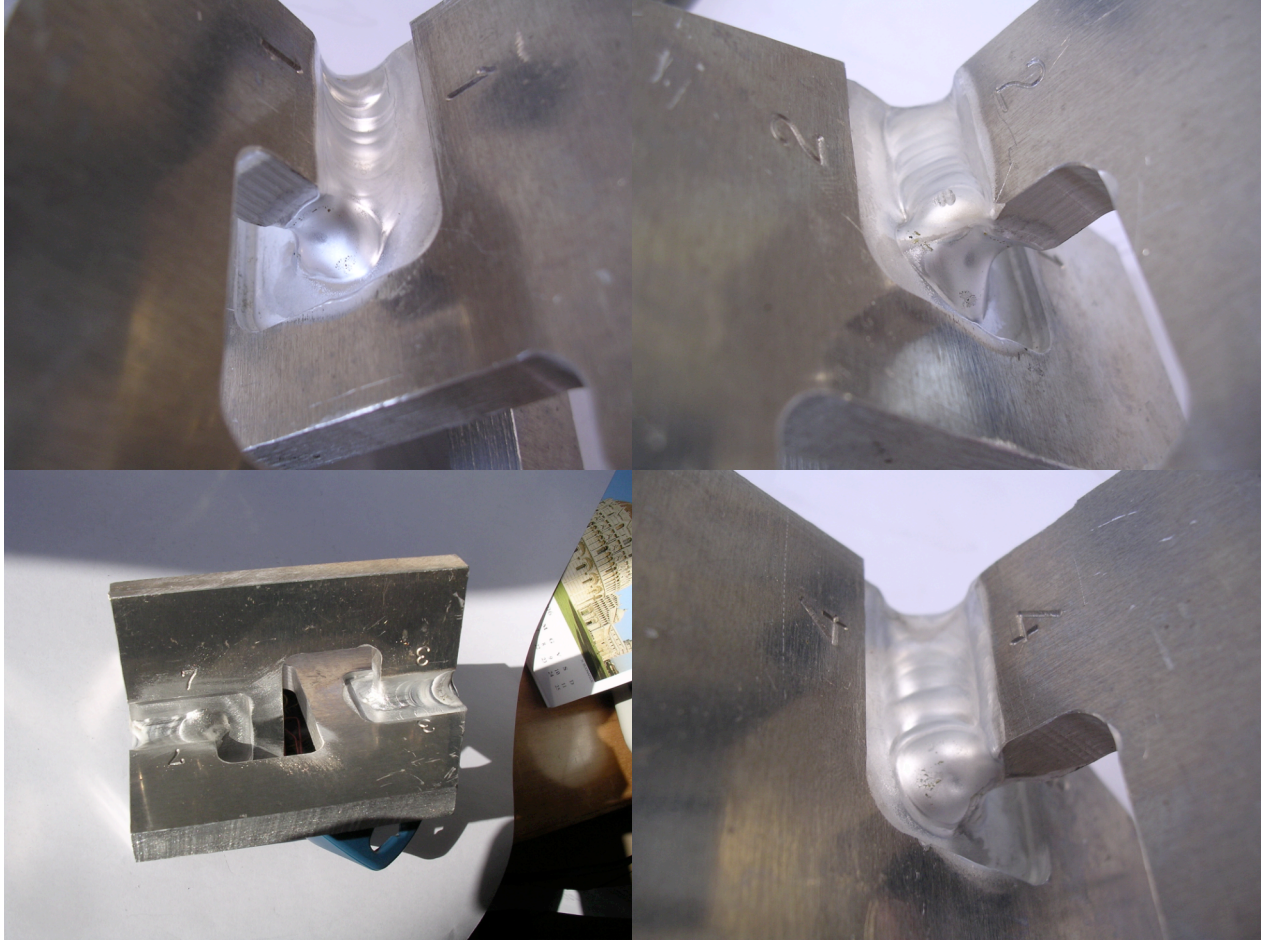
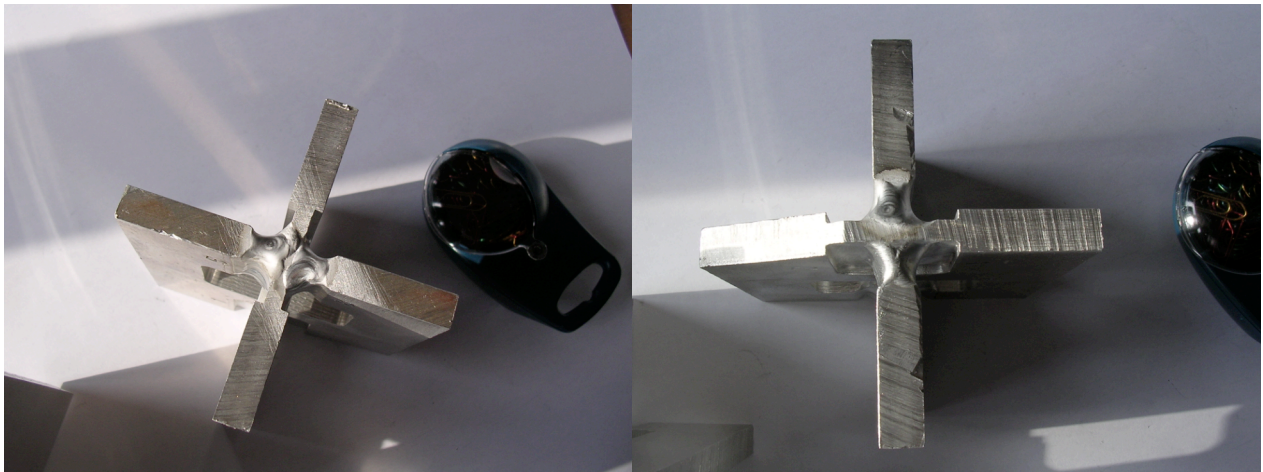
View from the inside point of view of the 8 welds of the **first** test sample and edge view of the two sides of the crosses.

Most welds have the geometry shown in the first 8 images (view from inside) on both sides, while the welds at the outer edges of the honeycomb structure have the edge view geometry.

Most of attention was dedicated to the welds shown in the first 8 images, but even the edge welds (last two images) came out satisfactorily.

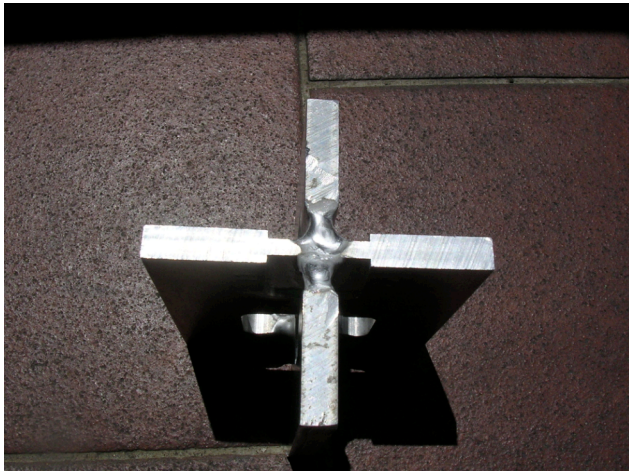
View from the inside point of view of the 8 welds of the **second** test sample and edge view of the two sides of the crosses.

The results are the same as in the first test. Although the image seems to

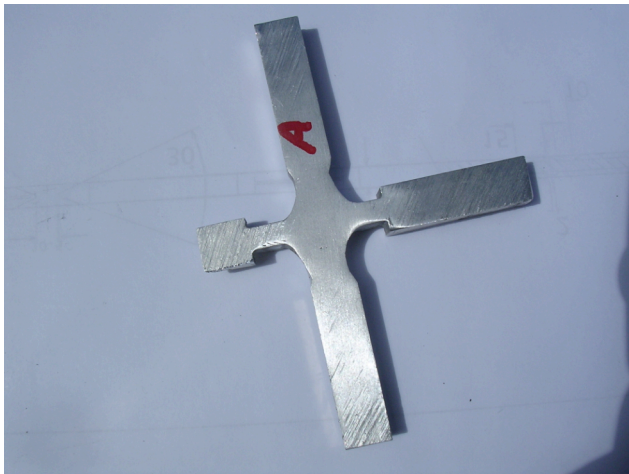
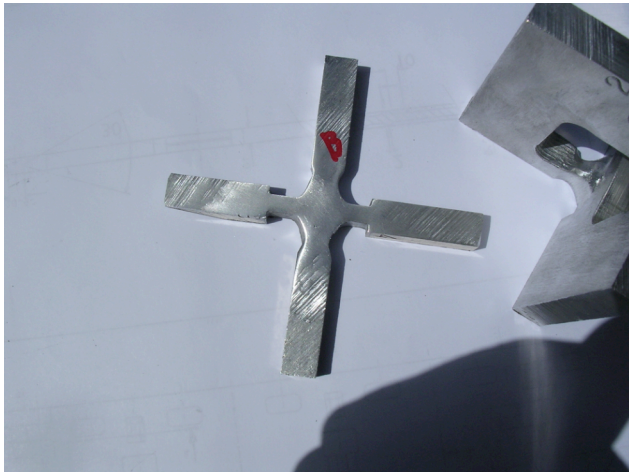
The following images show the cuts of the first sample
Only small localized cavities are visible in some of the cuts.
Some cavities do not even extend through the thickness of the cut.

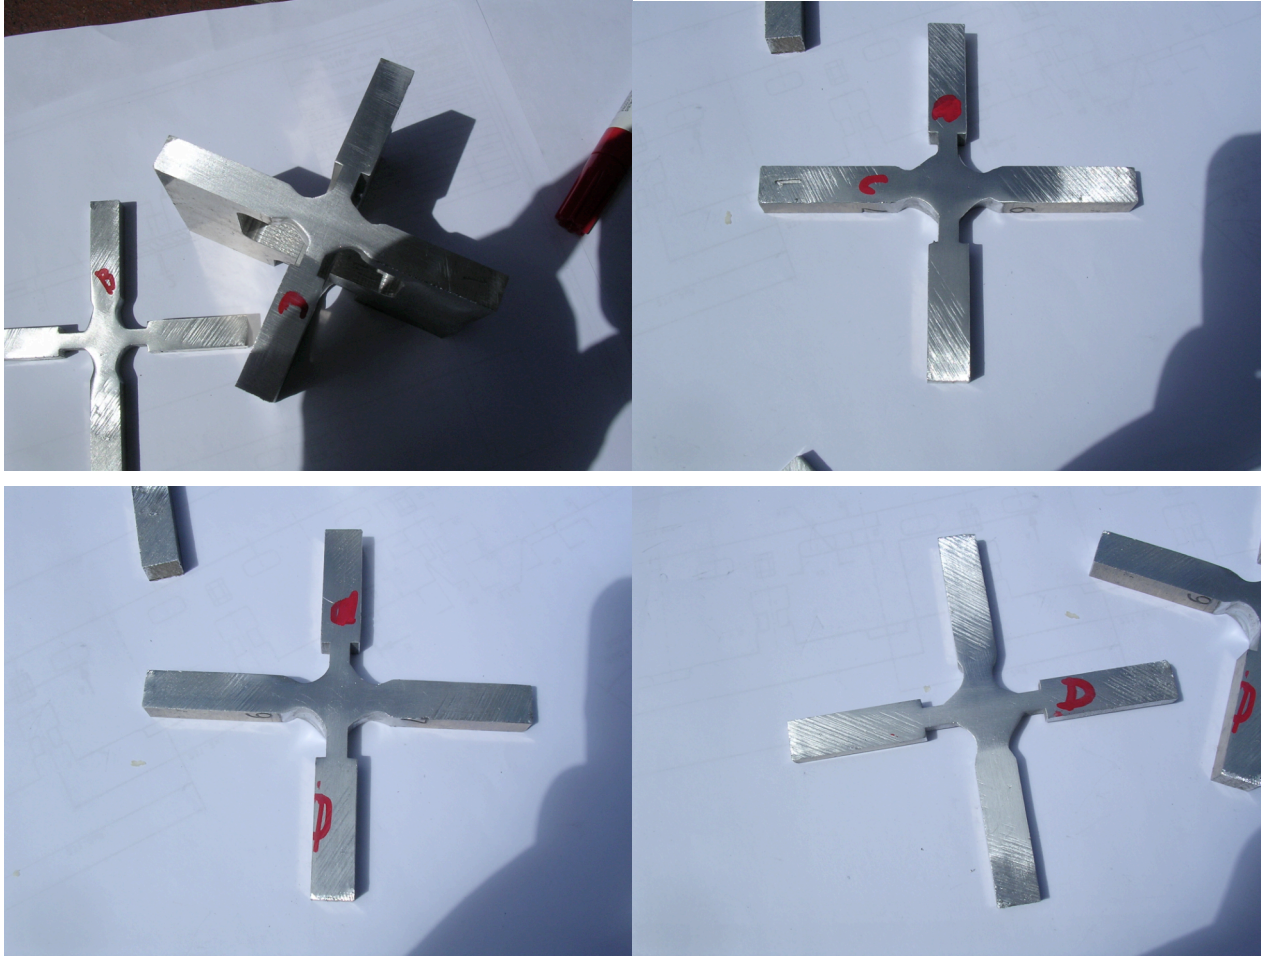
View of the edge of the cross weld.

It is clearly visible that even these welds, that were given less attention assuming that they were not used in the weldments, are acceptable.

We conclude that with the machined geometry, the cross welds satisfy the LIGO requirements.

Welds with an opening larger than 90° are satisfactory and produce the desired full penetration welds.
