LIGO-T1100081-v1

ADVANCED LIGO

7th April 2011

Shear strength testing of hydroxide catalysis bonded discs

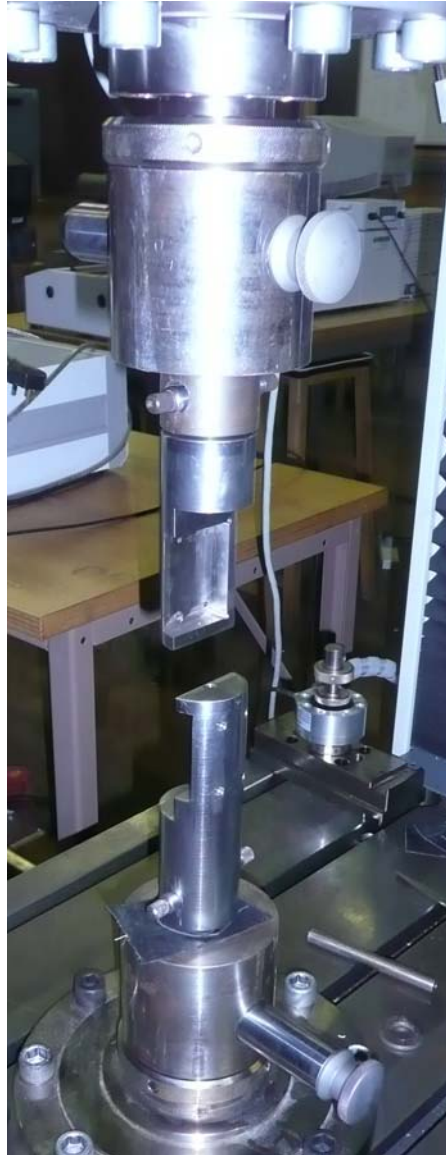
The holder with sample were slid together into the shear strength set-up which is installed on a Zwick 250 kN strength testing machine (Figure 2.1).

Figure 2.1 Shear strength testing set-up

The sample was loaded in shear by moving the loading bar away with a rate of 1 mm/min. The load was recorded with a 50 kN load cell. The measurement was stopped when the load drops to 80% the maximum load achieved in the test or if the load became higher than approximately 12 kN for safety reasons and because this bends the set-up itself so much that the loading conditions on the sample change.

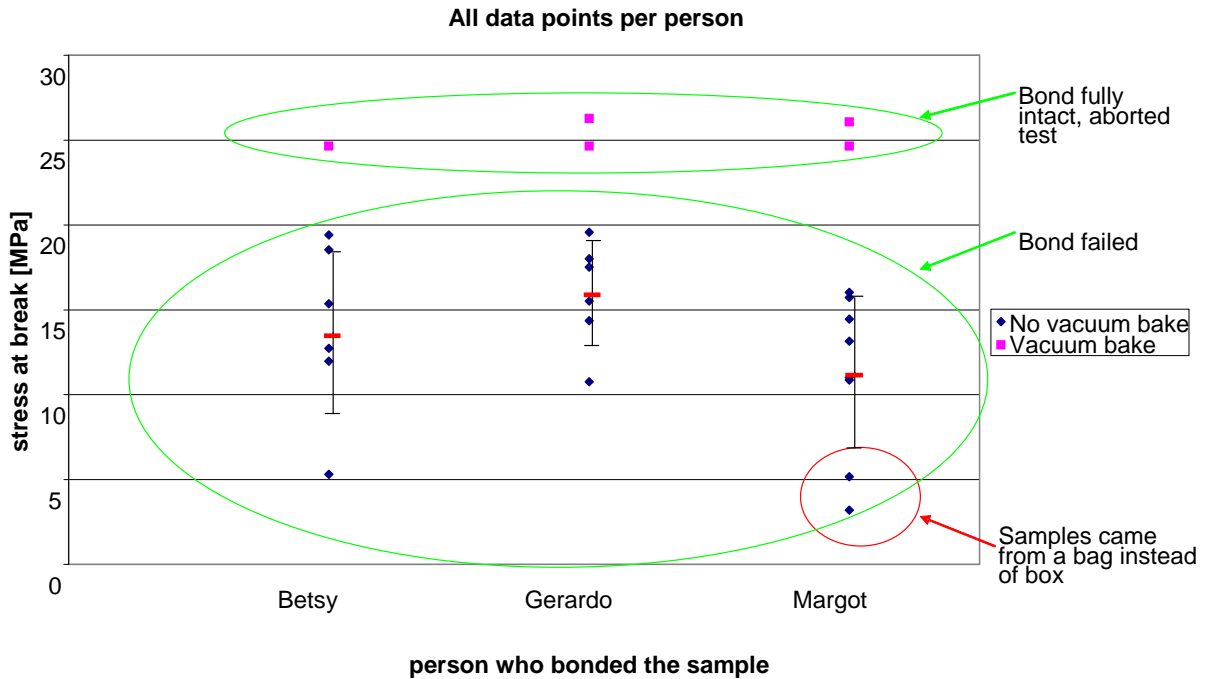
An overview of the strength testing results is given in Figure 3.2, in which the maximum load measured in N has been converted to a maximum shear stress by dividing the force by the bond surface area. More detailed results can be found in appendix A, in which all data can be found in tabulated format.

Figure 3.2 Strength testing results for all samples with stress at break as a function of the person who bonded the sample.

Firstly it can be noted that all samples that were vacuum baked show a significantly higher strength than any of the samples that were not vacuum baked. In fact these samples never broke across the bond. In all five vacuum bake cases the test was aborted, because at 12000 N, which is equivalent to ~ 25 MPa shear stress in the bond, the set-up itself was in fact bending so much that it wasn't deemed safe to continue the tests. On inspection afterwards, the edges were damaged because of the high contact load there, but the bulk of the samples including the bond appeared to be undamaged.

All non-vacuum-baked samples broke at equivalent stresses averaging 13.4 MPa with a standard deviation of 4.7 MPa. The large standard deviation is caused by three very low strength samples. The reason for the low strength of these samples is unknown. Bond

The average strengths and standard deviation on the measurements of each of the three people are $13.9 \pm 5.2 \text{ MPa}$ for Betsy, $16.0 \pm 3.1 \text{ MPa}$ for Gerardo and $11.2 \pm 4.8 \text{ MPa}$ for Margot. The average strength found for Gerardo's bonds is somewhat higher than for Betsy and Margot, but their averages are pulled down by the three low strength samples and consequently their standard deviations are higher as well.

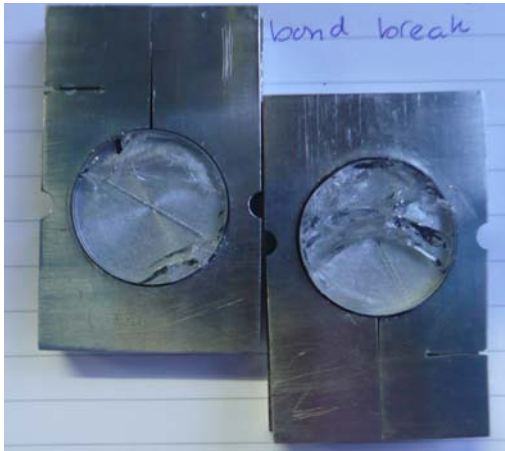
Figure 3.3 Disc MP2 broken at ~ 5 MPa

For all other samples the test was continued till brake and in fact all apart from the three samples with very low strength, disintegrated completely into an uncountable number of pieces. Upon inspection the bonds in these samples were broken as well as the bulk material. The three samples with strengths below 10 MPa were primarily broken across the bond but tended to have a number of fractures in the bulk as well. An example of this can be seen in Figure 3.3. No significant differences have been observed between these three low strength samples and the other samples. All three were bonded over 98.5% of their surface area and no observations were made during bonding that could explain the low strength. The only difference between the two low strength samples bonded by Margot was that they were stored in a plastic bag just prior to strength testing, whereas all other samples were stored in a plastic box at this point. It seems unlikely that this is the cause of those low strength breakages though.

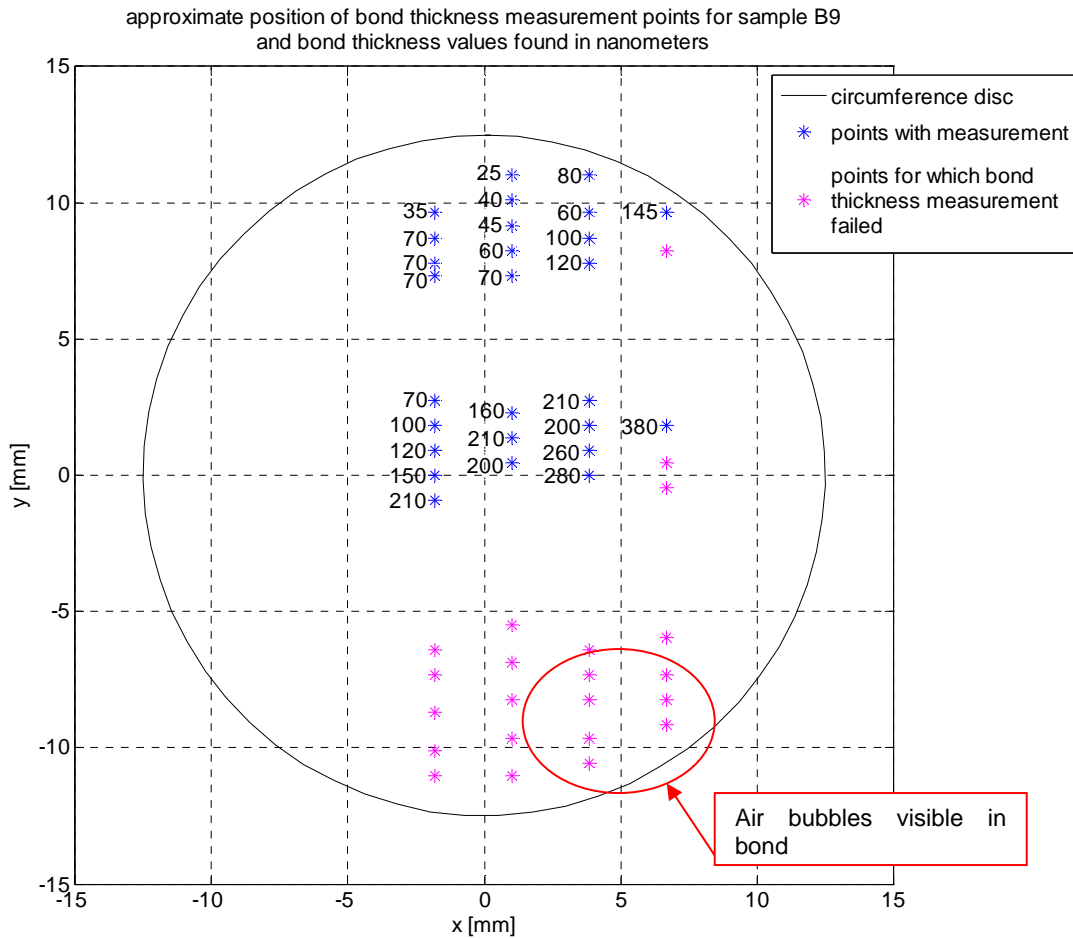
Figure 3.6 shows an overview of the approximate (± 1 mm) positions of the thickness measurements made with respect to the full size original disc and where possible a number for the thickness found.

Figure 3.6 Approximate position of bond thickness measurement points for sample B9 and bond thickness values found in nanometers.

At the top of the sample the measurements show that the bond is very thin; around 25 nm, but moving down and somewhat to the right the bond becomes very wide until in the bottom it was not possible to make any thickness measurements presumably because of charging effects due to an even higher bond thickness (this wedge shaped bond is visualized in Figure 3.7 as well). If one looks at Figure 3.1 and looks up sample B9, one will find that this sample did have some bubbles in. The approximate location of the bubbles is indicated in Figure 3.6 as well. It appears that the bubbles might have had some effect on the bond thickness here.

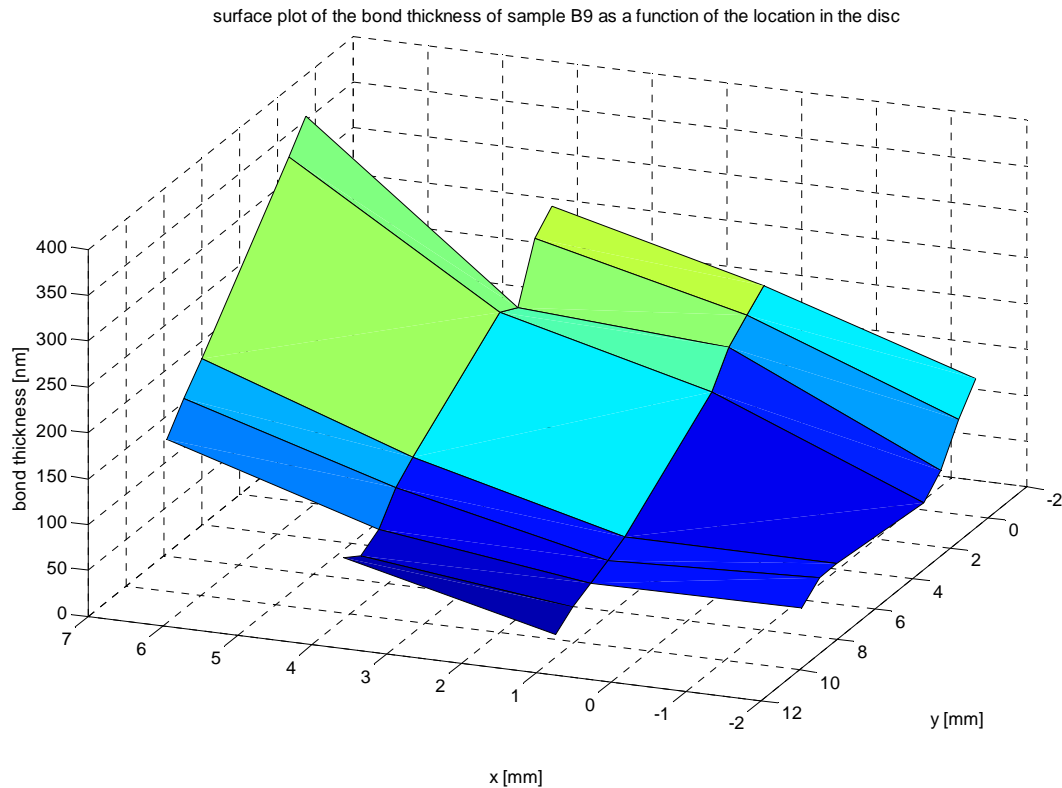
Figure 3.7 Surface plot of interpolated bond thickness values at set intervals. In this image the measured bond thicknesses have been interpolated to set locations (close to where measurements have been taken) using the `datagrid` function in Matlab and plotted as a surface plot to illustrate that the bond appears to be wedged.
