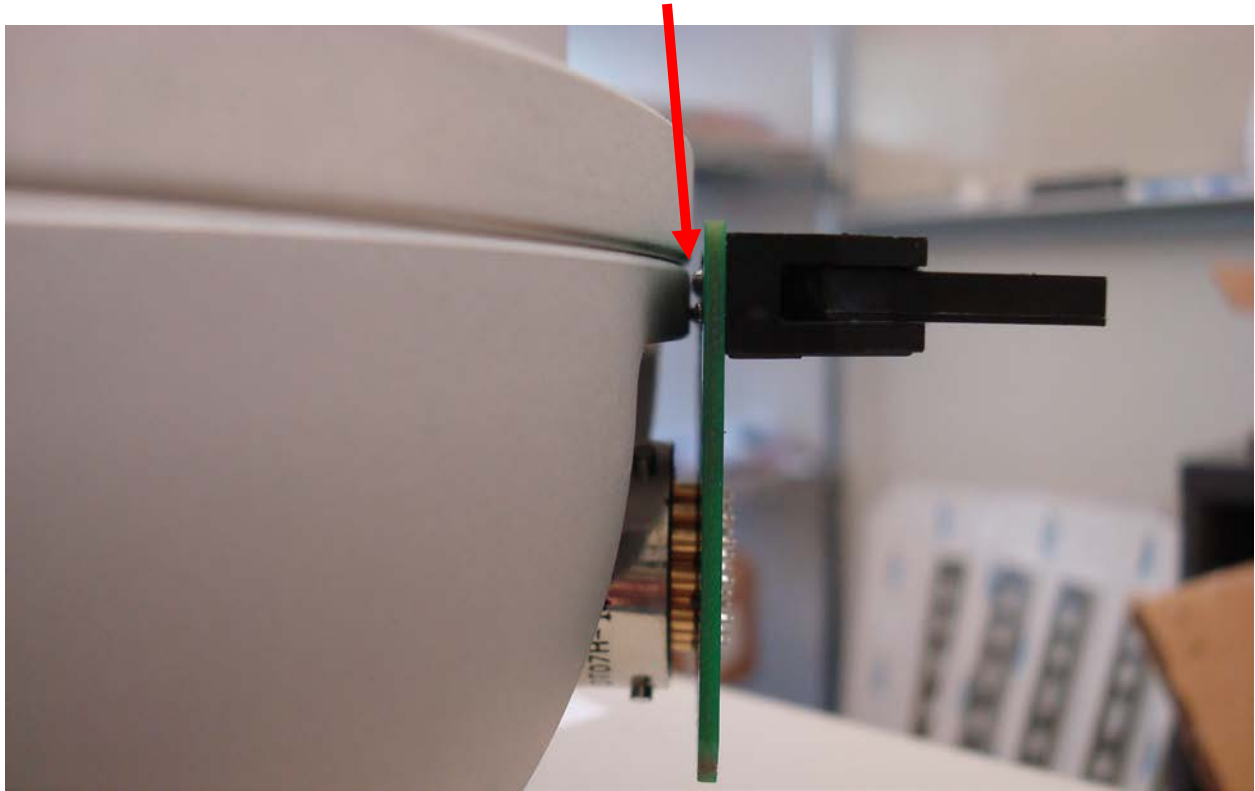
The old connector from the side. It can be seen that, although we have trimmed the pins of the IDC connector, they still touch the enclosure, and would short out.

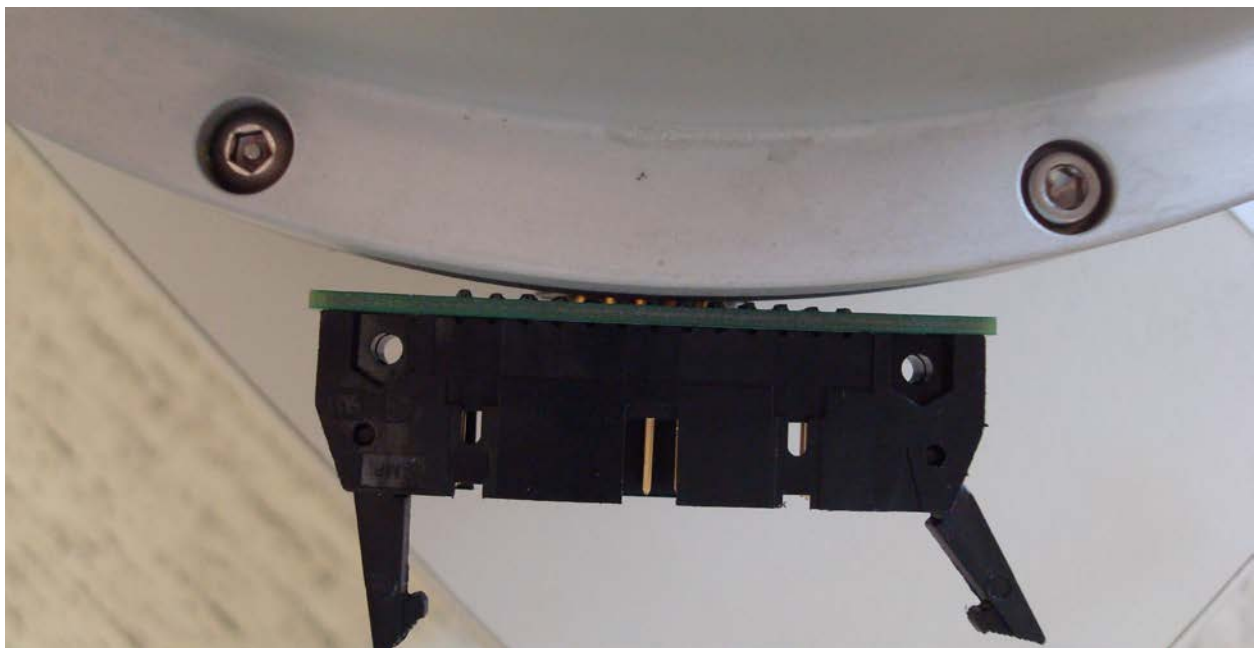
This is a top view of the same connector board, showing the pins contacting the enclosure.

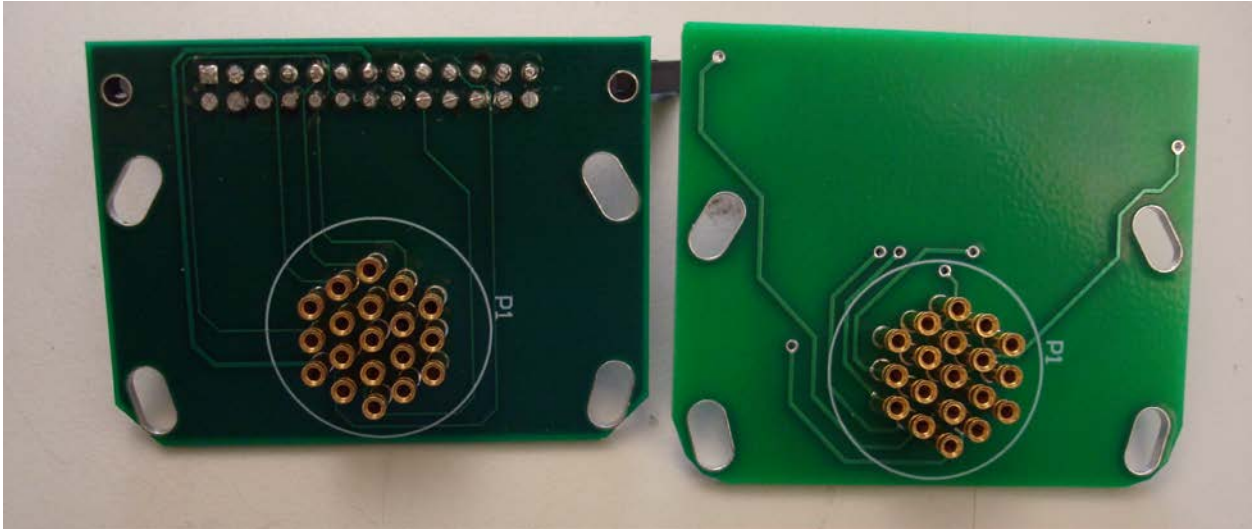
Here is a picture of the old board (Left), and the new board (Right). The new board uses a SMT Header , so there are no pins to short out. The new board is 1/4" taller than the old one, I hope it doesn't interfere with the fit. The extra height made room for the surface traces for the SMT header.

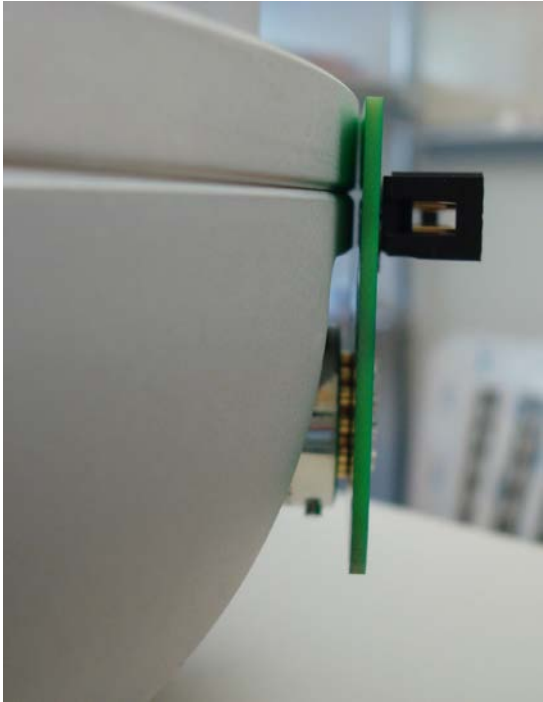
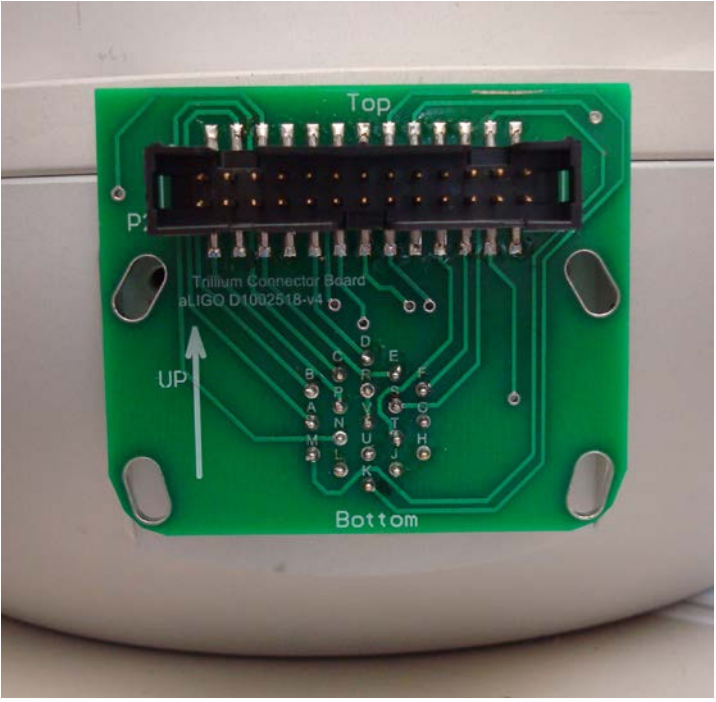
The new board installed: The screws are on order, which is why they're not installed yet. The holes seem to line up well.
