LIGO Laboratory / LIGO Scientific Collaboration

**aLIGO HAM-ISI, Installation Test Report, Phase II,
LLO HAM 3**

E1200104-V6

This document presents the tests performed to characterize and validate the “HAM-ISI LLO Unit #3”. This unit was the 3rd unit assembled for aLIGO at LLO. This unit was partially assembled in Fall 2010, but following the discovery of unauthorized repairs in the parts, the assembly was interrupted. All parts in questions were disassembled. This unit was the 1st to be re-assembled when the assembly started back in Spring 2011.

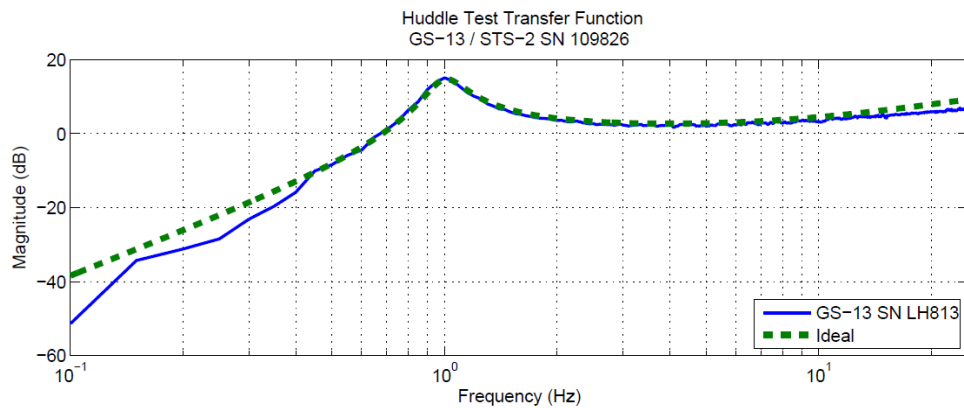
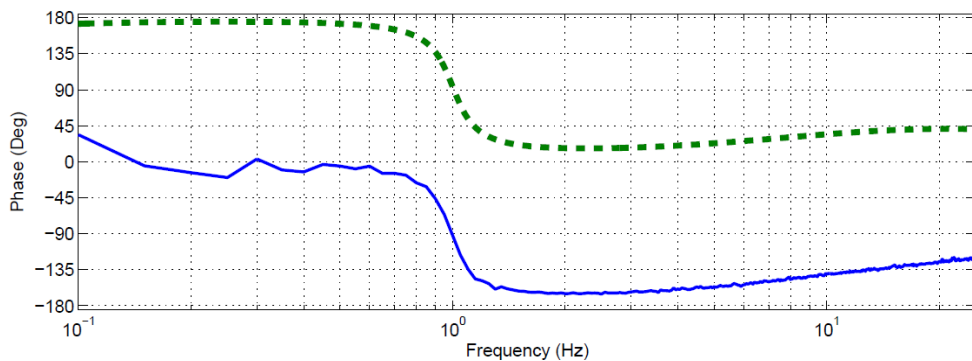
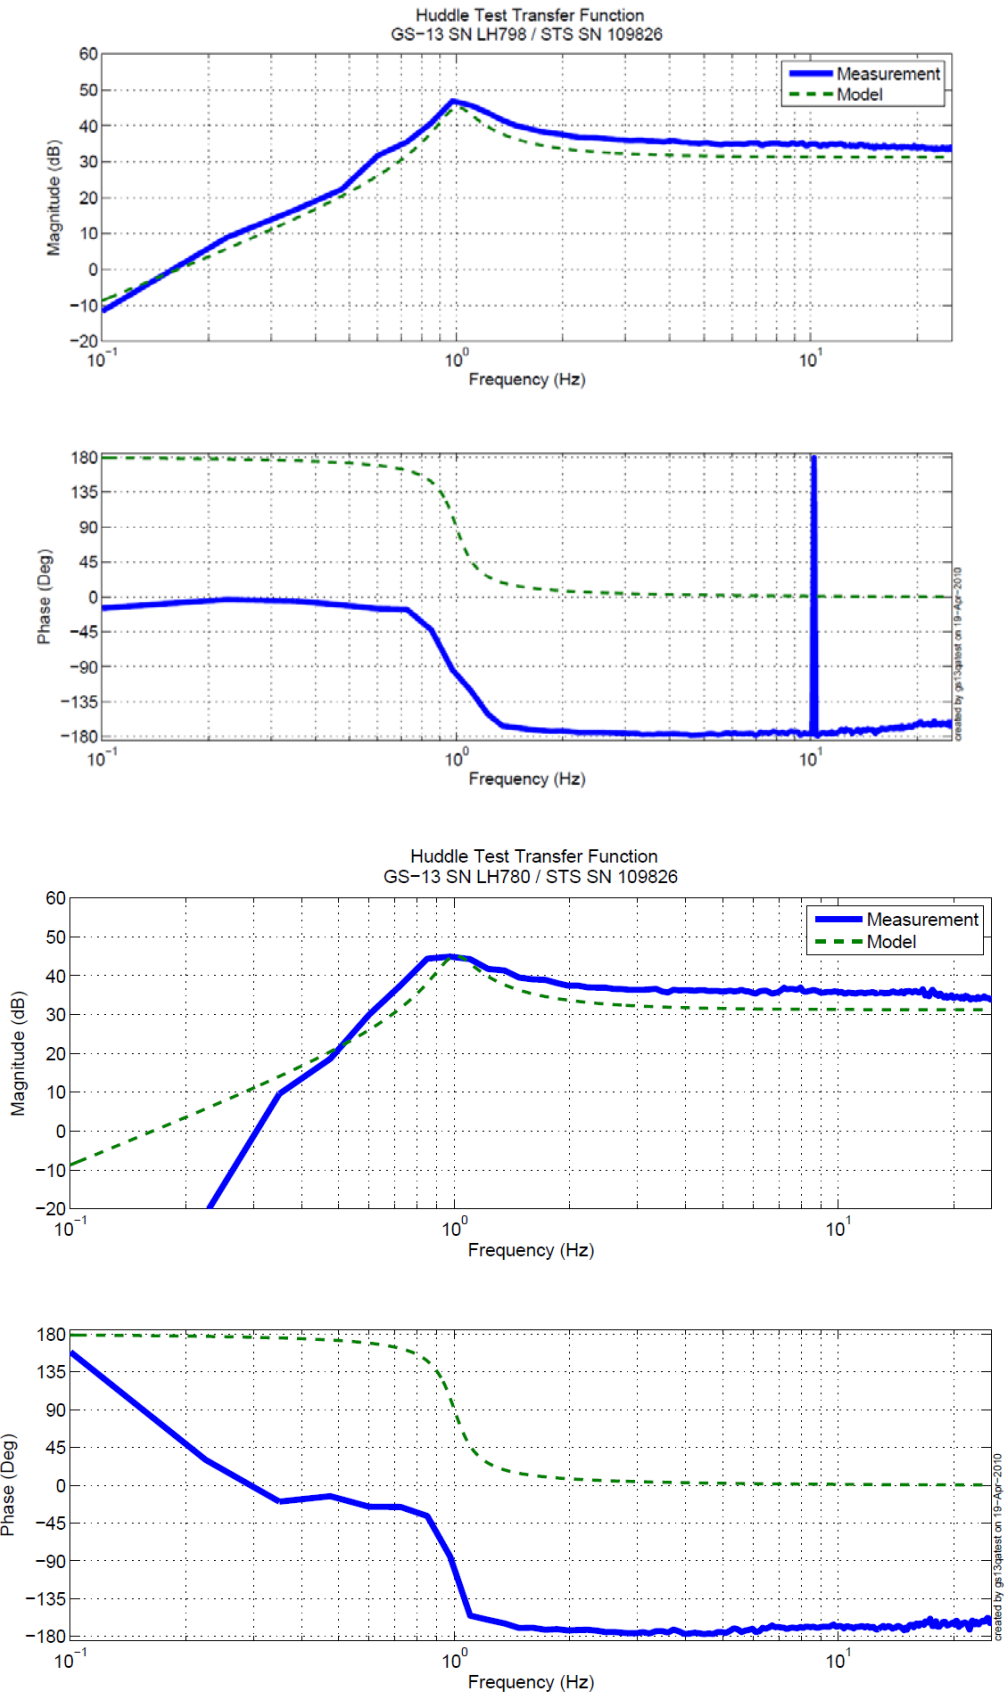
Figure - Huddle testing of Horiz GS-13 813,798, and 780 after aLIGO modifications

Huddle testing

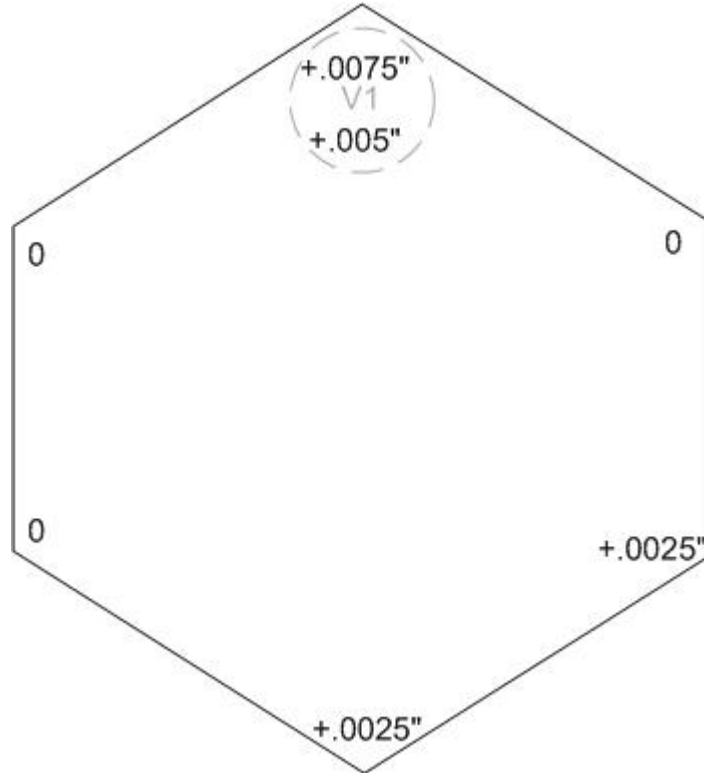
Initially this test was failed, but we adjusted the shim thickness to pass this test (see following step for new locker shims).

Optical Level measurement of Stage 1 at large (12 - 15) number of points.

The table here does not appear to be really tilted. Most of the difference can be included within the .005” flatness of the table.

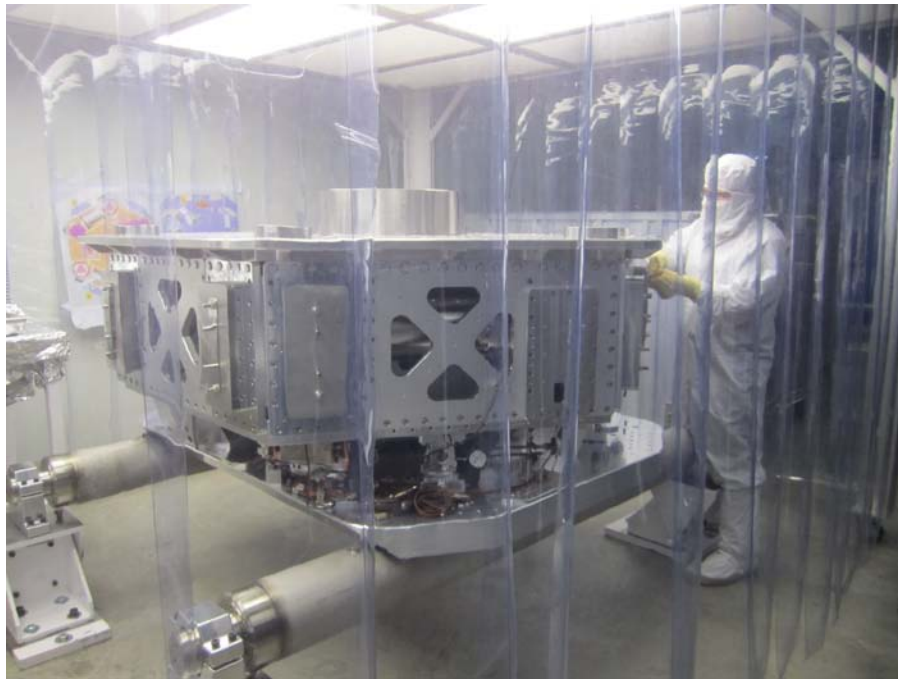
Figure - Optical table masses distribution

Table - Optical Table Masses distribution

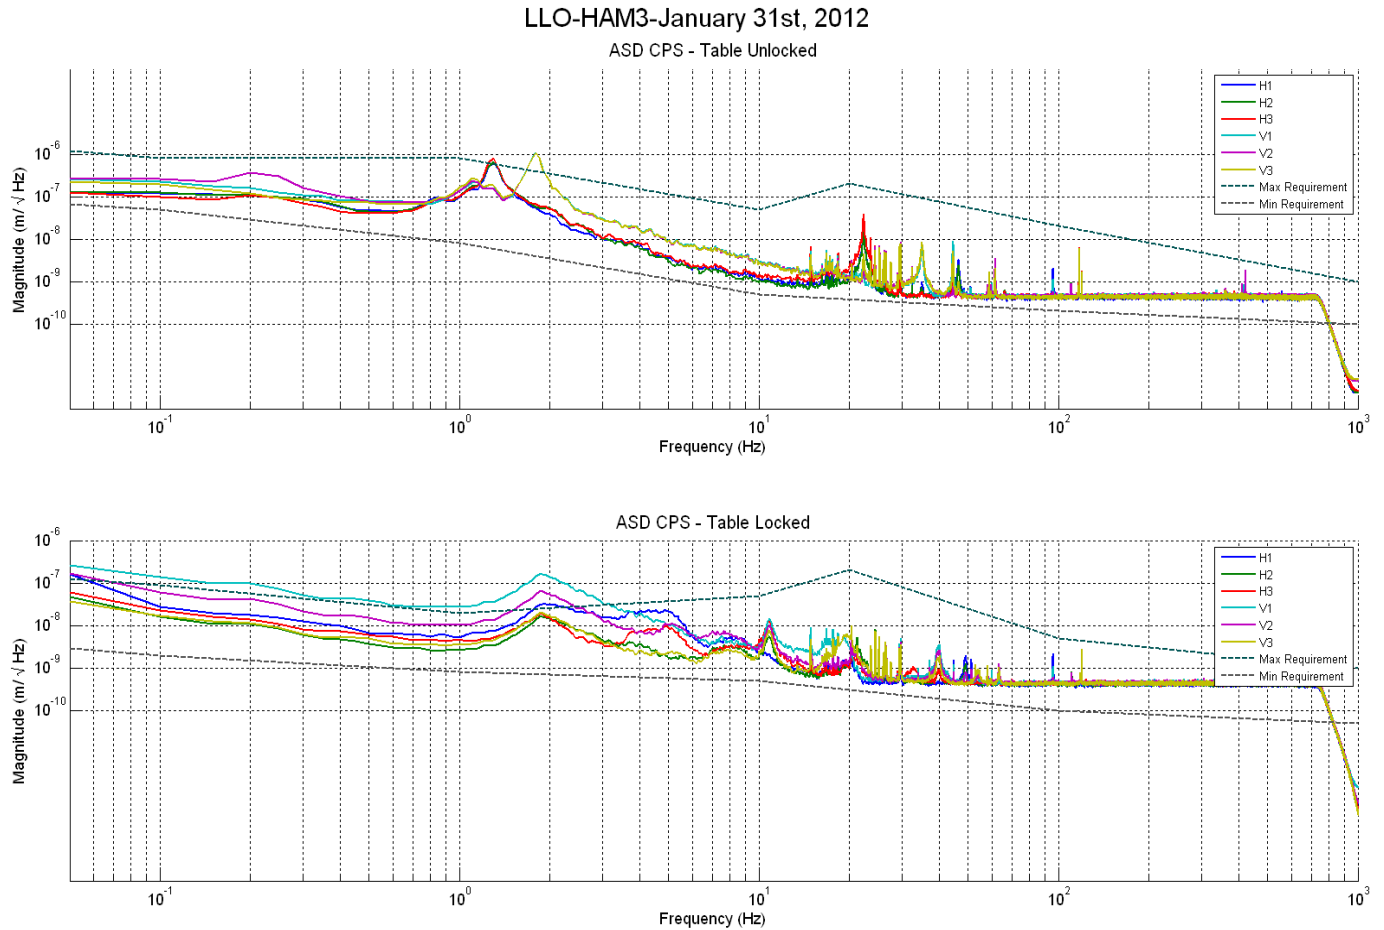
Figure - Calibrated CPS power spectrum

The CPS power spectrums are calibrated by using a sensitivity of 30.2 nm/count.

Measurement length: 1010s - Sample window: 20s - Overlap: 50% - Frequency resolution: 50mHz - Averages: 100 - Measurement start (GPS): 1012062615

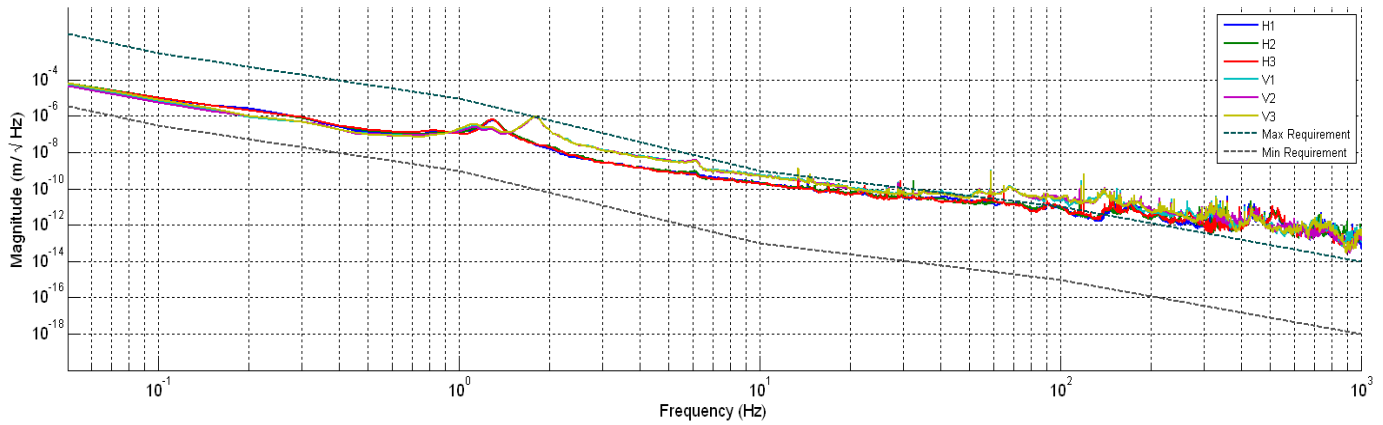
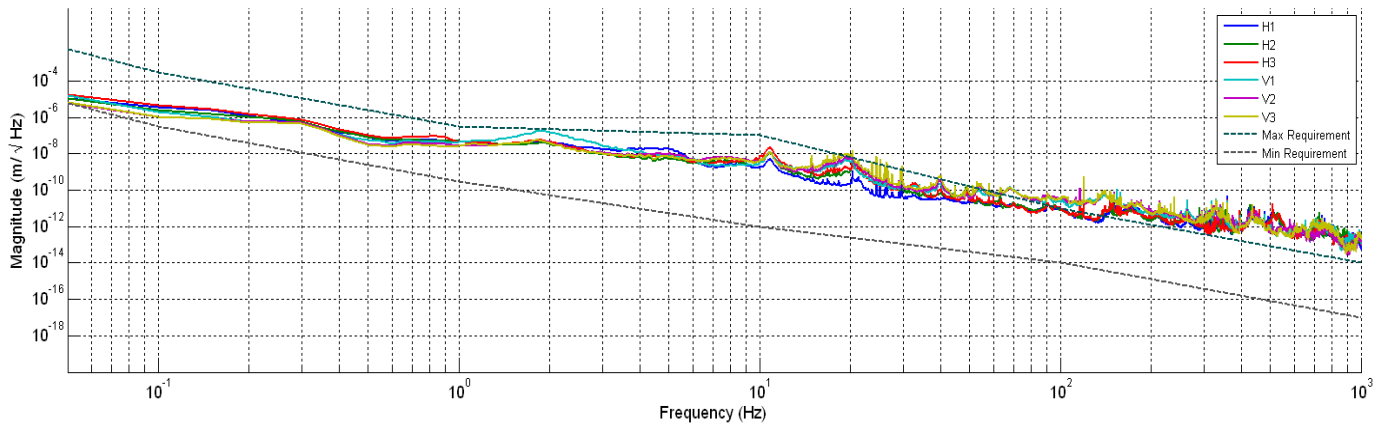
Figure – Power spectrum Calibrated GS13

ASD GS13 - Table Unlocked

ASD GS13 - Table Locked

Measurement length: 1010s - Sample window: 20s - Overlap: 50% - Frequency resolution: 50mHz - Averages: 100 - Measurement start (GPS): 1012062615

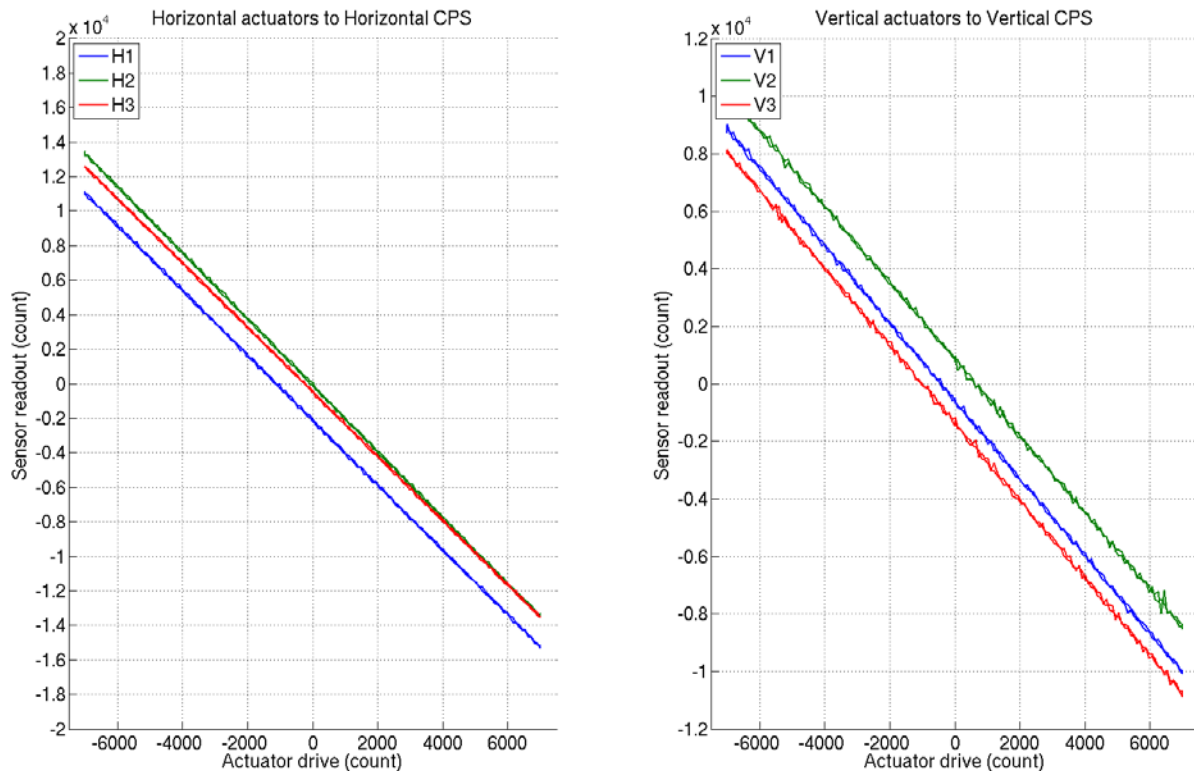
Figure - Horizontal and vertical actuators x HAM-ISI x sensors

Slope	Offset	Average slope	Variation from average(%)
H1	-1.877	-2115.5	-1.8847	-0.4068
H2	-1.9143	-85.46		1.5723
H3	-1.8627	-469.99		-1.1655
V1	-1.3472	-590.08	-1.3396	0.5648
V2	-1.3273	843.02		-0.9206
V3	-1.3444	-1365.5		0.3558

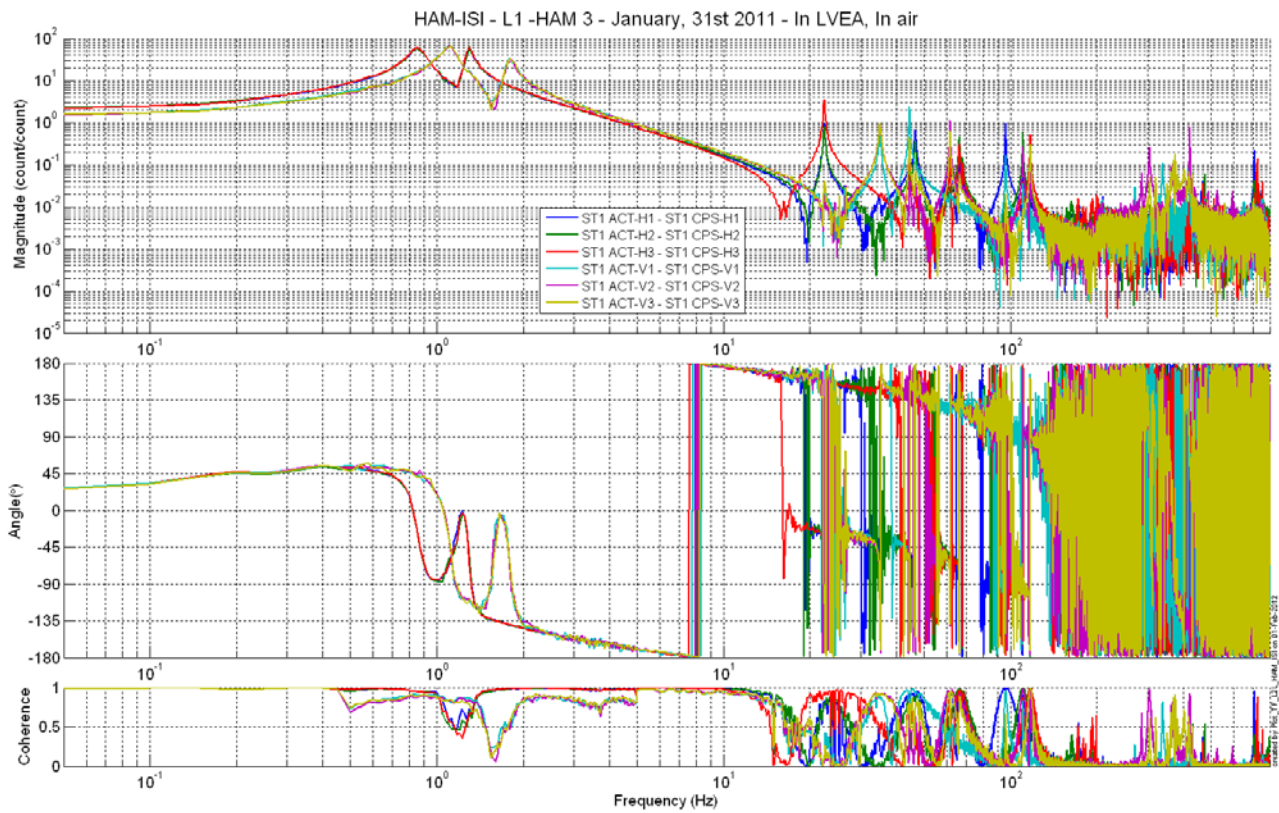
Figure - Local to Local Measurements –Capacitive Position Sensors

The local to local transfer functions are presented below.

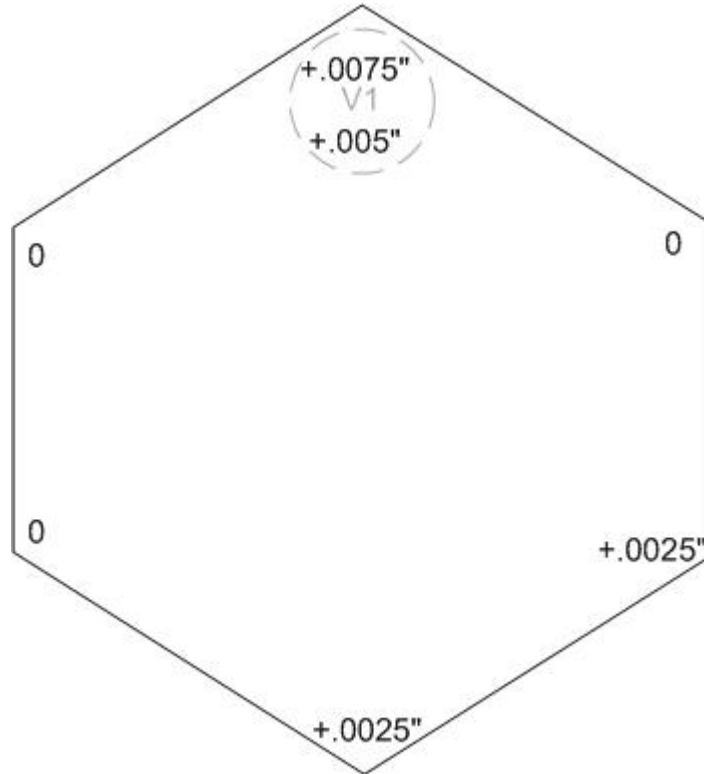
Initially this test was failed, but we adjusted the shim thickness to pass this test (see following step for new locker shims).

The table here does not appear to be really tilted. Most of the difference can be included within the $.005''$ flatness of the table.

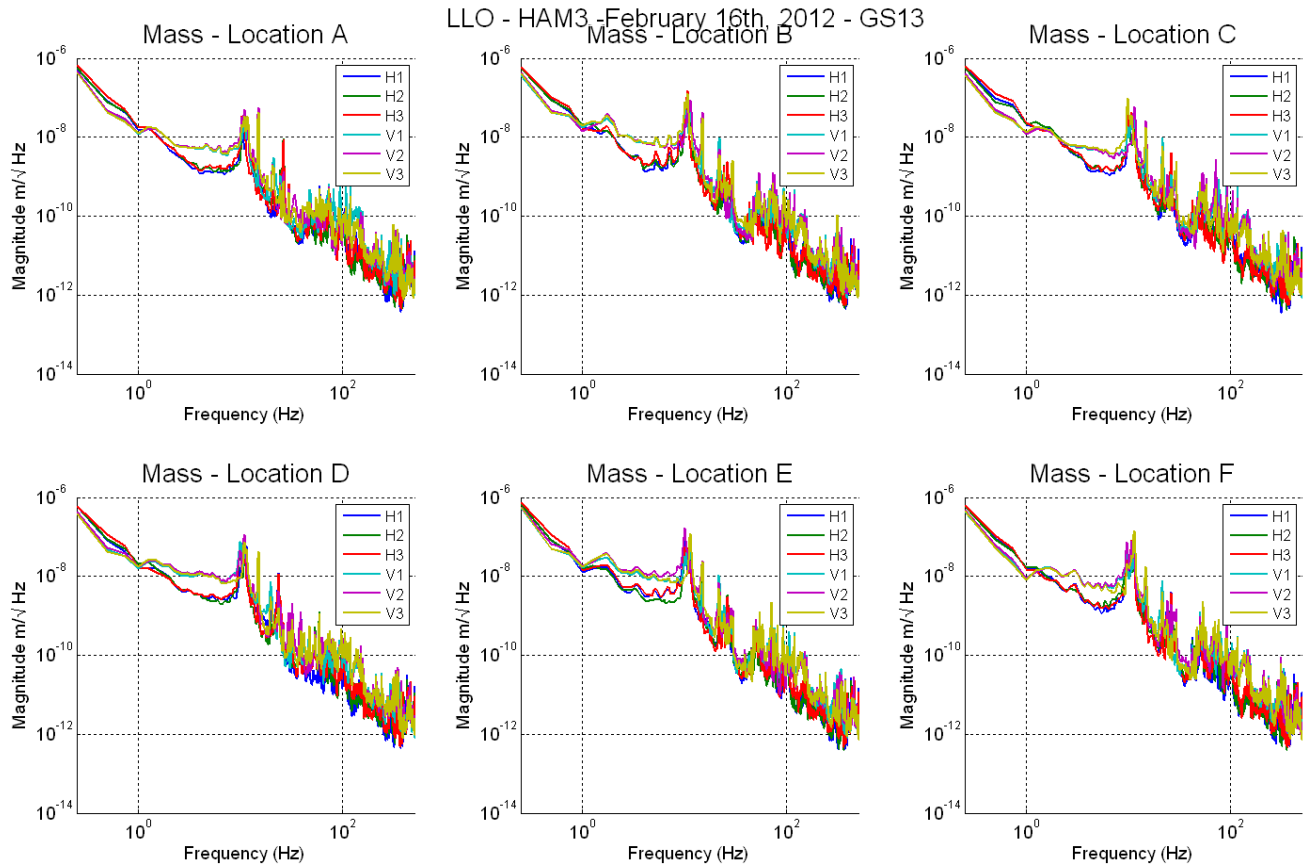
Figure – ASD Calibrated GS13 with mass at corner

The figure below presents the GS13 power spectrum when the table is unlocked and loaded with a 20Kg mass at one of its corner.

Measurement length: 102s - Sample window: 4s - Overlap: 50% - Frequency resolution: 250mHz - Averages: 50 - Measurement start (GPS): 1013463090

The issue that we had during side chamber testing was found to be combination of 2 factors:

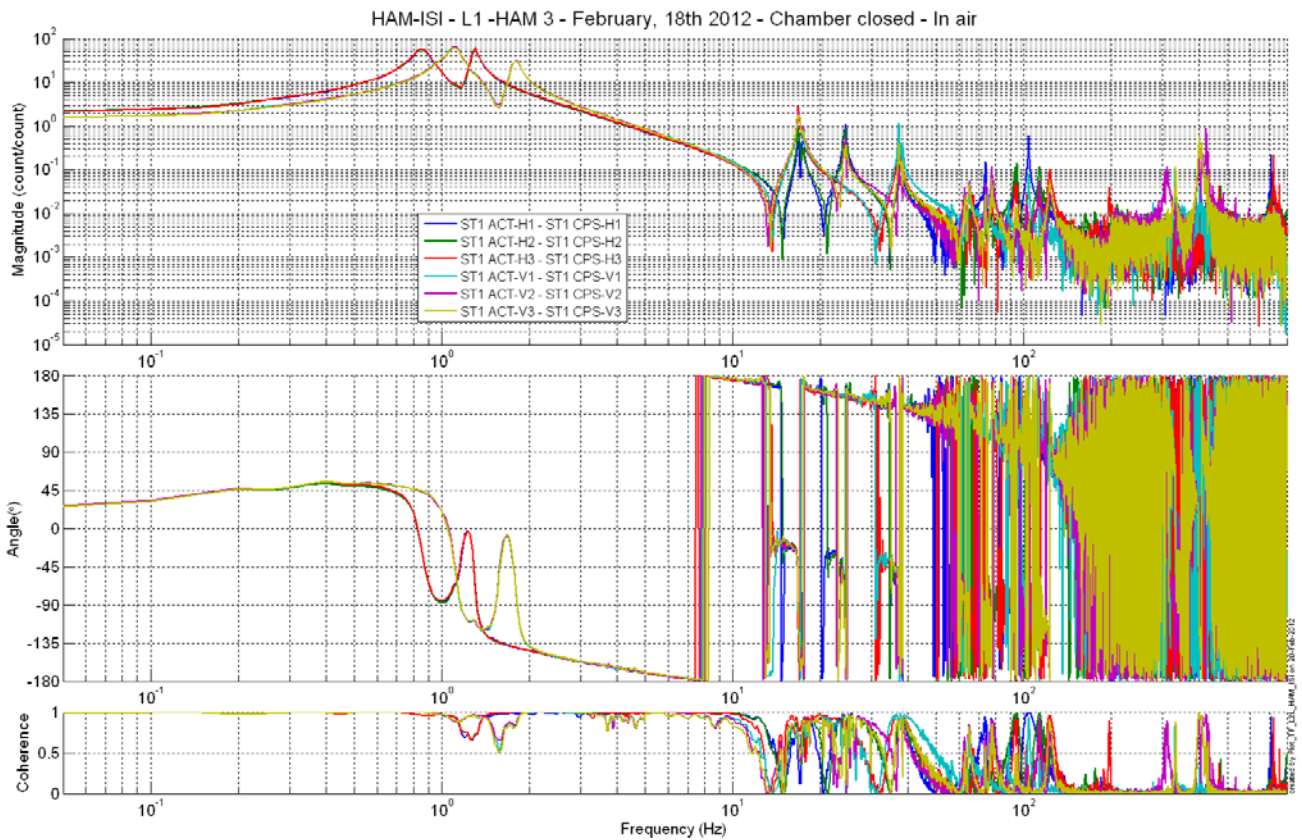
Figure - Local to Local Measurements –Capacitive Position Sensors

The local to local transfer functions are presented below.

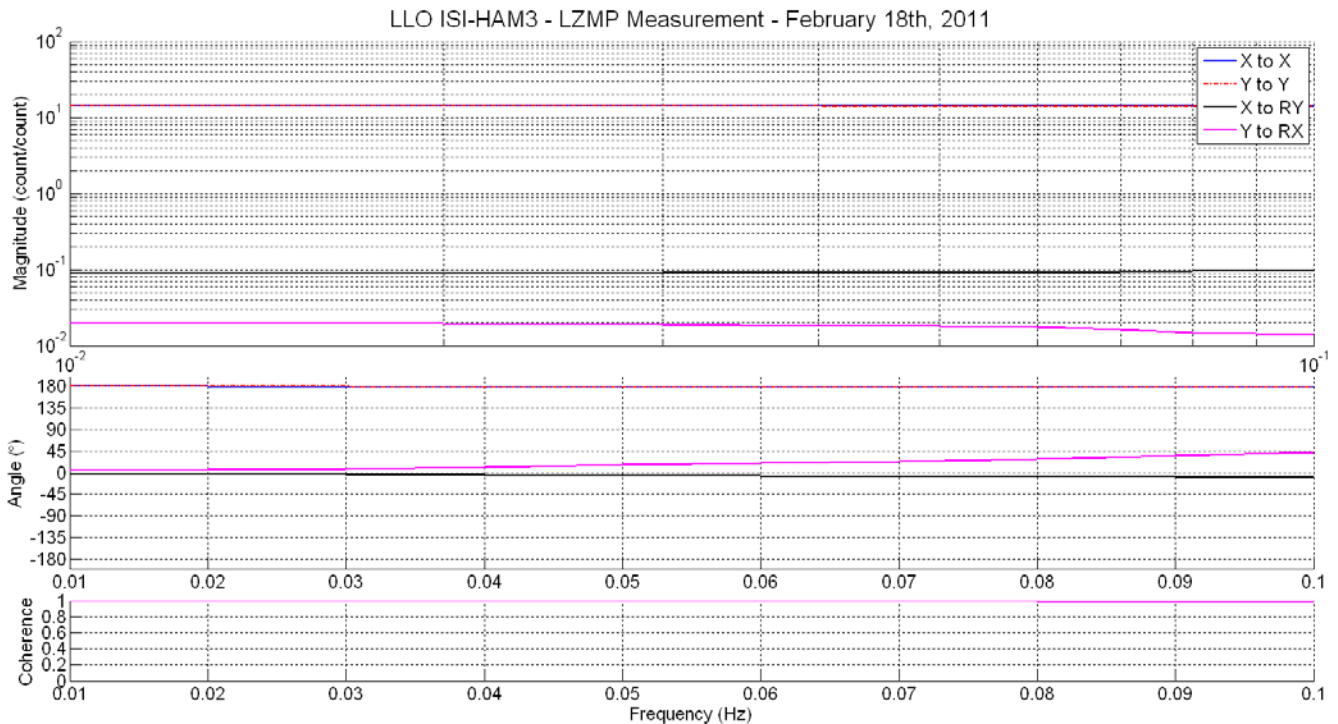
Figure - Lower Zero moment plane – Main and cross couplings at low frequency

The results from two measurements are presented on the figure below:
