LIGO- E1200506

aLIGO HAM-ISI, Installation Test Report, Phase II
Chamber-Side Testing & Initial Chamber Testing
LHO HAM2-ISI (Unit #4)

E1200506-V4

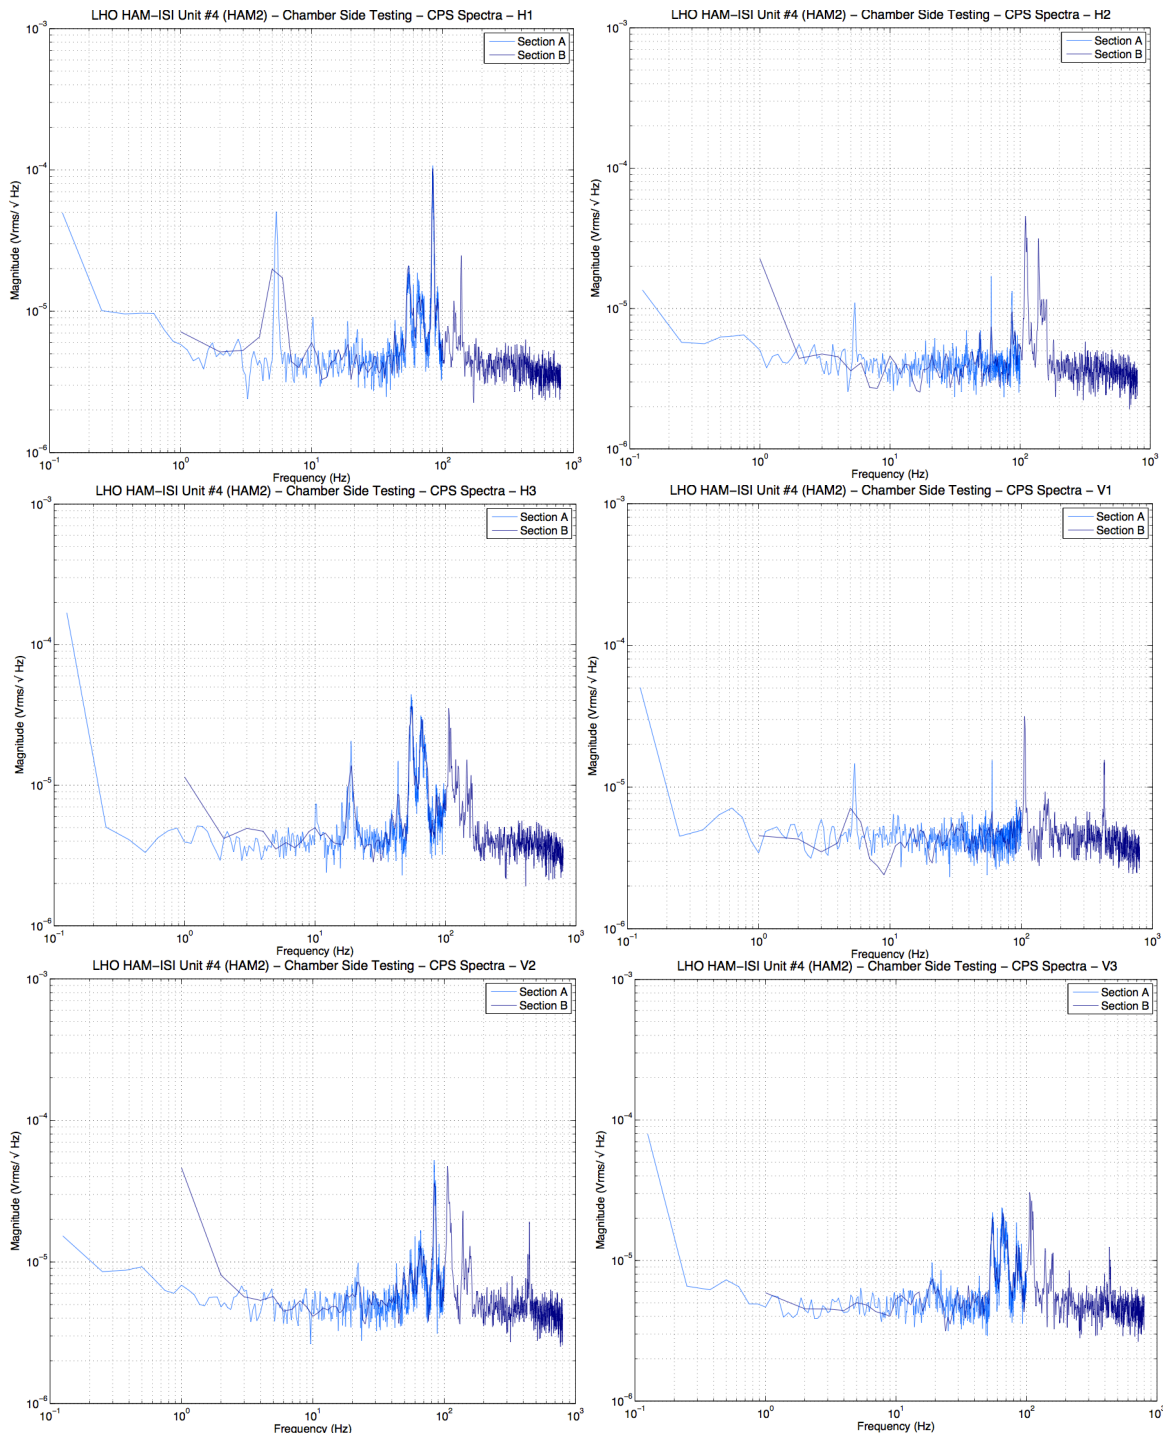
Figure – CPS Spectra - Section Check

A spectrum analyzer is used. The maximum number of points available for the FFT (800) limits the frequency resolution. Measurements are performed in two sections that are combined afterwards to allow getting good resolution in low frequency. Sections overlap to allow checking for potential mismatch.

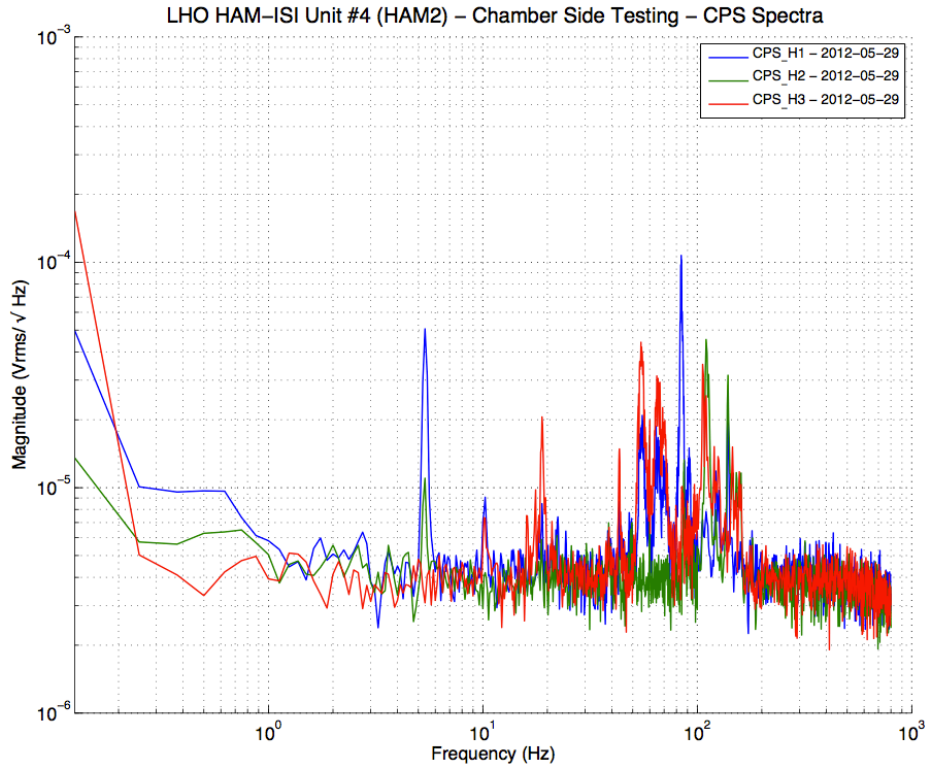
Figure – Horizontal CPSs spectra

- H1, V1 and H2 spectra feature a narrow peak at 5.375Hz.
- This peak is also noticeable on the spectra taken two weeks earlier, with the GS13s:
 - It is recorded at the same locations: H1, V1, and H2 (see below, and p.9)
 - It is recorded with very similar proportions: H1 is the most affected.
 - Even if the frequency it is observed at varied between the two measurements (5.25Hz vs 5.375Hz), it is very similar.
- Seeing this peak at the same locations, and at almost the same frequency, on two measurements taken 15 days apart from each other, with a different set of sensors/electronics, shows us that this peak is not caused by a malfunctioning of the sensor(s) and/or the electronics, and reveals that this peak is related to real motion.
- Measurements were performed in the LVEA, during the day, which is a noisy environment.

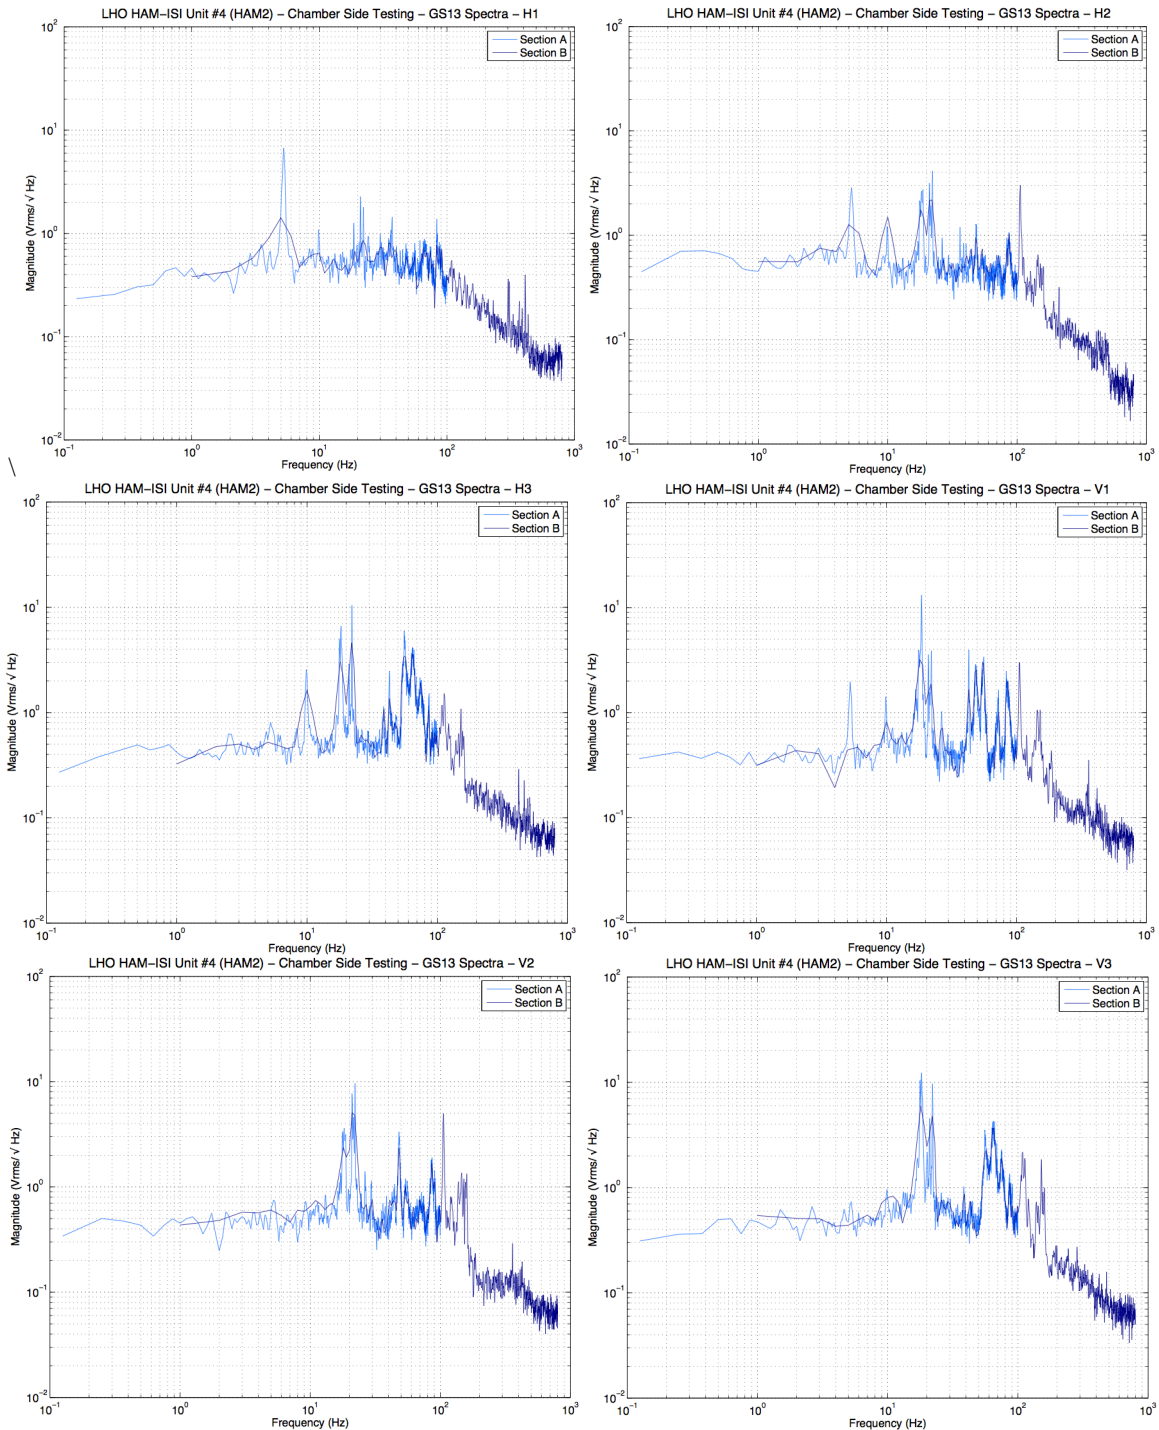
Figure – GS13 Spectra- Section Check

A spectrum analyzer is used. The maximum number of points available for the FFT (800) limits the frequency resolution. Measurements are performed in two sections that are combined afterwards to allow getting good resolution in low frequency. Sections overlap to allow checking for potential mismatch.

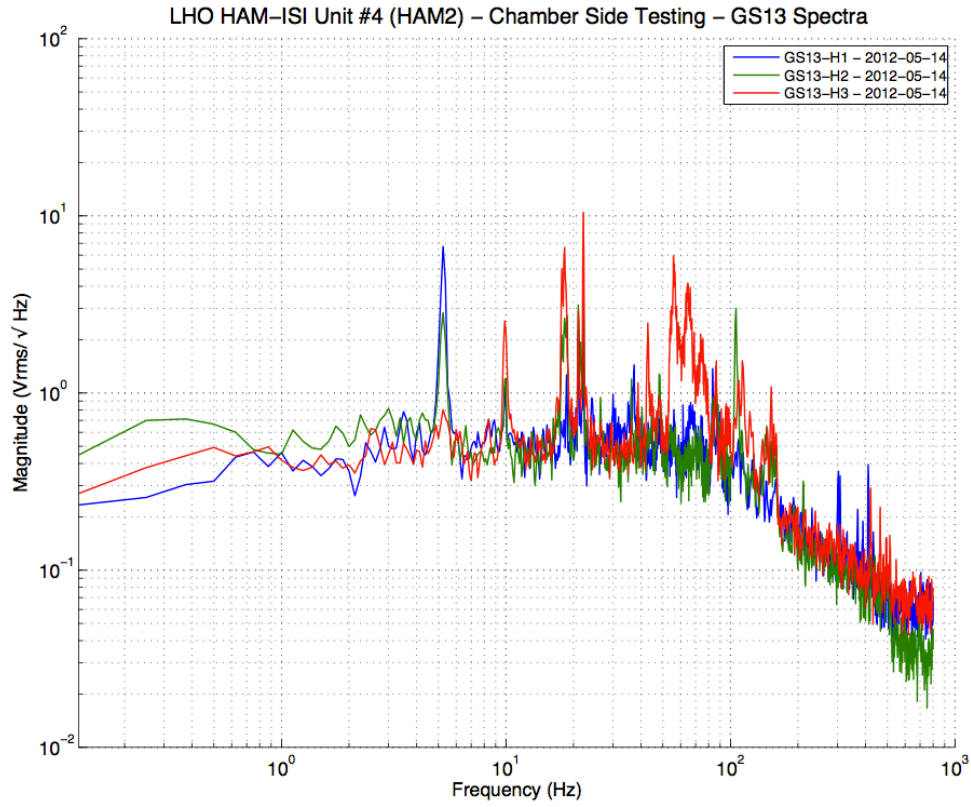
Figure – Horizontal GS13s Spectra

- H1, V1 and H2 spectra feature a narrow peak at 5.25Hz.
- This peak was associated to real motion. See comments p.9 for more details.
- Measurements were performed in the LVEA, during the day, which is a noisy environment.

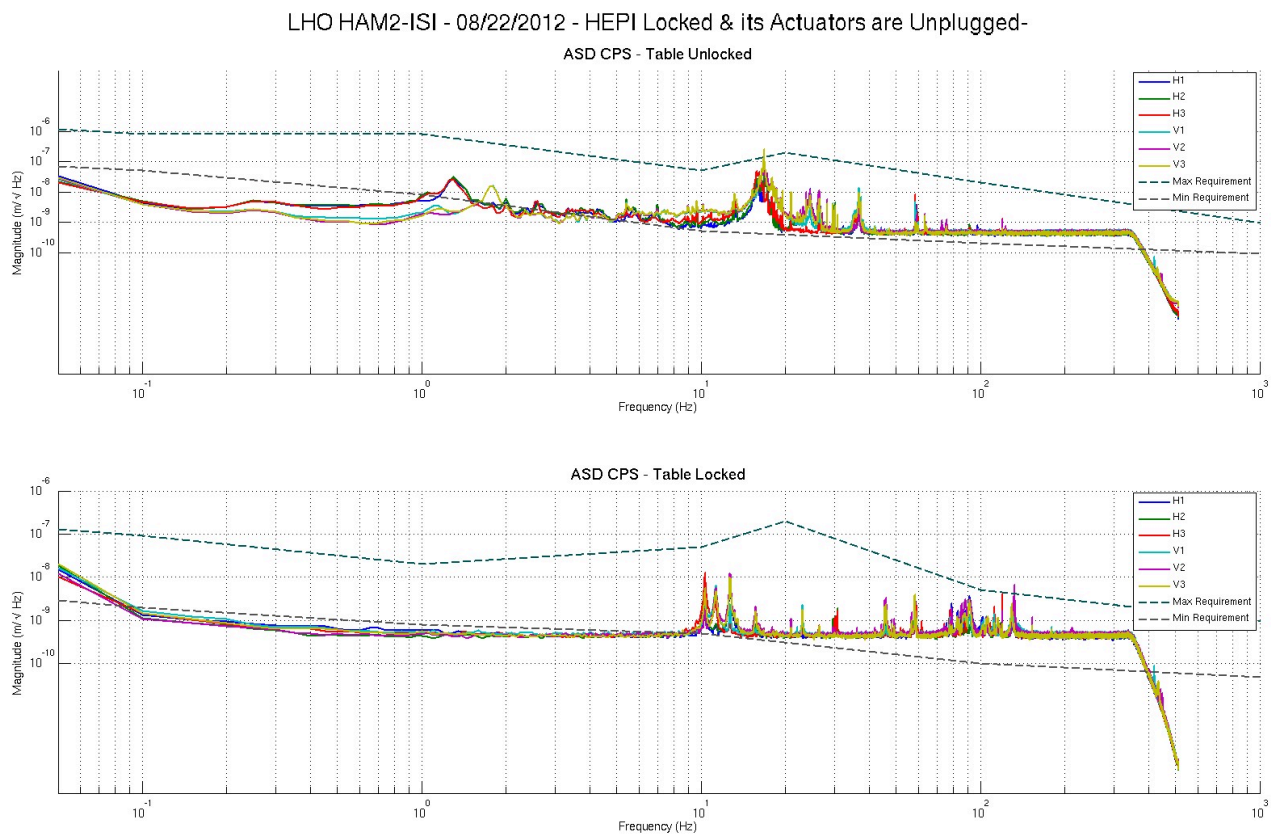
Figure - Calibrated CPS power spectrum – ISI Unlocked/Locked

The CPS power spectrums are calibrated by using a sensitivity of 30.2 nm/count.

Measurement length: 1010s - Sample window: 20s - Overlap: 50% - Frequency resolution: 50mHz - Averages: 100 - Measurement start (GPS): 1030096020

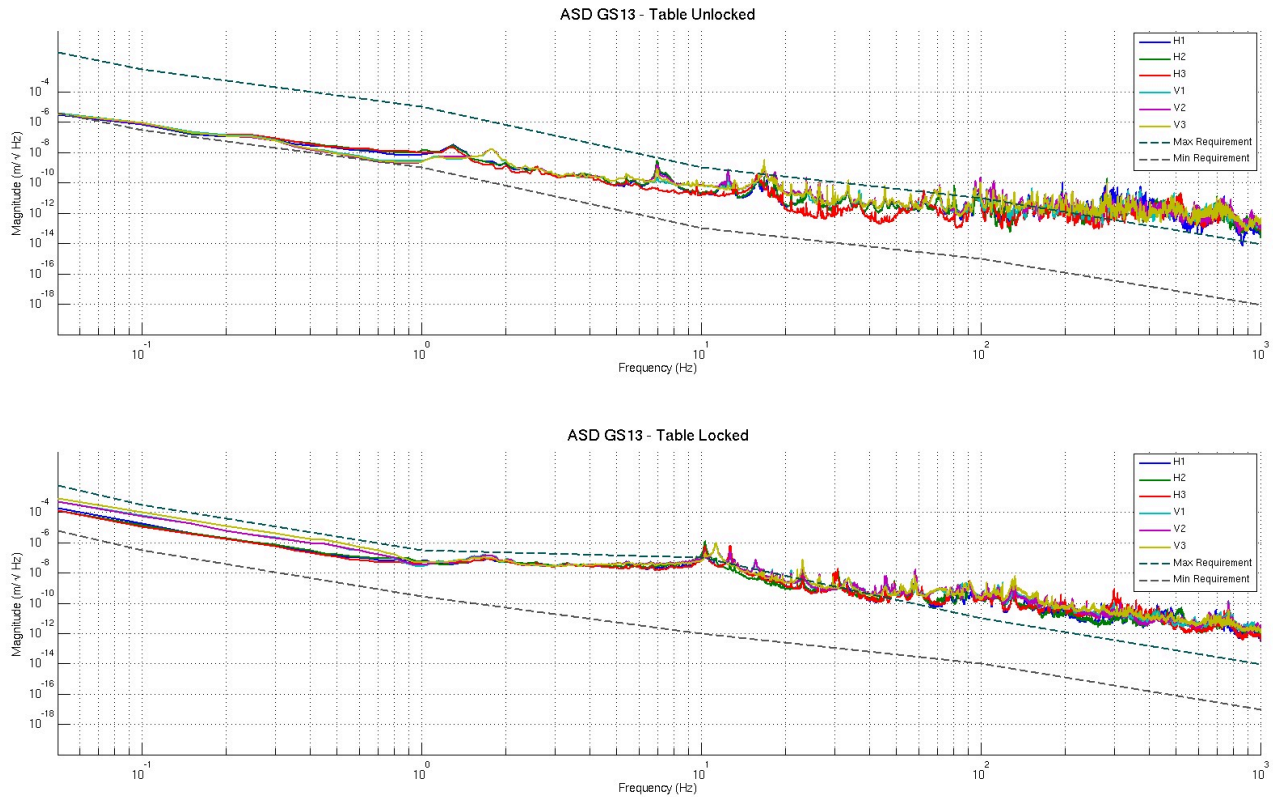
Figure – Power spectrum Calibrated GS13 – ISI Unlocked/Locked

Measurement length: 1010s - Sample window: 20s - Overlap: 50% - Frequency resolution: 50mHz - Averages: 100 - Measurement start (GPS): 1030096020

- When a seismometer fails, its low frequency response is affected. Spectra are within requirements in low frequency. The GS13s installed on this unit are functional.
- GS13 requirement curves need to be updated.

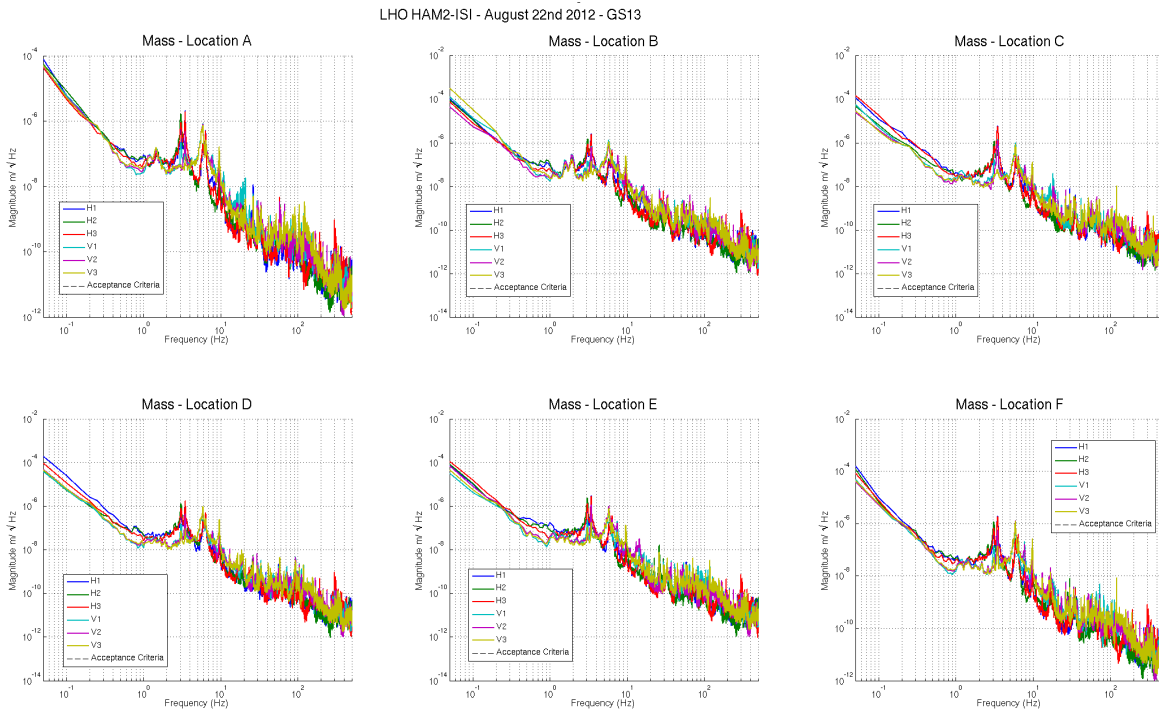
Figure – ASD Calibrated GS13 with mass at corner

The figure below presents the GS13 power spectrum when the table is unlocked and loaded with a 10Kg mass at each of its corner.

Measurement length: 110s - Sample window: 20s - Overlap: 50% - Frequency resolution: 50mHz - Averages: 10 - Measurement start (GPS): 1029696494

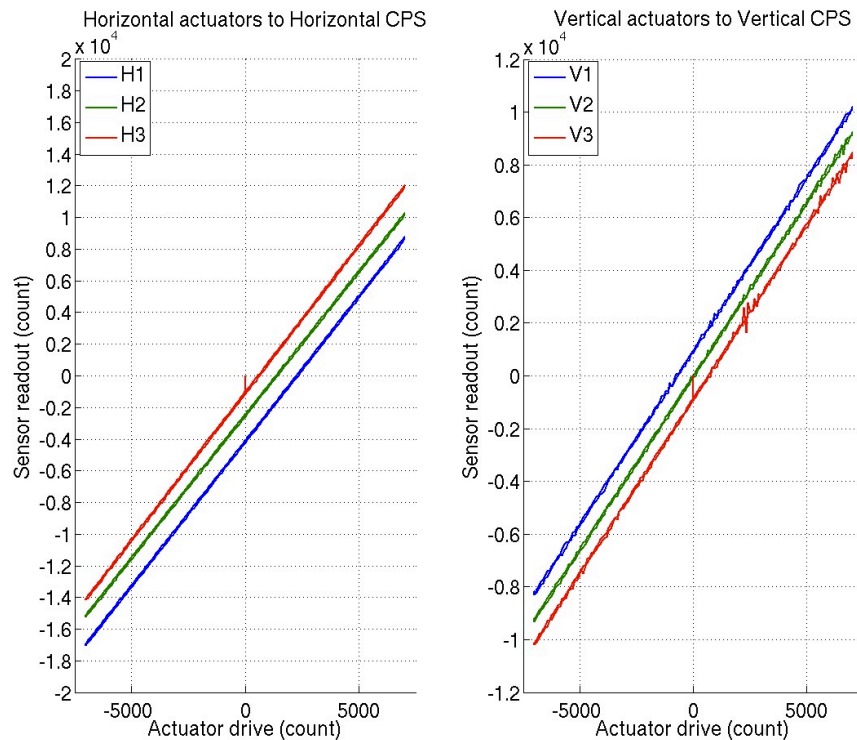
Figure - Horizontal and vertical actuators x HAM-ISI x sensors

Slope	Offset	Average slope	Variation from average(%)
H1	1.8281	-4151.4	1.83	-0.26
H2	1.8098	-2481.7		-1.26
H3	1.8606	-1082.4		1.51
V1	1.312	933.38	1.32	-0.33
V2	1.3159	-22.437		-0.03
V3	1.3211	-884.41		0.36

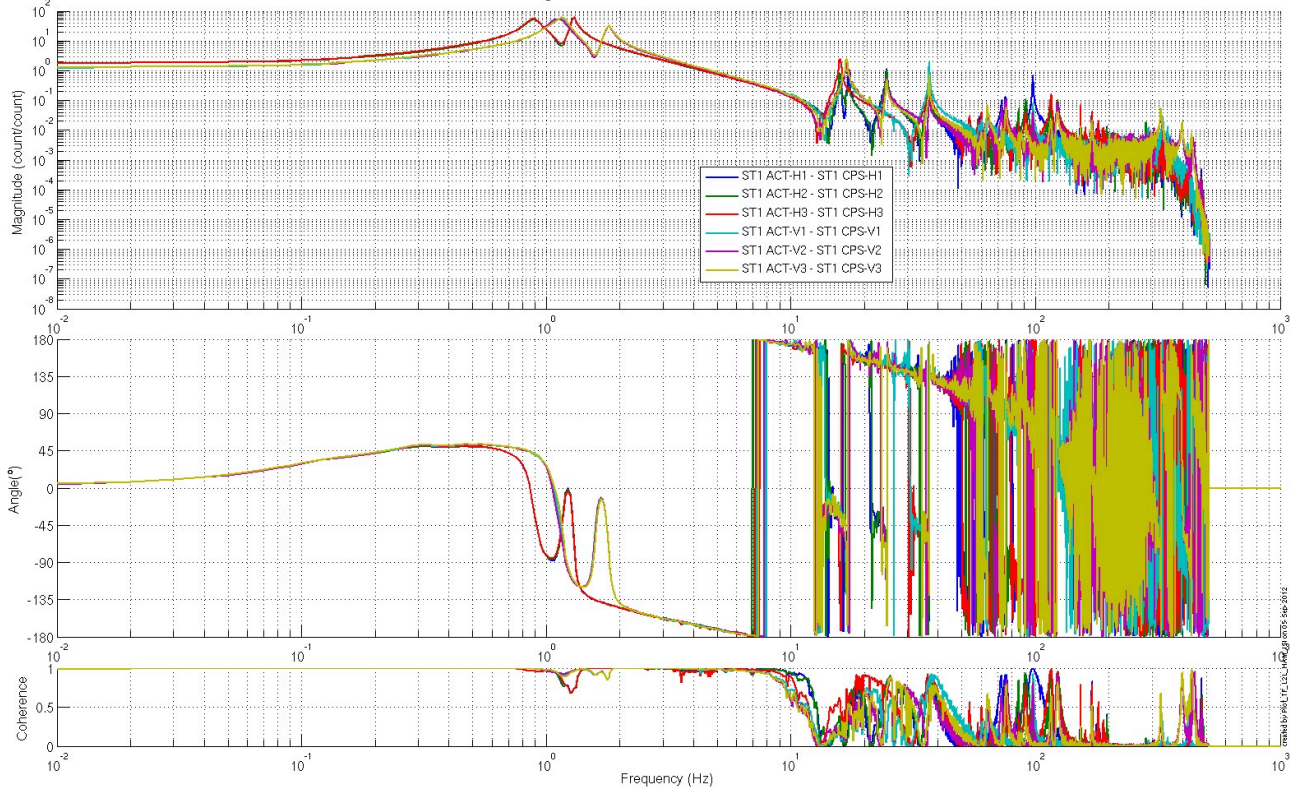
Figure - Local to Local Measurements –Capacitive Position Sensors

LHO HAM2-ISI - August 25 2012 - HEPI locked - In Chamber - In Air

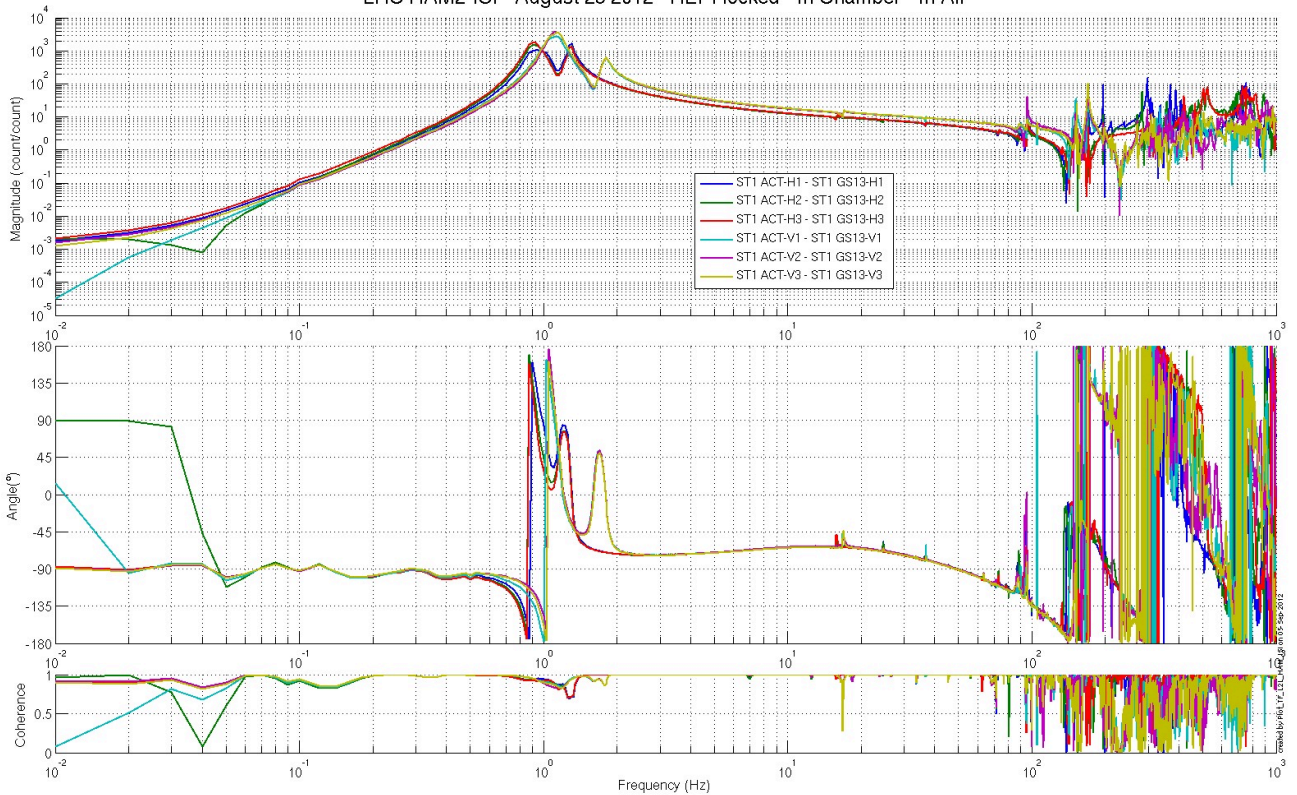
Figure - Local to Local Measurements – Inertial sensors

LHO HAM2-ISI - August 25 2012 - HEPI locked - In Chamber - In Air

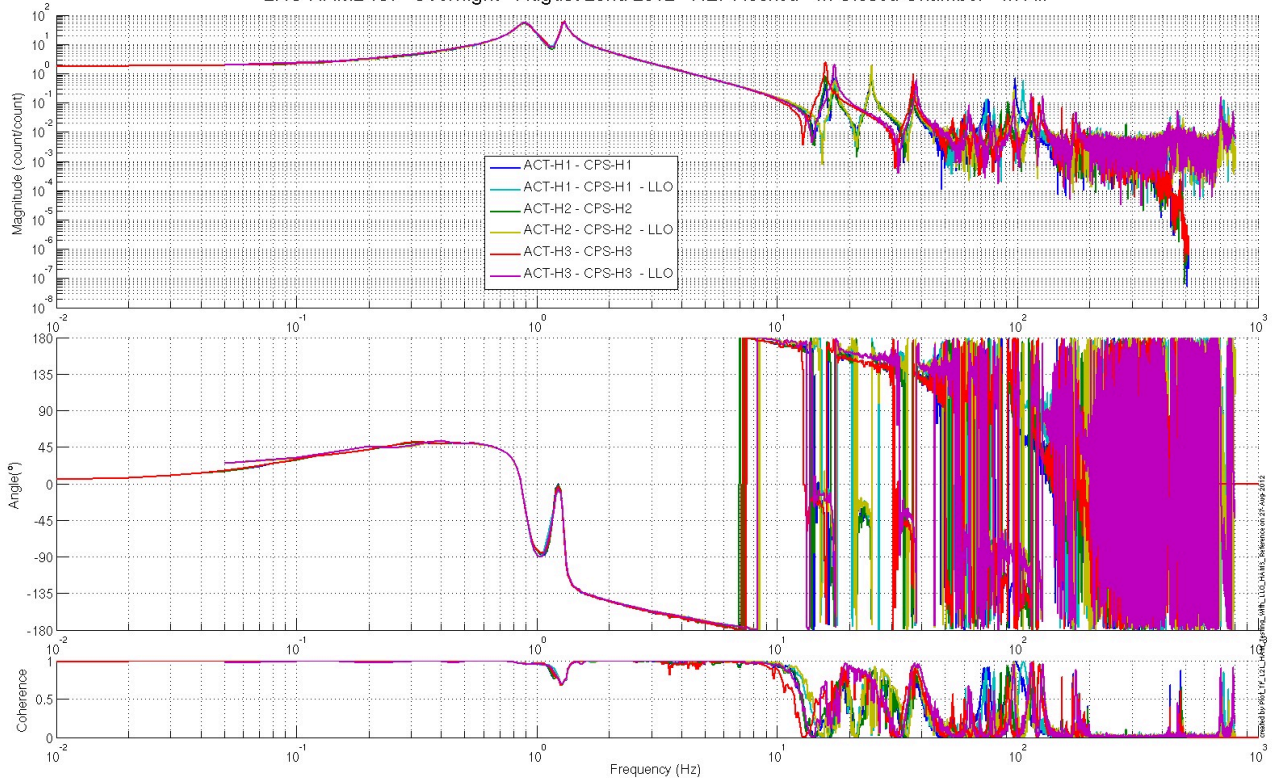
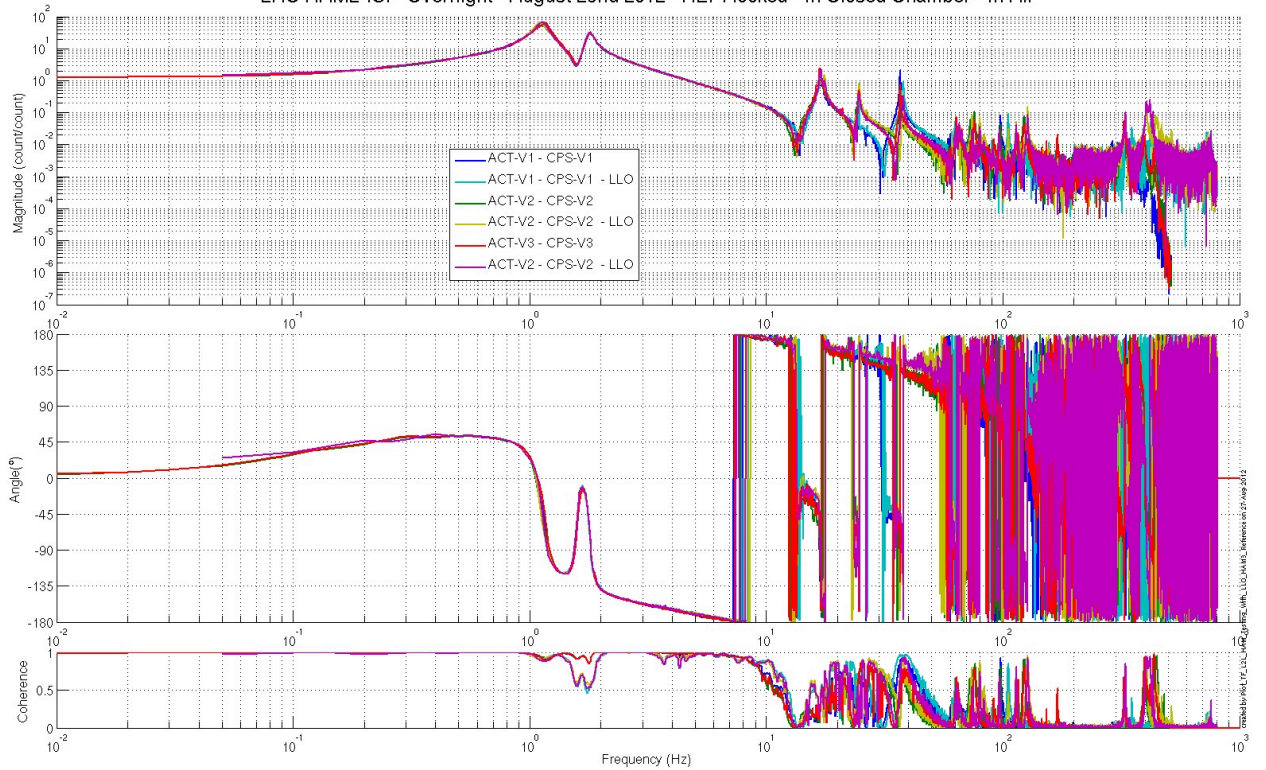
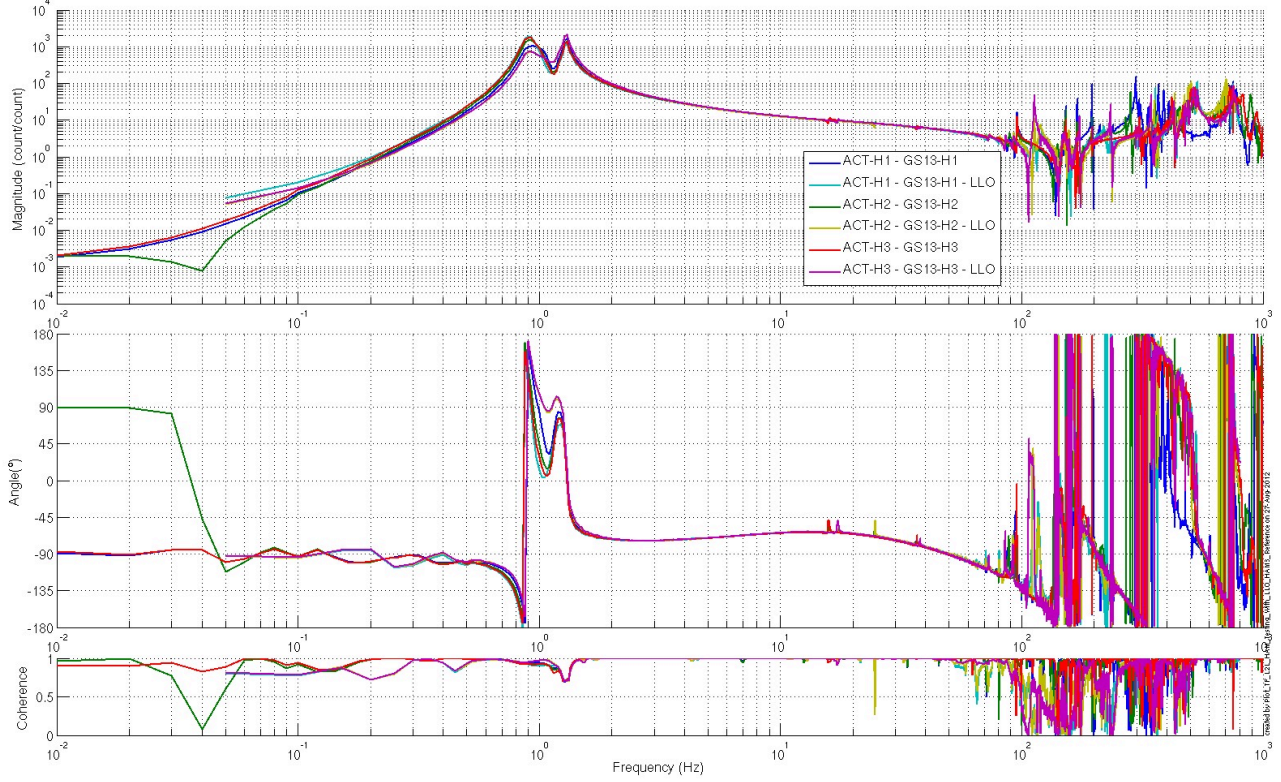
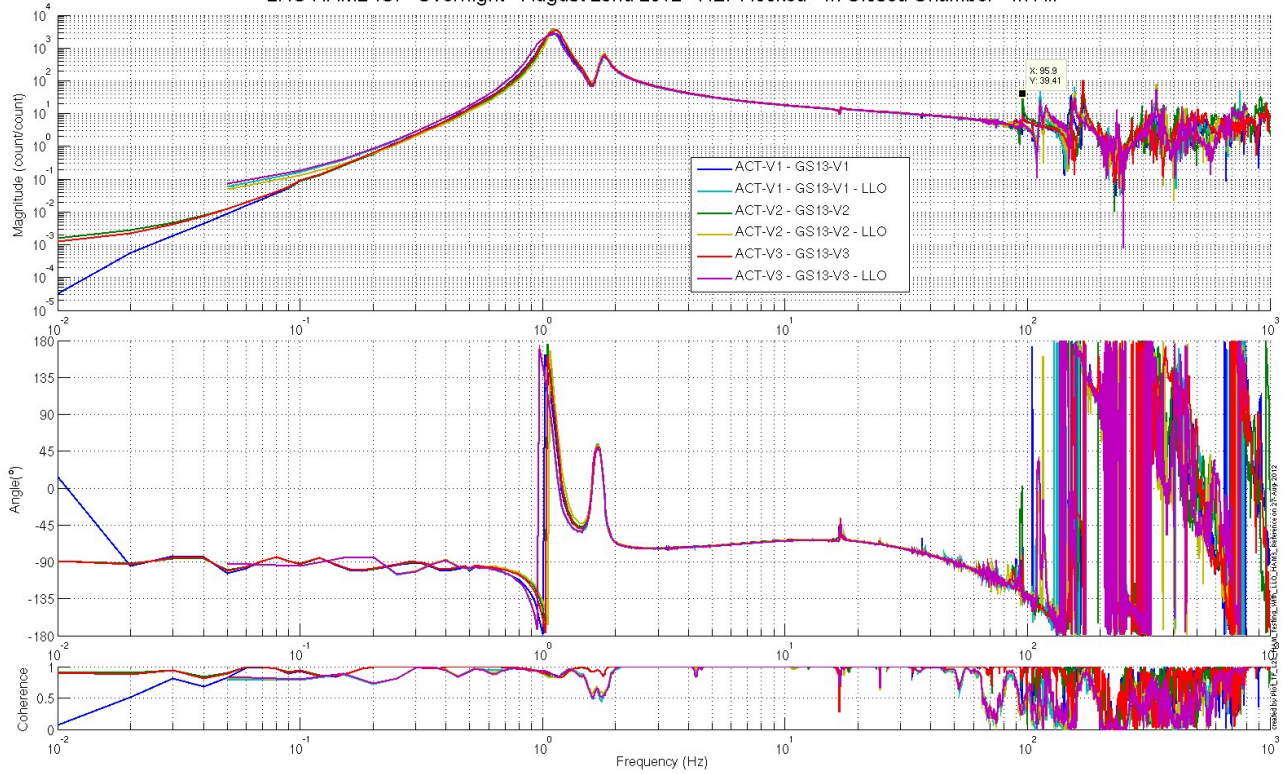
Good concordance with TF measured under the same conditions at LLO.

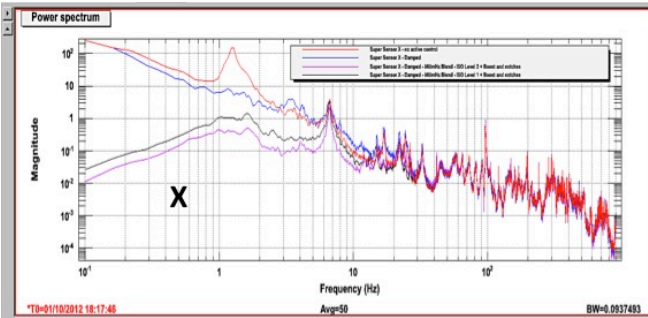
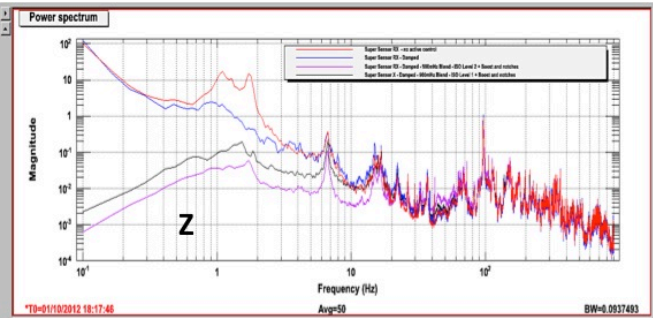
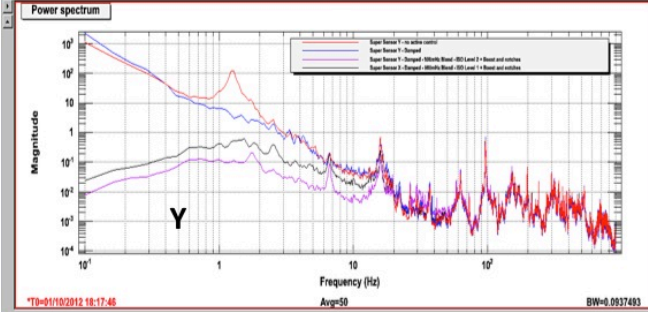
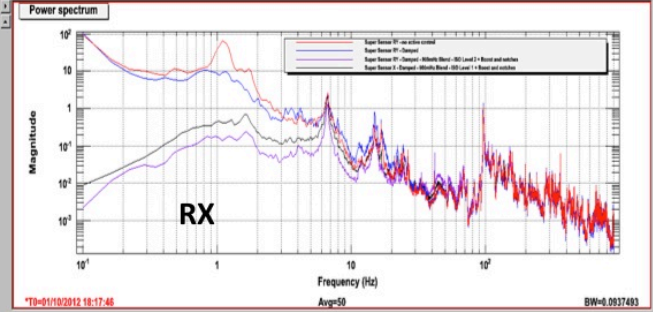
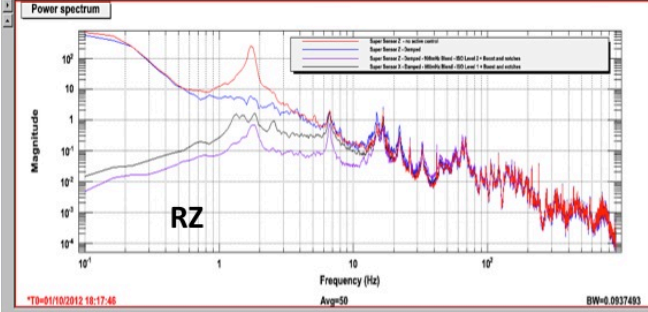
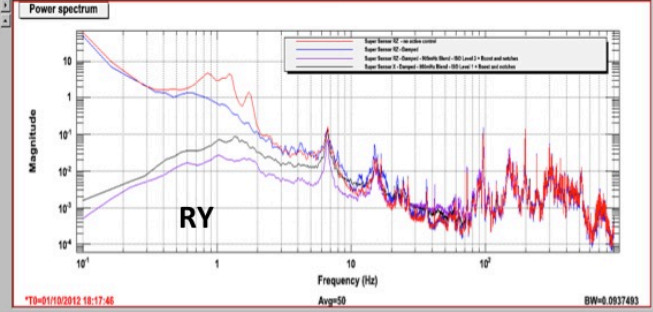
We installed the HAM-ISI control loops level-1 and Level-2 on HAM2-ISI. Notches were needed to account for HEPI resonances. They were added in both levels of controllers. Details of the investigation that led to this conclusion can be found in LHO aLogs #4341 and #4345.

Super Sensor	no active control
	Super Sensor	Damped
	Super Sensor	Damped - 900mHz Blend - ISO Level 2 + Boost and notches
	Super Sensor	Damped - 900mHz Blend - ISO Level 1 + Boost and notches

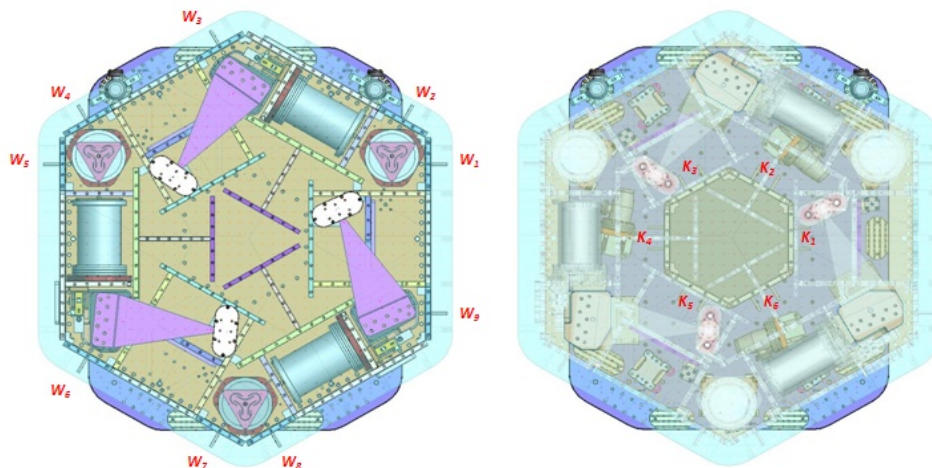
Figure – Wall Masses (W) and Keel masses (K) location. *South of picture = corner 1*

Side	Keel	Top	Total
Weight (kg)	34.52	90.22	216.08	340.82

Table – Mass Budget Sum Up

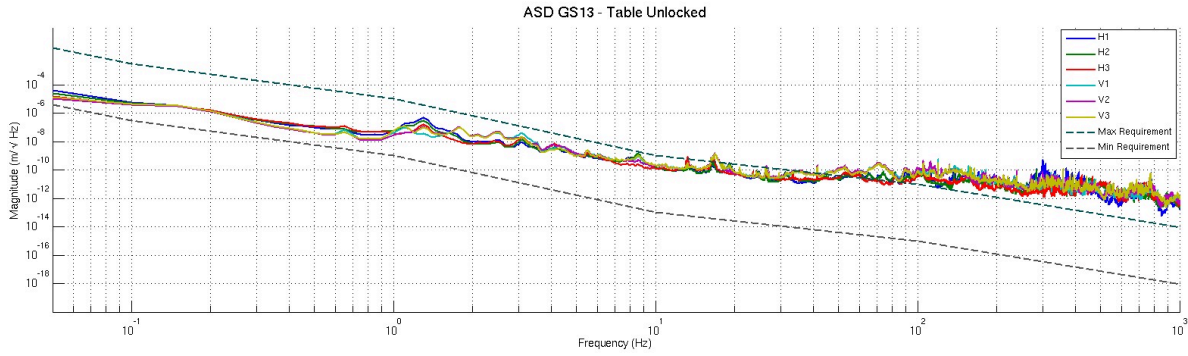
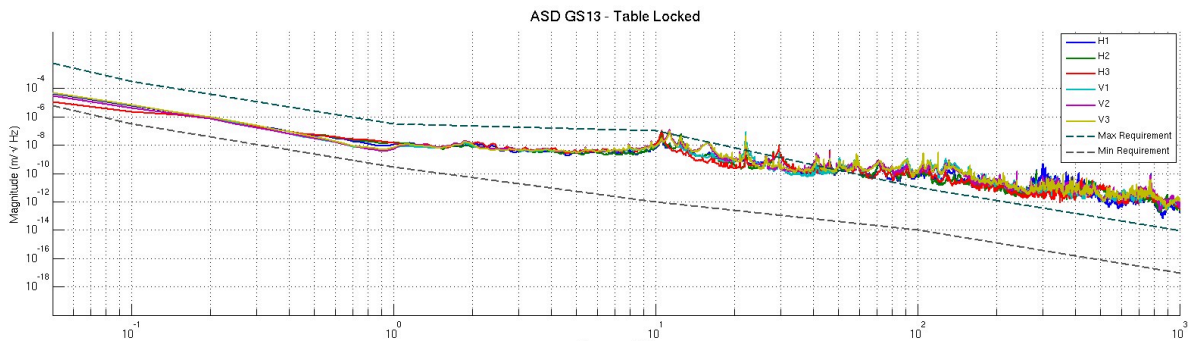
Figure - Calibrated CPS power spectrum – ISI Unlocked/Locked

LHO HAM2-ISI - In Chamber - In Air - Sheets on

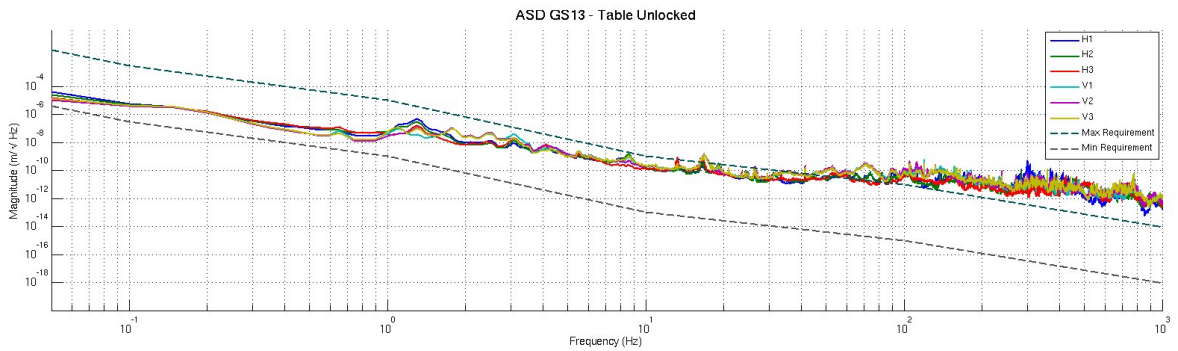
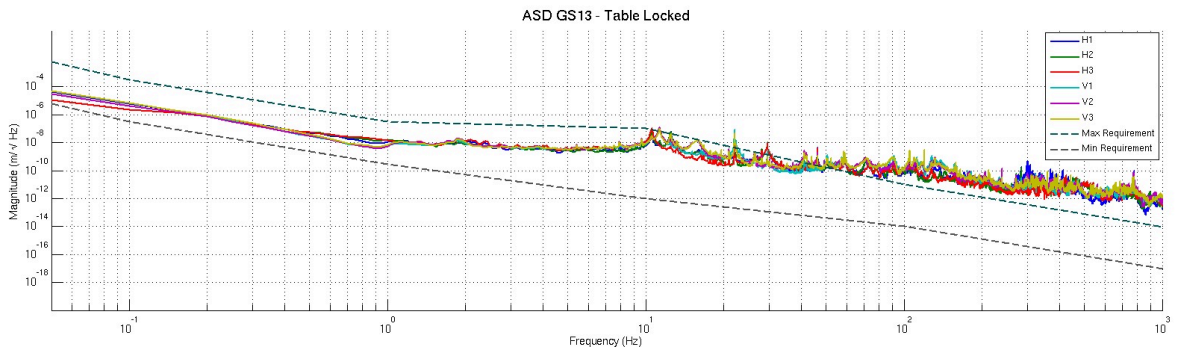
Figure – Power spectrum Calibrated GS13 – ISI Unlocked/Locked

LHO HAM2-ISI - In Chamber - In Air - Sheets on

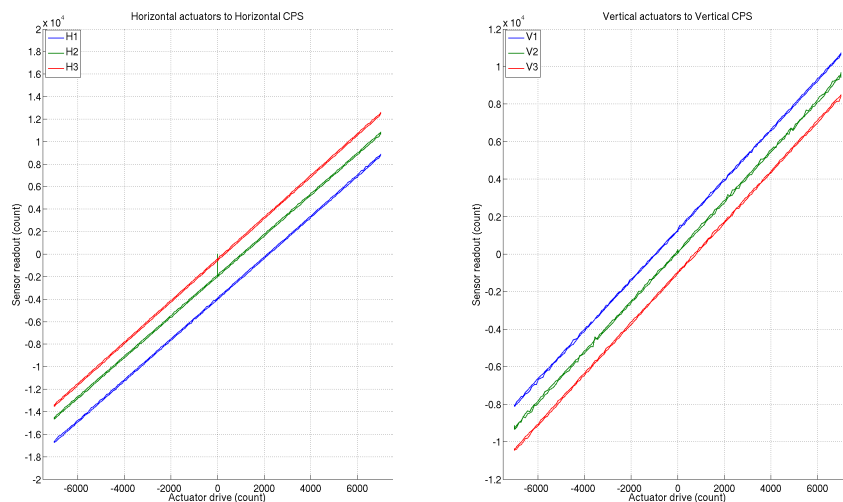
Table – Linearity test, December 17th 2012

Slope	Offset	Average slope	Variation from average(%)
H1	1.82	-3939.89	1.83	-0.37
H2	1.81	-1903.29		-1.05
H3	1.85	-474.80		1.43
V1	1.34	1291.50	1.34	-0.39
V2	1.34	139.11		-0.16
V3	1.35	-993.25		0.55

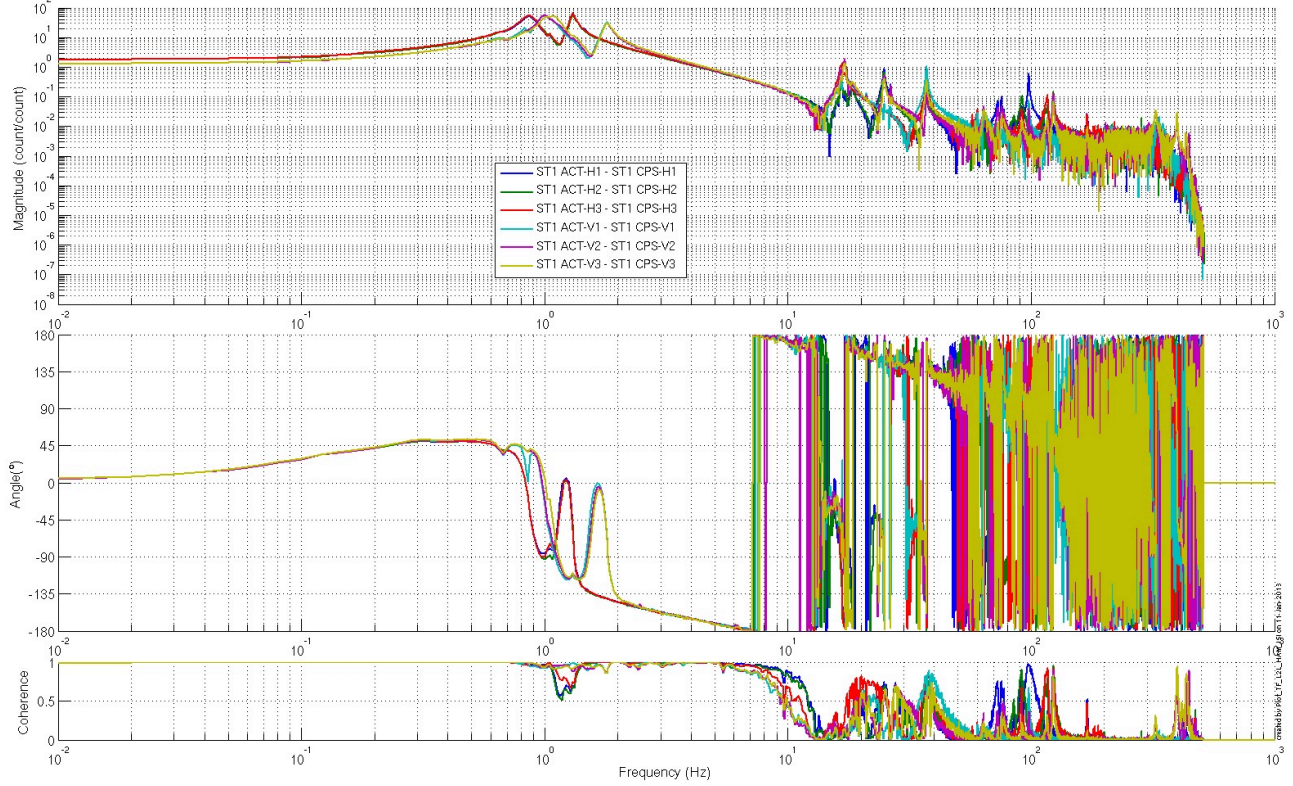
Figure – Local-to-Local Transfer Function – Capacitive Position Sensors

LHO HAM2-ISI - Overnight - December 19th 2012 - HEPI locked - In Chamber - In Air - MC1 MC3 Damped - TMDs on - No PRM, No PR3

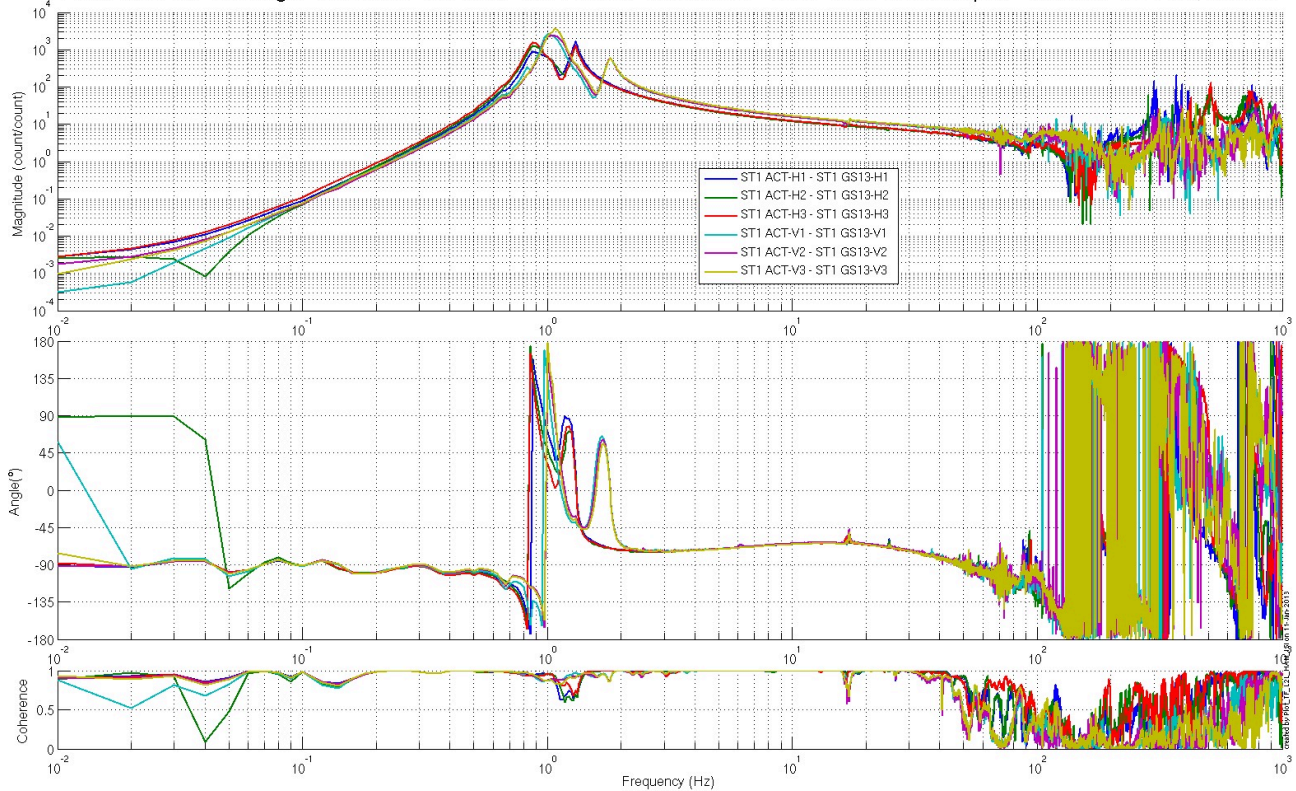
Figure– Local-to-Local Transfer Function – Inertial Sensors

LHO HAM2-ISI - Overnight - December 19th 2012 - HEPI locked - In Chamber - In Air - MC1 MC3 Damped - TMDs on - No PRM, No PR3
