LIGO- E1200506

aLIGO HAM-ISI, Installation Test Report, Phase II
Chamber-Side Testing & Initial Chamber Testing
LHO HAM2-ISI (Unit #4)

E1200506-V4

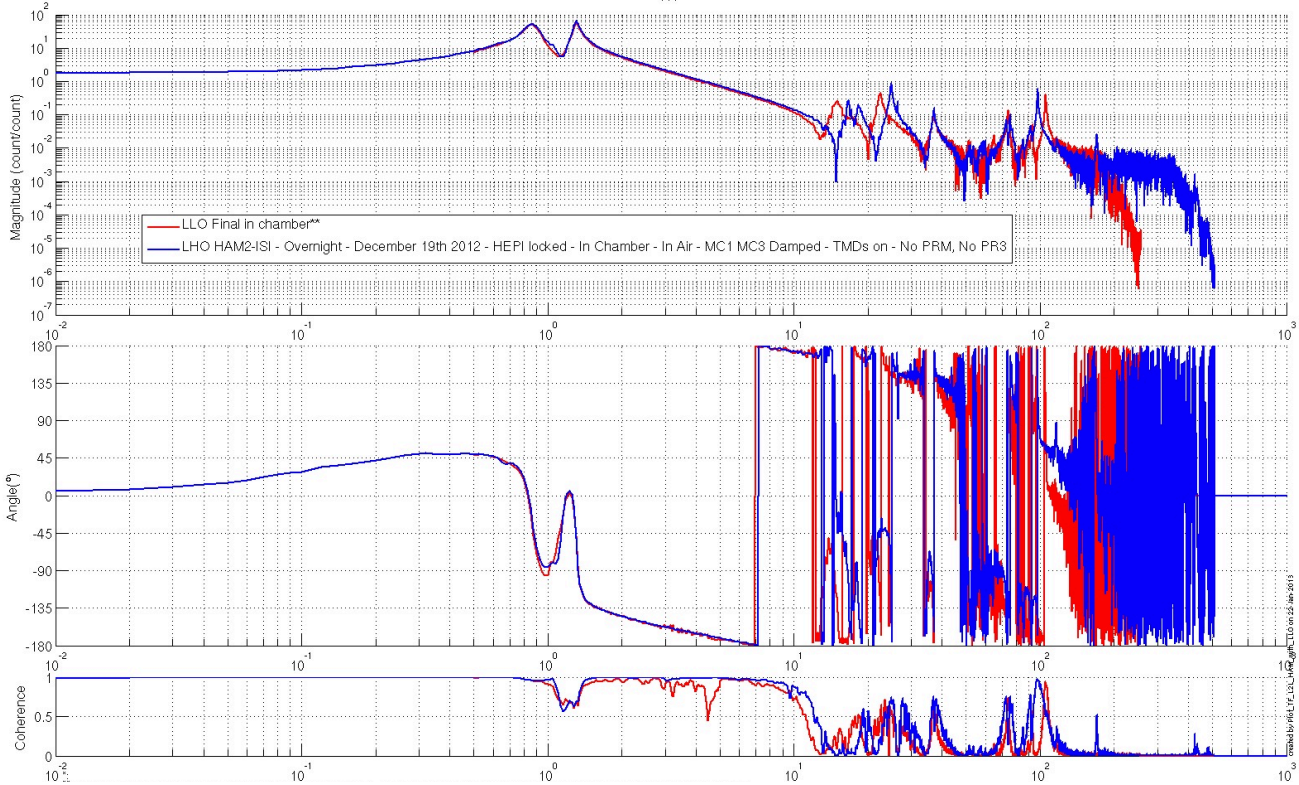
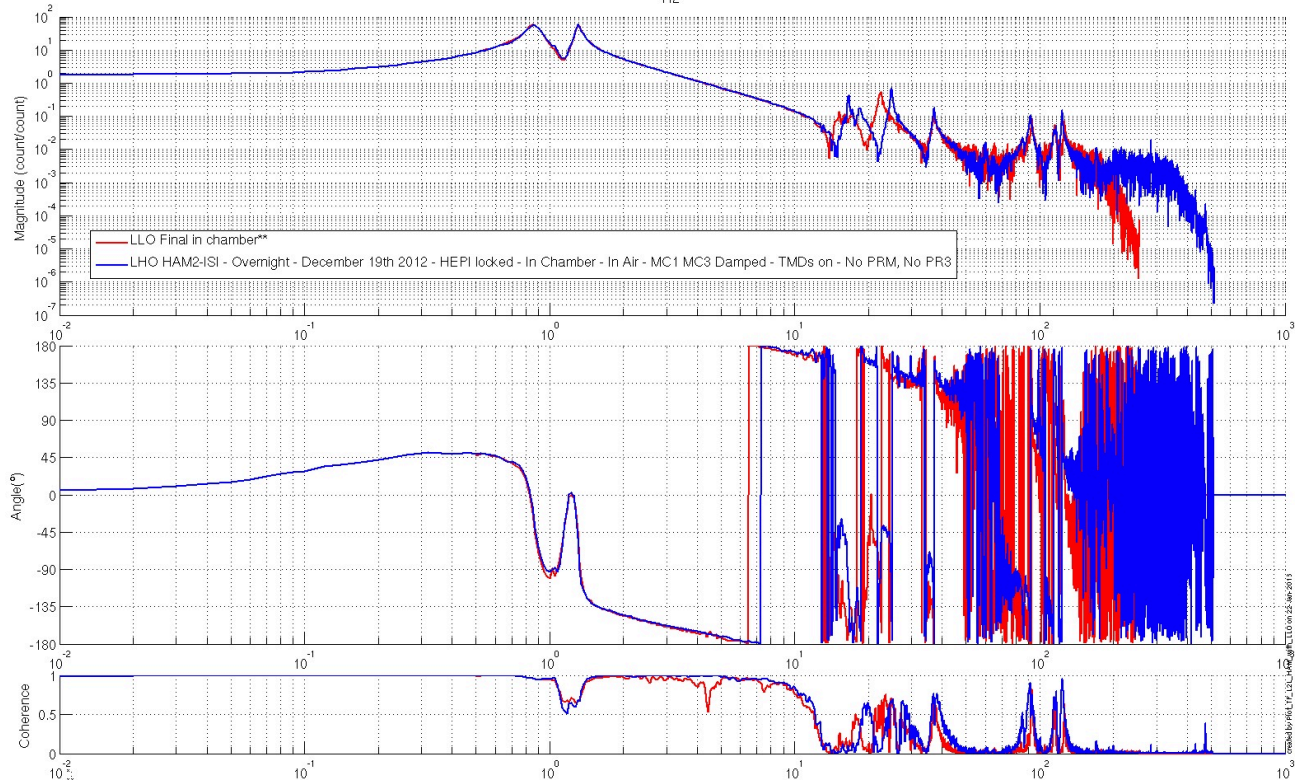
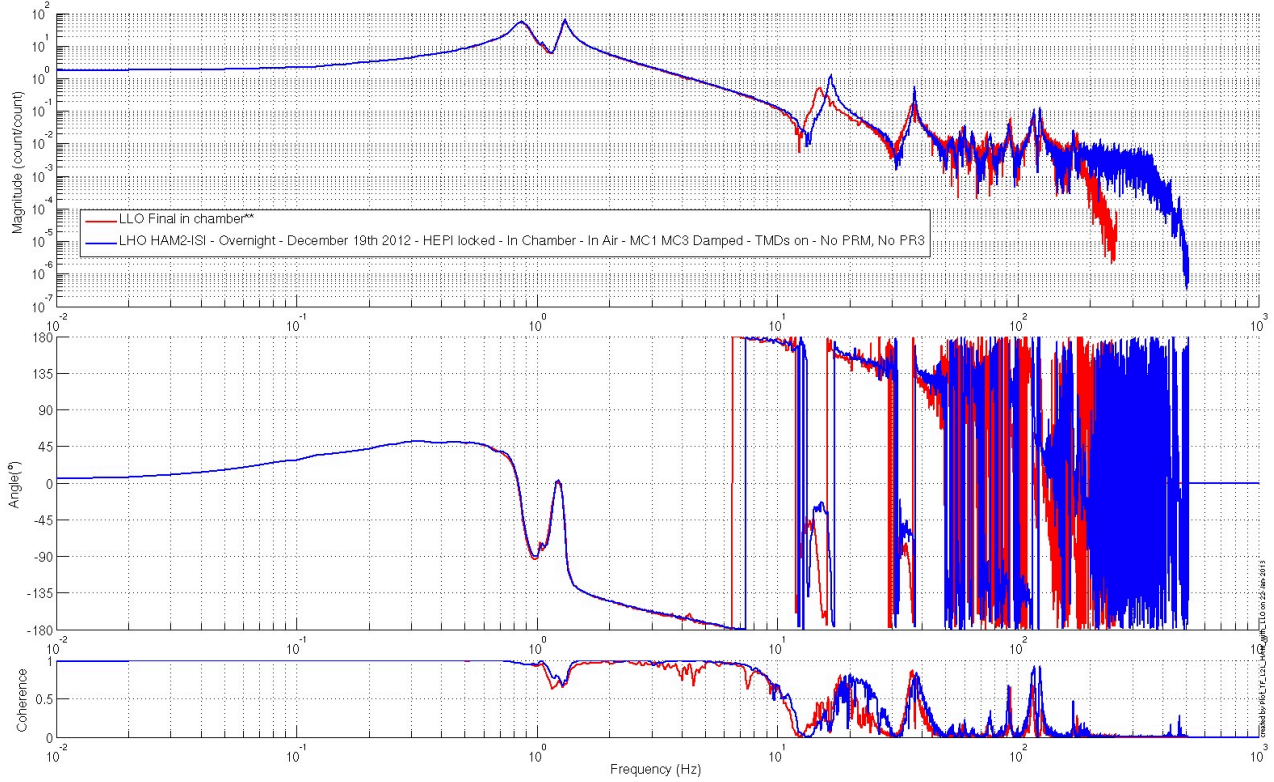
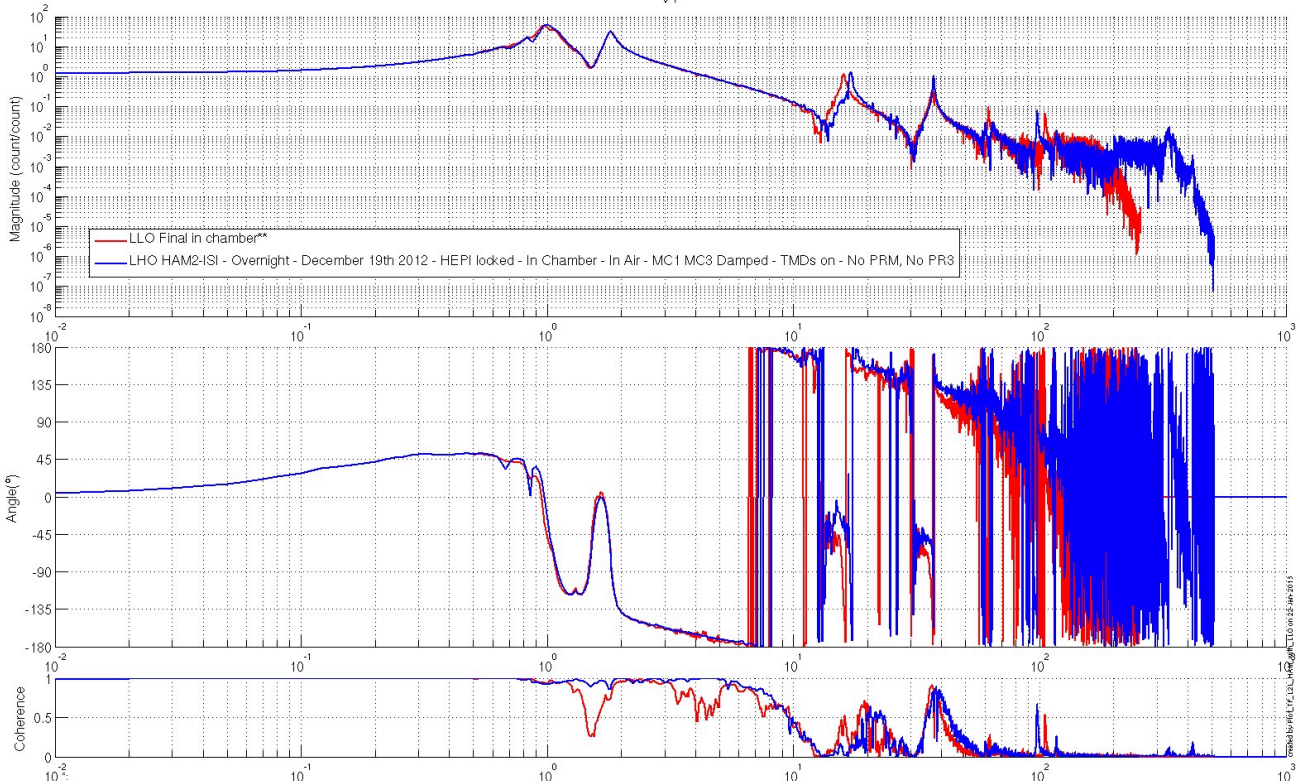
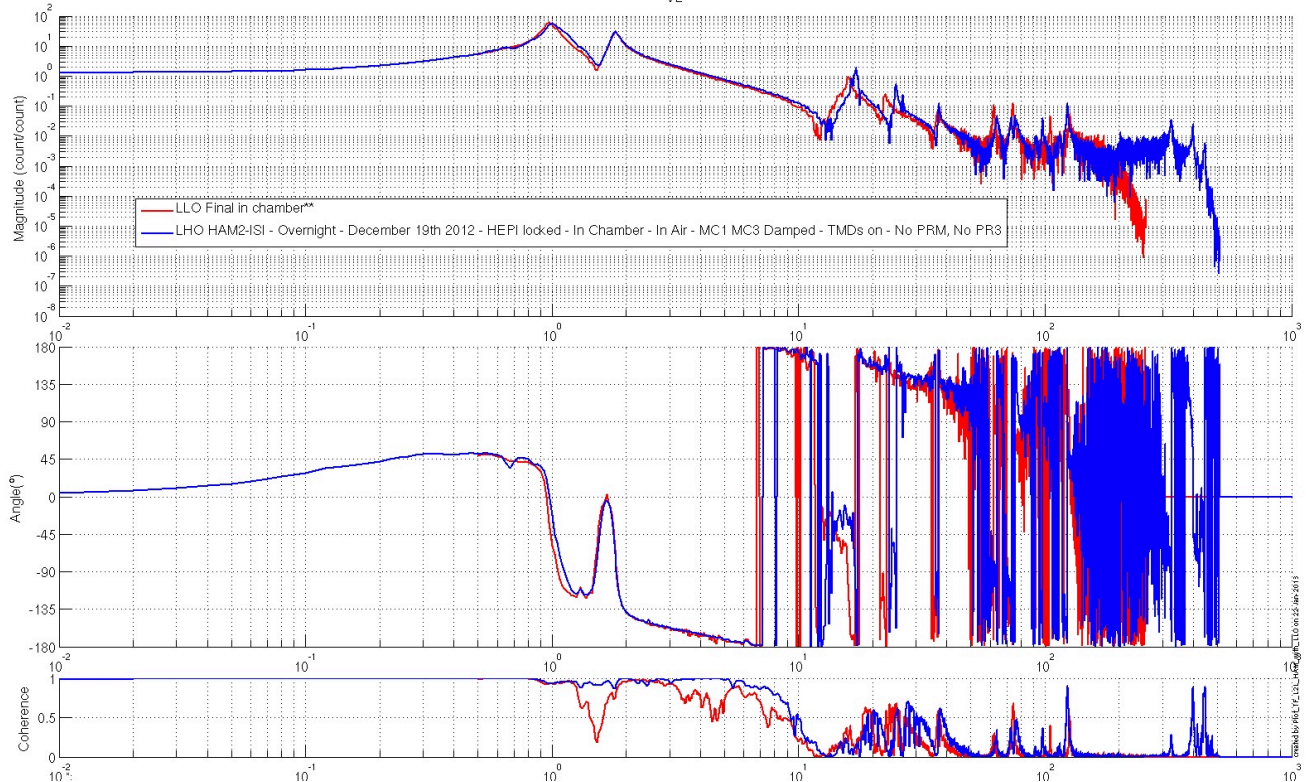
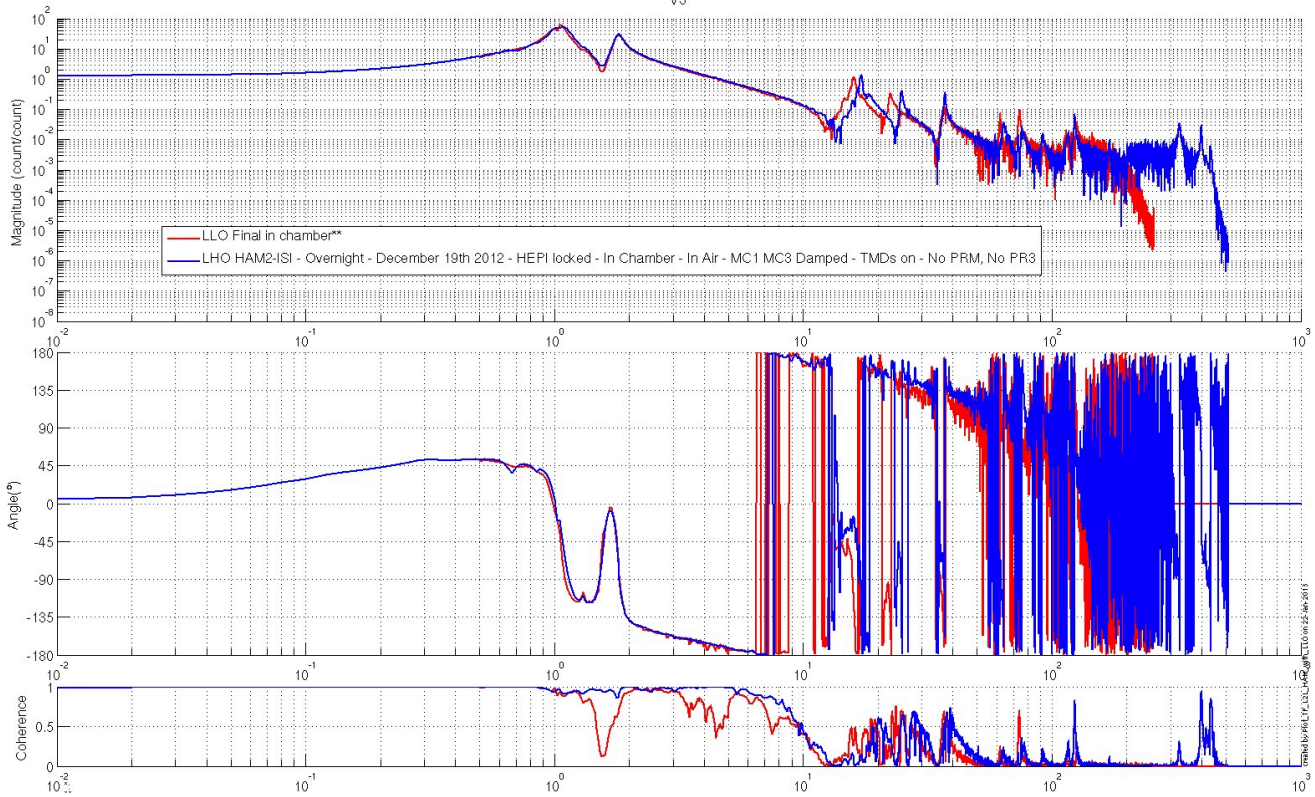
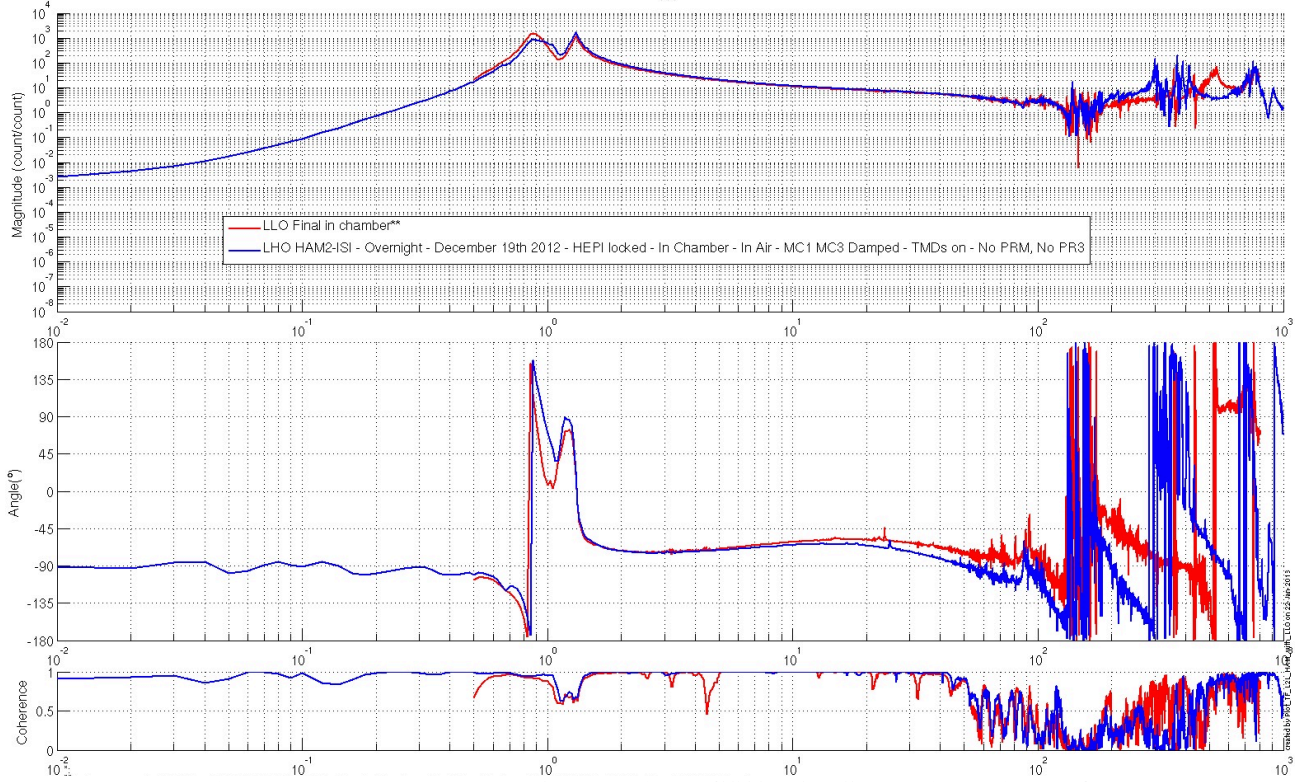
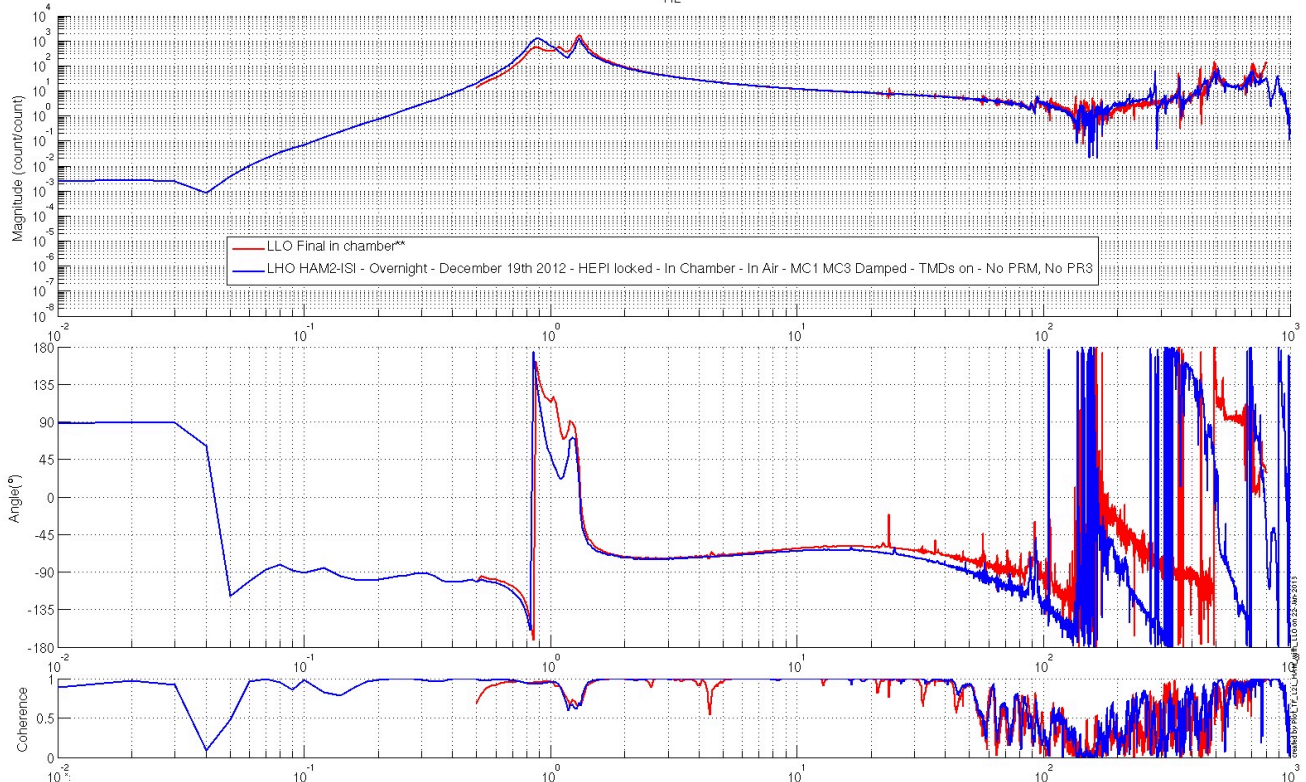
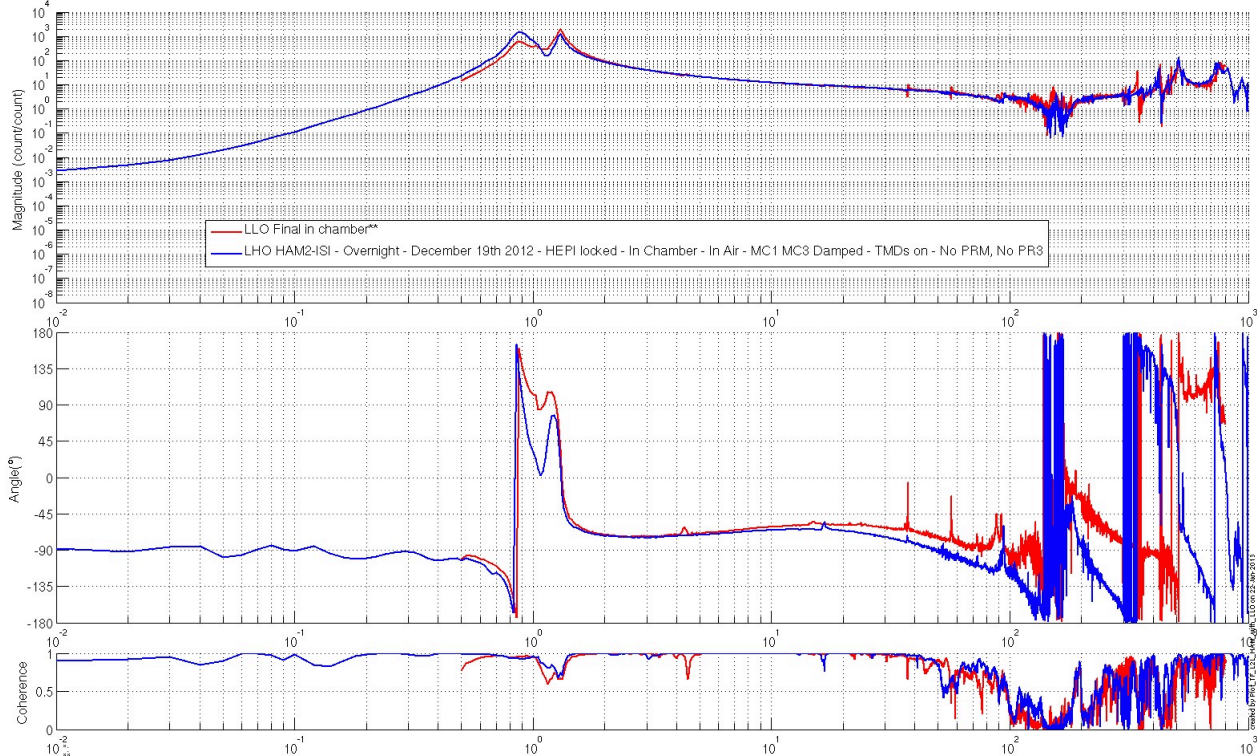
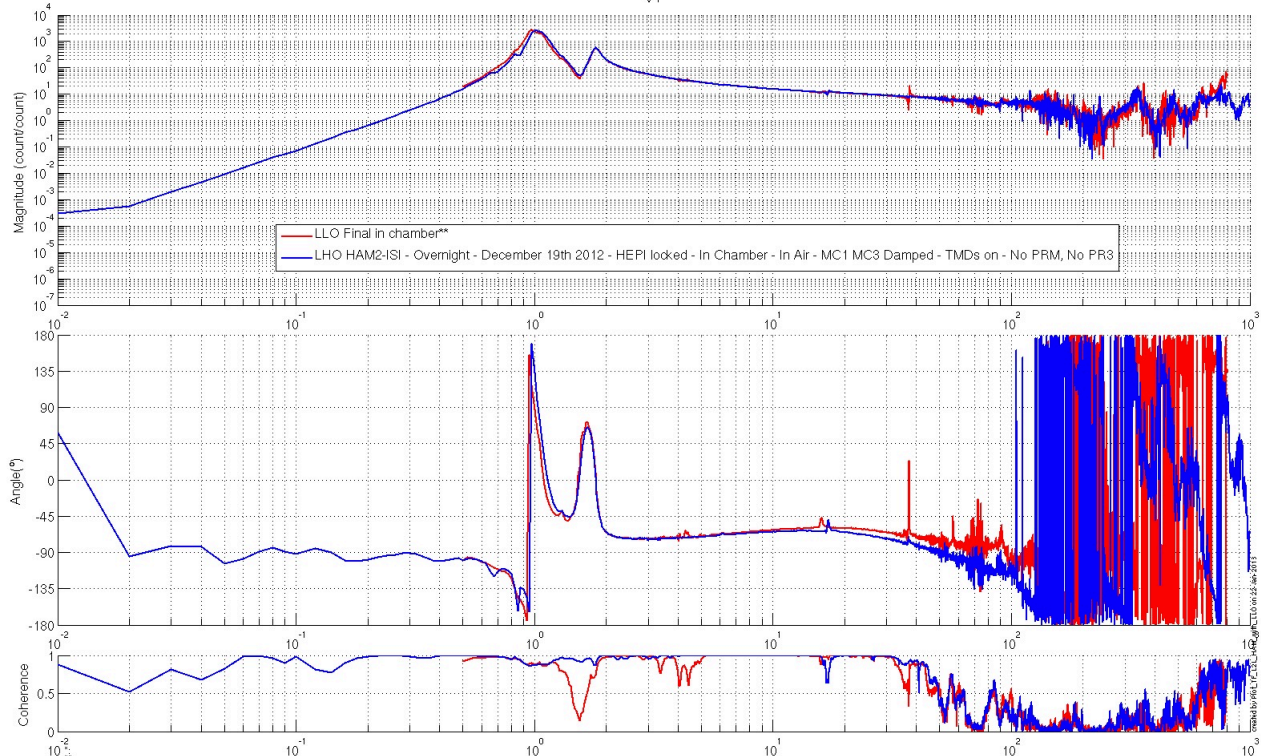
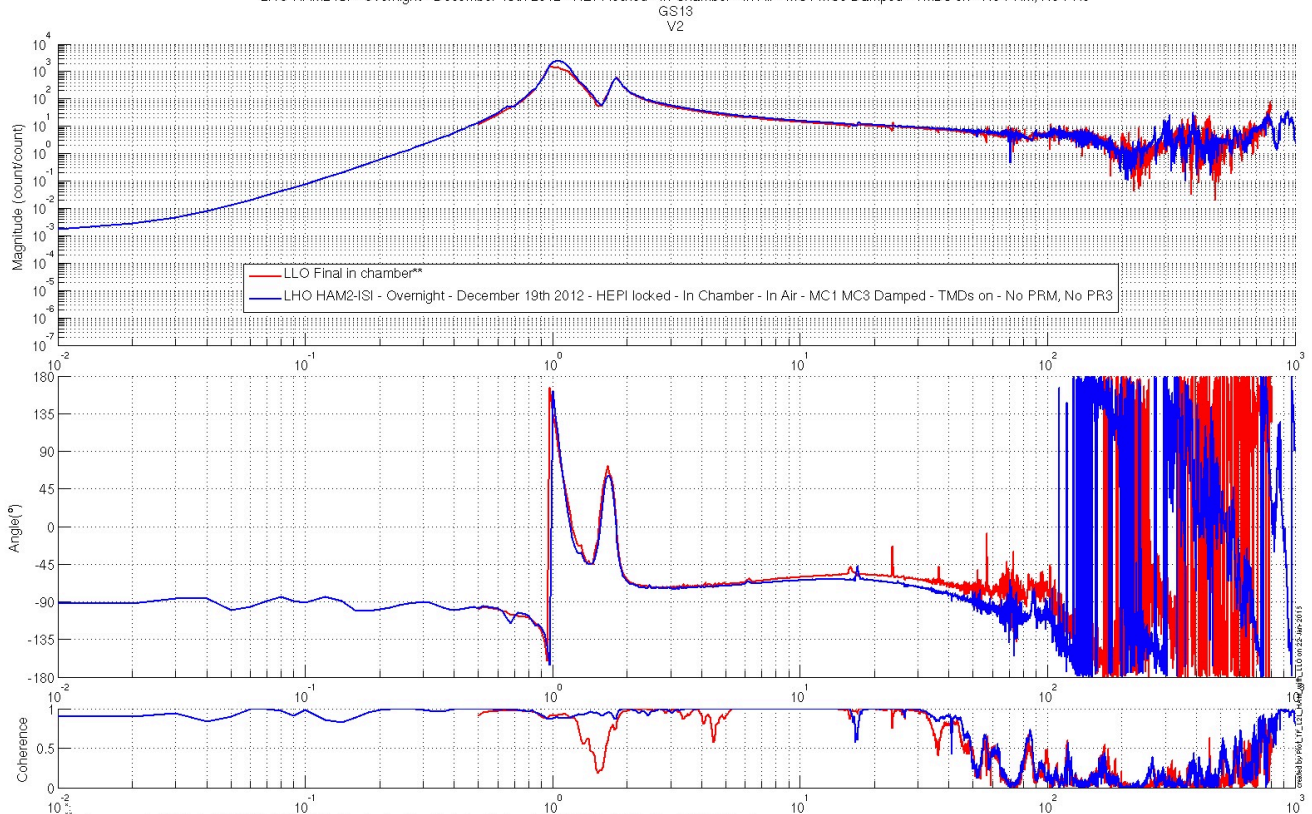
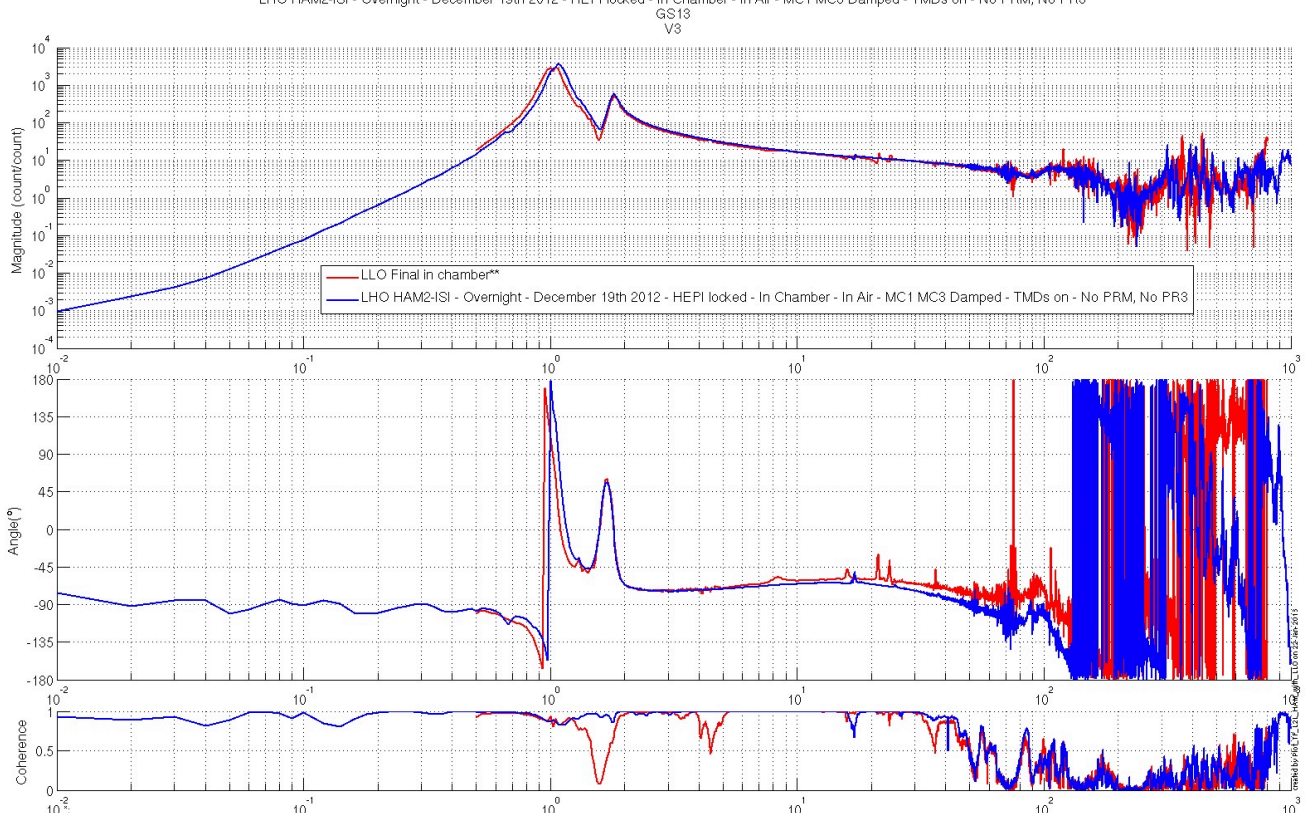
- Transfer functions corresponding to the same phase of testing could not be found for LLO HAM2-ISI.
- The transfer functions used as reference were measured at LLO on December 18th. It is likely that HEPI was then unlocked.

- Good concordance with TF measured under the same conditions at LLO.
- Local to local measurements
 - o On CPS, the phase must be 0° at DC
 - o On Geophones, the phase must be -90° at DC
 - o Identical shape in each corner
- Cartesian to Cartesian measurements
 - o On CPS, the phase must be 0° at DC
 - o On Geophones, the phase must be -90° at DC
 - o Identical shape X/Y and RX/RX

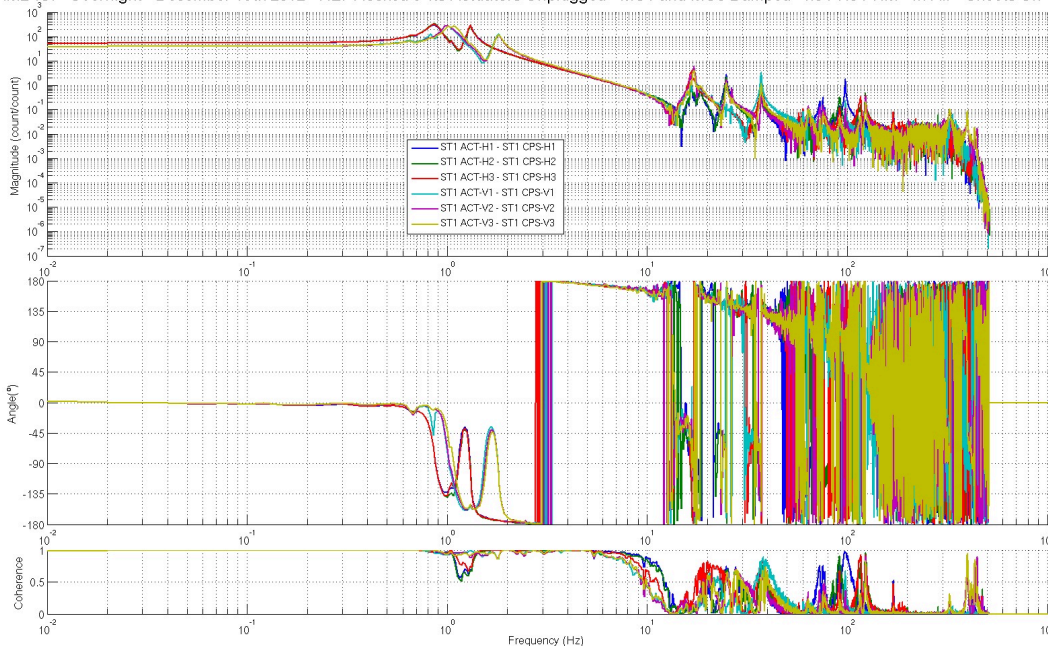
Figure– Local-to-Local Transfer Function – Capacitive Position Sensors – Symmetrized

The following symmetrized transfer functions were calculated from the Local-to-Local transfer functions presented above, in step 15. They are provided as extra material. Hence, they are not subject to acceptance (fail/pass).

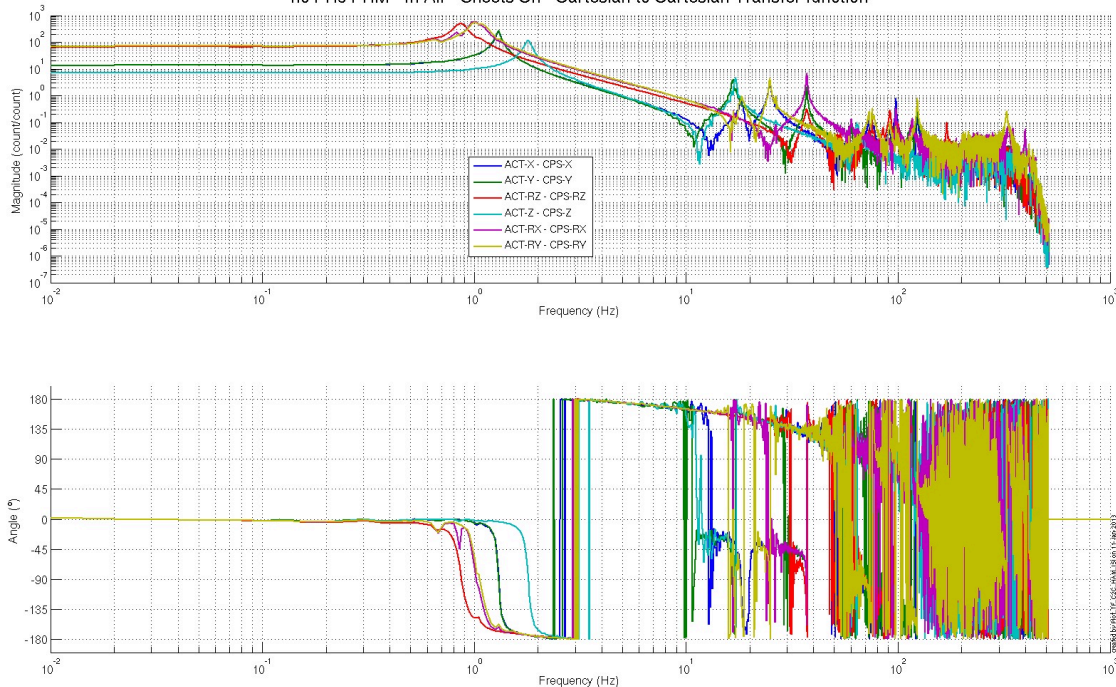
Figure– Cartesian-to-Cartesian Transfer Function – CPSs – Symmetrized

The following Cartesian-to-Cartesian symmetrized transfer functions were calculated from the Local-to-Local transfer functions presented above, in step 15. They are provided as extra material. Hence, they are not subject to acceptance (fail/pass).
