LASER INTERFEROMETER GRAVITATIONAL WAVE OBSERVATORY

LIGO-T1300081-v2

**OMC Lower Wire Clamp Development, Crimp and Testing  
Procedures**

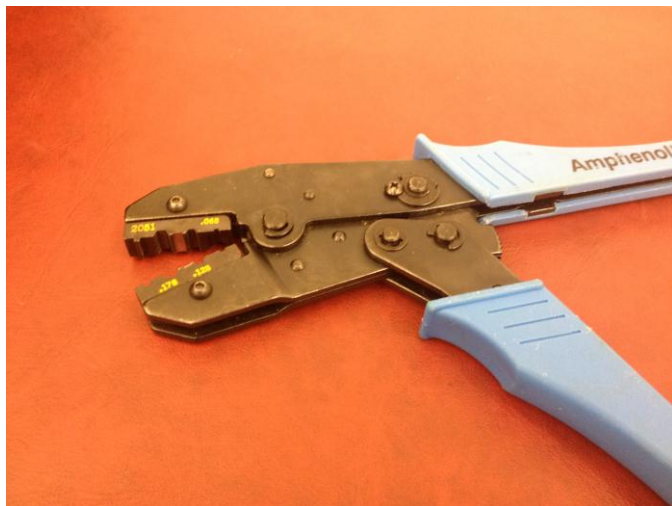
Figure 1. Modified Amphenol Crimpers → D1300083 (the blue handles were removed before C&B)

Finally, the jaws of a pair of Amphenol crimpers model CTL-9 were modified per [D1300081](#) by adding grooves top and bottom which give a flat crush to the clamps. The part number of these crimpers in the DCC and ICS is [D1300083](#). The target amount of crush was the same as the successful vice test mentioned above. These crimpers provide an easy to use and repeatable method to apply a crimp above and below the cone. This is the method which was finally selected to crimp the D1200971 clamps for the aLIGO OMC.

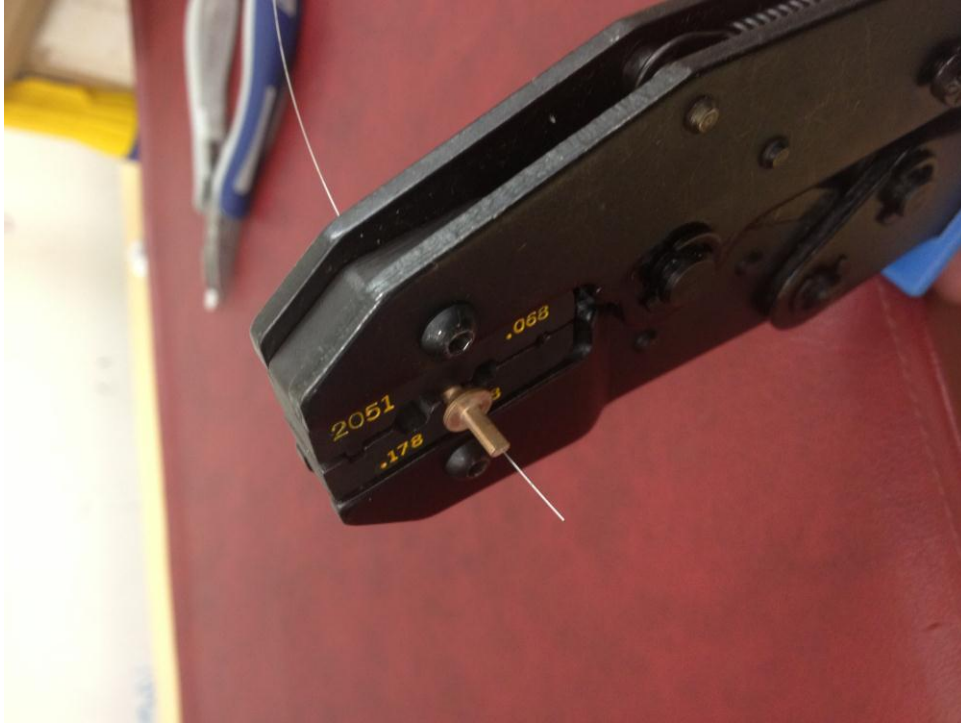
Figure 2. Crimping the clamp

1. Insert the music wire through the D1200971 clamp.
2. Place one side of the clamp into the custom machined groove in the crimper jaws, referring to D1300081 if necessary. It doesn't matter which side is crimped first. Try to keep the clamp perpendicular and centered in the groove. Refer to Figures 2 and 3.

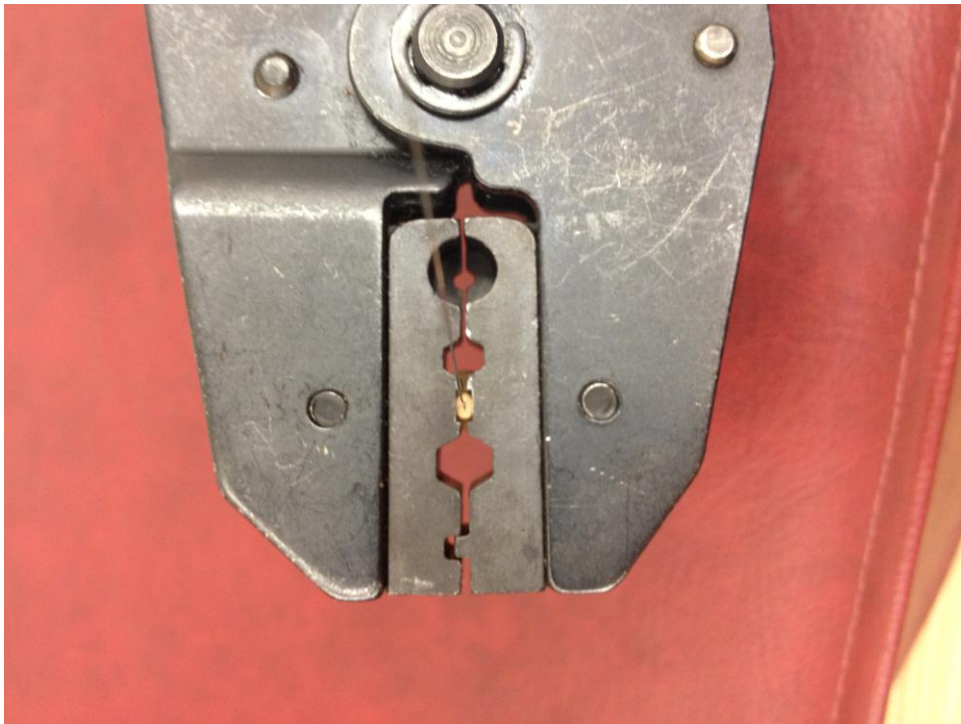
Figure 3. End view – not fully crimped yet

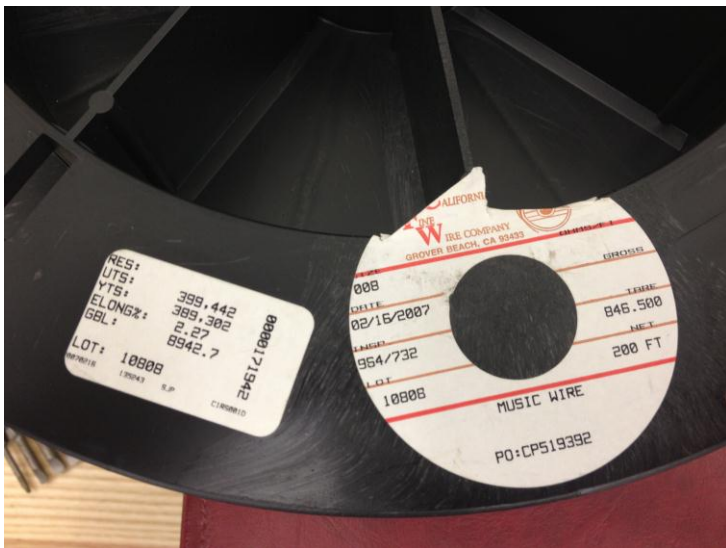
Figure 8. Music wire used for all tests
