LIGO Laboratory / LIGO Scientific Collaboration

aLIGO HEPI Assembly Validation Procedure

E1300824

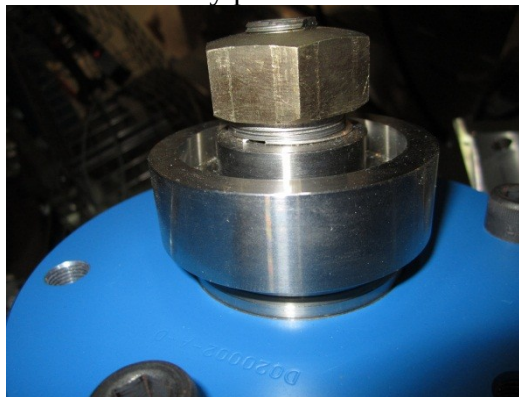
For the BSC HEPI springs, check the assembly per D030324. See LLO aLOG 7162 for more details.

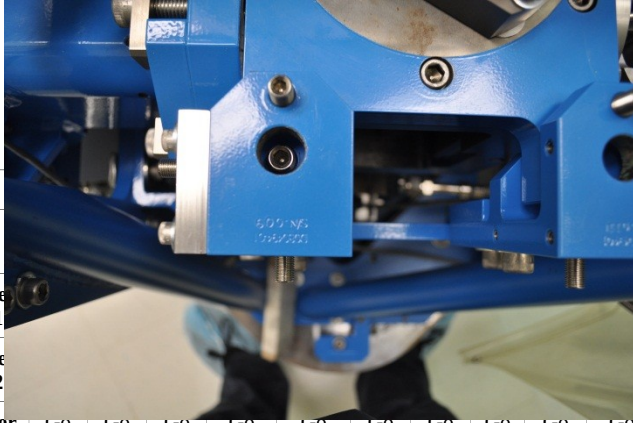
The stops must not touch the boot. There is 15 stops per boot, 5 per F bracket. **There is actually only 13 stops and one of those is not accessible.**

- A 0.062" shim must fit into the gaps

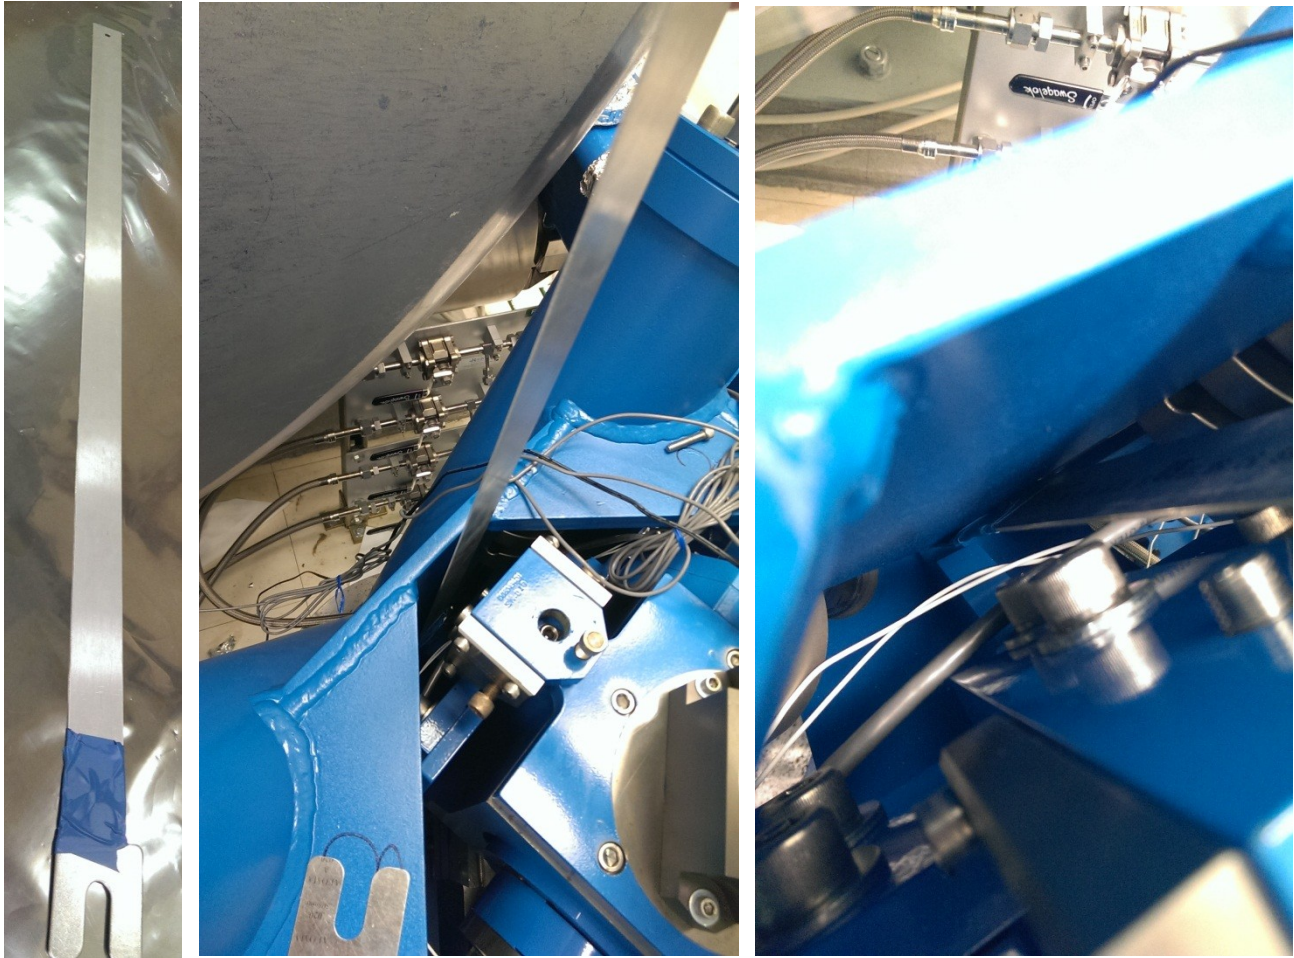
Issues/difficulties/comments regarding this test: Gap#1 is tricky to reach. At LASTI, the solution found was to tape the shim to an extension (rod, rigid ruler, etc.).

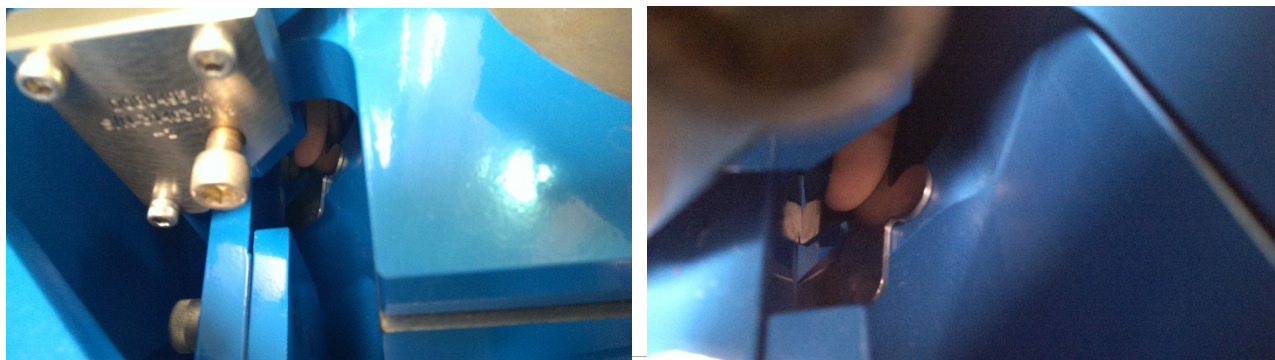
Gap#2 should be reachable by hand.

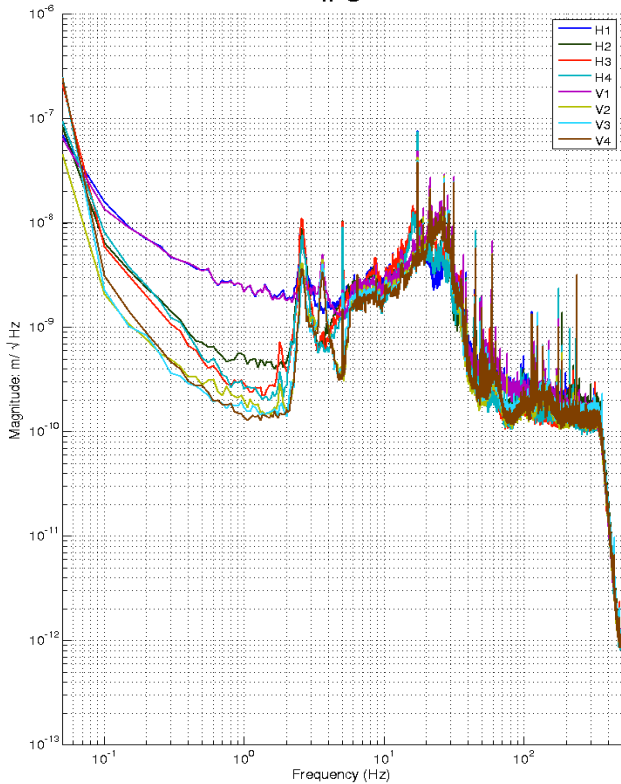
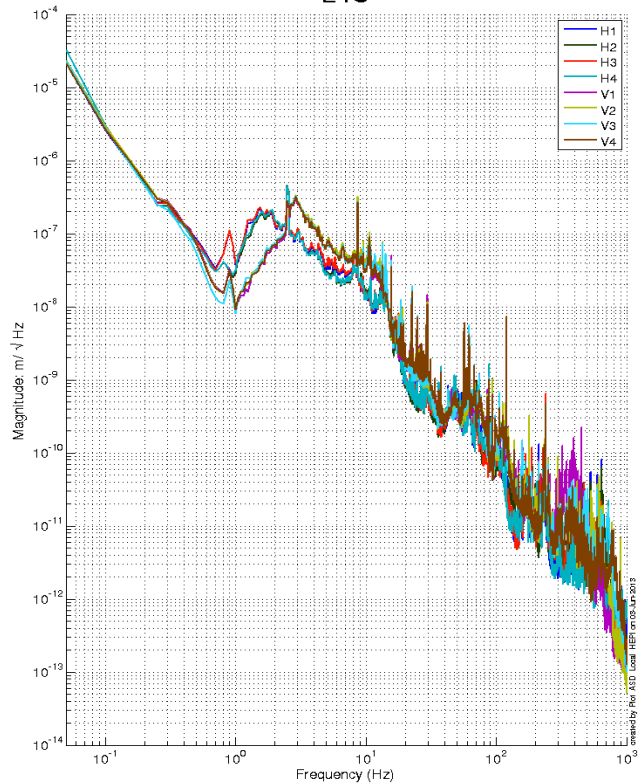
IPS M1 HEPI - HAMX - June 03, 2013 - In vacuum L4C

Issues/difficulties/comments regarding this test:
 Measurements were performed with all PreFilters ON.
