LIGO- E1300926-V2

January 30th, 2014

aLIGO HEPI L1 HAM5 Assembly Validation Report

Adrien Le Roux, Céline Ramet, for the SEI Team

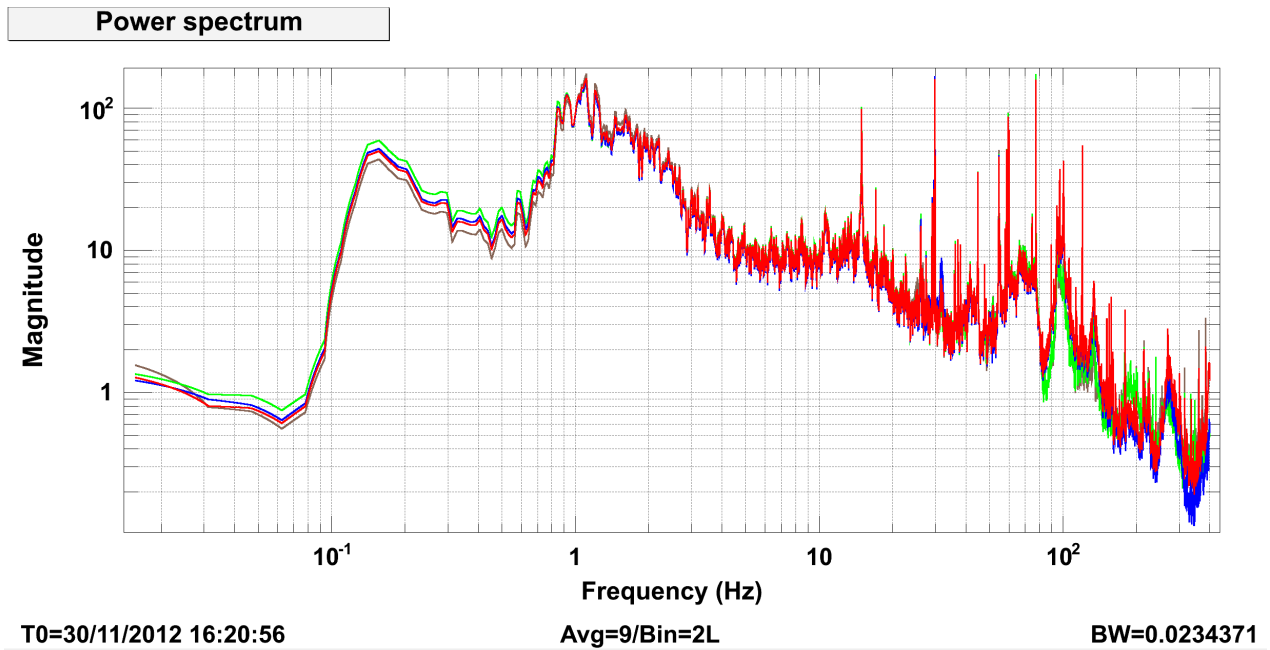
Figure 1: Power spectra of L1 HAM 5 horizontal L4Cs

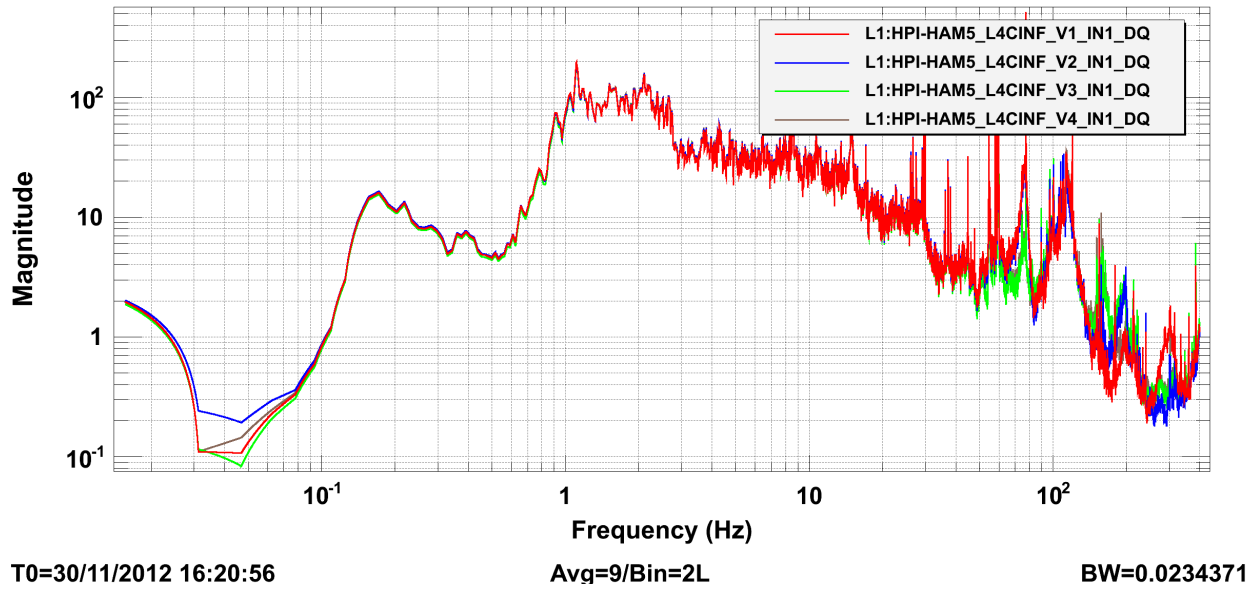
**Figure 2: Power spectra of L1 HAM 5 horizontal L4Cs**

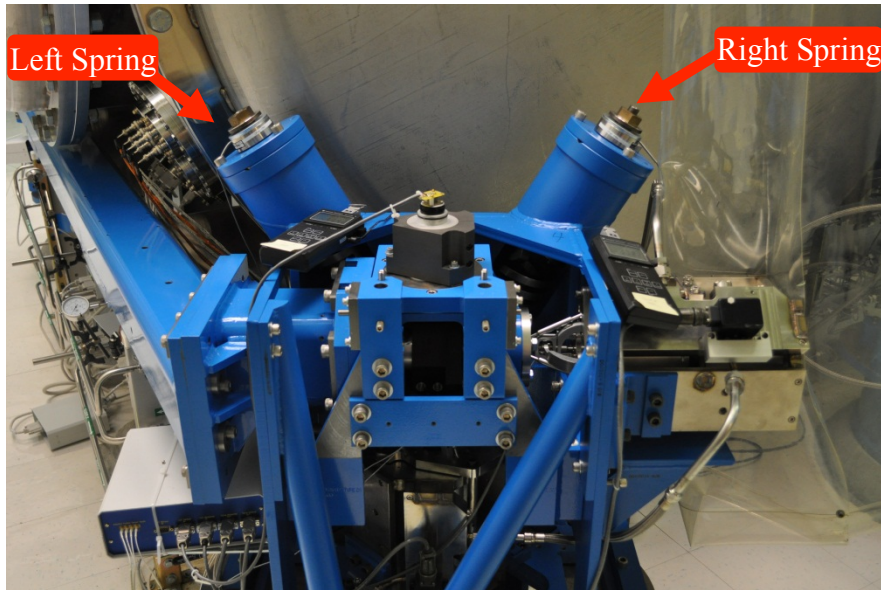
HAM HEPI load cell capacity → 2000 lbs

Figure 3: HAM-HEPI example at LASTI

Left Spring (lbs)	Right Spring (lbs)
Pier 1	1279	1352
Pier 2	1301	1366
Pier 3	1100	1295
Pier 4	1479	1369

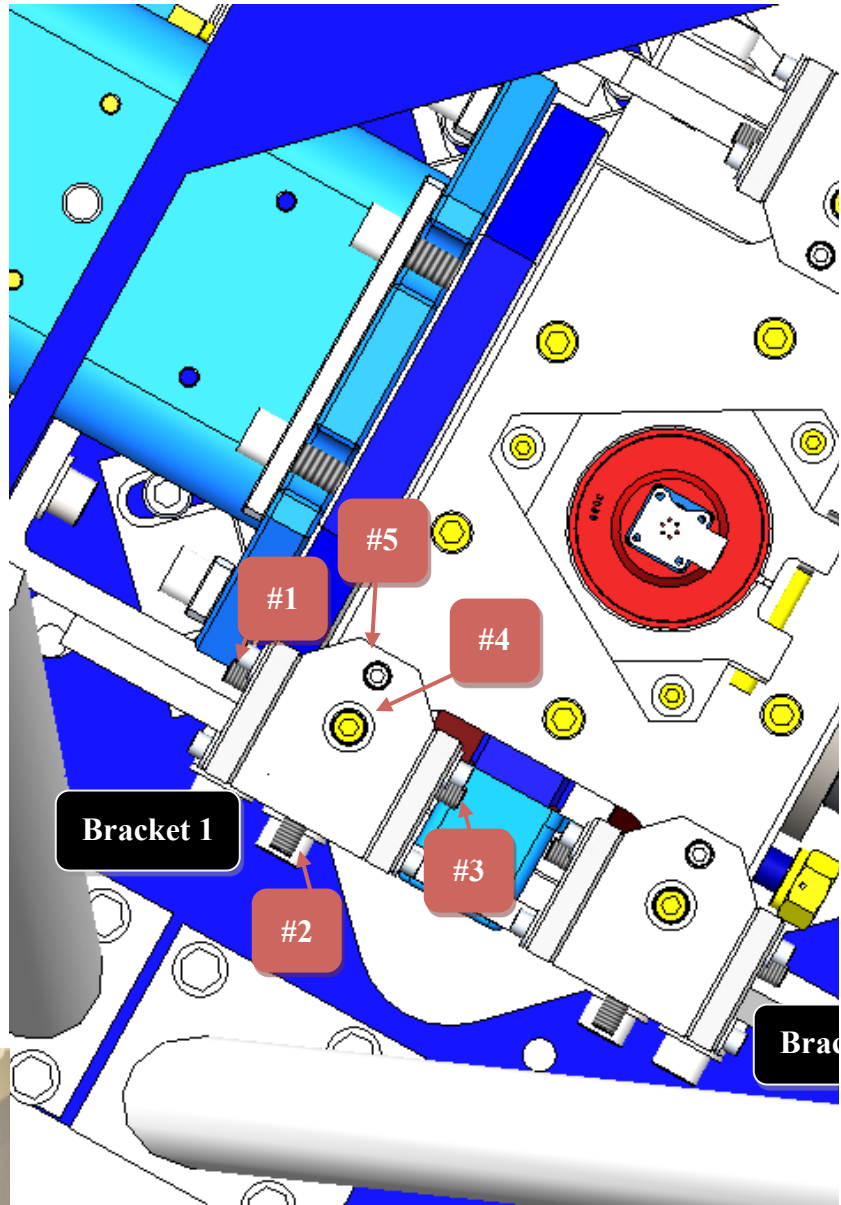
The stops must not touch the boot. There are 15 stops per boot, 5 per F bracket.

Figure 4: Locations of the boot's stops

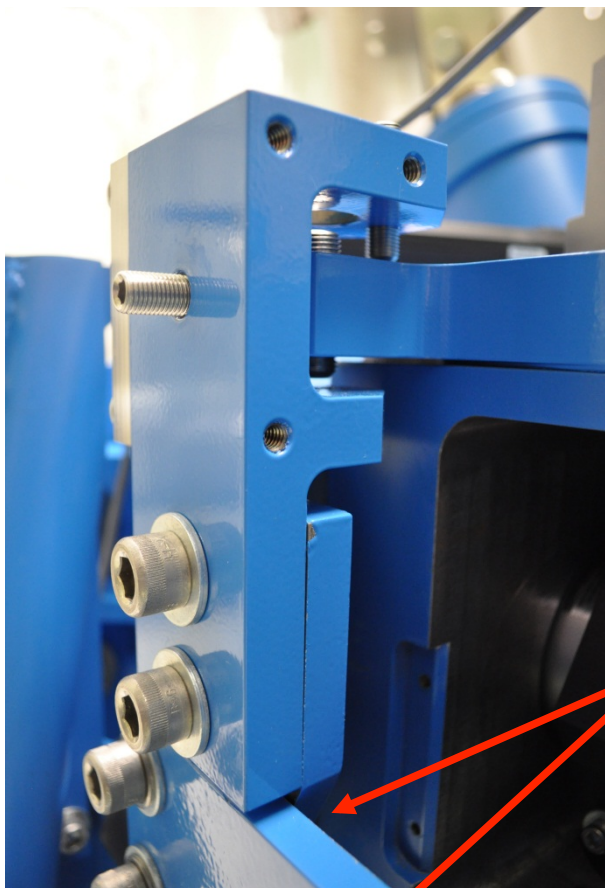
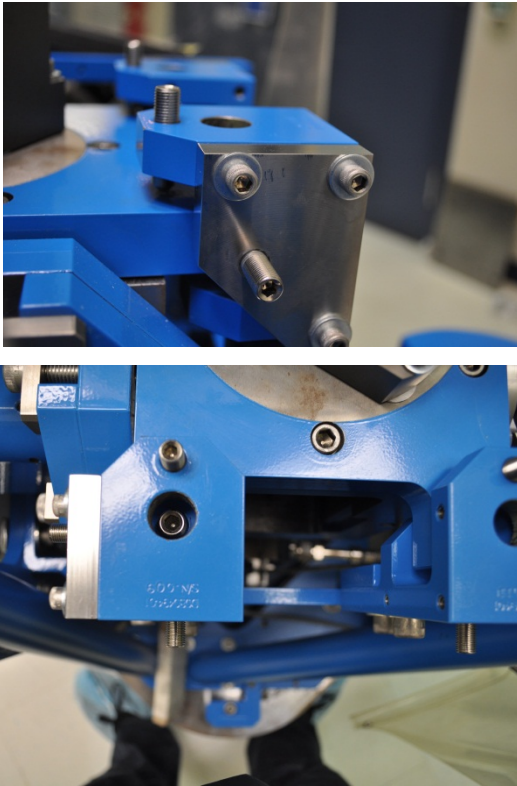
- A 0.062" shim must fit into the gaps

A 0.062" must fit into the gaps

Figure 5: Locations of the boot's gaps to measure

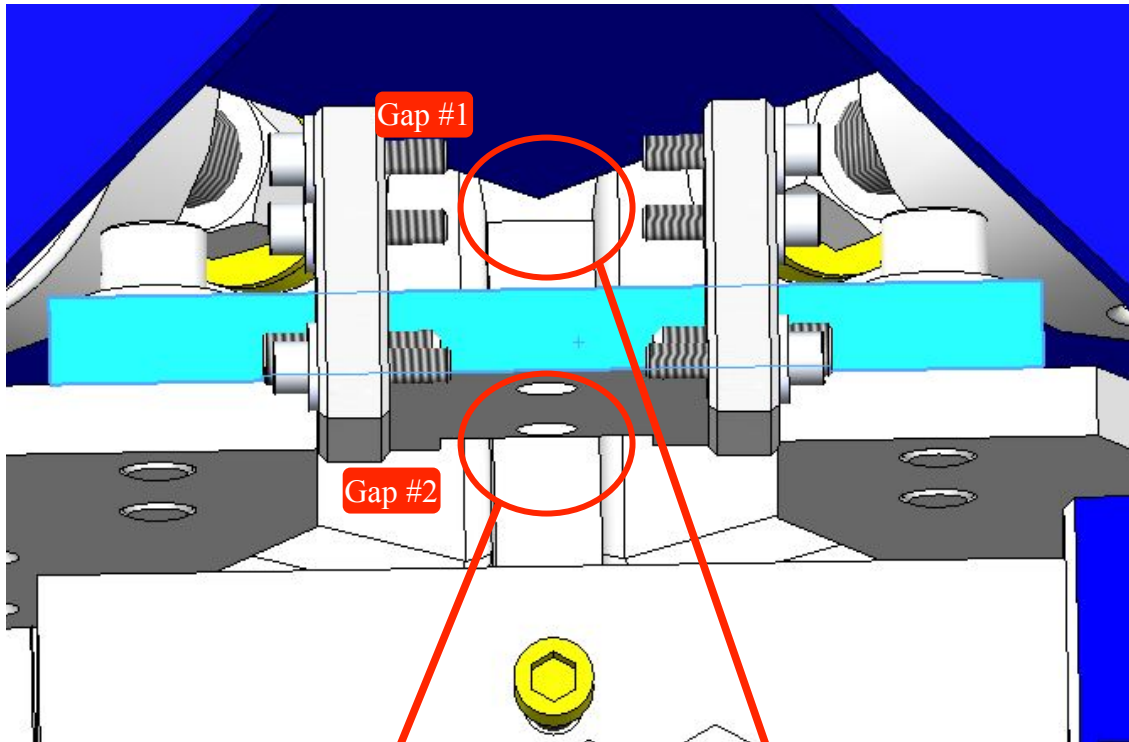
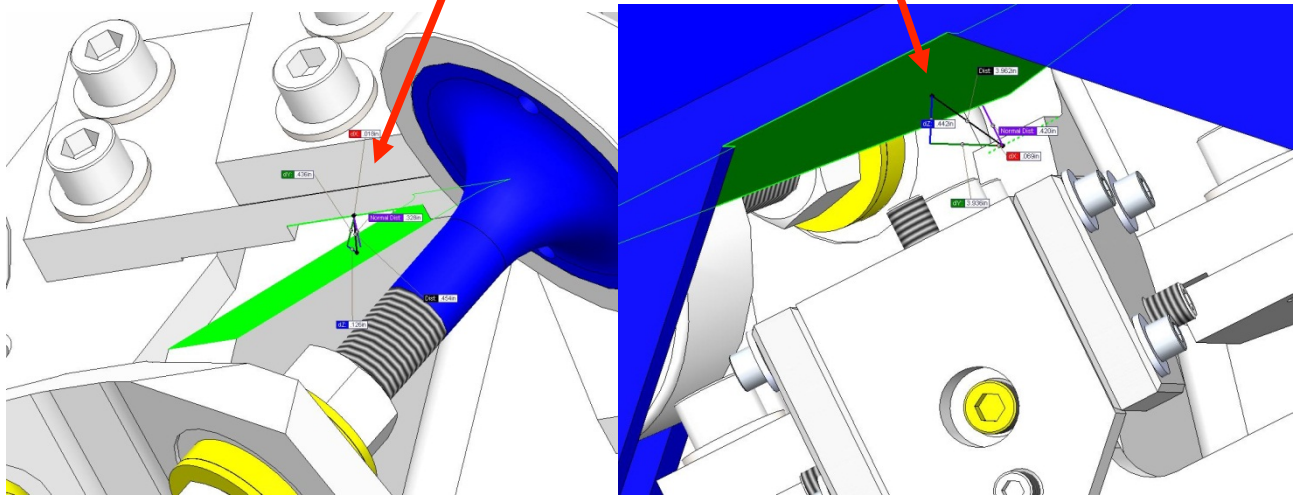
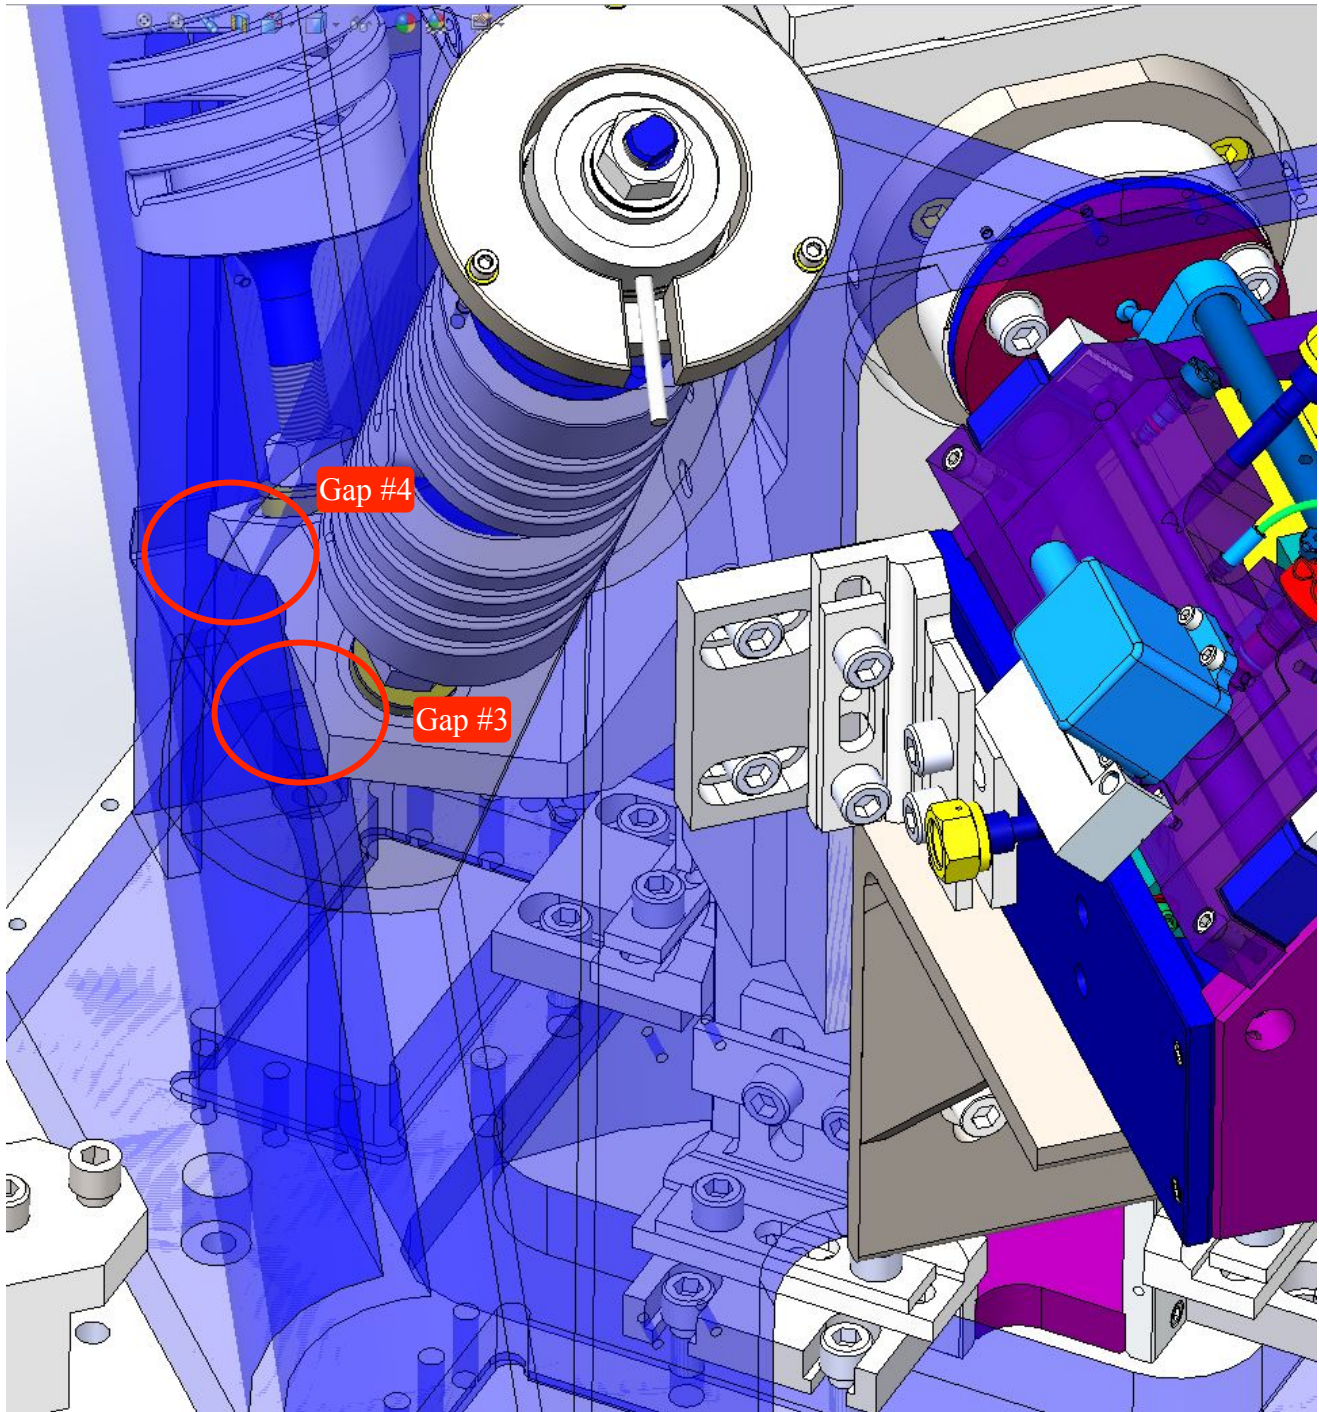
Four particular gaps need to be check.

Note: The F bracket has been removed for a better visibility

Figure 6: Gaps which need to be checked

- a 0.08" shim must fit in these two gaps

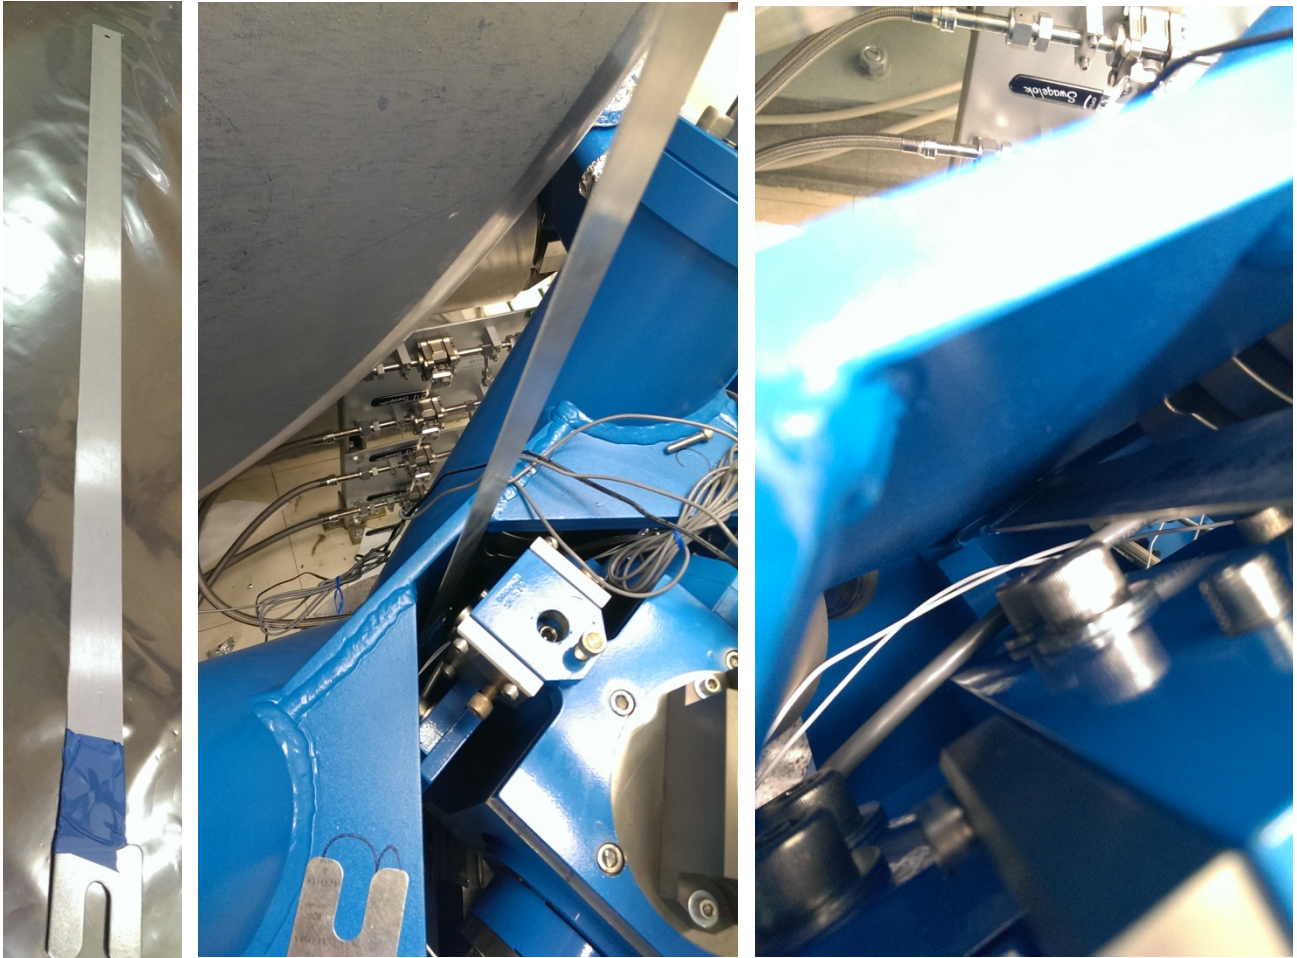
Issues/difficulties/comments regarding this test: Gap#1 is tricky to reach. At LASTI, the solution found was to tape the shim to an extension (rod, rigid ruler, etc.).

Figure 7: First gap to measure (on the first picture, we can see the tool used to measure that gap)

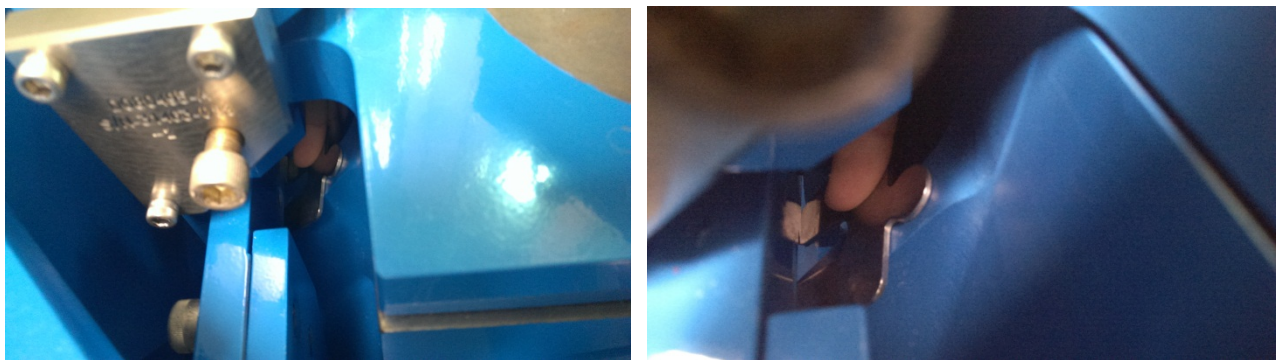
Gap#2 should be reachable by hand.

Figure 8: Second gap to measure

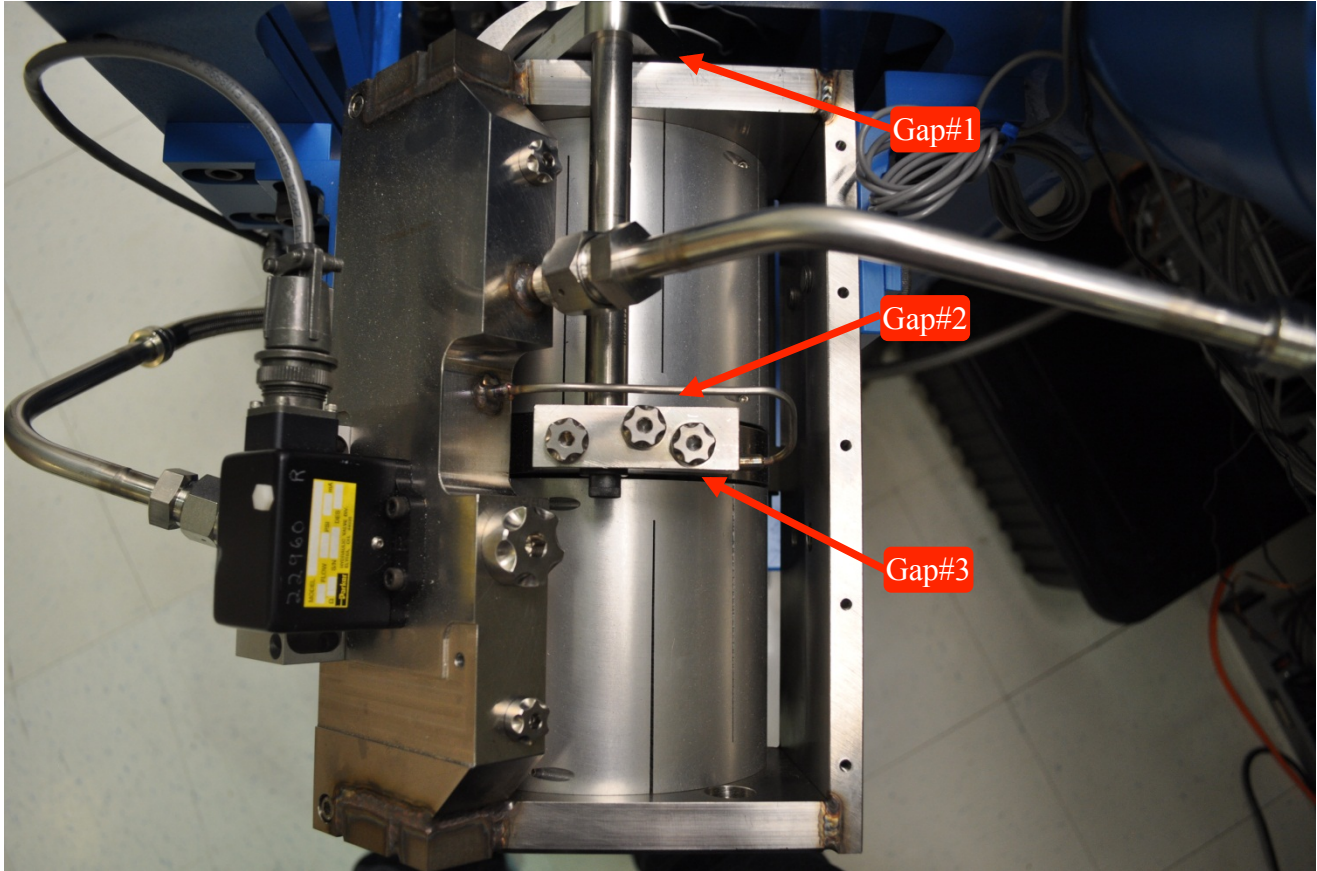
Figure 14: Locations of the actuator gaps to check if Step 1.10 Linearity Test/Range of motion in the local basis failed

Three gaps per actuator need to be checked as shown on Figure 19: Locations of the actuator gaps to check if Step 1.10 Linearity Test/Range of motion in the local basis failed .

- A 0.1” shim must fit into the gap #1
- A 0.05 shim must fit into gap #2 and #3

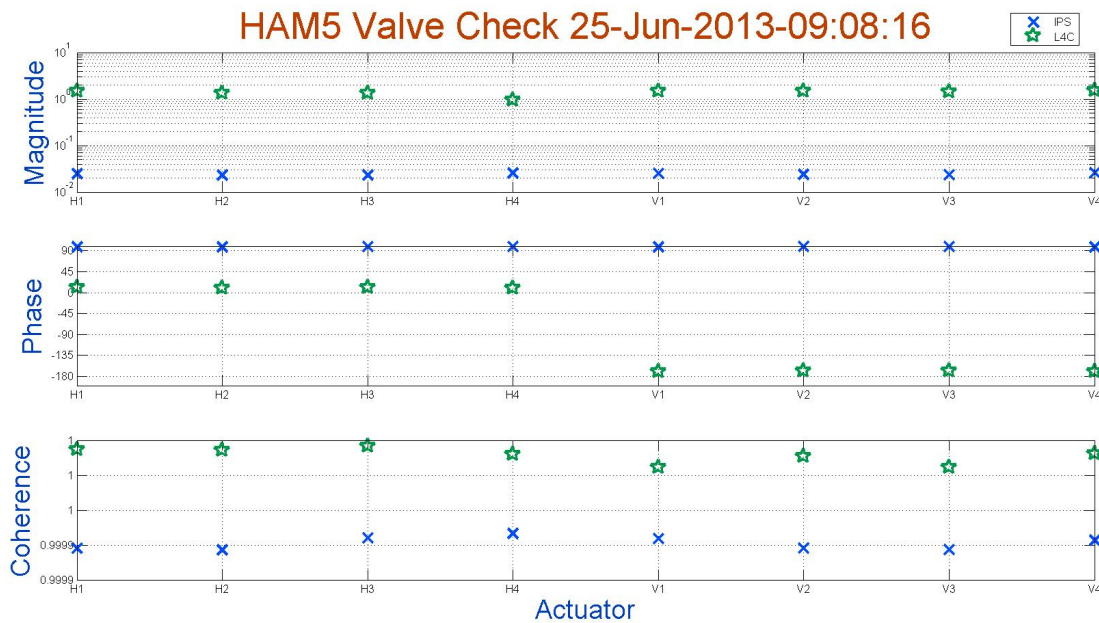
Figure 15: Valve check individual plot

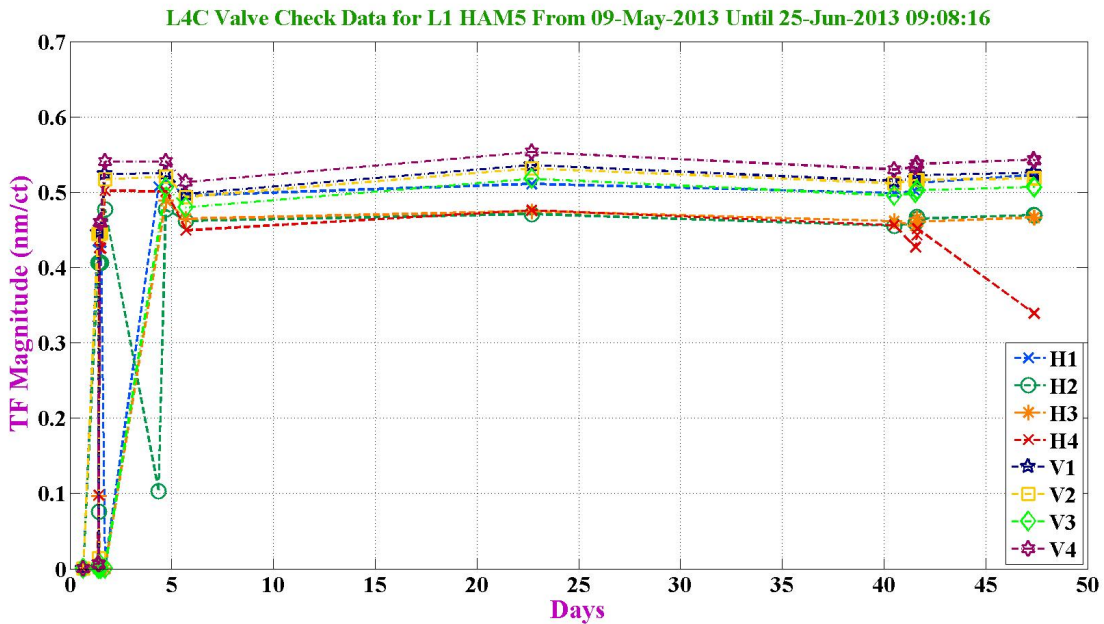
Figure 16: Valve check evolution plot

Note: On this last figure, we can see that H4 valve is faulty. This is confirmed by the Local to local measurements. The valve will be replaced when time permits and the failed tests will be redone.

So far, we have the 1.3 Boot Location that fails, but the requirements might be a little bit too strict for this test and our results are in the ballpark, the real issue with this HEPI is the H4 faulty actuator valve. This valve will be swapped and all the failed tests will be redone in order to approve this Unit.

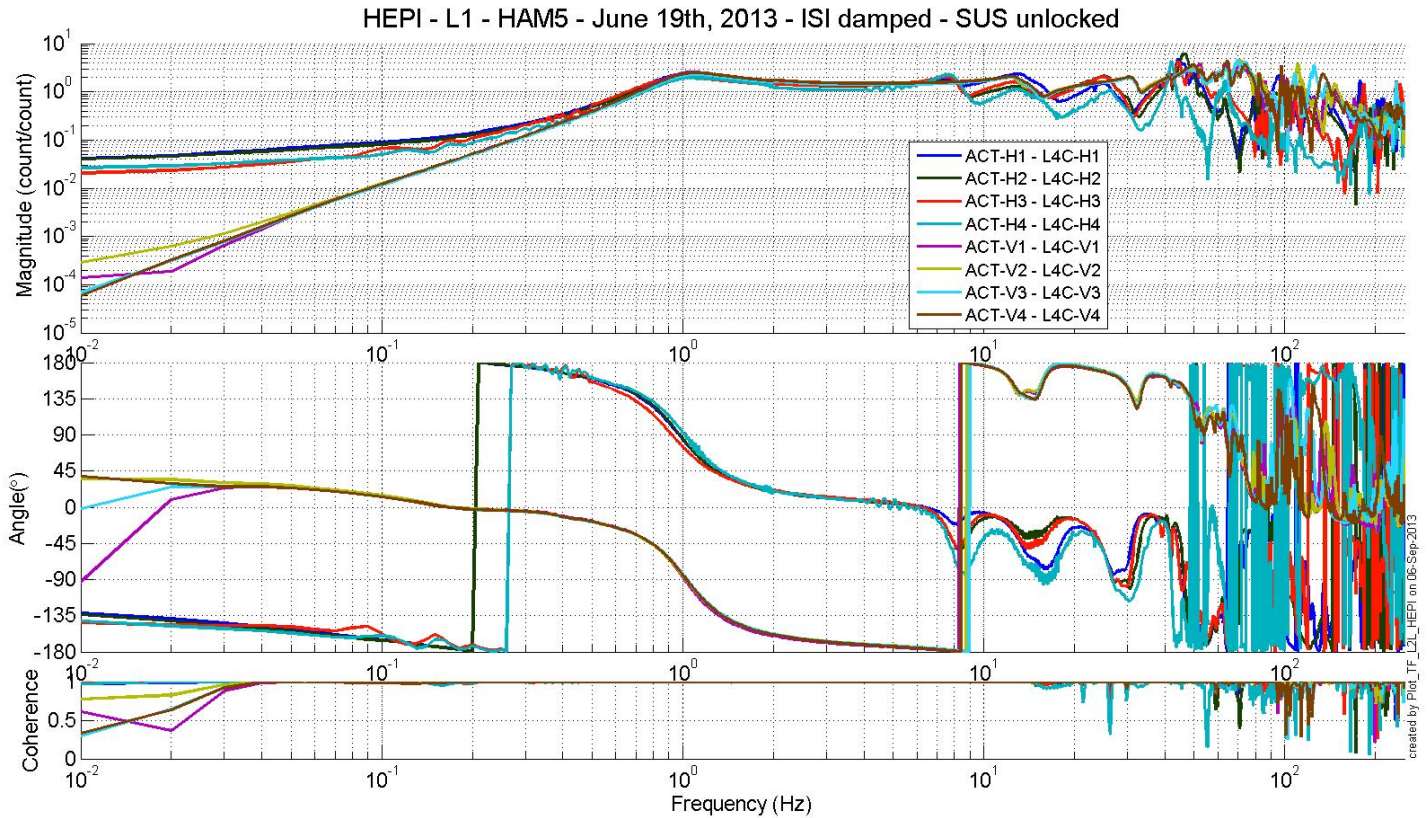
Figure 17:L1 HAM 5 HEPI Act to L4C Transfer Functions

- On IPS, the phase must be 0° at DC
- On geophones, the phase must be 90° at DC
- Identical shape in each corner

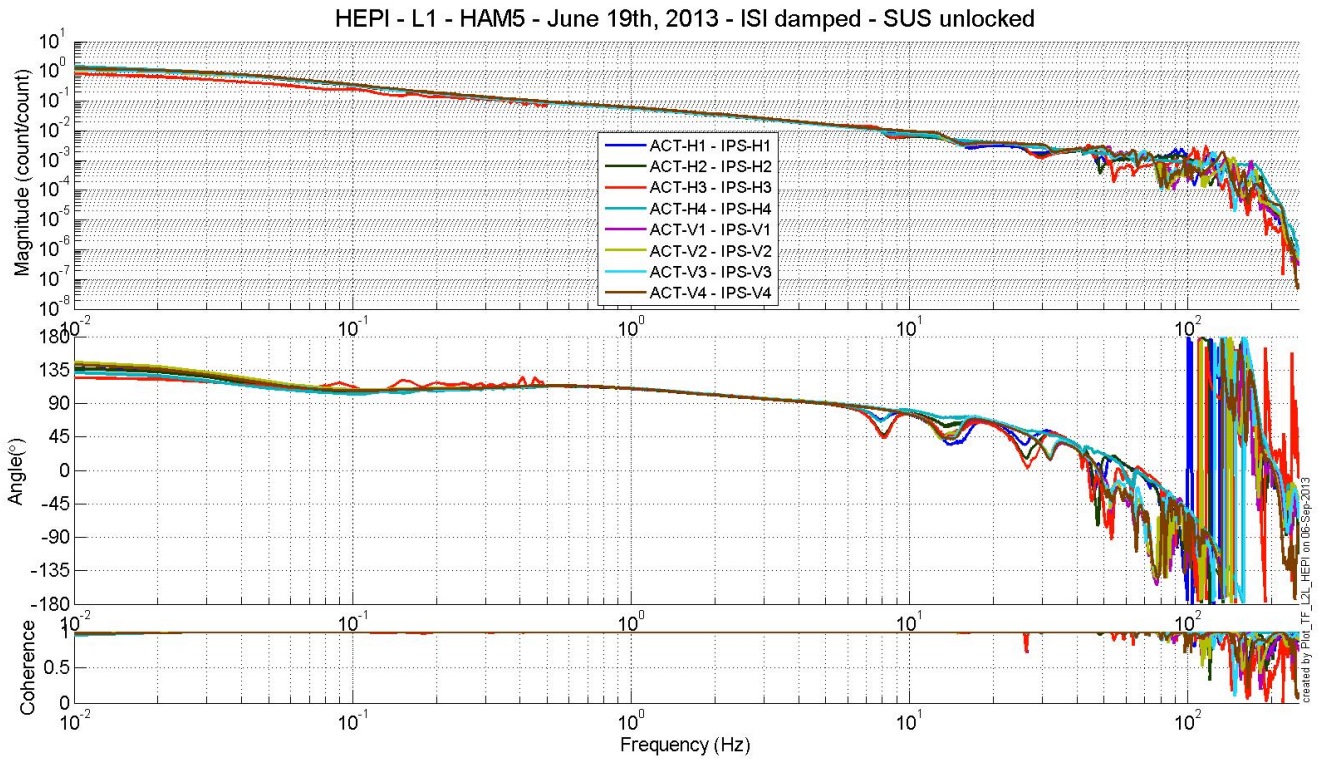
Figure 18: L1 HAM 5 HEPI Act to IPS Transfer Functions
