Installation of the input optics in the underground site of KAGRA

K. Yano, Y. Kataoka, T. Kagawa, M. Nakano, C. Mueller, R. Goetz, D. Tanner, and K. Somiya
Tokyo Institute of Technology, ICRR, U. Toyama, U. Florida

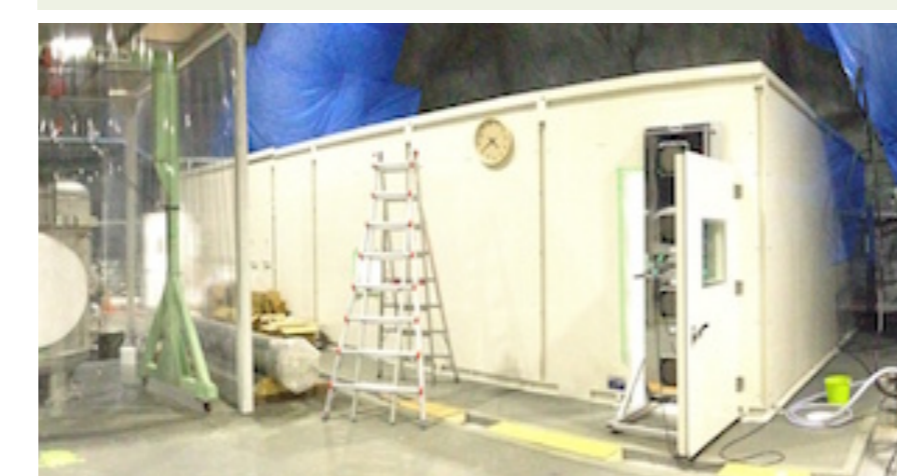
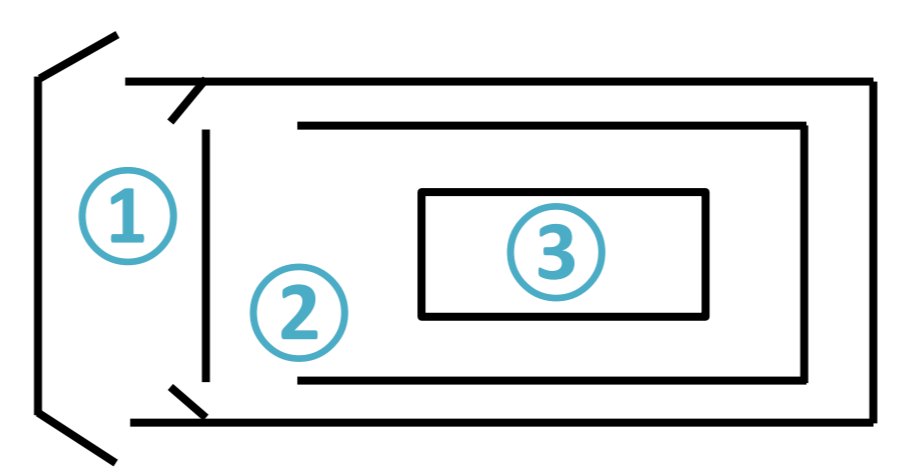
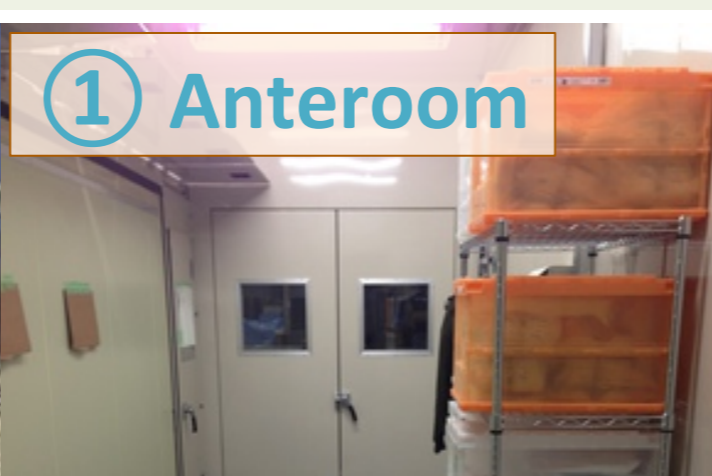
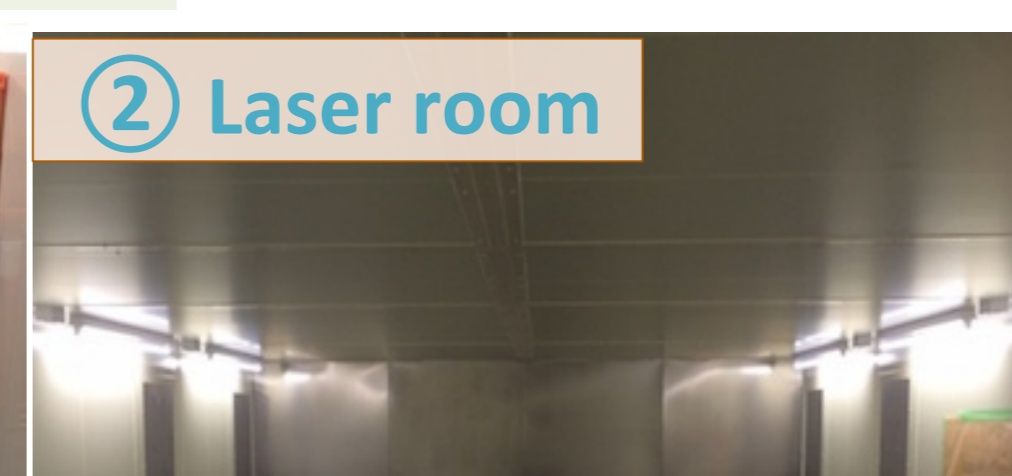
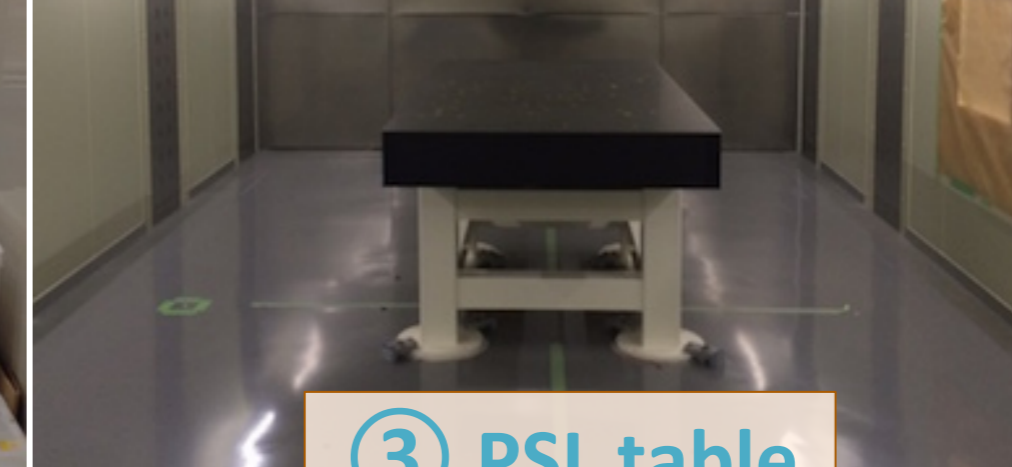
Clean room @center of the tunnel

- We can only use limited chemicals for cleaning.
- We cannot eat anything.
- Construction & installation continue.
- **Bad environment** (dust, humidity, water, etc...)

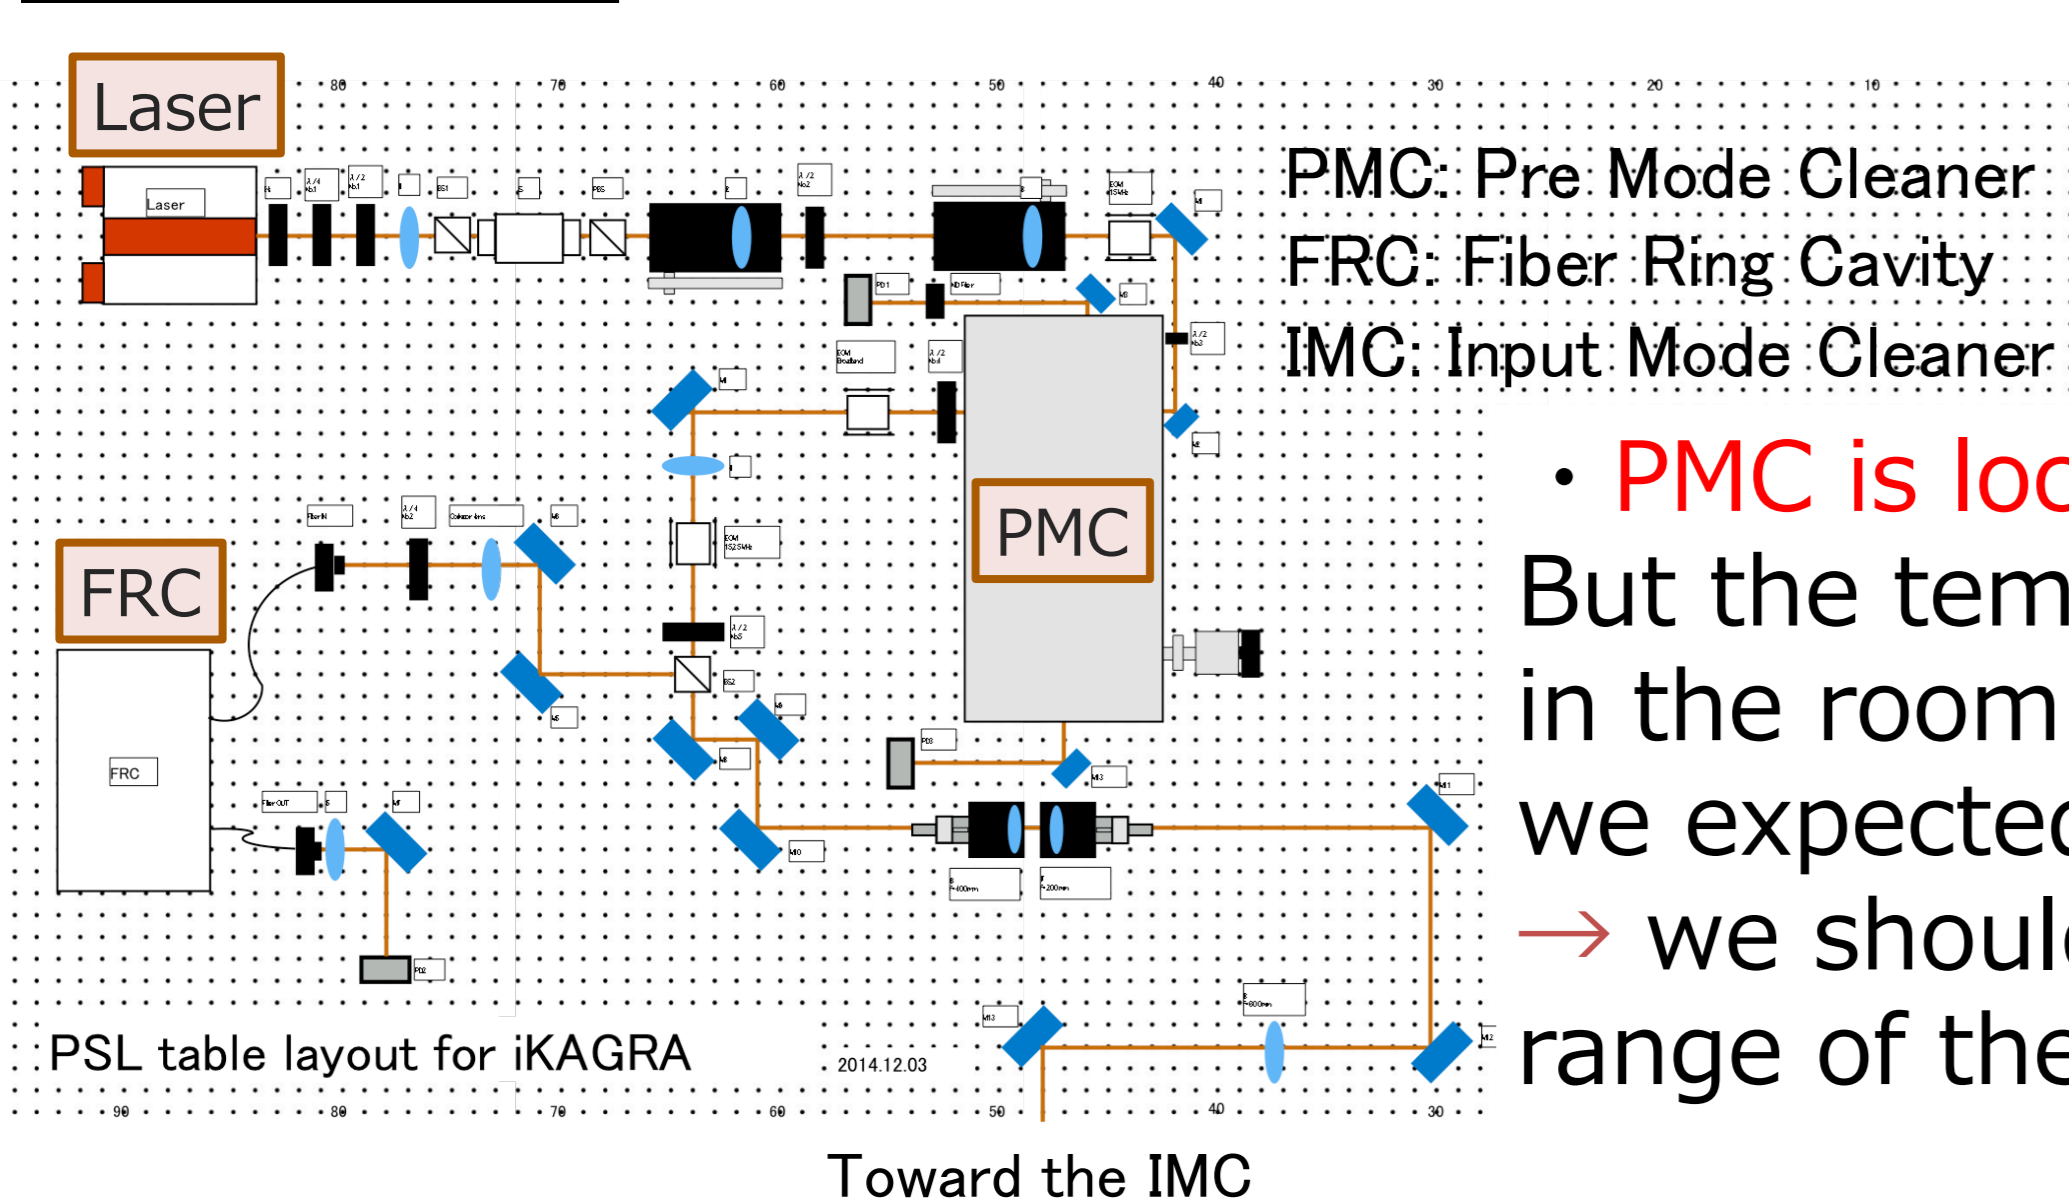
Built the PSL

- **PMC is locked 27 hours.** But the temperature stability in the room is not as good as we expected.
- we should increase the range of the control.

- Install the optics after the PMC (FRC, IMC).
- Improve the PMC range.

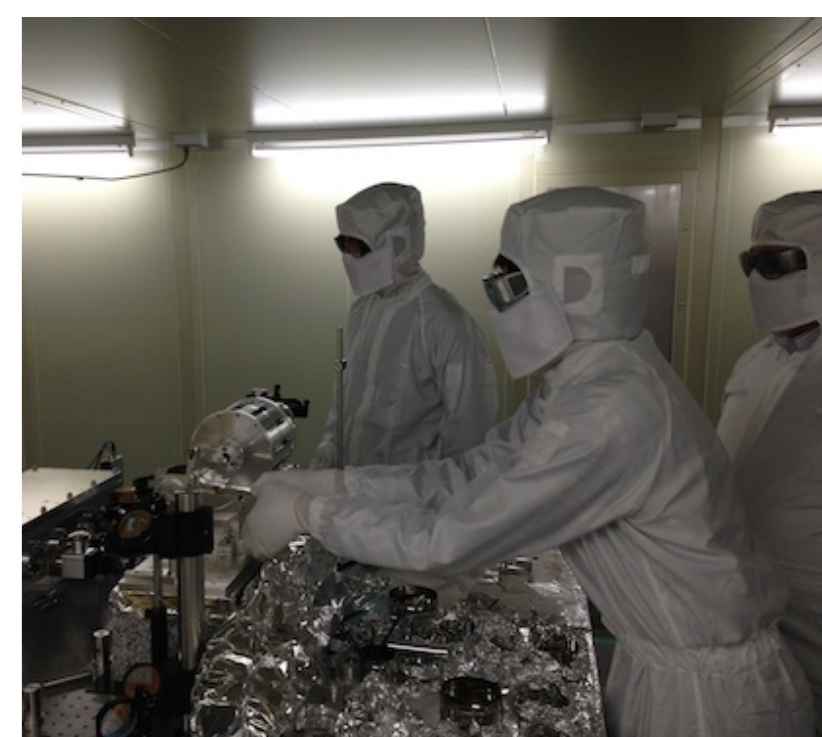
IFI (Input Faraday Isolator) assembly

We shipped some equipment from Tokyo Tech for the assembling. During the assembly, we dropped the CWP. We measured with the broken one.

The broken CWP may have invisible cracks. So we replaced the broken one by a new one. But we dropped it again. Fortunately the CWP was not broken. We should prepare the safety stop.

We achieved **Transmittance — 93 % (w/o DKDP)**
Isolation ratio — 41 dB

- Optimize the transmittance.
- Install it in the vacuum chamber.

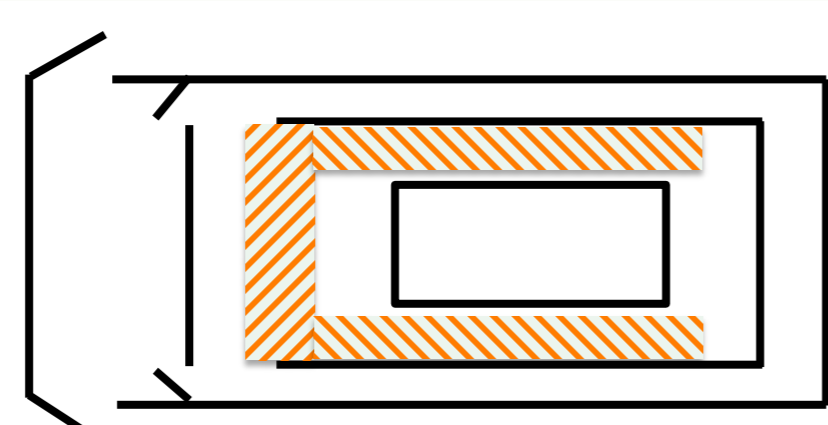
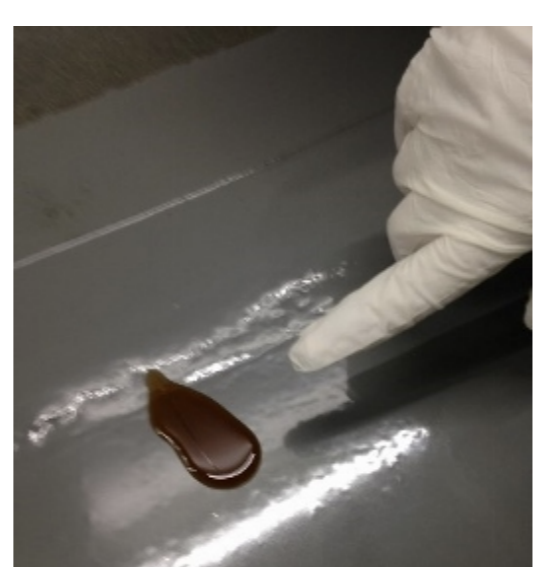
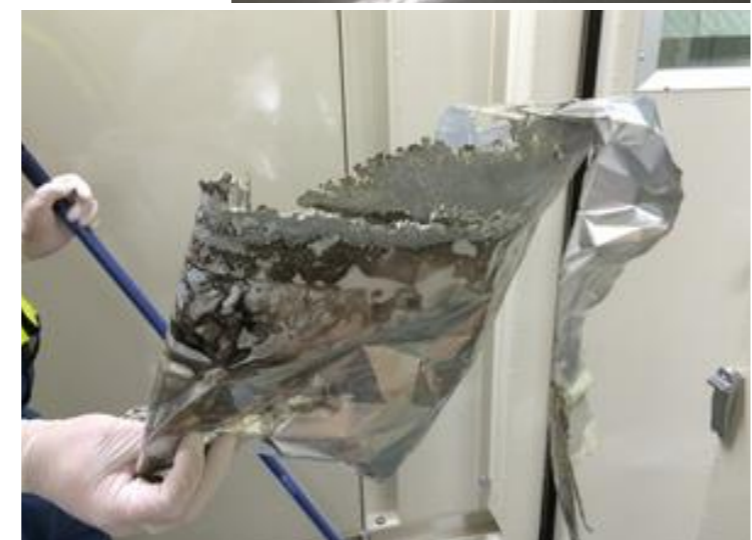
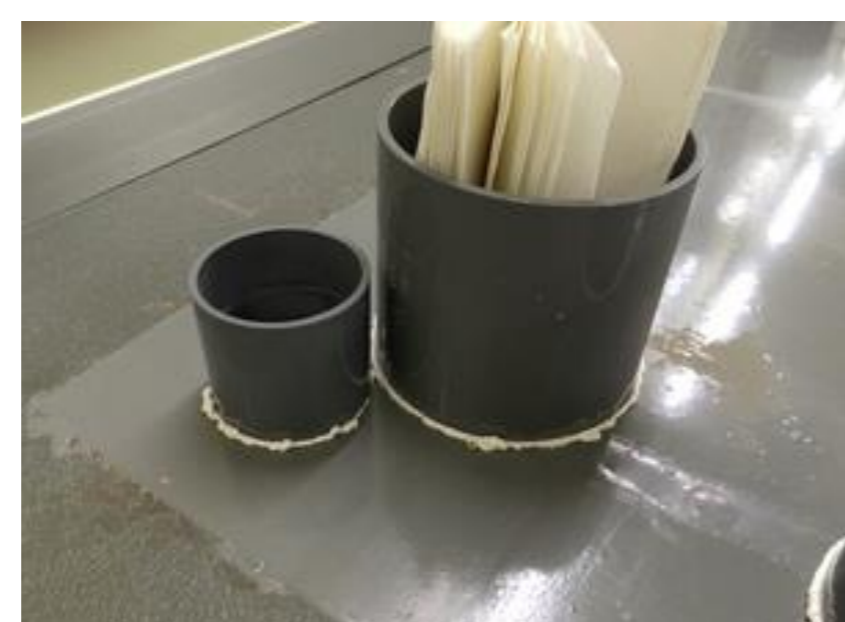
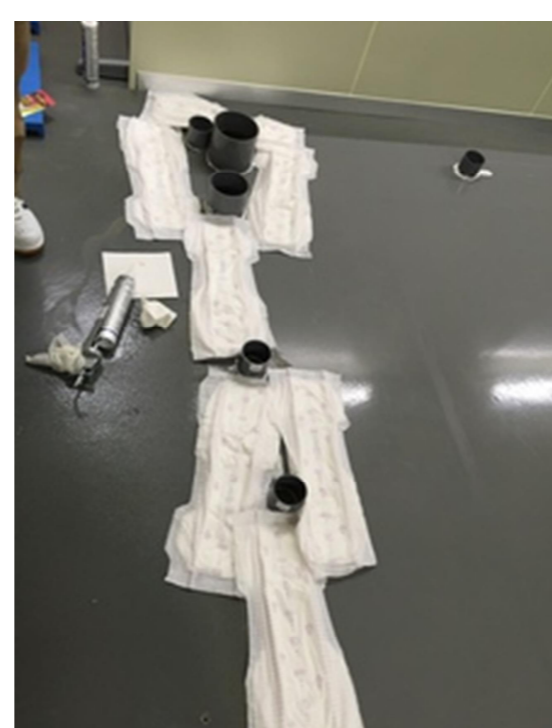
Water spring

Dirty water came out from the floor.

pH: 10, dissolved concrete

with plastic pipes & hygroscopic papers

Gradually the area of water spring is expanding.
