SFP Final Report

SURF: Stephen Trembath-Reichert
Mentors: Anamaria Effler, Valery Frolov
DCC: T1500285-v1

September 24, 2015

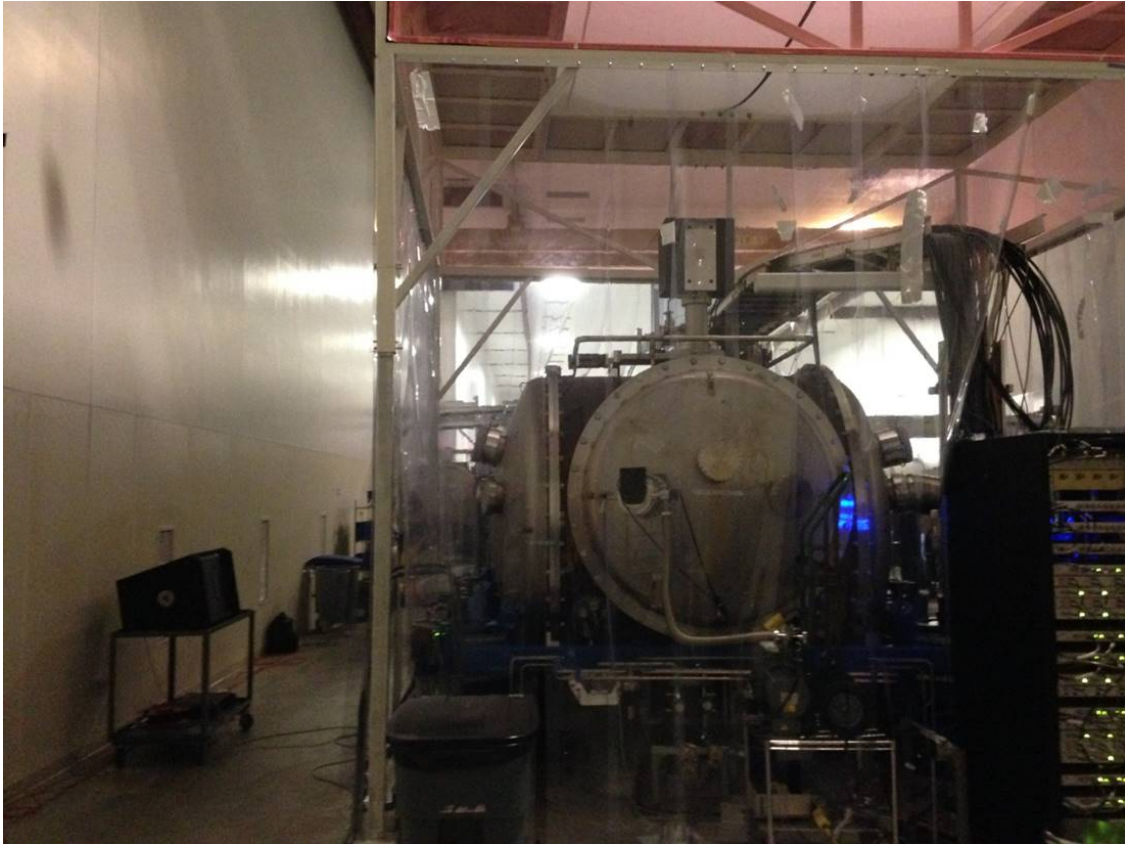
Figure 1: Image of the HAM6 Chamber and Its Surroundings

Previously, there have been many attempts at characterizing and modeling the scattering noise in the LLO detector [5, 6, 7, 8, 10]. We have, in the course of this program, focused specifically on the components in the HAM6 chamber as potential noise sources, although we did investigate some other parts of the interferometer. We spent the majority of our efforts looking at how acoustic/seismic noise directed at the HAM6 chamber couples with noise in DARM, with specific attention towards the ISI table in HAM6.

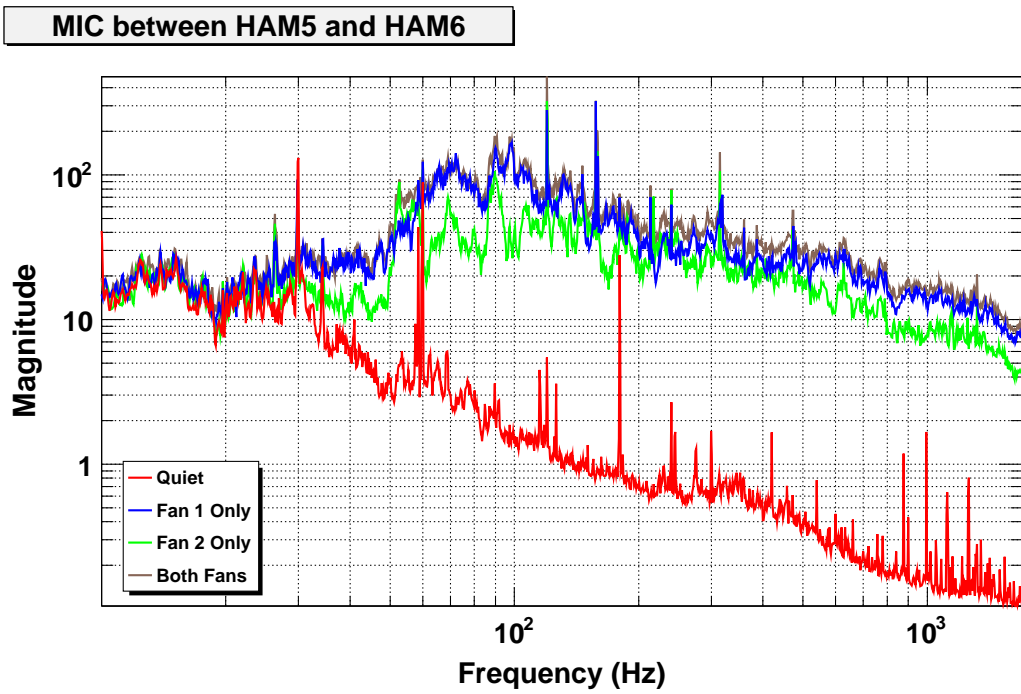
Figure 4: Clean Room Injection MIC Spectrum

We saw broadband noise on the accelerometers and the microphone at about 100x background over the range above 100Hz, but this petered out at lower frequencies and we noticed no noise below 20Hz (Figures 3 and 4). The ISI sensors showed a few specific excited regions, all at 10x background: 100-200Hz, 300-500Hz, and 800-1000Hz. Other than one very sharp peak at 25Hz, we observed no significant peaks in the lower frequencies (Figure 5). The DARM spectrum showed some broadband noise at about 2x background in the 30-170Hz region and showed three sharp peaks that may roughly correspond to the three excited regions in the ISI table spectra. There was a fairly weak peak (2x) at 130-140Hz, a stronger (10x) peak at 450Hz, and a region of a few 2-3x peaks in the 850-1000Hz region (Figure 6). Since the maximum noise injected by the clean room fan was roughly 80x background (Figure 4), noise levels of about 2x above background are just above the lower limit of acceptable levels, whereas peaks of 10x background strength certainly warrant more study. These noise levels were the main motivation for the following tests.

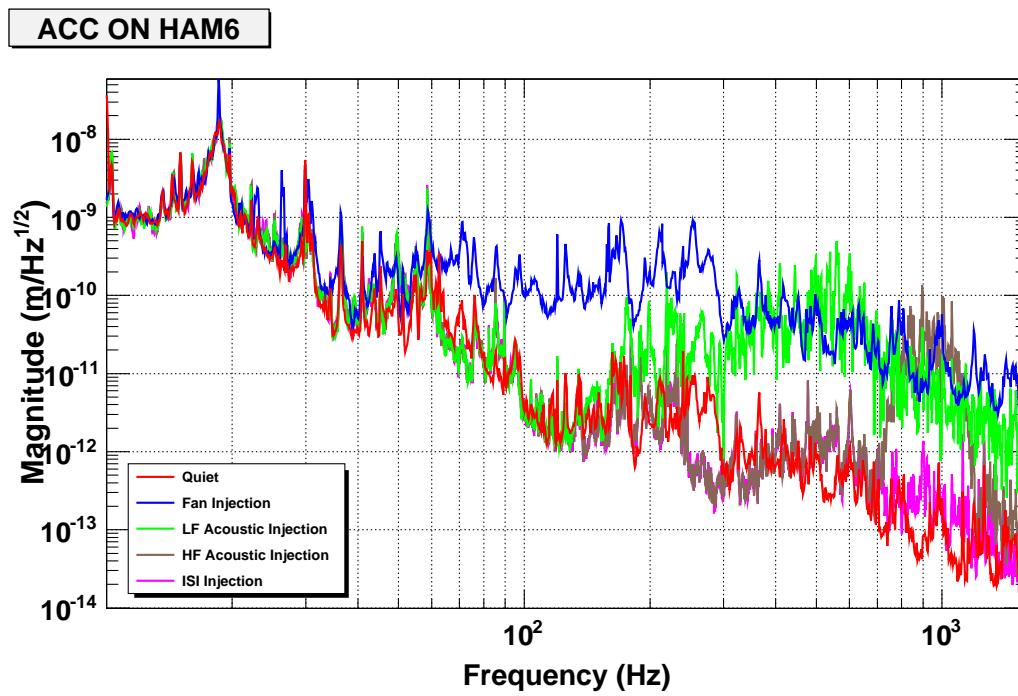
Figure 8: All injections summarized, as seen by the HAM6 Accelerometer (-X side)

The microphone and accelerometers showed the expected broadband noise in the 700-1200Hz range and nothing below that (Figures 8 and 9). The noise was roughly the same strength as the fan injections within

Figures 8, 9, 10, and 7 give a brief summary of the noise observed in all 4 tests in DARM, the microphone between HAM5 and HAM6, and the ISI table.

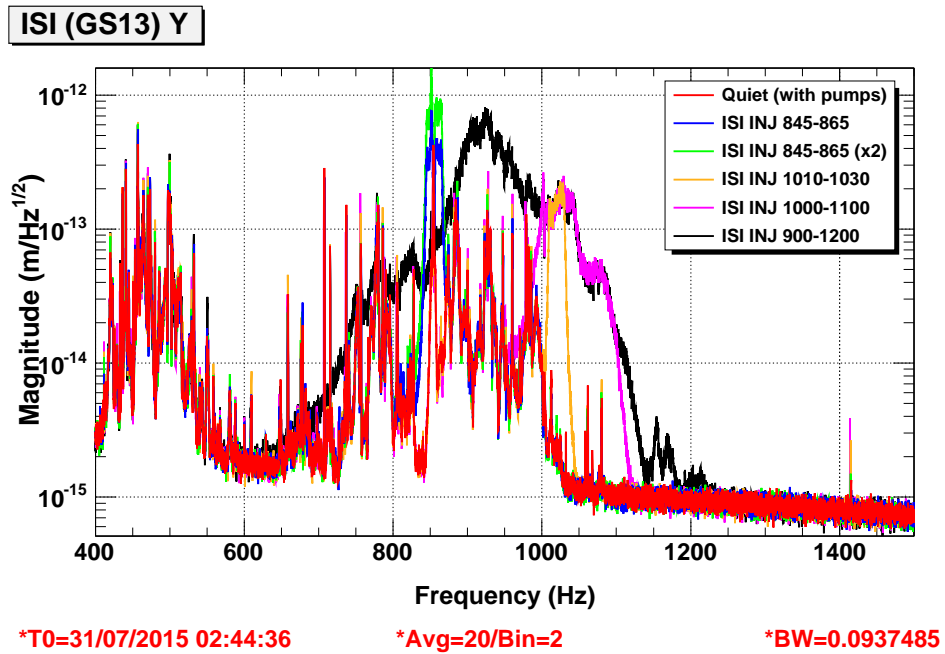
Figure 14: HAM6 ISI Table readout during various ISI injections

It was noticed during the 900-1200Hz injection (Fig 14) (which also created low frequency DARM noise (Fig 13)) that we observed corresponding noise in the output mode cleaner (OMC) length error noise readout (Fig 15).

Next, we injected over narrower bands that spanned the frequency range just above our previous ISI injections in an effort to isolate the specific peak or peaks responsible for the observed DARM noise (Figs 13-15). We injected over 1000-1100Hz and then an even narrower band between 1010 and 1030Hz and observed not only the aforementioned LF DARM noise, but also narrowing noise bands in the OMC length error readout. This further supported that the noise in the OMC length error readout was coming from the ISI injections. Then we briefly inspected the band just below our original ISI injection band with two injections over the relatively narrow band from 845 to 865Hz. This time we noticed LF DARM noise only around 150Hz due to this injection, and we saw noise over the injection interval in the OMC length error signal.

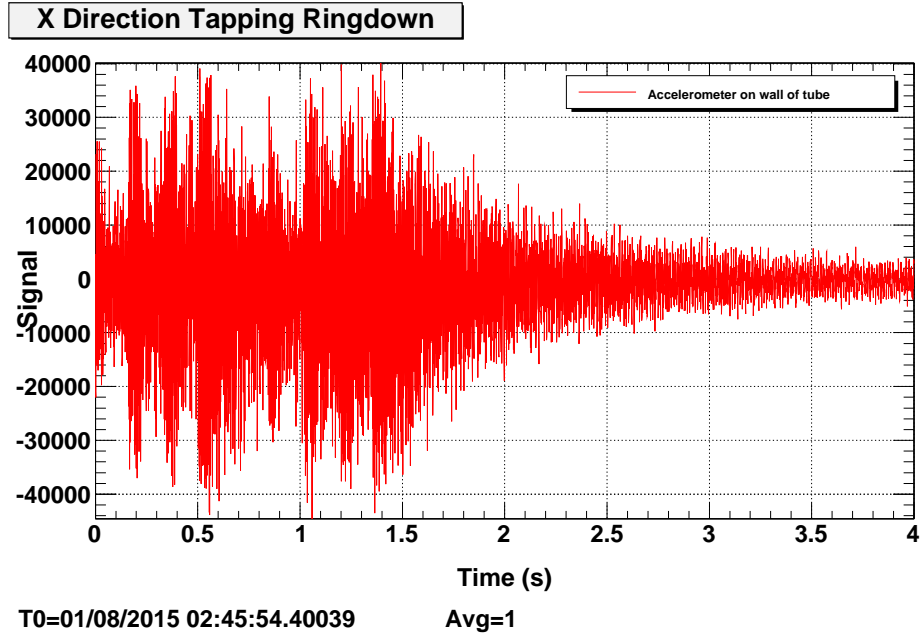
Figure 25: Time series of an example ringdown

In order to determine this factor, we chose to look at the time constant of the tube’s ringdown after being excited. In this case, our excitations came from gentle tapping on the tube, both in the +X and -Y directions, in order to see if there were different resonances for the different directions. [PSD for long. and trans. taps]

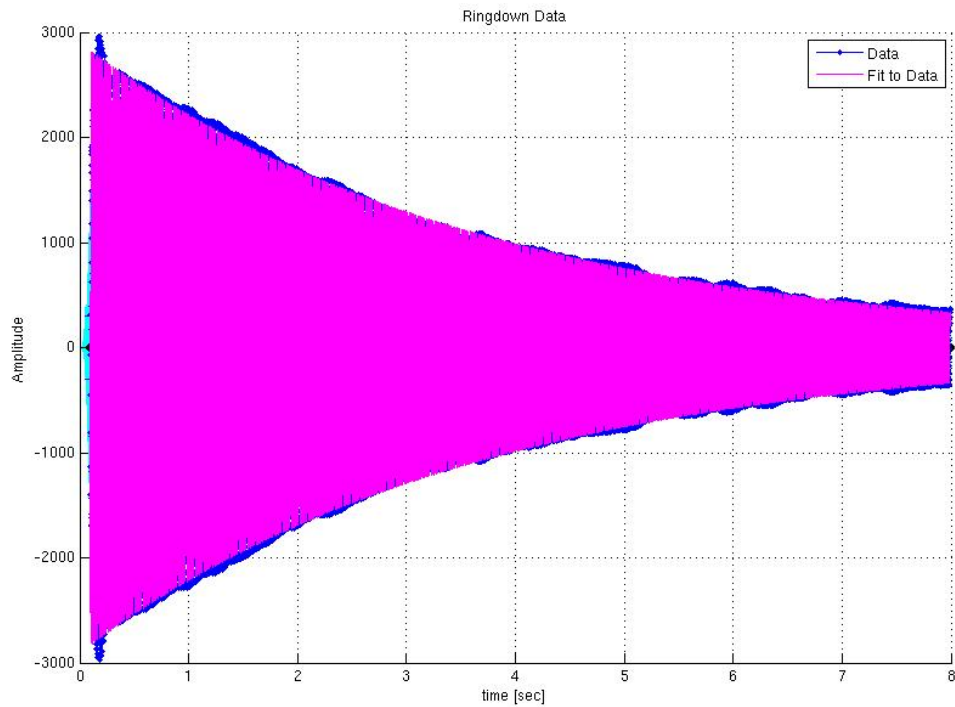
Figure 26: Ringdown data after bandpass filtering and model fit on top

Before analyzing the recorded ringdown function, we used a simple butterworth bandpass filter to isolate the tube’s main resonance at 77.2Hz. We found the Q s of several recorded ringdowns using a special MatLab function created by M. A. Hopcroft specially for finding the Q of a ringdown series [4]. Using these tools, we observed high Q s of roughly 1000, which were consistent between different ringdowns within an interval of ± 30 . This very high Q suggests that this portion of the tube is very susceptible to being rung up by environmental vibrations.

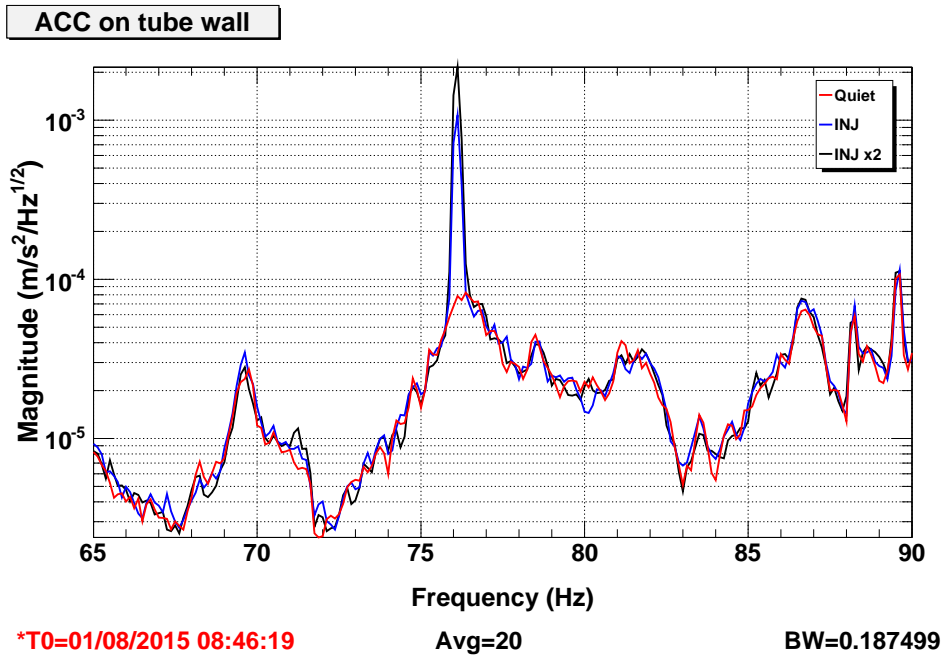
Figure 29: Accelerometer on the tube during 77Hz tube injection

In response to these findings regarding the susceptibility of this section of the vacuum tube, we injected a line at 77Hz at about 400x and 200x background to try to observe any DARM response (Figs 28 and 29). We observed a broad, two-peaked response about 20x above background in DARM around the 77Hz resonance we observed previously (Fig 27). Assuming a linear system, this tube section’s contribution to DARM

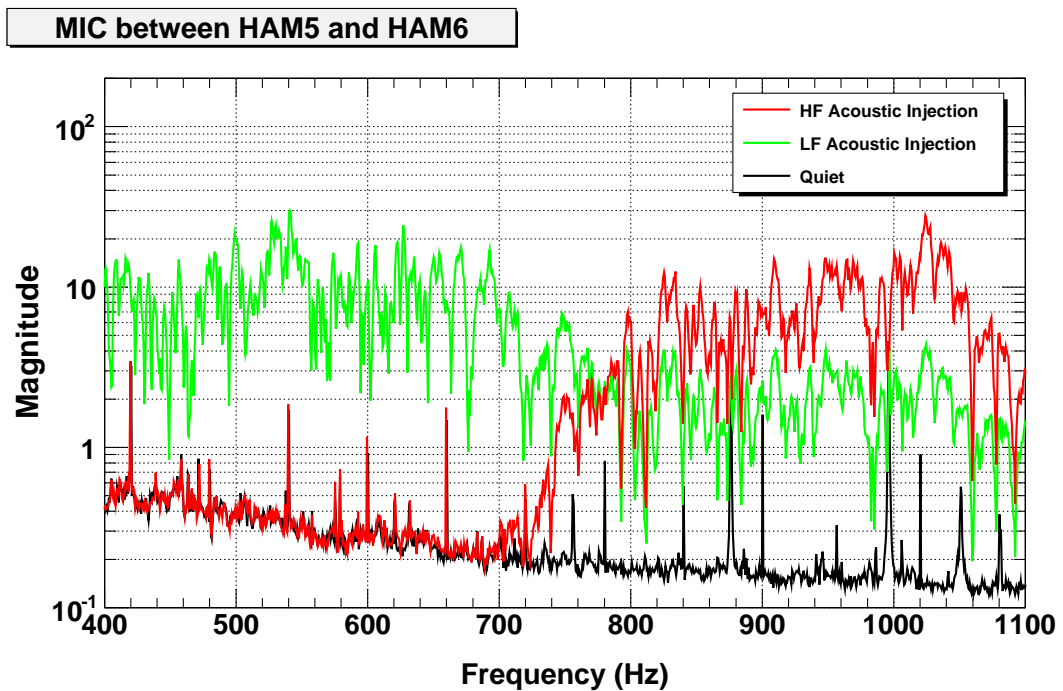
Figure 31: A closer look at the microphone signal observed during the various acoustic injections

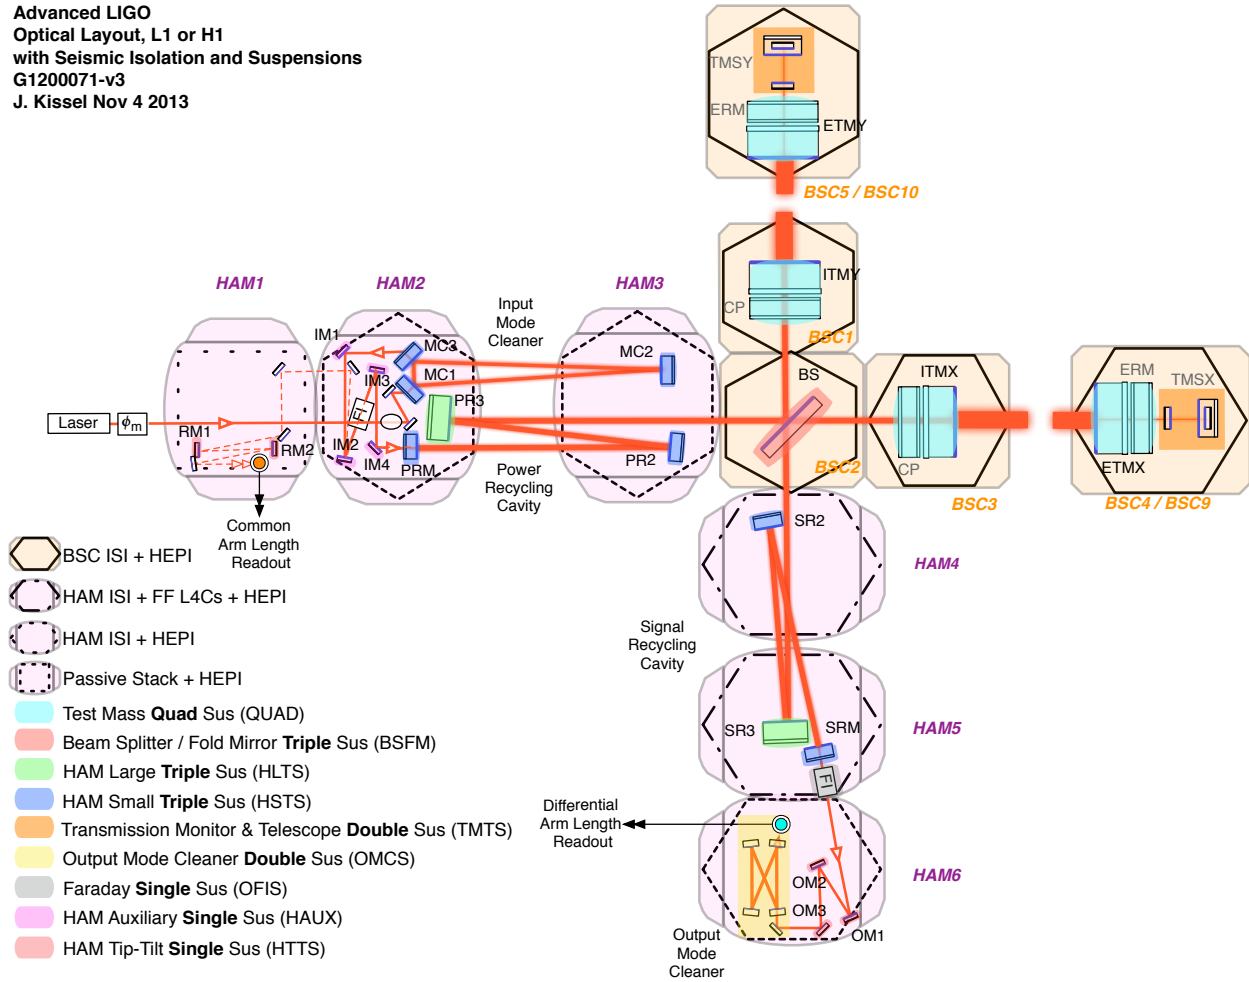
Figure 34: Diagram of the LLO facility

Advanced LIGO
 Optical Layout, L1 or H1
 with Seismic Isolation and Suspensions
 G1200071-v3
 J. Kissel Nov 4 2013

¹defined by the interferometer axes shown in fig 34
