Vacuum Problems

LIGO-G1500936

LIGO Management Advance @ Caltech

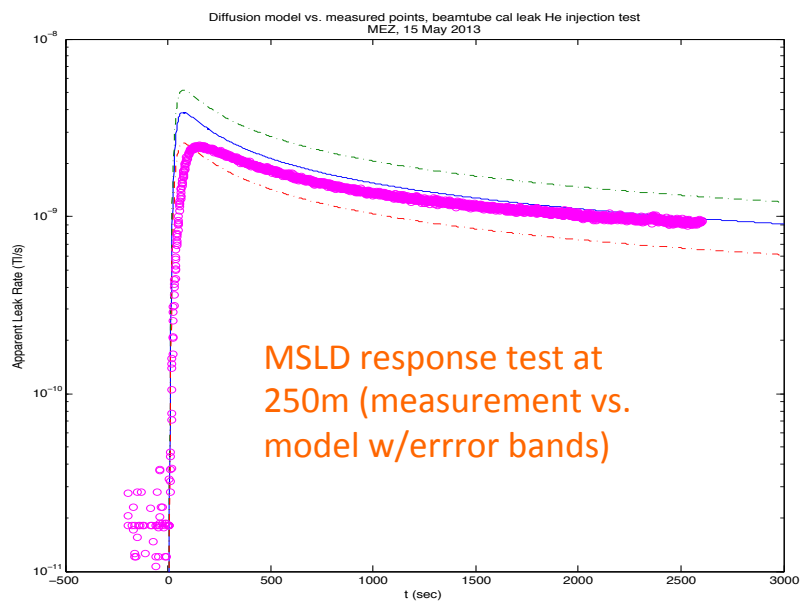
Figure 2: Leak detector response to 30 second calibrated injection of helium test gas at $z = 250$ meters (pink circles). Also plotted is predicted response from diffusion model (solid blue) and approximate standard error margins (dash-dot red and green).

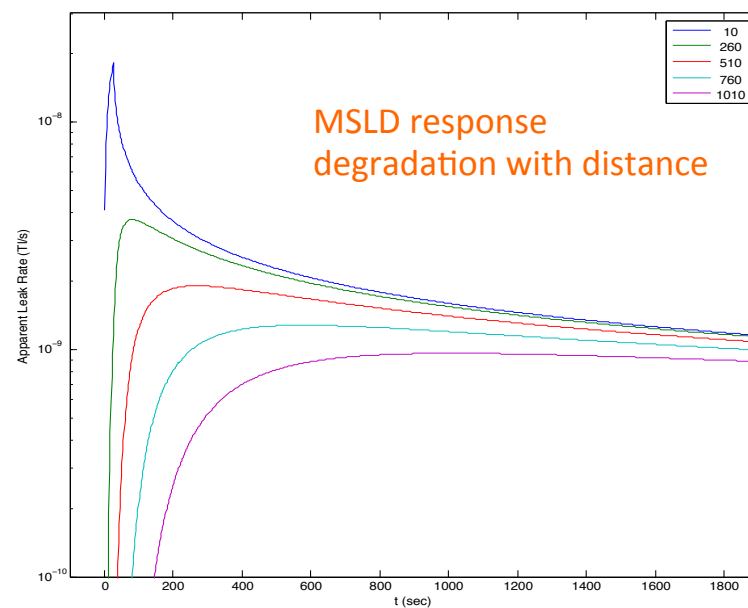
Figure 1: Model leak detector response for He test injections as described in text, assuming different injection positions z ranging from 10m (blue) to 1.01 km (purple). The actual test (Fig. 2) was performed at $z = 250$ m (green).

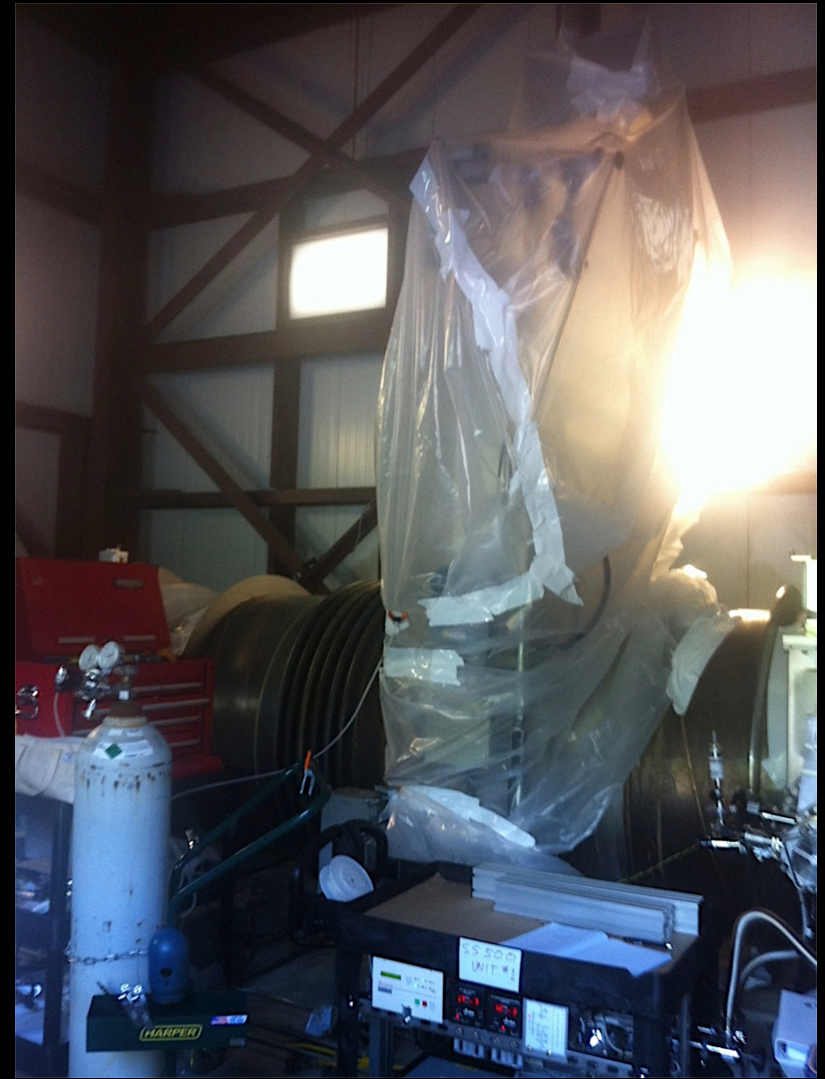
He Response: “Direct leak” vs. GV7

He MSLD responses measured adjacent to GV7 (green) and 550m north (blue). For comparison, corresponding responses are also plotted (cyan and red, respectively) for a direct 60-second timed He injection of $1.8\text{e-}7$ TI/s near the valve location. In all cases $t=0$ corresponds to the start of He flow. The delayed GV7 response is unequivocal, but also inconsistent with a simple leak.

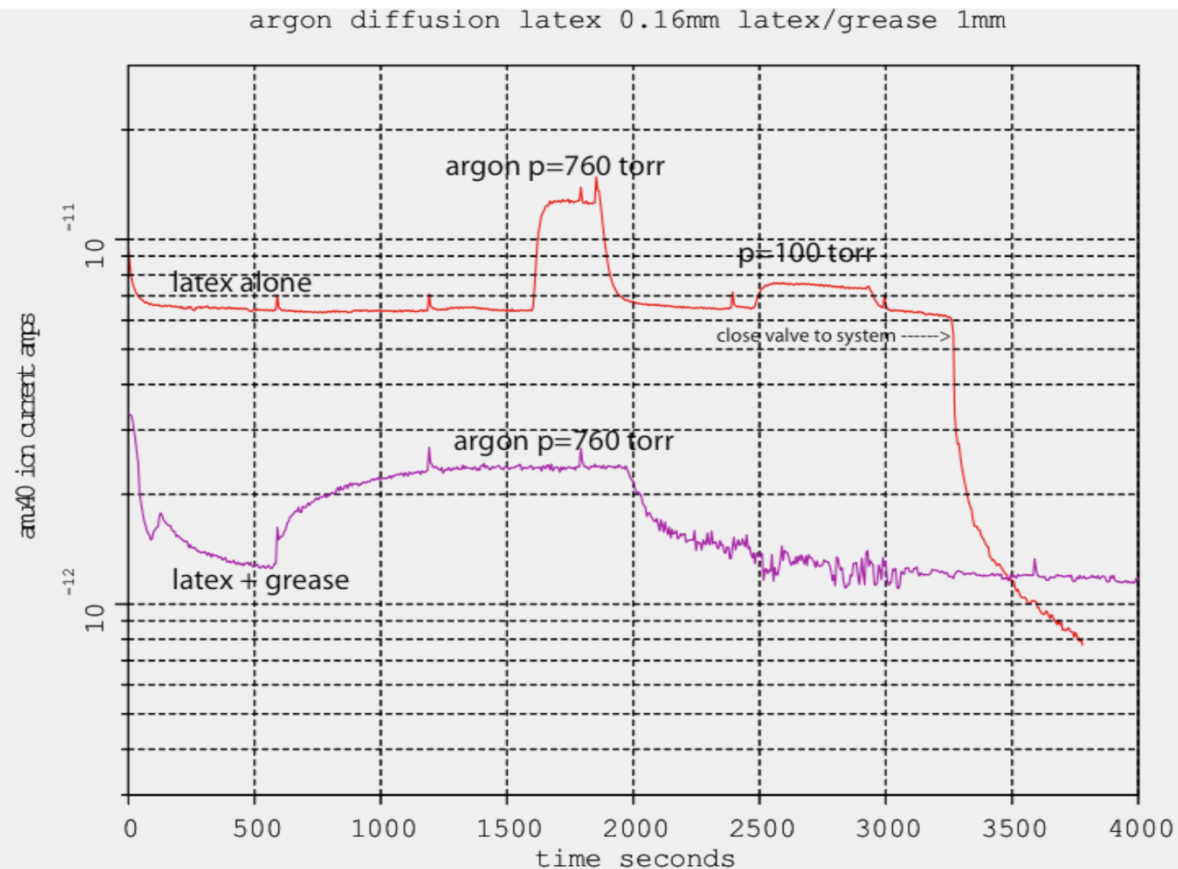
Test of Ar diffusion through a sample of valve mechanism lubricant

Figure 3 The permeation by Argon through the 0.16mm latex at pressures of 760 and 100 torr in red and the permeation of Argon with an additional 1mm layer of grease in violet. The curve for the latex alone has an argon background due to the chamber V2 which is removed by closing the valve between V1 and V2 at 3200 seconds. The combined latex and grease has a flow of 1.4×10^{-5} torr liters/sec with 760 torr of Argon on the grease. Again, using a surface area of 5 cm^2 , the permeation constant is $5.3 \times 10^{-10} \text{ cc@stp/sec cm torr}$. The diffusion time constant for argon in the grease is 600 seconds leading to a diffusion constant for Argon of $8.3 \times 10^{-6} \text{ cm}^2/\text{sec}$.

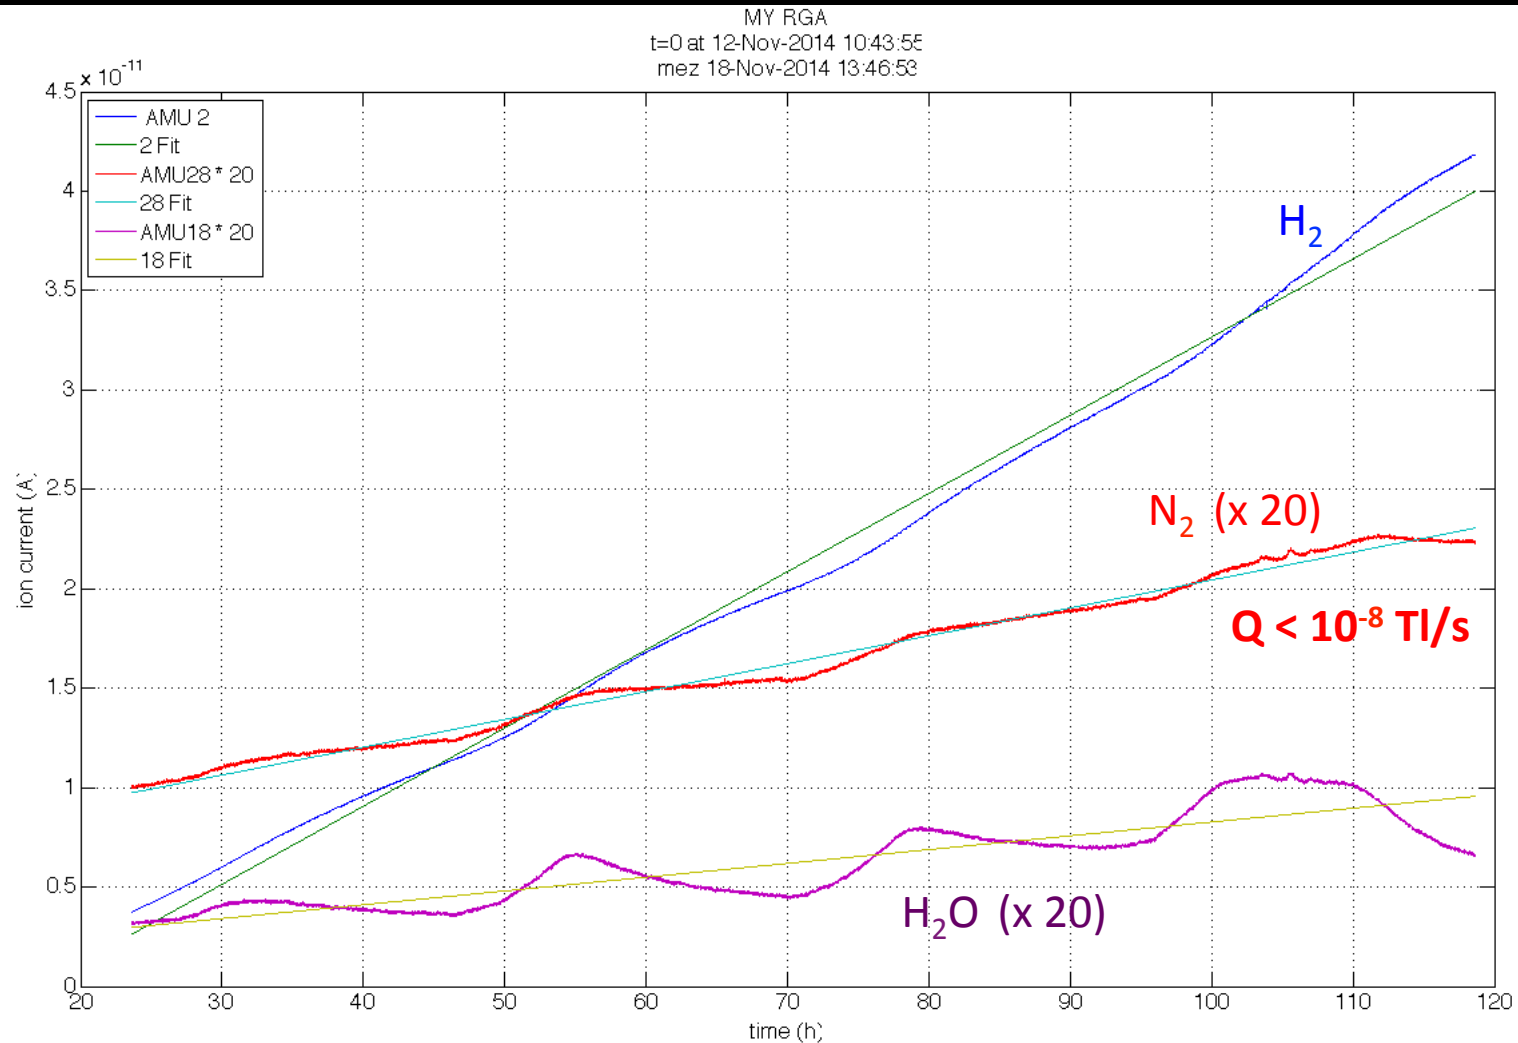
LLO Y ARM ACCUMULATION (AFTER GV7 CONTAINMENT)

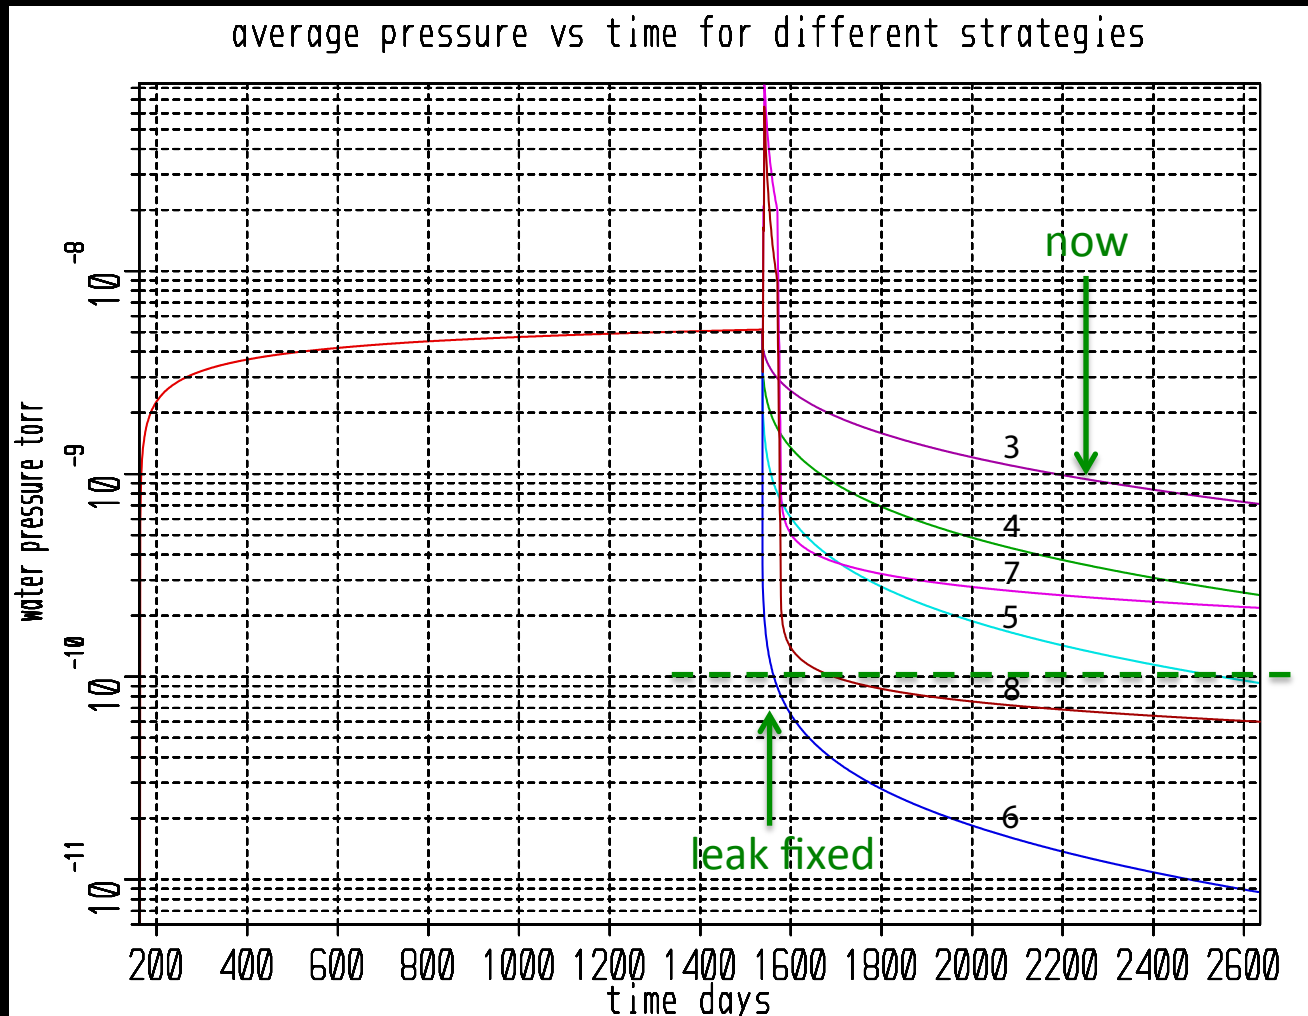
Modeled desorption of water adsorbed from atmospheric leakage (assuming constant T)

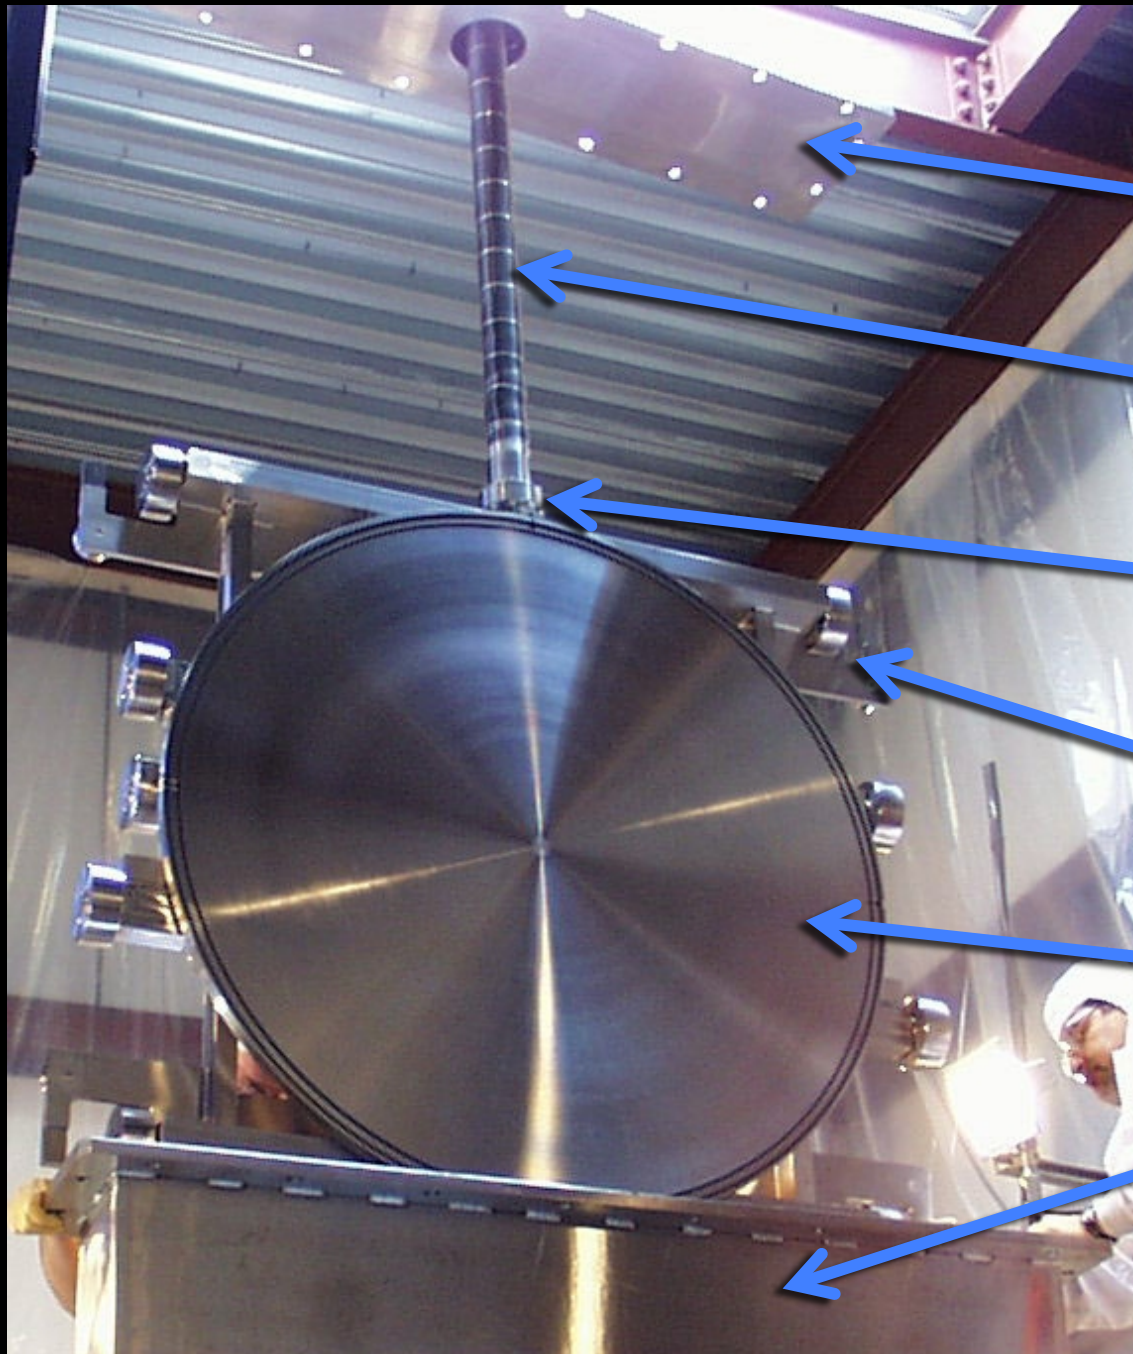
GNB Valve Anatomy

bonnet plate

bellows

ballscrew socket & flange

carriage

gate (this side to beamtube)

trunk
