LIGO- E1600086-v1

Material Qualification RGA Test Results:
High Quantum Efficiency InGaAs Photodiode

Bob Taylor, Dennis Coyne

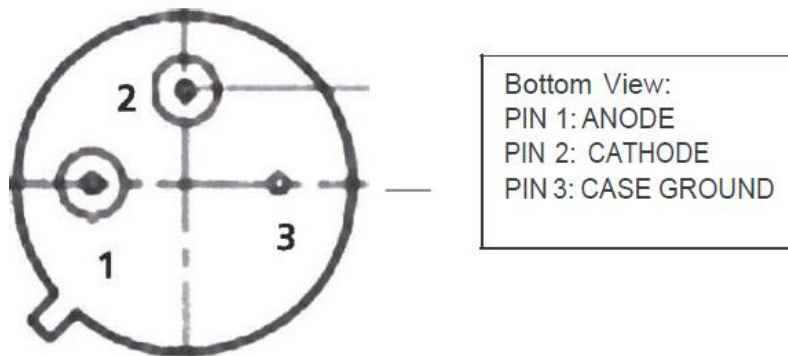
Figure 1: Pin connections (IGHQEX3000)

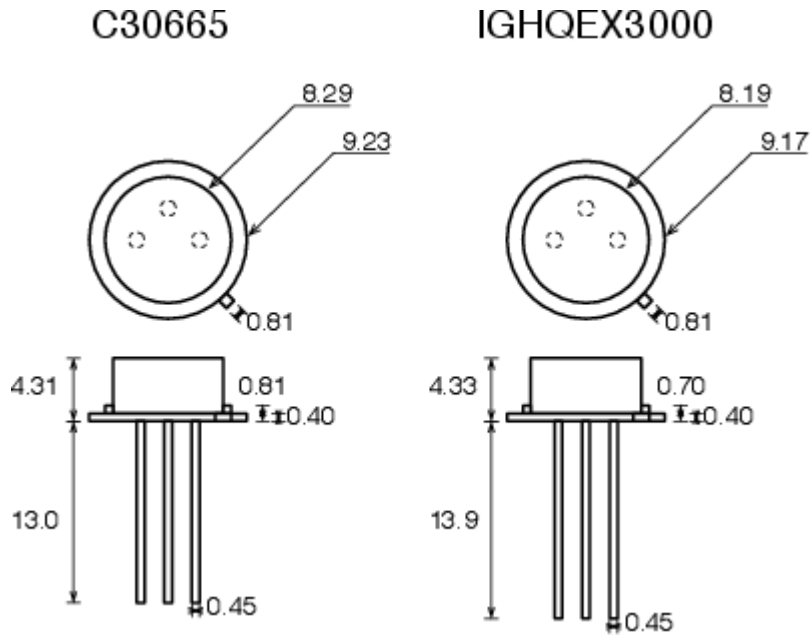
Figure 2: Package dimensions (in mm).

The package dimensions¹ are similar to the photodiode currently used in aLIGO (Perkin Elmer/Excelitas C30665), as indicated in Figure 2. The PDs came in a “reduced dust” case (Figure 3). The bottom of the case has a spongy (presumably conductive) material.

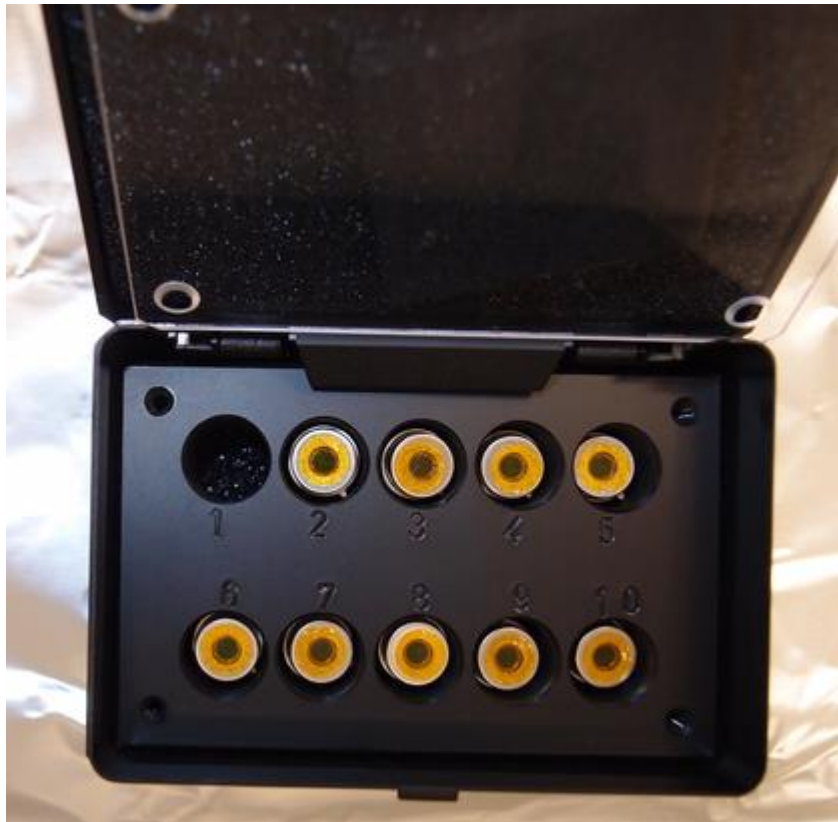
Figure 3: As-received packaging container.

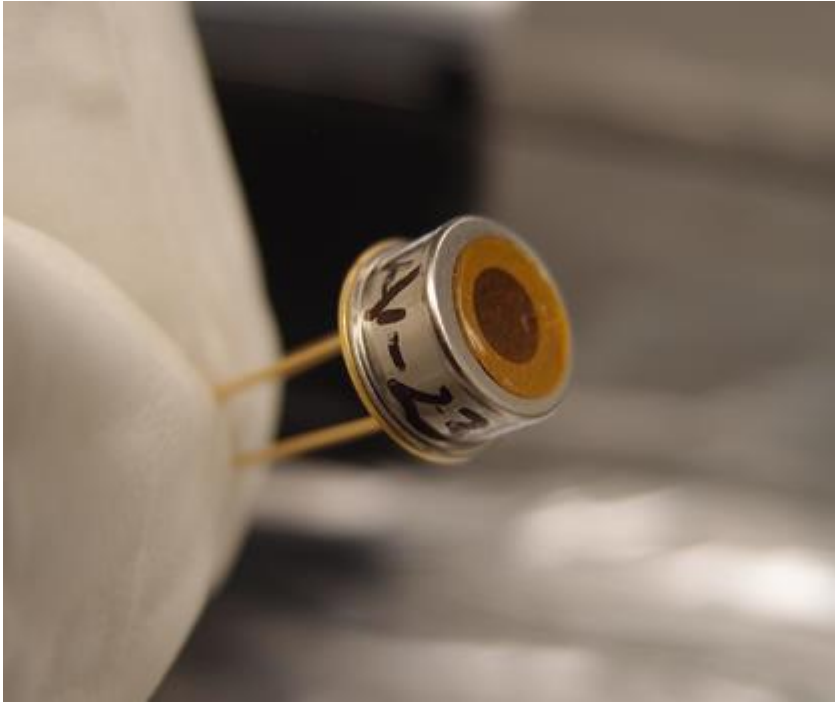
Figure 4: IGHQEX3000 InGaAs Photodiode (as-received with removable adhesive cap and serial number marking on the side)

The diodes have no window. Each came with an adhesive seal over the opening (no window) and serial numbering in marker on the side. (Figure 4 and Figure 5).

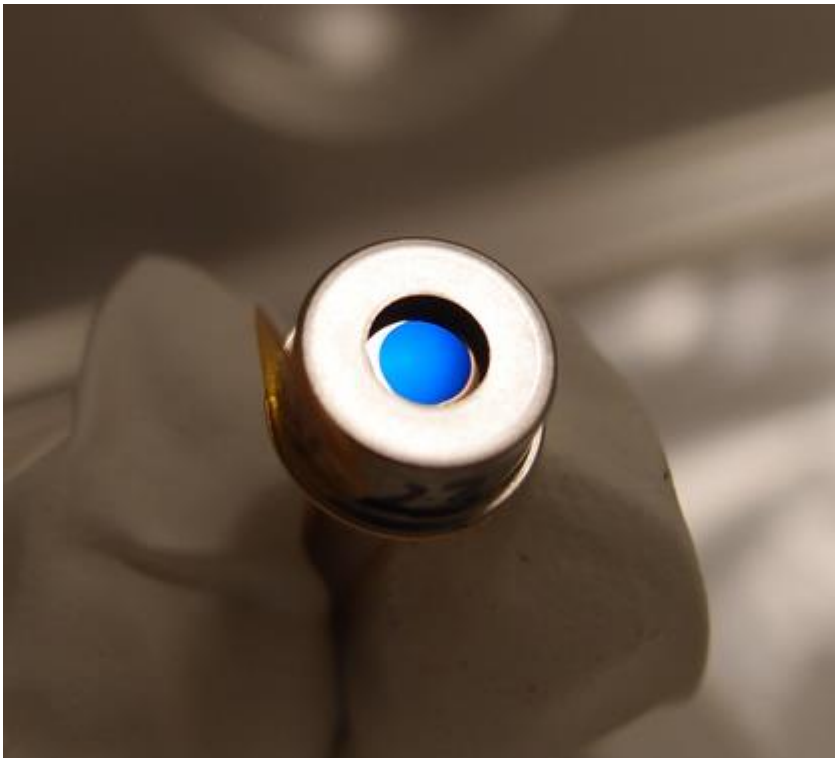
Figure 5: IGHQEX3000 InGaAs Photodiode with seal removed

The seals were removed and the area where an adhesive residue might have been left was wiped with isopropyl alcohol. The seals were replaced with FirstContact.

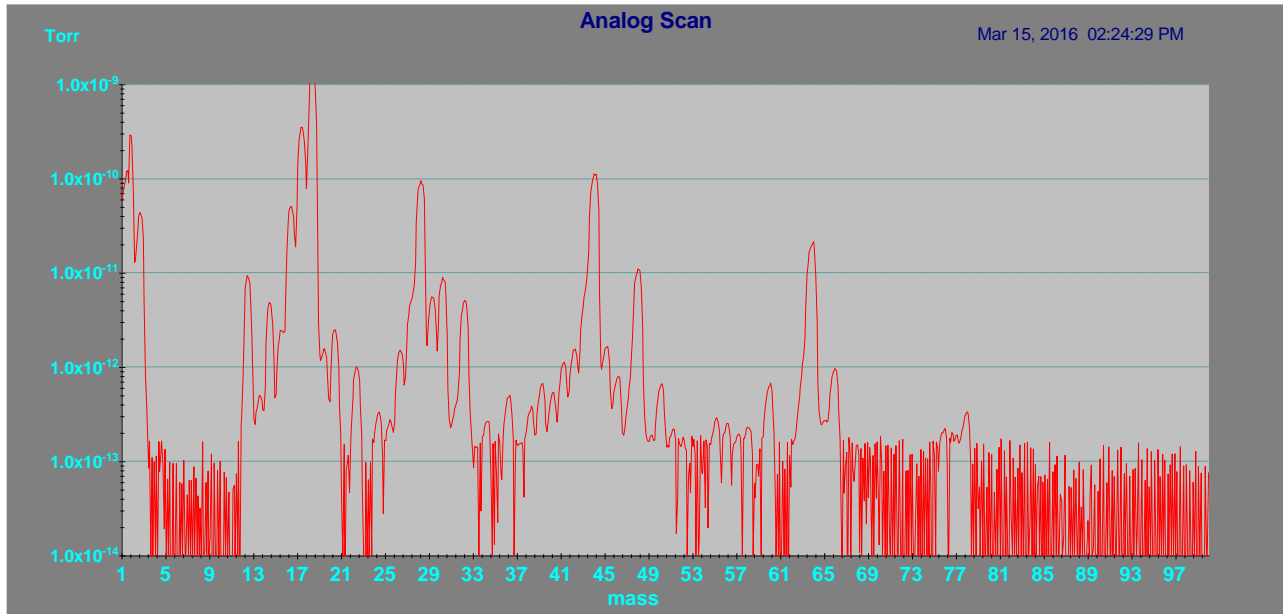
The RGA scan of the two “wet” photodiodes after pumping down to vacuum () shows a fair amount of hydrocarbon outgassing. Although a scan with a calibrated leak was not taken at this

time, if one uses the post-bake, calibrated leak scan the apparent hydrocarbon outgassing is WHAT Note in particular a very high peak at AMU 64.

Figure 6: Pre-bake RGA Scan

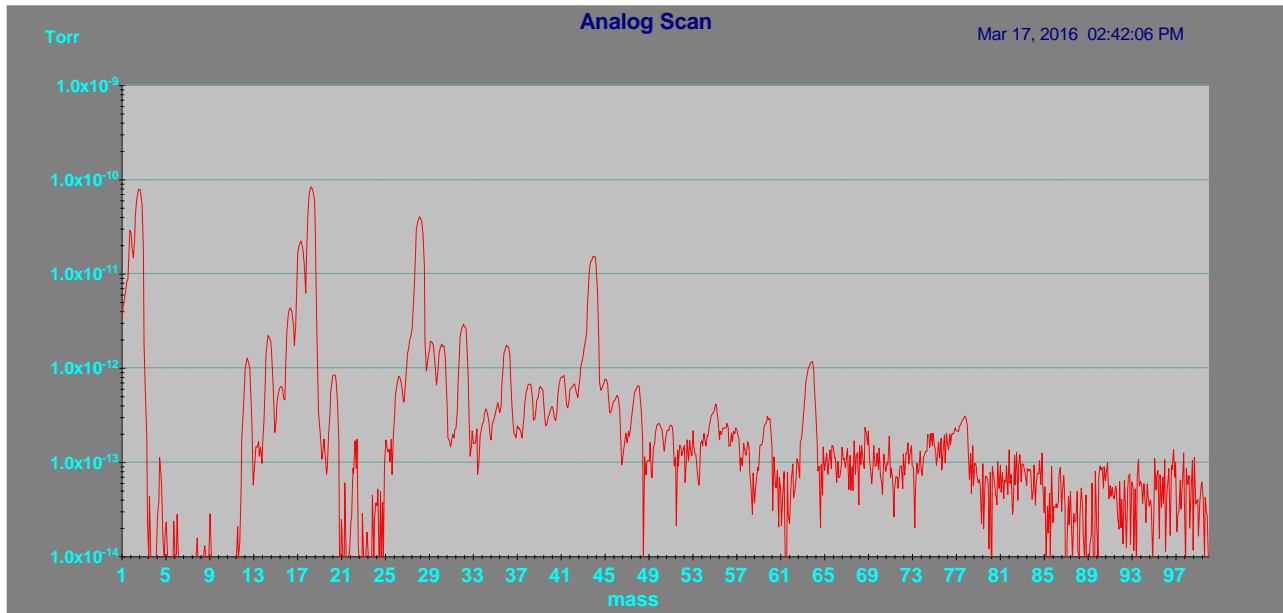
The post bake (40C, 48 hours) RGA scan at 40C shows some hydrocarbon signature/components in the spectrum (including a prominent peak at AMU 64).

Figure 7: Post-bake (40C, 48 hours) RGA Scan taken at 40C

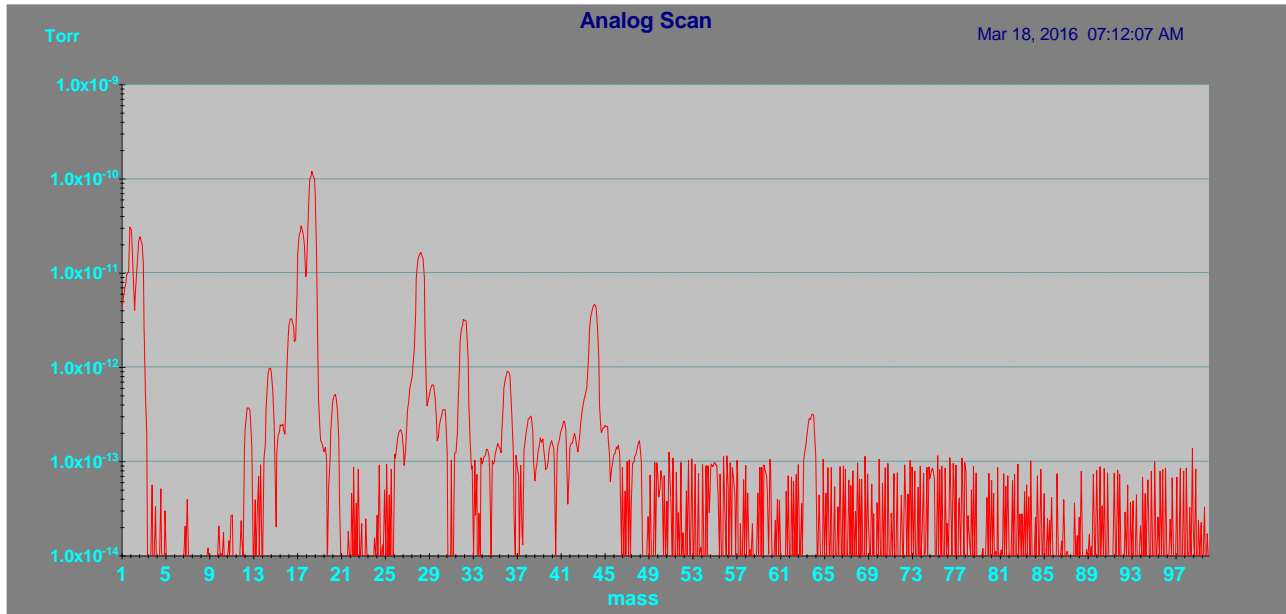
The post bake (40C, 48 hours) RGA scan at room temperature shows a clean spectrum except for a peak at AMU 64 above the background. The apparent hydrocarbon outgassing is $2.7\text{E-}11$ torr-L/s based on the standard five hydrocarbon flag AMUs (or $3.8\text{E-}11$ torr-L/s including AMU 64). This is pretty clean, considering only a 40C bake. It is higher than the desired $\sim 2\text{e-}12$ torr-L/s level for a

small oven load (limited by mass spectrometer noise floor), but much less than the maximum acceptable level of $\sim 4 \times 10^{-10}$ torr-L/s for a large oven load (per [E080177](#)).

Figure 8: Post-bake (40C, 48 hours) RGA Scan taken at room temperature

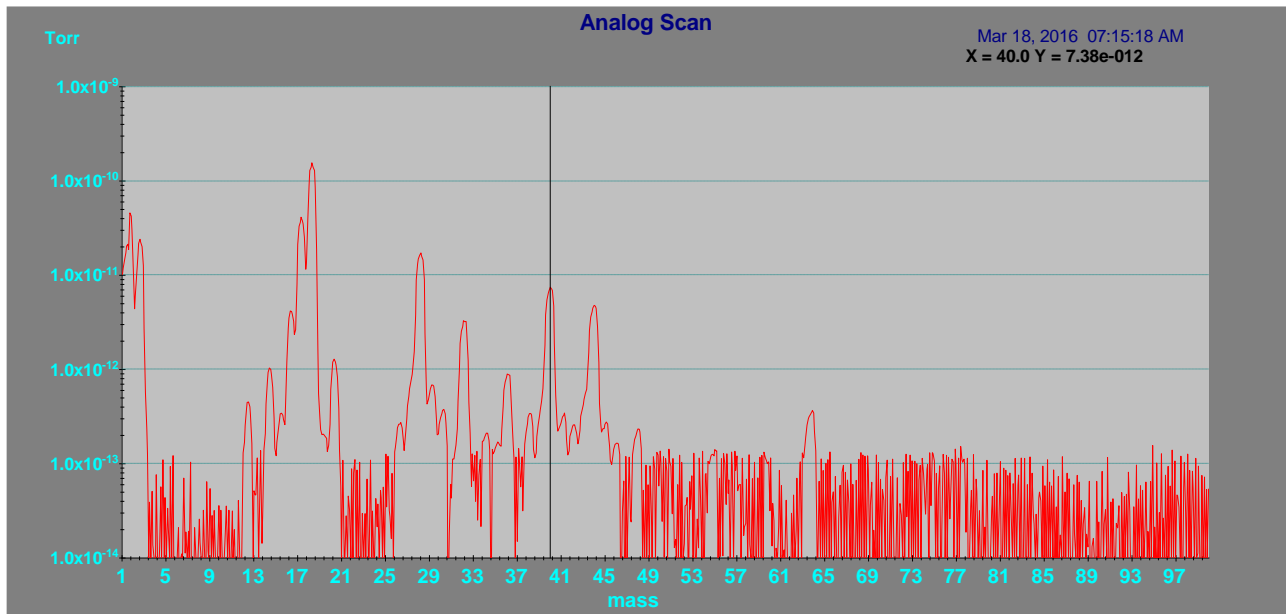
Figure 9: Post-bake (40C, 48 hours) RGA Scan taken at room temperature with a Calibrated leak Open (2.36×10^{-10} torr-L/s Argon)

Pressure Contribution from Flag Hydrocarbons			
40M Lab RGA Scan Results			
		Description:	High Quantum Efficiency Photodiodes
		Oven Used:	D Date: 3/15/2016
AMU 41	2.12E-13	amps	from RGA scan listing
AMU 43	4.11E-13	amps	from RGA scan listing
AMU 53	1.53E-14	amps	from RGA scan listing
AMU 55	9.72E-14	amps	from RGA scan listing
AMU 57	1.02E-13	amps	from RGA scan listing
AMU 63.9	3.17E-13	amps	from RGA scan listing
Sum Flag H/C AMUs	1.15E-12	amps	
Calib leak rate	2.36E-10	torr l/s (Argon)	
AMU 40 (w/leak open)	7.38E-12	amps	
AMU 40 (background)	1.50E-13	amps	
Calib leak contributes	7.23E-12	amps	= (w/leak open) - (background)
Flag H/C Outgassing	3.77E-11	torr l/s	= (Sum Flag H/C AMUs) x (Calib leak rate)/(Calib leak contrib.)
