Radio Frequency Noise in IFO Sensing and Control System

Abstract

Radio Frequency (RF) signals are used in the sensing and control subsystem of the interferometer to lock the output port to a dark fringe. This is necessary to maintain the sensitivity of the instrument. RF noise in this subsystem can cause the interferometer to lose lock or cause incorrect readings such as whistles in the differential arm length signal (DARM) as read at the output port. It was previously discovered that a significant contributor to RF noise in the sensing and control system were the ground isolation transforms known as baluns, making a redesign of the component necessary. A corrected design is proposed and prototyped and the resulting attenuation of RF noise is measured.

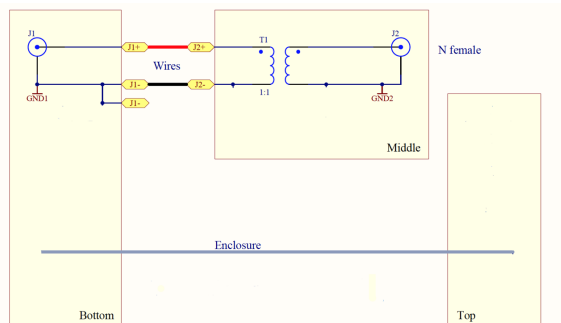
Figure 3: Effective Balun Design

Previous investigation found that nearly all installed baluns were missing the capacitors designed to prevent the balun enclosure from floating with respect to ground. Additionally the wires inside the balun on which the signal is carried were separate stranded wires instead of coaxial wire. This is not optimal for RF because the inconsistent impedance of such a configuration can cause reflections and radiation. Finally, each end of the enclosure was made from circuit board material which does little to shield the circuit from outside radiation or prevent it from radiating.

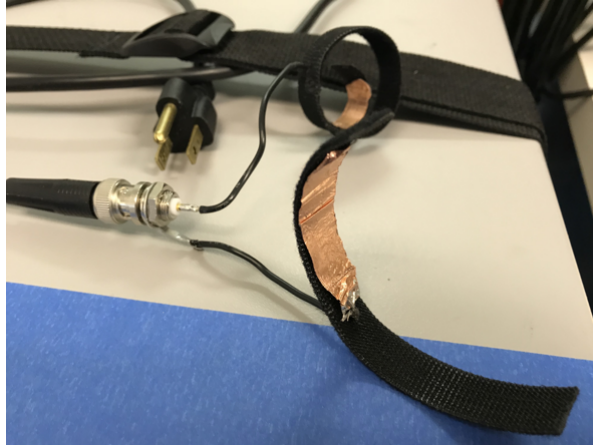
A custom test lead was built to probe the baluns without removing them from the system. The devices used two wrap around leads to measure the potential difference between the two isolated grounds as read at the back shell of the two coaxial connectors of the balun. With a spectrum analyzer and this test lead it was possible to measure the spectrum of the noise radiating into or

out of the line. In principle the back shells of both connectors should be capacitively coupled such that all steady state DC is blocked and any RF signals are shorted to ground. This means any RF signal measured across the back shells of the balun is being radiated into or out of the enclosed line and is not adequately being shorted to ground.

Figure 4: Test lead

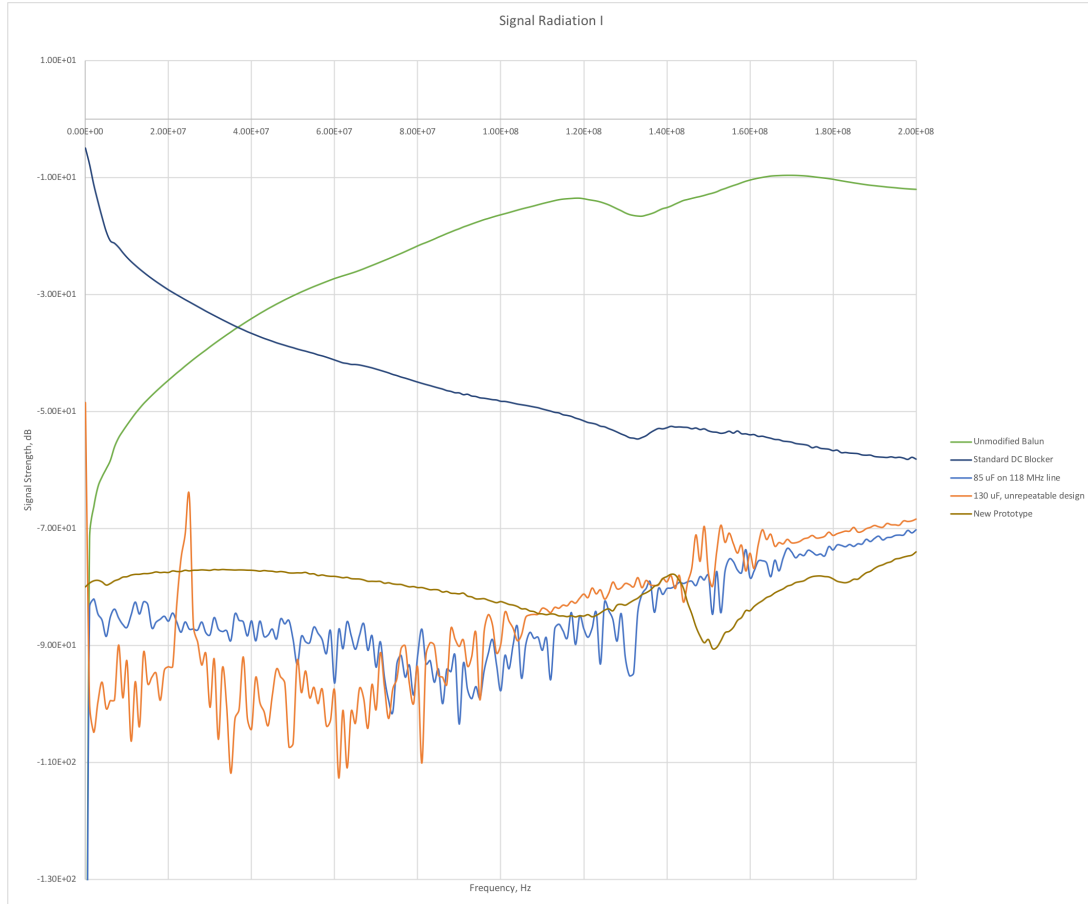
A test bench investigation of the devices was conducted using the same measurement device. The balun is connected to the output of a network analyzer, the opposite end is terminated (50Ω), and the test lead is connected to the back shell of both sides of the balun. The response spectrum of the balun was measured and compared to multiple prototypes of replacement balun. See Figure 5.

A copper plate was added to each test balun to ensure the back shell of one connector was connected to body of the balun. The circuit board on the opposite end was fitted with surface mount capacitors to ensure capacitive coupling of the grounds. To verify the efficacy of our measurement technique, measurements of a 9 Mhz line and a neighboring 118 Mhz line were taken before and after replacing the 118 MHz balun with a modified balun. These measurements were compared to and agreed with the spectrum measured on an antenna placed next to the electronics rack.

Figure 5: Balun Attenuation, Test Bench

Baluns of various capacitance were tested. While some variation was measured as capacitance changed, a greater variation was observed when the configuration of the inner conductor was changed. This suggests the inductance of the wires inside the balun are primarily responsible for radiation. This inductance is determined by the geometry of the conductors (size, shape, and placement).

The greatest noise attenuation was achieved in the 130 μF balun by replacing a stranded conductor ground wire with copper braiding, however attempts to replicate this configuration were unsuccessful. Other attempts at modification included replacing the ground wire with copper tubing, and replacing both wires with coax cabling.

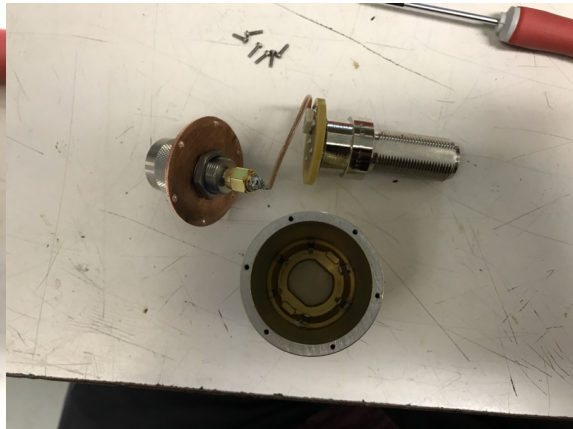
Figure 6: Prototype of Balun Redesign

Figure 7: Prototype of Balun Redesign

Significant attenuation was achieved in the prototype using a coaxial transmission line. This prototype was revised by replacing the solder cup N type bulkhead connector with a N type to SMA bulkhead adapter, allowing the inside conductor to be replaced with an SMA terminated coax line. This was found to be significantly more repeatable. The unterminated end of the coaxial line was split; the center conductor was connected to the positive end of the transformer, and the shielding to the ground end of the transformer. We found that replacing the balun on the 118 MHz line with a modified balun greatly attenuated the 118 MHz noise on the neighboring 9 MHz line.

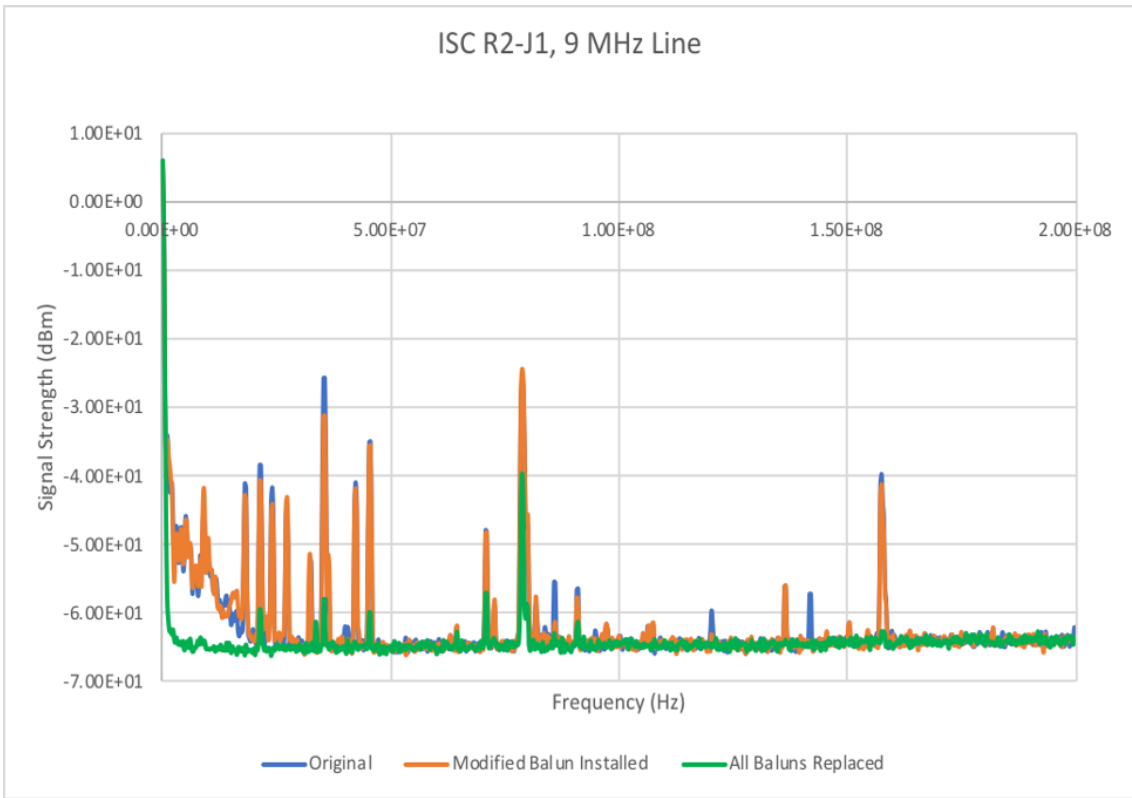
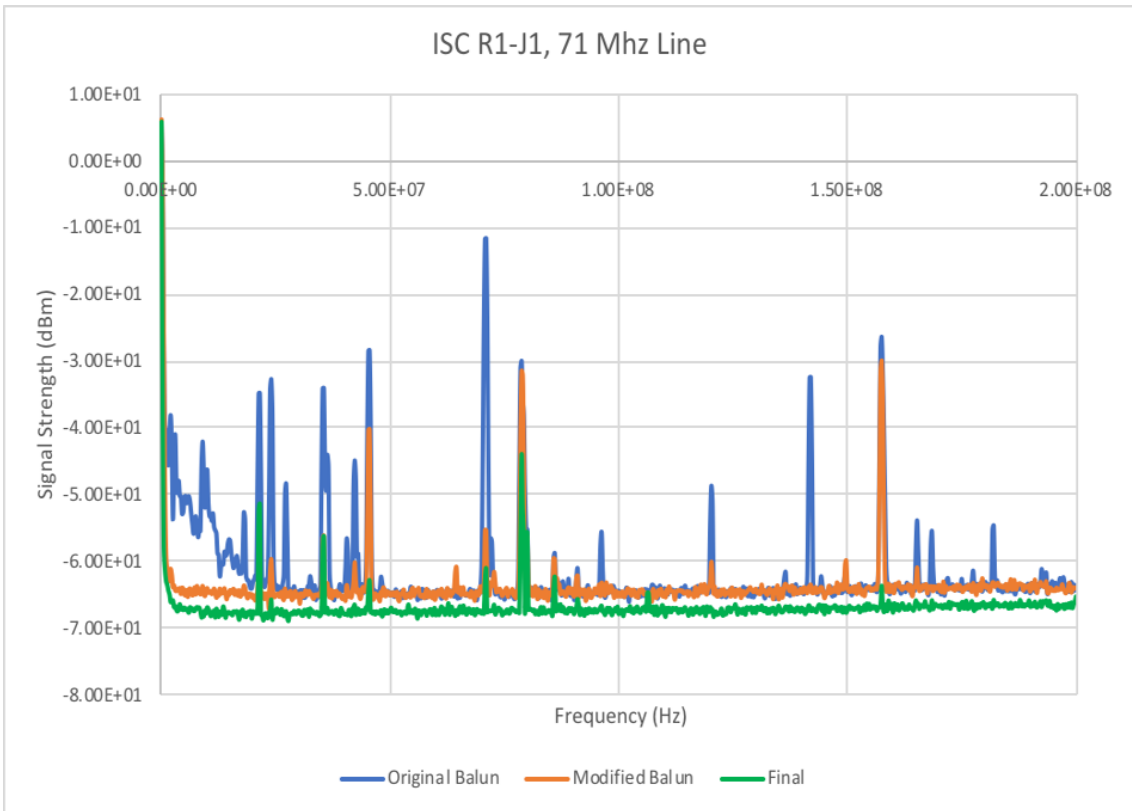
Figure 10: Representative Results of Balun Replacement

Figure 11: Representative Results of Balun Replacement

The installation of these six baluns completed the replacement of a total of eleven baluns that was started during the investigation and testing phase of the experiment. The final noise spectrum of each line was recorded after all baluns had been replaced. Most signals corresponding to leakage and coupling between baluns was attenuated below the noise floor at approximately -65 dBm, while a few remain in the -65 dBm to -55 dBm range. These remaining signals were attenuated by 25 to 30 dB. However, one prominent peak remains on each line's spectrum at approximately 79 MHz. It is thought that this is the 79 MHz signal that is generated for the Acoustic Optic Modulator in the pre-stabilized laser (PSL) rack next to the ISC Rack R1.

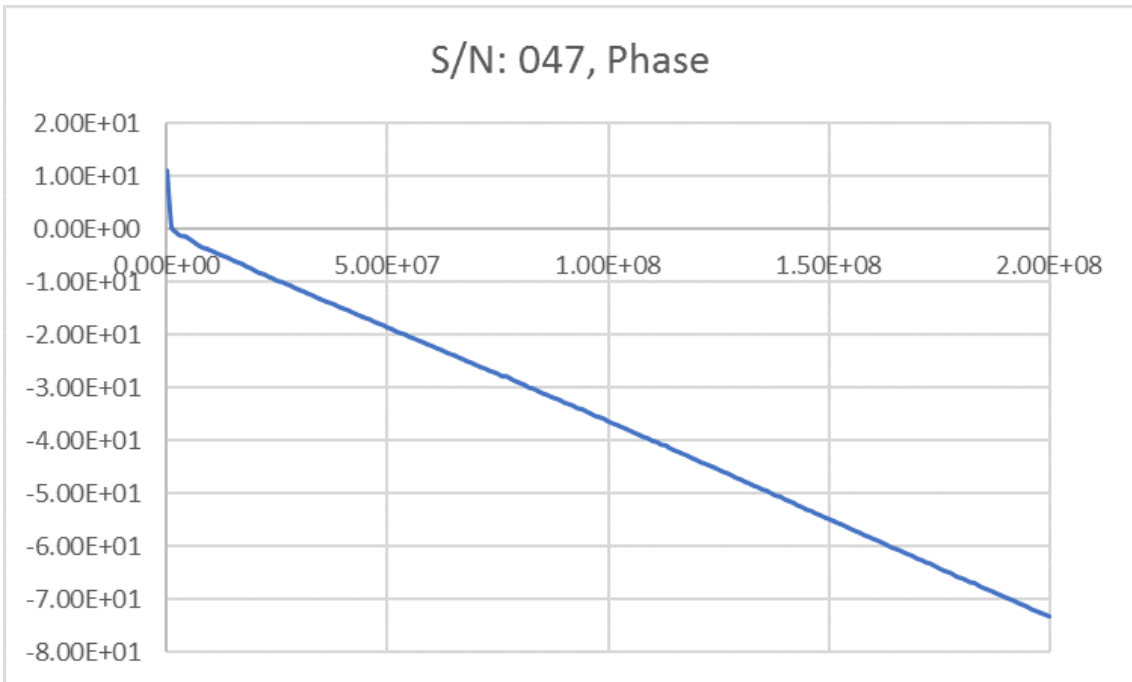
Figure 13: Representative Phase Shift of New Baluns

Three baluns reflecting the final design were fabricated and installed, along with three fabricated using the original copper braid method. Phase and insertion loss measurements were recorded for each of these six baluns before installation in the ISC racks. After installation of these six baluns measurements of the phase through each of the original baluns was recorded and the difference in

phase at the pertinent frequency of each line was recorded in the Alog for use by the commissioning team.
